Expertise

Protocol number: 46619639  
Order No. / Reference: 26652835  
Inspection date: 21 Jul 2026

Manufacturer: Mercedes-Benz

Model: C 220 d T 9G-TRONIC AMG Line

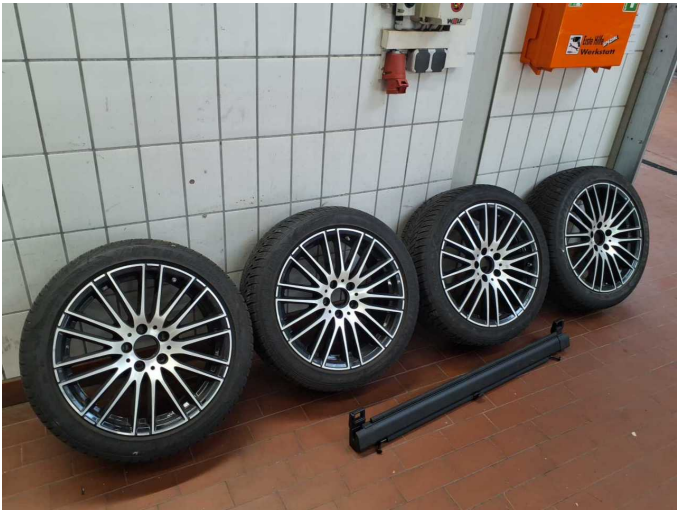
Figure 16: Additional tyres

| No. | Component group | Description |
|---|---|---|
| 4 | 2nd wheel set | 2 tyres (3mm) - Does not meet the leasing specifications - Replace |

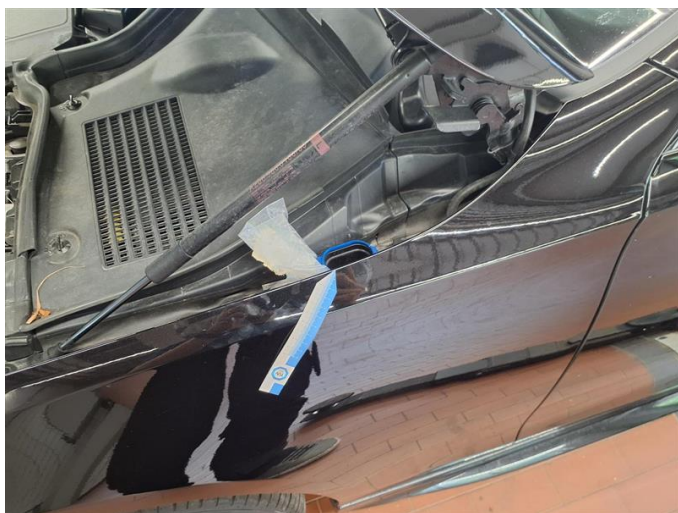
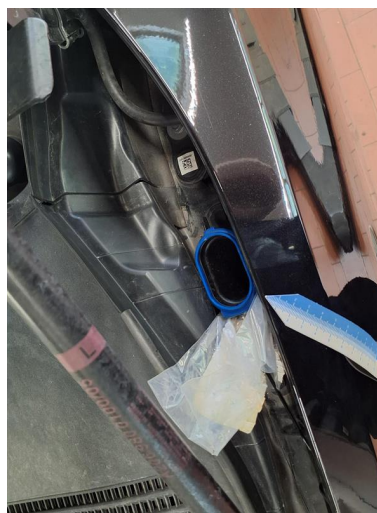
| No. | Component group | Description |
|---|---|---|
| 1 | Screen cleaning | Cover washing container (Abgebrochen) - Broken / torn - Replace |

**Damage 1:** Screen cleaning: Cover washing container (Abgebrochen) - Broken / torn - Replace

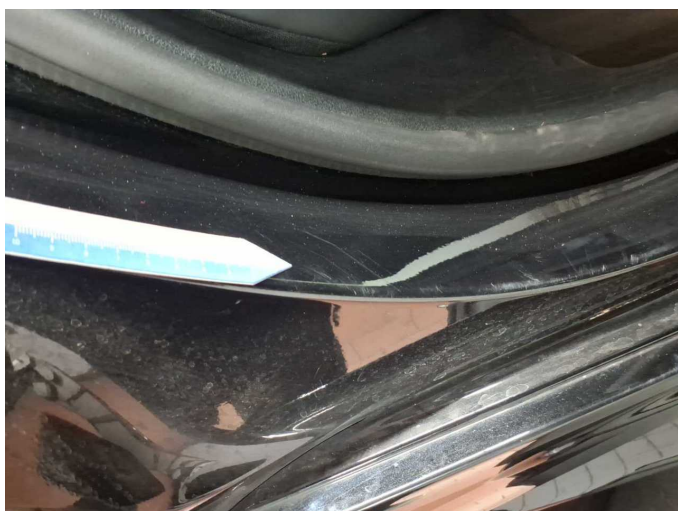
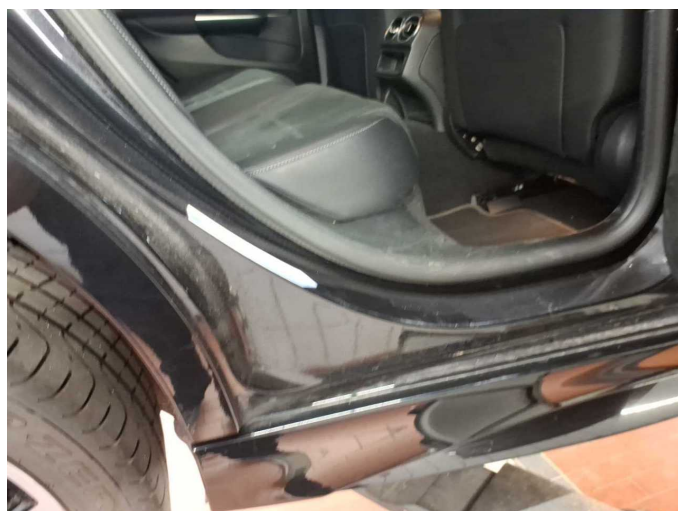
| No. | Component group | Description |
|---|---|---|
| 2 | Side panel - rear right side | Sill - Scratch(es) - Smart repair |

**Damage 2:** Side panel - rear right side: Sill - Scratch(es) - Smart repair

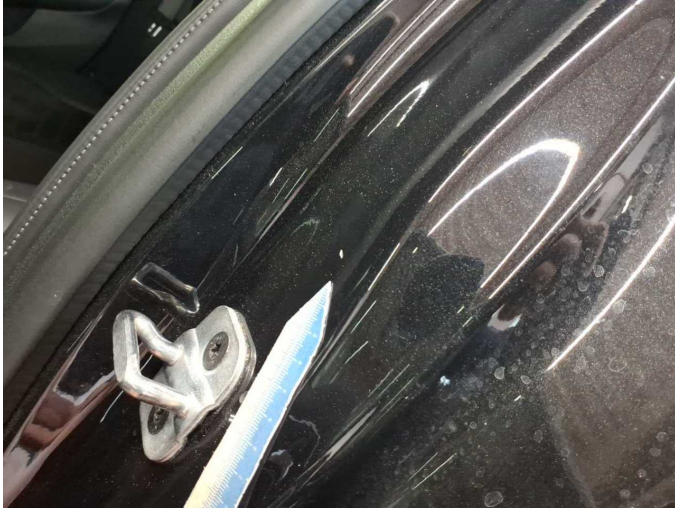
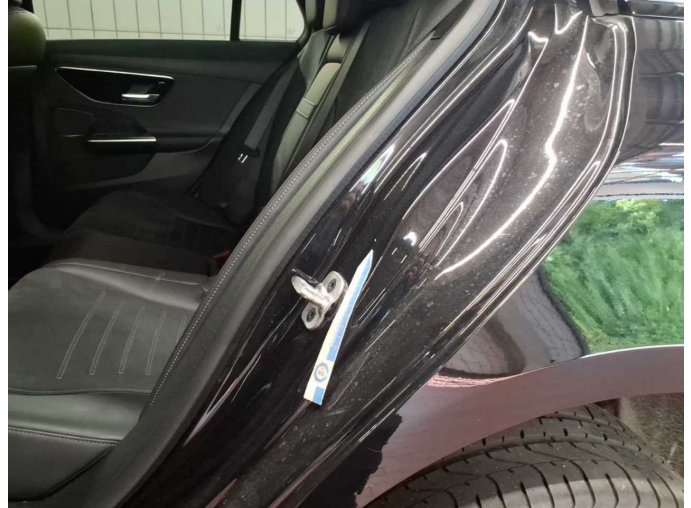
| No. | Component group | Description |
|---|---|---|
| 3 | Side panel - rear left side | Sill - Scratch(es) - Smart repair |

**Damage 3:** Side panel - rear left side: Sill - Scratch(es) - Smart repair

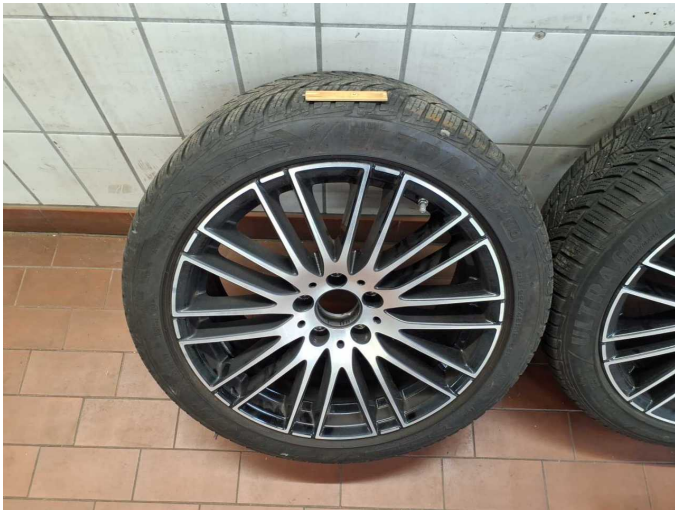
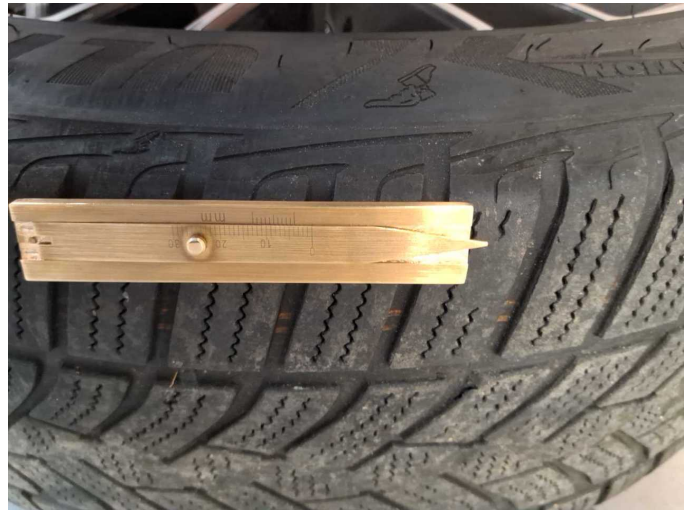
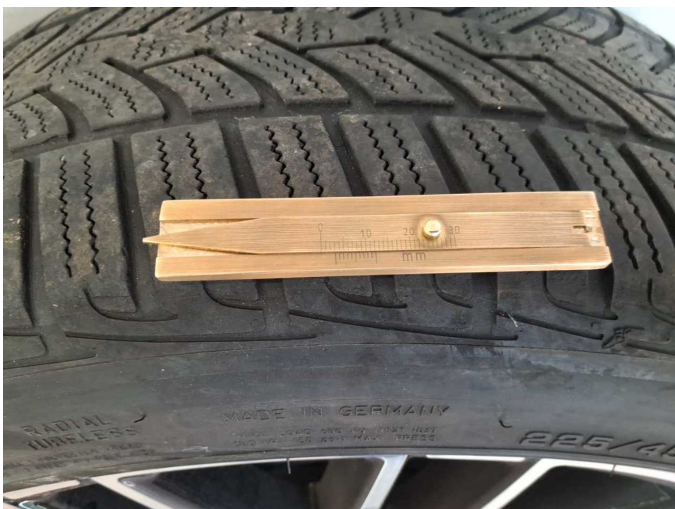
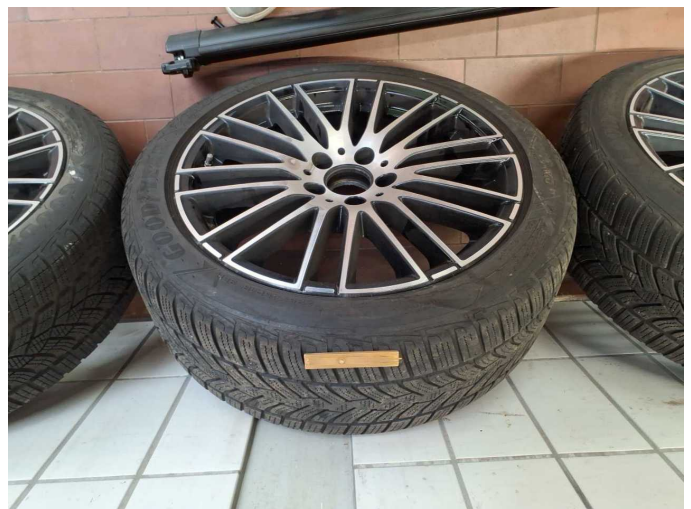
**Damage 4:** 2nd wheel set: 2 tyres (3mm) - Does not meet the leasing specifications - Replace

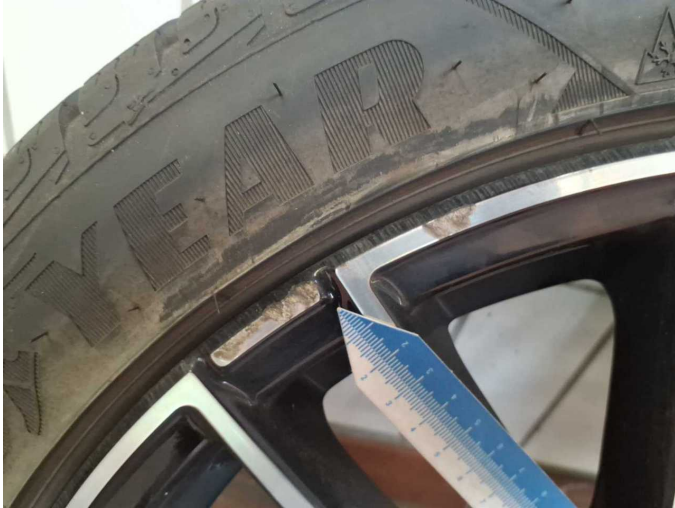
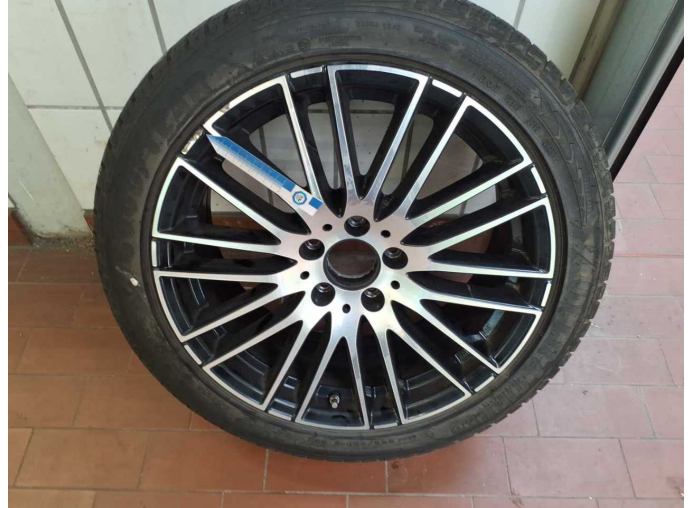
| No. | Component group | Description |
|---|---|---|
| 5 | 2nd wheel set | 1 alloy rim - Scratch(es) - Loss in value |

**Damage 5:** 2nd wheel set: 1 alloy rim - Scratch(es) - Loss in value

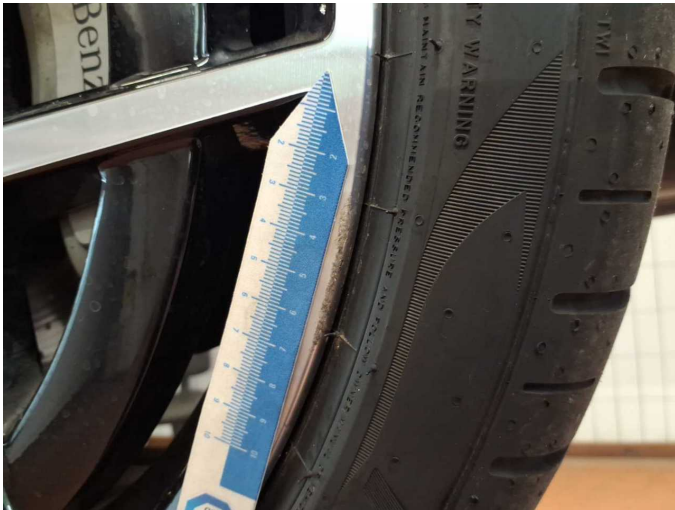
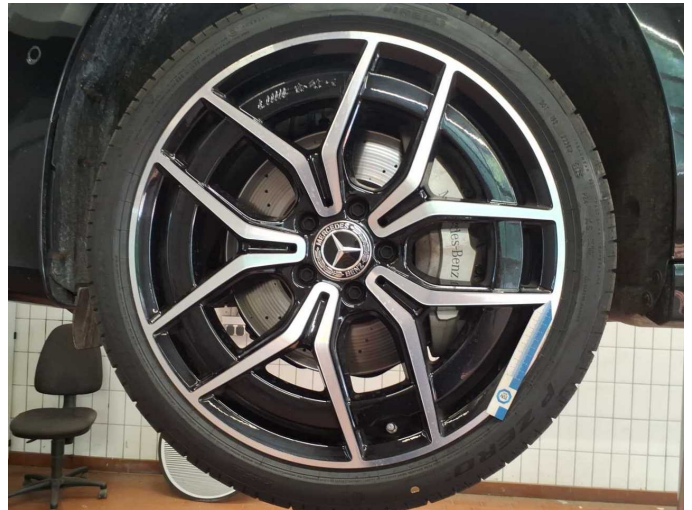
| No. | Component group | Description |
|---|---|---|
| 6 | Wheel / tyres | Alloy rim - front left side - Scratch(es) - Loss in value |

**Damage 6:** Wheel / tyres: Alloy rim - front left side - Scratch(es) - Loss in value

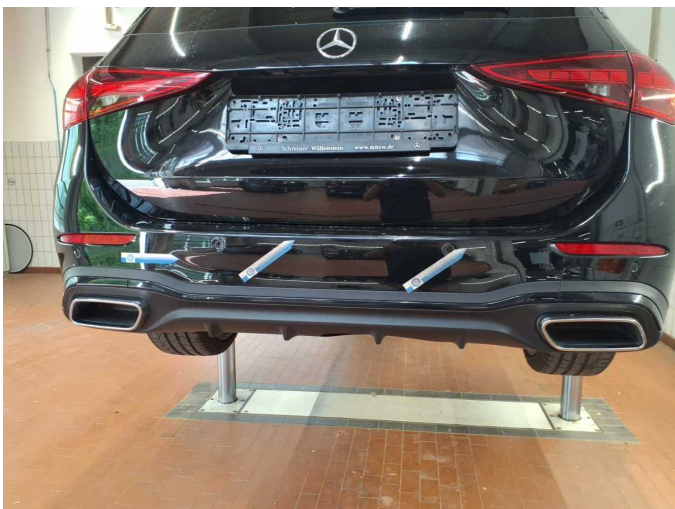
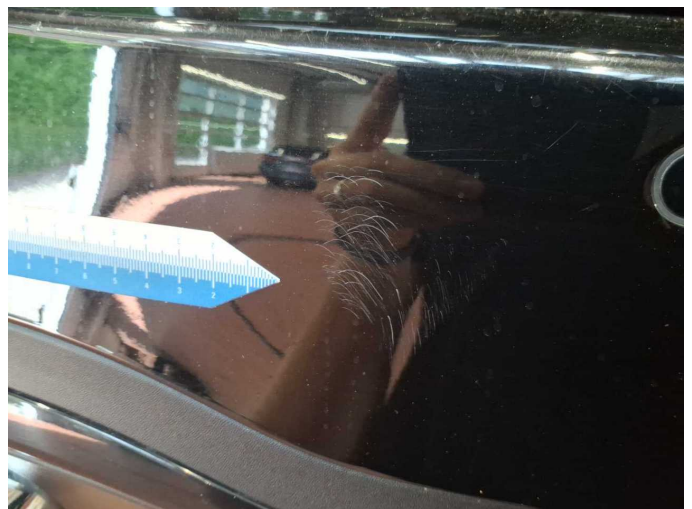
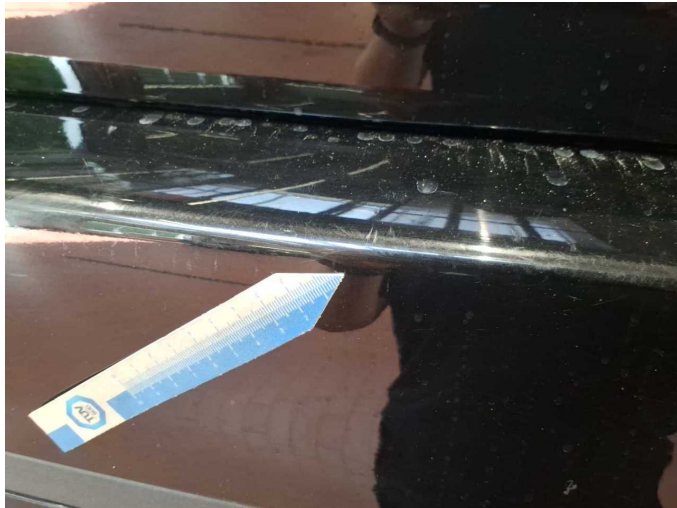
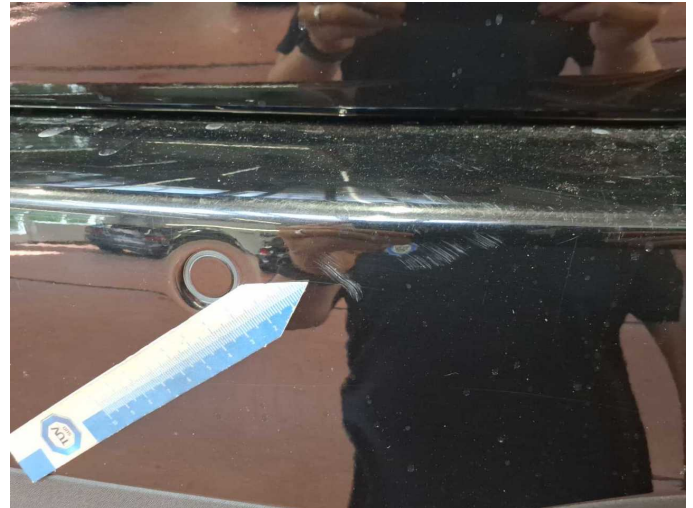
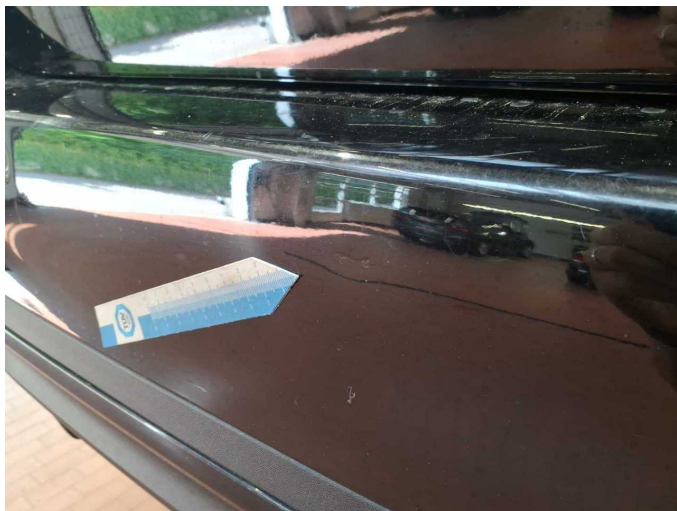
| No. | Component group | Description |
|---|---|---|
| 7 | Rear bumper | Rear bumper - Scratch(es) - Paint |

**Damage 7:** Rear bumper: Rear bumper - Scratch(es) - Paint

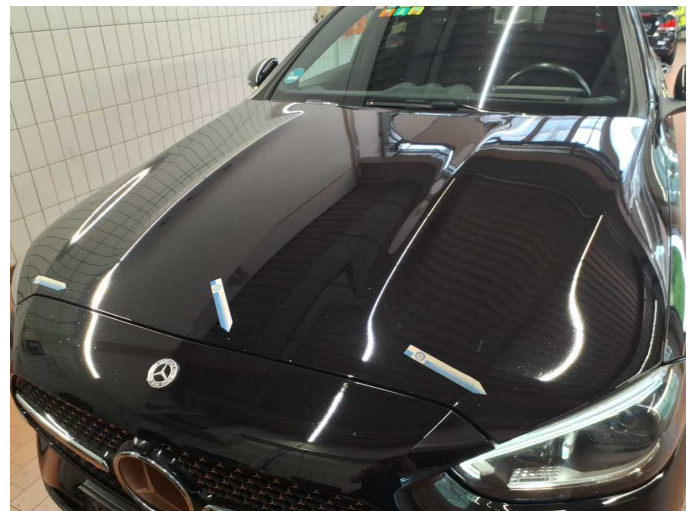
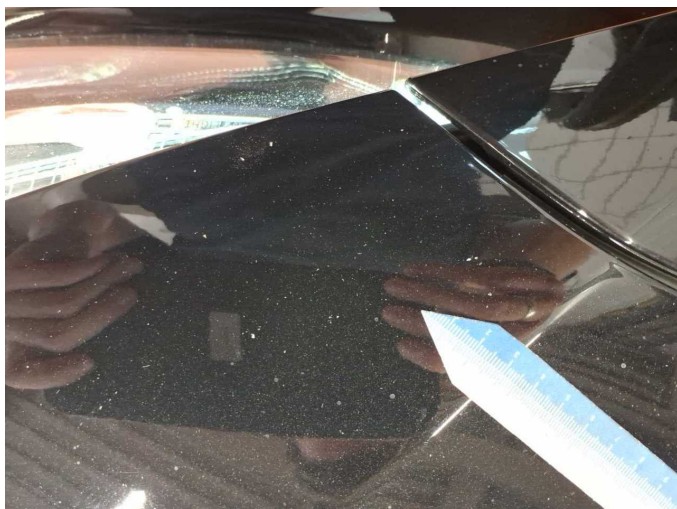
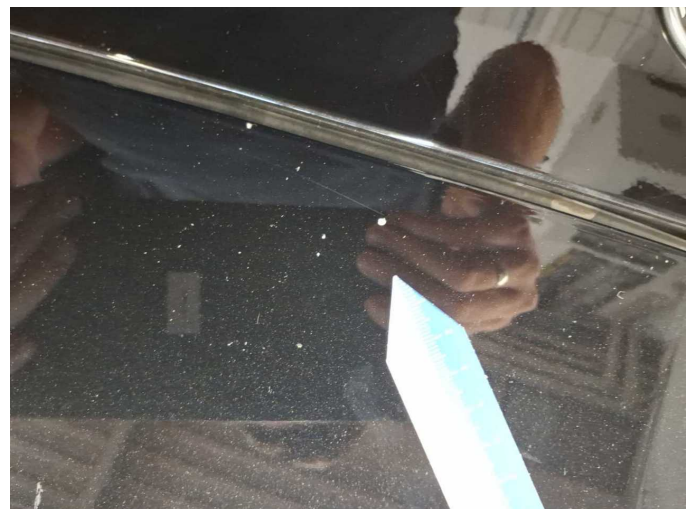
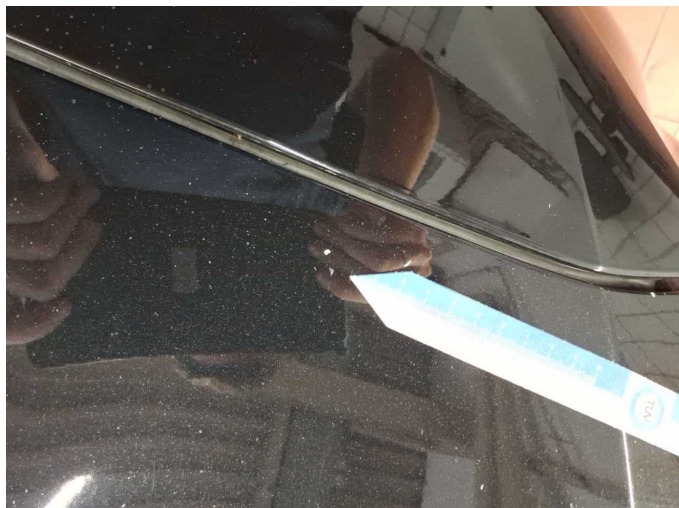
| No. | Component group | Description |
|---|---|---|
| 8 | Bonnet | Bonnet - Stone chips - Paint |

**Damage 8:** Bonnet: Bonnet - Stone chips - Paint

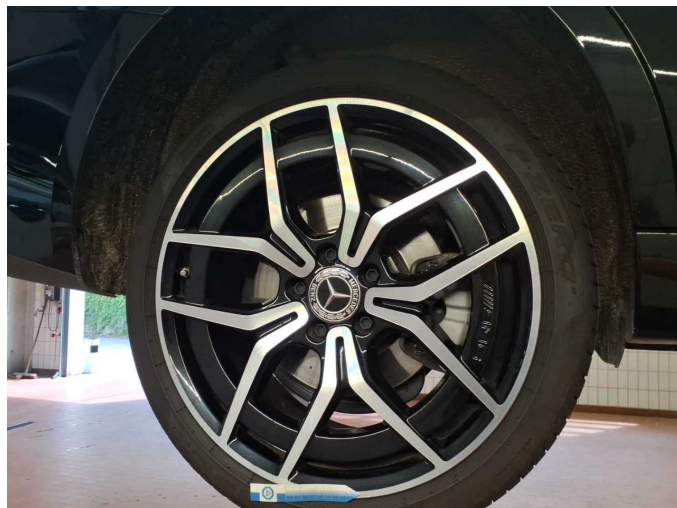
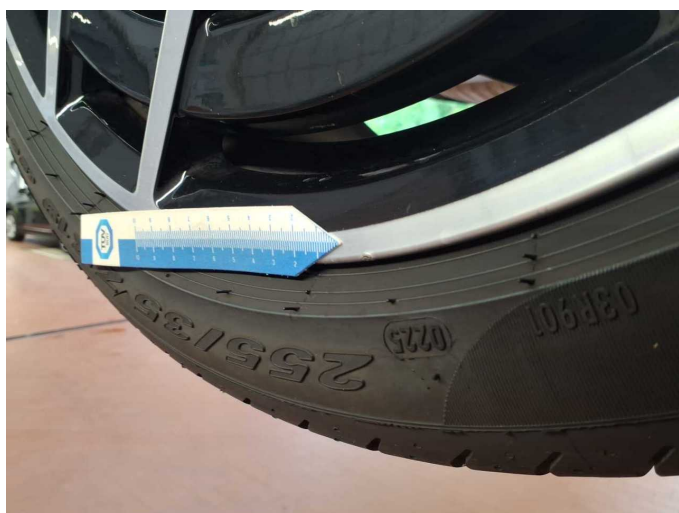
| No. | Component group | Description |
|---|---|---|
| 1 | Wheel / tyres | Alloy rim - rear right side - Scratch(es) - No deduction |

**Wear and tear 1:** Wheel / tyres: Alloy rim - rear right side - Scratch(es) - No deduction

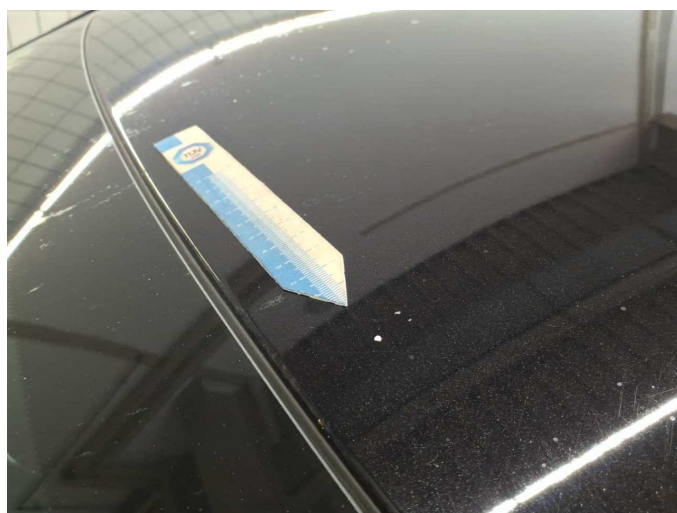
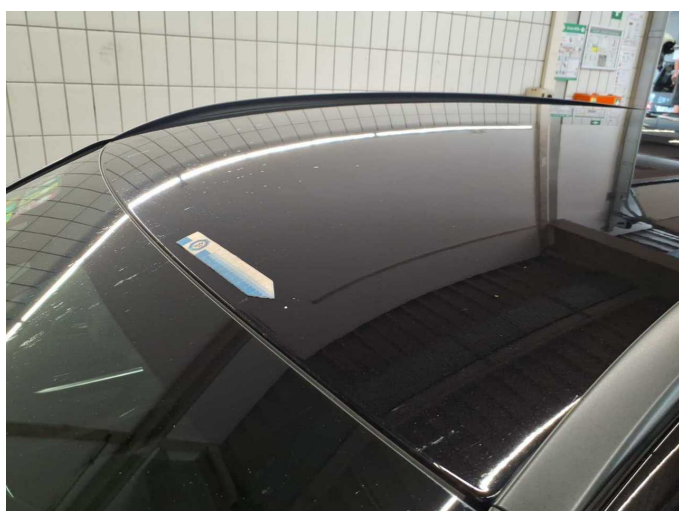
| No. | Component group | Description |
|---|---|---|
| 3 | Roof | Roof - Stone chips - No deduction |

**Wear and tear 3:** Roof: Roof - Stone chips - No deduction

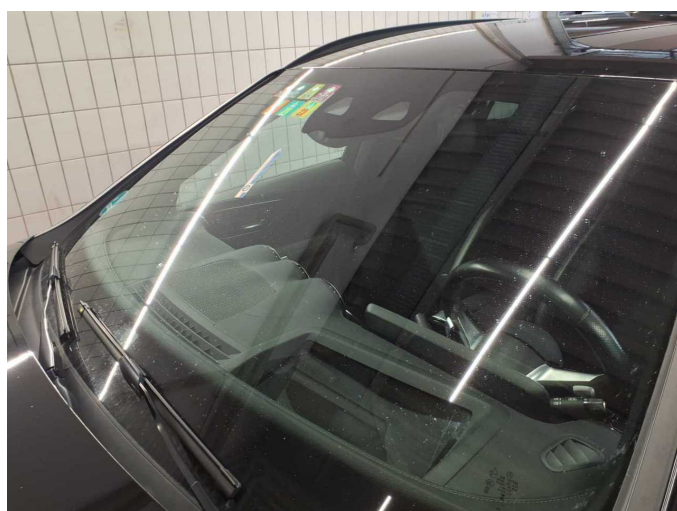
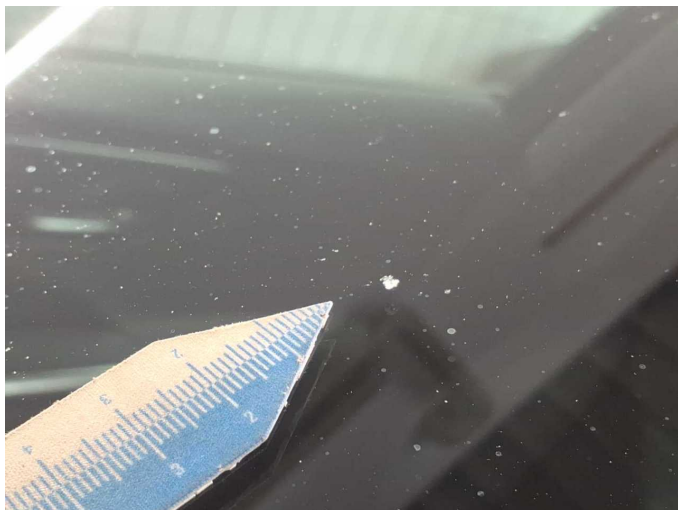
| No. | Component group | Description |
|---|---|---|
| 4 | Vehicle glazing | Windscreen - Stone chips - No deduction |

**Wear and tear 4:** Vehicle glazing: Windscreen - Stone chips - No deduction
