Expertise

Protocol number: 46616642  
Order No. / Reference: 26703191  
Inspection date: 21 Jul 2026

Manufacturer: Ford

Model: Mustang Mach-E AWD

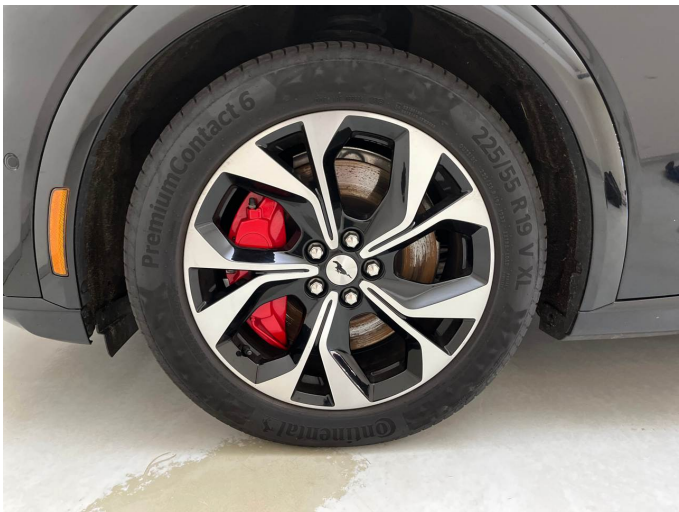
Figure 12: Mounted tyres

| Tyres | | | | |
|---|---|---|---|---|
| 1) | 225/55 R19 103V | Summer tyres on Light alloy | Continental | 7mm / 7mm |
| 2) | 225/55 R19 103V | Summer tyres on Light alloy | Continental | 7mm / 7mm |

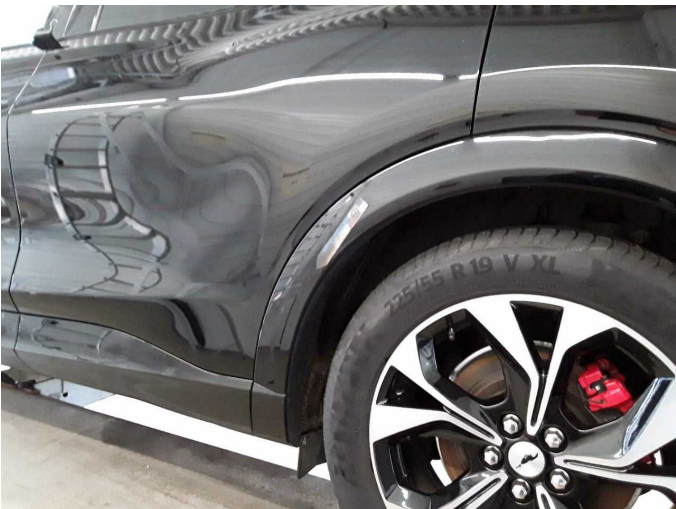
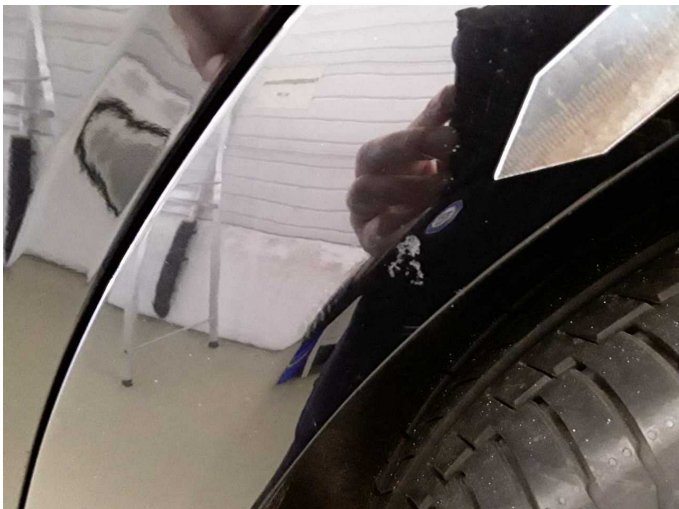
| No. | Component group | Description |
|---|---|---|
| 1 | Side panel - rear left side | Wheel arch - Scratch(es) - Smart repair |

Damage 1: Side panel - rear left side: Wheel arch - Scratch(es) - Smart repair

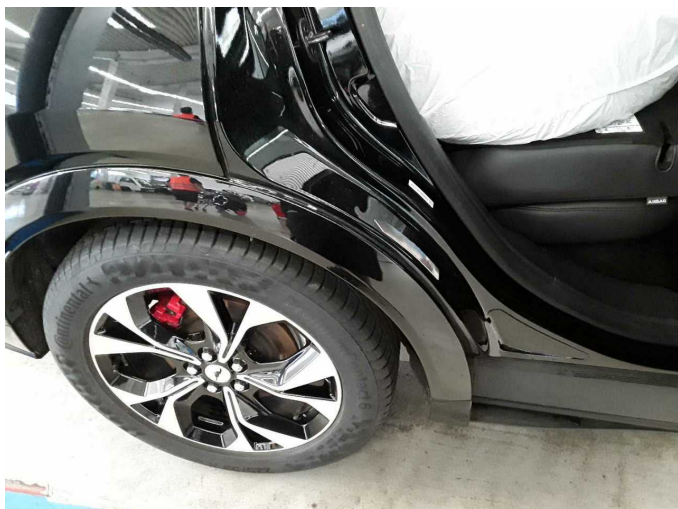
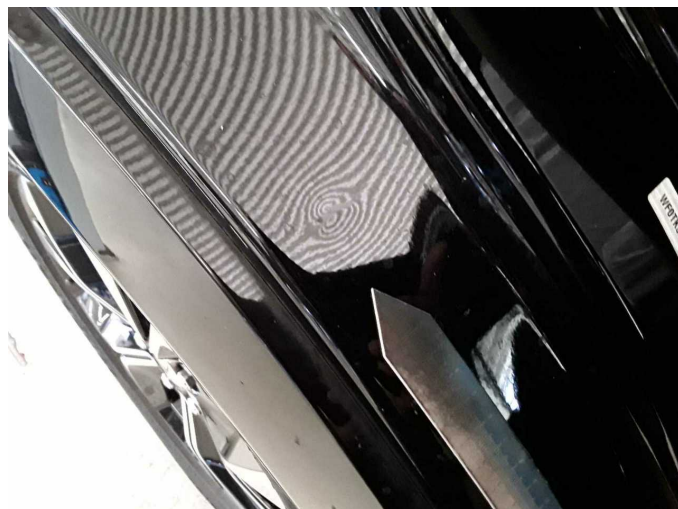
| No. | Component group | Description |
|---|---|---|
| 2 | Body | C-pillar - right side - dent(s) - Smart repair |

**Damage 2:** Body: C-pillar - right side - dent(s) - Smart repair

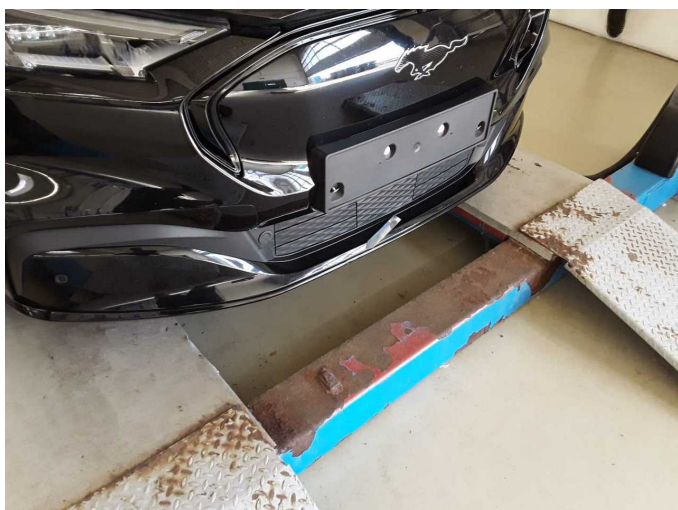
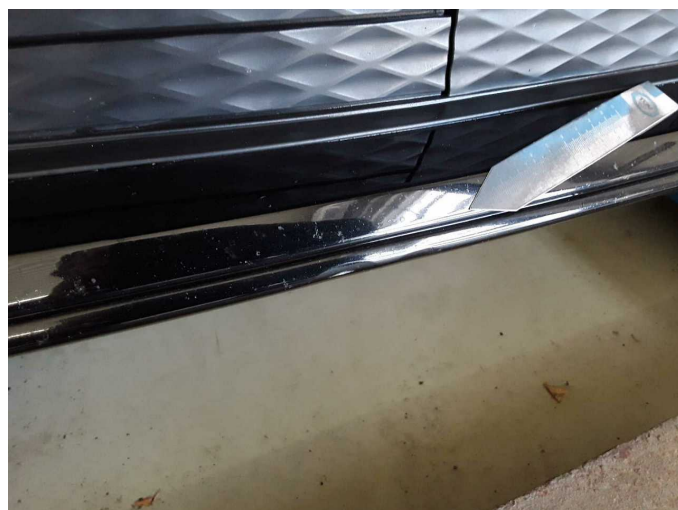
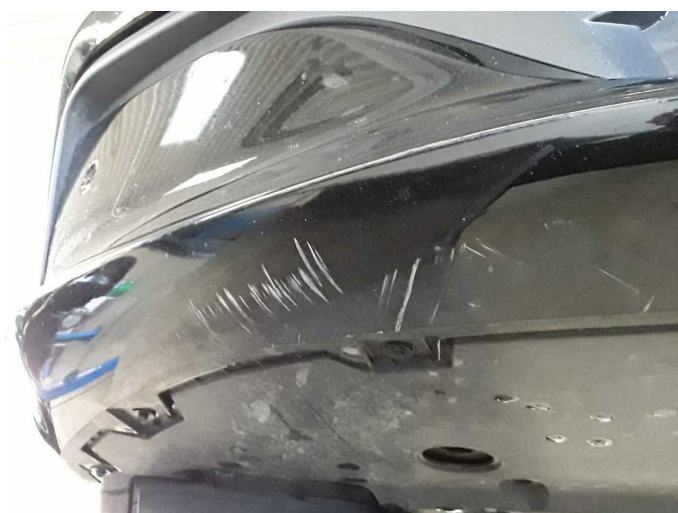
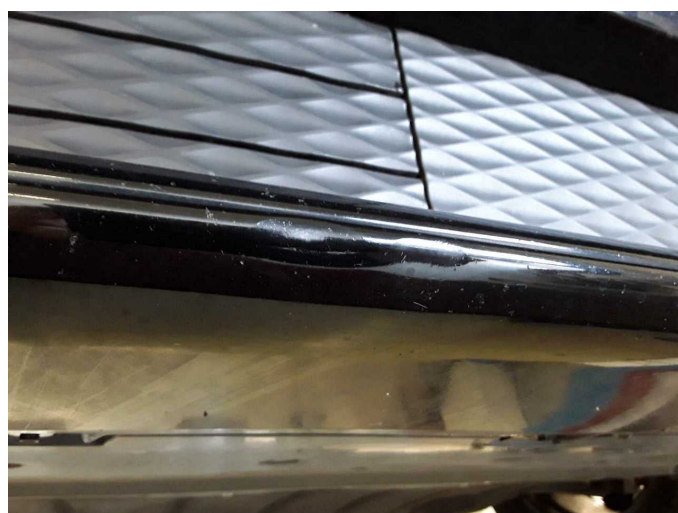
| No. | Component group | Description |
|---|---|---|
| 3 | Front bumper | Spoiler (Luftabweiser) - Deformed - Replace |

**Damage 3:** Front bumper: Spoiler (Luftabweiser) - Deformed - Replace
