Expertise

Protocol number: 46707864  
Order No. / Reference: 26712617  
Inspection date: 22 Jul 2026

Model: Marco Polo 250 d HORIZON

VIN: W1VVMKEZXP4311847

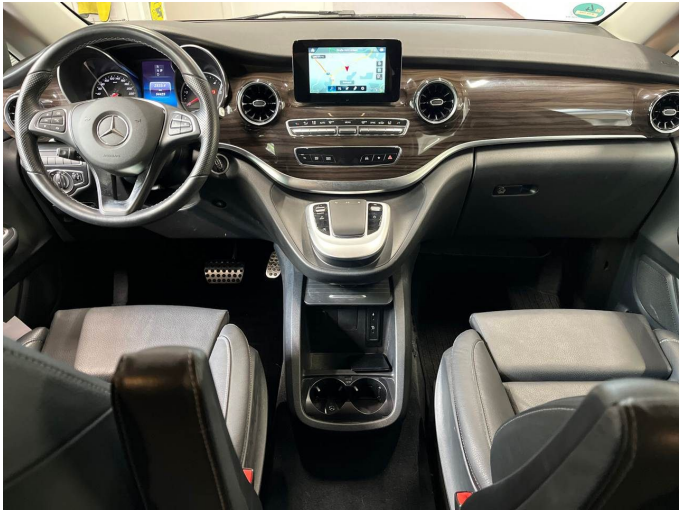
Figure 8: Instrument panel

| No. | Component group | Description |
|---|---|---|
| 1 | Instrument panel | Indicator light (Reifendruck) - on - Diagnosed and repair if necessary |

**Damage 1:** Instrument panel: Indicator light (Reifendruck) - on - Diagnosed and repair if necessary

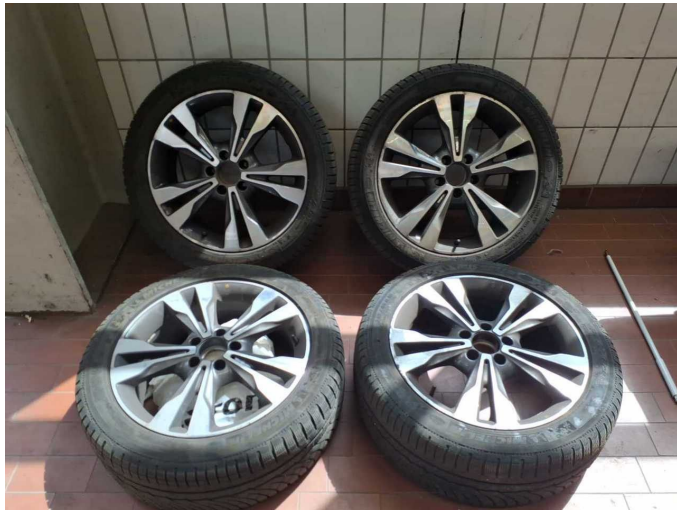
Figure 15: Additional tyres

| No. | Component group | Description |
|---|---|---|
| 5 | 2nd wheel set | 1 tyre - Broken / torn - No deduction |

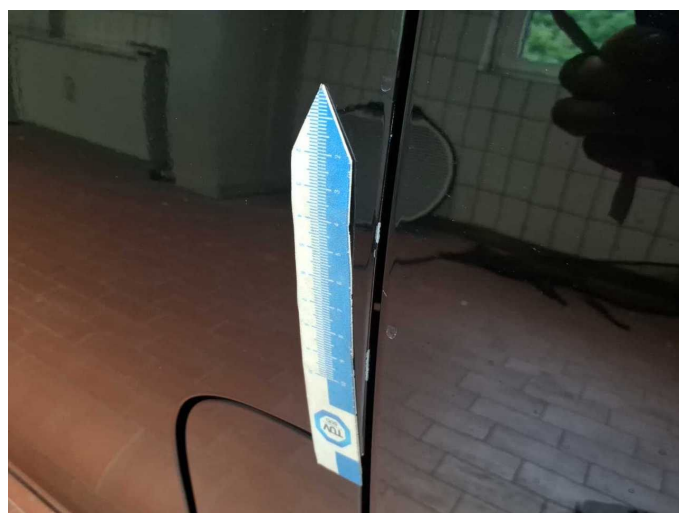
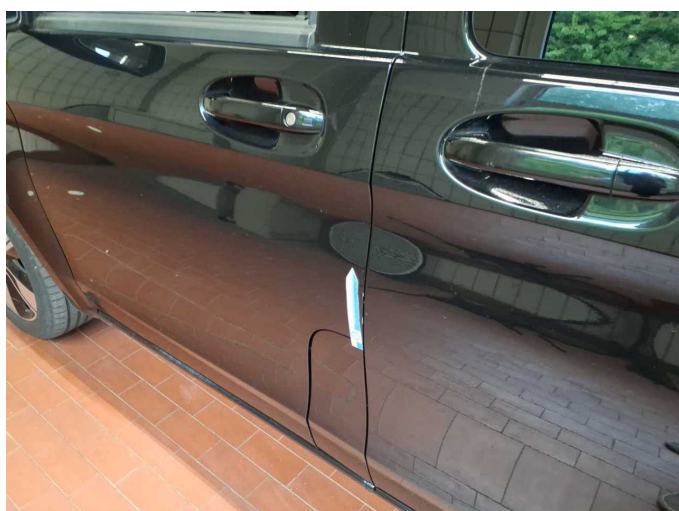
**Damage 2:** Door - front left side: Door edge - Scratch(es) - Smart repair

| No. | Component group | Description |
|---|---|---|
| 2 | Door - front left side | Door edge - Scratch(es) - Smart repair |

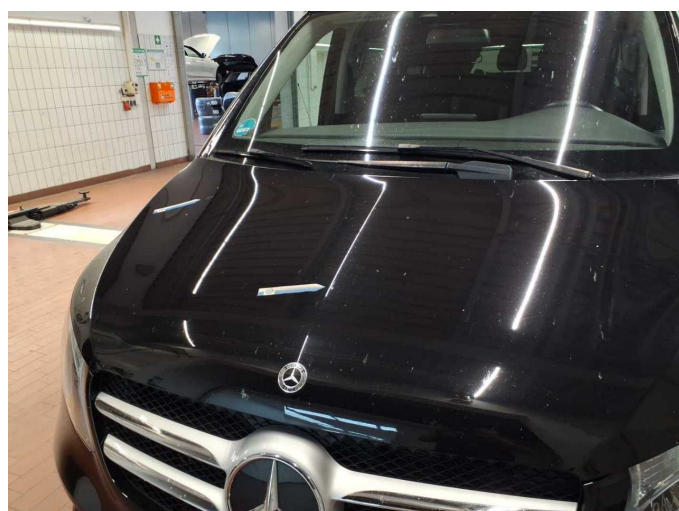
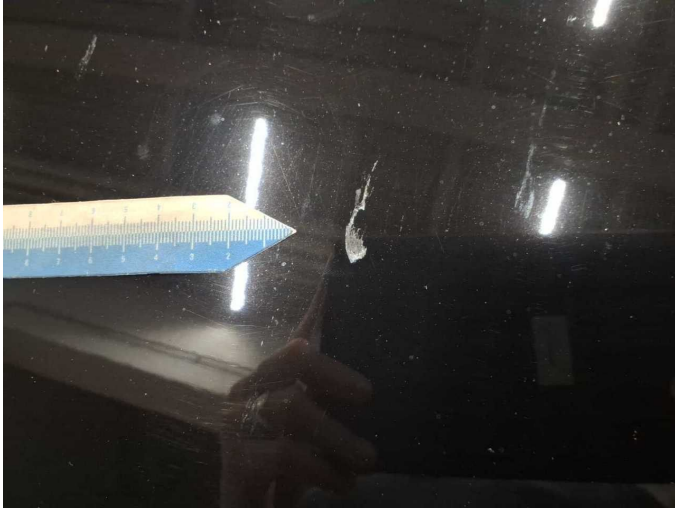
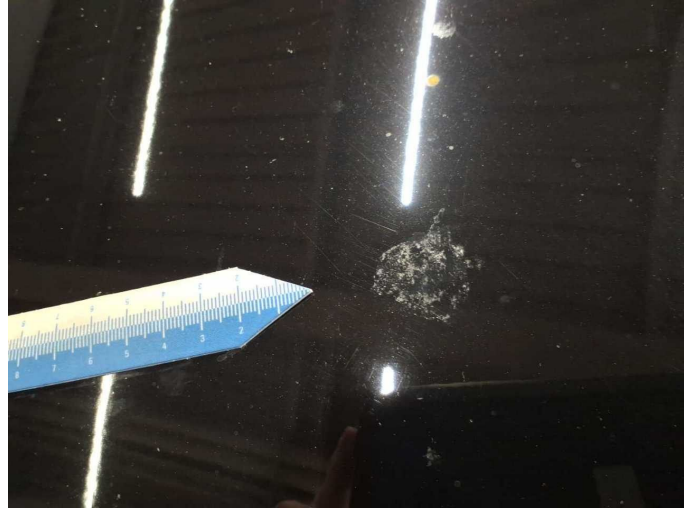
**Damage 3:** Bonnet: Bonnet (Mehrkosten können entstehen) - Soiled - Conditioning

| No. | Component group | Description |
|---|---|---|
| 3 | Bonnet | Bonnet (Mehrkosten können entstehen) - Soiled - Conditioning |

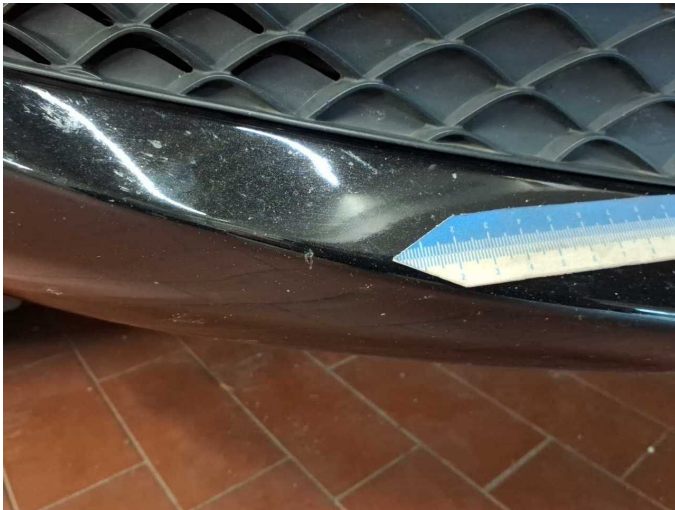
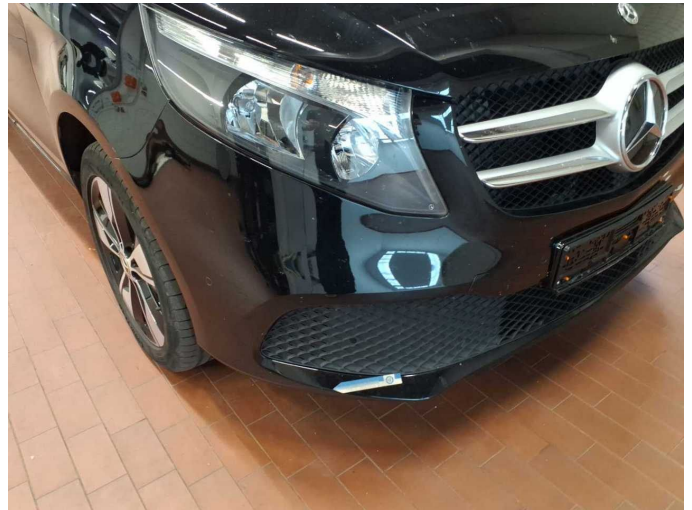
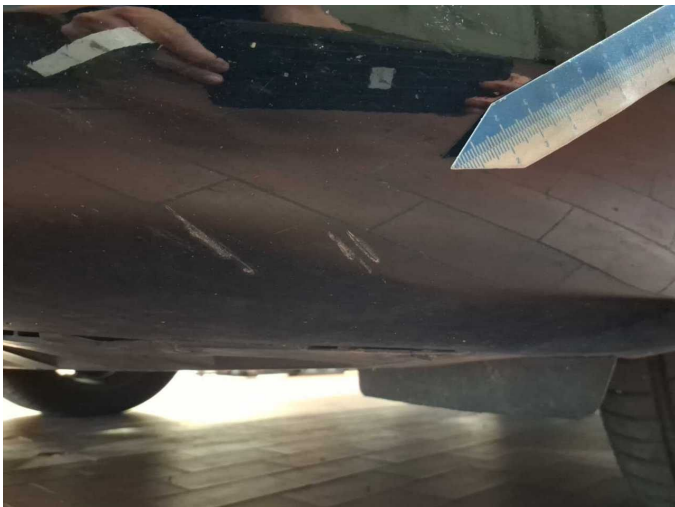
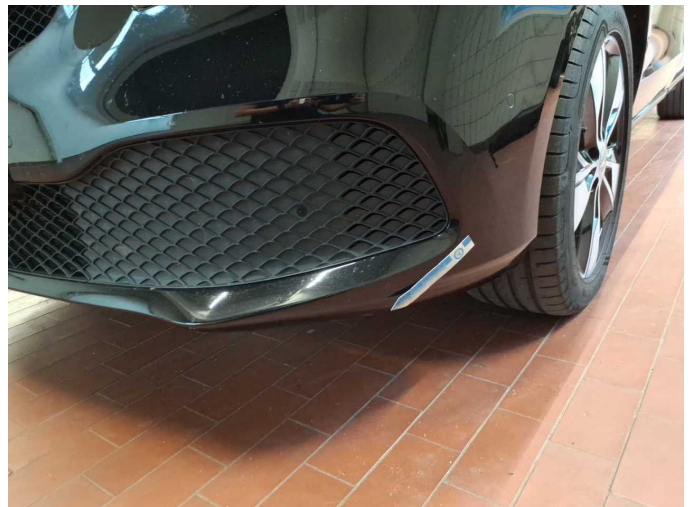
**Damage 4:** Front bumper: Front bumper - Scratched - Smart repair

| No. | Component group | Description |
|---|---|---|
| 4 | Front bumper | Front bumper - Scratched - Smart repair |

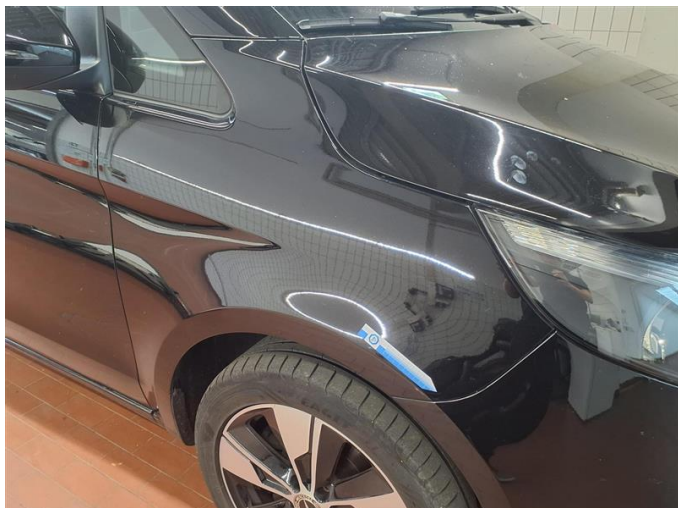
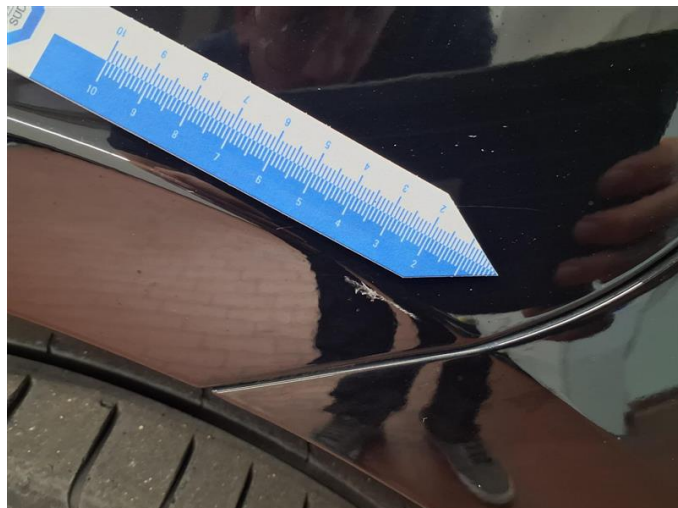
**Damage 5:** Mudguard - right side: Mudguard - right side - Scratch(es) - Smart repair

| No. | Component group | Description |
|---|---|---|
| 5 | Mudguard - right side | Mudguard - right side - Scratch(es) - Smart repair |

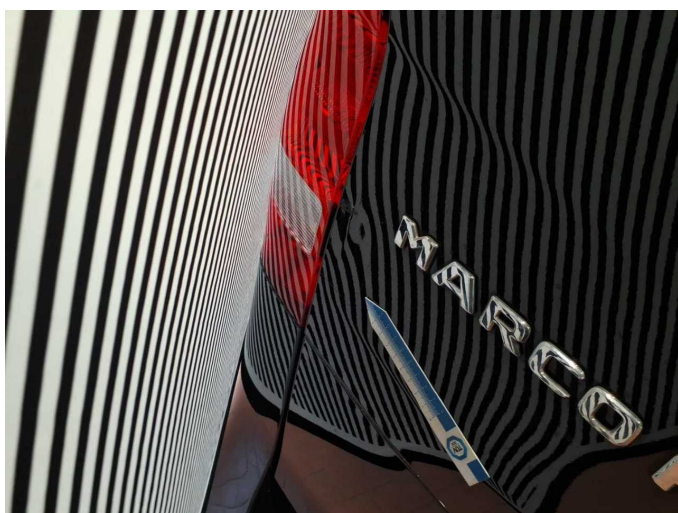
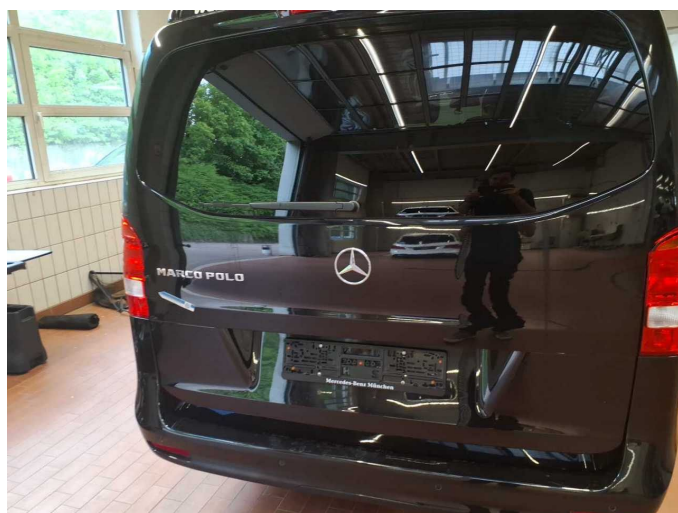
**Damage 6:** Boot lid / rear door: Boot lid - dent(s) - Smooth repair work

| No. | Component group | Description |
|---|---|---|
| 6 | Boot lid / rear door | Boot lid - dent(s) - Smooth repair work |

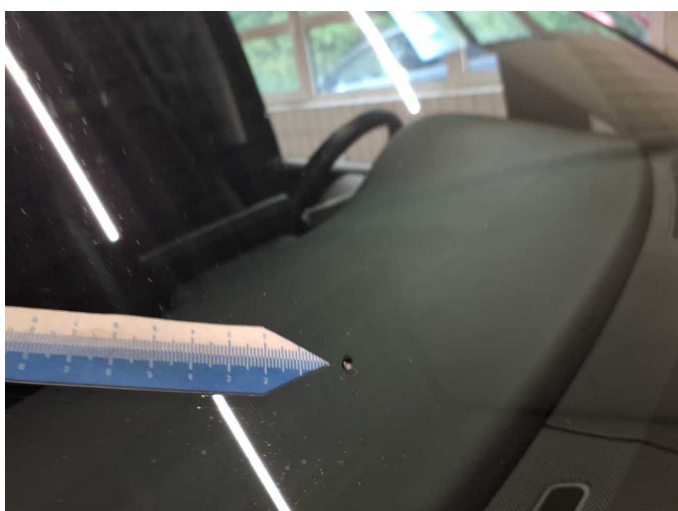
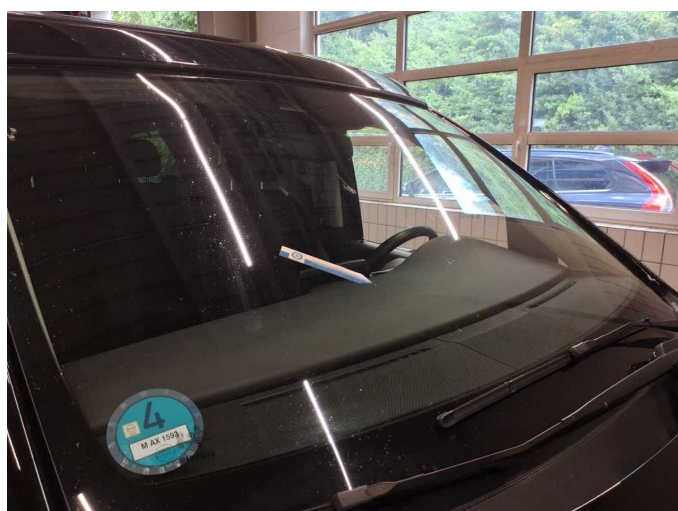
**Damage 7:** Vehicle glazing: Windscreen - Stone chips - Smart repair

| No. | Component group | Description |
|---|---|---|
| 7 | Vehicle glazing | Windscreen - Stone chips - Smart repair |

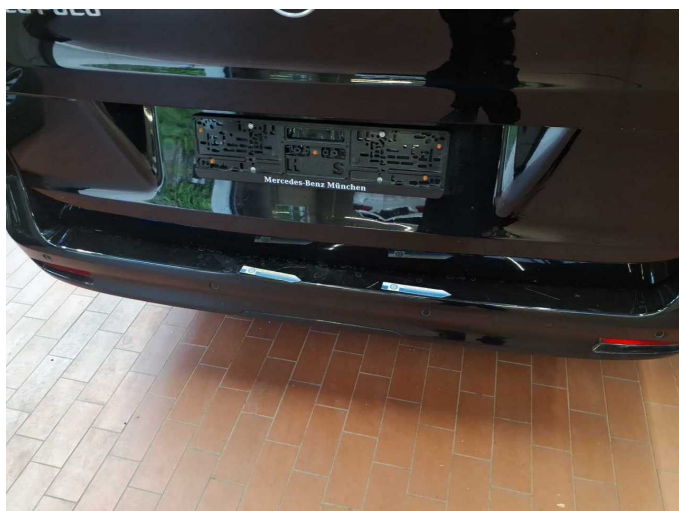
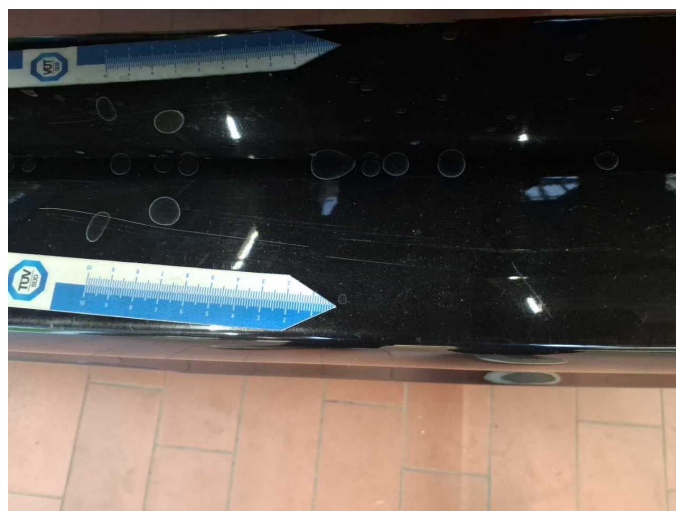
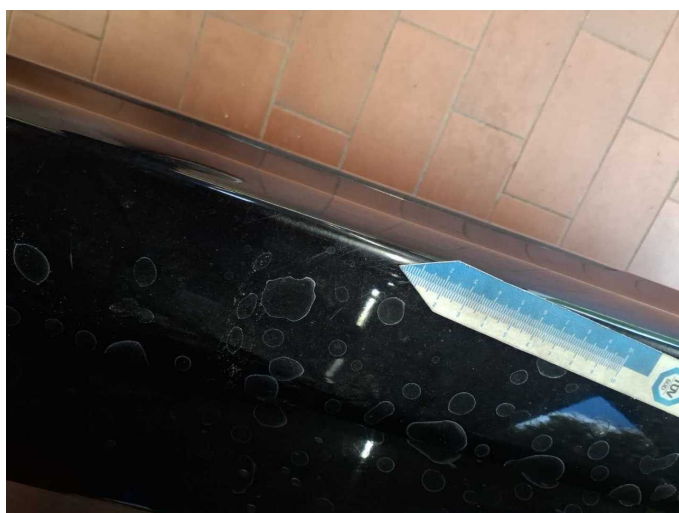
**Damage 8:** Rear bumper: Rear bumper - Scratch(es) - Paint

| No. | Component group | Description |
|---|---|---|
| 8 | Rear bumper | Rear bumper - Scratch(es) - Paint |

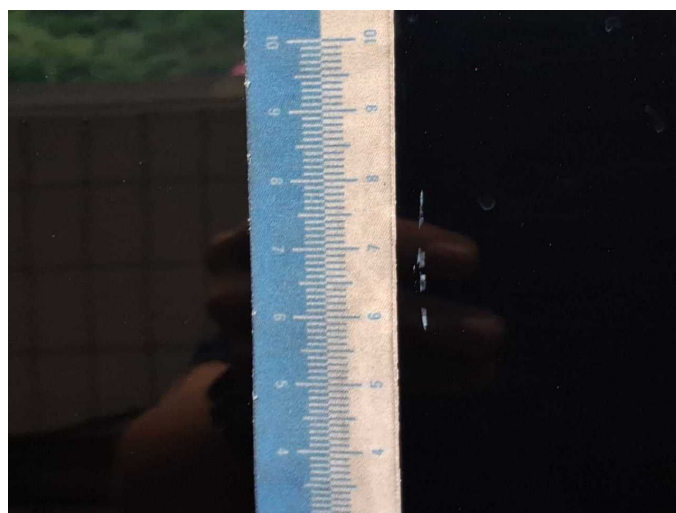
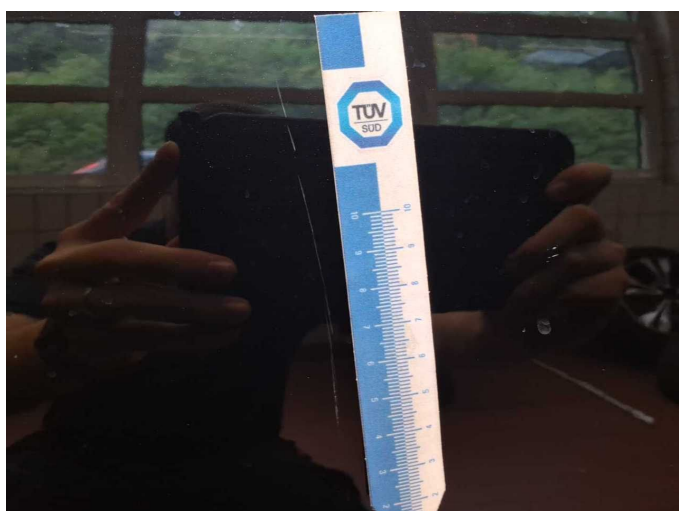
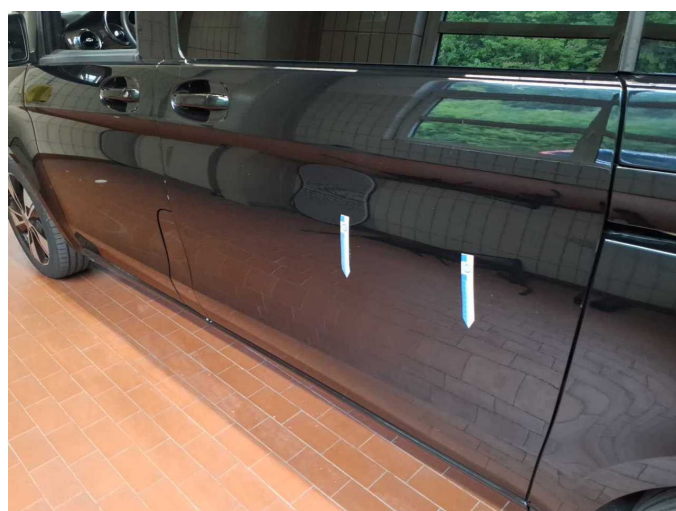
**Damage 9:** Sliding door - left side: Sliding door with glass panel - Scratch(es) - Paint

| No. | Component group | Description |
|---|---|---|
| 9 | Sliding door - left side | Sliding door with glass panel - Scratch(es) - Paint |

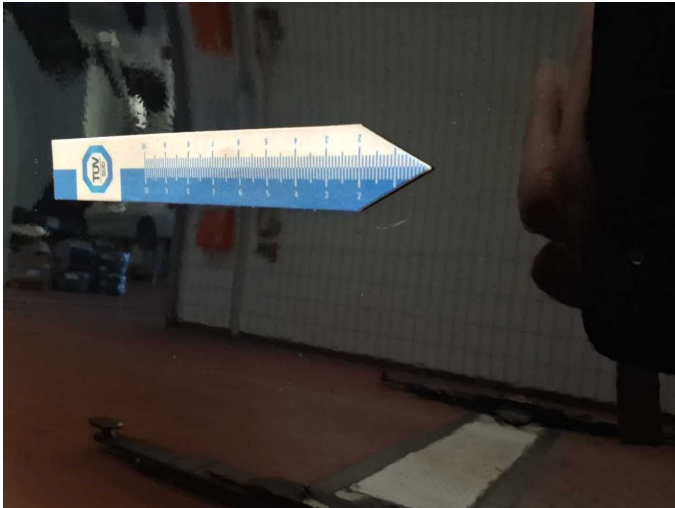
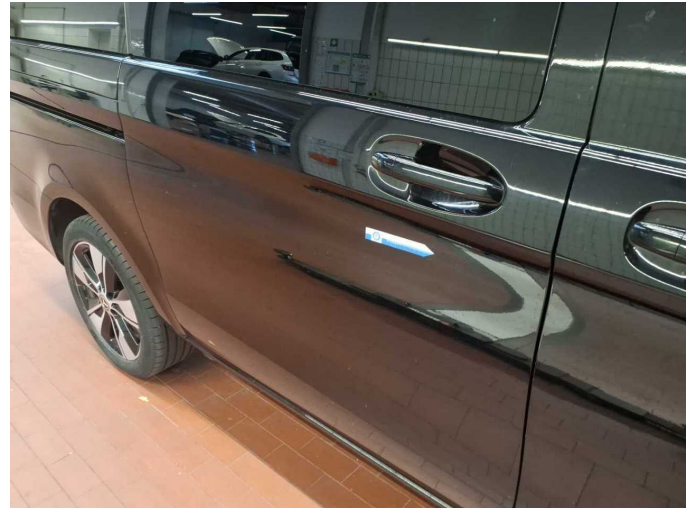
**Wear and tear 2:** Sliding door, right: Sliding door with glass panel - Scratch(es) - No deduction

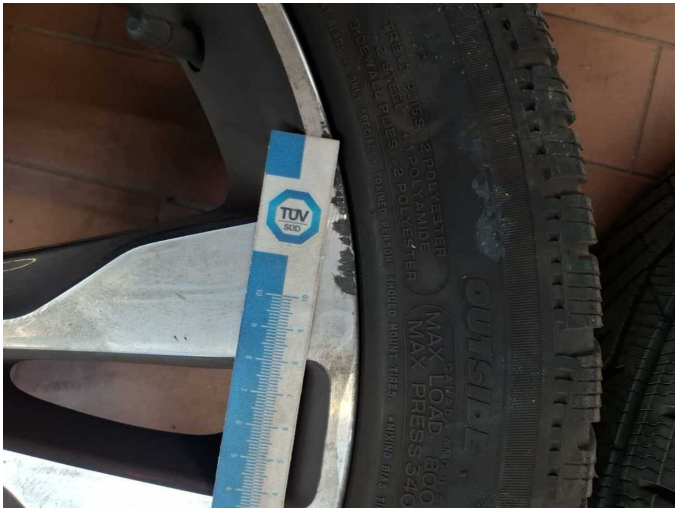
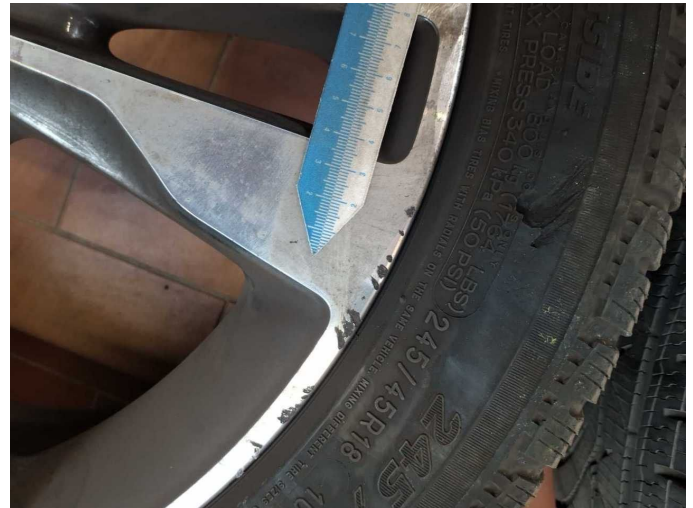
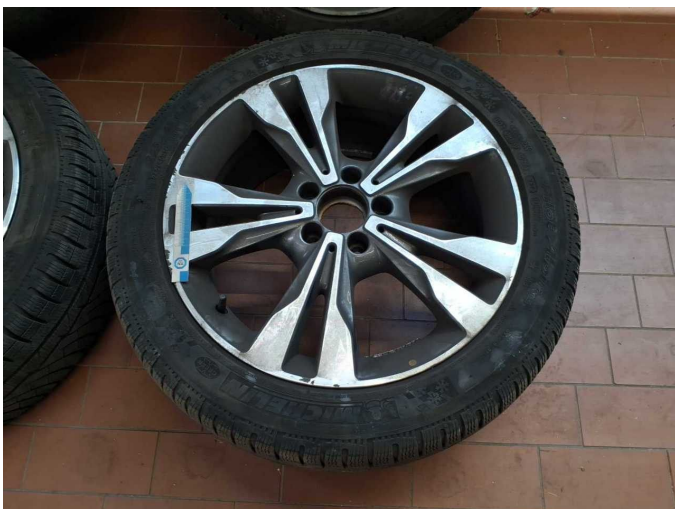
**Wear and tear 4:** 2nd wheel set: 1 alloy rim - Scratched - No deduction

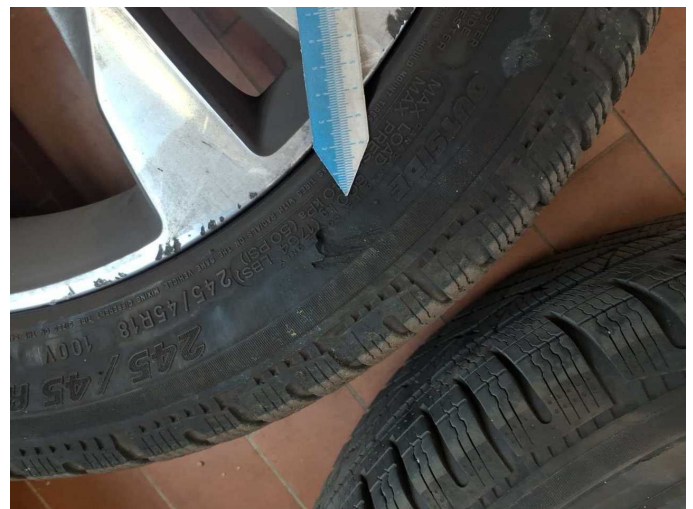
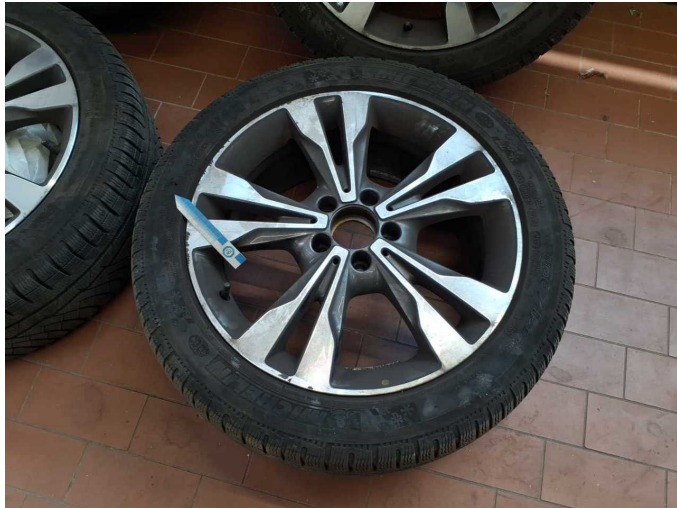
**Wear and tear 5:** 2nd wheel set: 1 tyre - Broken / torn - No deduction

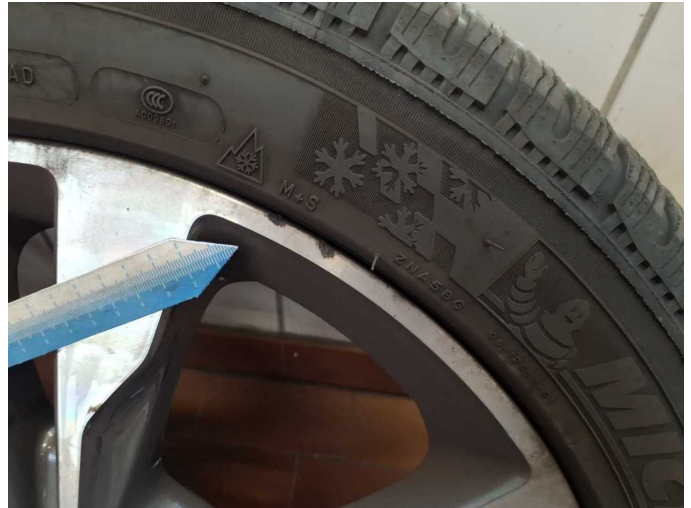
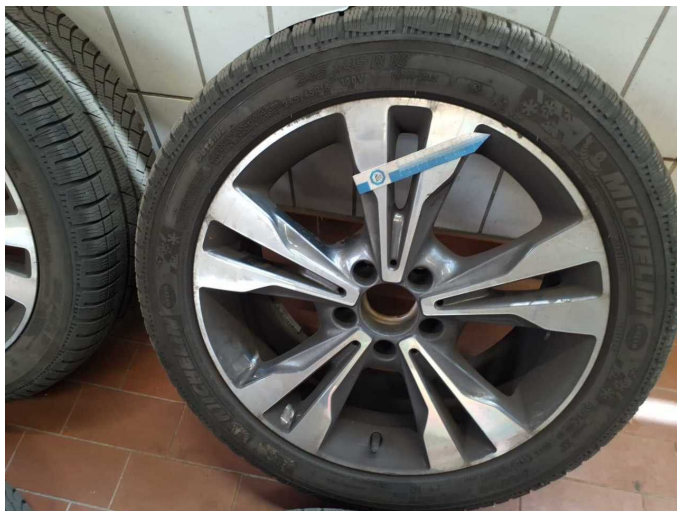
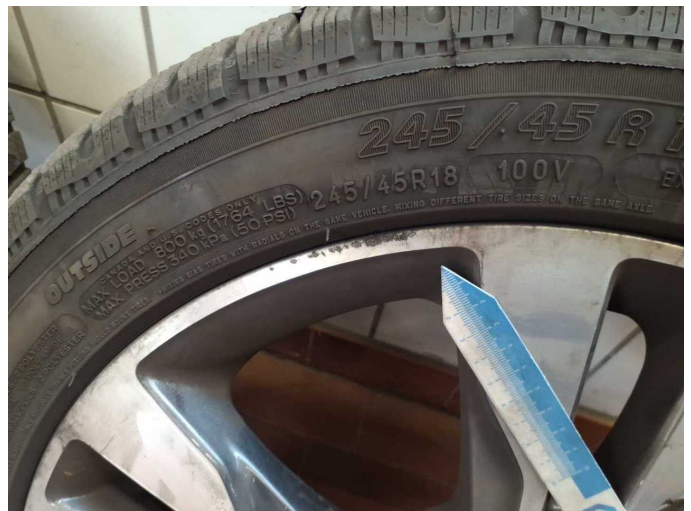
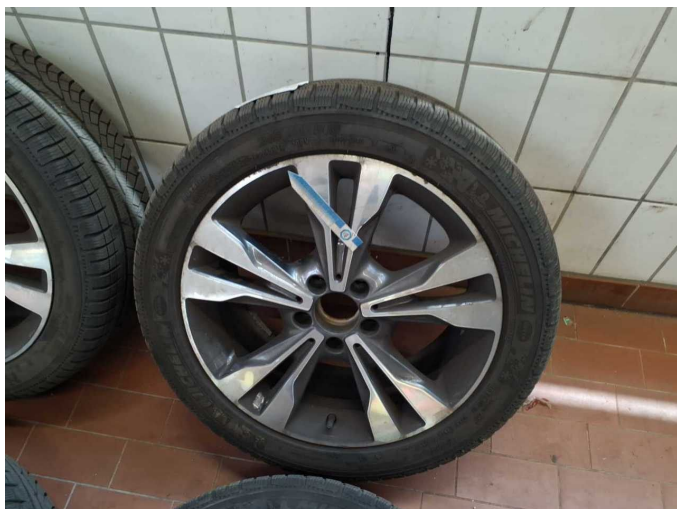
**Wear and tear 6:** 2nd wheel set: 1 alloy rim - Scratch(es) - No deduction

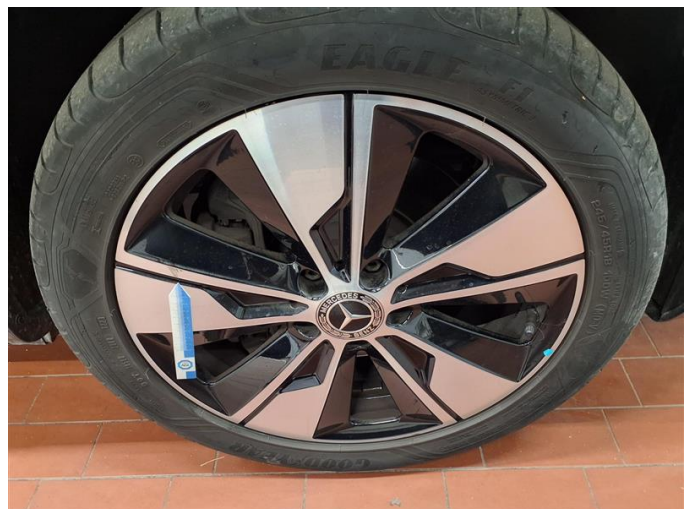
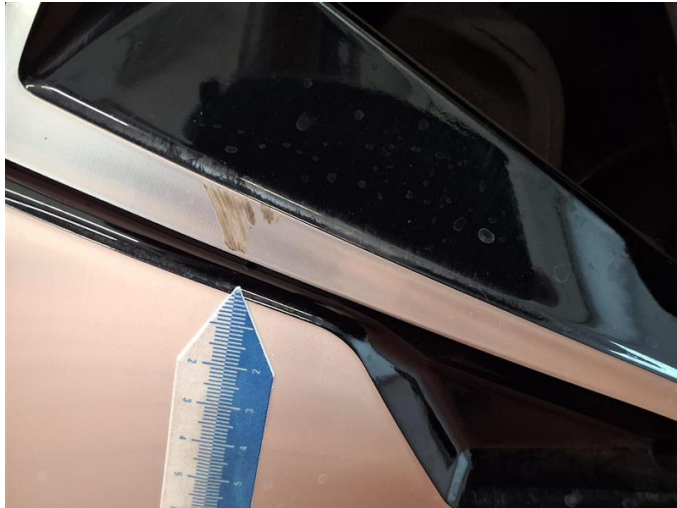
**Wear and tear 7:** Wheel / tyres: Alloy rim - front right side - Scratch(es) - No deduction

**Wear and tear 7:** Wheel / tyres: Alloy rim - front right side - Scratch(es) -  
No deduction

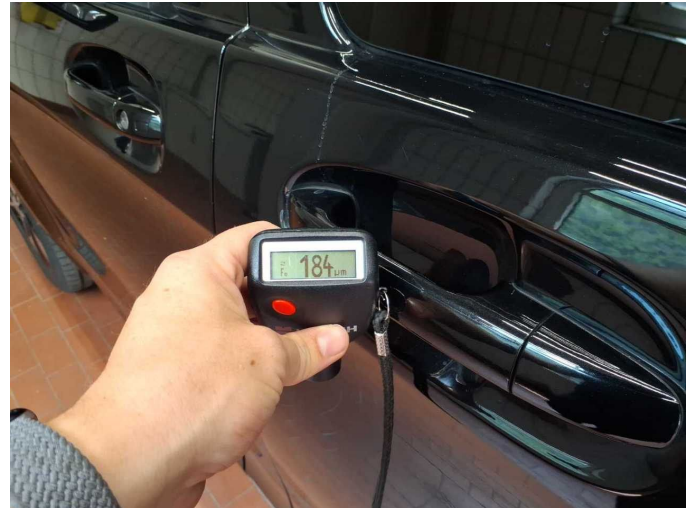
| No. | Repainting |
|---|---|
| 1 | Door - rear left side, Professionally carried out, Invoice of repair done Non-existent |

| Door - rear left side | 184 µm | Door - front left side | 207 µm |

**Repainting 1:** Door - rear left side

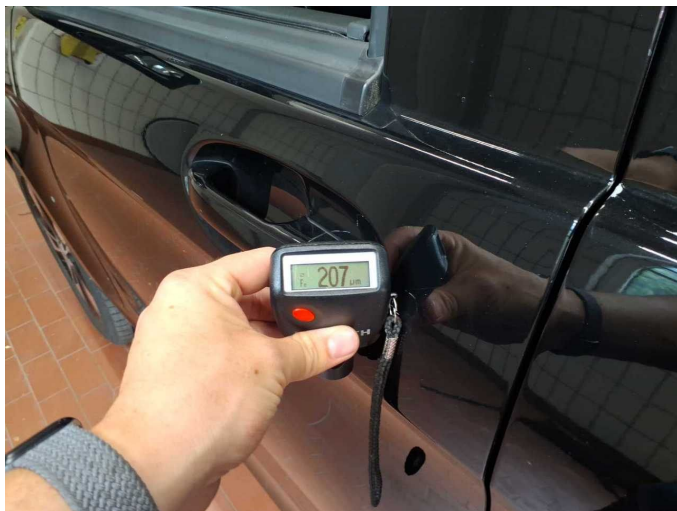
| No. | Repainting |
|---|---|
| 2 | Door - front left side, Professionally carried out, Invoice of repair done Non-existent |

**Repainting 2:** Door - front left side
