Expertise

Protocol number: 46053710  
Order No. / Reference: 26520525  
Inspection date: 19 Jun 2026

Manufacturer: Audi  
VIN: WAUZZZFZ4NP037507

Model: Q4 e-tron 40 Sportback

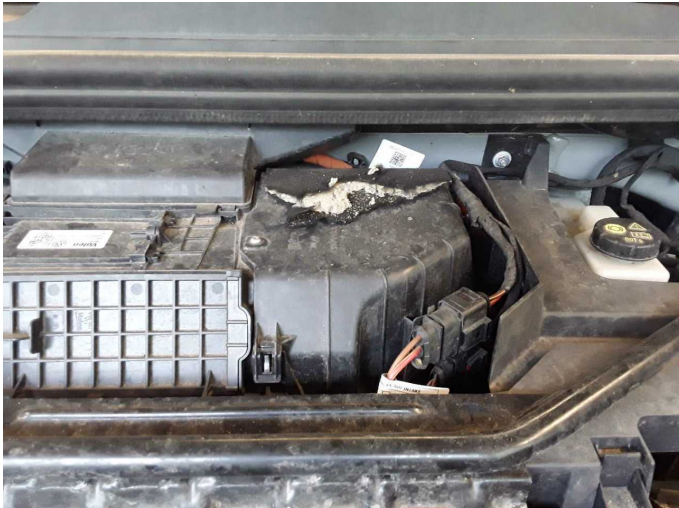
Damage 1: Engine: Engine cover - Damaged - Replace

| No. | Component group | Description |
|---|---|---|
| 1 | Engine | Engine cover - Damaged - Replace |

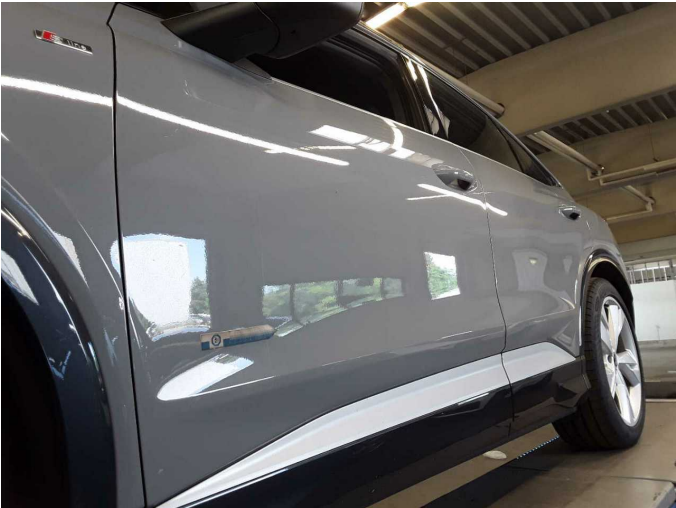
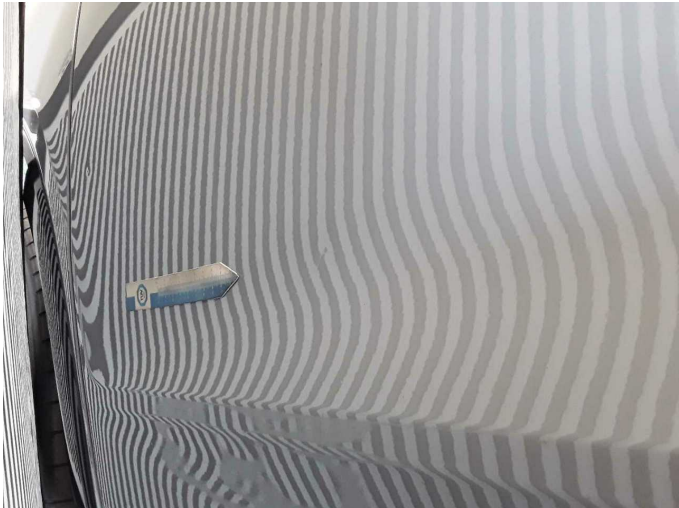
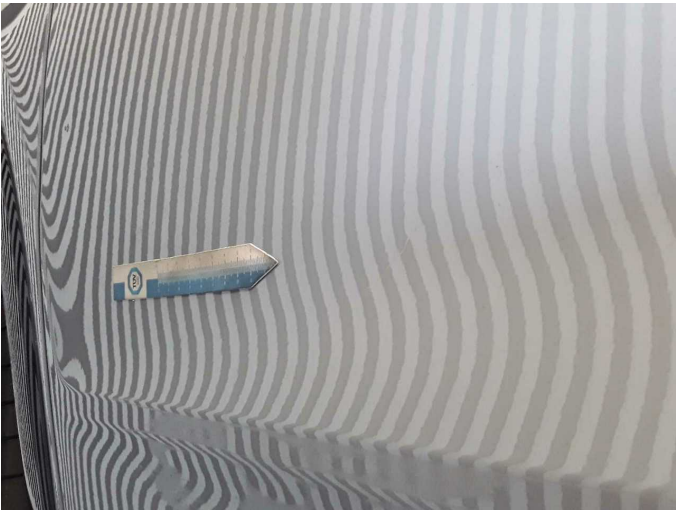
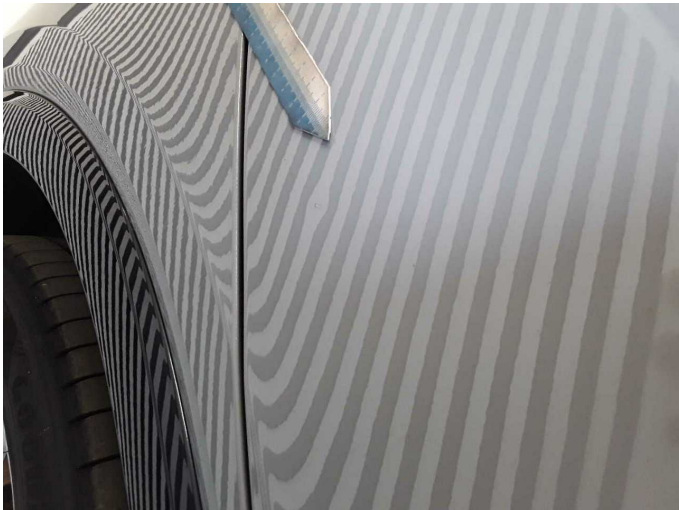
Damage 2: Door - front left side: Door - Dent / paintcoat damage - Smart repair

| No. | Component group | Description |
|---|---|---|
| 2 | Door - front left side | Door - Dent / paintcoat damage - Smart repair |

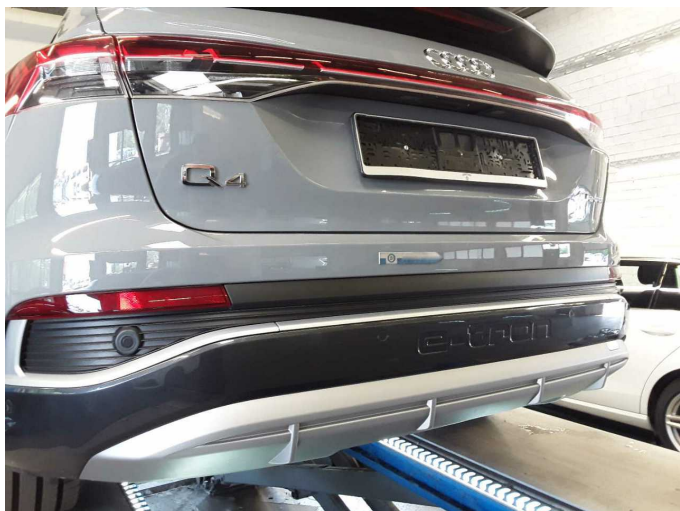
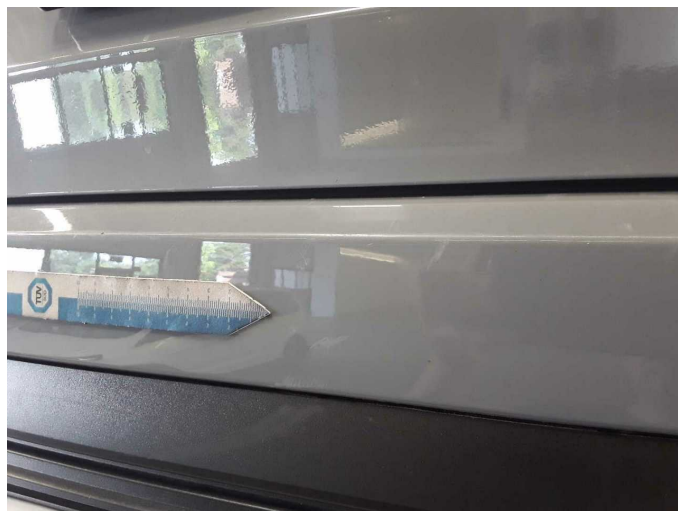
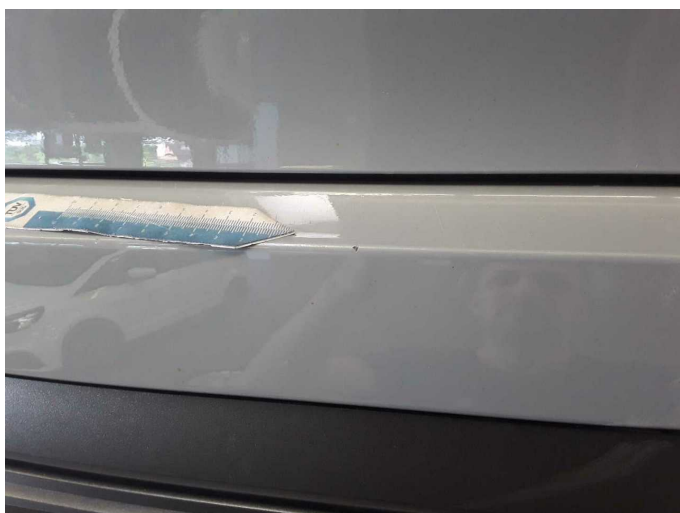
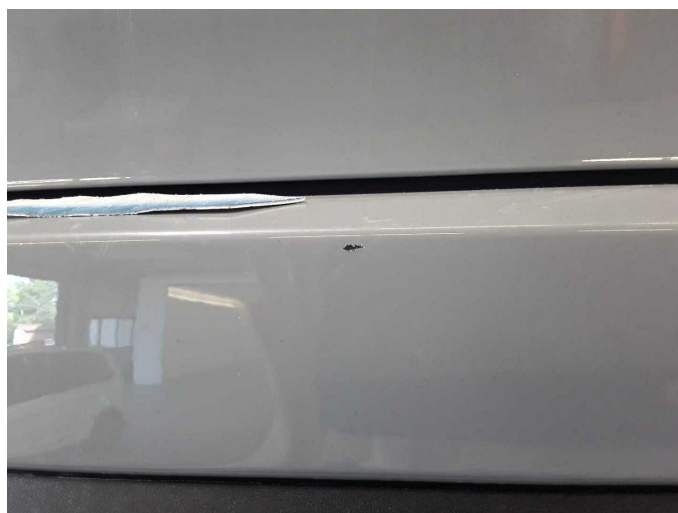
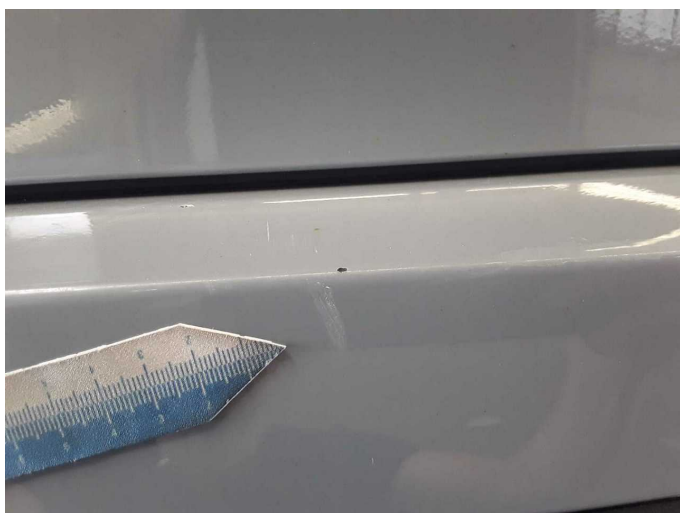
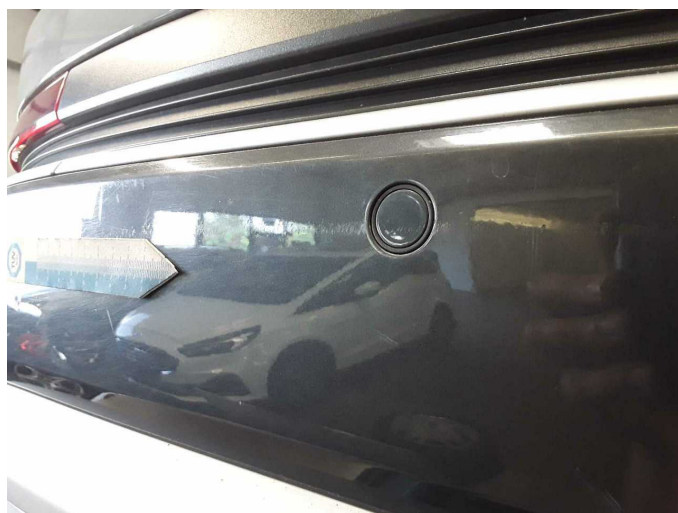
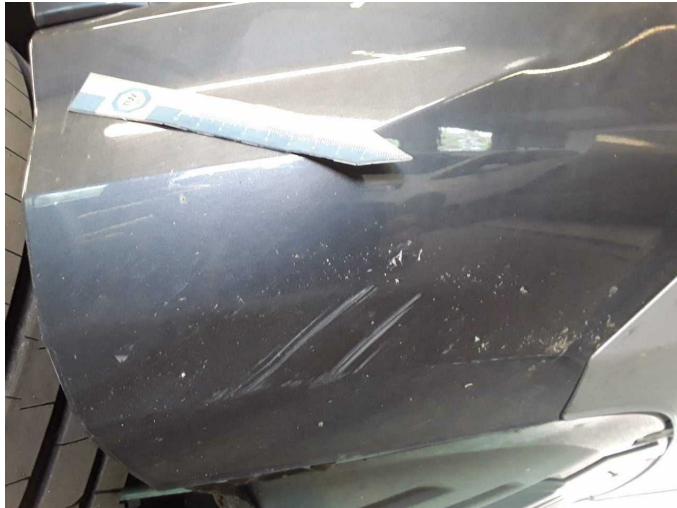
**Damage 3:** Rear bumper: Rear bumper - Scratch(es) - Smart repair

| No. | Component group | Description |
|---|---|---|
| 3 | Rear bumper | Rear bumper - Scratch(es) - Smart repair |

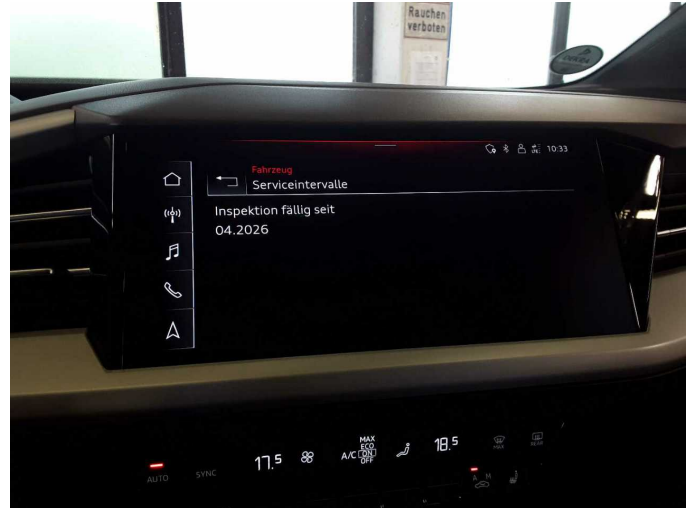
**Damage 4:** Misc.: Inspection / maintenance - Due - Perform

| No. | Component group | Description |
|---|---|---|
| 4 | Misc. | Inspection / maintenance - Due - Perform |

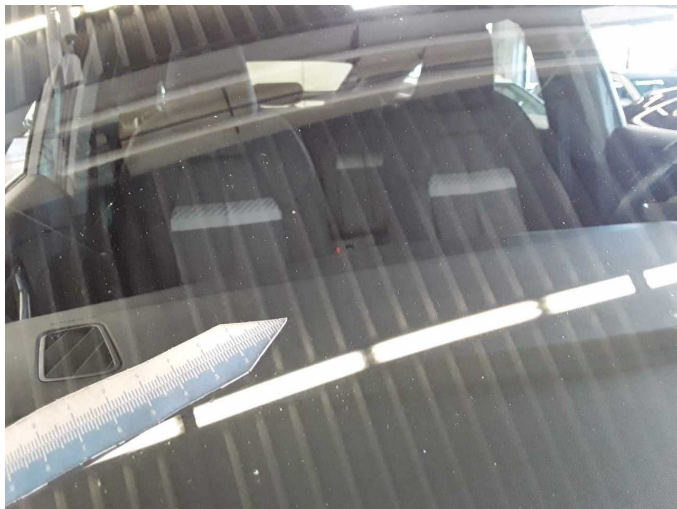
| No. | Component group | Description |
|---|---|---|
| 3 | Vehicle glazing | Windscreen - Stone chips - No deduction |

**Wear and tear 3:** Vehicle glazing: Windscreen - Stone chips - No deduction

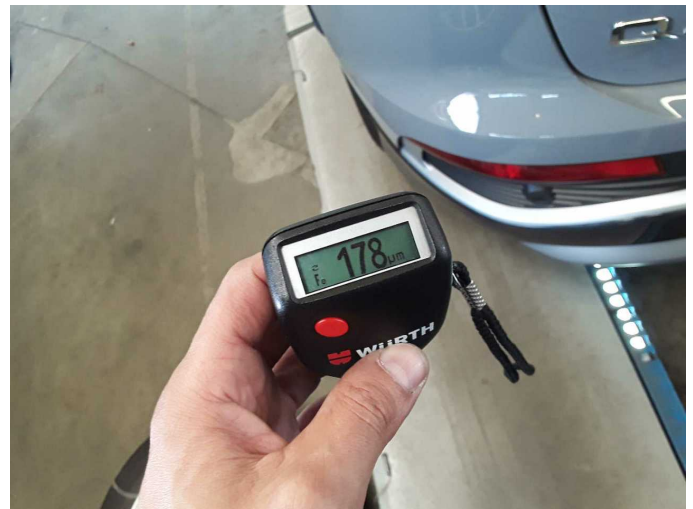
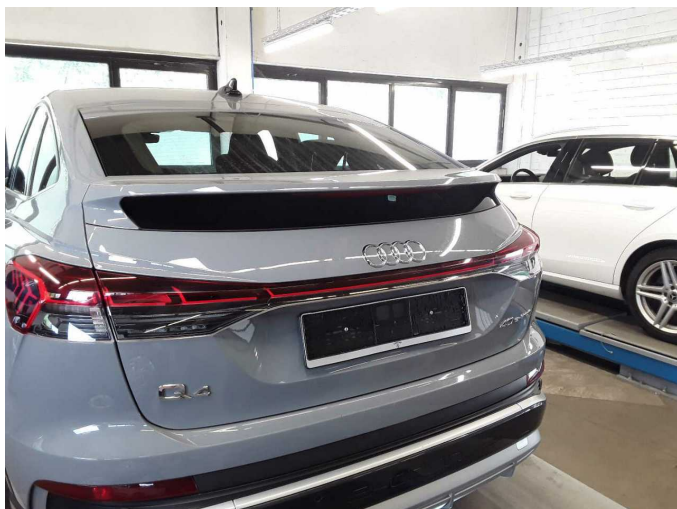
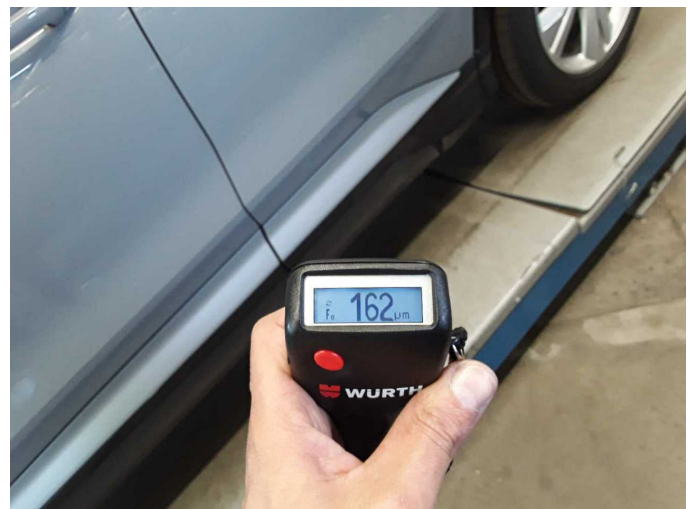
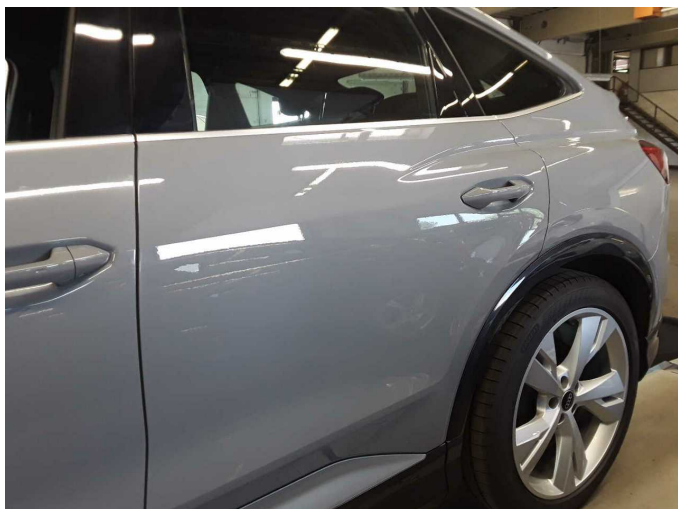
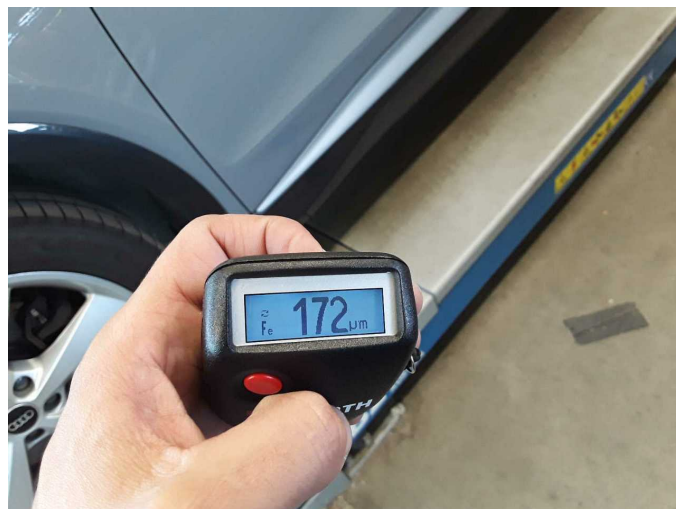
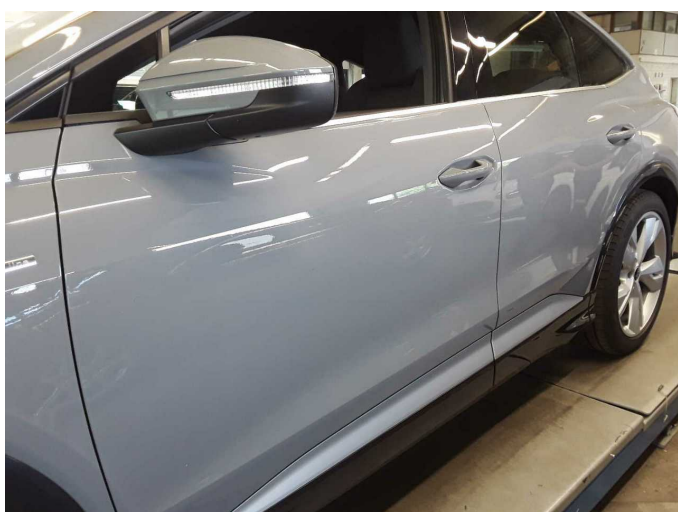
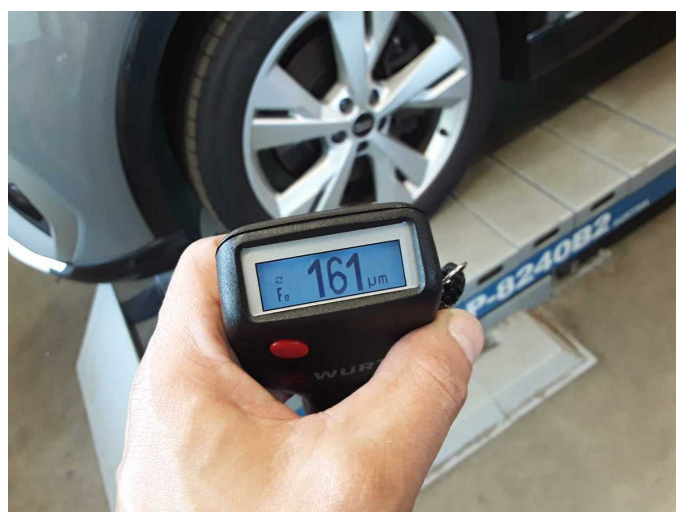
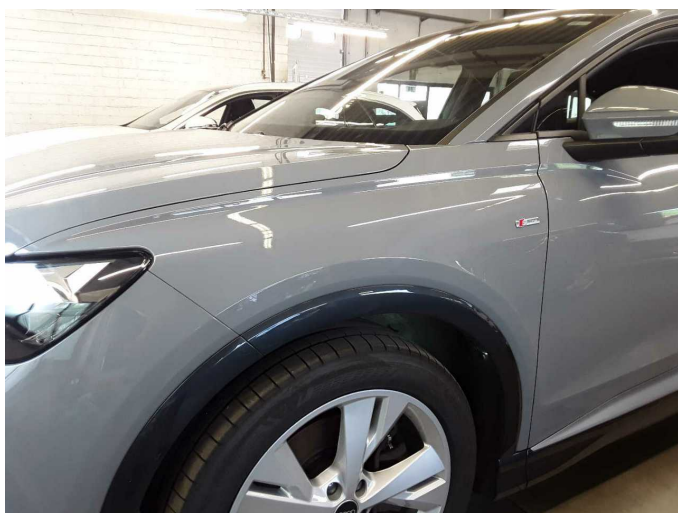
| No. | Repainting |
|---|---|
| 1 | Boot lid / rear door, Mudguard - left side, Door - rear left side, Door - front left side, Professionally carried out, Invoice of repair done Non-existent |

| Boot lid / rear door | 178 µm | Mudguard - left side | 161 µm |
| Door - rear left side | 162 µm | Door - front left side | 172 µm |

**Repainting 1:** Boot lid / rear door, Mudguard - left side, Door - rear left side, Door - front left side
