Expertise

Protocol number: 46838820  
Order No. / Reference: 26497818  
Inspection date: 30 Jul 2026

Manufacturer: Mercedes-Benz  
VIN: W1KAH0EB8PF074853

Model: C 220 d T 9G-TRONIC Avantgarde

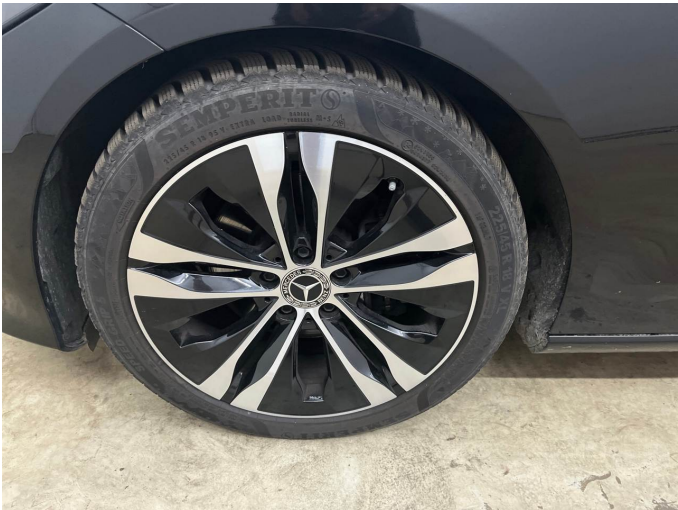
Figure 12: Mounted tyres

| # | Tyre size | Type of tyre | Manufacturer | Tread depth |
|---|---|---|---|---|
| 1) | 225/45 R18 95V | Winter tyres on Light alloy | Semperit | 8mm / 8mm |
| 2) | 245/40 R18 97V | Winter tyres on Light alloy | Goodyear | 8mm / 8mm |

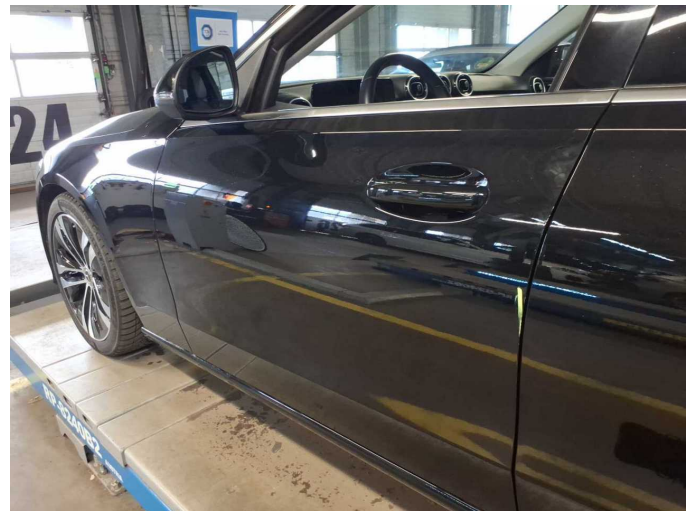
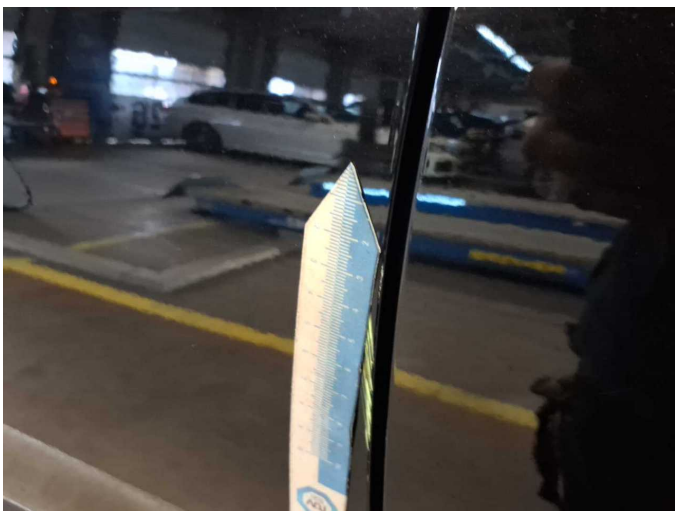
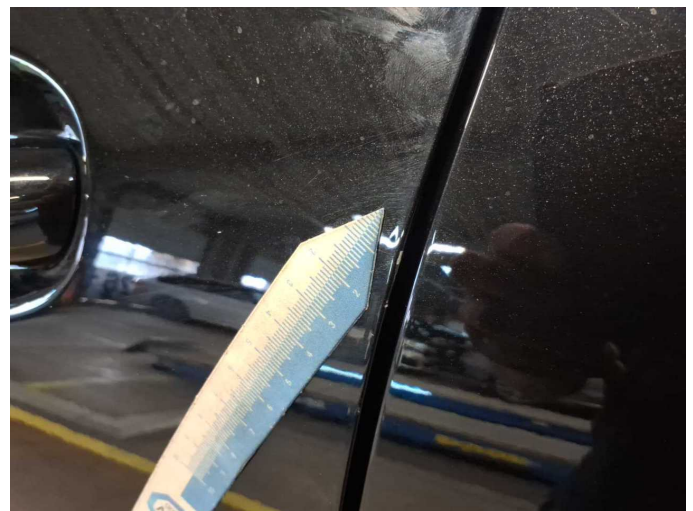
| No. | Component group | Description |
|---|---|---|
| 1 | Door - front left side | Door - Scratch(es) - Smart repair |

Damage 1: Door - front left side: Door - Scratch(es) - Smart repair

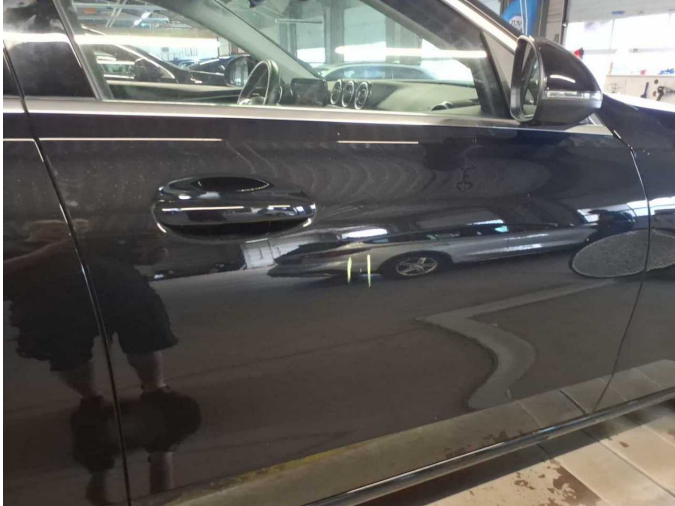
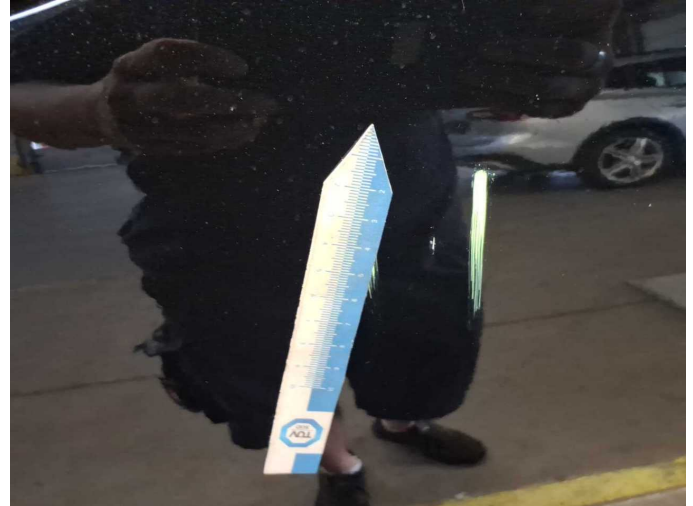
| No. | Component group | Description |
|---|---|---|
| 2 | Door - front right side | Door - Scratch(es) - Smart repair |

**Damage 2:** Door - front right side: Door - Scratch(es) - Smart repair

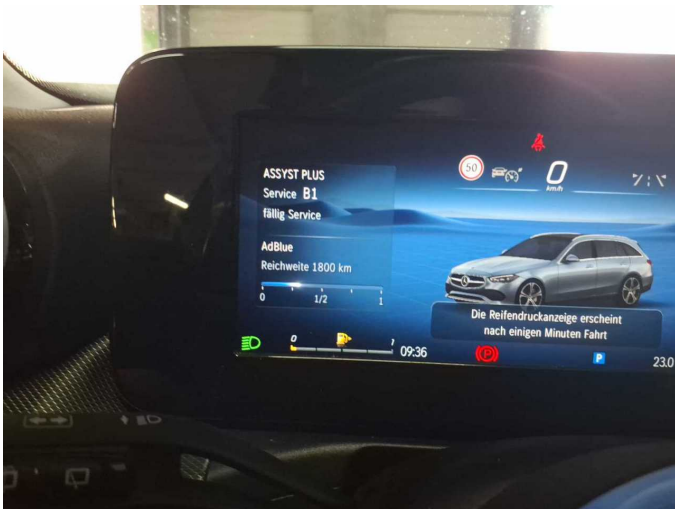
| No. | Component group | Description |
|---|---|---|
| 3 | Misc. | Inspection / maintenance - Due - Perform |

**Damage 3:** Misc.: Inspection / maintenance - Due - Perform

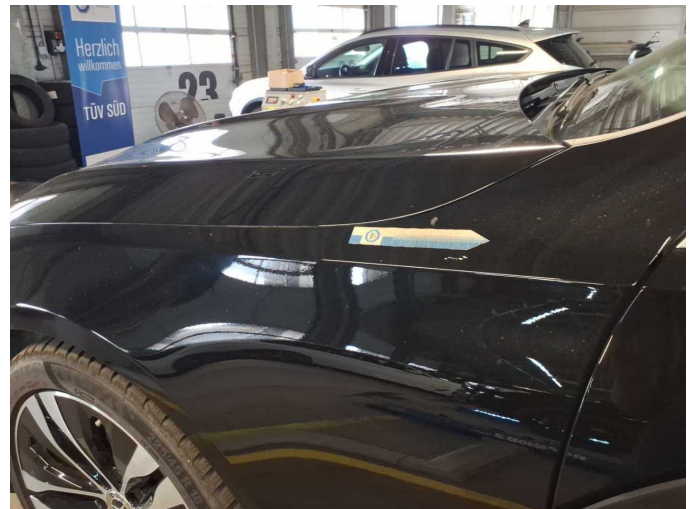
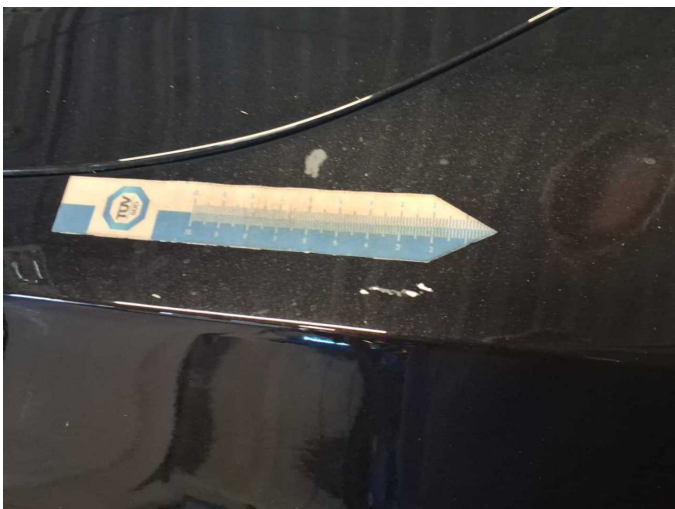
| No. | Component group | Description |
|---|---|---|
| 4 | Mudguard - left side | Mudguard - left side - Scratched - Paint |

**Damage 4:** Mudguard - left side: Mudguard - left side - Scratched - Paint

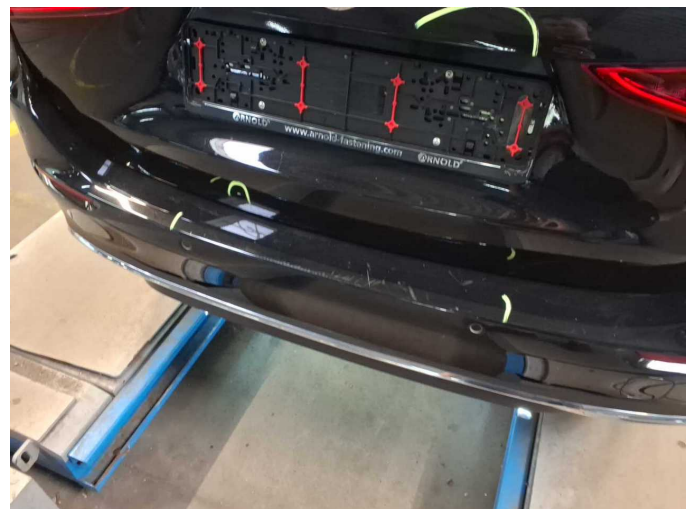
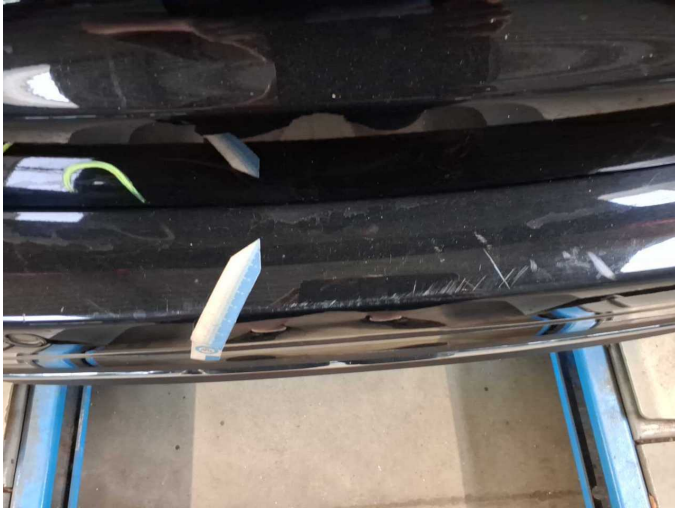
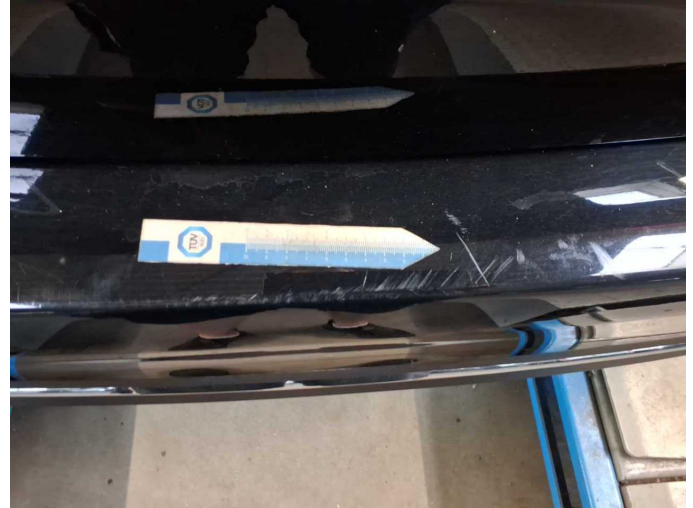
| No. | Component group | Description |
|---|---|---|
| 5 | Rear bumper | Rear bumper - Scratched - Paint |

**Damage 5:** Rear bumper: Rear bumper - Scratched - Paint

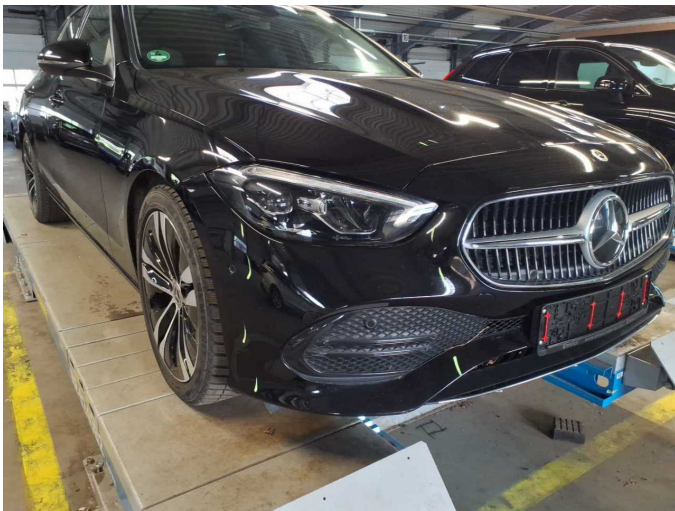
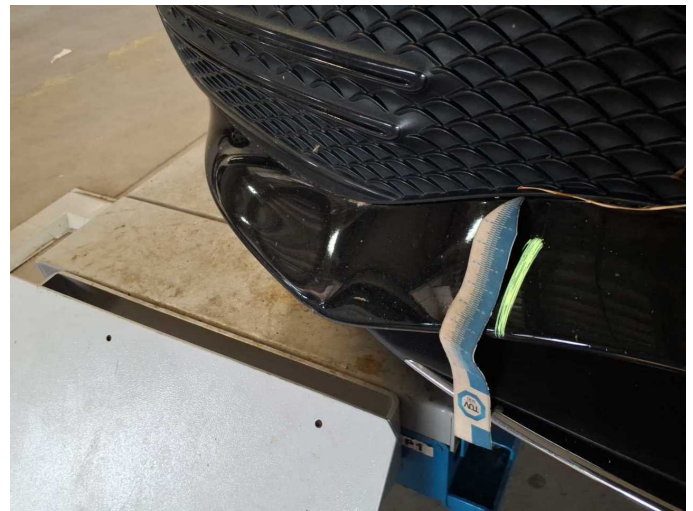
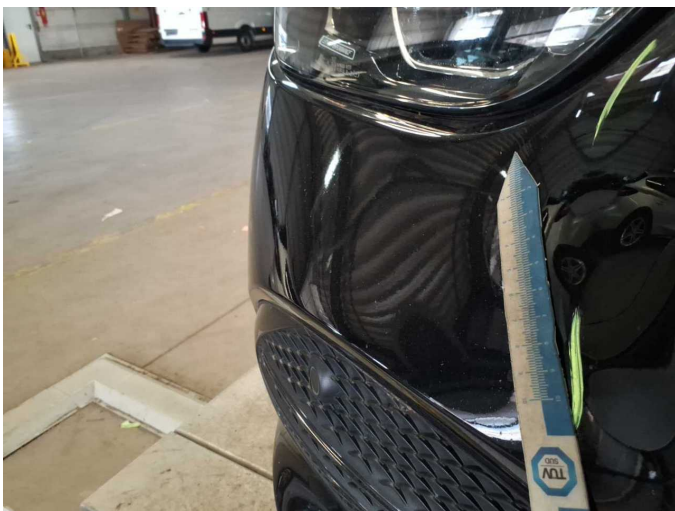
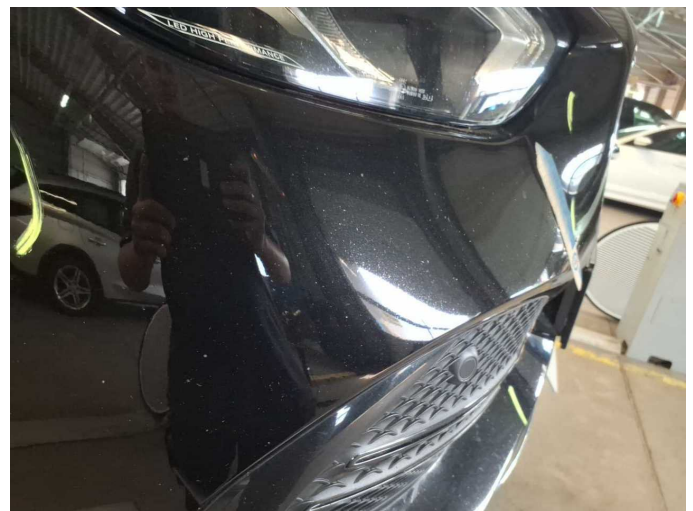
| No. | Component group | Description |
|---|---|---|
| 6 | Front bumper | Front bumper (Sandstrahleffekt) - Stone chips - Paint |

**Damage 6:** Front bumper: Front bumper (Sandstrahleffekt) - Stone chips - Paint

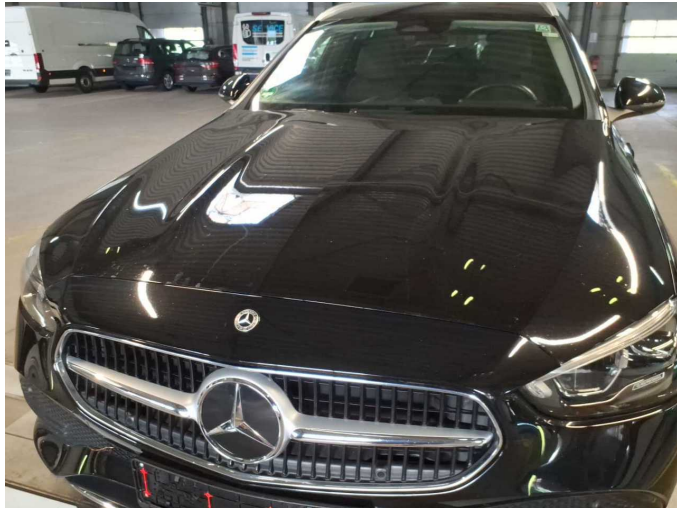
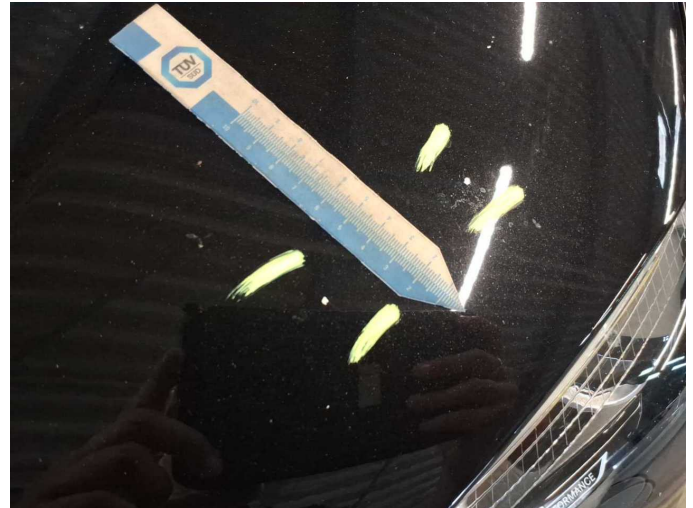
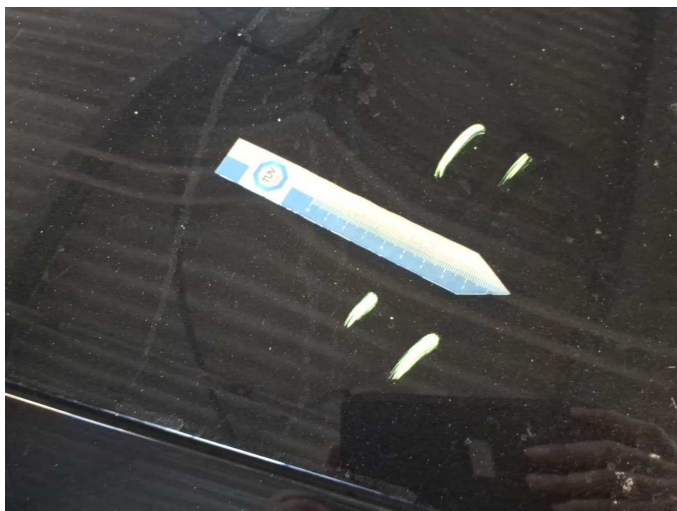
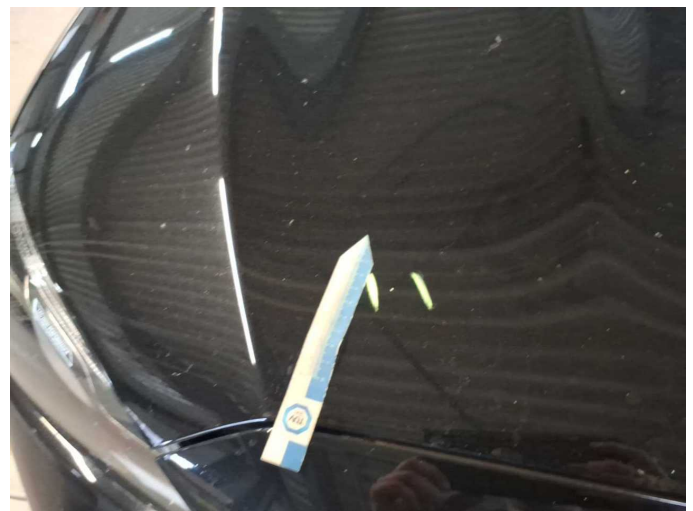
| No. | Component group | Description |
|---|---|---|
| 7 | Bonnet | Bonnet (Sandstrahleffekt) - Stone chips - Paint |

**Damage 7:** Bonnet: Bonnet (Sandstrahleffekt) - Stone chips - Paint

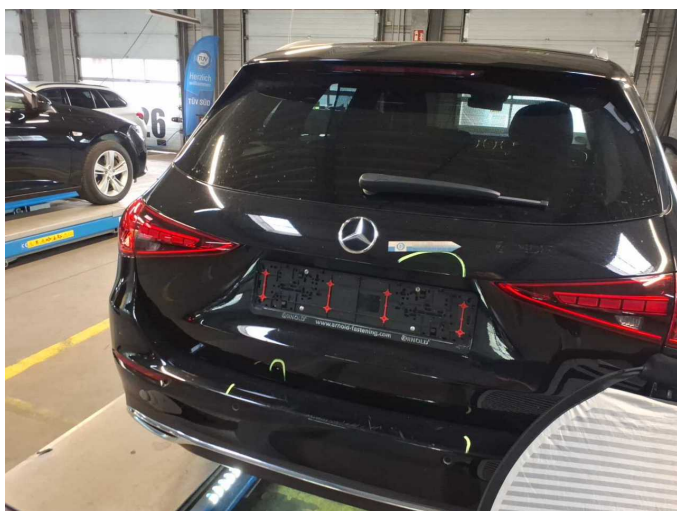
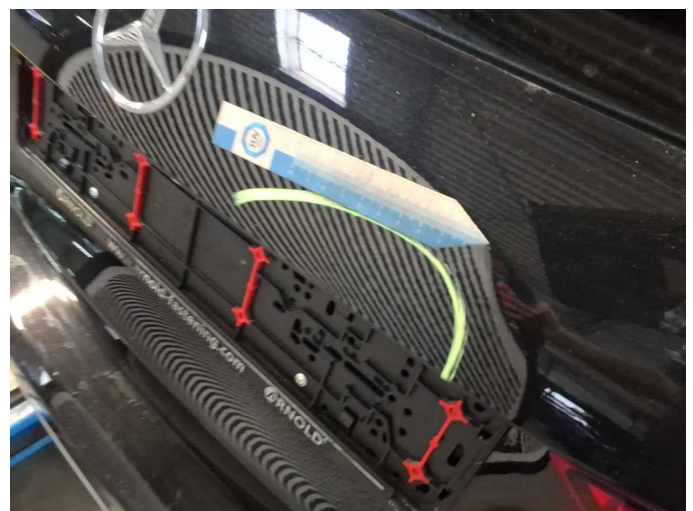
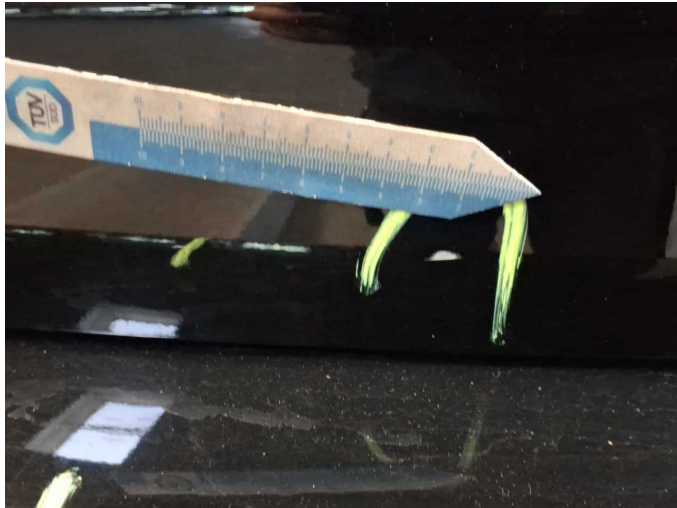
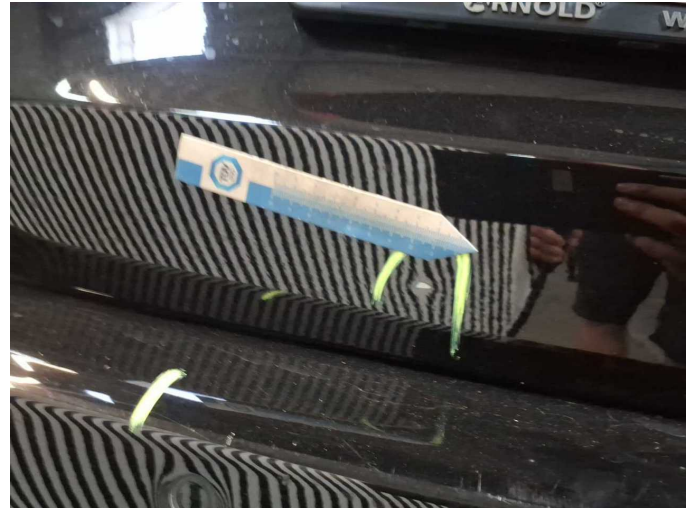
| No. | Component group | Description |
|---|---|---|
| 8 | Boot lid / rear door | Boot lid - Dent / paintcoat damage - Repair and paint |

**Damage 8:** Boot lid / rear door: Boot lid - Dent / paintcoat damage - Repair and paint

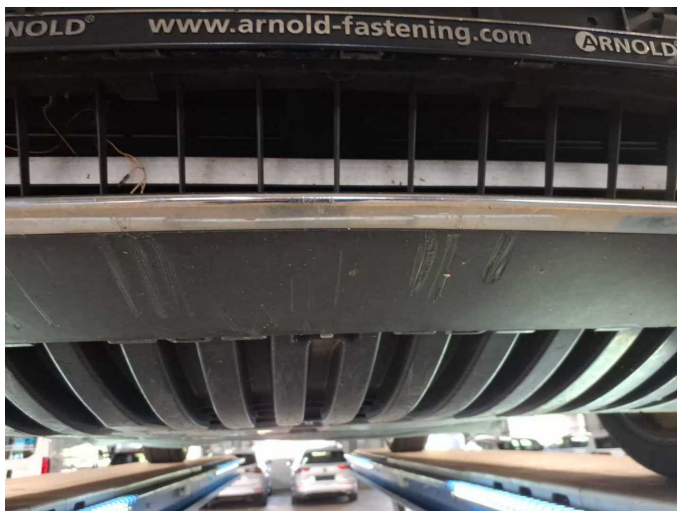
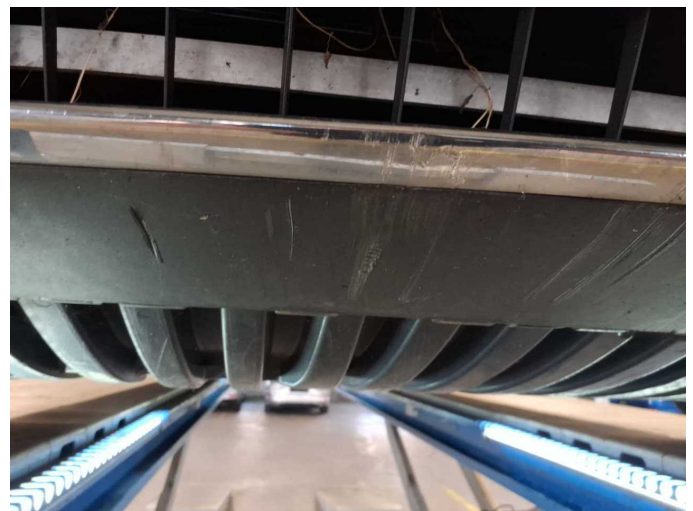
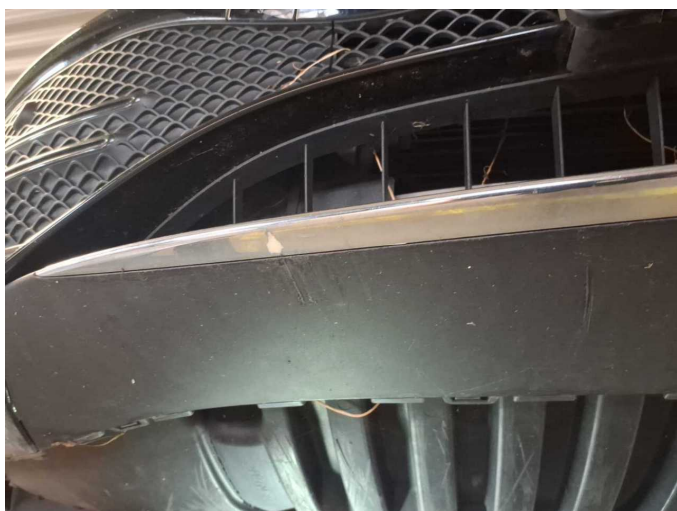
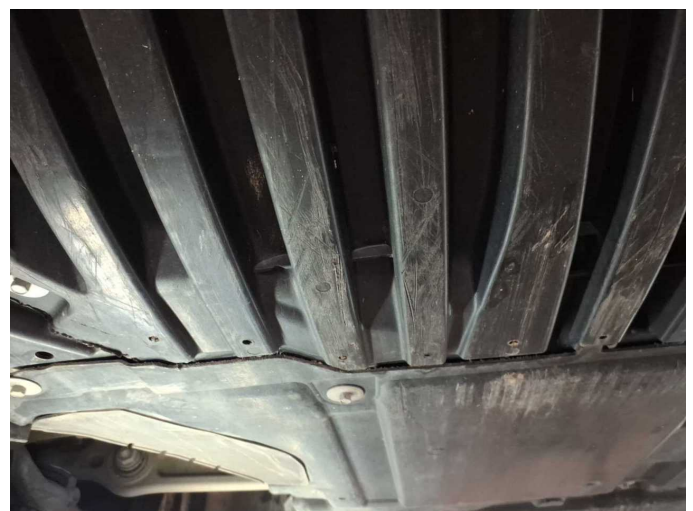
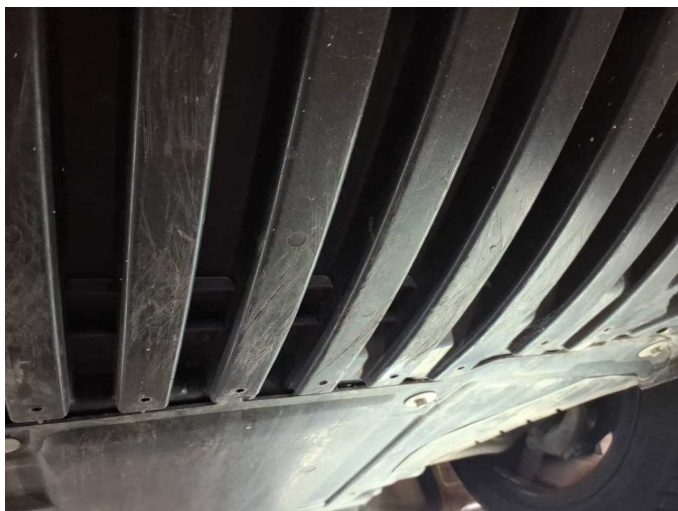
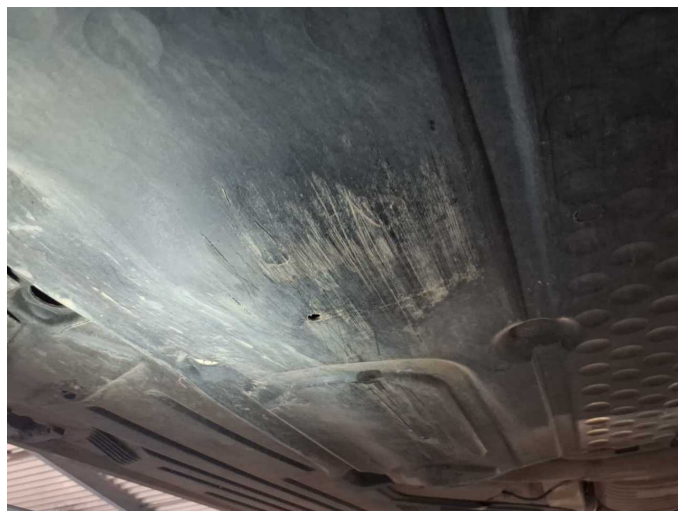
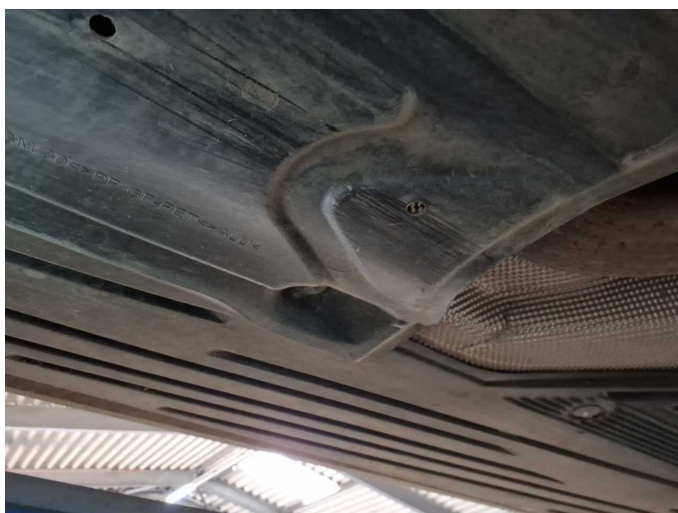
1 Front, Underbody

Non-repaired previous damages were found at the vehicle. The necessary repair costs are listed in the expert report or if necessary, are listed in detail in a separately enclosed repair cost calculation.

**Accident 1:** Front, Underbody
