Expertise

Protocol number: 46010577  
Order No. / Reference: 26510561  
Inspection date: 18 Jun 2026

Manufacturer: Volkswagen

Model: Passat Variant 2.0 TDI SCR DSG Business

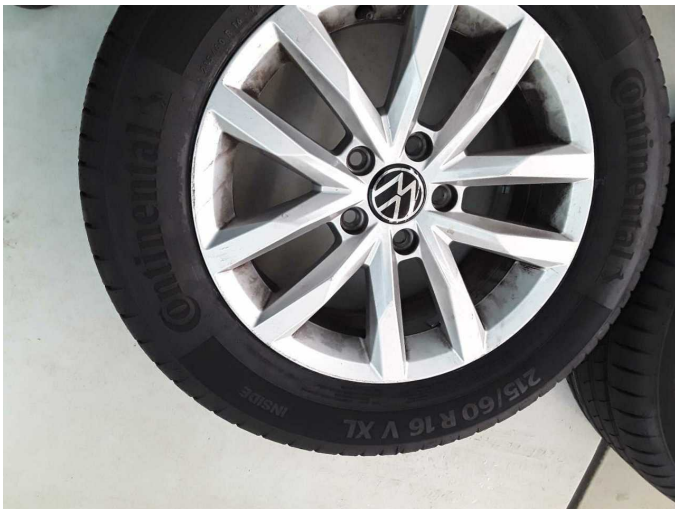
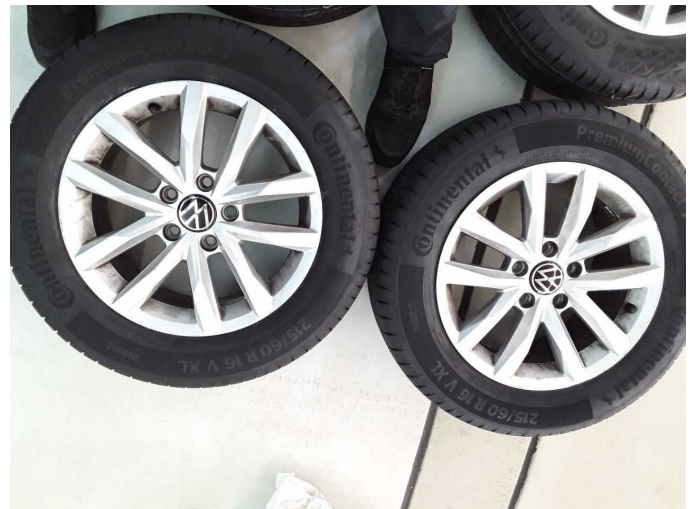
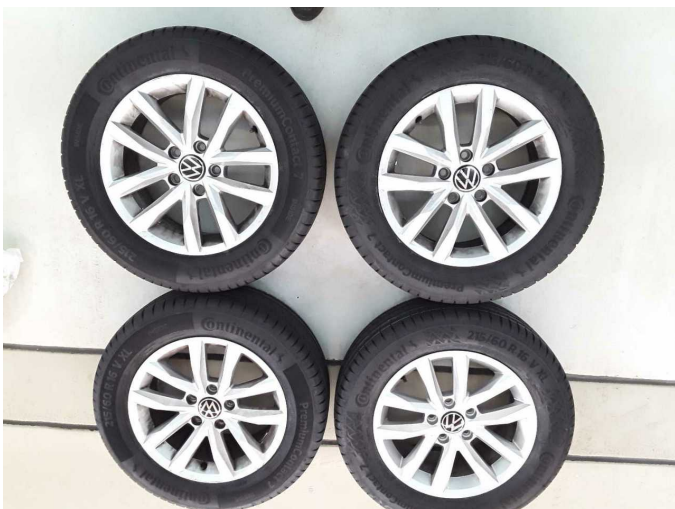
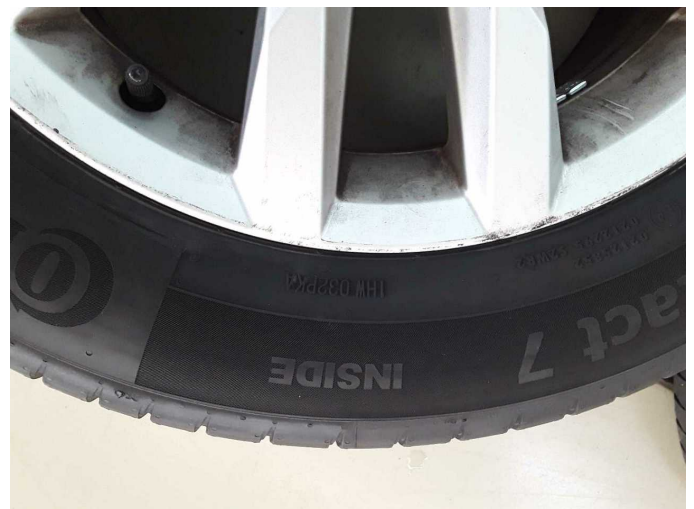
| No. | Component group | Description |
|---|---|---|
| 1 | 2nd wheel set | 2 tyres (Inside steht Außen am Reifen) - Malposition - Un- / install |

Damage 1: 2nd wheel set: 2 tyres (Inside steht Außen am Reifen) - Malposition - Un- / install

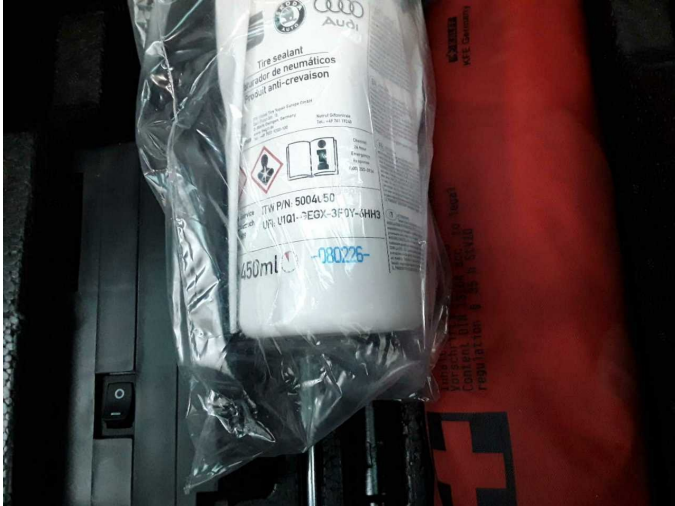
| No. | Component group | Description |
|---|---|---|
| 2 | Equipment | Tirefit filler - Due - Replace |

**Damage 2:** Equipment: Tirefit filler - Due - Replace

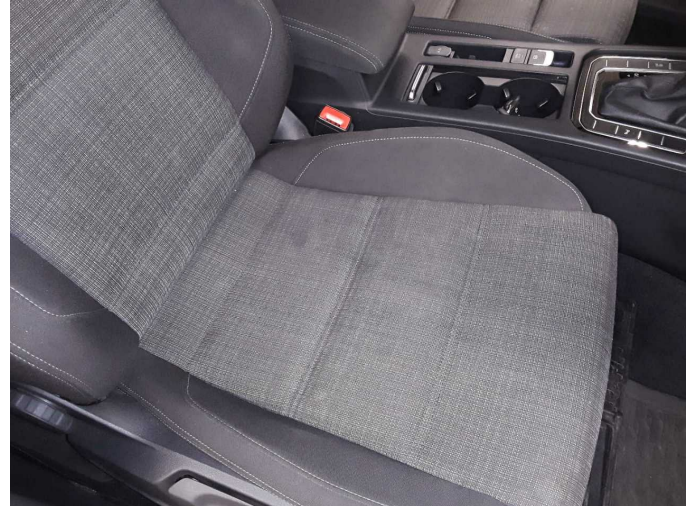
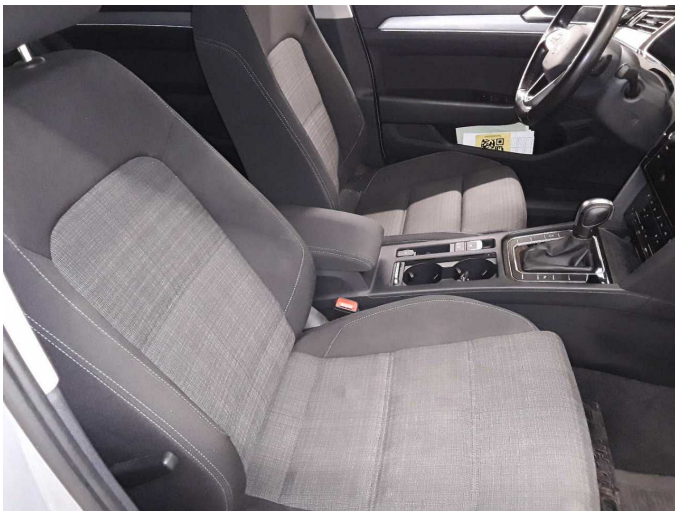
| No. | Component group | Description |
|---|---|---|
| 3 | Seat - front | Seat cover - right side (Sitze) - Soiled - Clean |

**Damage 3:** Seat - front: Seat cover - right side (Sitze) - Soiled - Clean

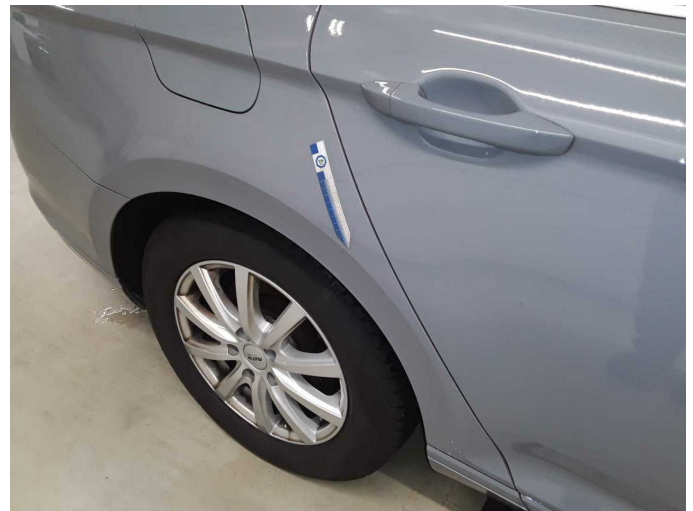
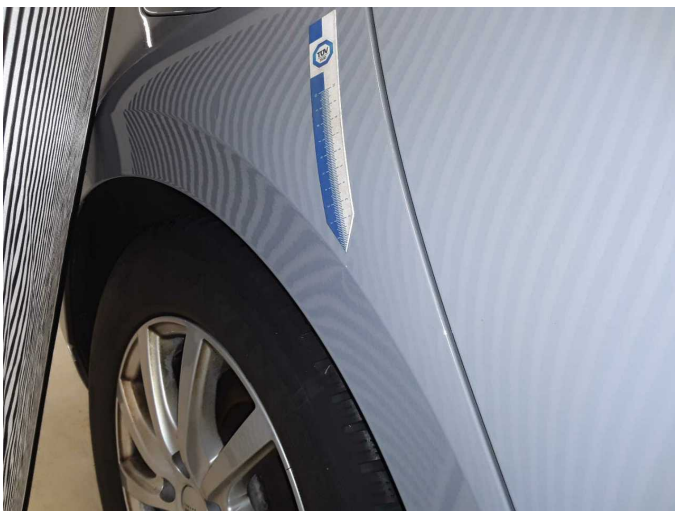
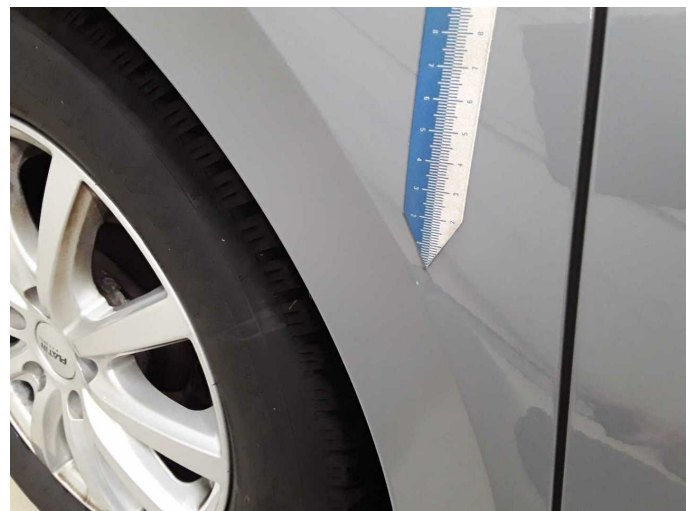
| No. | Component group | Description |
|---|---|---|
| 4 | Side panel - rear right side | Side panel - Dent / paintcoat damage - Smart repair |

**Damage 4:** Side panel - rear right side: Side panel - Dent / paintcoat damage - Smart repair
