Expertise

Protocol number: 46408420  
Order No. / Reference: 26416747  
Inspection date: 8 Jul 2026

Manufacturer: Volkswagen

Model: Golf 2.0 TDI SCR Life

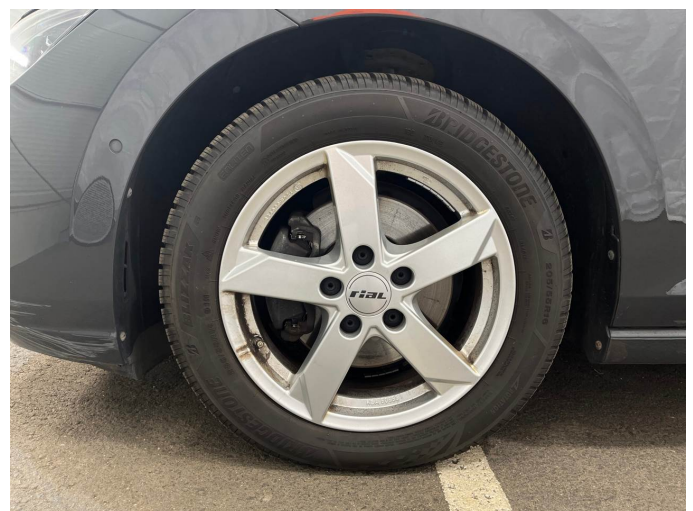
| # | Tyre size | Type of tyre | Manufacturer | Tread depth |
|---|---|---|---|---|
| 1) | 205/55 R16 91H | Winter tyres on Light alloy | Bridgestone | 7mm / 7mm |
| 2) | 205/55 R16 91H | Winter tyres on Light alloy | Hankook | 7mm / 7mm |

Figure 12: Mounted tyres

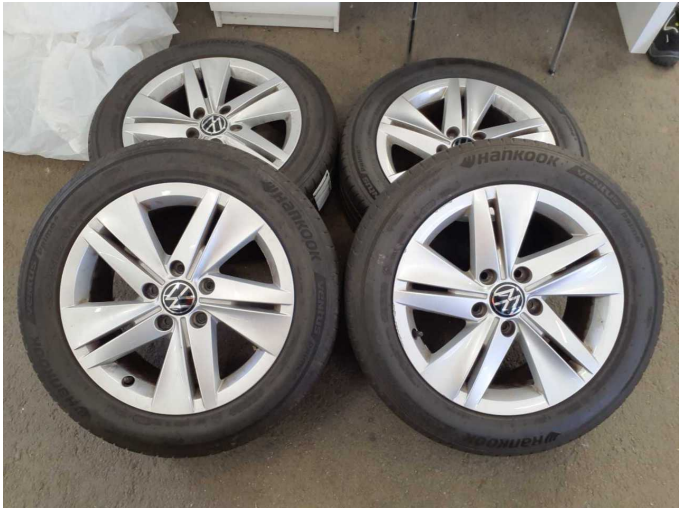
| # | Tyre size | Type of tyre | Manufacturer | Tread depth |
|---|---|---|---|---|
| 1) | 205/55 R16 91V | Summer tyres on Light alloy | Hankook | 6mm / 6mm |
| 2) | 205/55 R16 91V | Summer tyres on Light alloy | Hankook | 6mm / 6mm |

Figure 16: Additional tyres

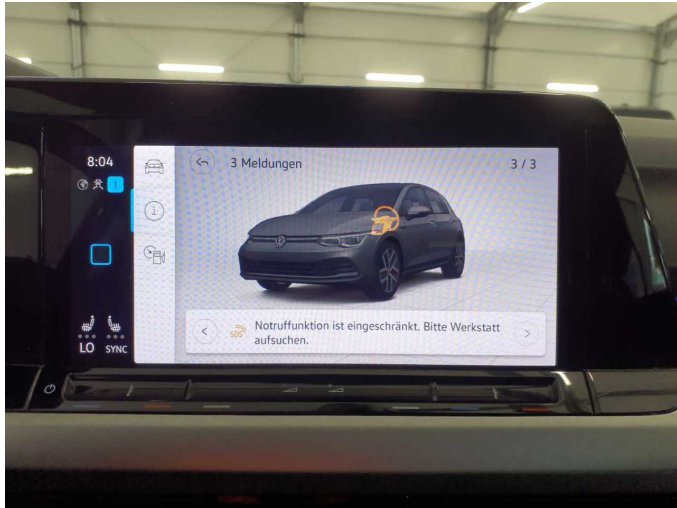
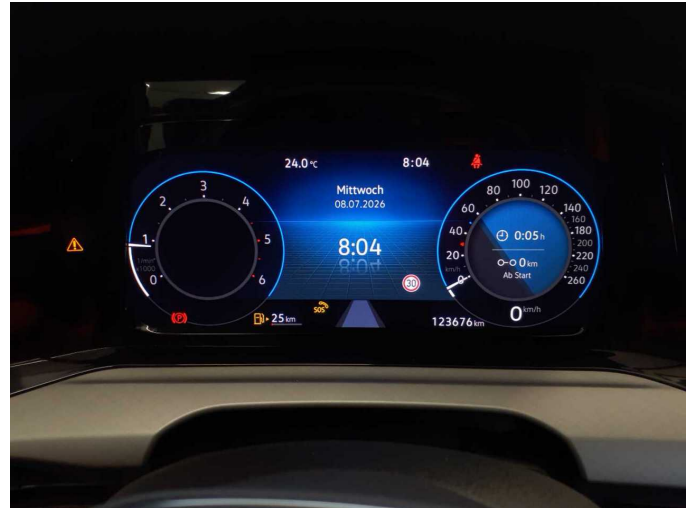
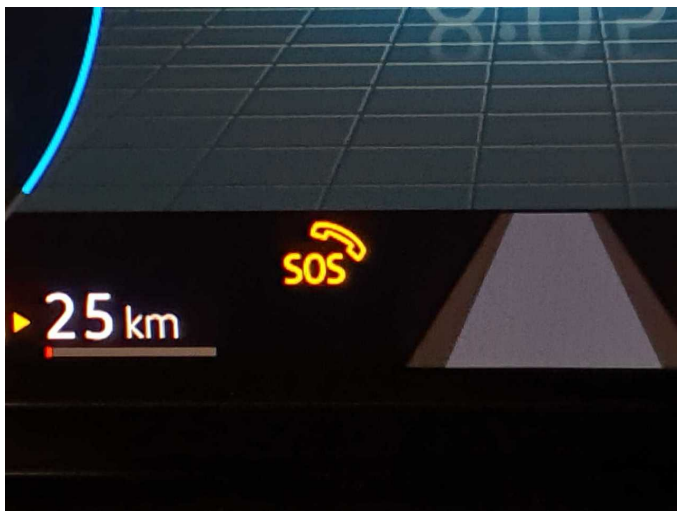
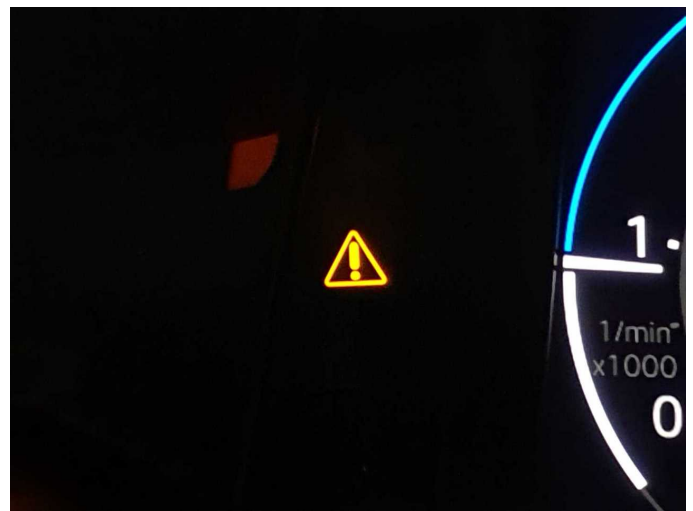
**Damage 1:** Instrument panel: Indicator light (Notruffunktion) - Specify findings - Perform diagnosis

| No. | Component group | Description |
|---|---|---|
| 1 | Instrument panel | Indicator light (Notruffunktion) - Specify findings - Perform diagnosis |

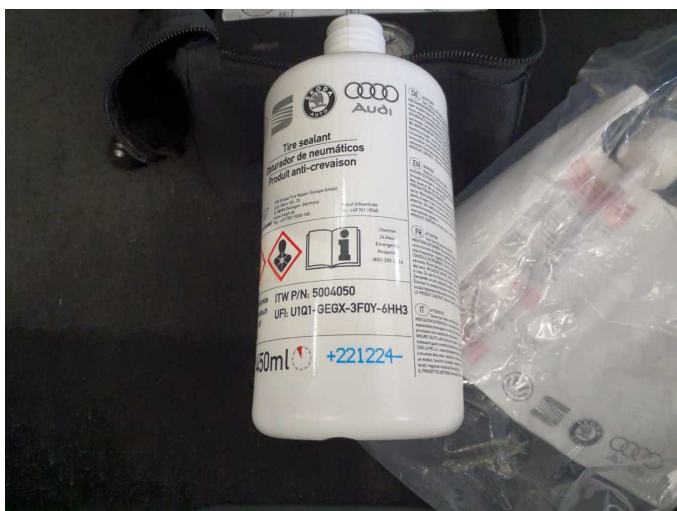
**Damage 2:** Equipment: Tirefit filler - Expired - Replace

| No. | Component group | Description |
|---|---|---|
| 2 | Equipment | Tirefit filler - Expired - Replace |

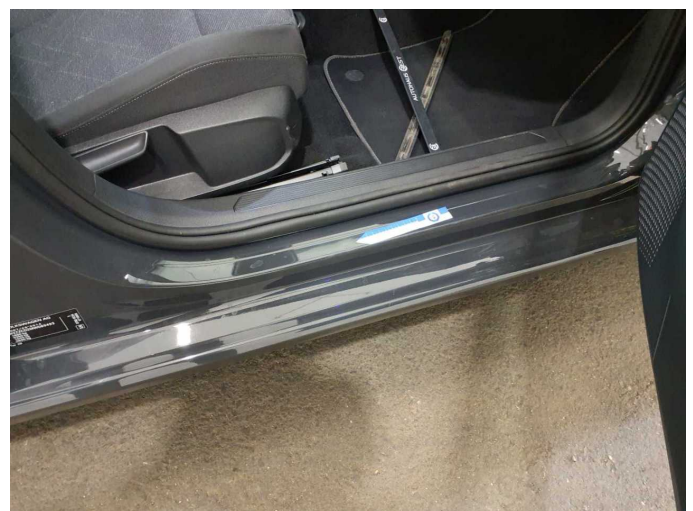
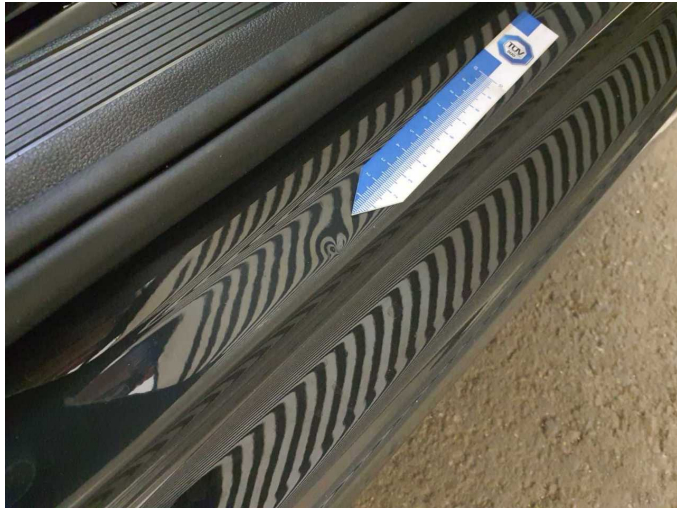
**Damage 3:** Sill - right side: Sill - dent(s) - Smart repair

| No. | Component group | Description |
|---|---|---|
| 3 | Sill - right side | Sill - dent(s) - Smart repair |

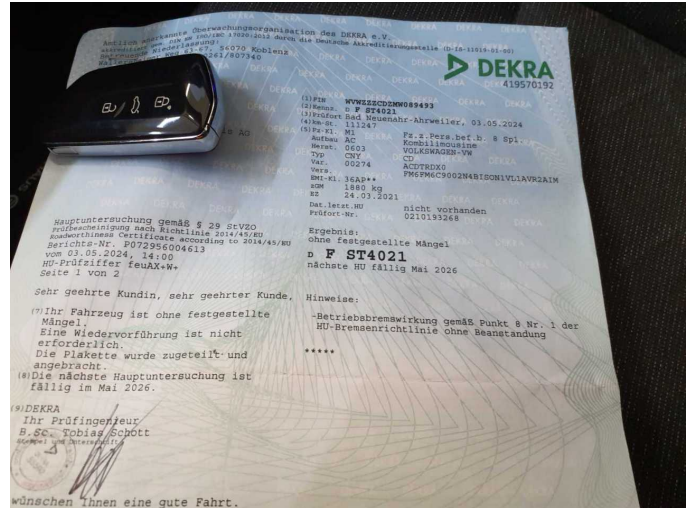
**Damage 4:** Misc.: Main inspection - Expired - Replace

| No. | Component group | Description |
|---|---|---|
| 4 | Misc. | Main inspection - Expired - Replace |

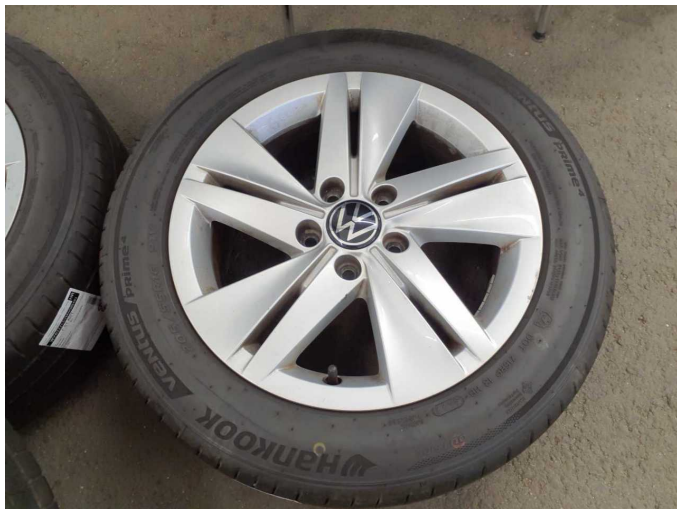
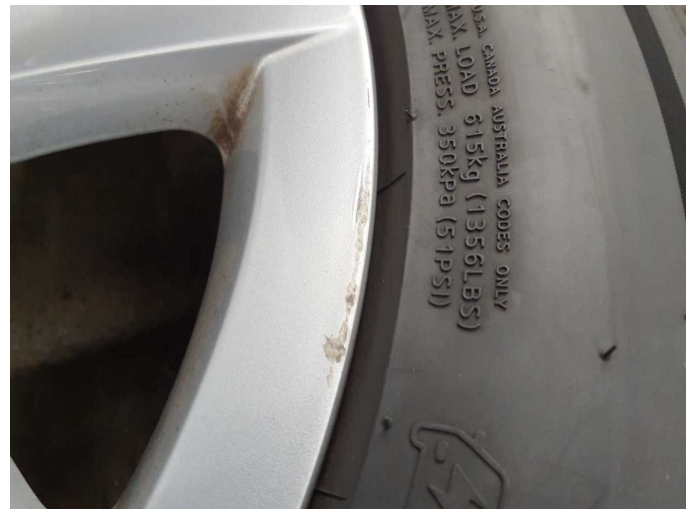
**Damage 5:** 2nd wheel set: 1 alloy rim - Scratch(es) - Loss in value

| No. | Component group | Description |
|---|---|---|
| 5 | 2nd wheel set | 1 alloy rim - Scratch(es) - Loss in value |

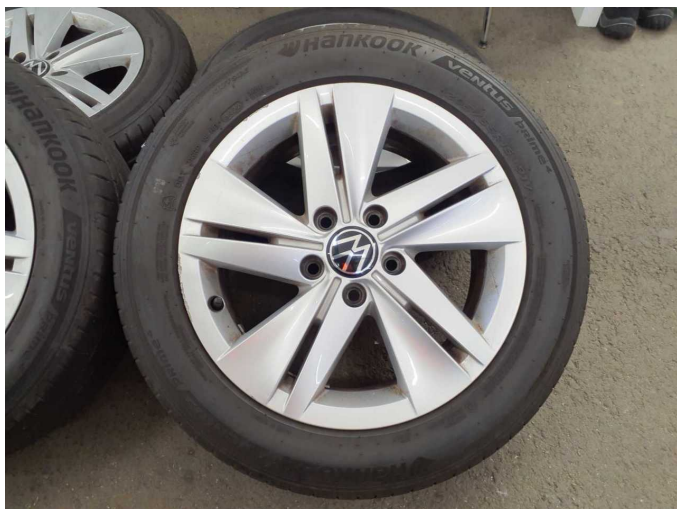
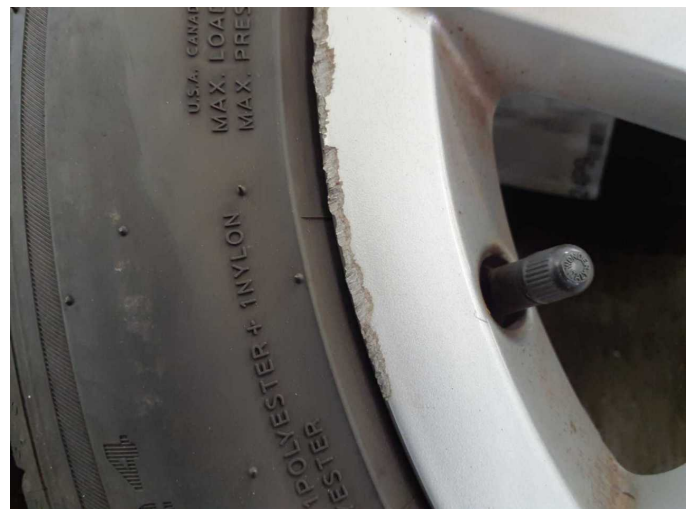
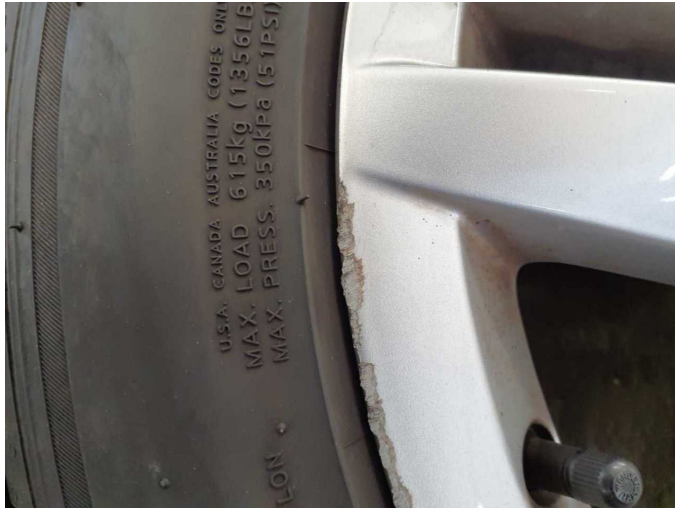
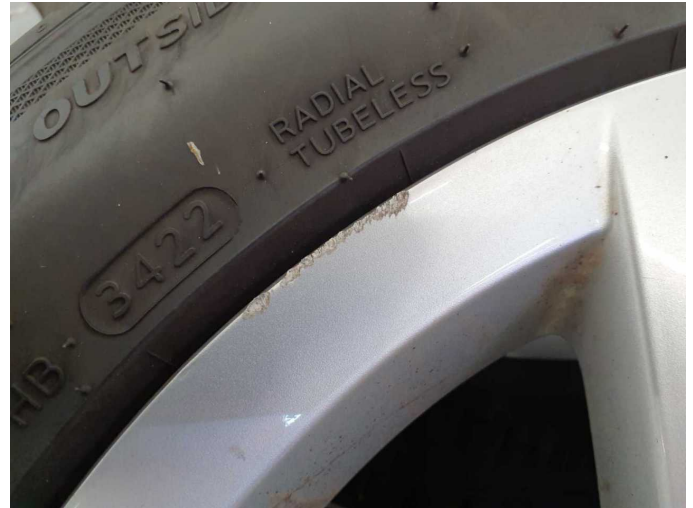
**Damage 6:** 2nd wheel set: 1 alloy rim - Scratched - Replace

| No. | Component group | Description |
|---|---|---|
| 6 | 2nd wheel set | 1 alloy rim - Scratched - Replace |

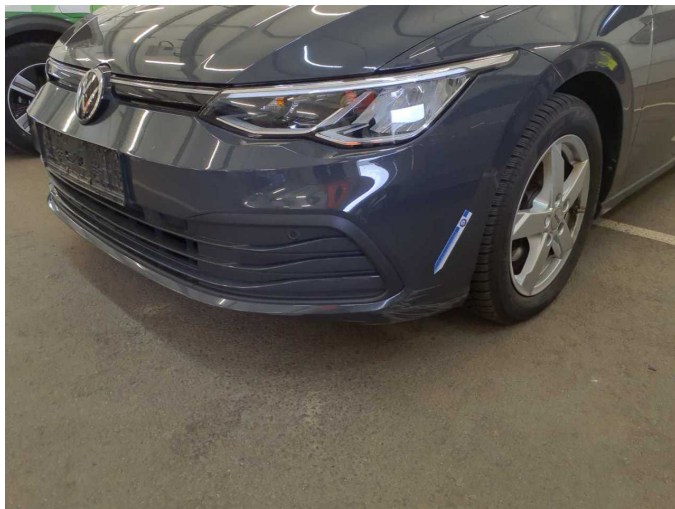
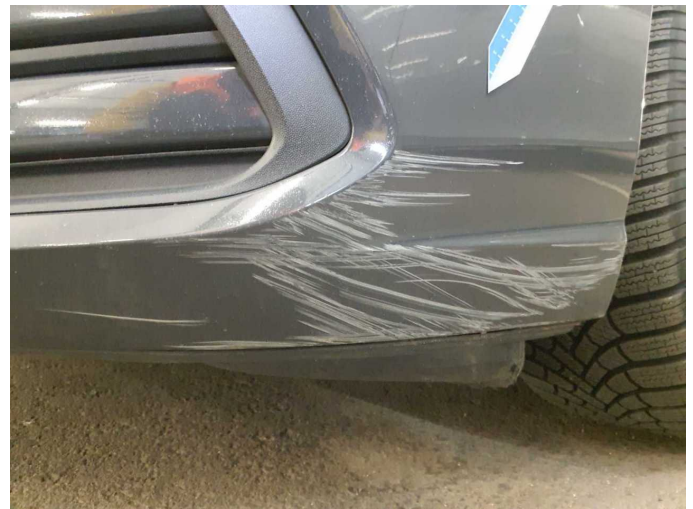
**Damage 7:** Front bumper: Front bumper - Scratch(es) - Paint

| No. | Component group | Description |
|---|---|---|
| 7 | Front bumper | Front bumper - Scratch(es) - Paint |

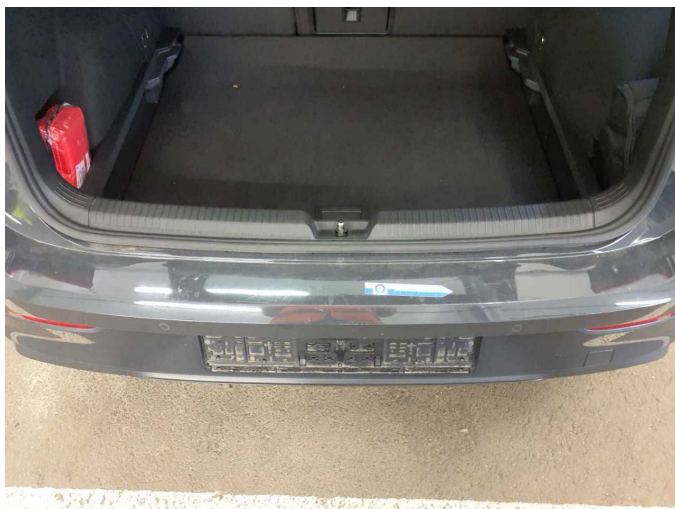
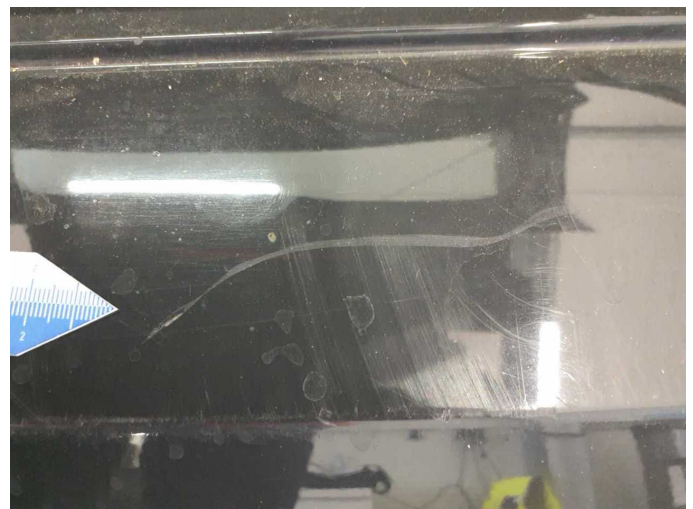
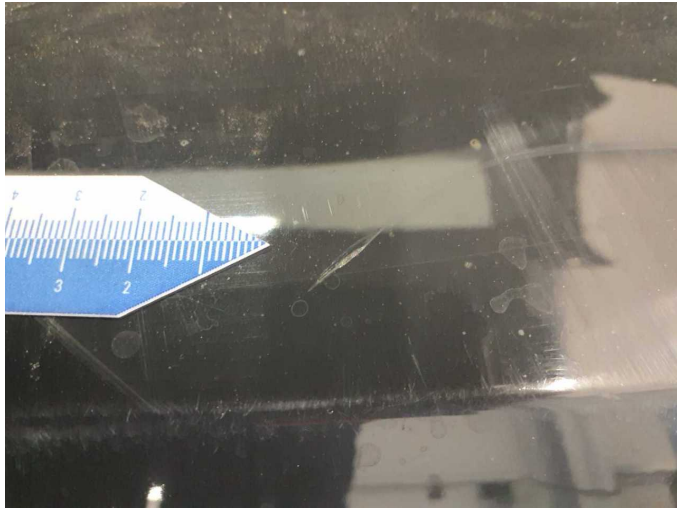
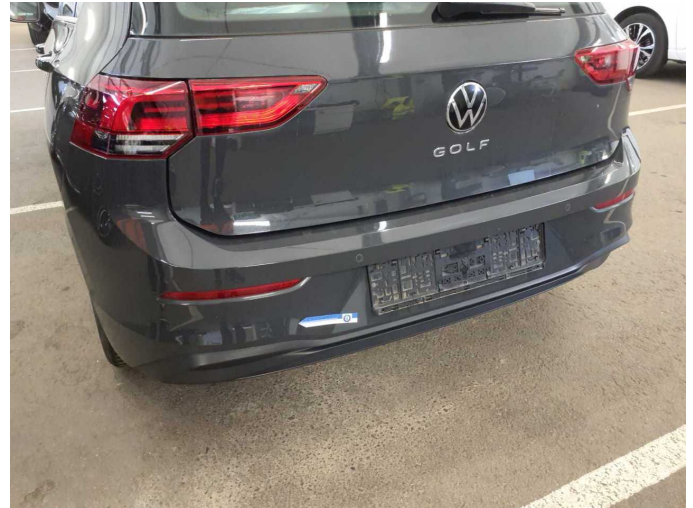
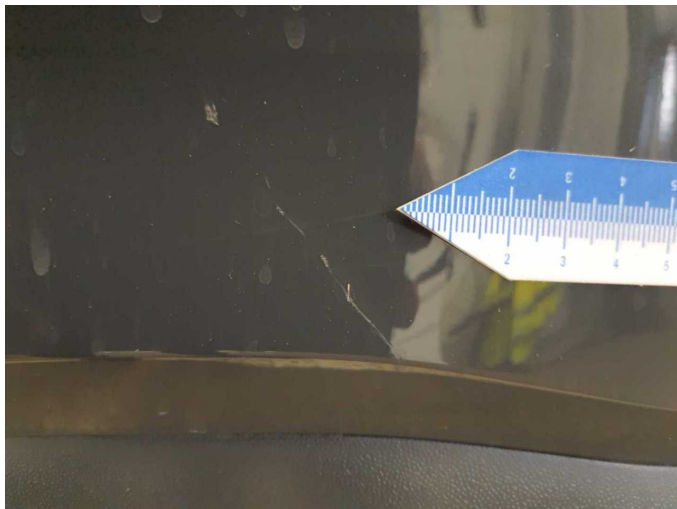
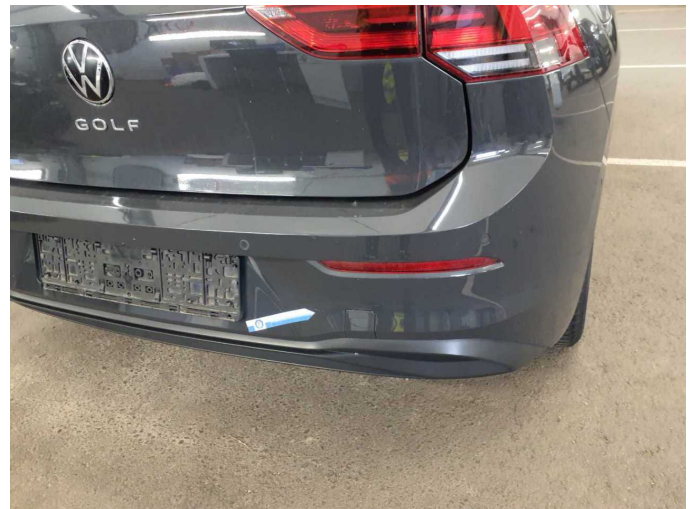
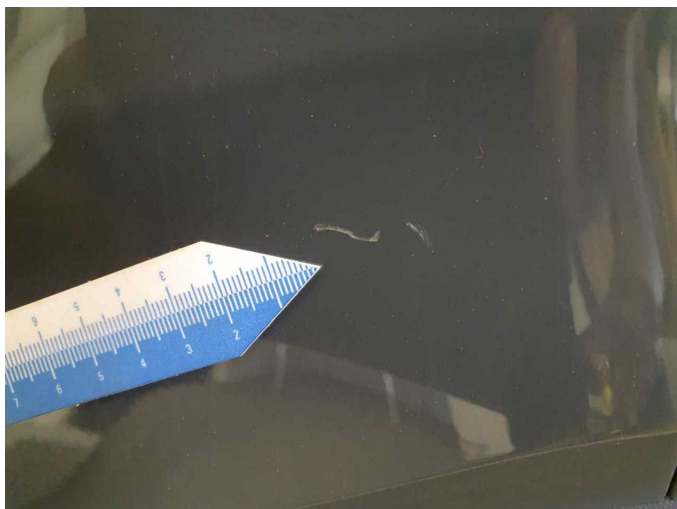
**Damage 8:** Rear bumper: Rear bumper - Scratch(es) - Paint

| No. | Component group | Description |
|---|---|---|
| 8 | Rear bumper | Rear bumper - Scratch(es) - Paint |

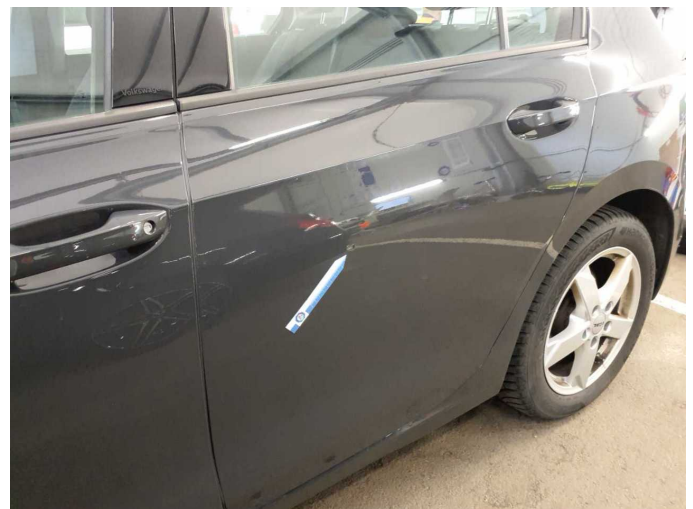
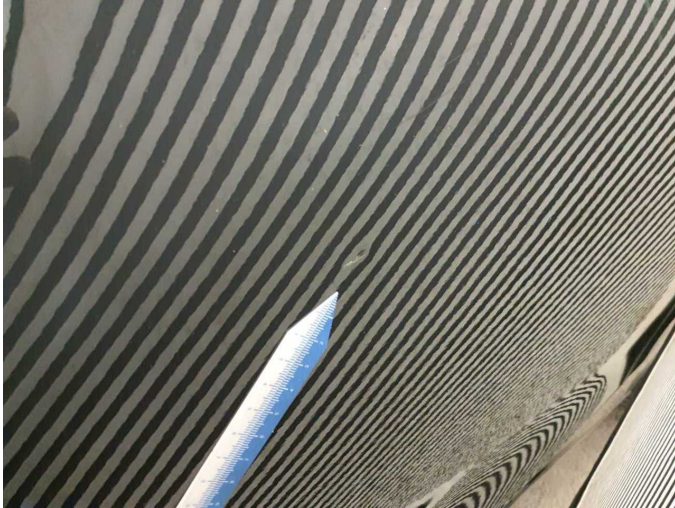
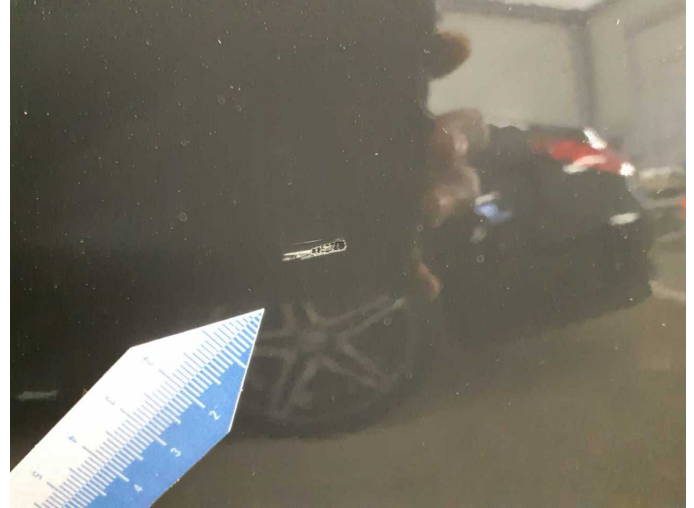
**Damage 9:** Door - rear left side: Door - Dent / paintcoat damage - Repair and paint

| No. | Component group | Description |
|---|---|---|
| 9 | Door - rear left side | Door - Dent / paintcoat damage - Repair and paint |

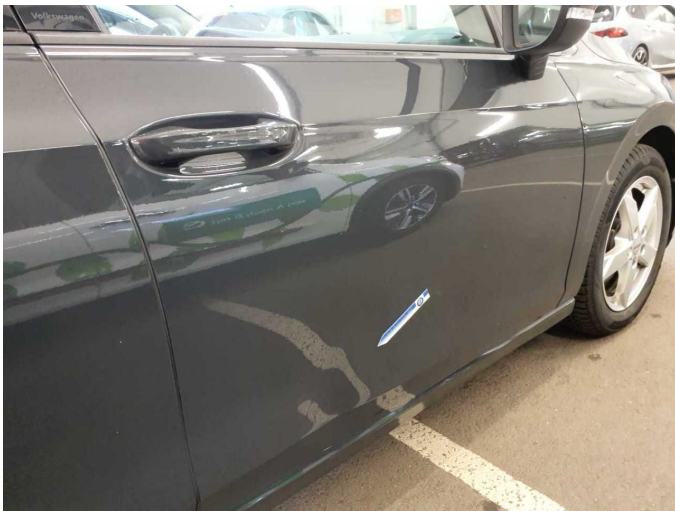
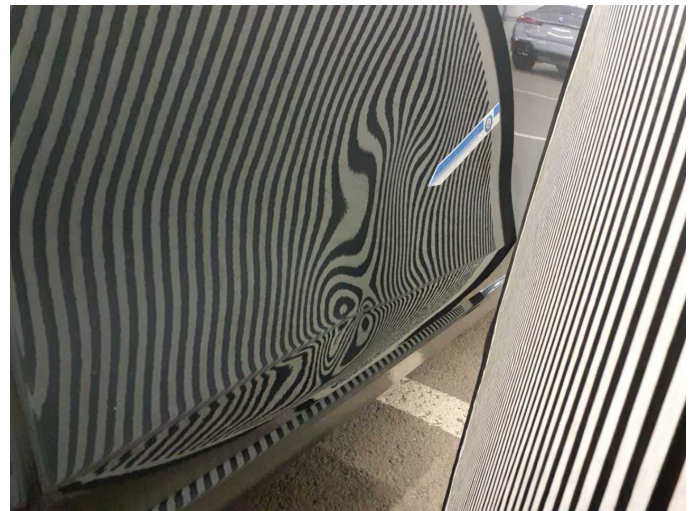
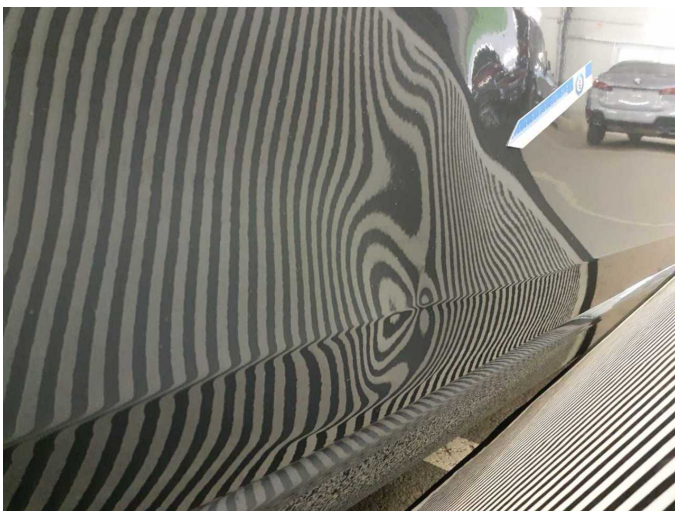
**Damage 10:** Door - front right side: Door - dent(s) - Repair and paint

| No. | Component group | Description |
|---|---|---|
| 10 | Door - front right side | Door - dent(s) - Repair and paint |
