Expertise

Protocol number: 46480839  
Order No. / Reference: 26595511  
Inspection date: 10 Jul 2026

Manufacturer: Peugeot

Model: 208 Elektromotor 136 Allure

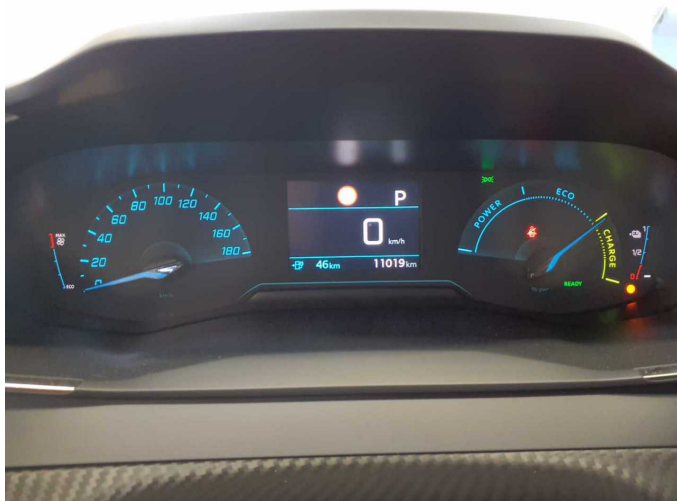
Figure 7: Instrument cluster

Mileage (Read) 11,019 km

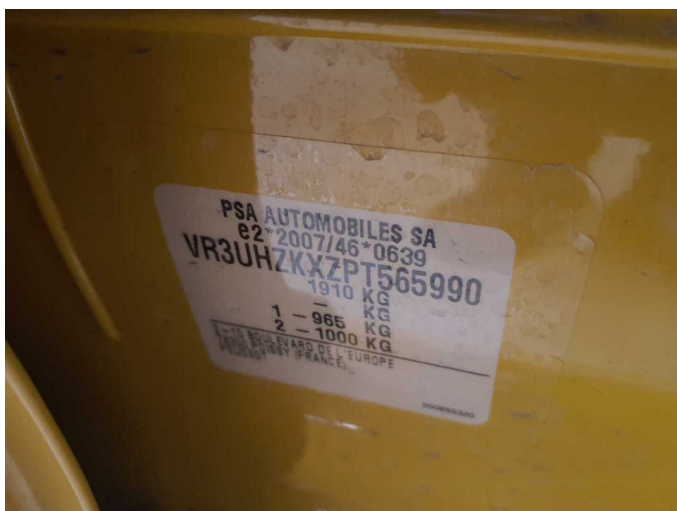
Figure 11: VIN

| VIN comparison | The vehicle identification number (VIN) was read from the vehicle and its conformity with the submitted documents was confirmed by the undersigned during the inspection. |

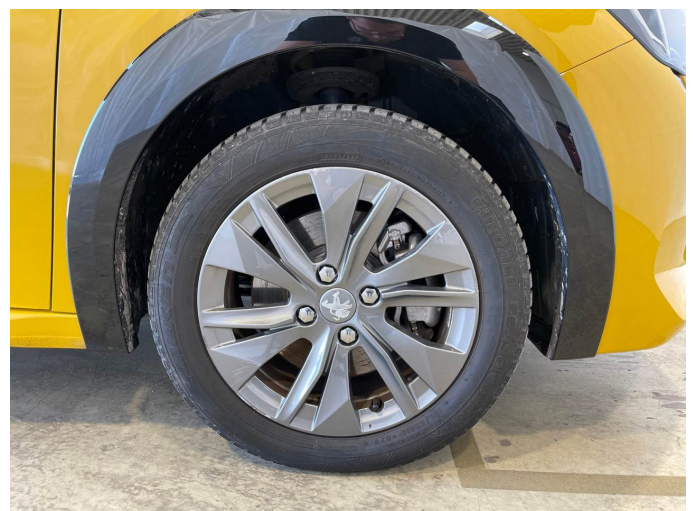
Figure 12: Mounted tyres

| # | Tyre size | Type of tyre | Manufacturer | Tread depth |
|---|---|---|---|---|
| 1) | 195/55 R16 87V | All-season tyres on Light alloy | Falken | 5mm / 5mm |
| 2) | 195/55 R16 87V | All-season tyres on Light alloy | Falken | 6mm / 6mm |

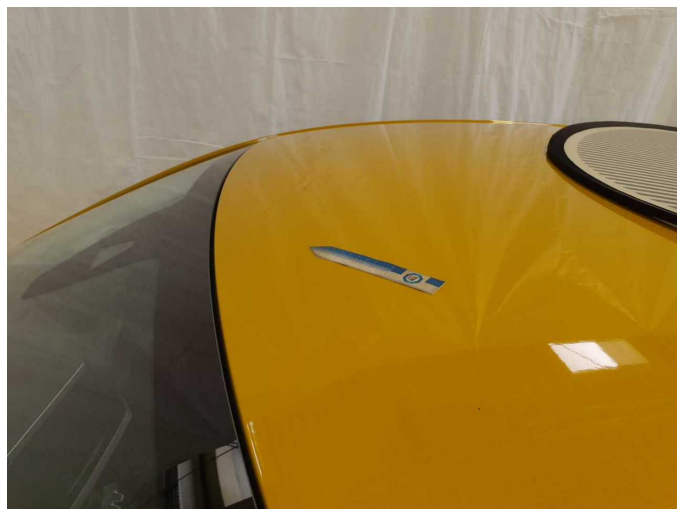
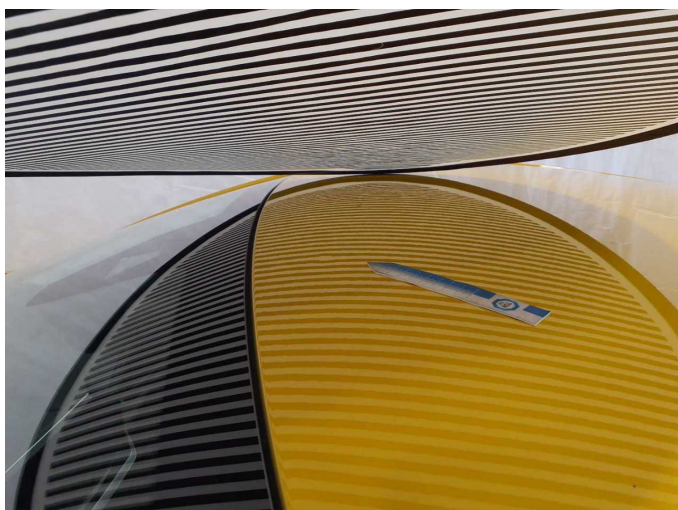
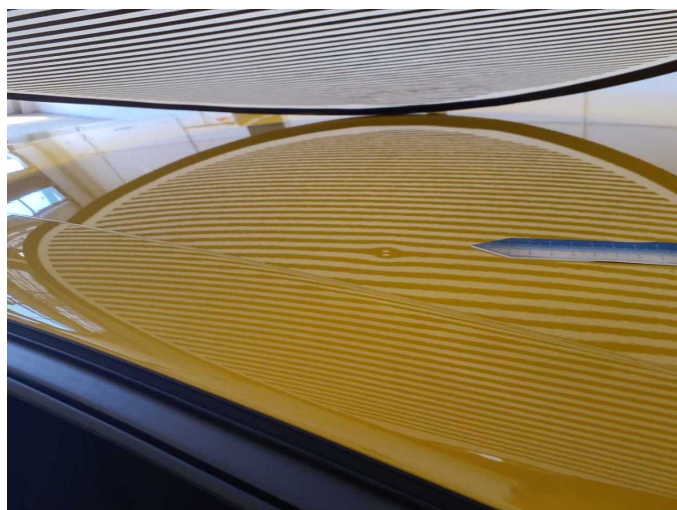
**Damage 1:** Roof: Roof - dent(s) - Smooth repair work

| No. | Component group | Description |
|---|---|---|
| 1 | Roof | Roof - dent(s) - Smooth repair work |

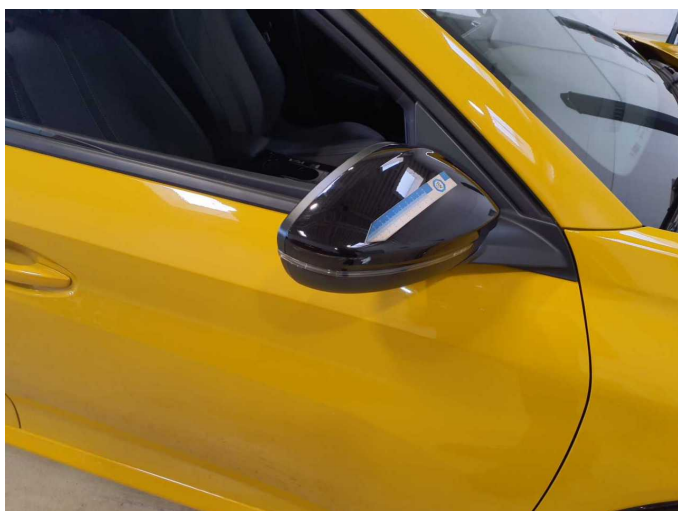
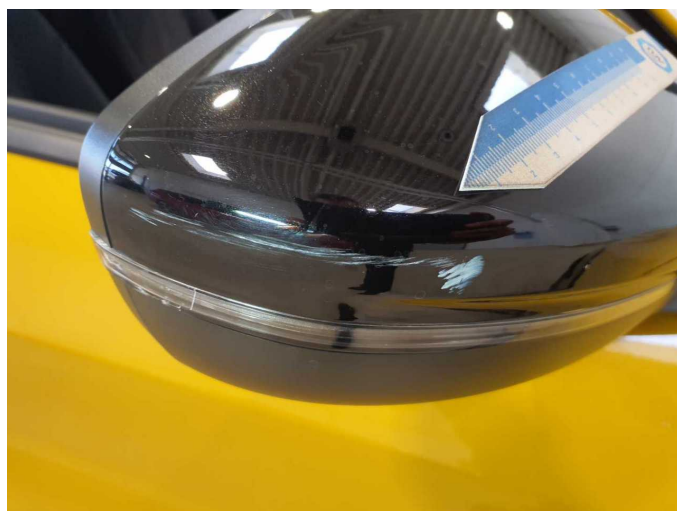
**Damage 2:** Wing mirror - right side: Cap - Scratch(es) - Smart repair

| No. | Component group | Description |
|---|---|---|
| 2 | Wing mirror - right side | Cap - Scratch(es) - Smart repair |

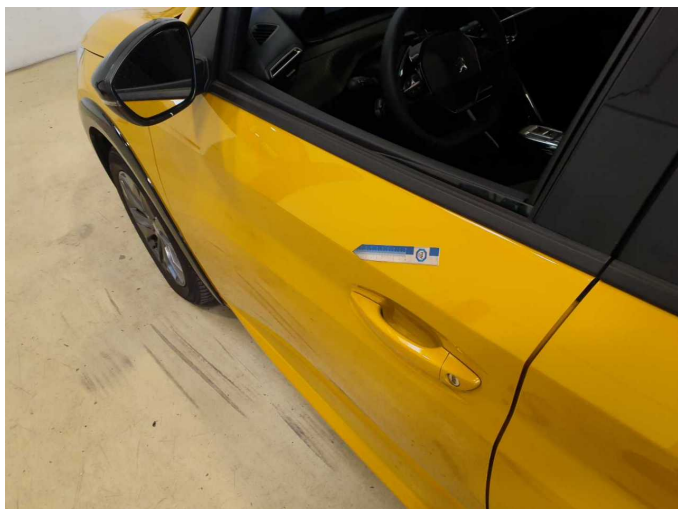
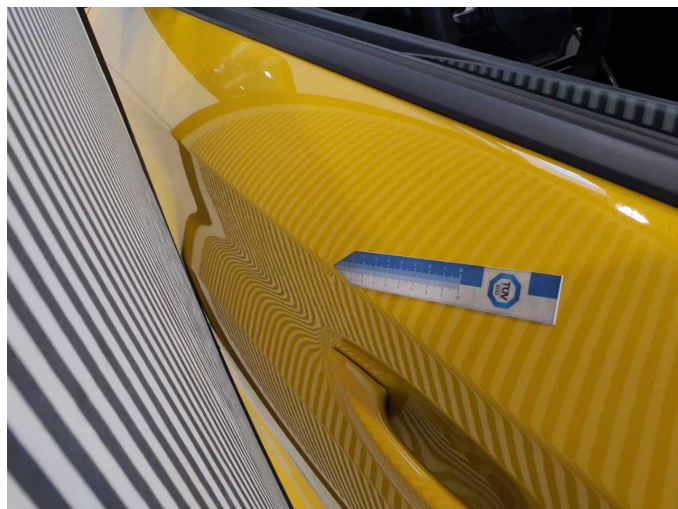
**Damage 3:** Door - front left side: Door - dent(s) - Smart repair

| No. | Component group | Description |
|---|---|---|
| 3 | Door - front left side | Door - dent(s) - Smart repair |

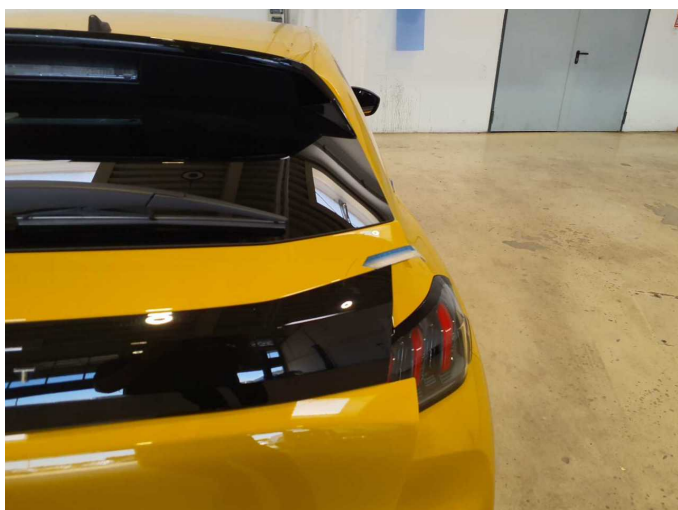
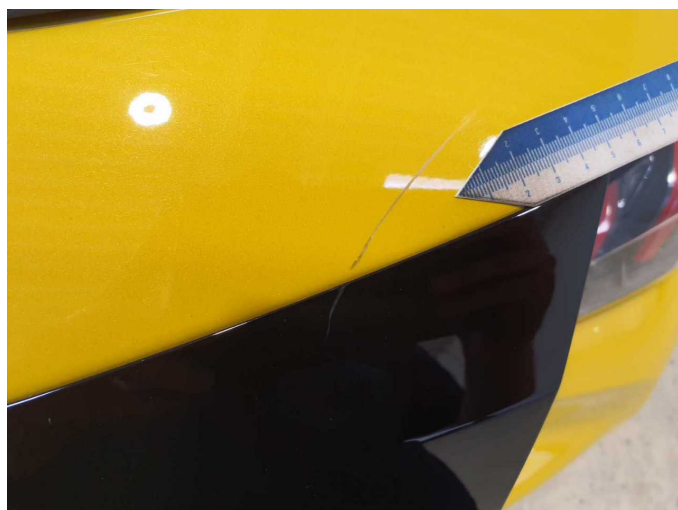
**Damage 4:** Boot lid / rear door: Boot lid - Scratch(es) - Smart repair

| No. | Component group | Description |
|---|---|---|
| 4 | Boot lid / rear door | Boot lid - Scratch(es) - Smart repair |

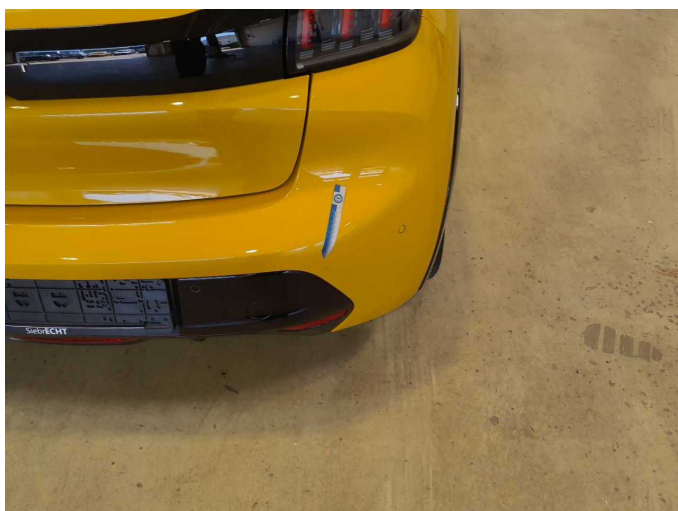
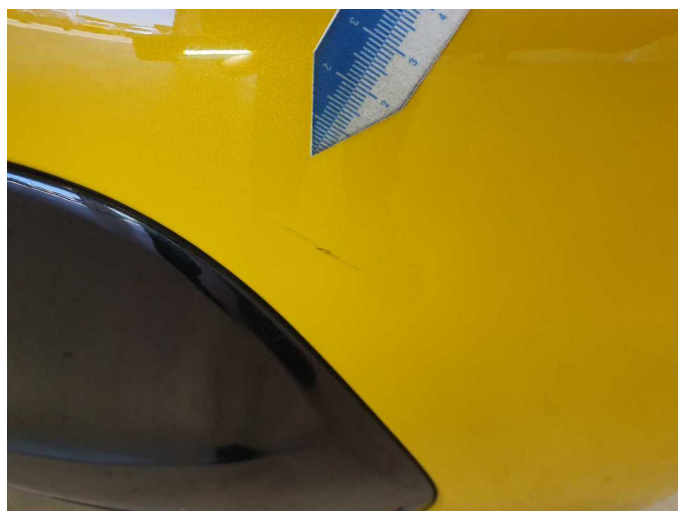
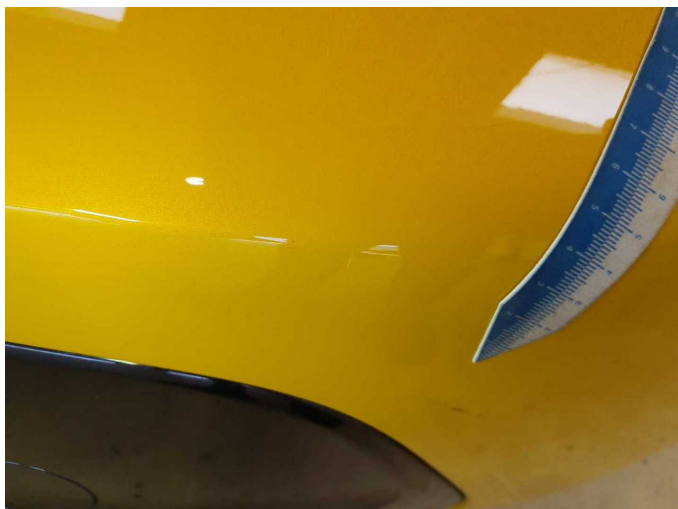
**Damage 5:** Rear bumper: Rear bumper - Scratch(es) - Smart repair

| No. | Component group | Description |
|---|---|---|
| 5 | Rear bumper | Rear bumper - Scratch(es) - Smart repair |

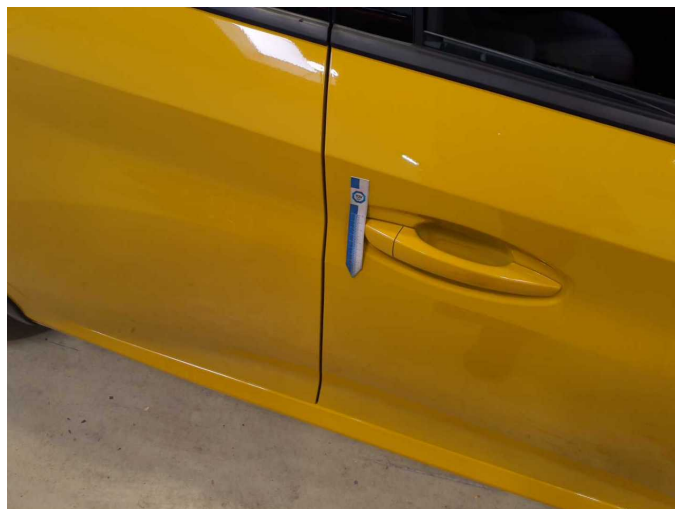
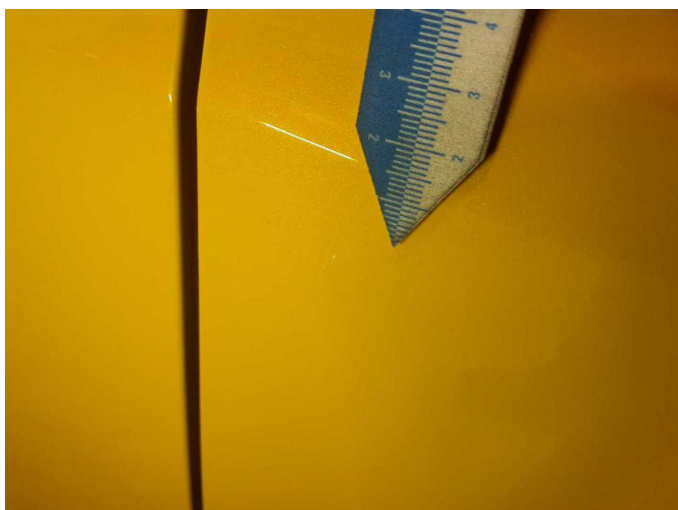
**Damage 6:** Door - front right side: Door - Scratch(es) - Smart repair

| No. | Component group | Description |
|---|---|---|
| 6 | Door - front right side | Door - Scratch(es) - Smart repair |

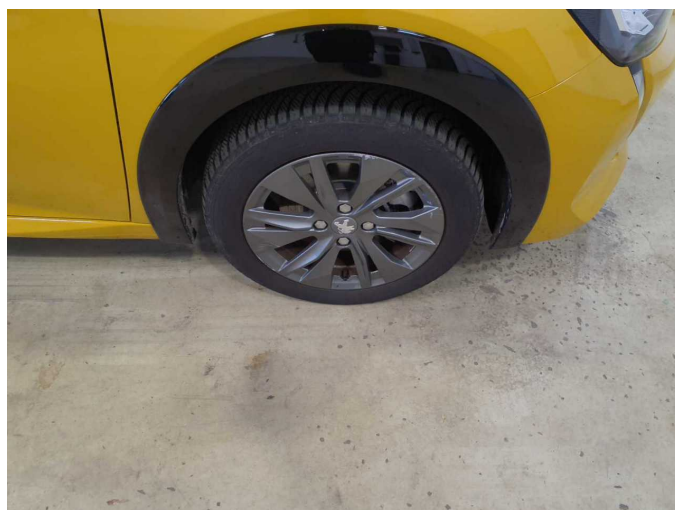
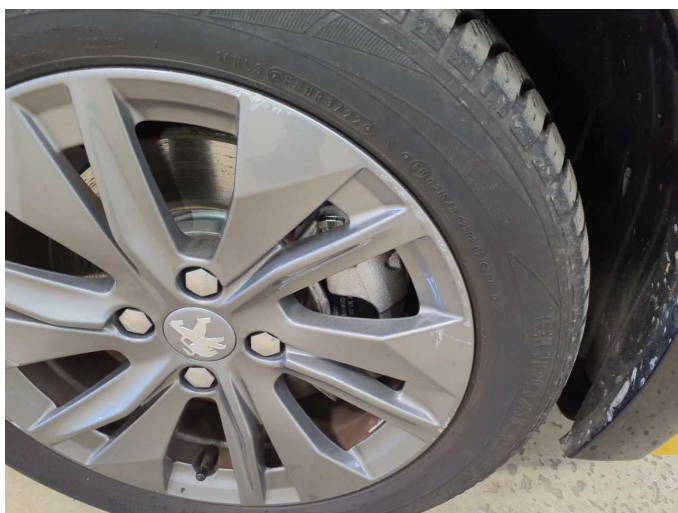
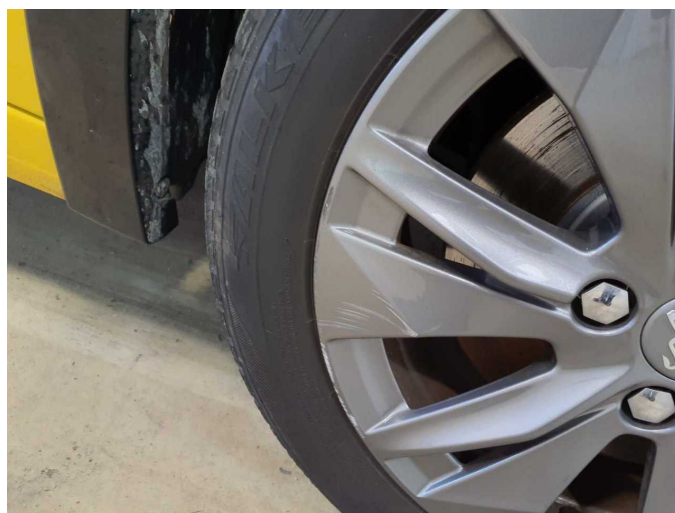
**Damage 7:** Wheel / tyres: Alloy rim - front right side - Scratch(es) - Replace

| No. | Component group | Description |
|---|---|---|
| 7 | Wheel / tyres | Alloy rim - front right side - Scratch(es) - Replace |

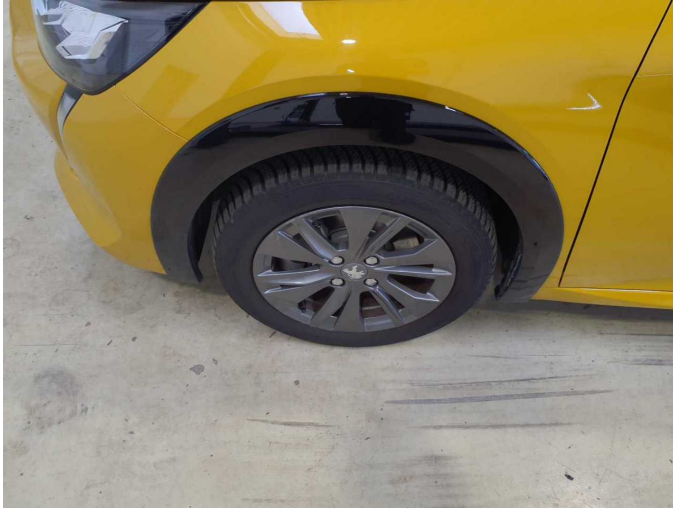
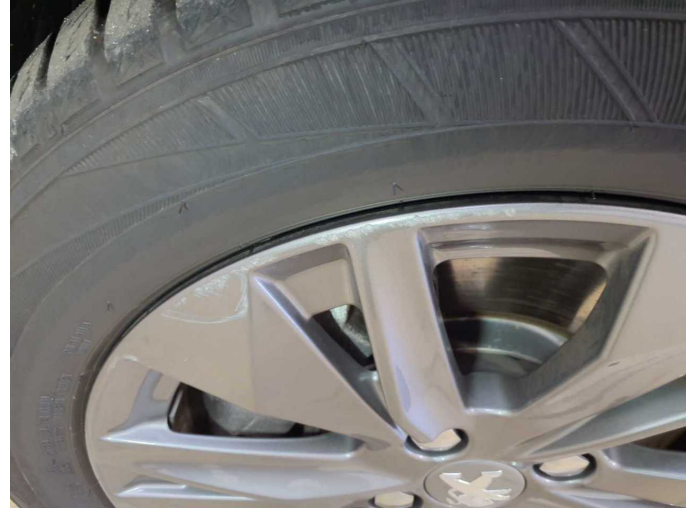
**Damage 8:** Wheel / tyres: Alloy rim - front left side - Scratch(es) - Replace

| No. | Component group | Description |
|---|---|---|
| 8 | Wheel / tyres | Alloy rim - front left side - Scratch(es) - Replace |
