Expertise

Protocol number: 46526002  
Order No. / Reference: 26521442  
Inspection date: 15 Jul 2026

Manufacturer: Volkswagen

Model: Tiguan Allspace 2.0 TDI SCR DSG Life

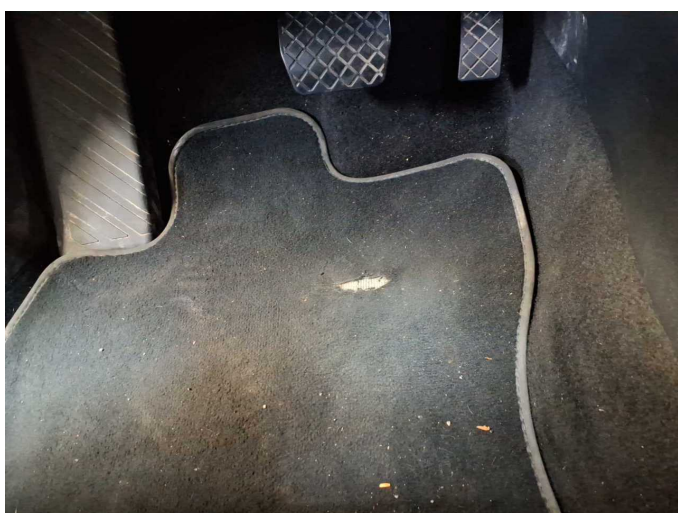
| No. | Component group | Description |
|---|---|---|
| 2 | Trim / covers | Floor mats - Broken / torn - Replace |

**Damage 2:** Trim / covers: Floor mats - Broken / torn - Replace

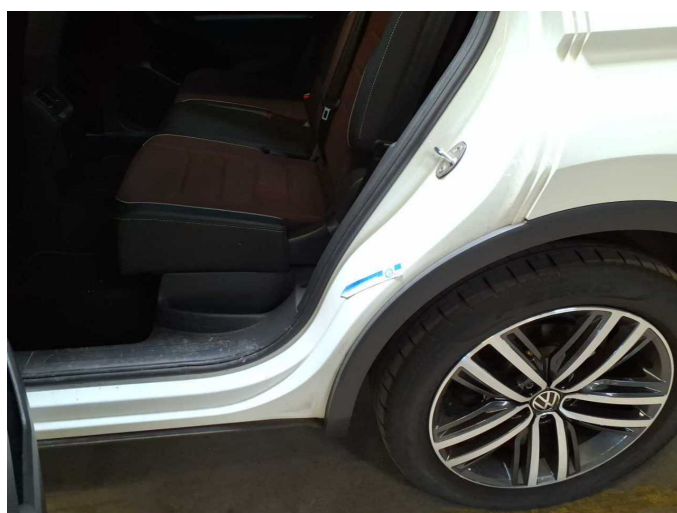
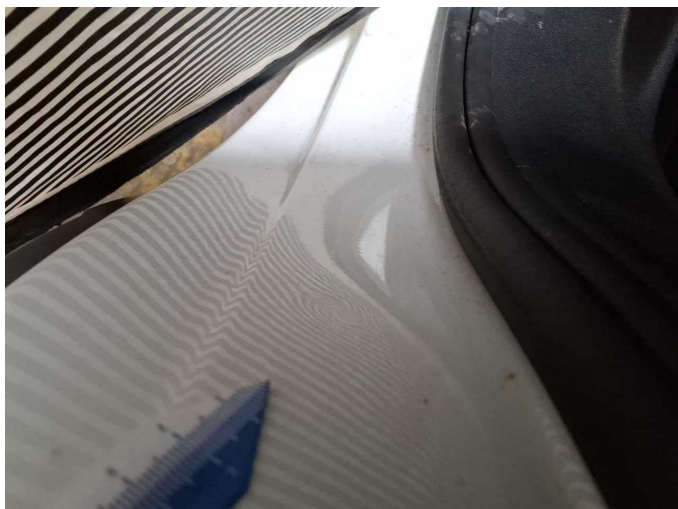
| No. | Component group | Description |
|---|---|---|
| 3 | Side panel - rear left side | Sill - dent(s) - Smooth repair work |

**Damage 3:** Side panel - rear left side: Sill - dent(s) - Smooth repair work

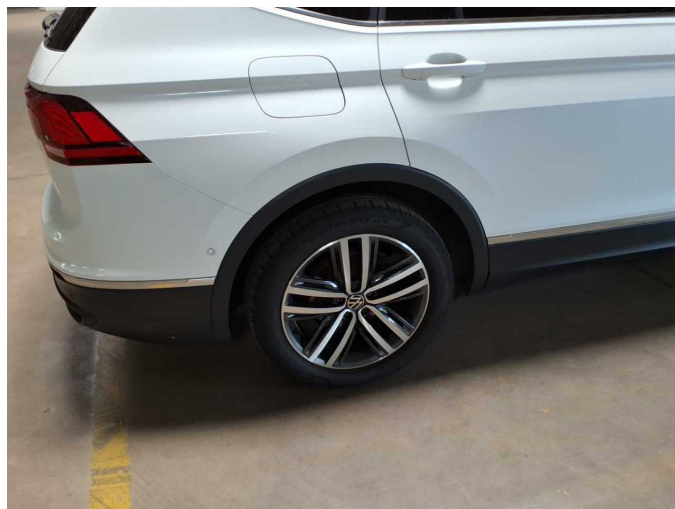
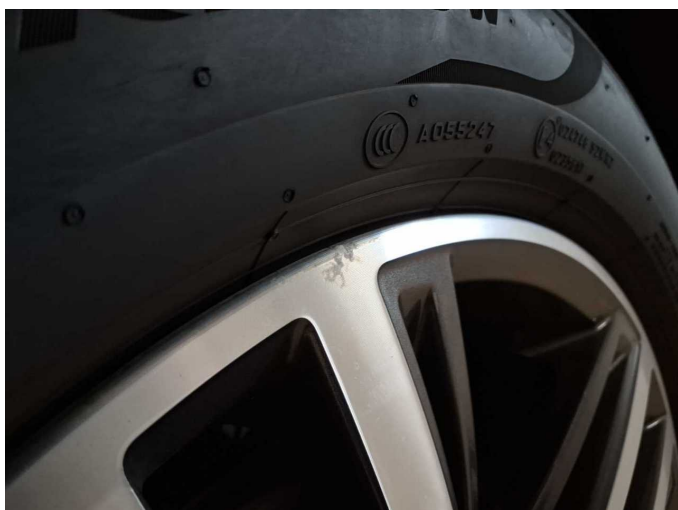
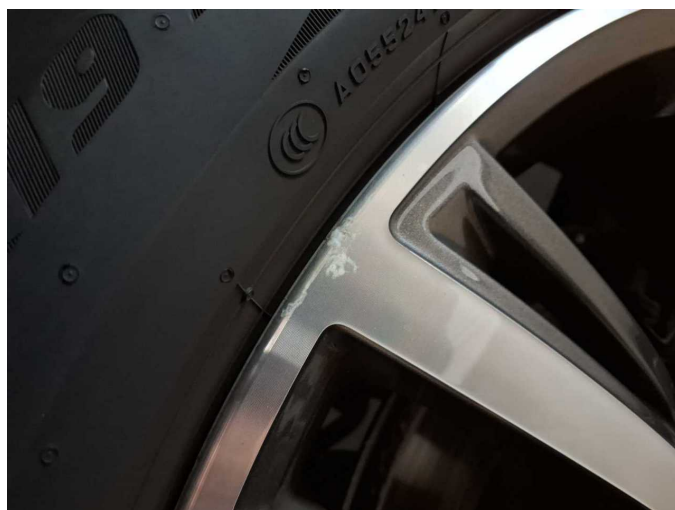
| No. | Component group | Description |
|---|---|---|
| 4 | Wheel / tyres | Alloy rim - rear right side - Scratch(es) - Loss in value |

**Damage 4:** Wheel / tyres: Alloy rim - rear right side - Scratch(es) - Loss in value

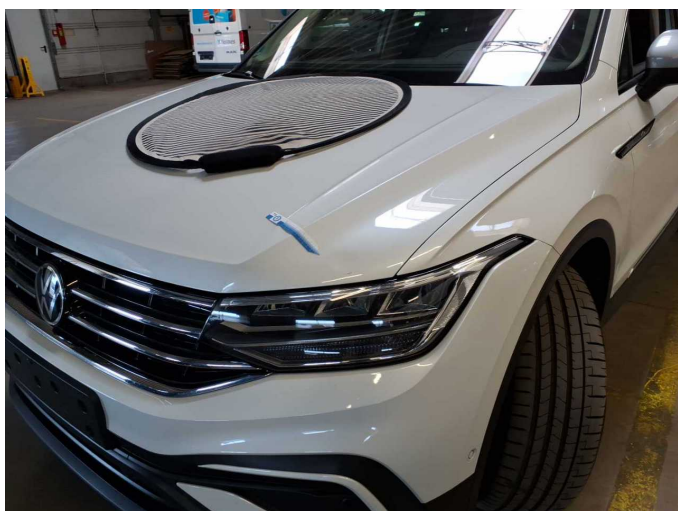
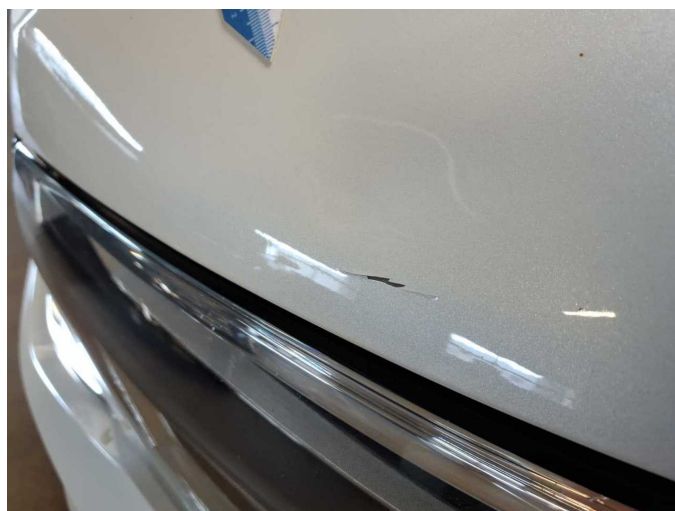
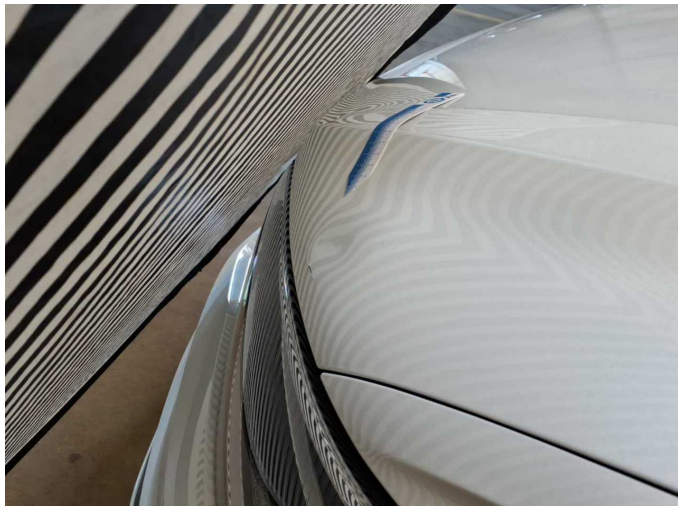
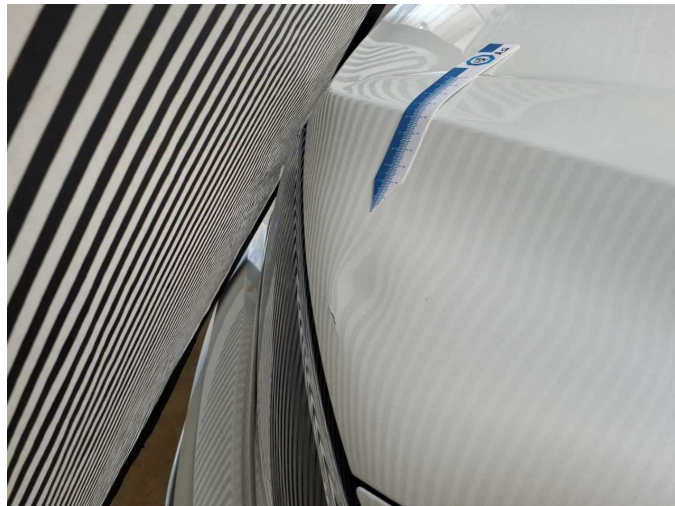
| No. | Component group | Description |
|---|---|---|
| 5 | Bonnet | Bonnet - Deformed - Repair and paint |

**Damage 5:** Bonnet: Bonnet - Deformed - Repair and paint

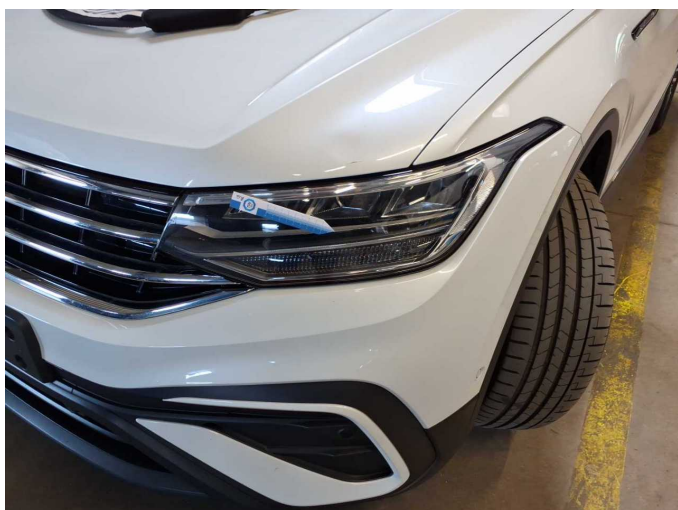
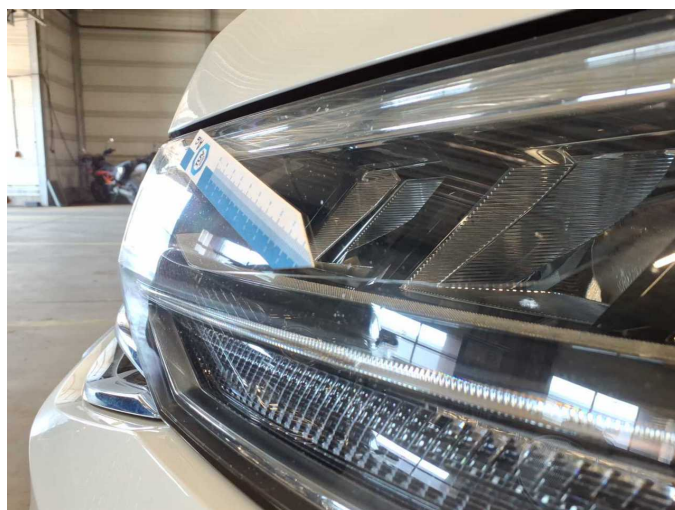
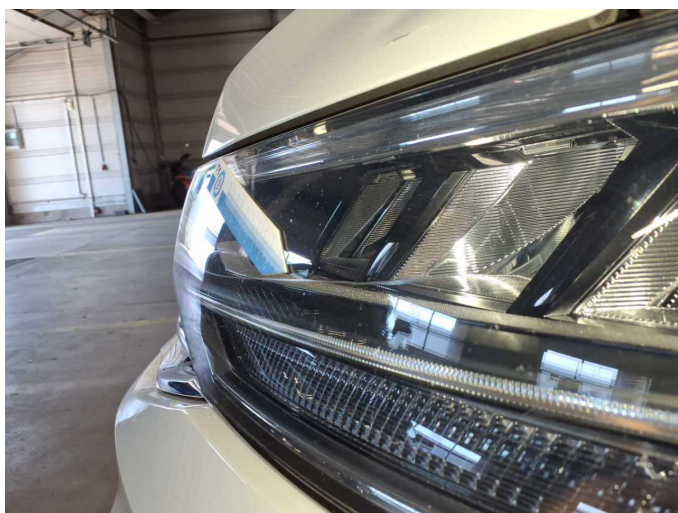
| No. | Component group | Description |
|---|---|---|
| 6 | Headlight | Headlight - left side (im Streubereich) - Scratch(es) - Replace |

**Damage 6:** Headlight: Headlight - left side (im Streubereich) - Scratch(es)  
- Replace

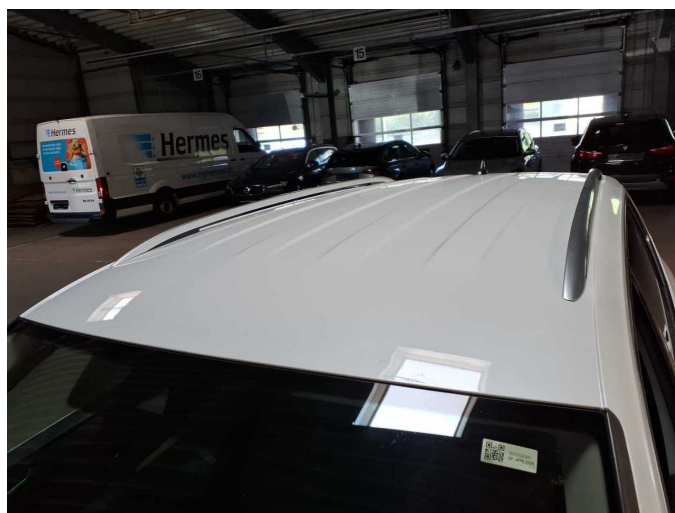
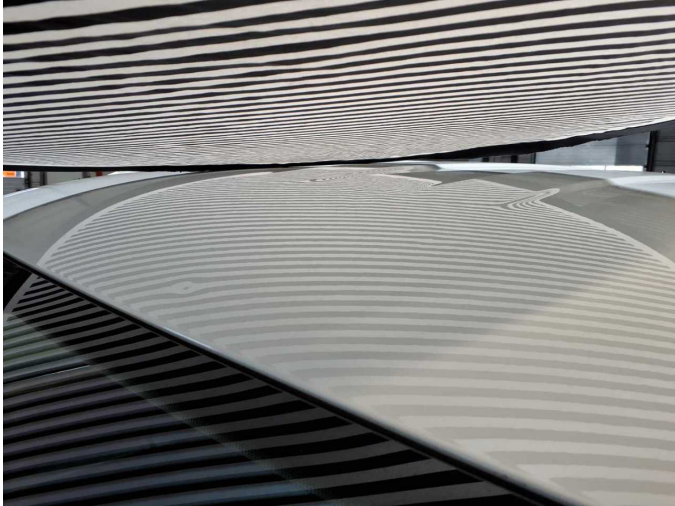
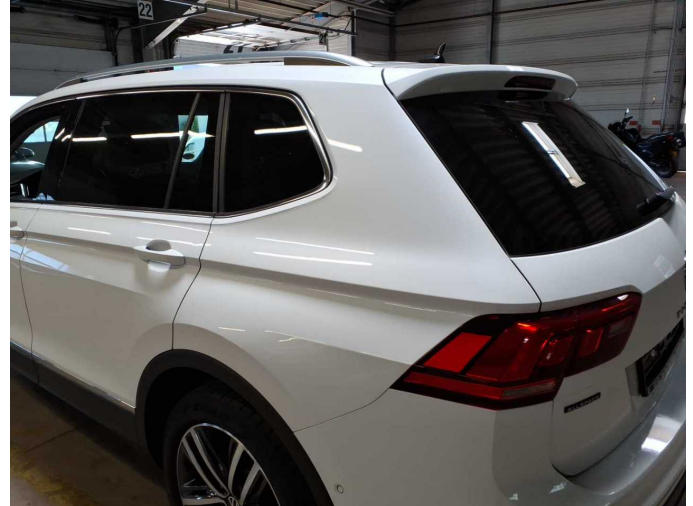
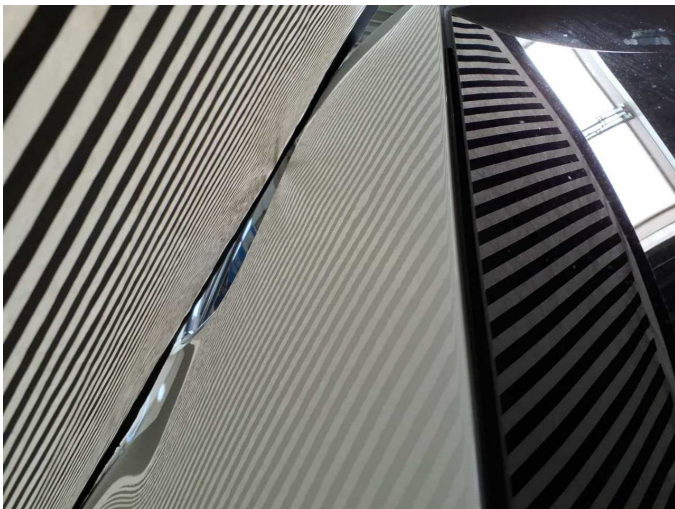
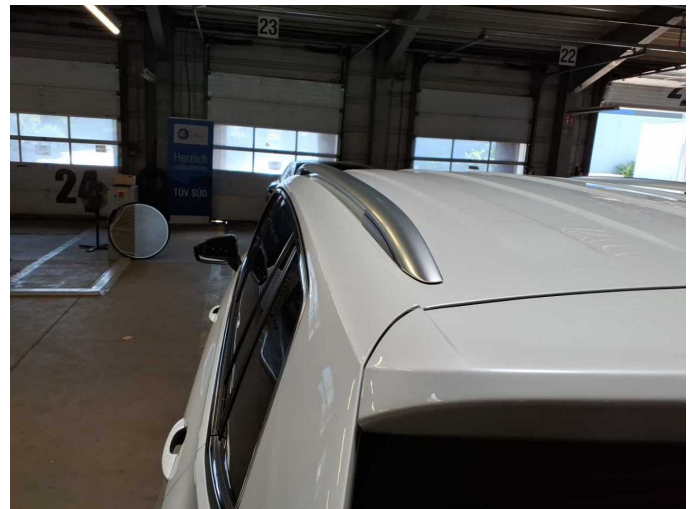
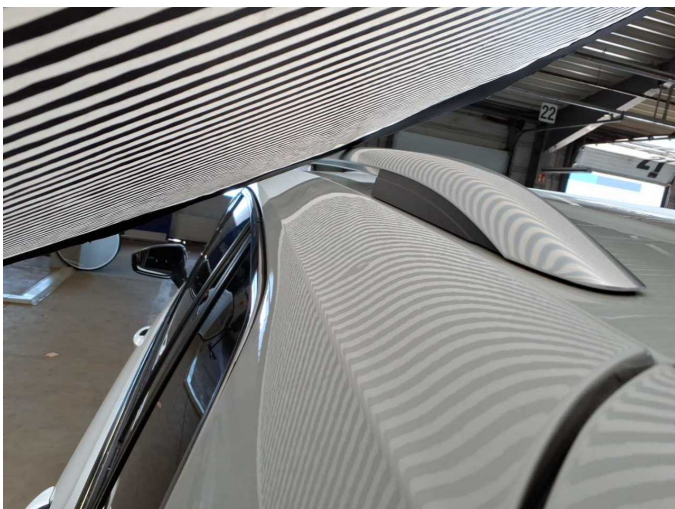
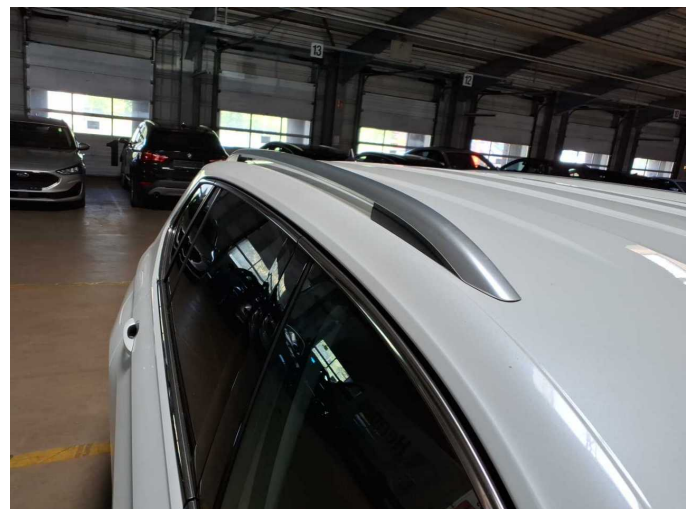
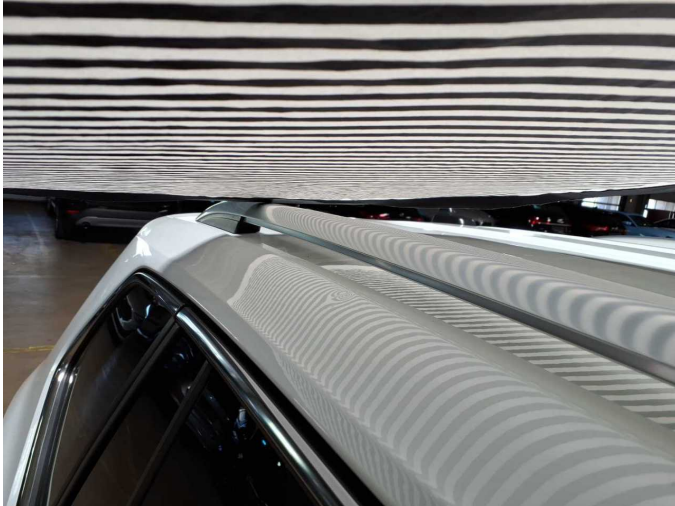
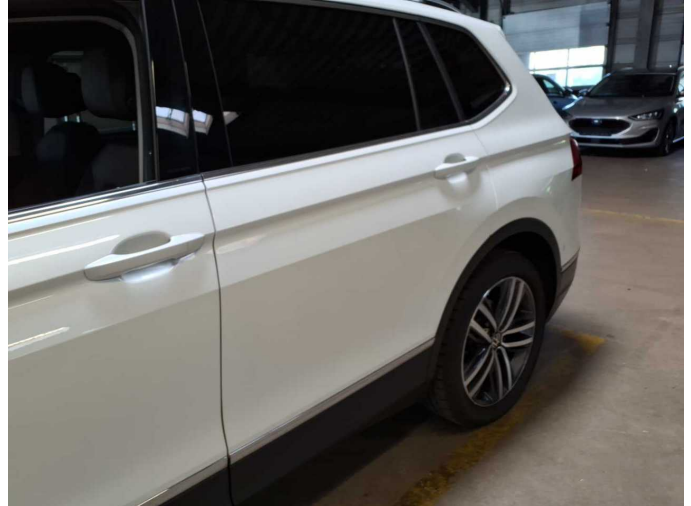
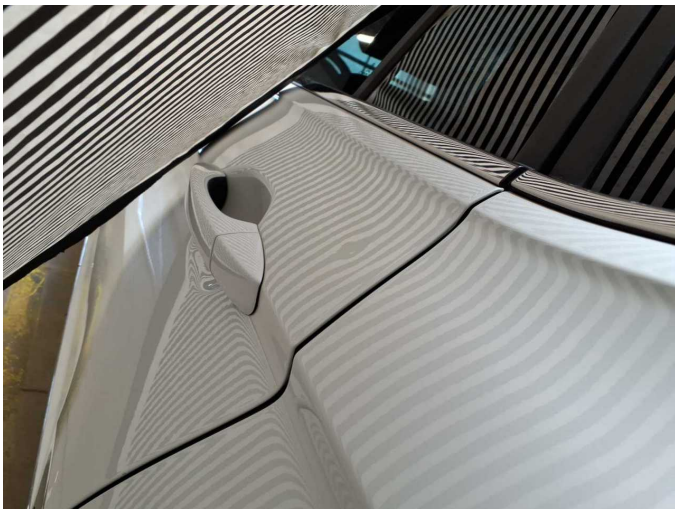
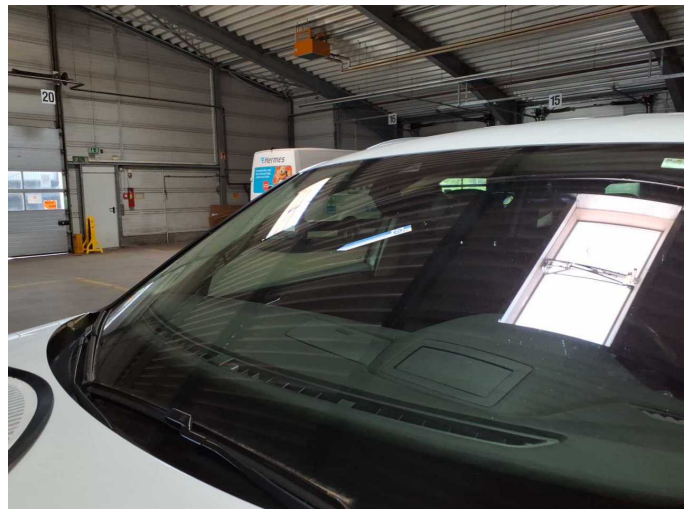
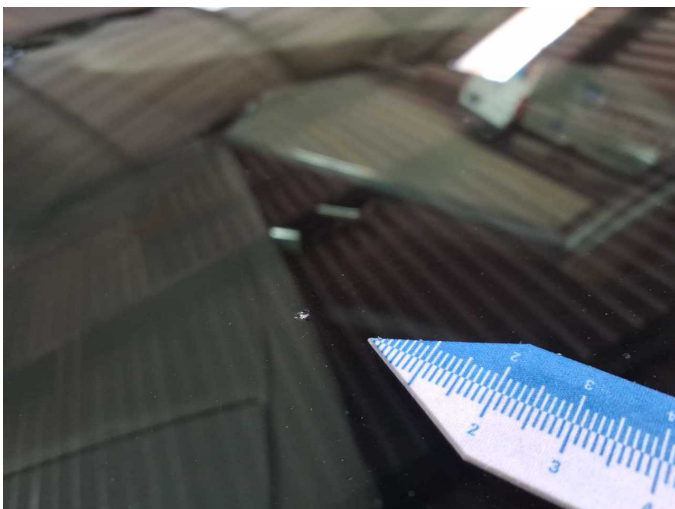
| No. | Component group | Description |
|---|---|---|
| 7 | Body | Body - Damage by hail - repair according to calculation |

**Damage 7:** Body: Body - Damage by hail - repair according to calculation
