Expertise

Protocol number: 46057402
Order No. / Reference: 26521344
Inspection date: 19 Jun 2026

Model: XC40 Recharge 69 kWh Single Motor Ultimate

VIN: YV1XZEFV6P2104392

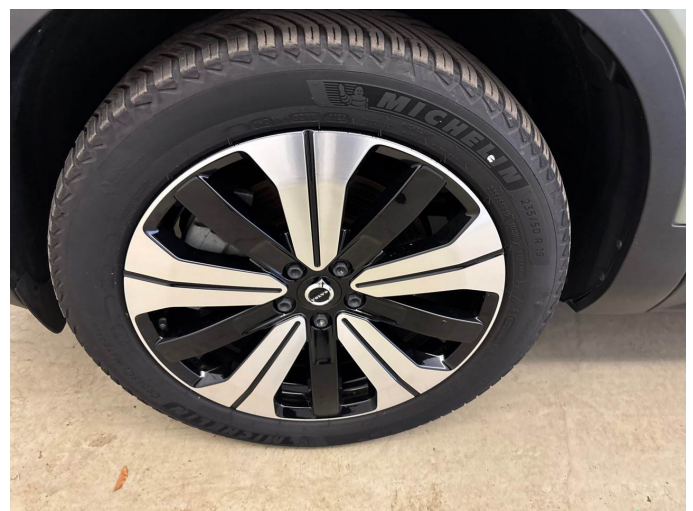
Figure 12: Mounted tyres

#	Tyre size	Type of tyre	Manufacturer	Tread depth
1)	235/50 R19 103H	All-season tyres on Light alloy	Michelin	5mm / 5mm
2)	235/50 R19 103H	All-season tyres on Light alloy	Michelin	5mm / 5mm

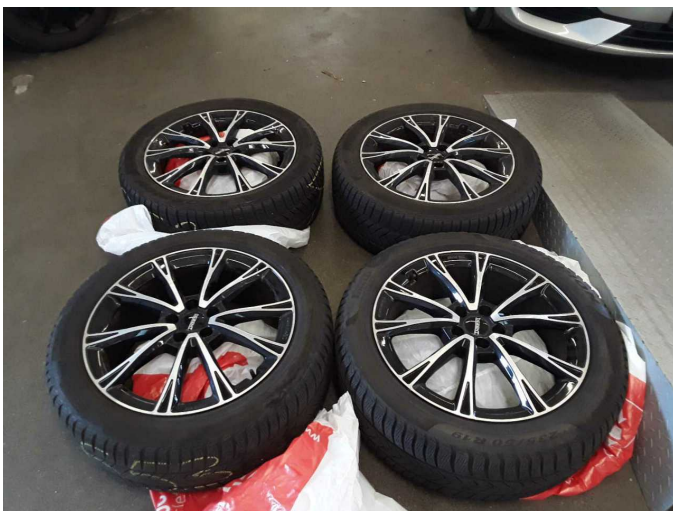
Figure 15: Additional tyres

#	Tyre size	Type of tyre	Manufacturer	Tread depth
1)	235/50 R19 103H	Winter tyres on Light alloy	Pirelli	4mm / 4mm
2)	235/50 R19 103H	Winter tyres on Light alloy	Pirelli	5mm / 5mm

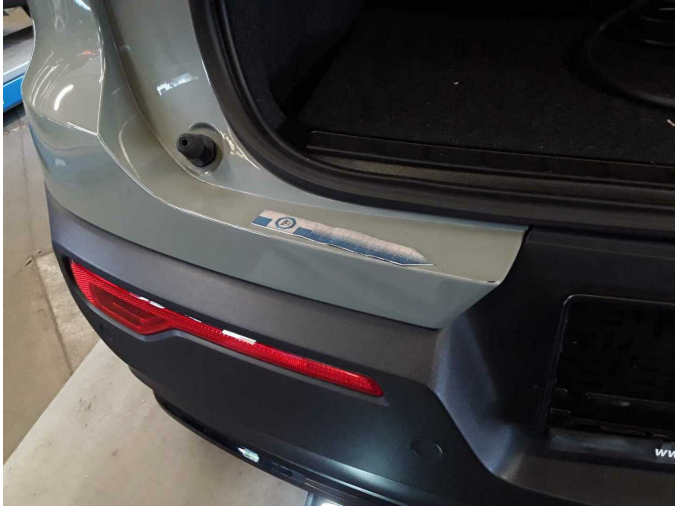
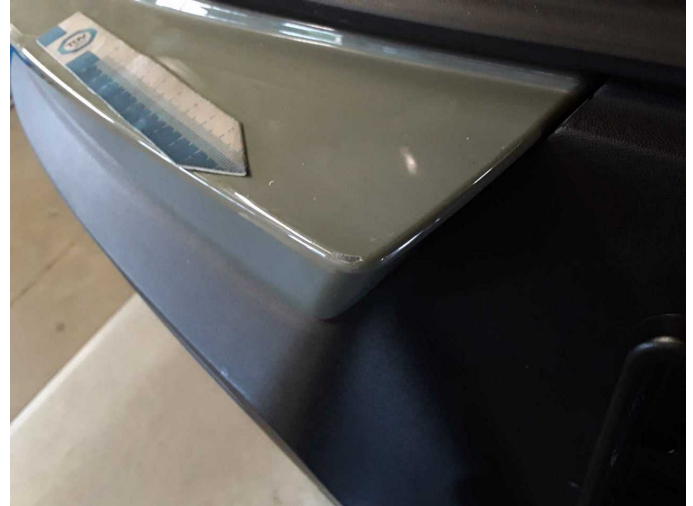
Damage 1: Rear bumper: Rear bumper - Scratch(es) - Smart repair

No.	Component group	Description
1	Rear bumper	Rear bumper - Scratch(es) - Smart repair
2	Front bumper	Front bumper - Scratch(es) - Smart repair
3	Rear bumper	Rear bumper (unpainted) - Scratched - Smart repair

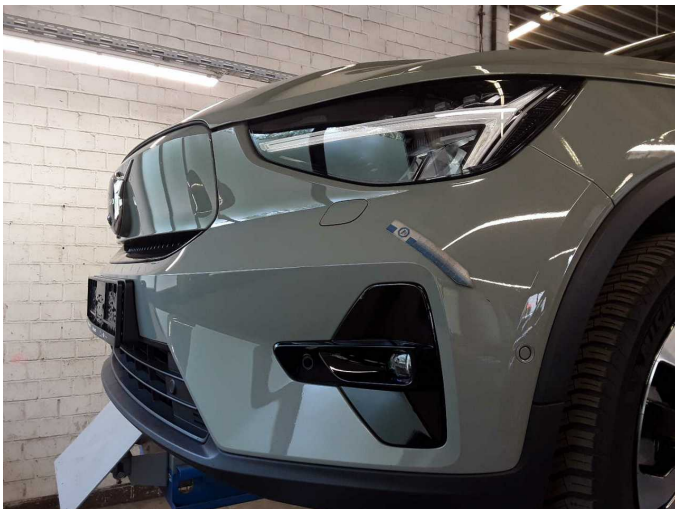
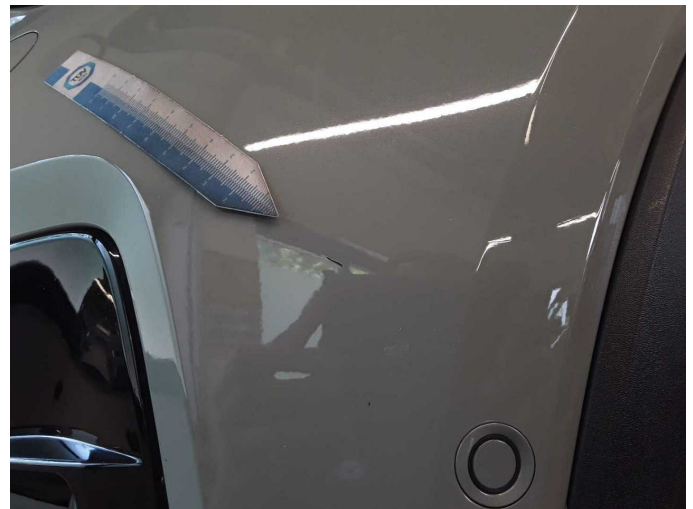
Damage 2: Front bumper: Front bumper - Scratch(es) - Smart repair

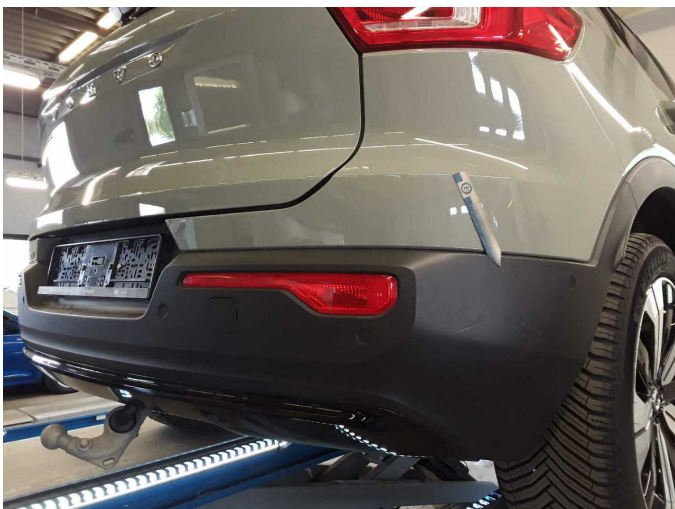
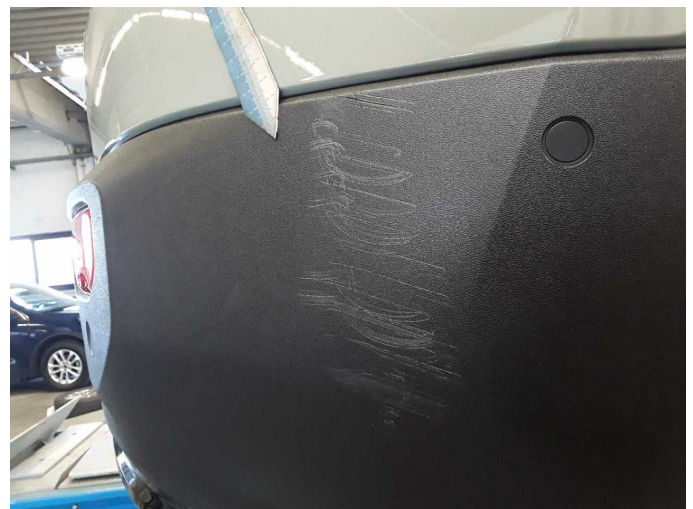
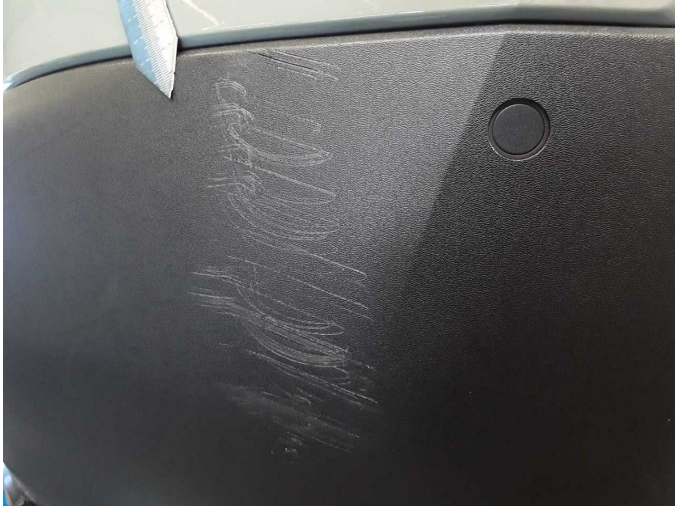
Damage 3: Rear bumper: Rear bumper (unpainted) - Scratched - Smart repair

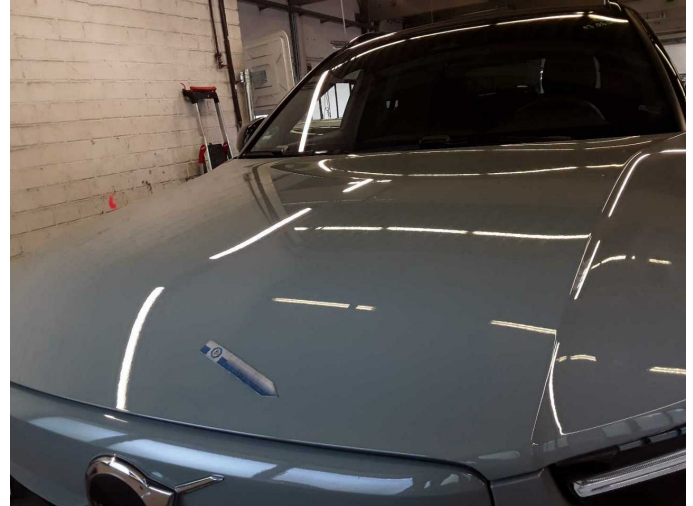
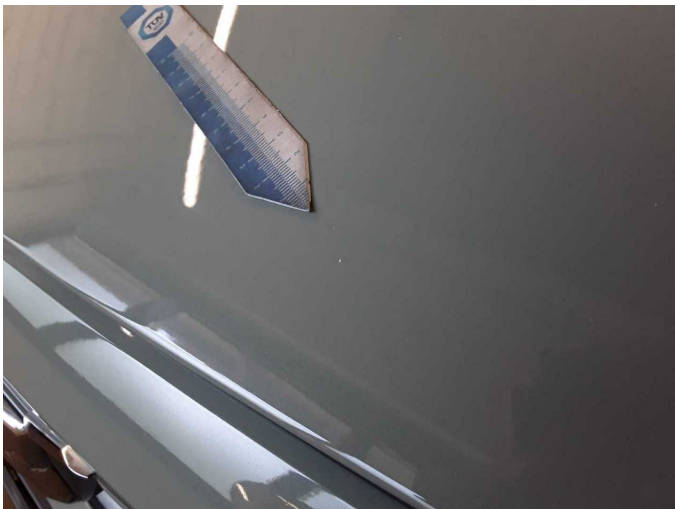
Wear and tear 1: Bonnet: Bonnet - Stone chips - No deduction

No.	Component group	Description
1	Bonnet	Bonnet - Stone chips - No deduction
2	Wheel / tyres	Alloy rim - rear right side - Scratch(es) - No deduction
3	Vehicle glazing	Windscreen - Stone chips - No deduction

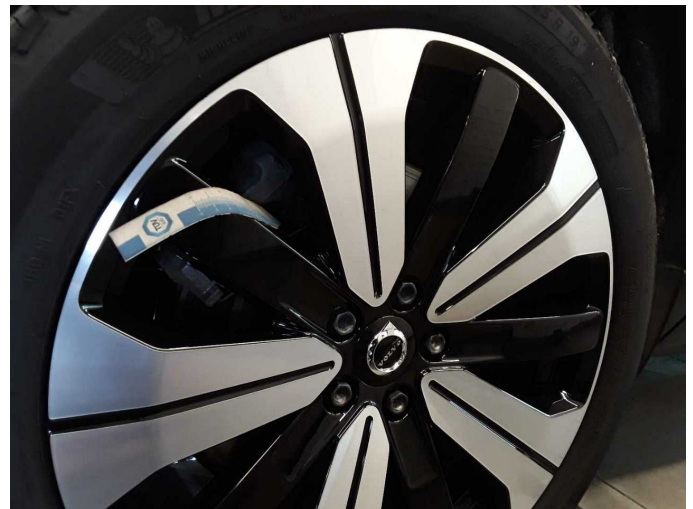
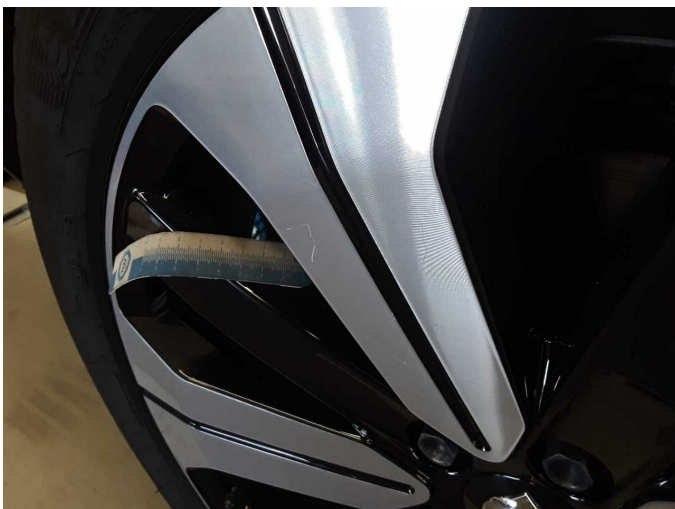
Wear and tear 2: Wheel / tyres: Alloy rim - rear right side - Scratch(es) - No deduction

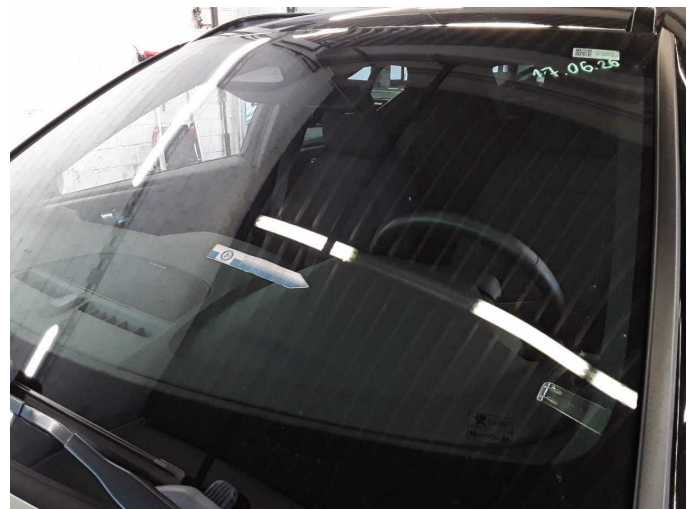
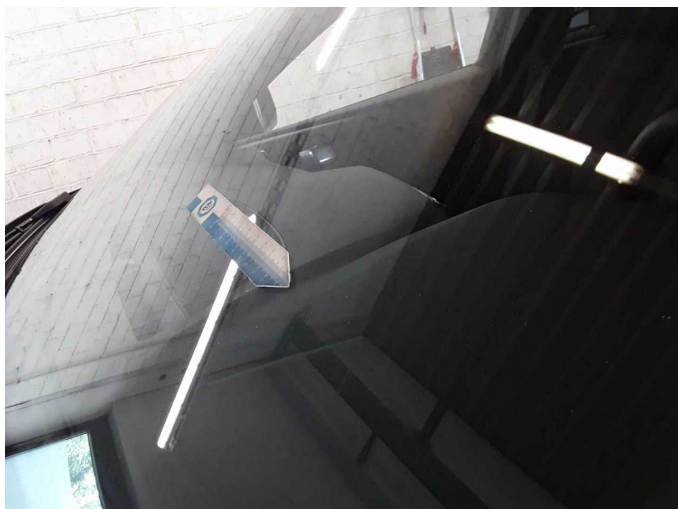
Wear and tear 3: Vehicle glazing: Windscreen - Stone chips - No deduction
