Expertise

Protocol number: 46416738  
Order No. / Reference: 26652907  
Inspection date: 8 Jul 2026

Manufacturer: Volkswagen

Model: Touran 2.0 TDI SCR DSG Highline

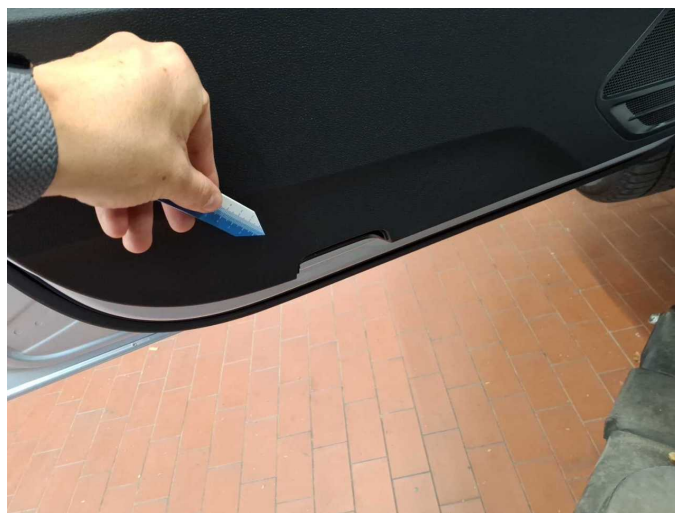
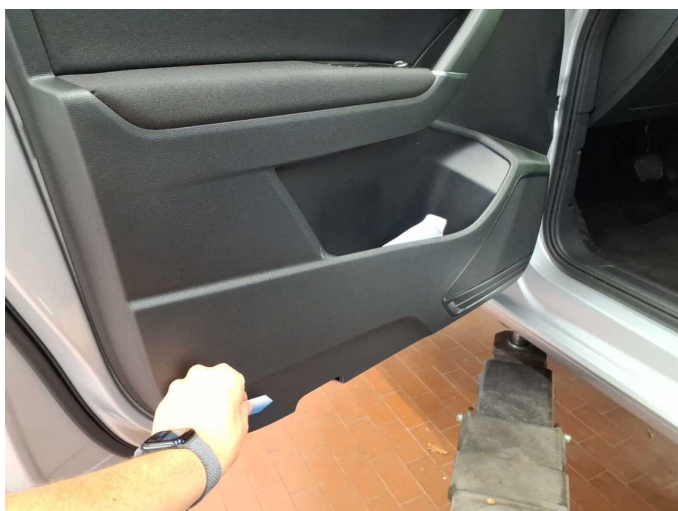
| No. | Component group | Description |
|---|---|---|
| 1 | Trim / covers | Door trim - front left side (Rückstrahler) - Missing - Replace |

**Damage 1:** Trim / covers: Door trim - front left side (Rückstrahler) - Missing - Replace

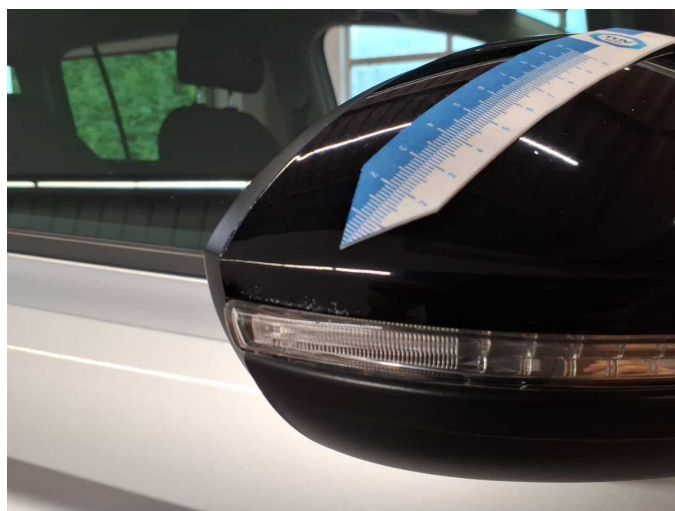
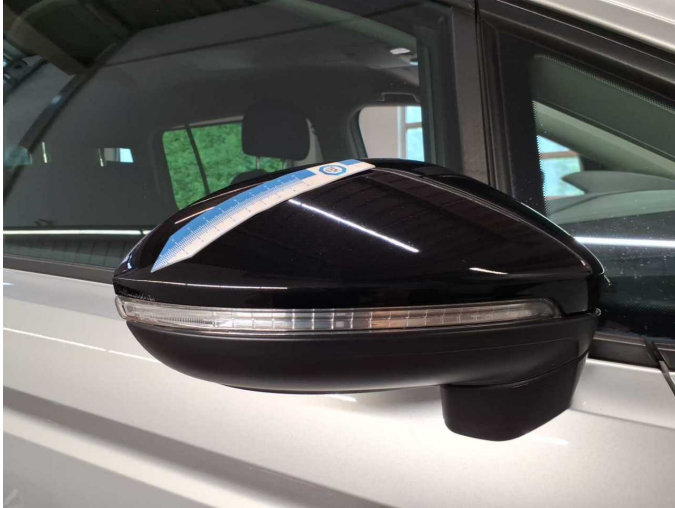
| No. | Component group | Description |
|---|---|---|
| 2 | Wing mirror - right side | Cap - Scratch(es) - Smart repair |

**Damage 2:** Wing mirror - right side: Cap - Scratch(es) - Smart repair

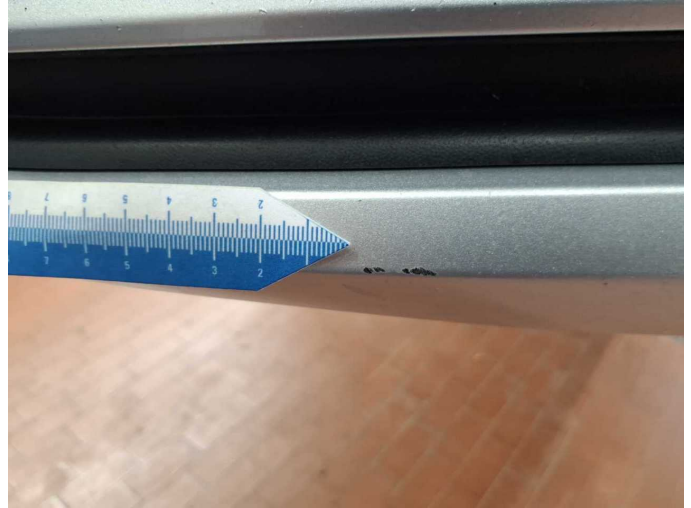
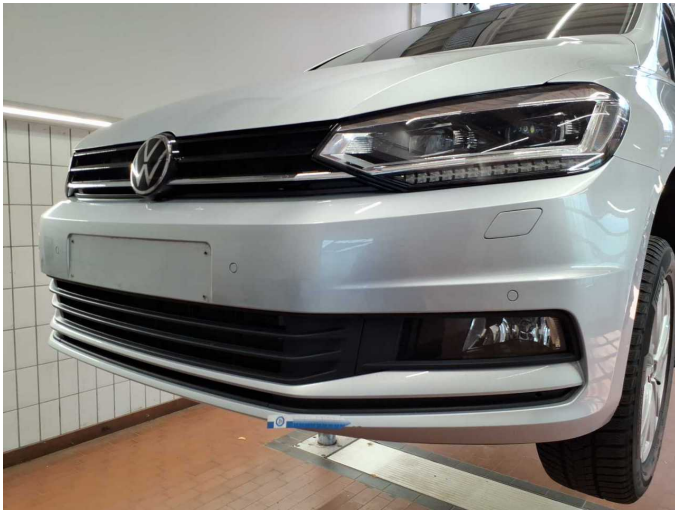
| No. | Component group | Description |
|---|---|---|
| 3 | Front bumper | Front bumper - Stone chips - Smart repair |

**Damage 3:** Front bumper: Front bumper - Stone chips - Smart repair

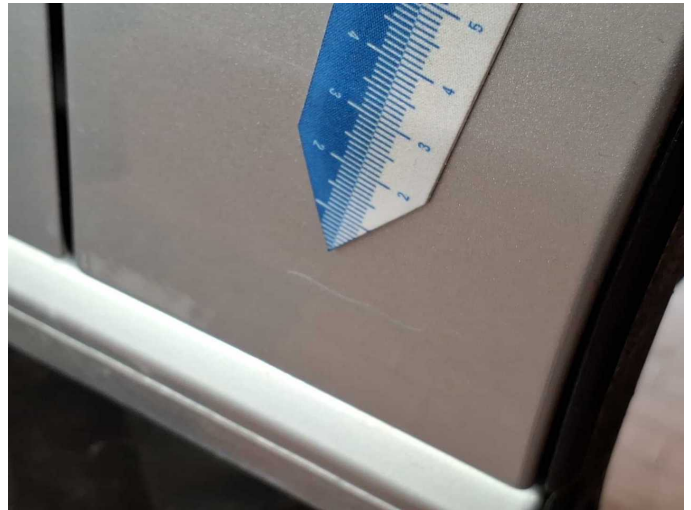
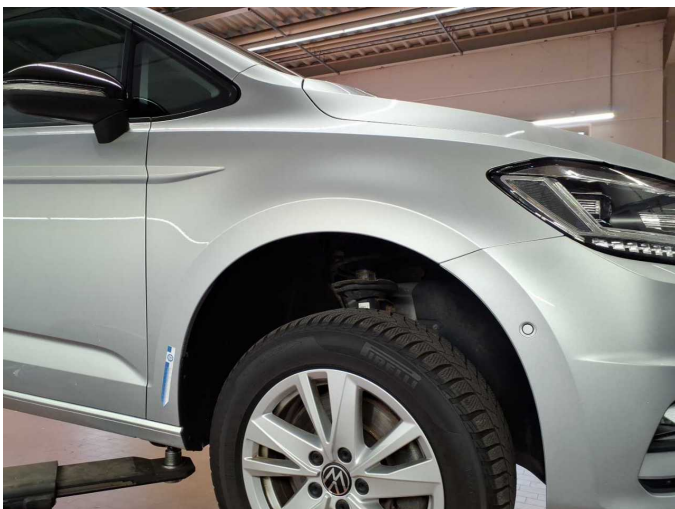
| No. | Component group | Description |
|---|---|---|
| 4 | Mudguard - right side | Mudguard - right side - Scratch(es) - Smart repair |

**Damage 4:** Mudguard - right side: Mudguard - right side - Scratch(es) - Smart repair

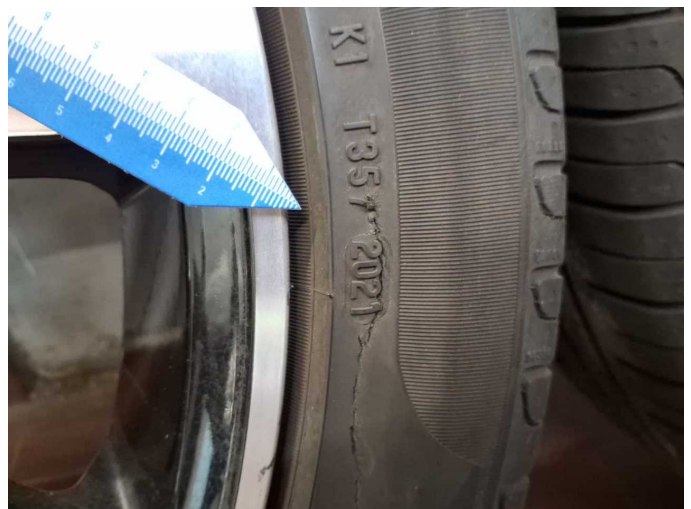
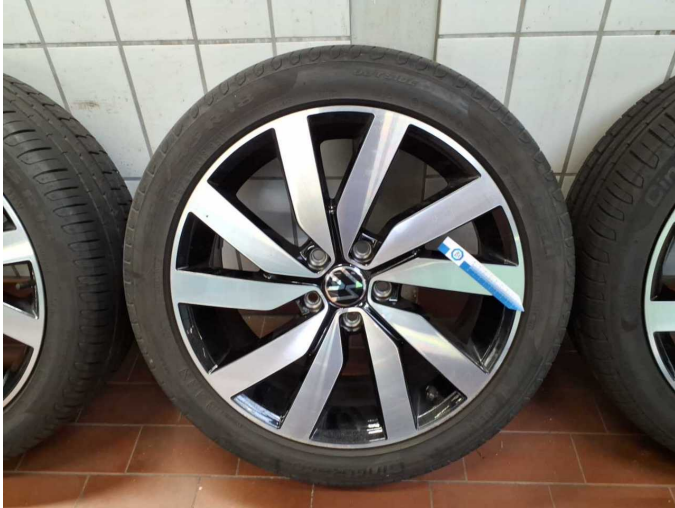
| No. | Component group | Description |
|---|---|---|
| 5 | 2nd wheel set | 1 tyre - Broken / torn - Replace |

**Damage 5:** 2nd wheel set: 1 tyre - Broken / torn - Replace

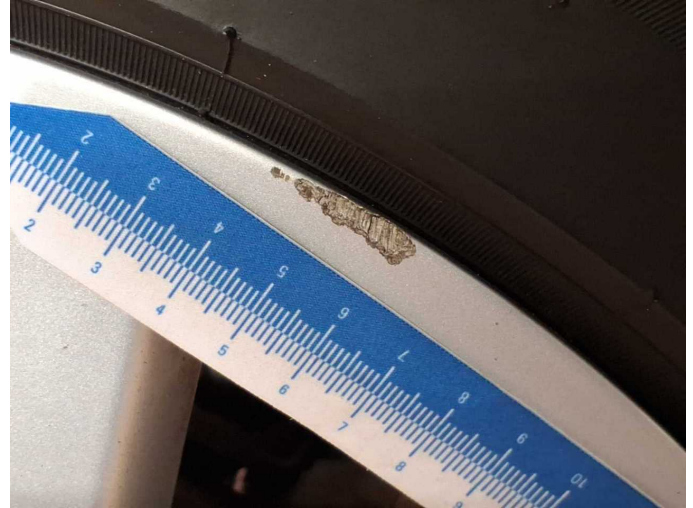
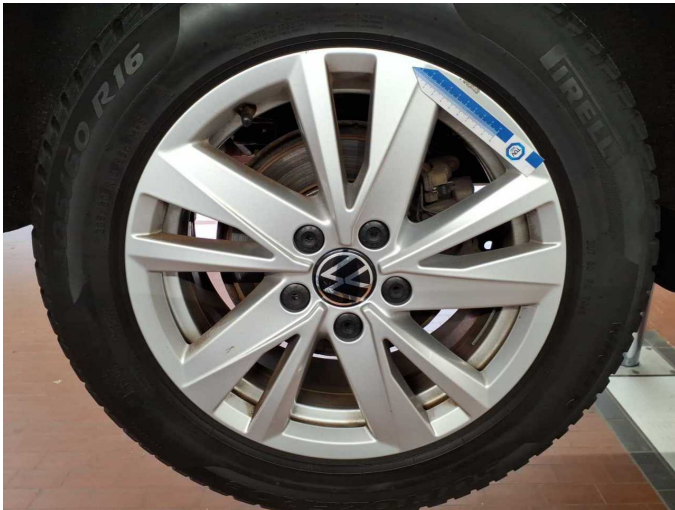
| No. | Component group | Description |
|---|---|---|
| 6 | Wheel / tyres | Alloy rim - rear right side - Scratch(es) - Loss in value |

**Damage 6:** Wheel / tyres: Alloy rim - rear right side - Scratch(es) - Loss in value

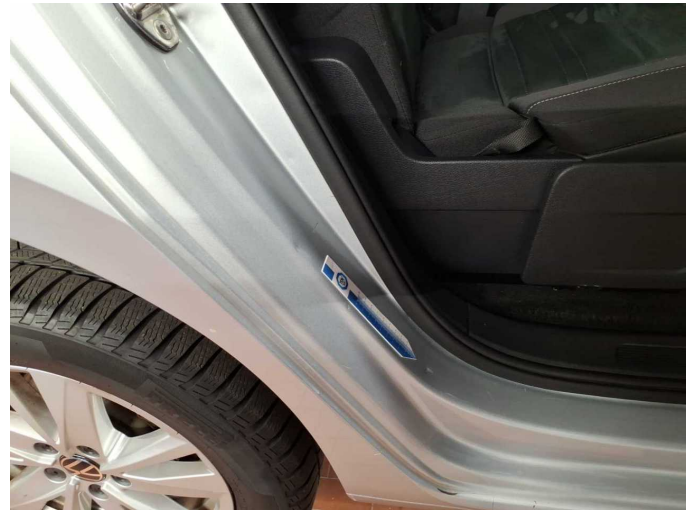
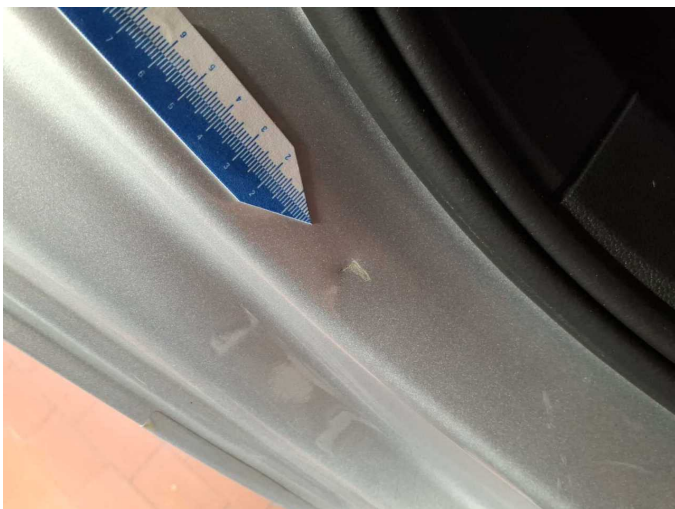
| No. | Component group | Description |
|---|---|---|
| 7 | Side panel - rear right side | Sill - Dent / paintcoat damage - Smart repair |

**Damage 7:** Side panel - rear right side: Sill - Dent / paintcoat damage - Smart repair

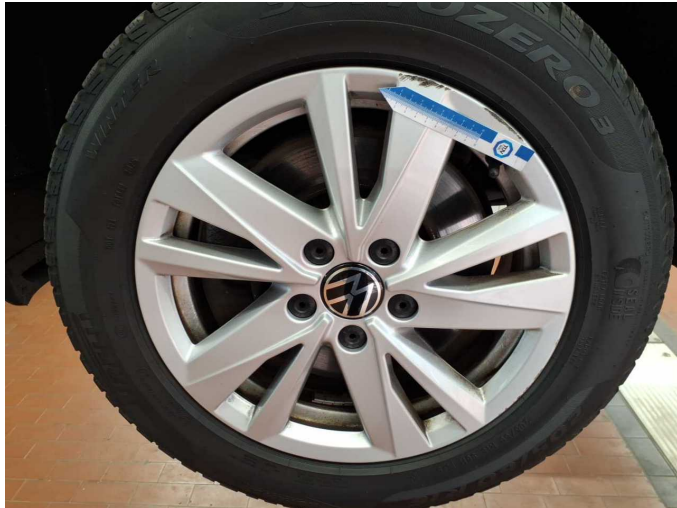
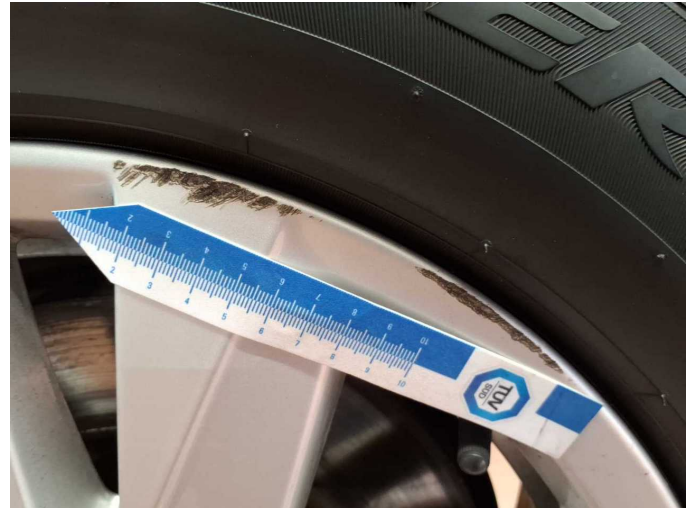
| No. | Component group | Description |
|---|---|---|
| 8 | Wheel / tyres | Alloy rim - front left side - Scratch(es) - Loss in value |

**Damage 8:** Wheel / tyres: Alloy rim - front left side - Scratch(es) - Loss in value

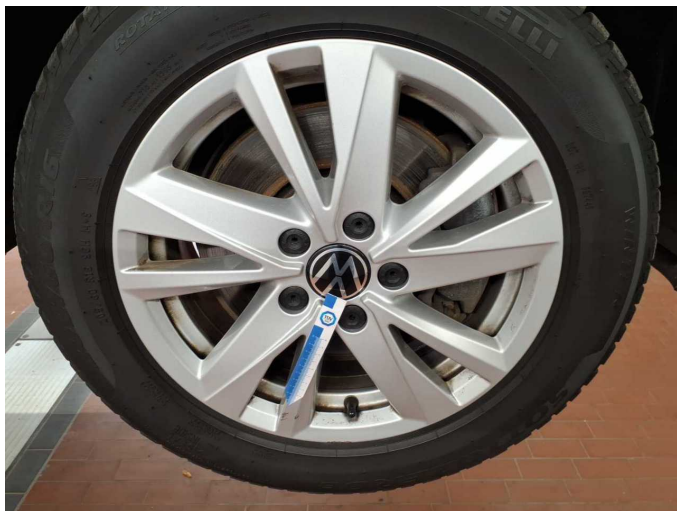
| No. | Component group | Description |
|---|---|---|
| 9 | Wheel / tyres | Alloy rim - front right side - Scratch(es) - Loss in value |

**Damage 9:** Wheel / tyres: Alloy rim - front right side - Scratch(es) - Loss in value

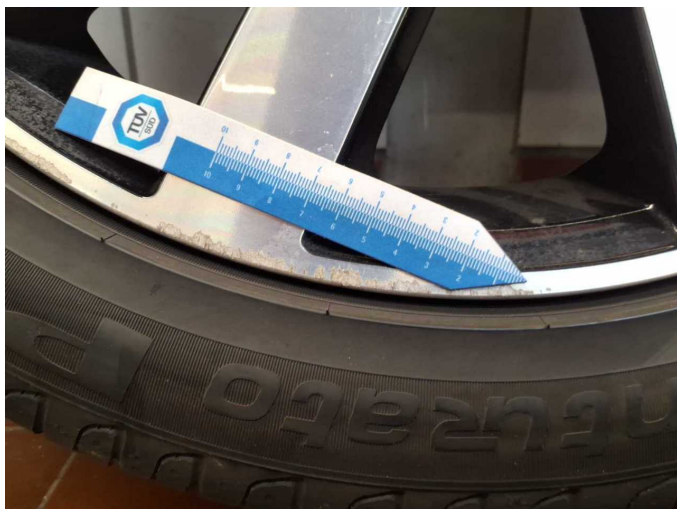
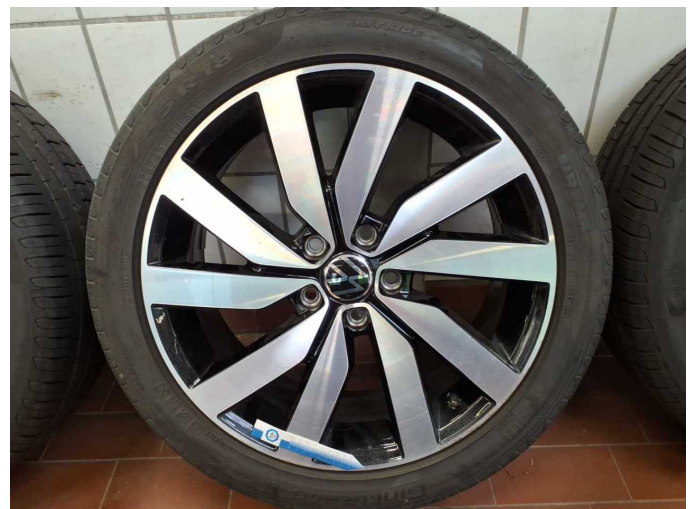
| No. | Component group | Description |
|---|---|---|
| 10 | 2nd wheel set | 1 alloy rim - Scratch(es) - Loss in value |

**Damage 10:** 2nd wheel set: 1 alloy rim - Scratch(es) - Loss in value

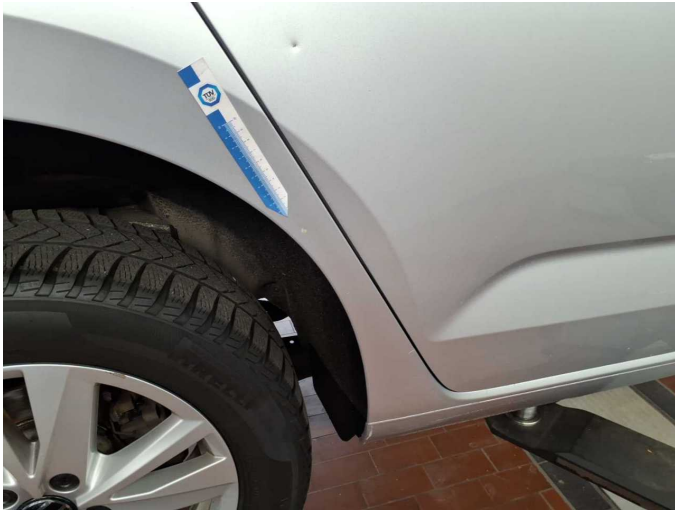
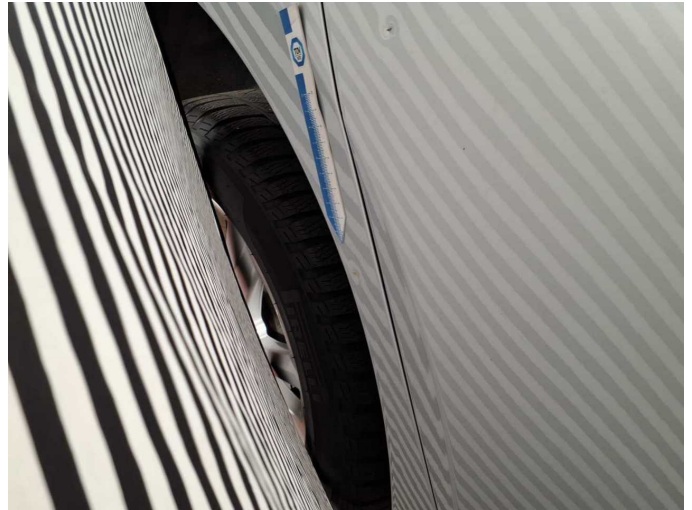
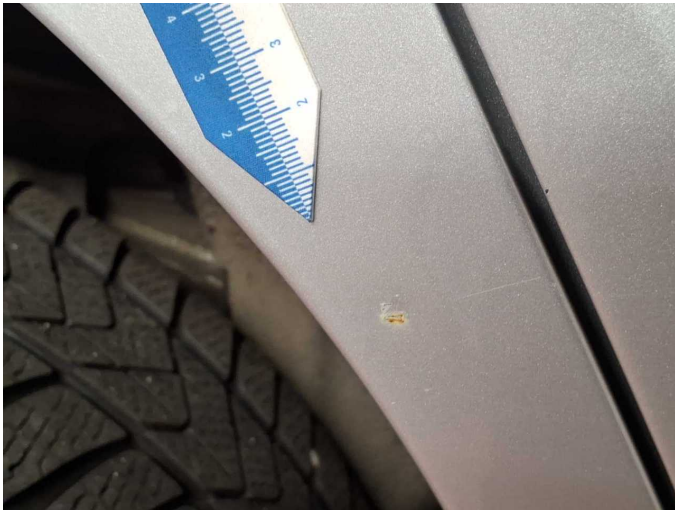
| No. | Component group | Description |
|---|---|---|
| 11 | Side panel - rear right side | Elbow - Dent / paintcoat damage - Paint |

**Damage 11:** Side panel - rear right side: Elbow - Dent / paintcoat damage - Paint

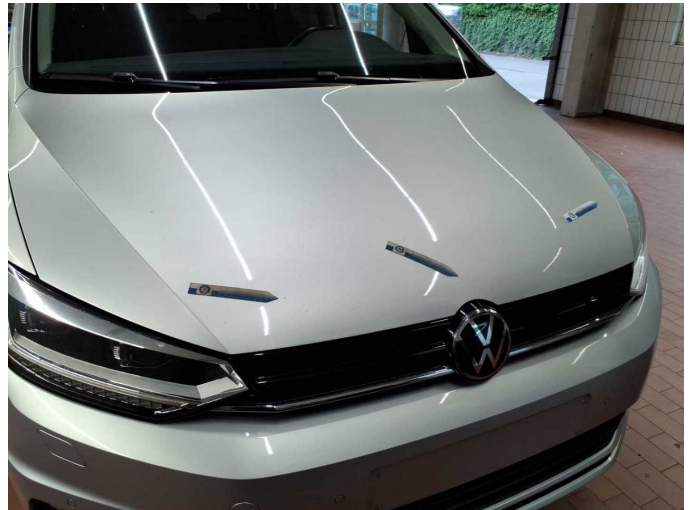
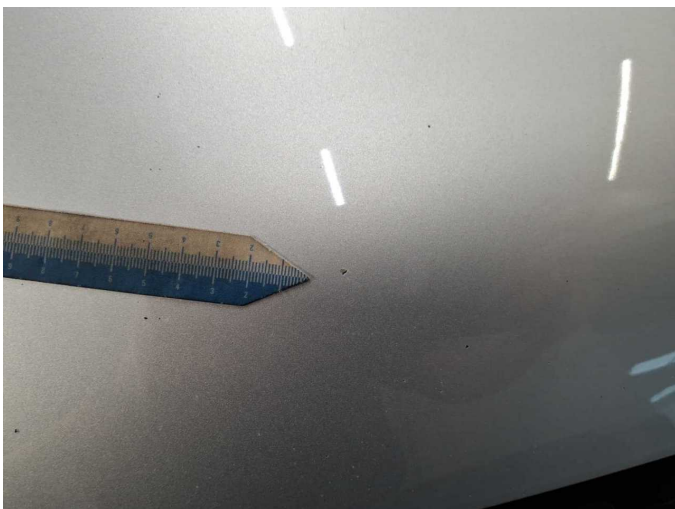
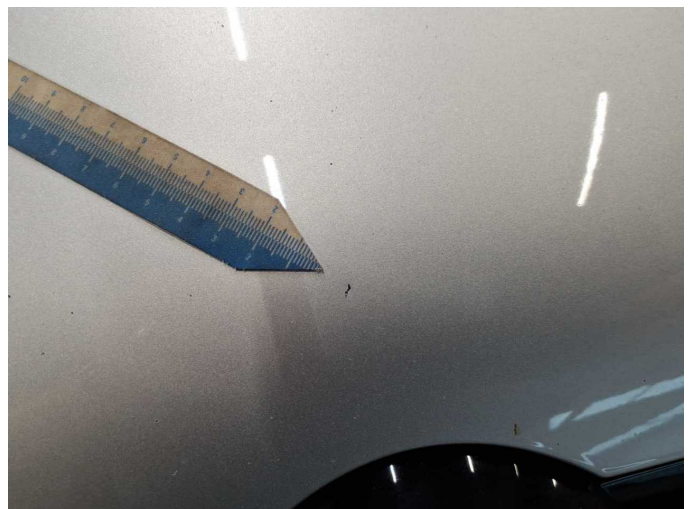
| No. | Component group | Description |
|---|---|---|
| 12 | Bonnet | Bonnet - Stone chips - Paint |

**Damage 12:** Bonnet: Bonnet - Stone chips - Paint

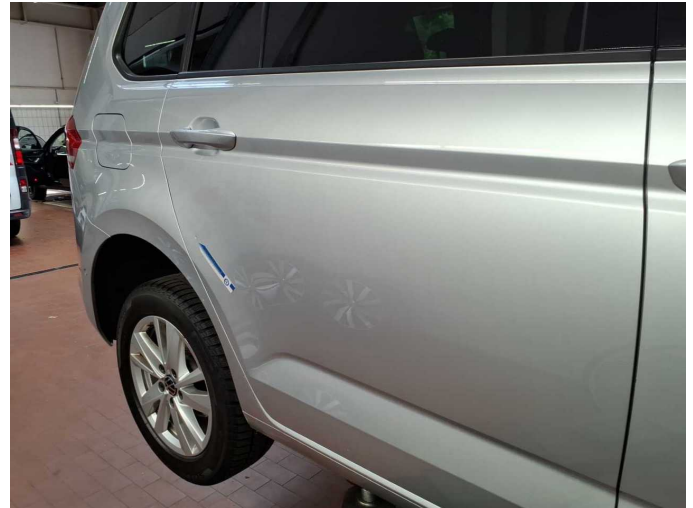
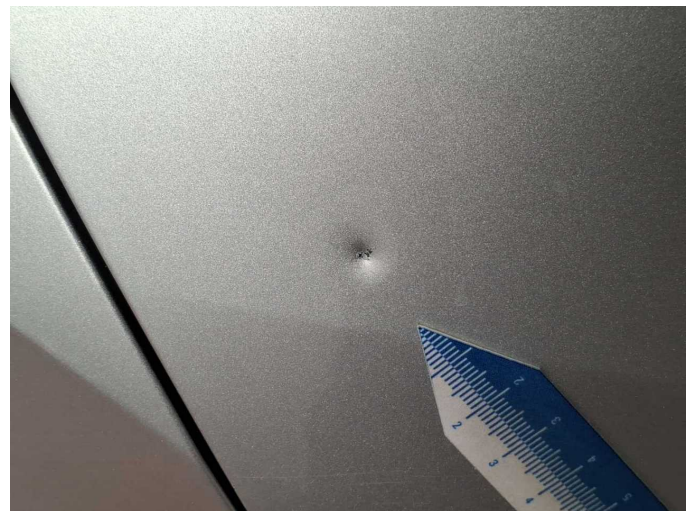
| No. | Component group | Description |
|---|---|---|
| 13 | Door - rear right side | Door - Dent / paintcoat damage - Repair and paint |

**Damage 13:** Door - rear right side: Door - Dent / paintcoat damage - Repair and paint

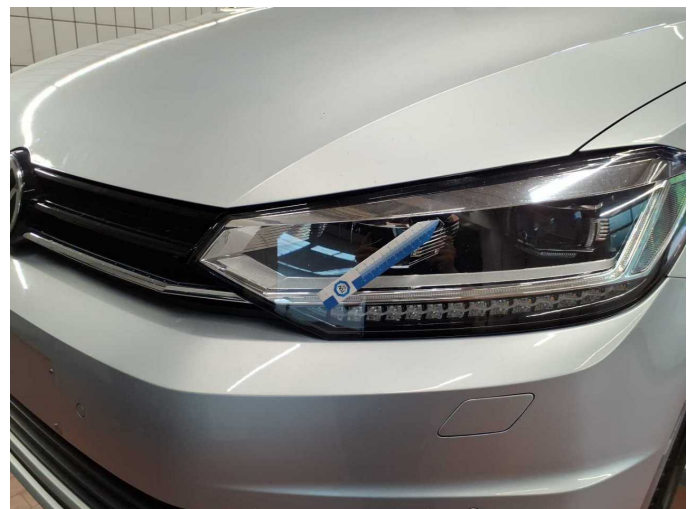
| No. | Component group | Description |
|---|---|---|
| 14 | Headlight | Headlight - left side - Scratch(es) - Replace |

**Damage 14:** Headlight: Headlight - left side - Scratch(es) - Replace

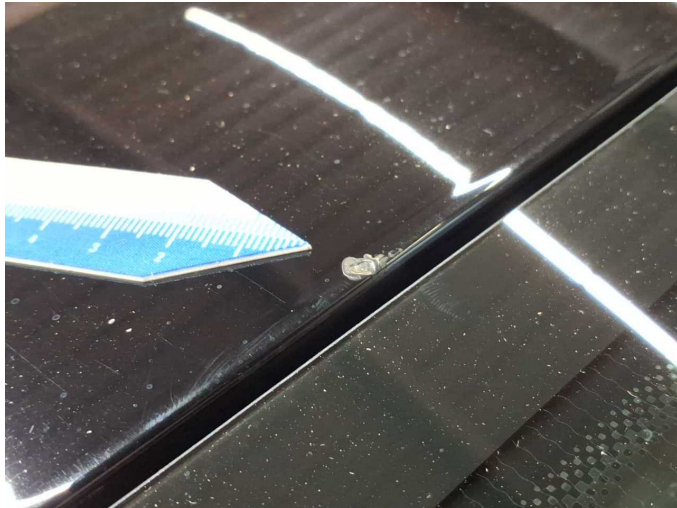
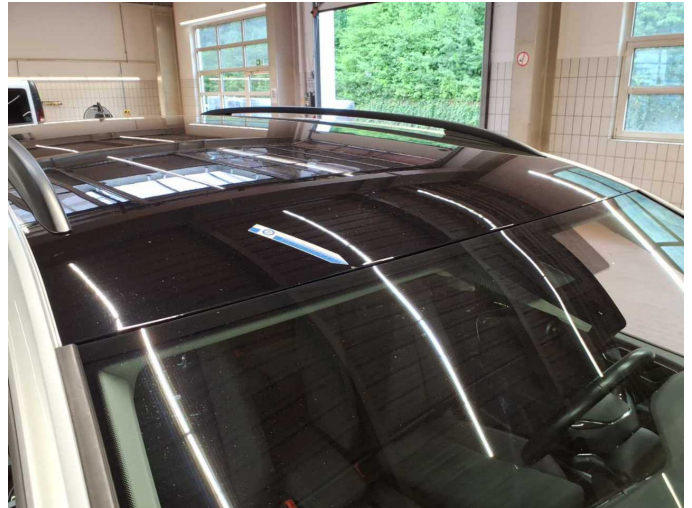
| No. | Component group | Description |
|---|---|---|
| 15 | Roof | Roof - Stone chips - Paint |

**Damage 15:** Roof: Roof - Stone chips - Paint

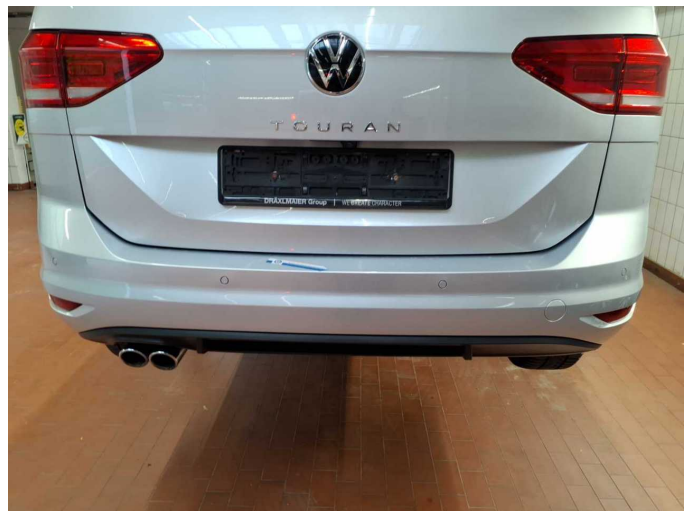
| No. | Component group | Description |
|---|---|---|
| 1 | Rear bumper | Rear bumper - Scratch(es) - No deduction |

**Wear and tear 1:** Rear bumper: Rear bumper - Scratch(es) - No deduction
