Expertise

Protocol number: 46802752  
Order No. / Reference: 26584860  
Inspection date: 29 Jul 2026

Model: Insignia Sports Tourer 1.5 Diesel Business Edition

VIN: W0VZT8GN3M1029349

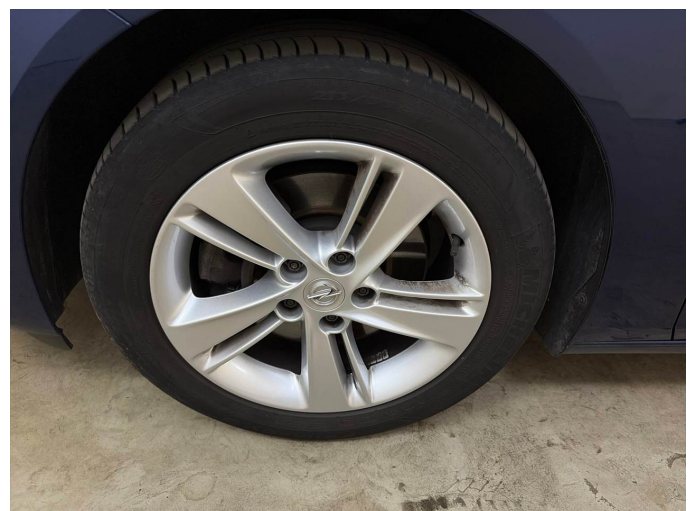
Figure 12: Mounted tyres

| # | Tyre size | Type of tyre | Manufacturer | Tread depth |
|---|---|---|---|---|
| 1) | 215/55 R17 94V | Summer tyres on Light alloy | Michelin | 5mm / 5mm |
| 2) | 215/55 R17 94V | Summer tyres on Light alloy | Michelin | 7mm / 7mm |

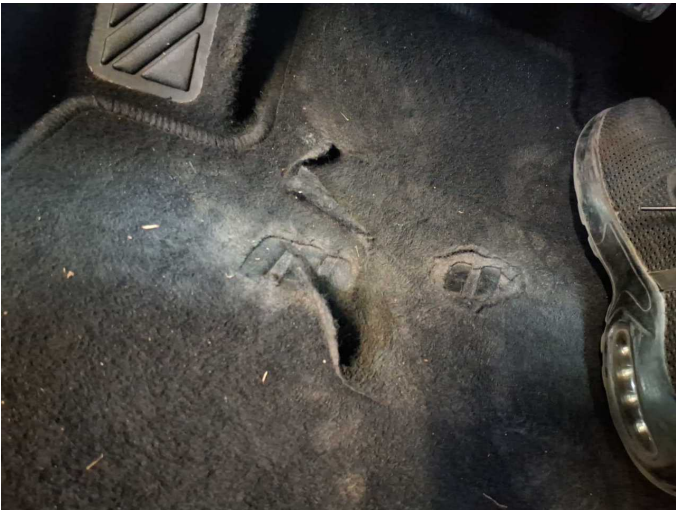
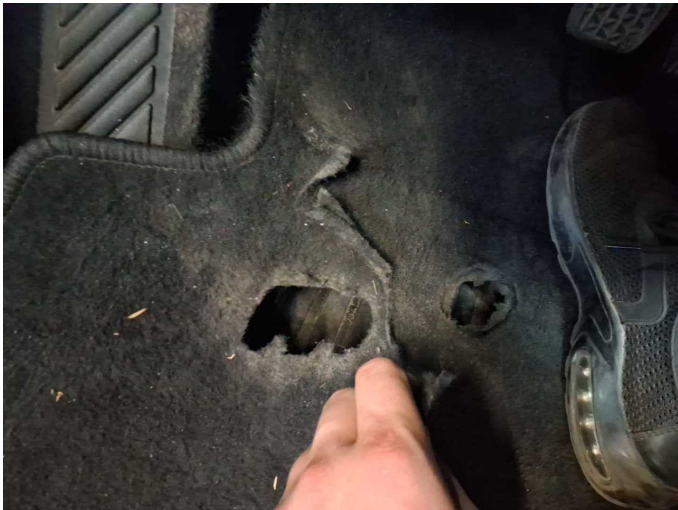
Damage 1: Trim / covers: Floor mats (Vorne links) - Holes - Replace

| No. | Component group | Description |
|---|---|---|
| 1 | Trim / covers | Floor mats (Vorne links) - Holes - Replace |

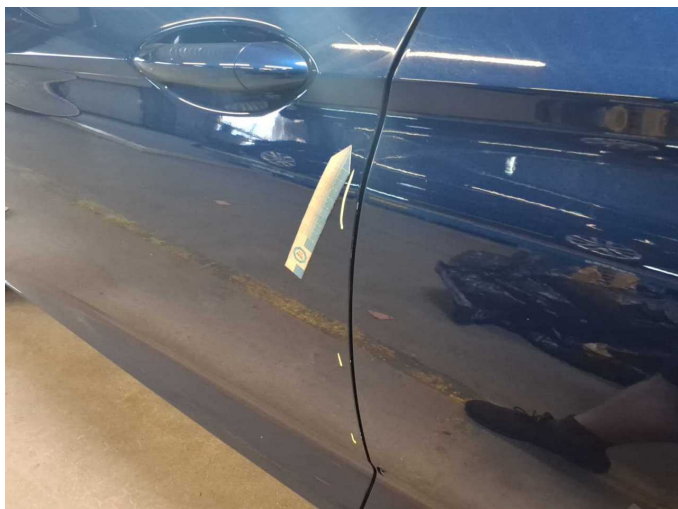
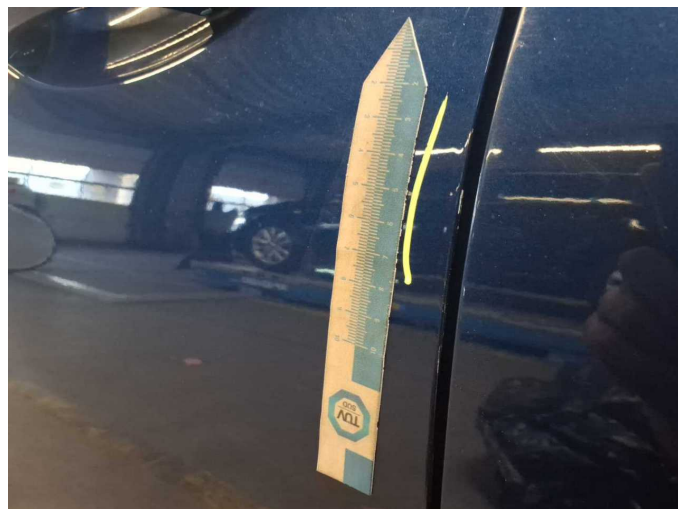
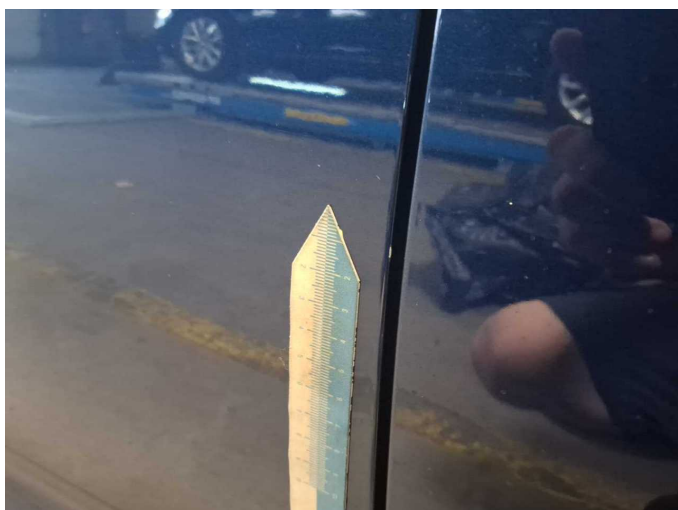
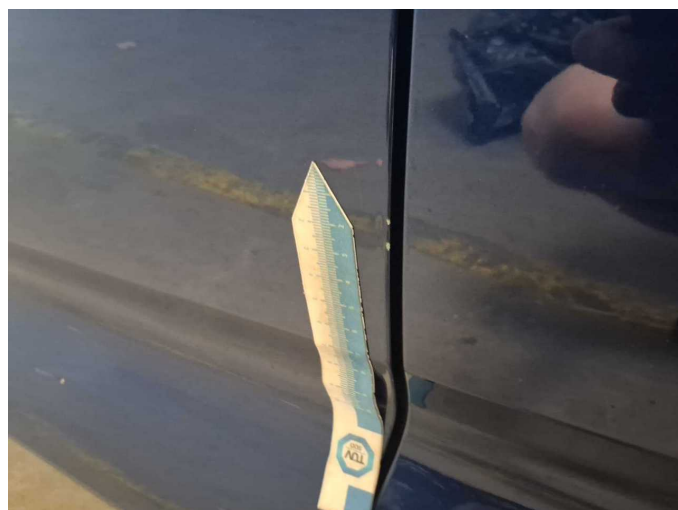
**Damage 2:** Door - front left side: Door - Scratch(es) - Smart repair

| No. | Component group | Description |
|---|---|---|
| 2 | Door - front left side | Door - Scratch(es) - Smart repair |

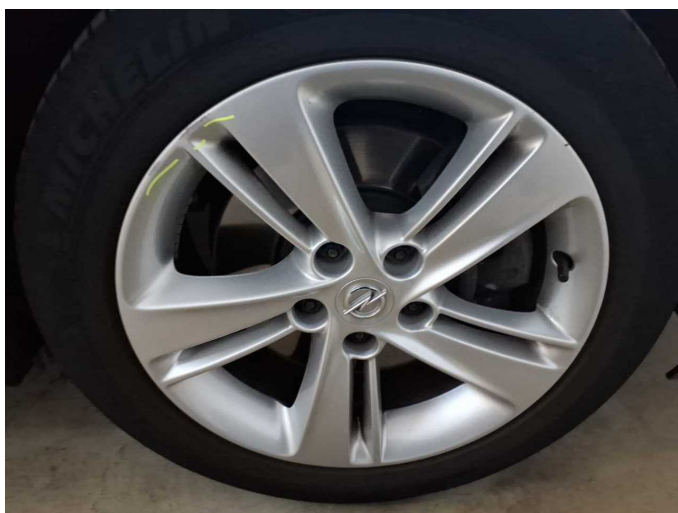
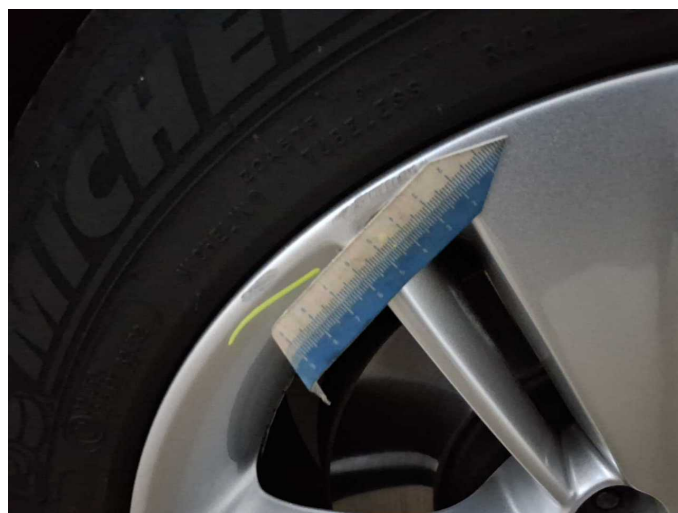
**Damage 3:** Wheel / tyres: Alloy rim - front right side - Scratched - Loss in value

| No. | Component group | Description |
|---|---|---|
| 3 | Wheel / tyres | Alloy rim - front right side - Scratched - Loss in value |

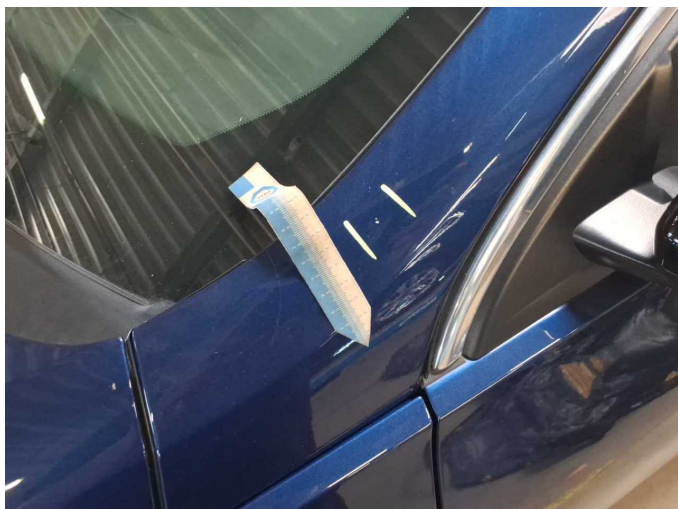
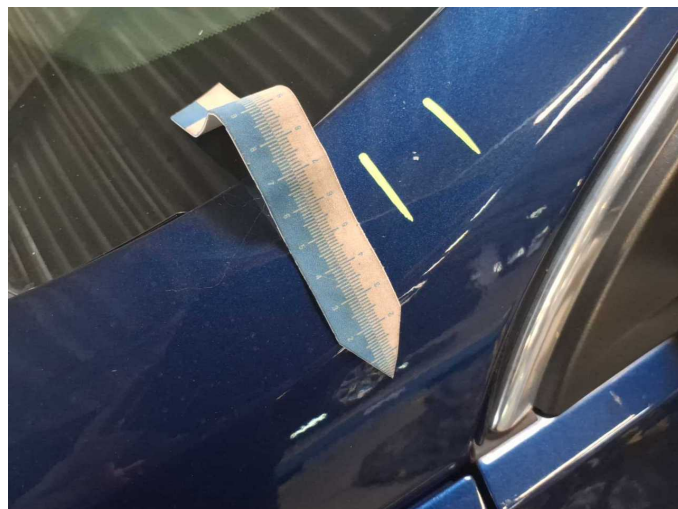
**Damage 4:** Body: A-pillar - left side - Stone chips - Smart repair

| No. | Component group | Description |
|---|---|---|
| 4 | Body | A-pillar - left side - Stone chips - Smart repair |

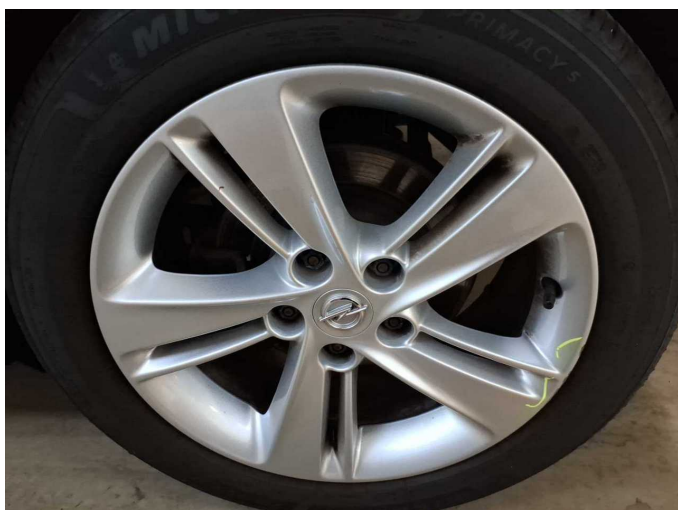
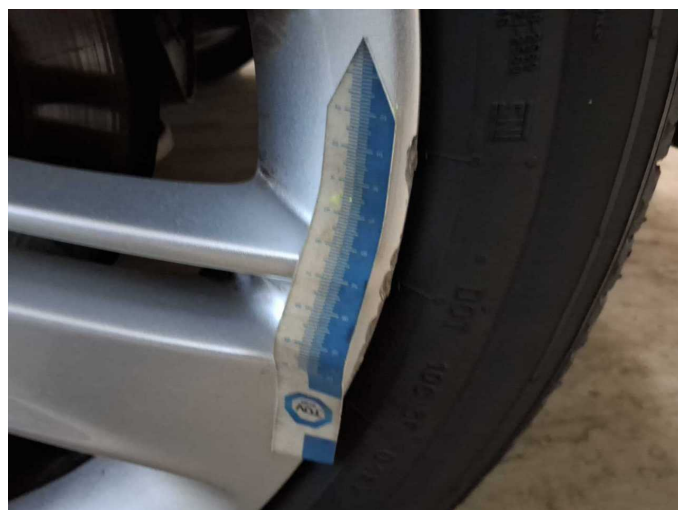
**Damage 5:** Wheel / tyres: Alloy rim - rear left side - Scratched - Loss in value

| No. | Component group | Description |
|---|---|---|
| 5 | Wheel / tyres | Alloy rim - rear left side - Scratched - Loss in value |

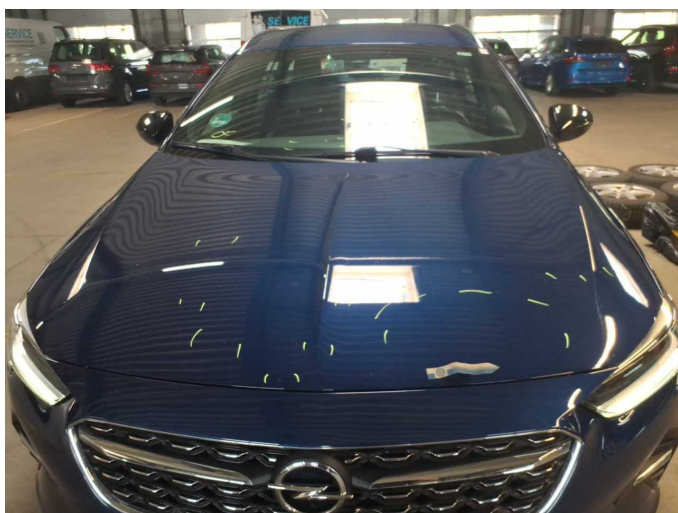
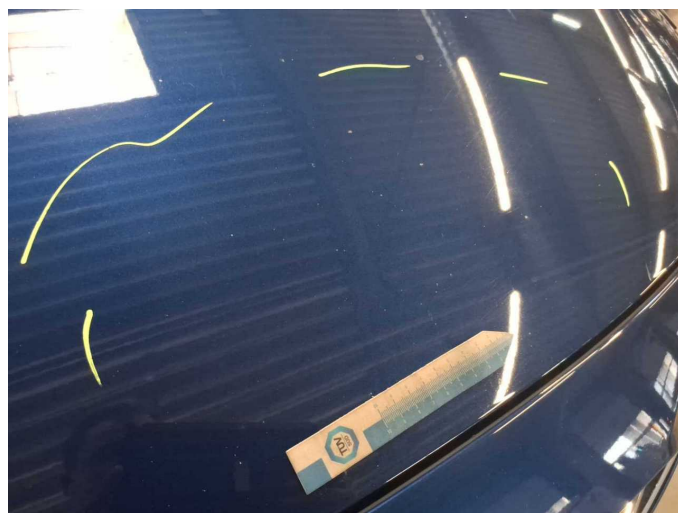
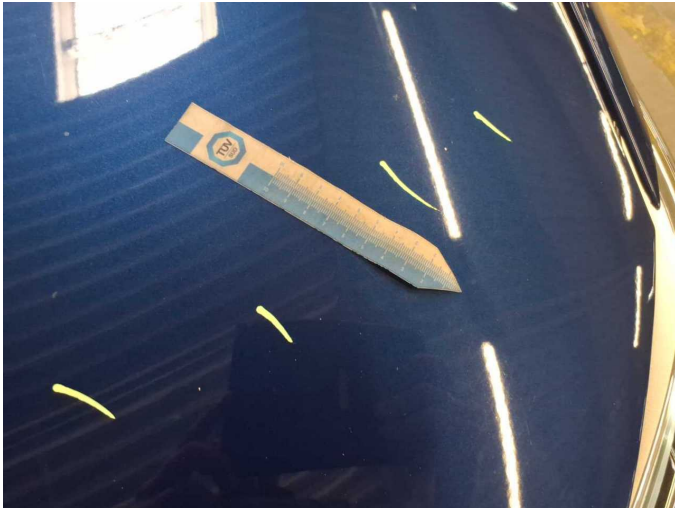
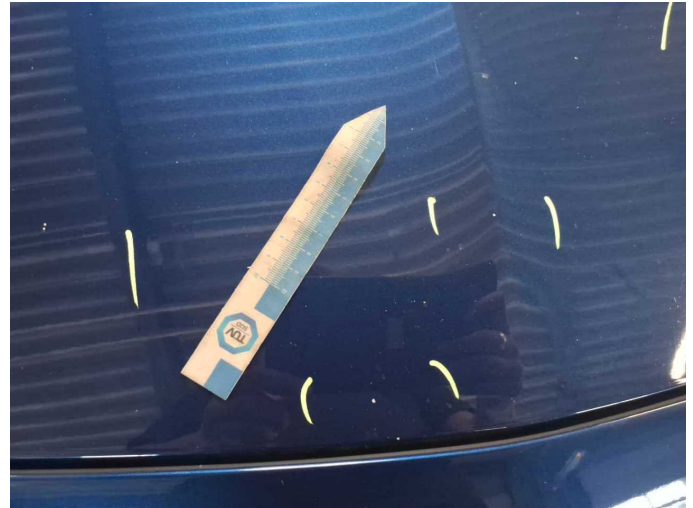
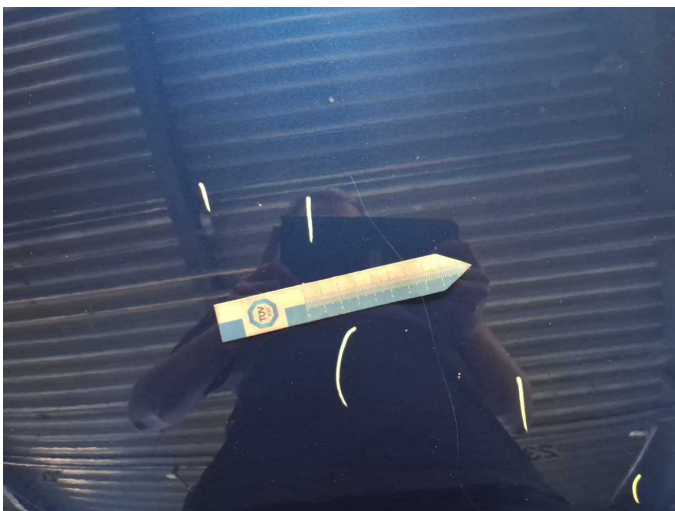
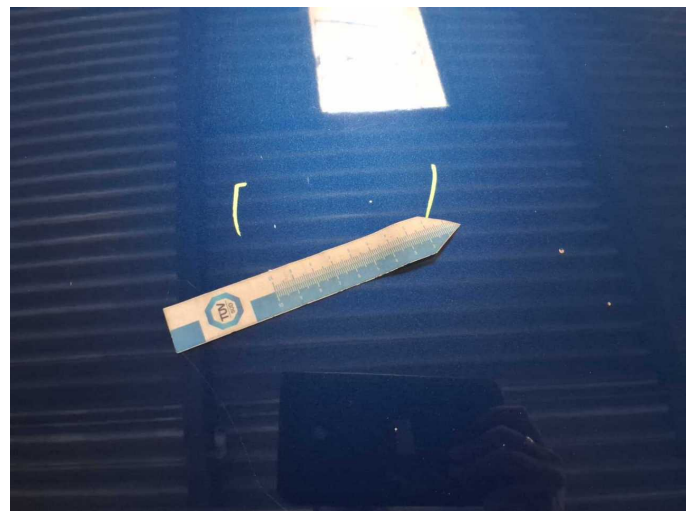
**Damage 6:** Bonnet: Bonnet (Sandstrahleffekt) - Stone chips - Paint

| No. | Component group | Description |
|---|---|---|
| 6 | Bonnet | Bonnet (Sandstrahleffekt) - Stone chips - Paint |

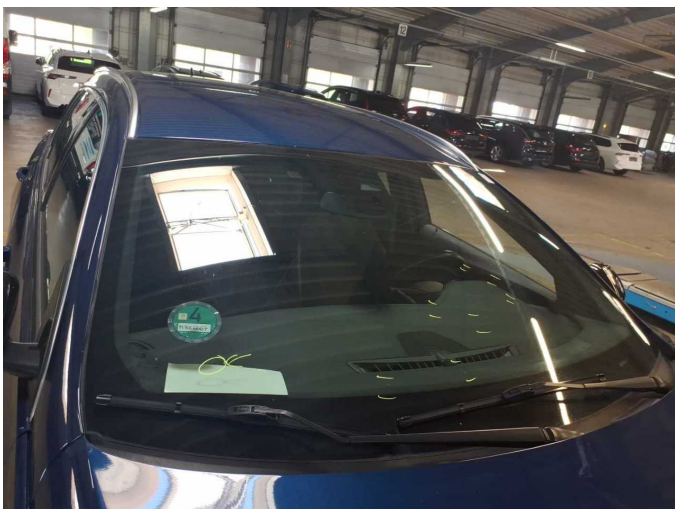
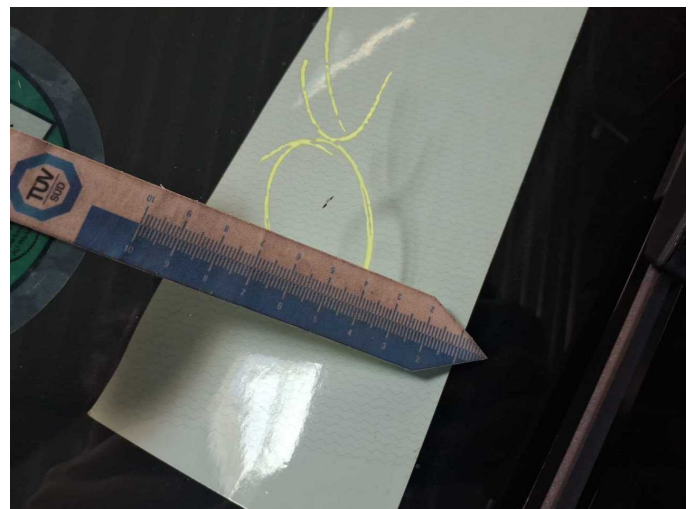
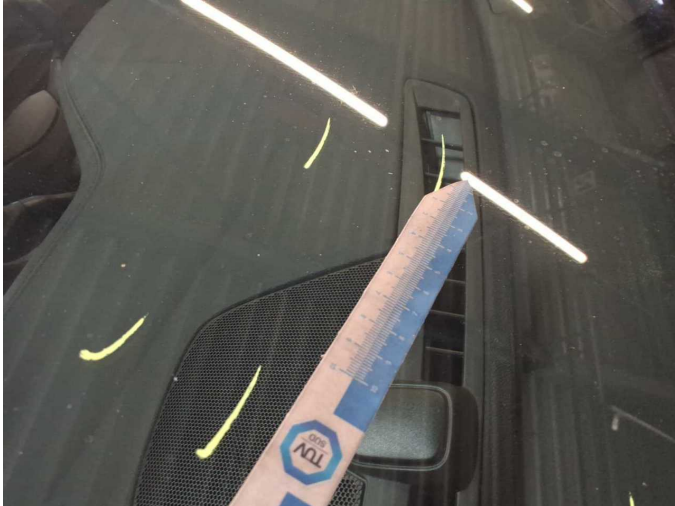
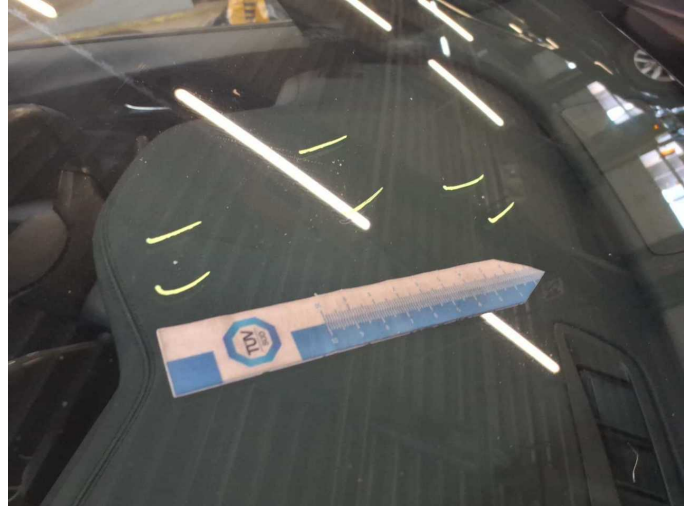
**Damage 7:** Vehicle glazing: Windscreen - Stone chips - Replace

| No. | Component group | Description |
|---|---|---|
| 7 | Vehicle glazing | Windscreen - Stone chips - Replace |

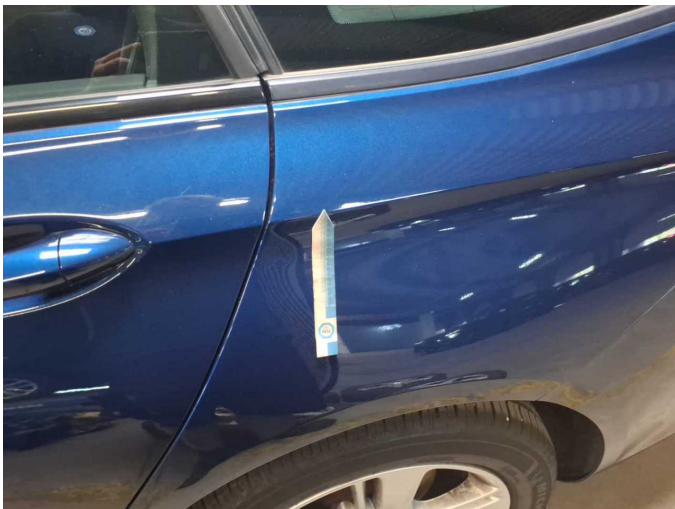
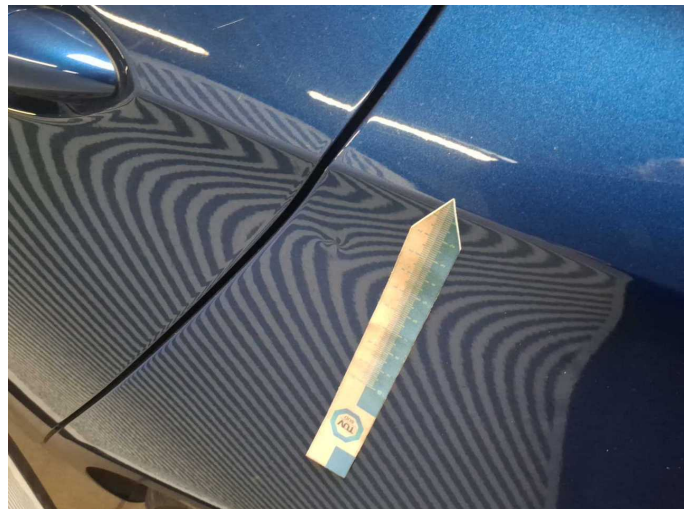
| No. | Component group | Description |
|---|---|---|
| 1 | Side panel - rear left side | Side panel - dent(s) - No deduction |

**Wear and tear 1:** Side panel - rear left side: Side panel - dent(s) - No deduction

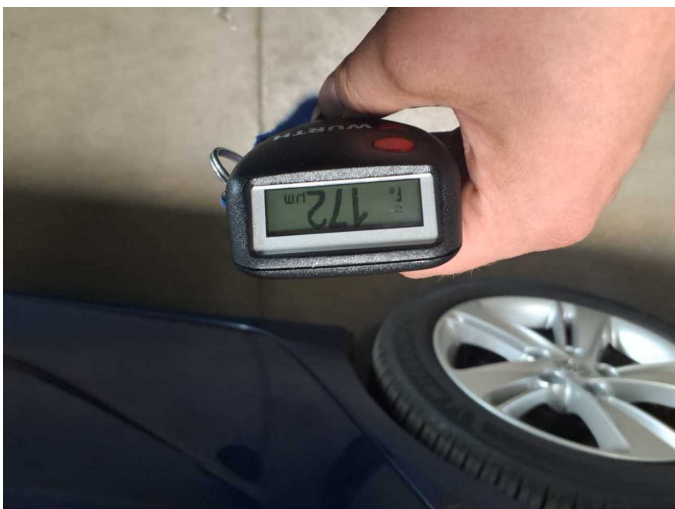
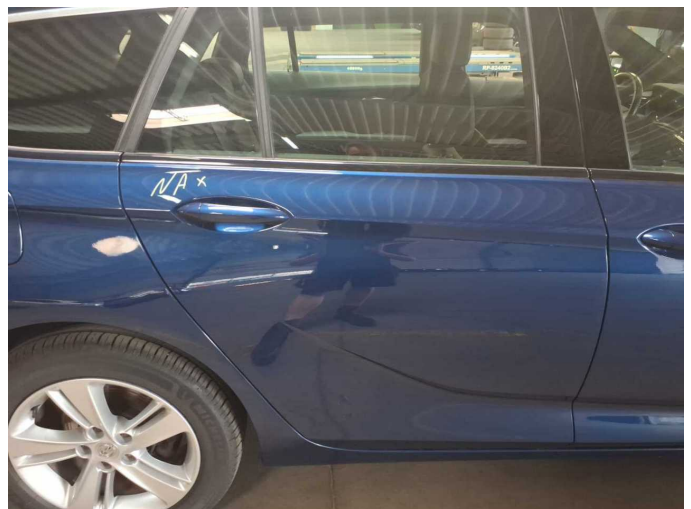
| No. | Repainting |
|---|---|
| 1 | Door - rear right side, Professionally carried out, Invoice of repair done Non-existent |

**Repainting 1:** Door - rear right side

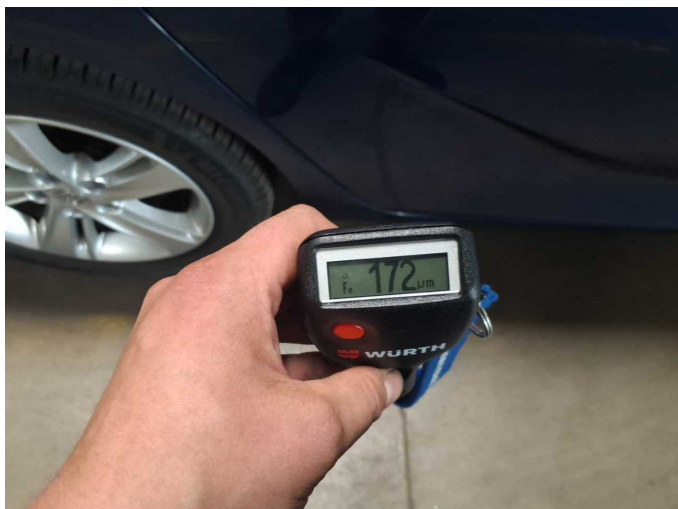
| Door - rear right side | 172 µm |

**Door - rear right side: 172 µm**
