Expertise

Protocol number: 46351781
Order No. / Reference: 26584390
Inspection date: 2 Jul 2026

Model: A3 35 TDI Sportback S tronic S line

VIN: WAUZZZGY6NA062224

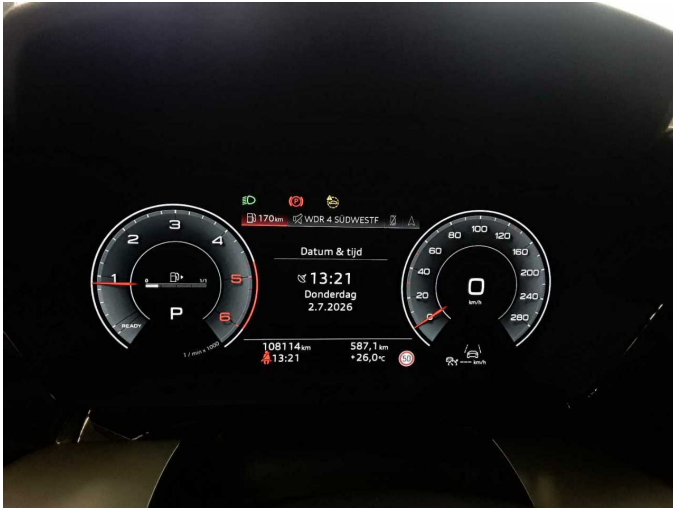
Figure 7: Instrument cluster

Mileage (Read) 108,114 km

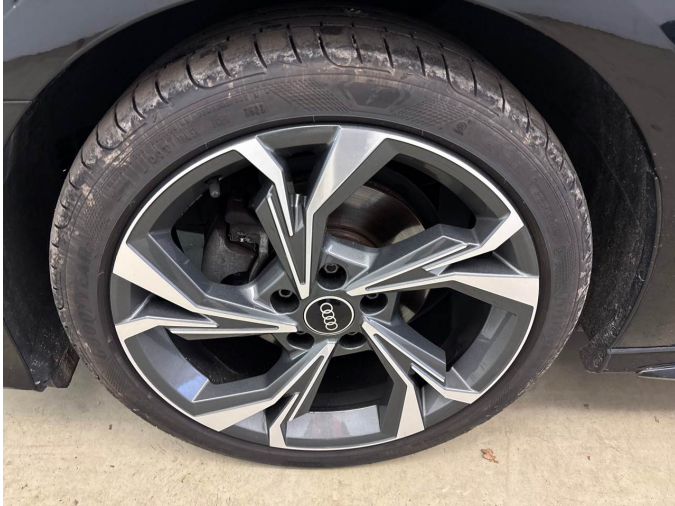
Figure 13: Mounted tyres

Mounted tyres				
#	Tyre size	Type of tyre	Manufacturer	Tread depth
1)	225/45 R18 92Y	Summer tyres on Light alloy	Goodyear	5mm / 5mm
2)	225/45 R18 92Y	Summer tyres on Light alloy	Goodyear	5mm / 5mm
Additional tyres				
#	Tyre size	Type of tyre	Manufacturer	Tread depth
1)	205/55 R16 91H	Winter tyres on Light alloy	Goodyear	5mm / 5mm
2)	205/55 R16 91H	Winter tyres on Light alloy	Goodyear	5mm / 5mm
Replacement				
Typ	Tyre size	Type of tyre	Manufacturer	Tread depth
	Tirefit	Expiration date 01/2026

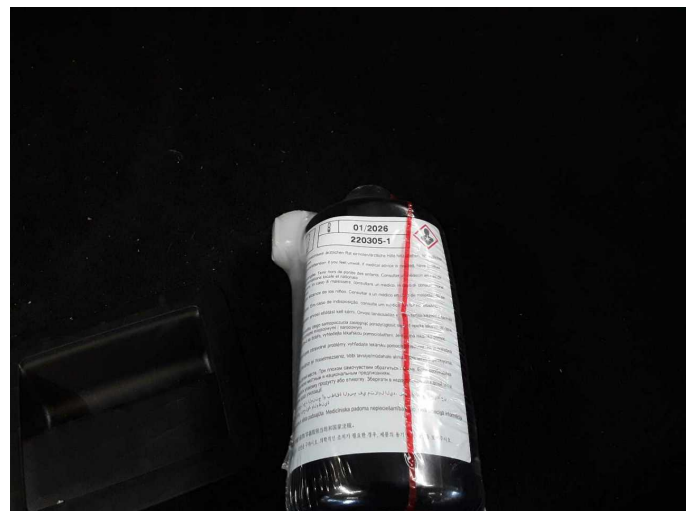
Damage 1: Equipment: Tirefit filler - Expired - Replace

No.	Component group	Description
1	Equipment	Tirefit filler - Expired - Replace
2	Bonnet	Insulation lining - Damage caused by marten / rodent - Replace
3	Wheel / tyres	Alloy rim - front right side - Scratched - Loss in value
4	Front bumper	Front bumper (+ Blende links) - Scratched - Paint

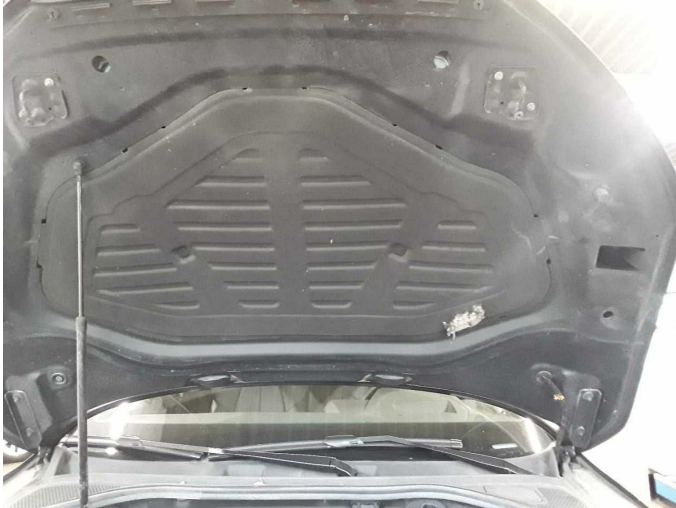
Damage 2: Bonnet: Insulation lining - Damage caused by marten / rodent
- Replace

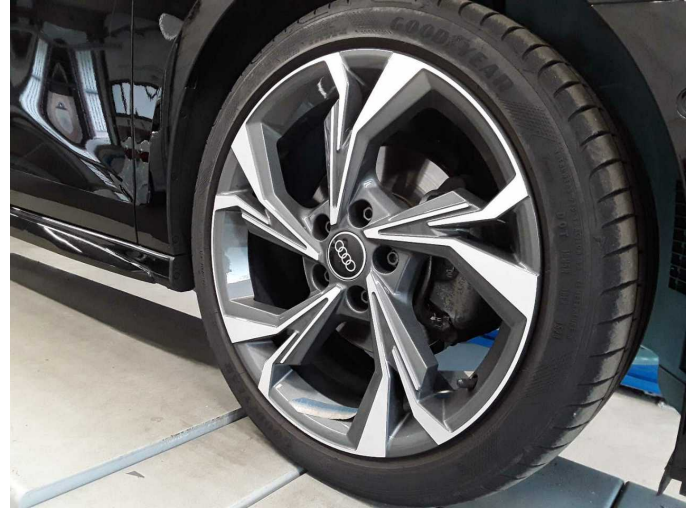
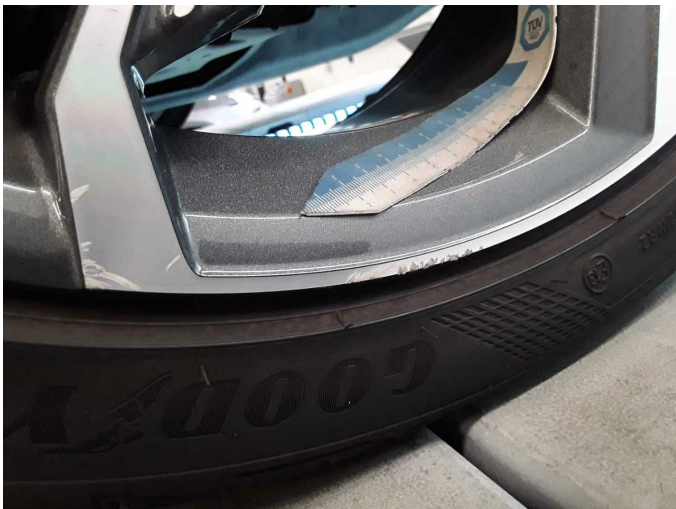
Damage 3: Wheel / tyres: Alloy rim - front right side - Scratched - Loss in value

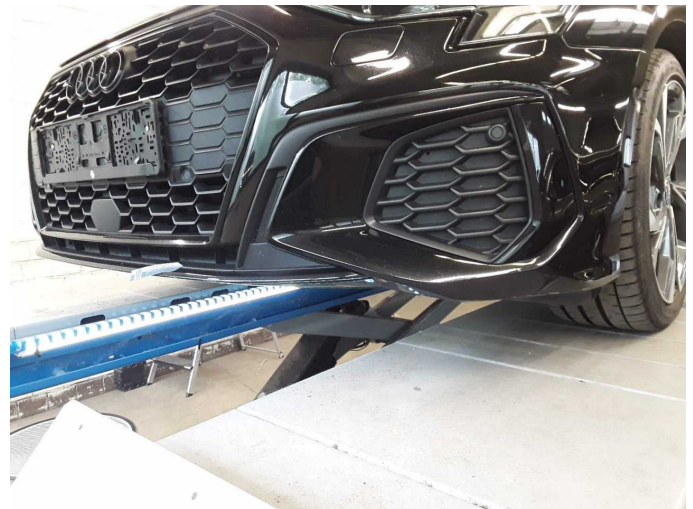
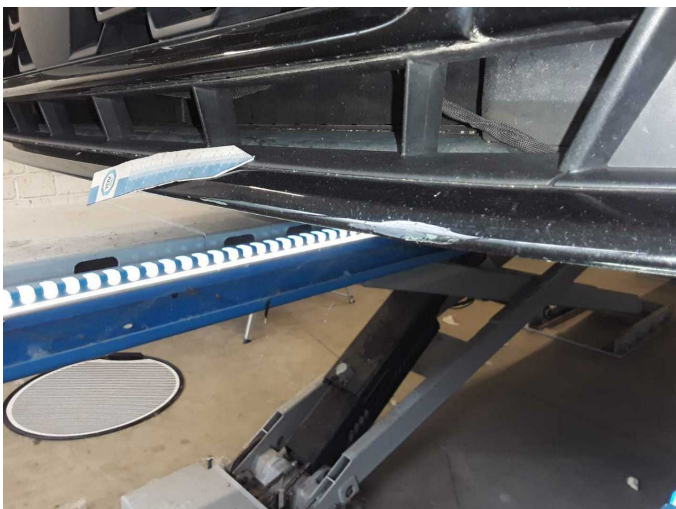
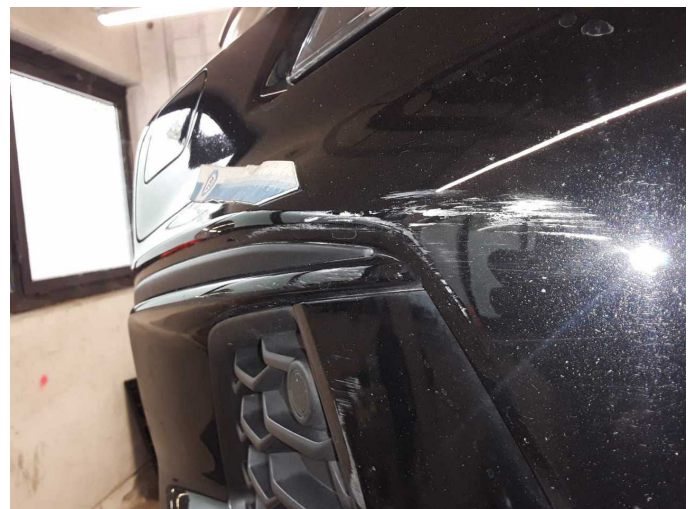
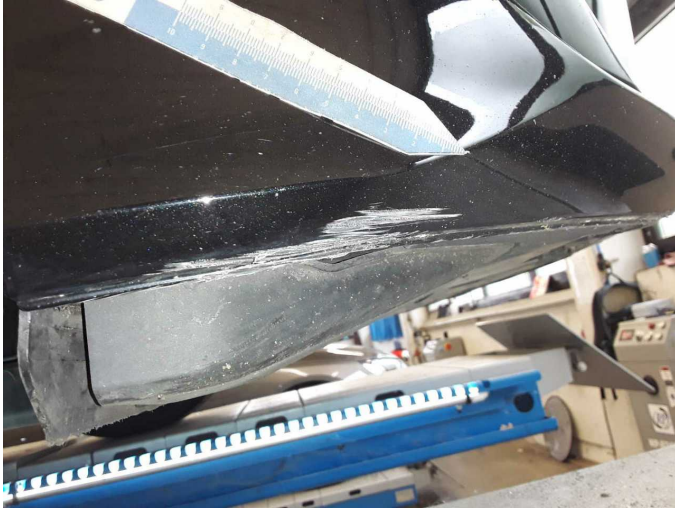
Damage 4: Front bumper: Front bumper (+ Blende links) - Scratched - Paint

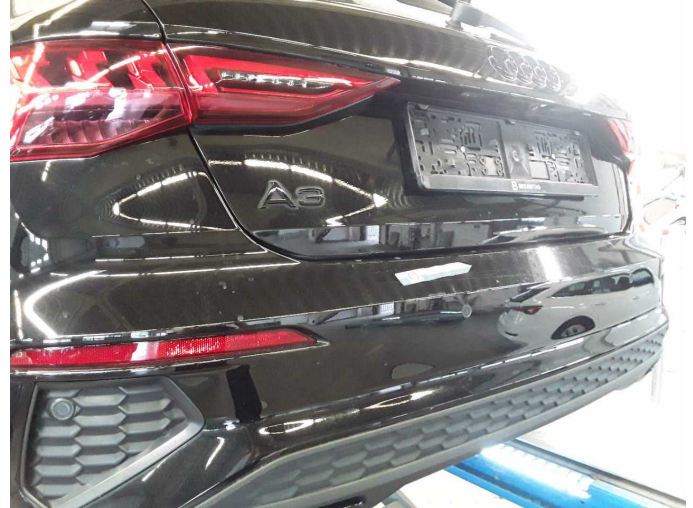
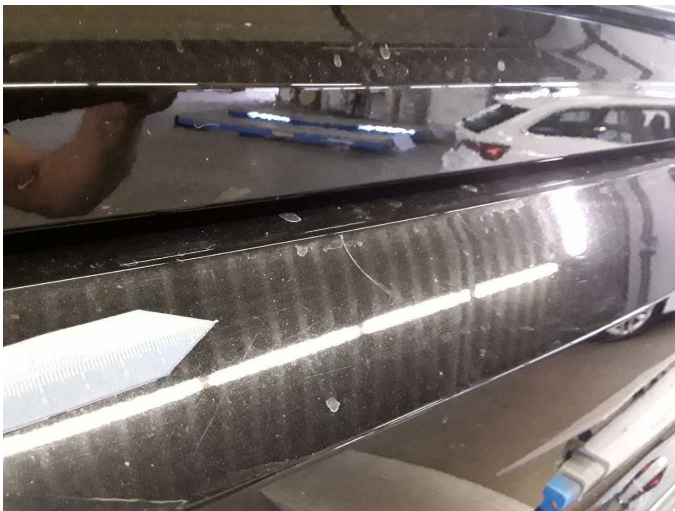
Wear and tear 5: Rear bumper: Rear bumper (Verladebereich / polierbar) - Scratch(es) - No deduction

No.	Component group	Description
1	Body	Underbody panelling - Scratch(es) - No deduction
2	Bonnet	Bonnet - Stone chips - No deduction
3	Vehicle glazing	Windscreen - Stone chips - No deduction
4	Wheel / tyres	Wheel rims - complete set - Scratched - No deduction
5	Rear bumper	Rear bumper (Verladebereich / polierbar) - Scratch(es) - No deduction

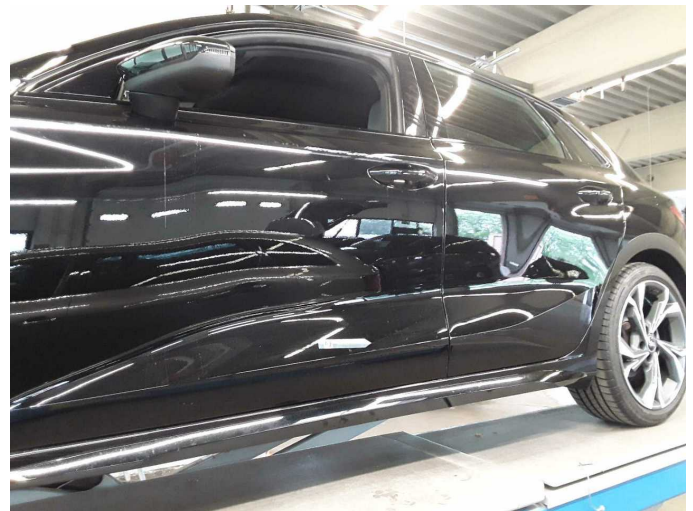
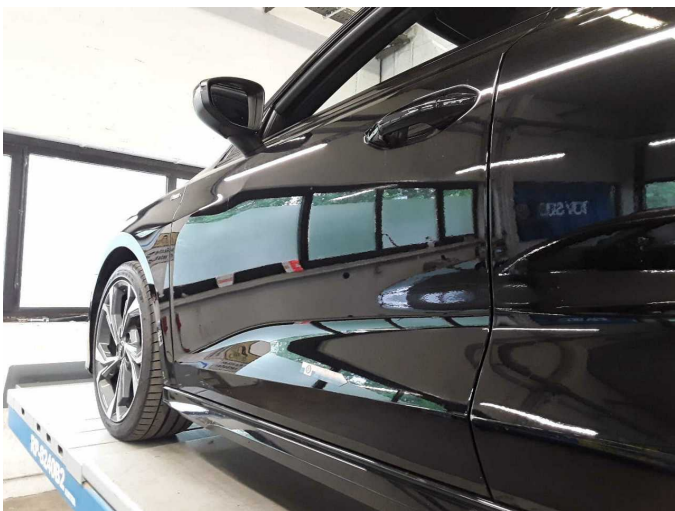
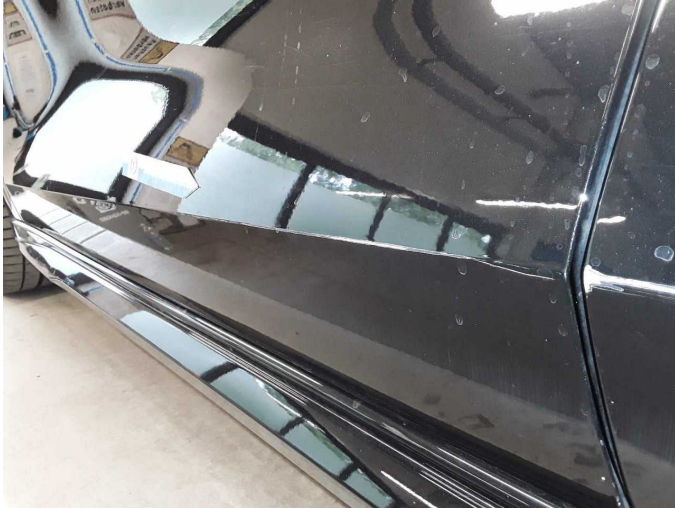
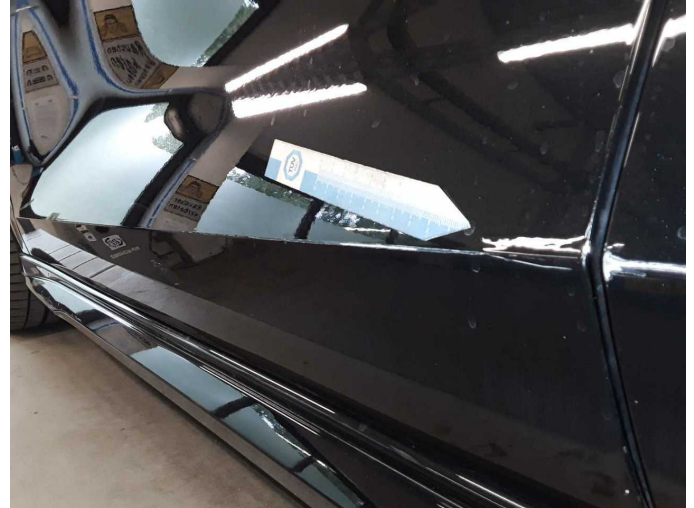
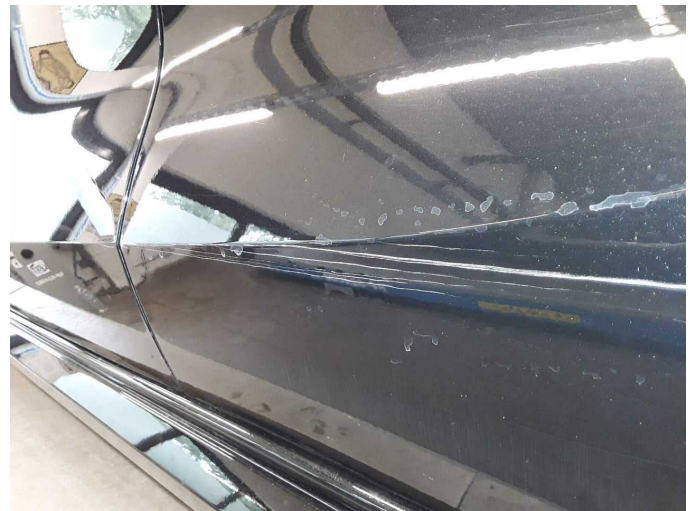
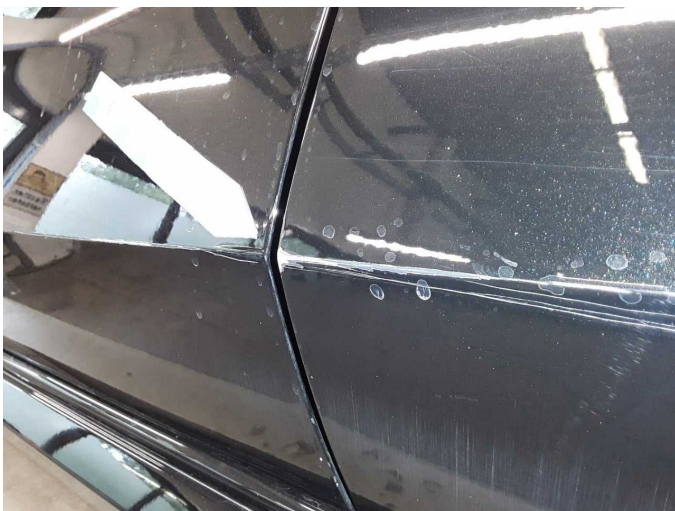
No.	Accident
1	Side - left

Non-repaired previous damages were found at the vehicle. The necessary repair costs are listed in the expert report or if necessary, are listed in detail in a separately enclosed repair cost calculation.

Accident 1: Side - left
