Expertise

Protocol number: 46634128  
Order No. / Reference: 26631672  
Inspection date: 21 Jul 2026

Manufacturer: Skoda  
VIN: TMBJJ8NX0PY120544

Model: Octavia Combi 2.0 TDI DSG Style

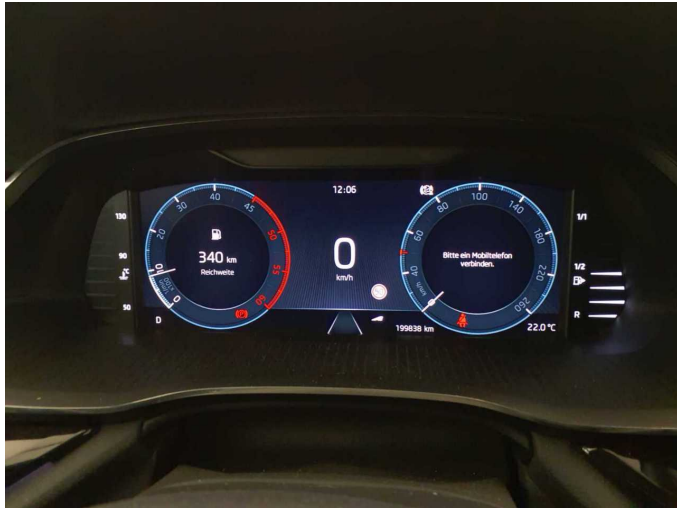
| Vehicle details | |
|---|---|
| Mileage (Read) | 199,838 km |

Figure 7: Instrument cluster

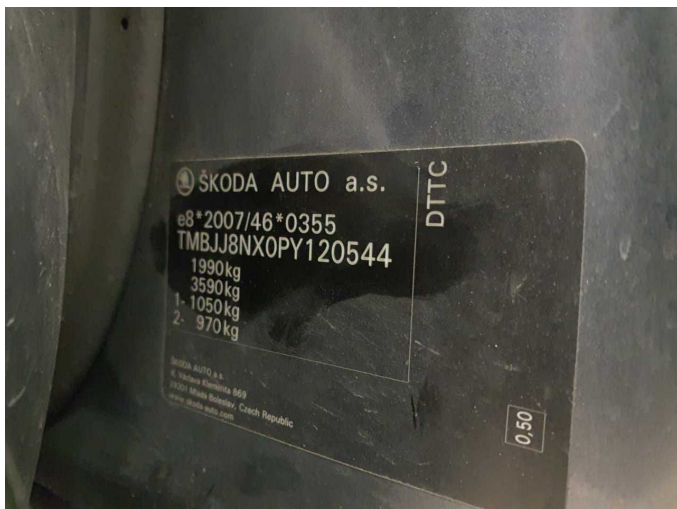
| VIN comparison | The vehicle identification number (VIN) was read from the vehicle and its conformity with the submitted documents was confirmed by the undersigned during the inspection. |

Figure 11: VIN

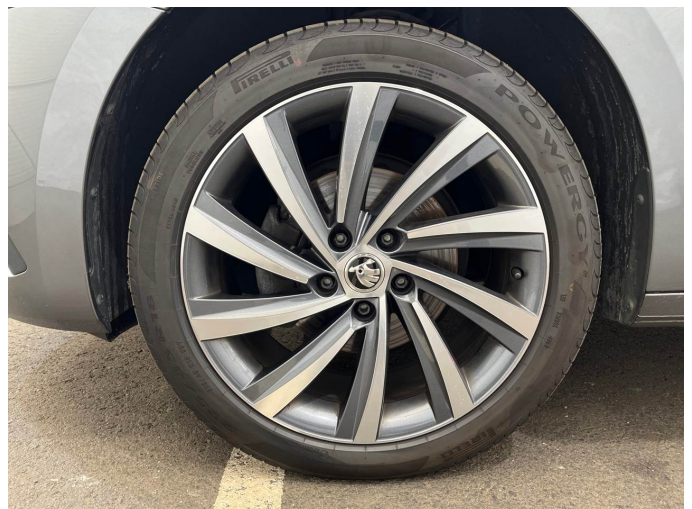
| # | Tyre size | Type of tyre | Manufacturer | Tread depth |
|---|---|---|---|---|
| 1) | 225/45 R18 95Y | Summer tyres on Light alloy | Pirelli | 4mm / 4mm |
| 2) | 225/45 R18 95Y | Summer tyres on Light alloy | Pirelli | 4mm / 4mm |

Figure 12: Mounted tyres

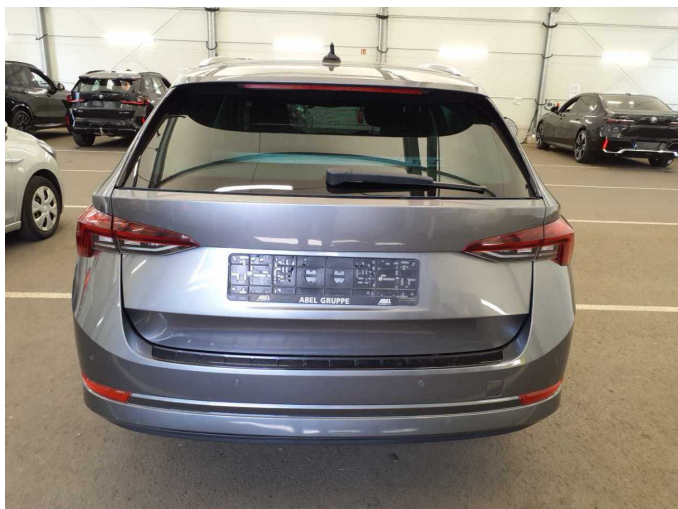
| No. | Component group | Description |
|---|---|---|
| 3 | Boot lid / rear door | Lettering - Missing - Replace |

**Damage 3:** Boot lid / rear door: Lettering - Missing - Replace

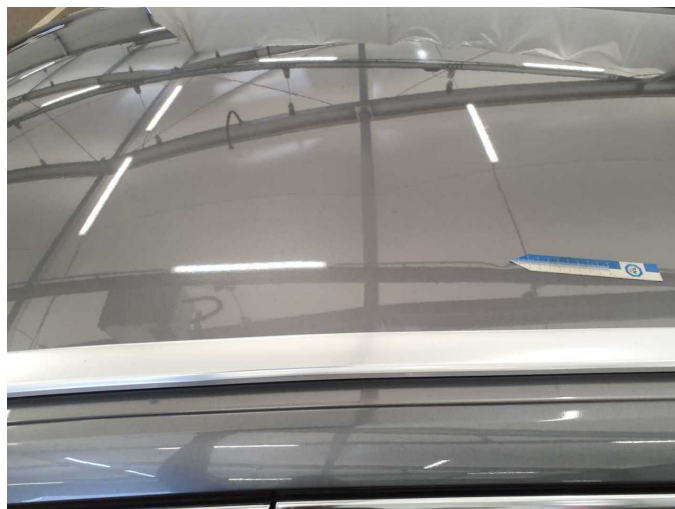
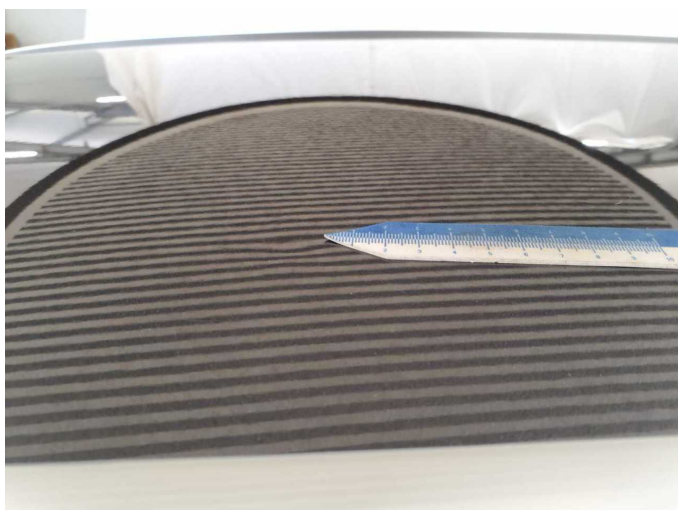
| No. | Component group | Description |
|---|---|---|
| 4 | Roof | Roof - dent(s) - Smart repair |

**Damage 4:** Roof: Roof - dent(s) - Smart repair

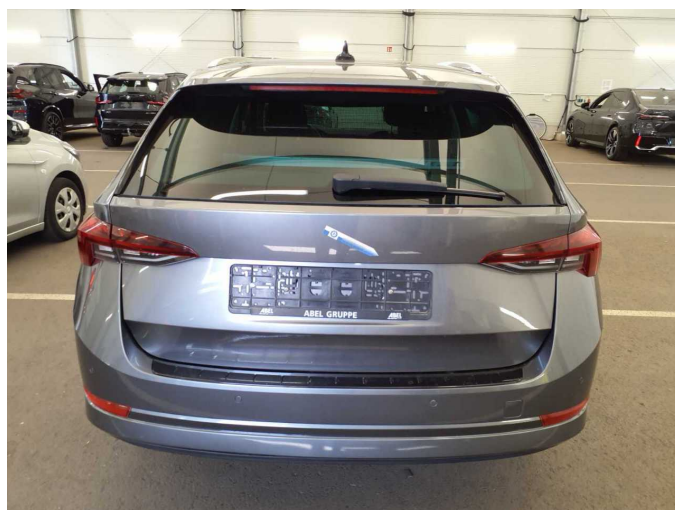
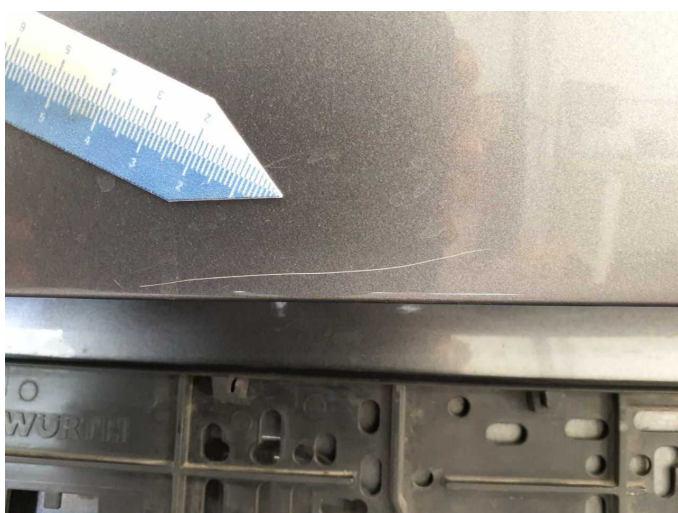
| No. | Component group | Description |
|---|---|---|
| 5 | Boot lid / rear door | Boot lid - Scratch(es) - Smart repair |

**Damage 5:** Boot lid / rear door: Boot lid - Scratch(es) - Smart repair

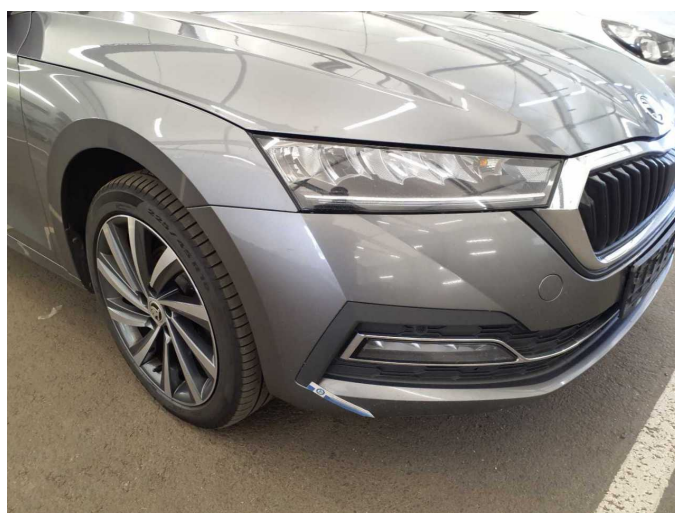
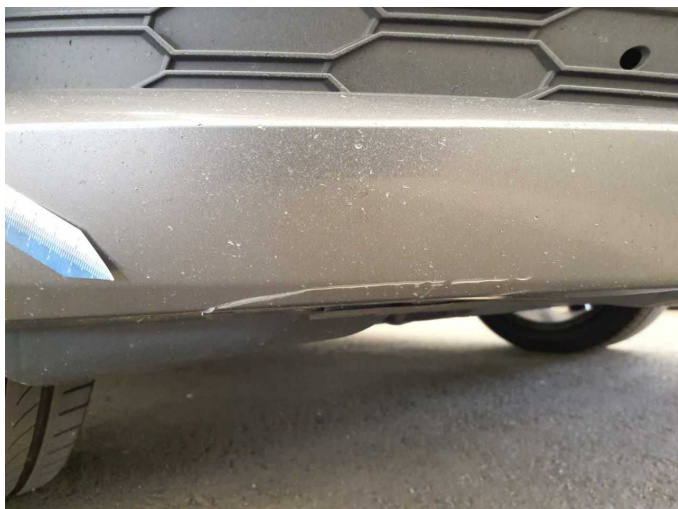
| No. | Component group | Description |
|---|---|---|
| 6 | Front bumper | Front bumper - Scratch(es) - Paint |

**Damage 6:** Front bumper: Front bumper - Scratch(es) - Paint

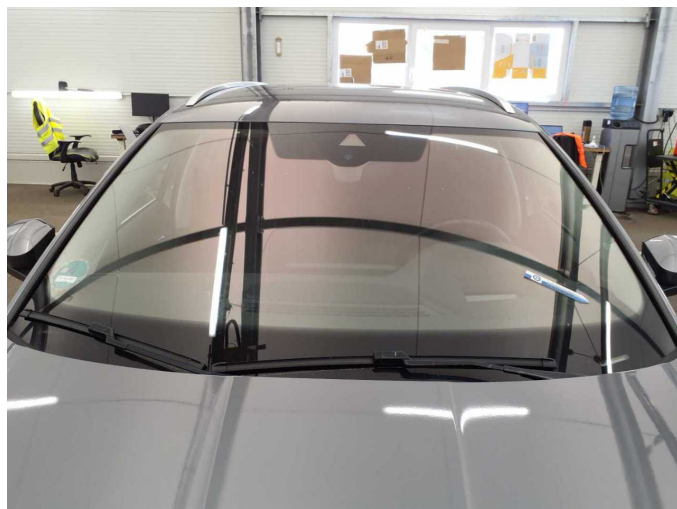
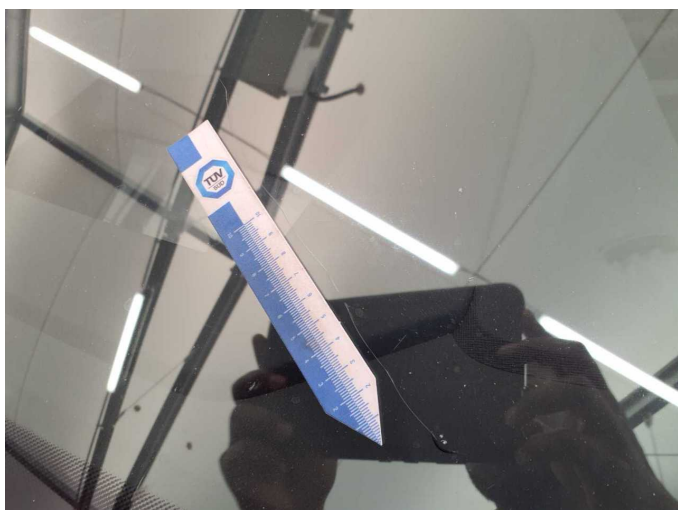
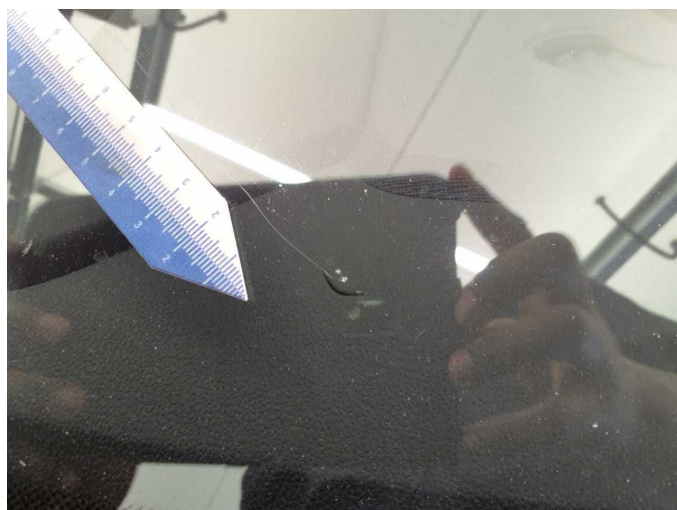
| No. | Component group | Description |
|---|---|---|
| 7 | Vehicle glazing | Windscreen with lane departure assistant - Broken / torn - Replace |

**Damage 7:** Vehicle glazing: Windscreen with lane departure assistant - Broken / torn - Replace

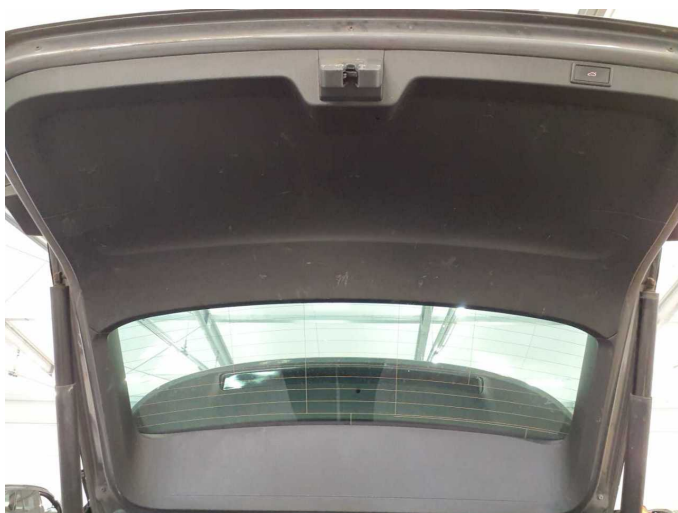
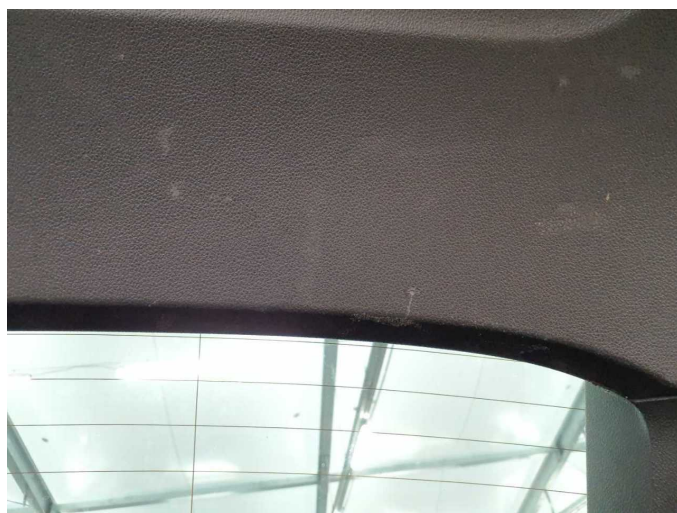
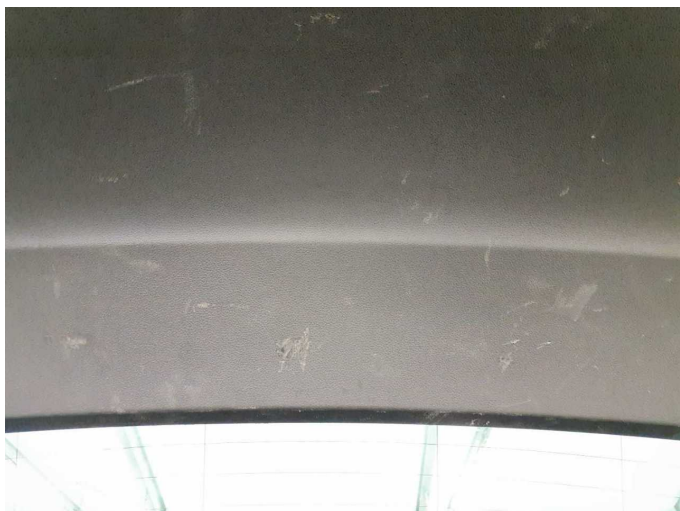
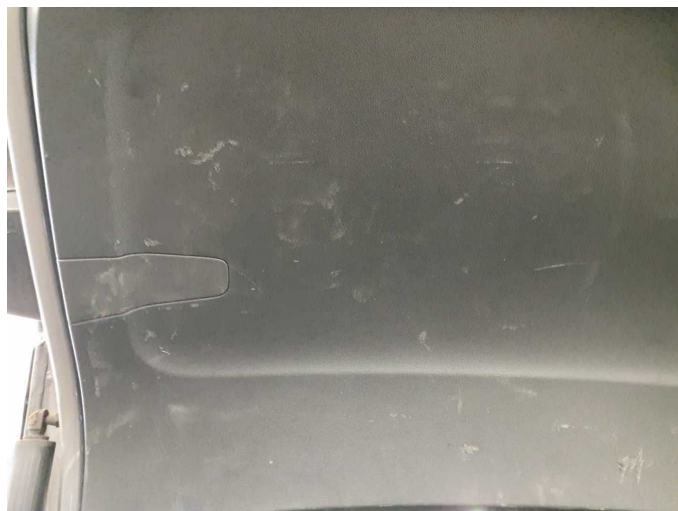
| No. | Component group | Description |
|---|---|---|
| 1 | Trim / covers | Boot lid - interior trim - Scratch(es) - No deduction |

**Wear and tear 1:** Trim / covers: Boot lid - interior trim - Scratch(es) - No deduction

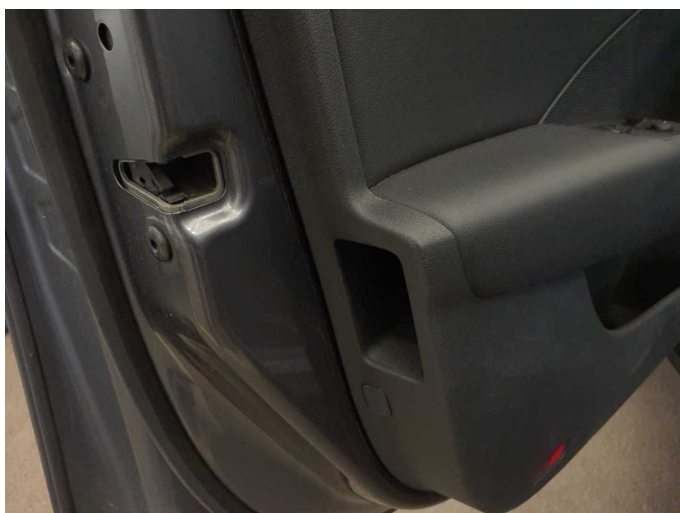
**Missing part 2:** Equipment: Umbrella - Missing - Replace

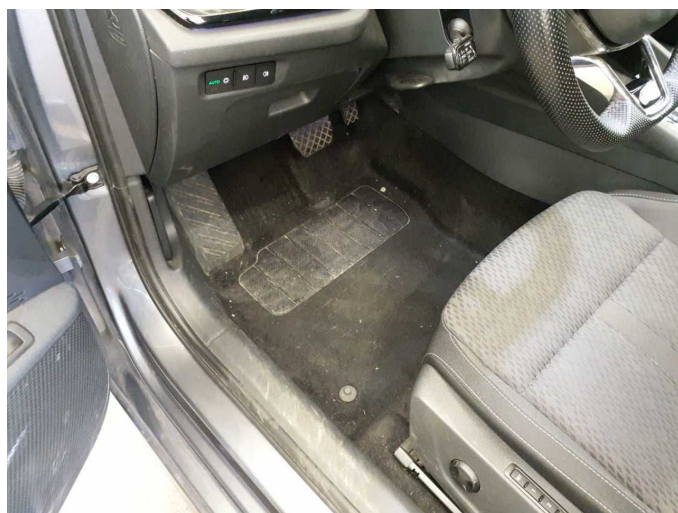
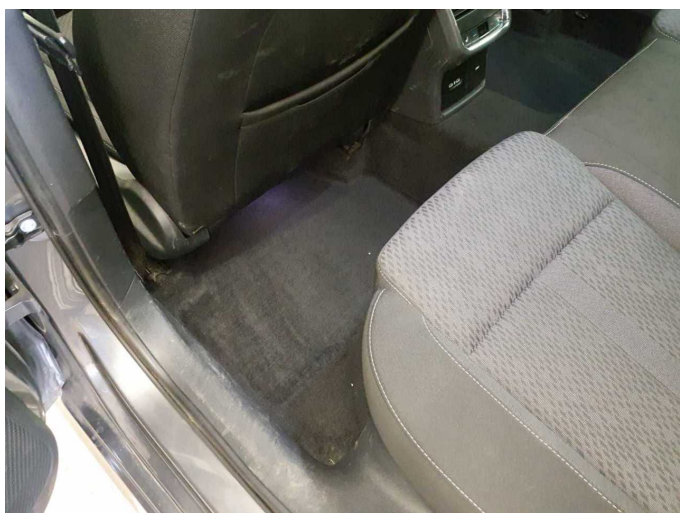
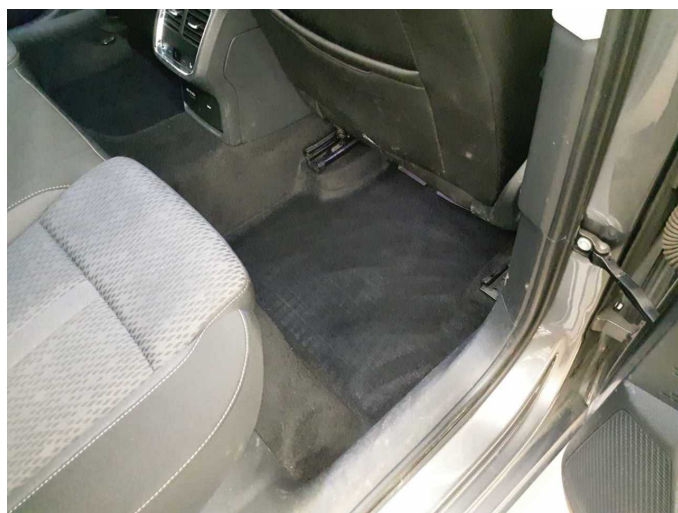
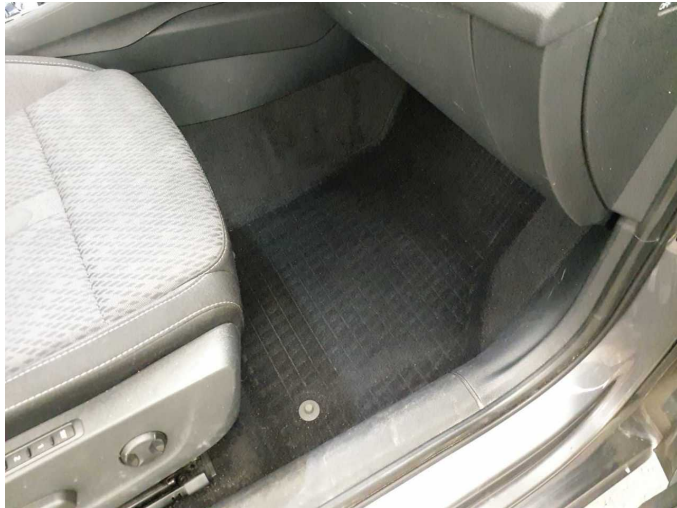
**Missing part 3:** Trim / covers: Floor mats - Missing - Replace

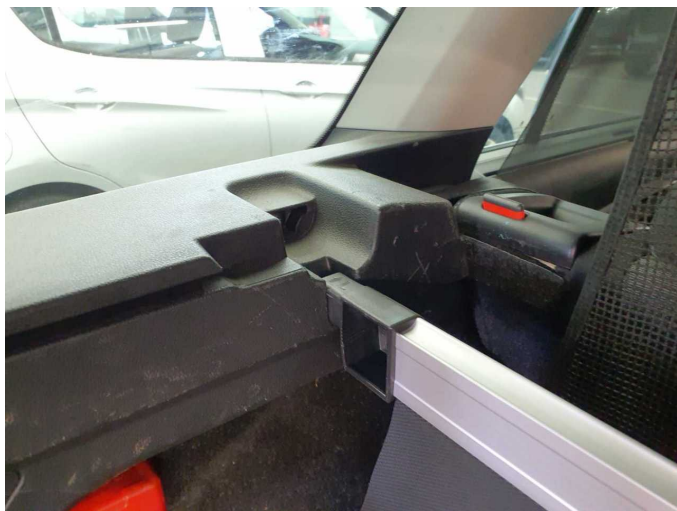
**Missing part 4:** Interior: Boot cover / roller cover - Missing - Replace

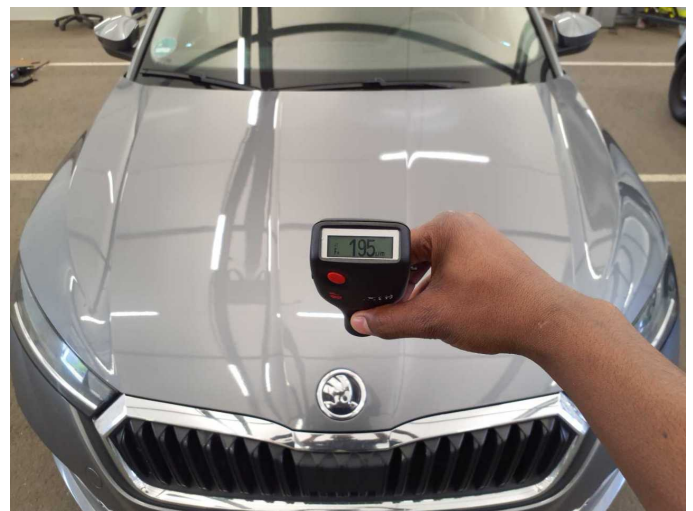
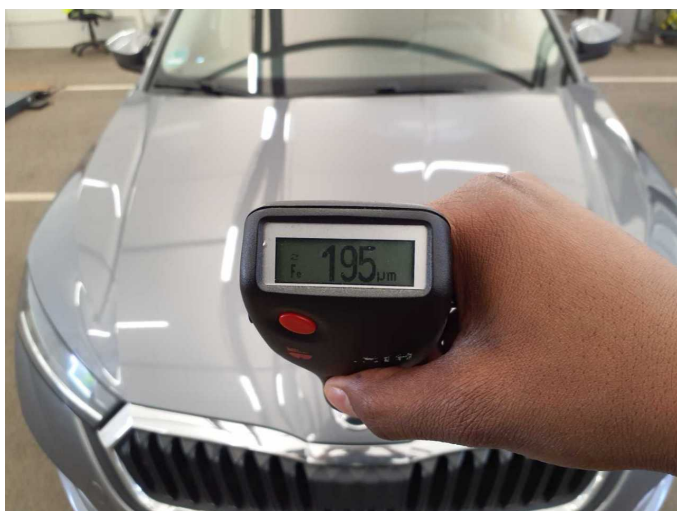
1 Bonnet, Professionally carried out, Invoice of repair done Non-existent

Bonnet 195 µm |

**Repainting 1:** Bonnet
