Expertise

Protocol number: 45922080  
Order No. / Reference: 26448910  
Inspection date: 12 Jun 2026

Manufacturer: Mercedes-Benz  
VIN: W1N4M1EB7PW294213

Model: GLB 220 d 8G-DCT AMG Line

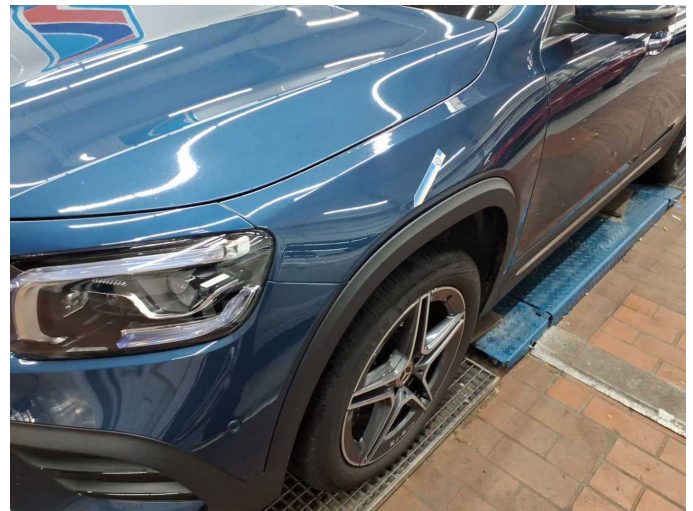
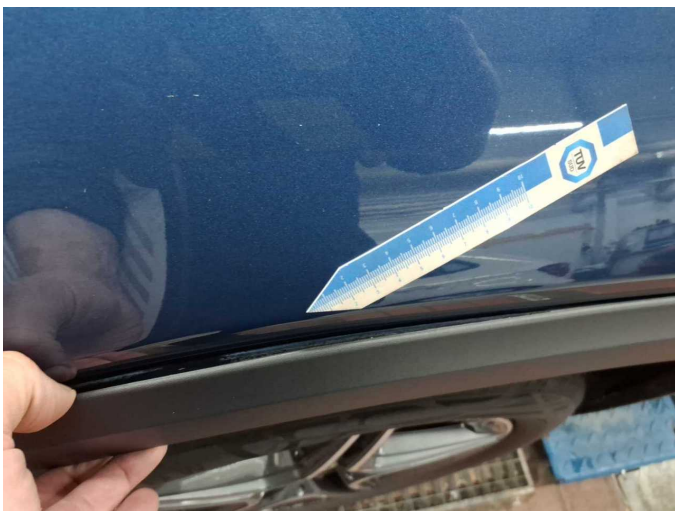
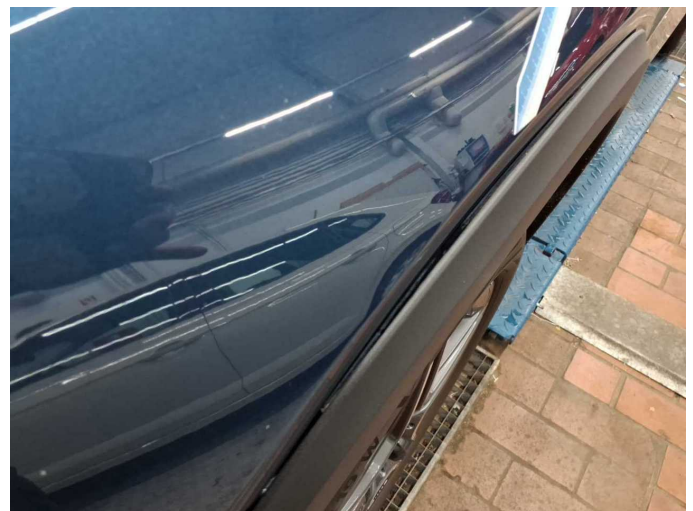
| No. | Component group | Description |
|---|---|---|
| 1 | Mudguard - left side | Wheel well extension (3 mm Spalt zwischen Kotflügel und Radlauf) - Loose - Diagnosed and repair if necessary |

**Damage 1:** Mudguard - left side: Wheel well extension (3 mm Spalt zwischen Kotflügel und Radlauf) - Loose - Diagnosed and repair if necessary

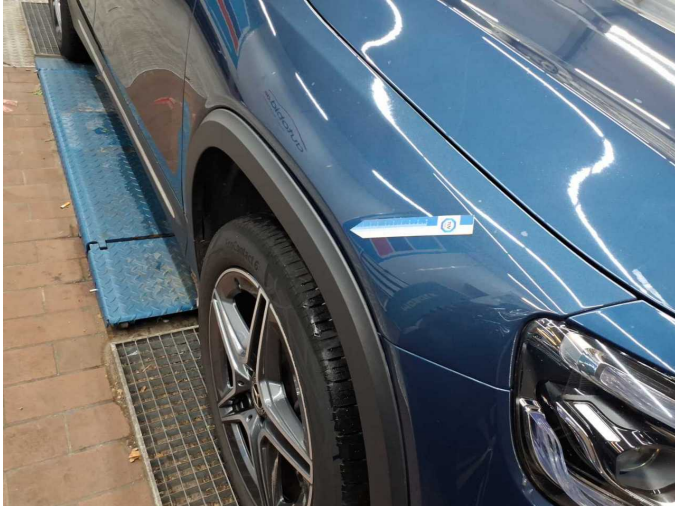
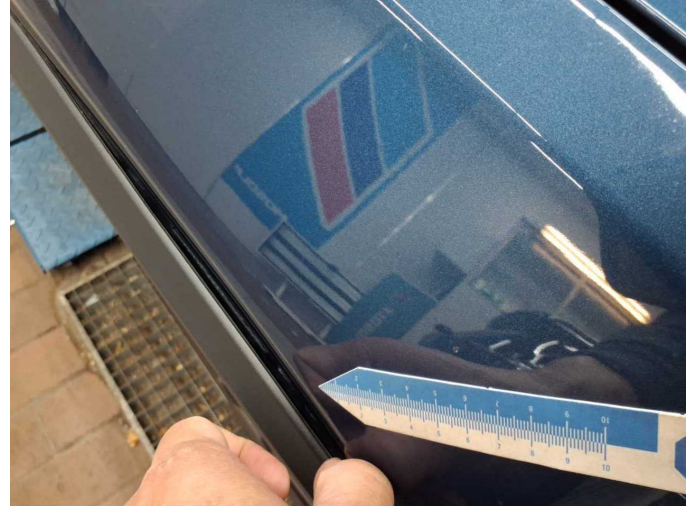
| No. | Component group | Description |
|---|---|---|
| 2 | Mudguard - right side | Wheel well extension (4 mm Spalt zwischen Kotflügel und Radlauf) - Loose - Diagnosed and repair if necessary |

**Damage 2:** Mudguard - right side: Wheel well extension (4 mm Spalt zwischen Kotflügel und Radlauf) - Loose - Diagnosed and repair if necessary

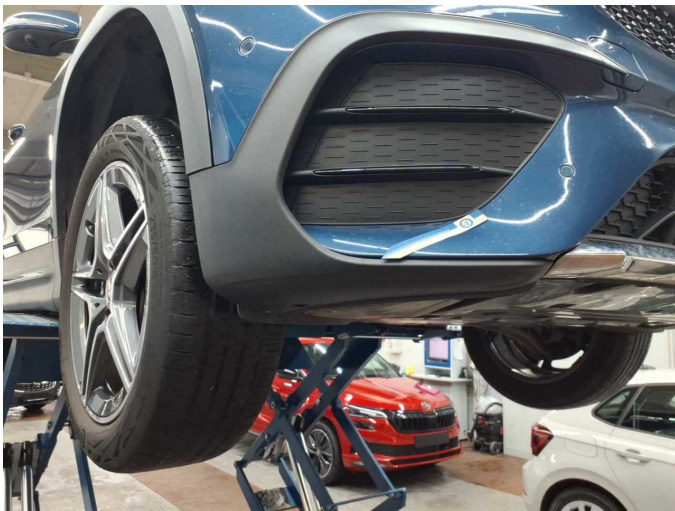
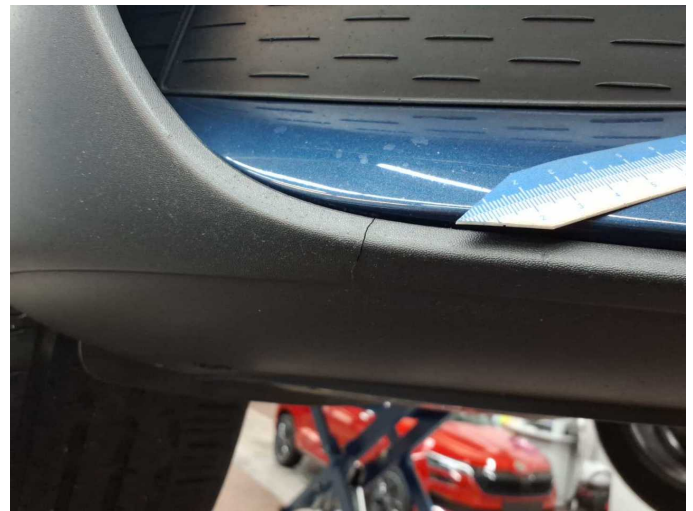
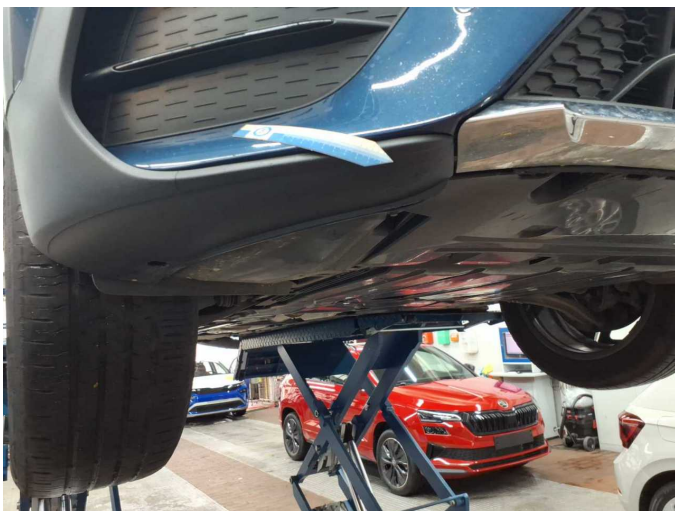
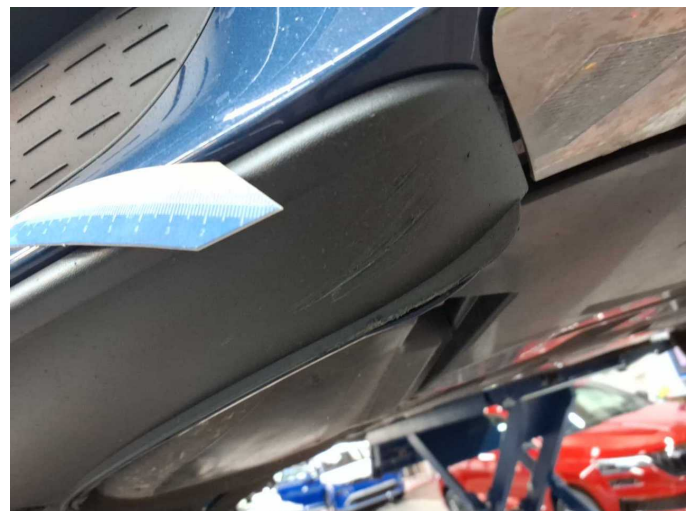
| No. | Component group | Description |
|---|---|---|
| 3 | Front bumper | Spoiler (Zierleiste re) - Broken / torn - Replace |

**Damage 3:** Front bumper: Spoiler (Zierleiste re) - Broken / torn - Replace

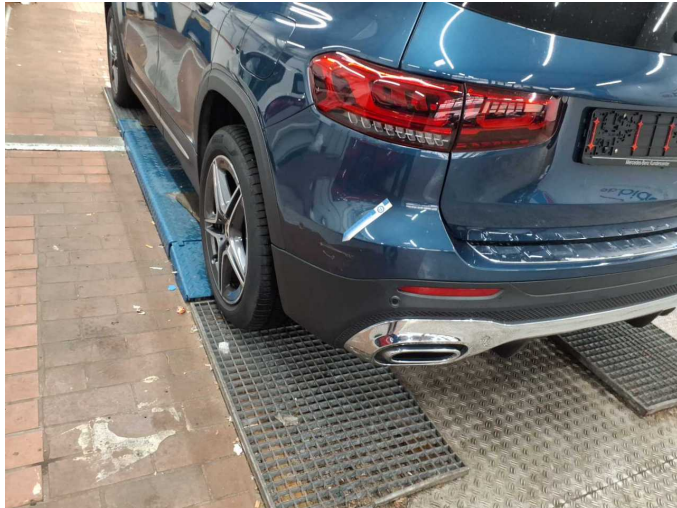
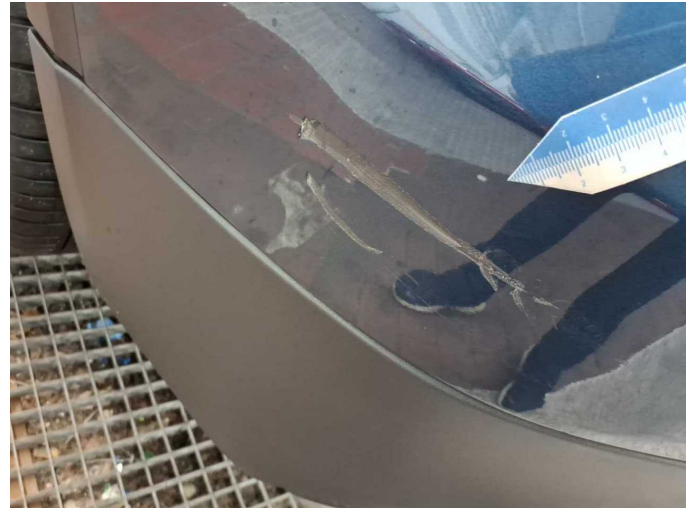
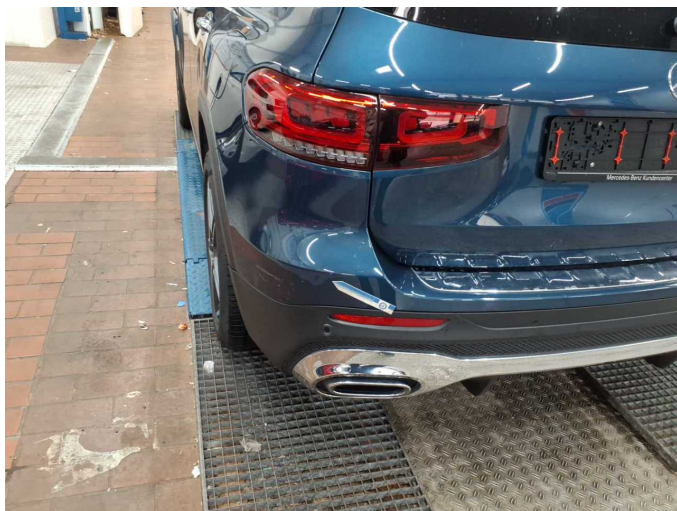
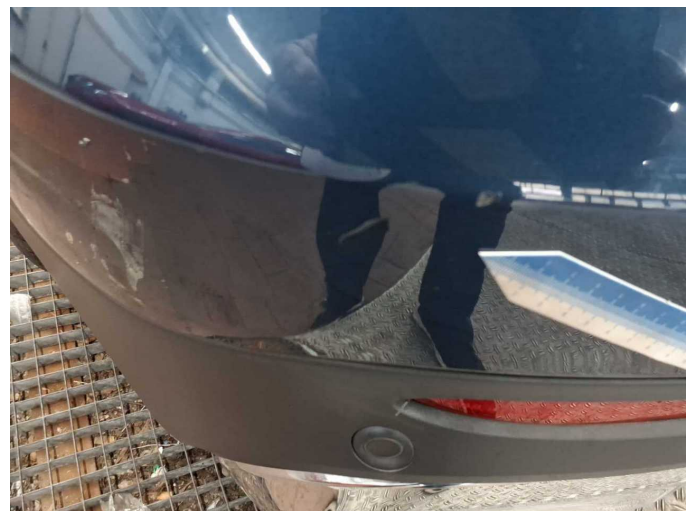
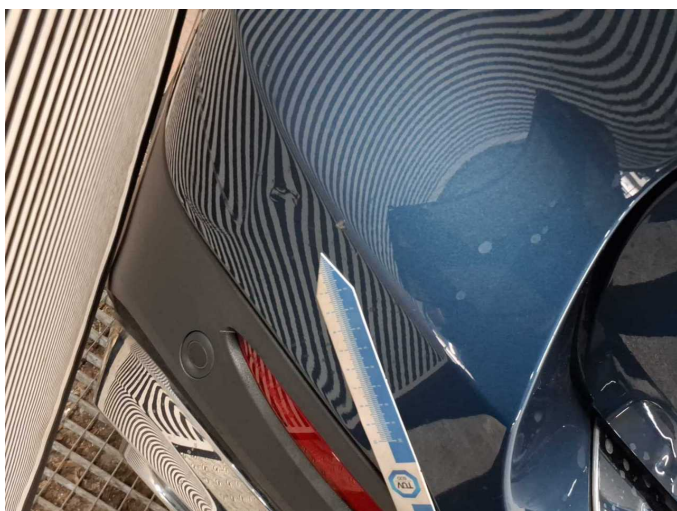
| No. | Component group | Description |
|---|---|---|
| 4 | Rear bumper | Rear bumper - Dent / paintcoat damage - Repair and paint |

**Damage 4:** Rear bumper: Rear bumper - Dent / paintcoat damage - Repair and paint

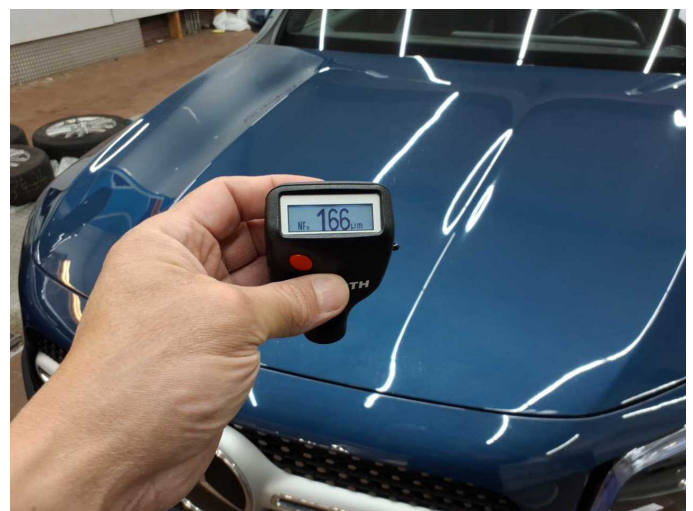
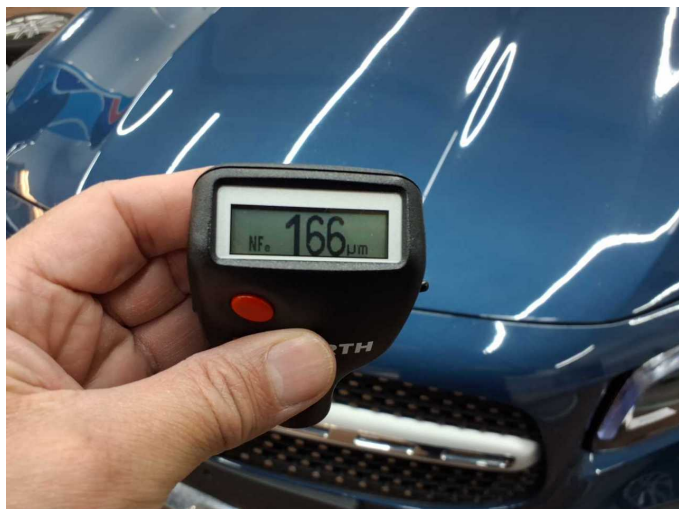
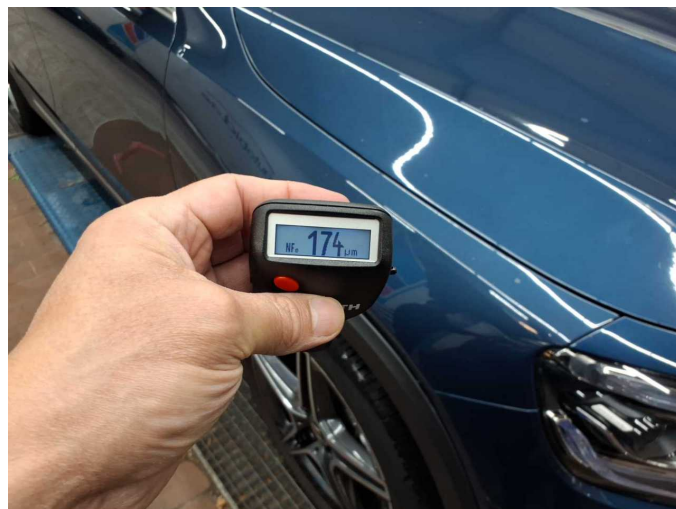
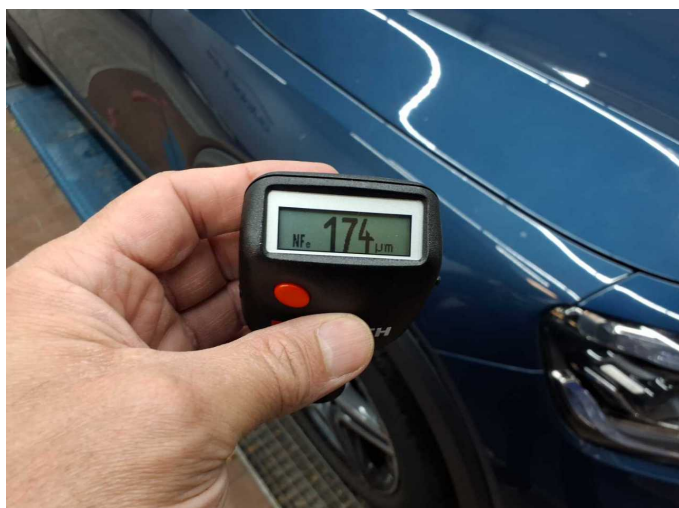
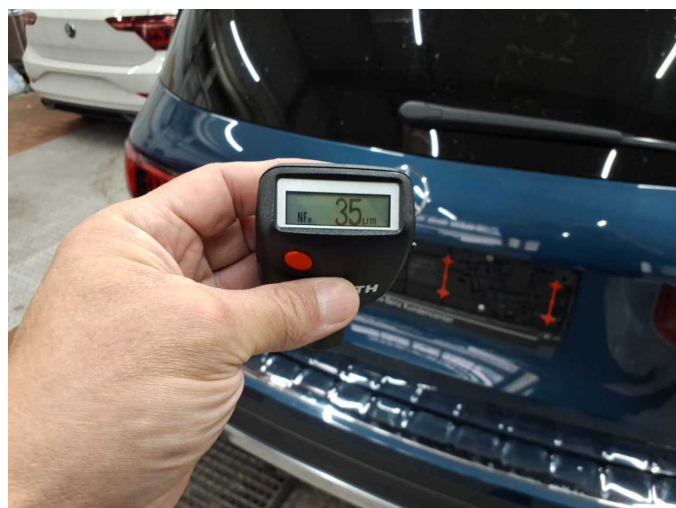
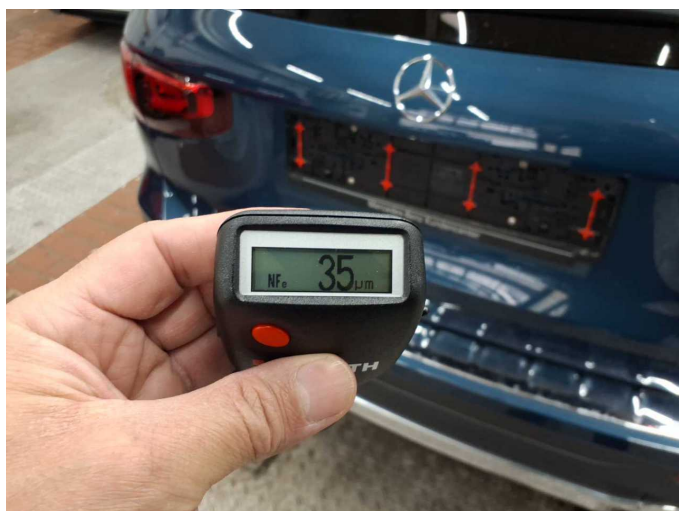
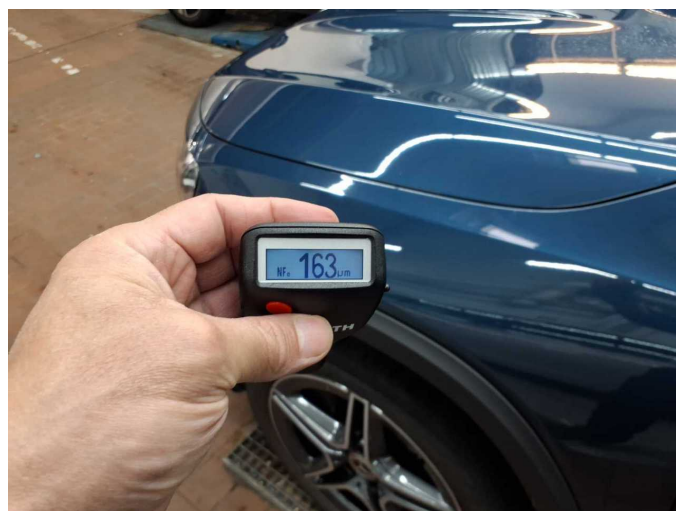
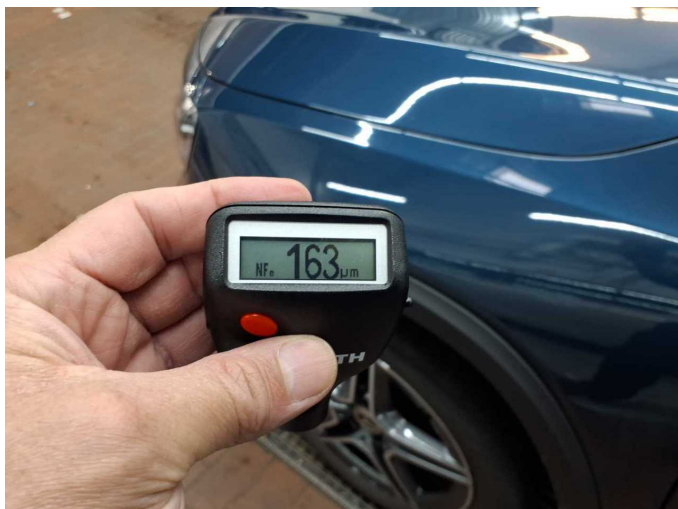
| No. | Repainting |
|---|---|
| 1 | Boot lid / rear door, Mudguard - left side, Mudguard - right side, Bonnet, Professionally carried out, Invoice of repair done Non-existent |

| Boot lid / rear door | 35 µm | Mudguard - left side | 163 µm |
| Mudguard - right side | 174 µm | Bonnet | 166 µm |

**Repainting 1:** Boot lid / rear door, Mudguard - left side, Mudguard - right side, Bonnet
