Expertise

Protocol number: 46635110  
Order No. / Reference: 26681634  
Inspection date: 21 Jul 2026

| Manufacturer: Ford | Model: Focus Turnier 1.5 EcoBlue Start-Stopp-System ST-LINE X |

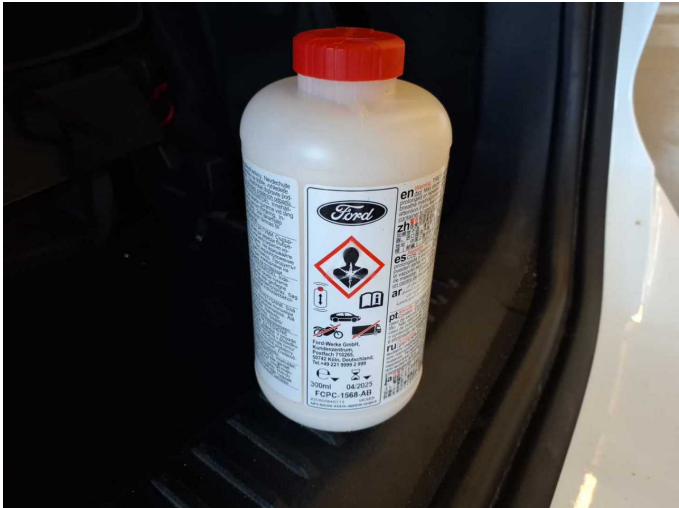
Damage 1: Equipment: Tirefit filler - Expired - Replace

| No. | Component group | Description |
|---|---|---|
| 1 | Equipment | Tirefit filler - Expired - Replace |

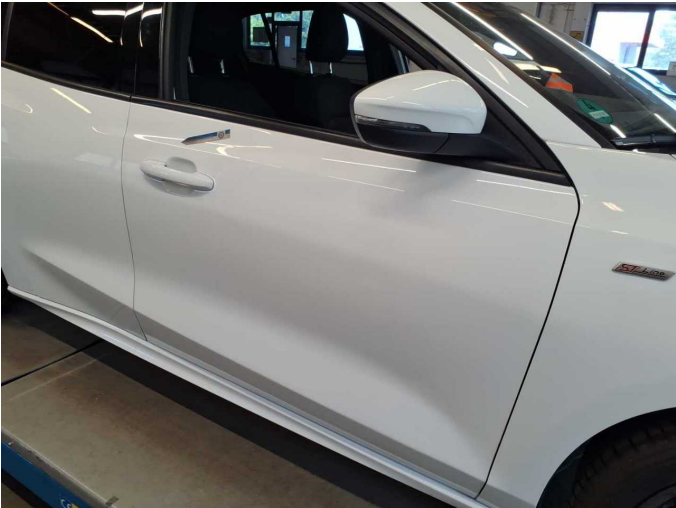
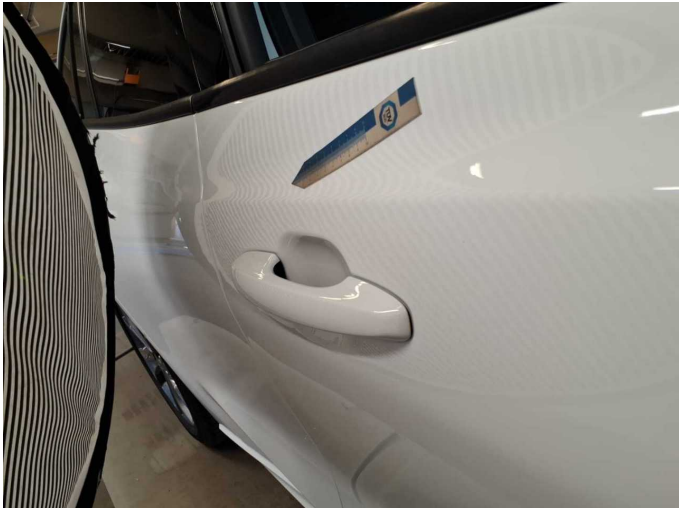
Damage 2: Door - front right side: Door (Lackläufer-Mehrkosten möglich)  
- Unprofessionally repaired - Conditioning

| No. | Component group | Description |
|---|---|---|
| 2 | Door - front right side | Door (Lackläufer-Mehrkosten möglich) - Unprofessionally repaired - Conditioning |

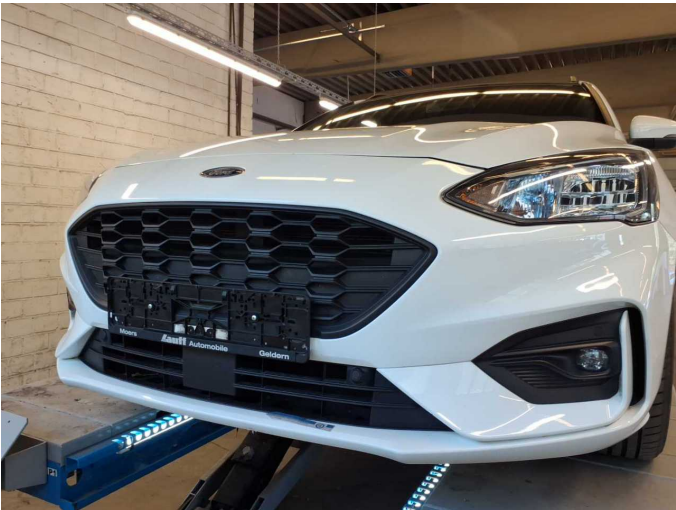
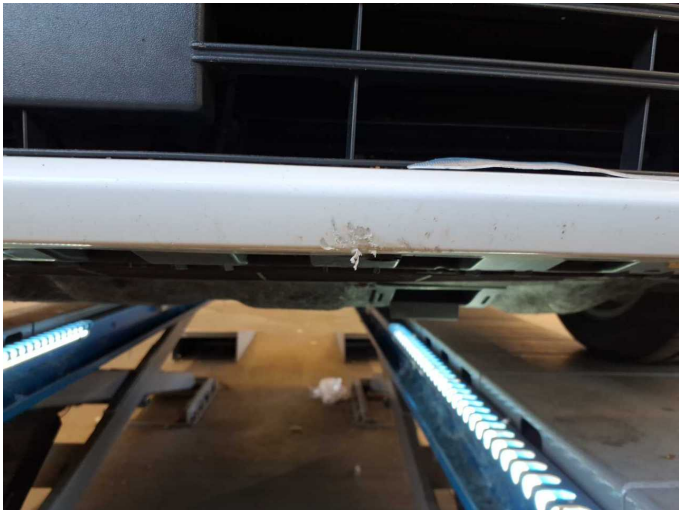
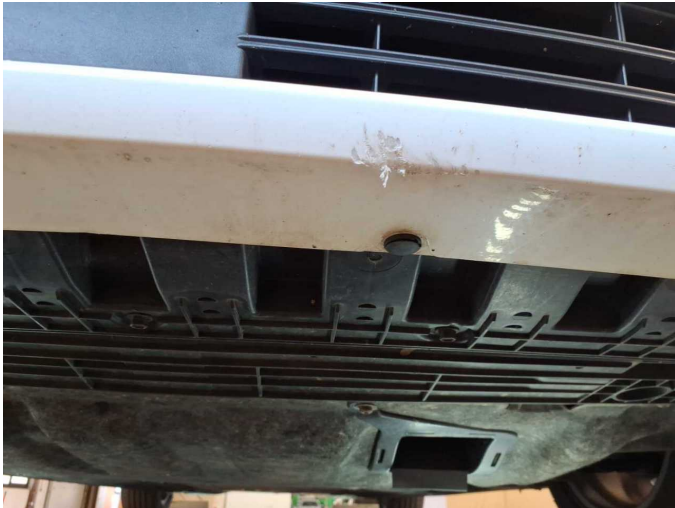
Damage 3: Front bumper: Front bumper - Scratched - Smart repair

**Damage 3:** Front bumper: Front bumper - Scratched - Smart repair

| No. | Component group | Description |
|---|---|---|
| 3 | Front bumper | Front bumper - Scratched - Smart repair |

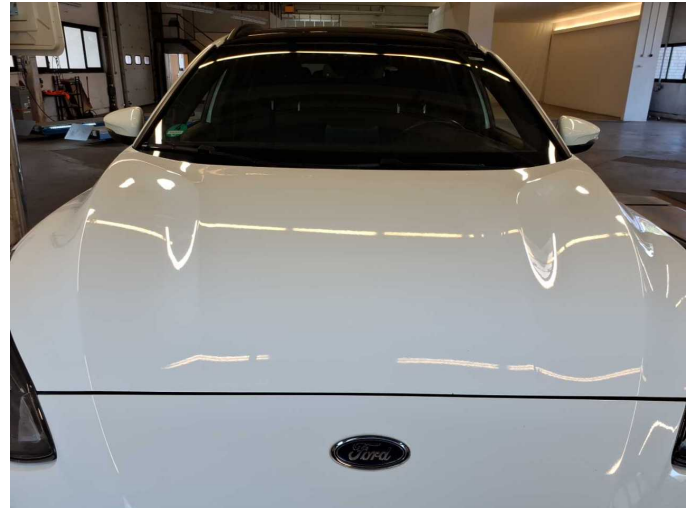
**Wear and tear 1:** Bonnet: Bonnet - Stone chips - No deduction

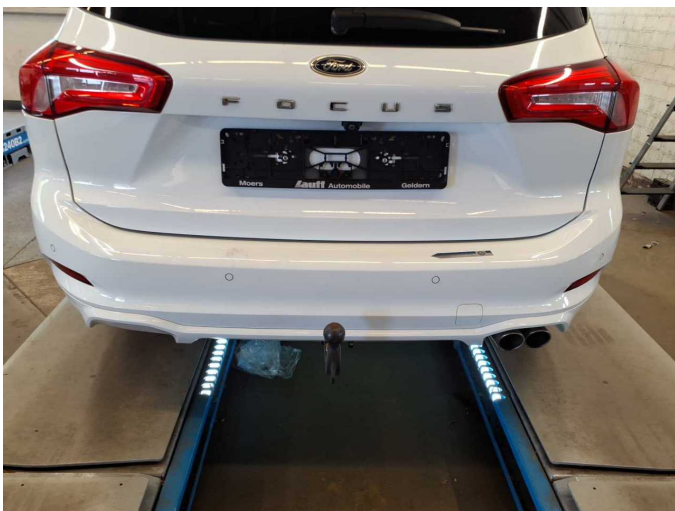
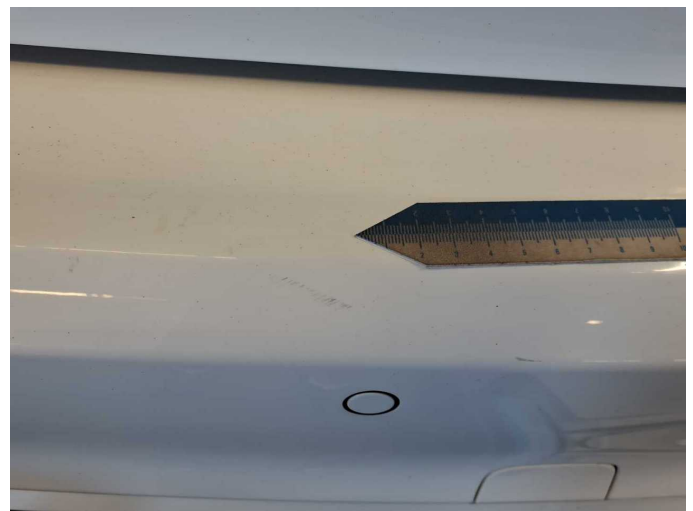
**Wear and tear 2:** Rear bumper: Rear bumper - Soiled - No deduction

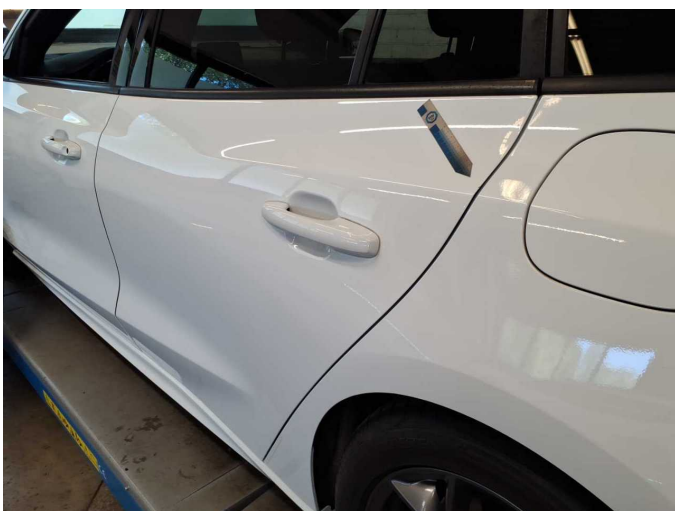
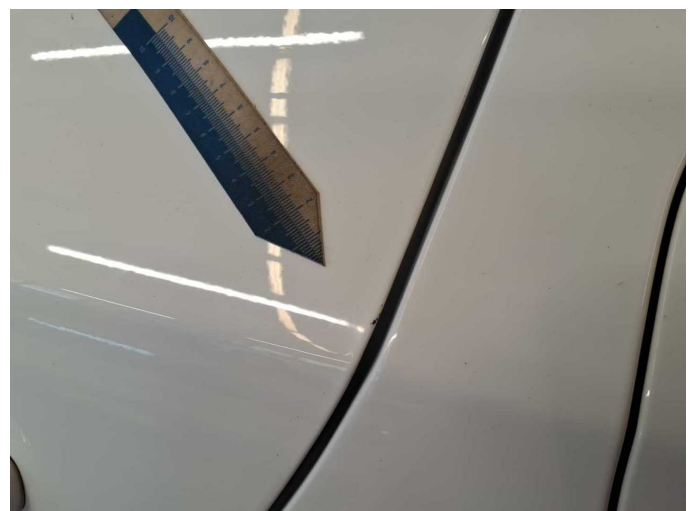
**Wear and tear 3:** Door - rear left side: Door edge - Scratched - No deduction

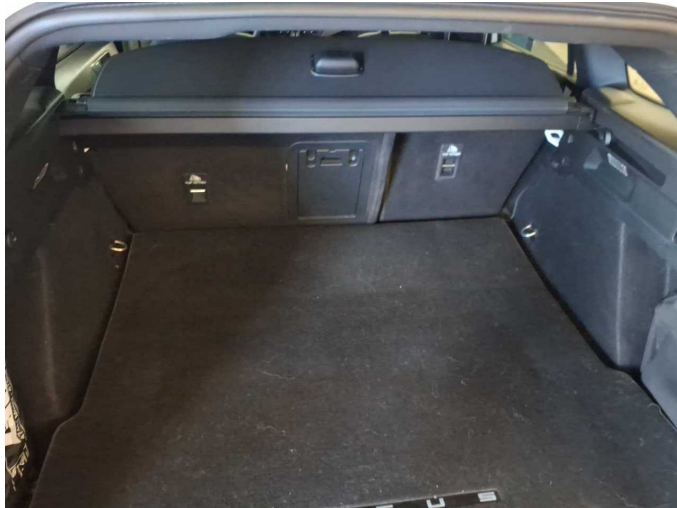
**Missing part 1:** Interior: Separation net - Missing - Replace

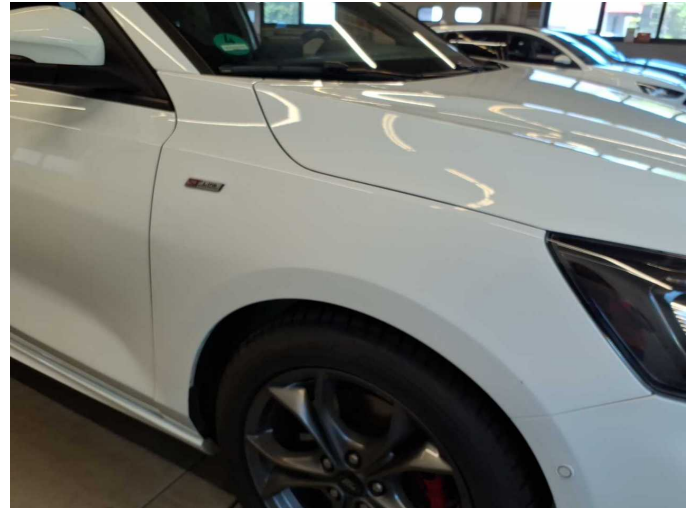
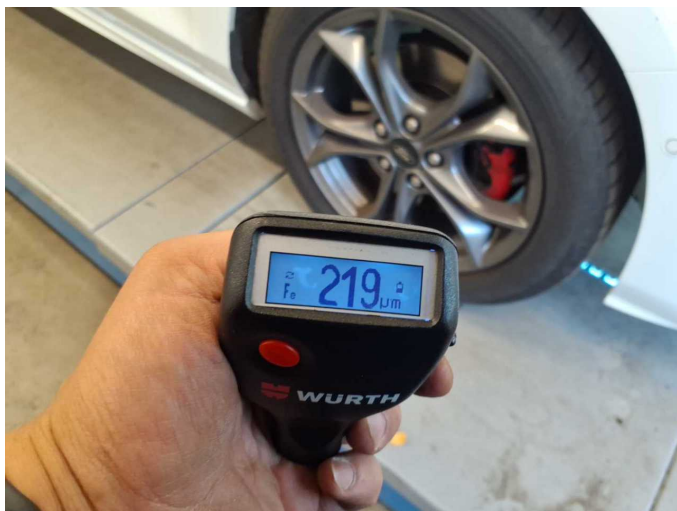
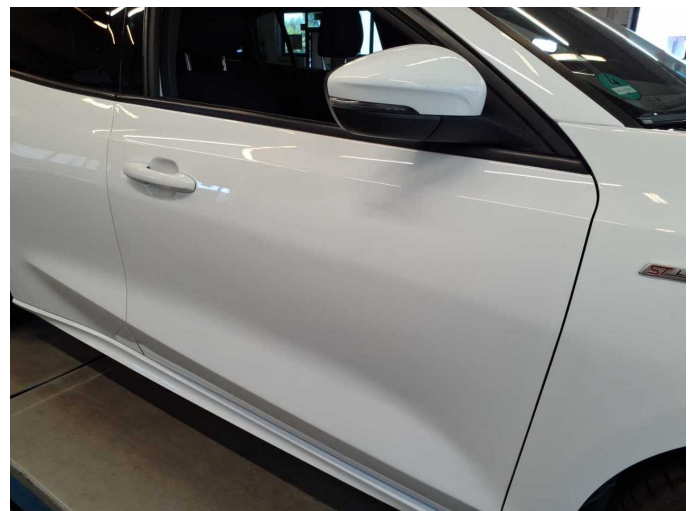
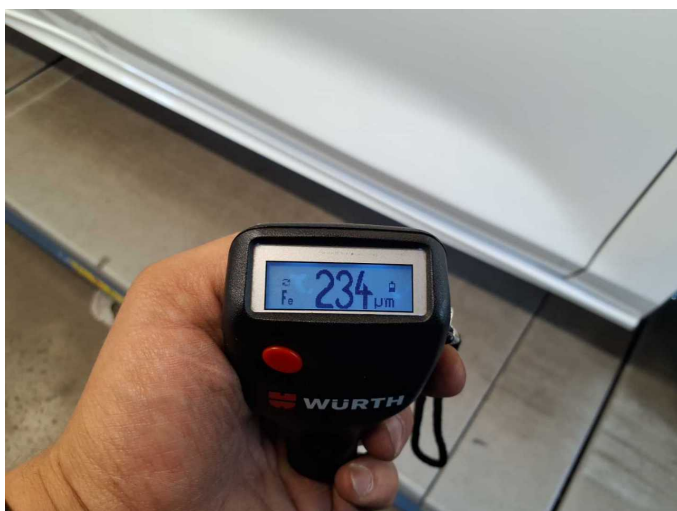
| Mudguard - right side | 205 µm | Door - front right side | 241 µm |

**Repainting 1:** Mudguard - right side, Door - front right side
