Expertise

Protocol number: 45919800
Order No. / Reference: 26461026
Inspection date: 12 Jun 2026

Model: Kodiaq 2.0 TDI 4x4 DSG Style

VIN: TMBLJ9NS7N8517362

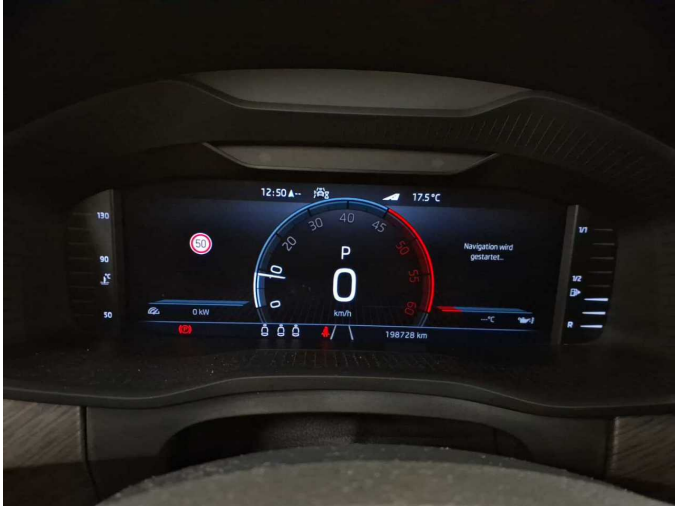
Figure 7: Instrument cluster

Mileage (Read) 198,728 km

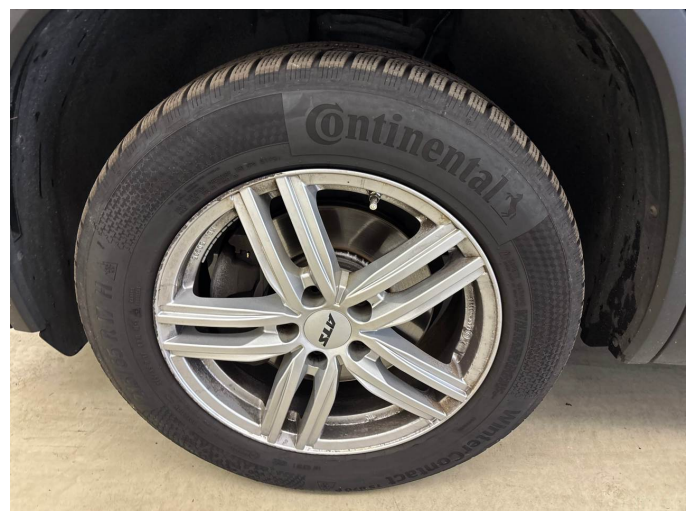
Figure 12: Mounted tyres

#	Tyre size	Type of tyre	Manufacturer	Tread depth
1)	215/65 R17 99H	Winter tyres on Light alloy	Continental	5mm / 5mm
2)	215/65 R17 99H	Winter tyres on Light alloy	Continental	5mm / 5mm

- Für den montierten Radsatz wurde kein Nachweis erbracht.
- Winterradsatz ist kein Bestandteil des Auslieferungsumfangs.

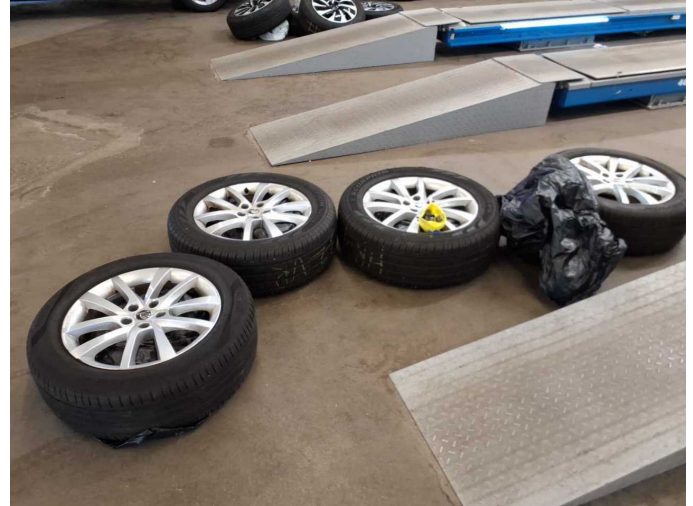
Figure 14: Additional tyres

#	Tyre size	Type of tyre	Manufacturer	Tread depth
1)	235/55 R18 100V	Summer tyres on Light alloy	Pirelli	5mm / 5mm
2)	235/55 R18 100V	Summer tyres on Light alloy	Pirelli	5mm / 5mm

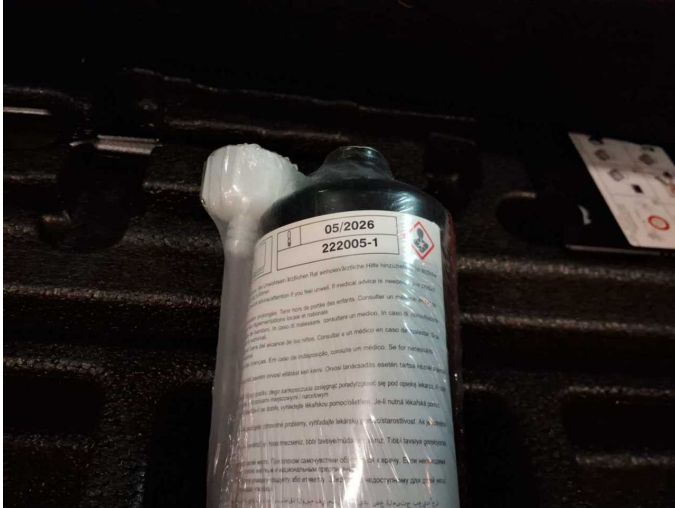
No.	Component group	Description
1	Equipment	Tirefit filler - Expired - Replace

Damage 1: Equipment: Tirefit filler - Expired - Replace

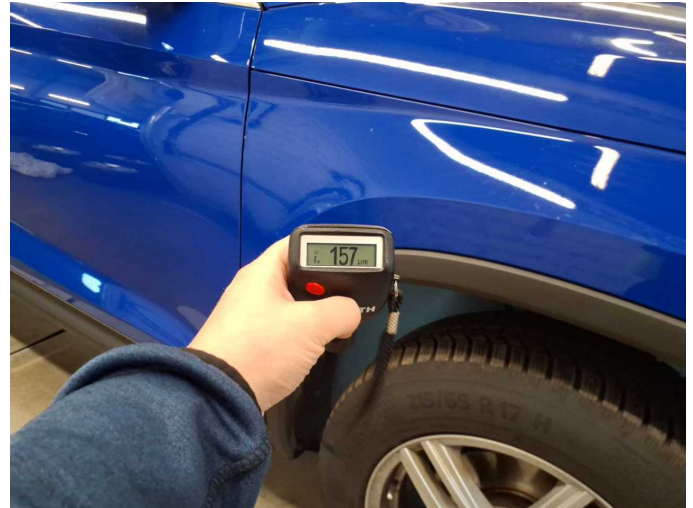
1 Mudguard - right side, Door - rear left side, Professionally carried out, Invoice of repair done Non-existent

Mudguard - right side	157 µm	Door - rear left side	236 µm
-----------------------	--------	-----------------------	--------

Repainting 1: Mudguard - right side, Door - rear left side

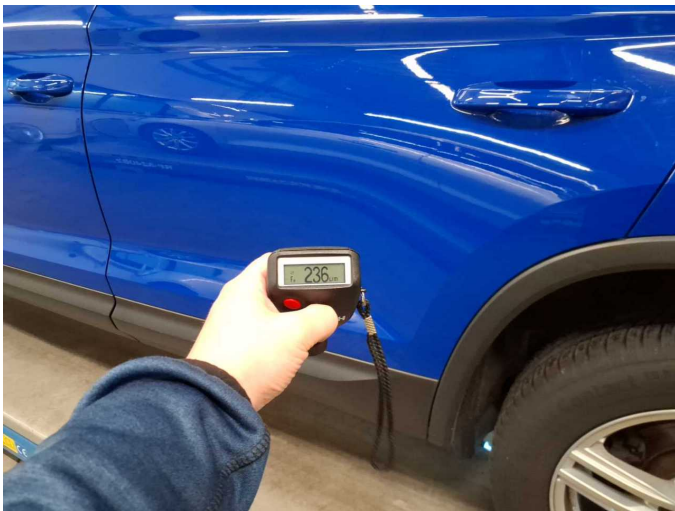
Repainting 1: Mudguard - right side, Door - rear left side
