Expertise

Protocol number: 46740697  
Order No. / Reference: 26712592  
Inspection date: 28 Jul 2026

Model: Passat Variant 2.0 TDI SCR DSG Business

VIN: WVGZZZ3CZPE069079

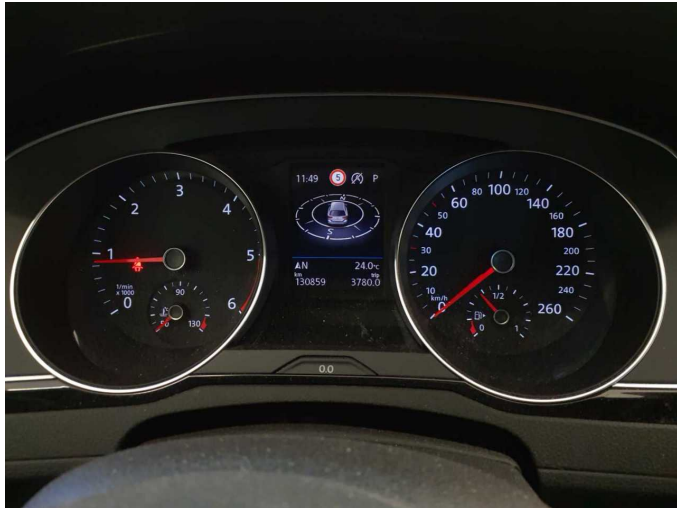
Figure 7: Instrument cluster

| Vehicle details | |
|---|---|
| Mileage (Read) | 130,859 km |

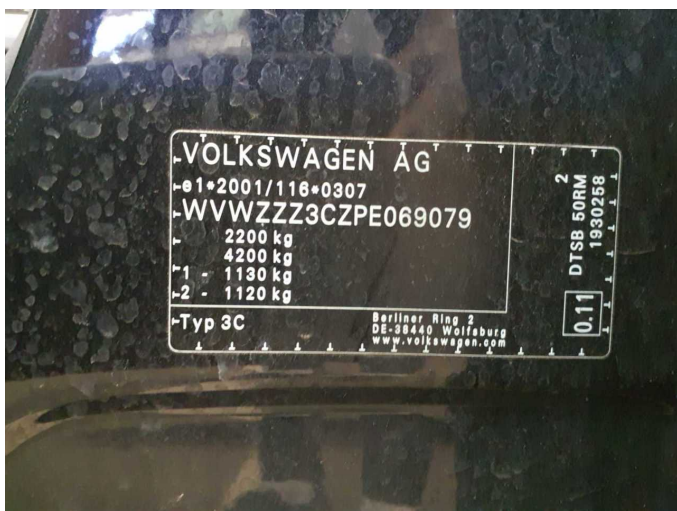
Figure 11: VIN

| VIN comparison | The vehicle identification number (VIN) was read from the vehicle and its conformity with the submitted documents was confirmed by the undersigned during the inspection. |

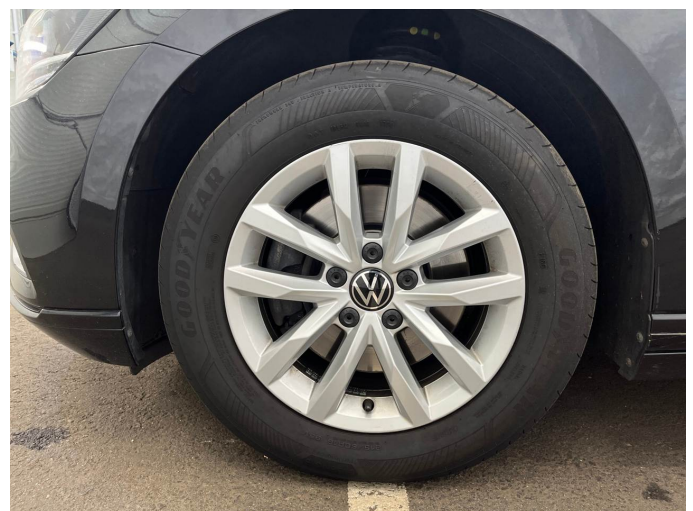
Figure 12: Mounted tyres

| # | Tyre size | Type of tyre | Manufacturer | Tread depth |
|---|---|---|---|---|
| 1) | 215/60 R16 95V | Summer tyres on Light alloy | Goodyear | 6mm / 6mm |
| 2) | 215/60 R16 95V | Summer tyres on Light alloy | Bridgestone | 4mm / 4mm |

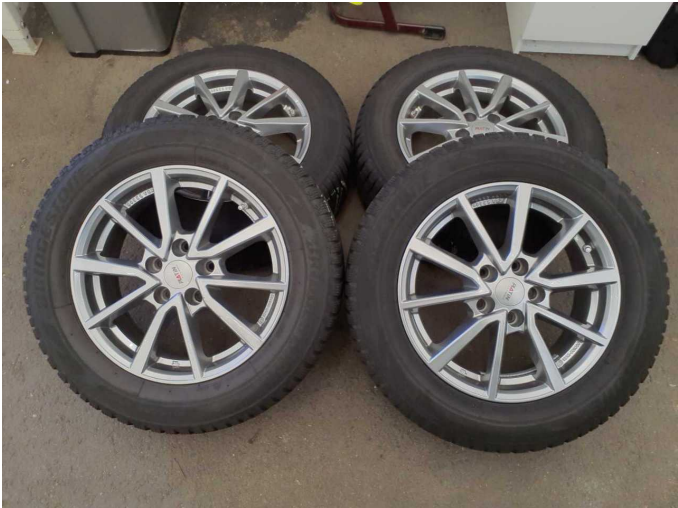
Figure 16: Additional tyres

| # | Tyre size | Type of tyre | Manufacturer | Tread depth |
|---|---|---|---|---|
| 1) | 215/60 R16 99H | Winter tyres on Light alloy | Bridgestone | 5mm / 5mm |
| 2) | 215/60 R16 99H | Winter tyres on Light alloy | Bridgestone | 5mm / 5mm |

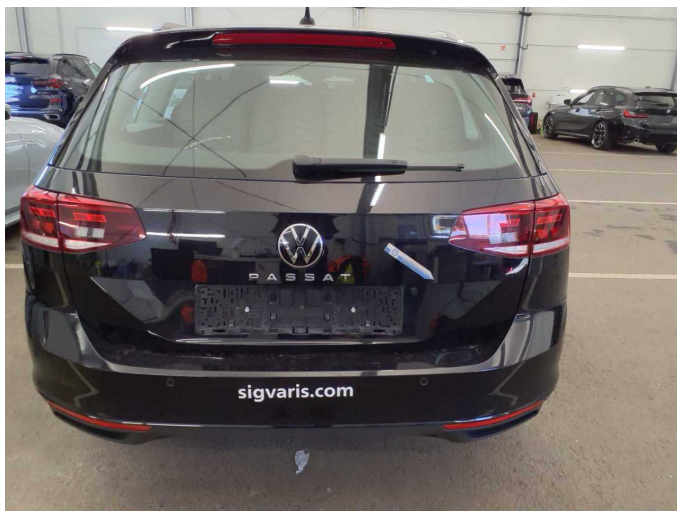
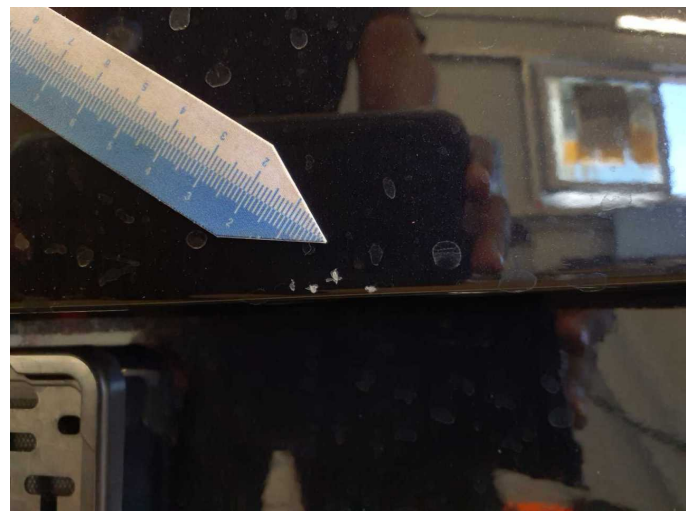
| No. | Component group | Description |
|---|---|---|
| 1 | Boot lid / rear door | Boot lid - Scratch(es) - Smart repair |

Damage 1: Boot lid / rear door: Boot lid - Scratch(es) - Smart repair

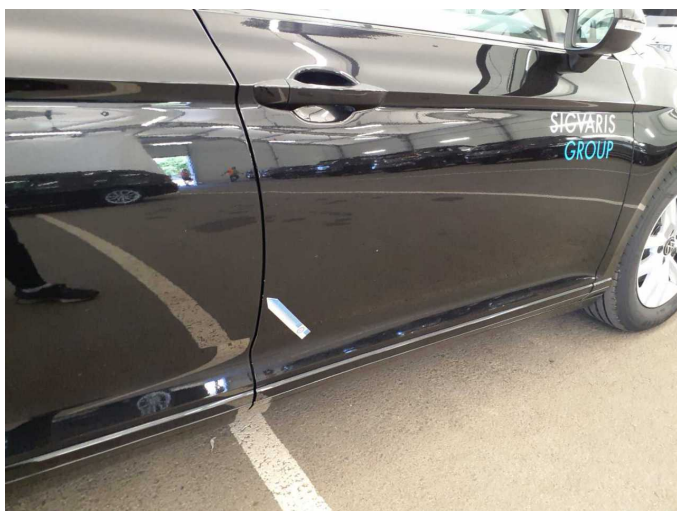
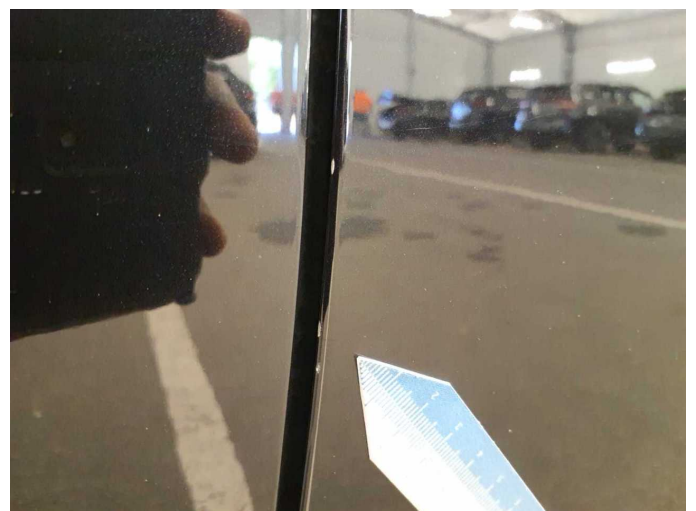
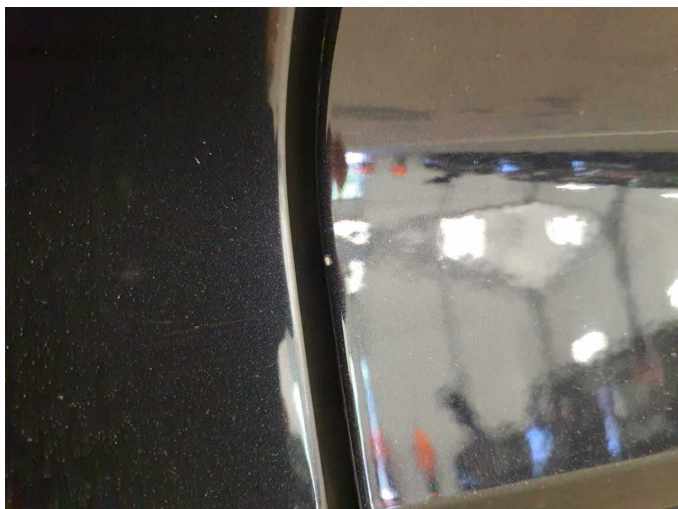
| No. | Component group | Description |
|---|---|---|
| 2 | Door - front right side | Door edge - Scratch(es) - Smart repair |

Damage 2: Door - front right side: Door edge - Scratch(es) - Smart repair

**Damage 2:** Door - front right side: Door edge - Scratch(es) - Smart repair

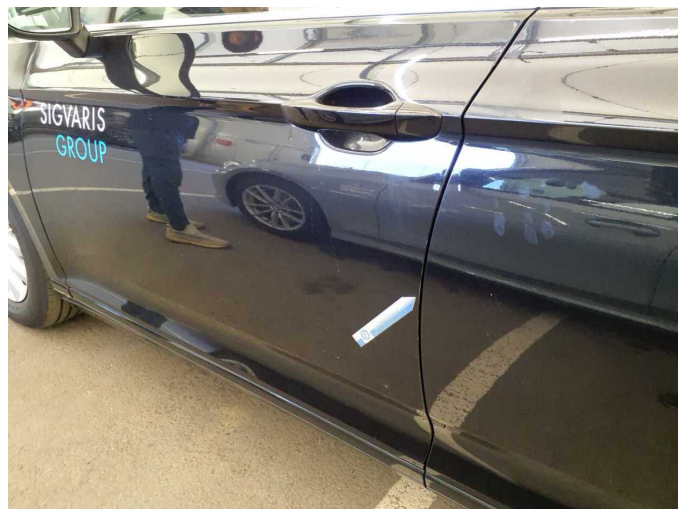
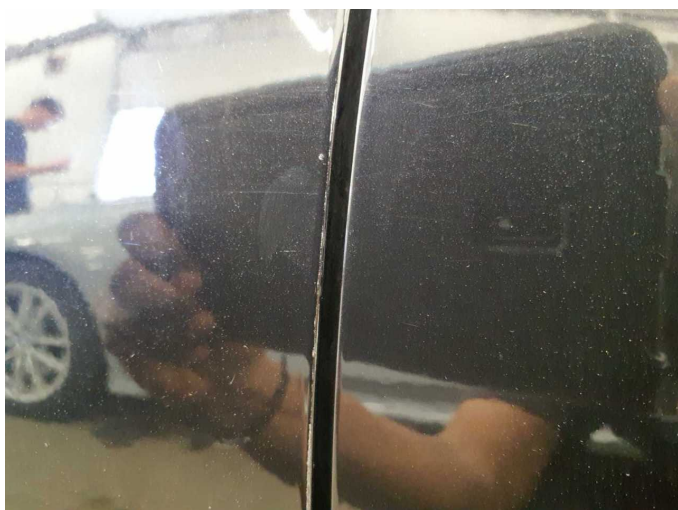
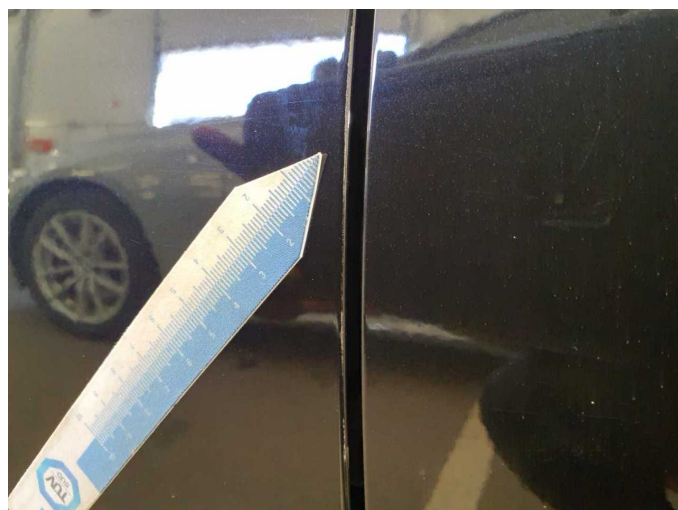
| No. | Component group | Description |
|---|---|---|
| 3 | Door - front left side | Door edge - Scratch(es) - Smart repair |

**Damage 3:** Door - front left side: Door edge - Scratch(es) - Smart repair

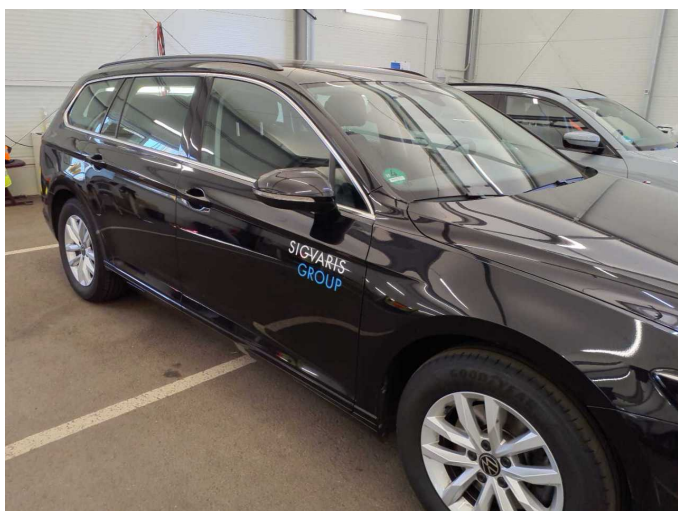
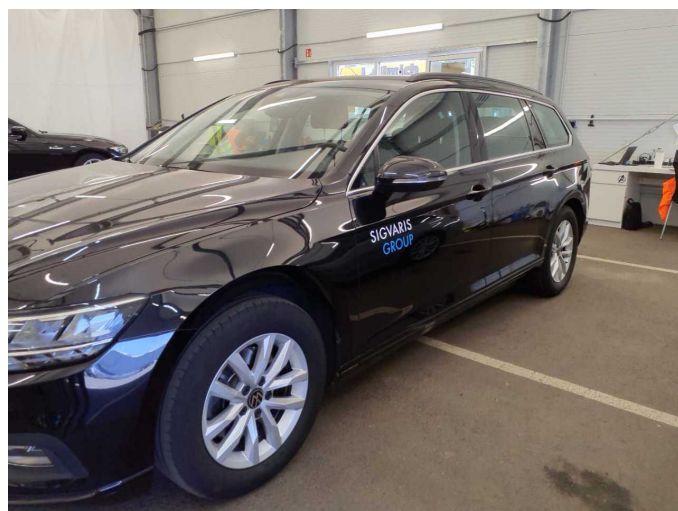
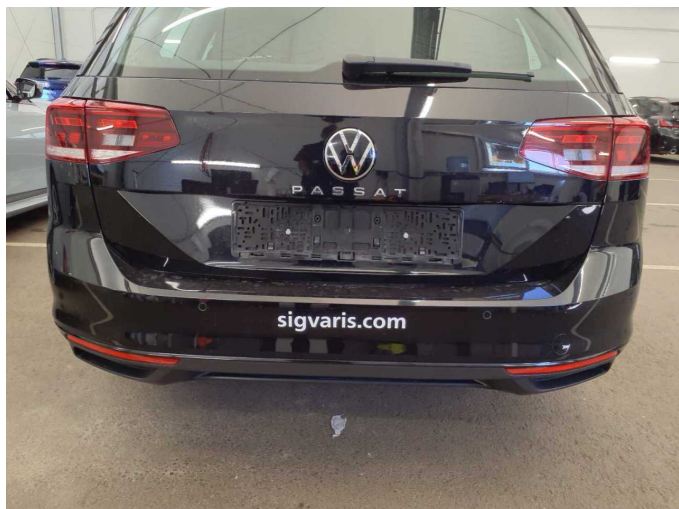
| No. | Component group | Description |
|---|---|---|
| 4 | Body | Body - Glued / labelled - De-glue / neutralise |

**Damage 4:** Body: Body - Glued / labelled - De-glue / neutralise

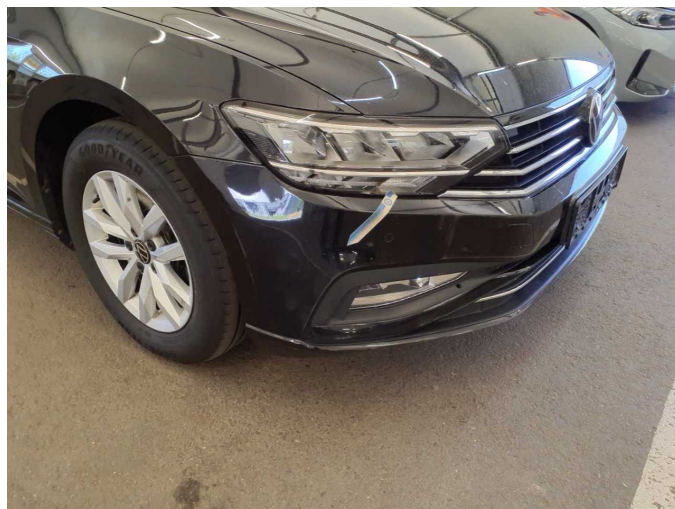
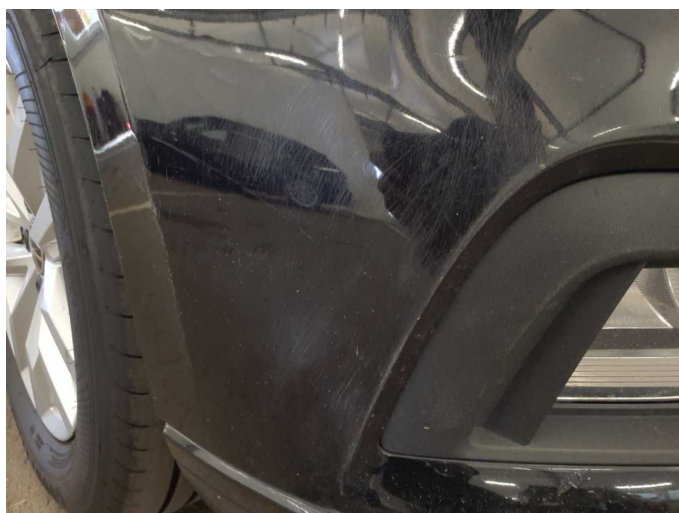
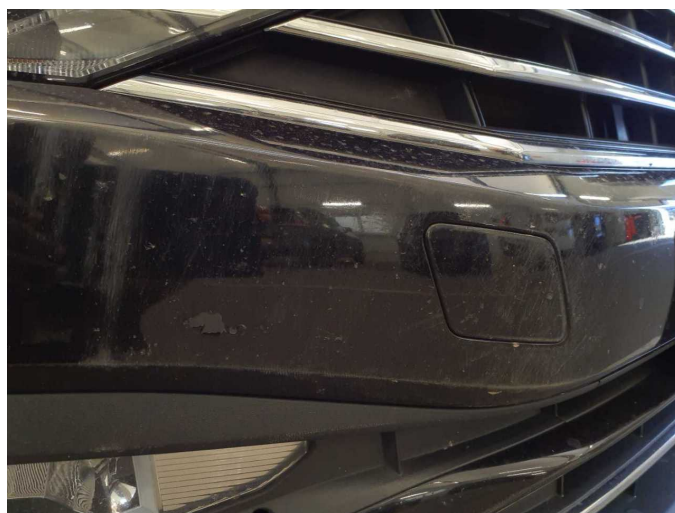
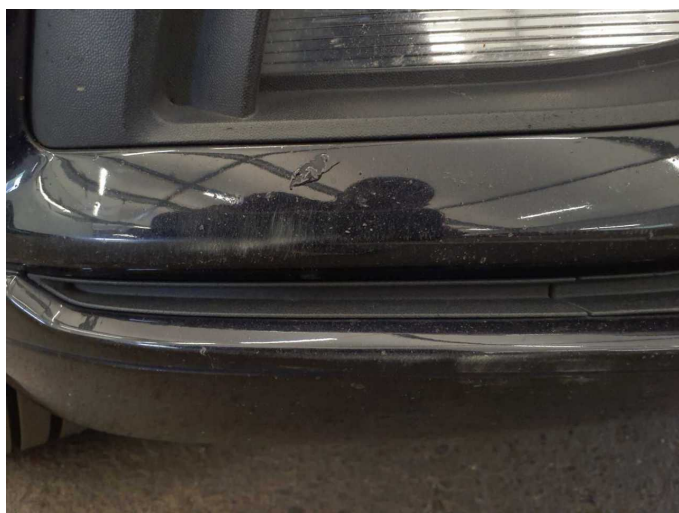
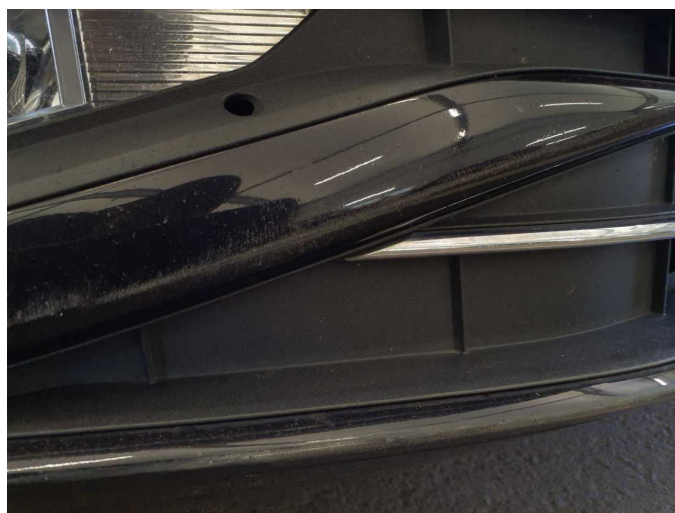
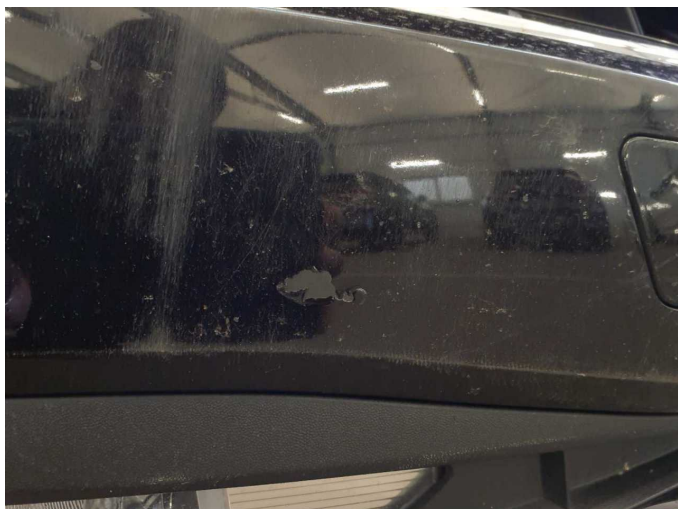
| No. | Component group | Description |
|---|---|---|
| 5 | Front bumper | Front bumper - Scratch(es) - Paint |

**Damage 5:** Front bumper: Front bumper - Scratch(es) - Paint
