Expertise

Protocol number: 46401905  
Order No. / Reference: 26653106  
Inspection date: 8 Jul 2026

Manufacturer: Skoda  
VIN: TMBLJ8NX8RY069435

Model: Octavia Combi 2.0 TDI DSG 4x4 Style

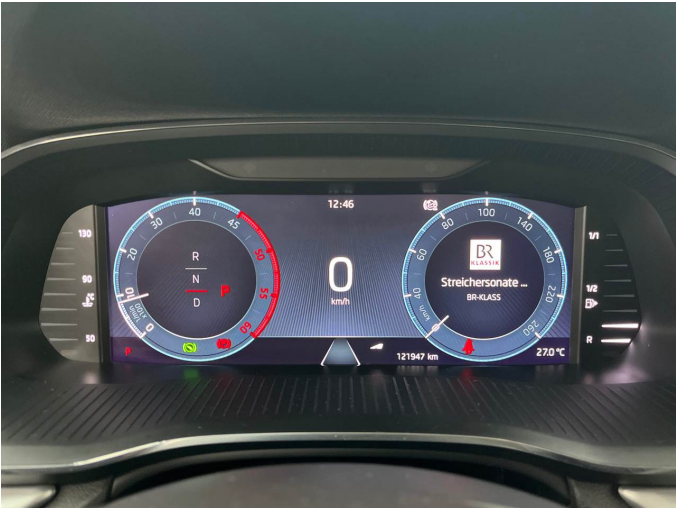
| Vehicle details | |
|---|---|
| Mileage (Read) | 121,947 km |

Figure 7: Instrument cluster

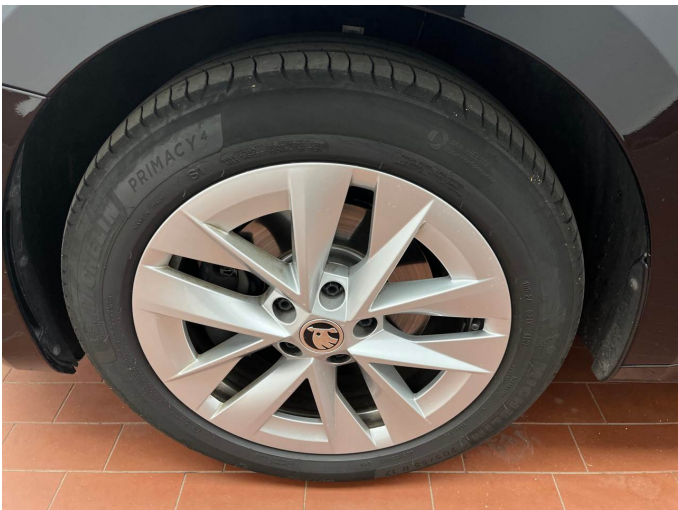
| # | Tyre size | Type of tyre | Manufacturer | Tread depth |
|---|---|---|---|---|
| 1) | 205/55 R17 91V | Summer tyres on Light alloy | Michelin | 5mm / 5mm |
| 2) | 205/55 R17 91V | Summer tyres on Light alloy | Michelin | 3mm / 3mm |

Figure 12: Mounted tyres

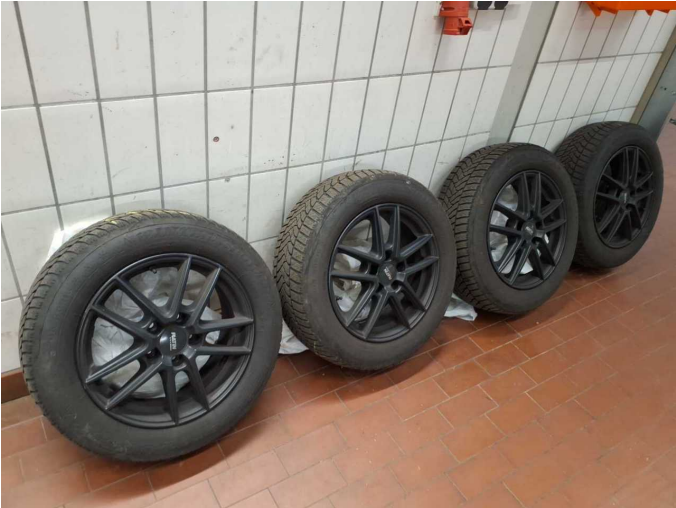
| # | Tyre size | Type of tyre | Manufacturer | Tread depth |
|---|---|---|---|---|
| 1) | 205/60 R16 92H | Winter tyres on Light alloy | Dunlop | 5mm / 5mm |
| 2) | 205/60 R16 92H | Winter tyres on Light alloy | Dunlop | 5mm / 5mm |

Figure 15: Additional tyres

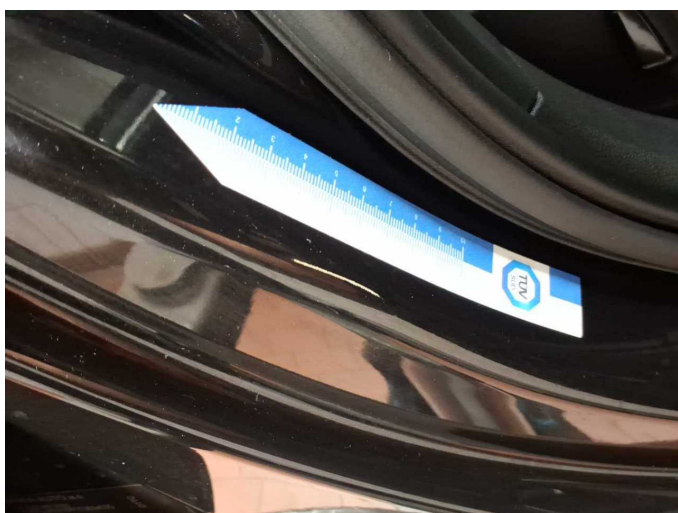
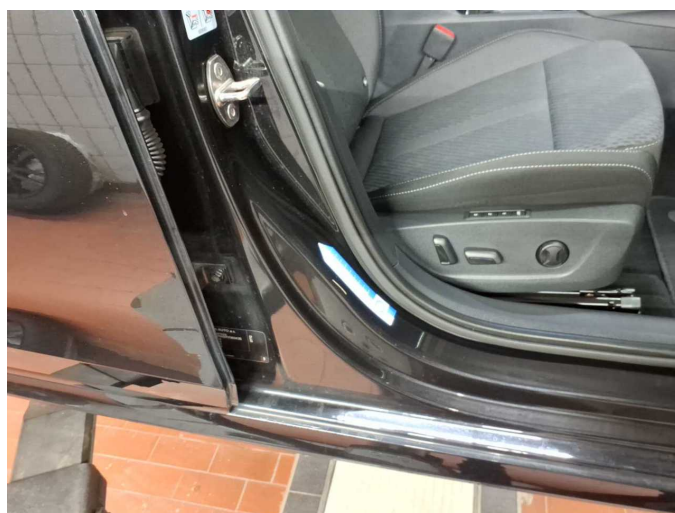
| No. | Component group | Description |
|---|---|---|
| 1 | Sill - right side | Sill - Scratch(es) - Smart repair |

Damage 1: Sill - right side: Sill - Scratch(es) - Smart repair

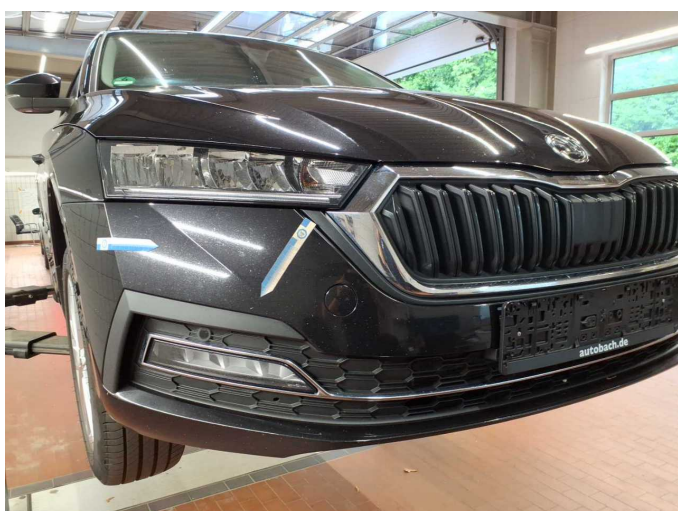
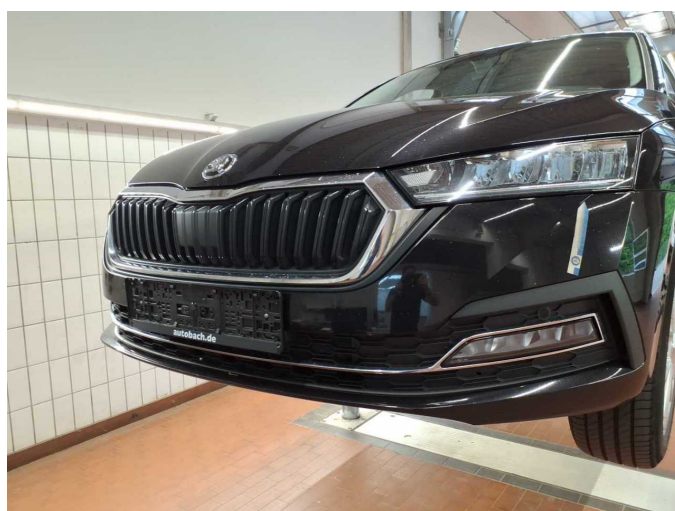
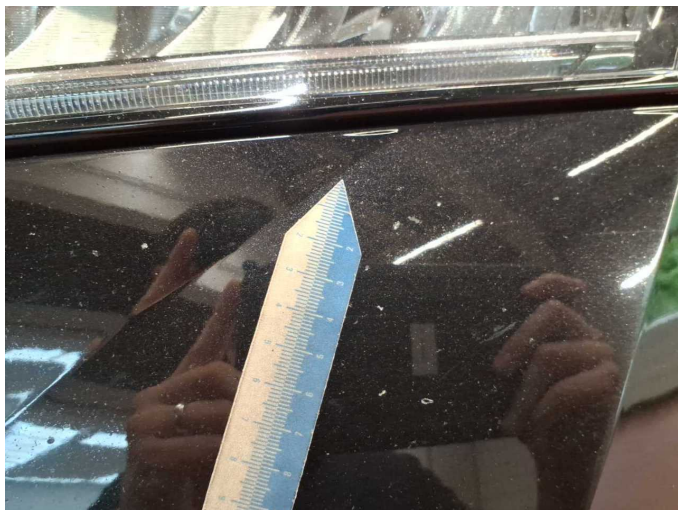
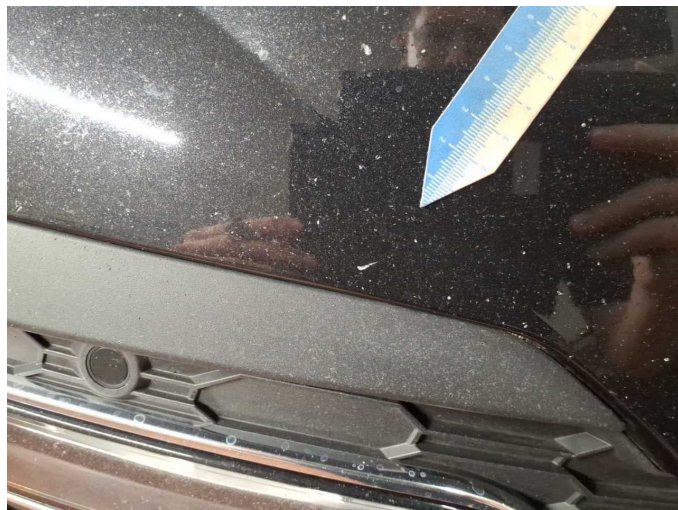
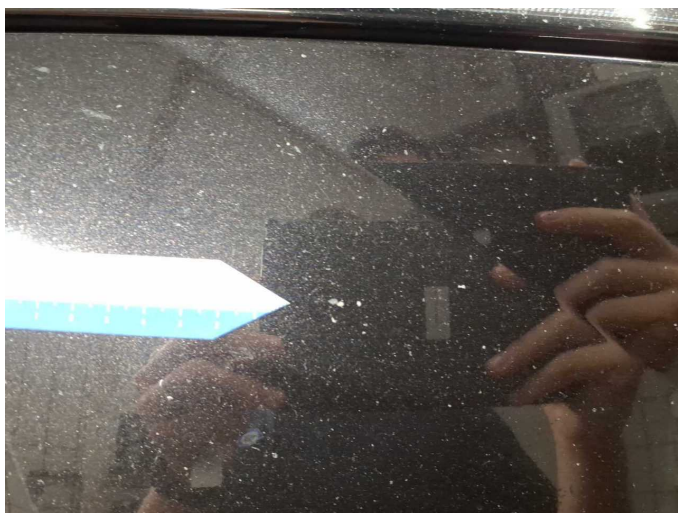
| No. | Component group | Description |
|---|---|---|
| 2 | Front bumper | Front bumper - Stone chips - Paint |

Damage 2: Front bumper: Front bumper - Stone chips - Paint

**Damage 2:** Front bumper: Front bumper - Stone chips - Paint

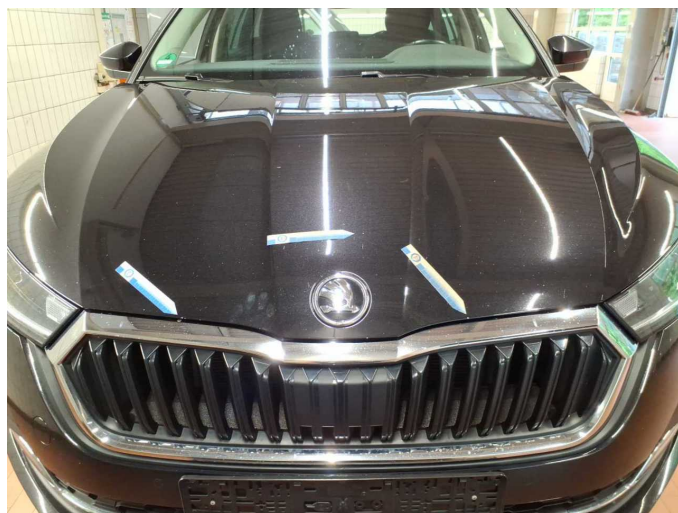
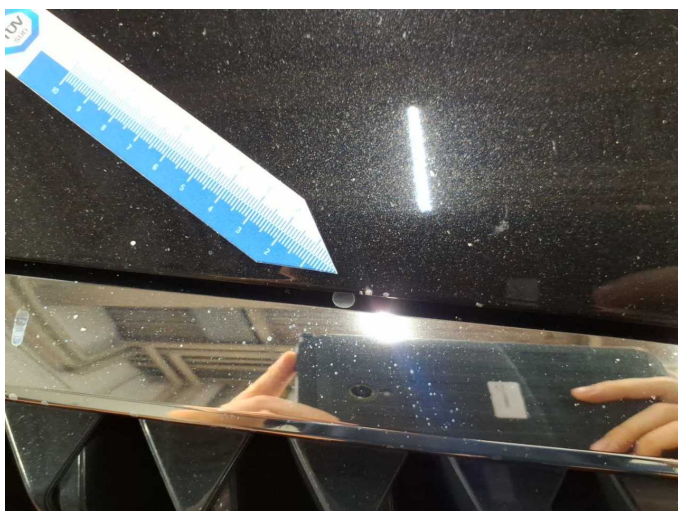
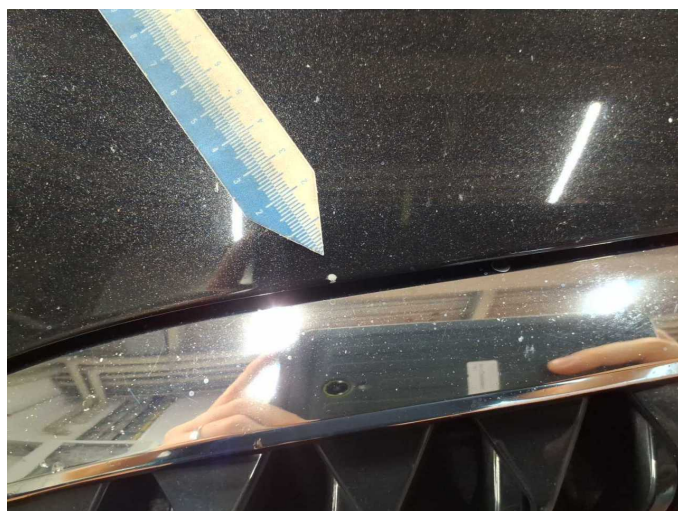
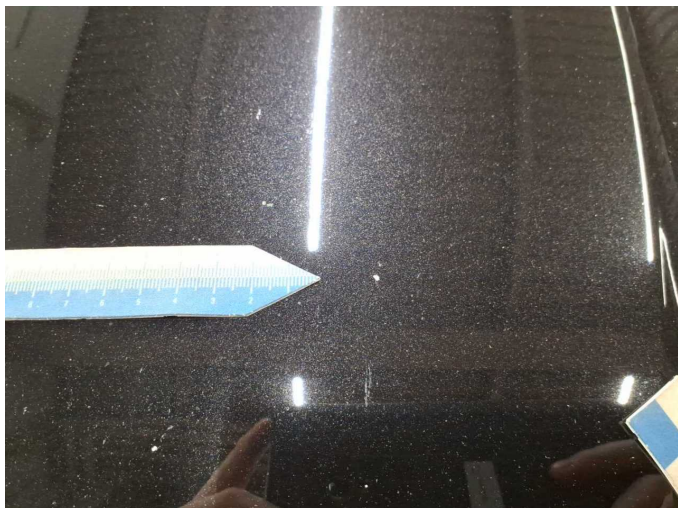
| No. | Component group | Description |
|---|---|---|
| 3 | Bonnet | Bonnet - Stone chips - Paint |

**Damage 3:** Bonnet: Bonnet - Stone chips - Paint

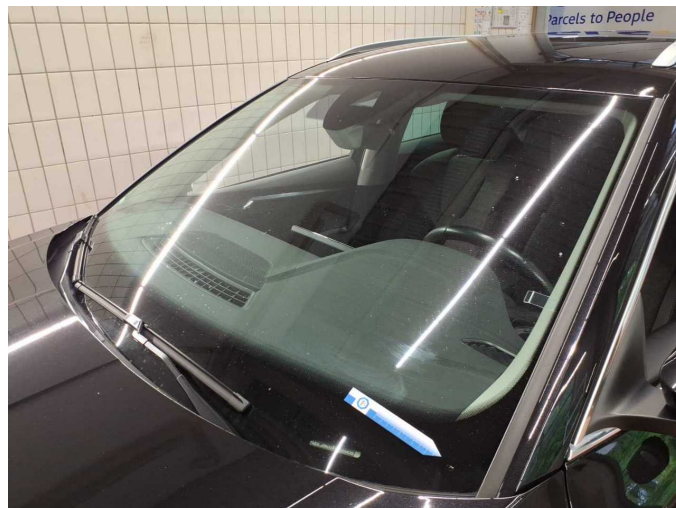
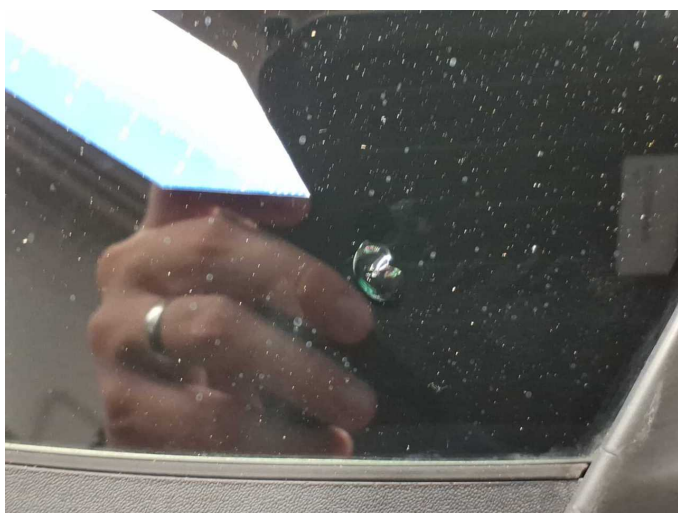
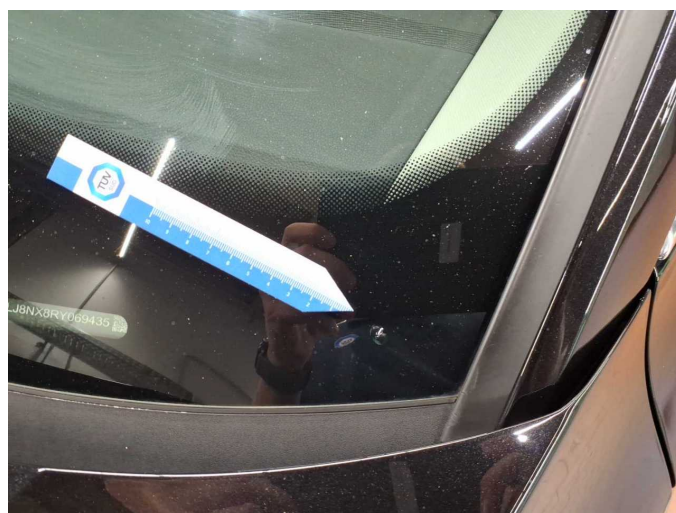
| No. | Component group | Description |
|---|---|---|
| 4 | Vehicle glazing | Windscreen - Stone chips - Replace |

**Damage 4:** Vehicle glazing: Windscreen - Stone chips - Replace

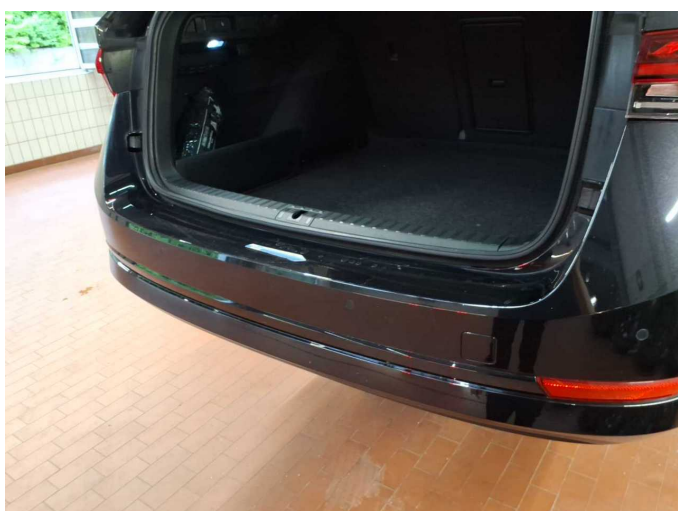
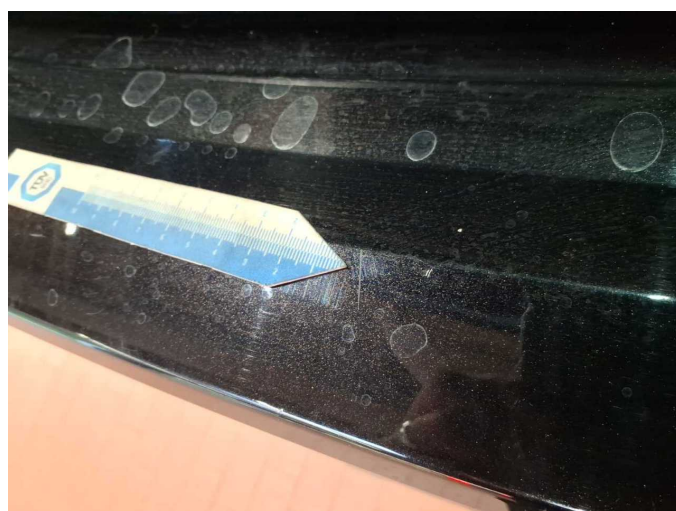
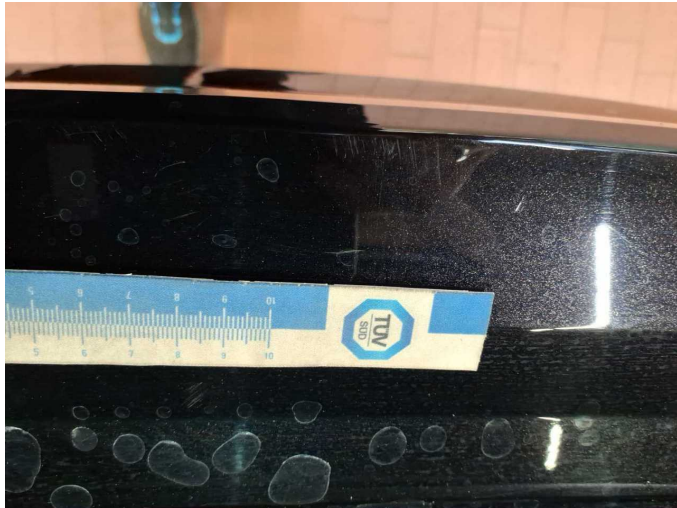
| No. | Component group | Description |
|---|---|---|
| 1 | Rear bumper | Rear bumper - Scratch(es) - No deduction |

**Wear and tear 1:** Rear bumper: Rear bumper - Scratch(es) - No deduction

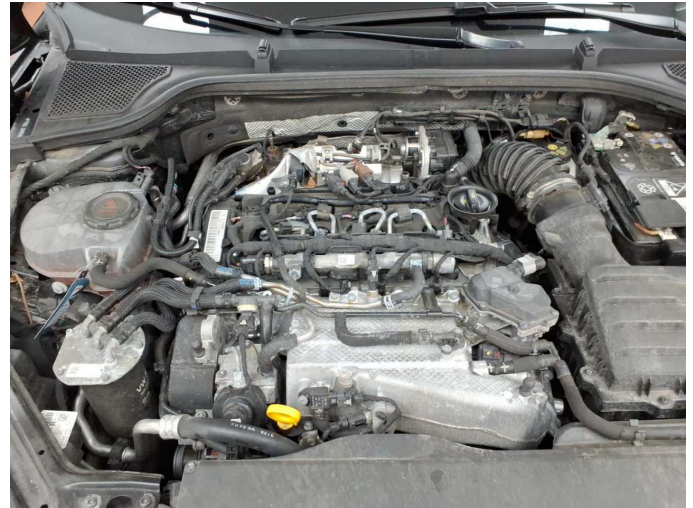
Engine - Engine cover

**Missing part 1:** Engine: Engine cover - Missing - Replace

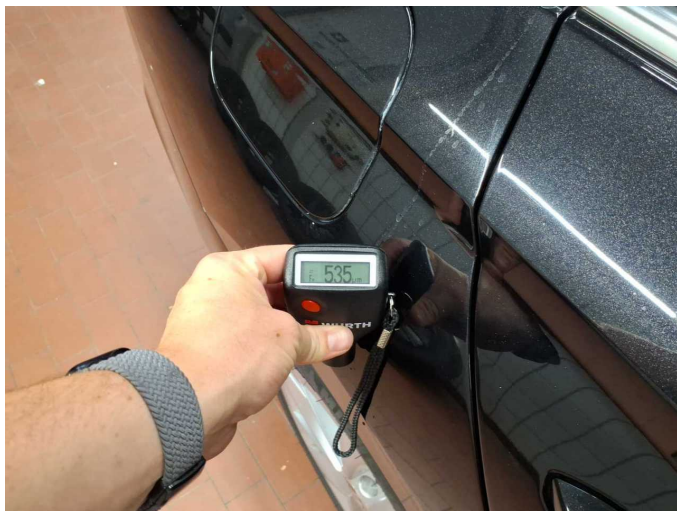
| No. | Repainting |
|---|---|
| 1 | Side panel - rear right side, Professionally carried out, Invoice of repair done Non-existent |

| Side panel - rear right side | 535 µm | Door - rear right side | 181 µm |

**Repainting 1:** Side panel - rear right side

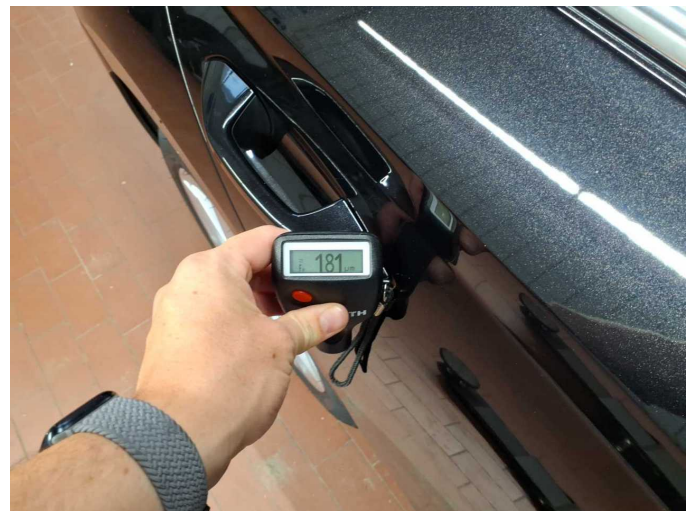
| No. | Repainting |
|---|---|
| 2 | Door - rear right side, Professionally carried out, Invoice of repair done Non-existent |

**Repainting 2:** Door - rear right side
