Expertise

Protocol number: 46545144  
Order No. / Reference: 26640190  
Inspection date: 14 Jul 2026

Model: Passat Variant 1.4 TSI Plug-In-Hybrid DSG GTE

An order was placed to prepare a sales report for the described vehicle. This report includes the following:

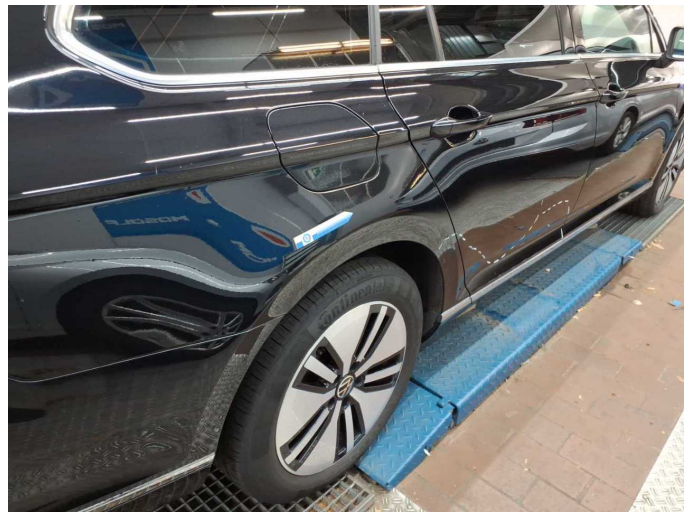
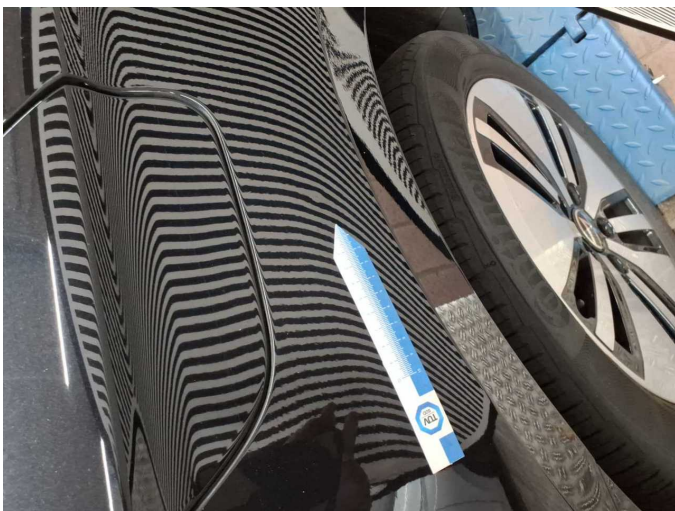
| No. | Component group | Description |
|---|---|---|
| 1 | Side panel - rear right side | Side panel - dent(s) - Smart repair |

Damage 1: Side panel - rear right side: Side panel - dent(s) - Smart repair

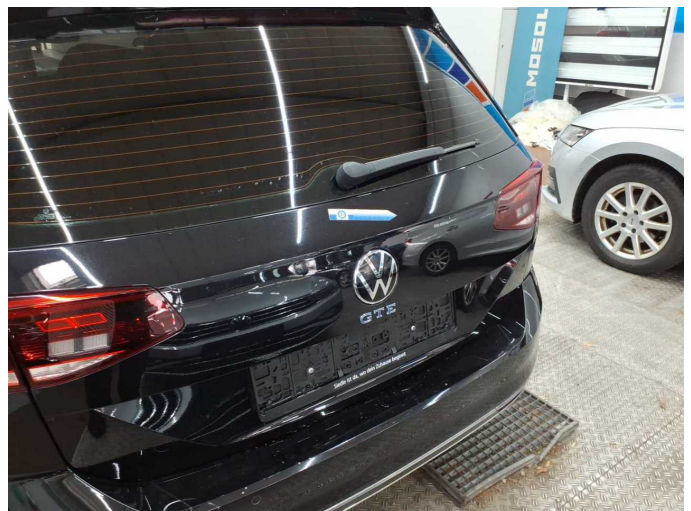
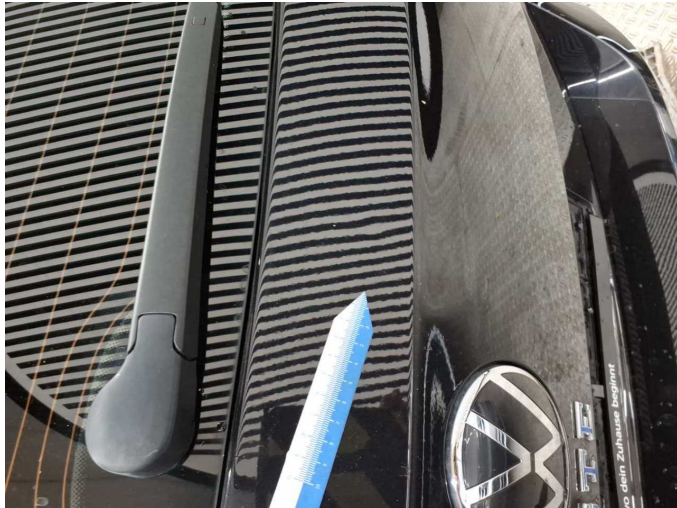
| No. | Component group | Description |
|---|---|---|
| 2 | Boot lid / rear door | Boot lid - dent(s) - Smart repair |

Damage 2: Boot lid / rear door: Boot lid - dent(s) - Smart repair

**Damage 2:** Boot lid / rear door: Boot lid - dent(s) - Smart repair

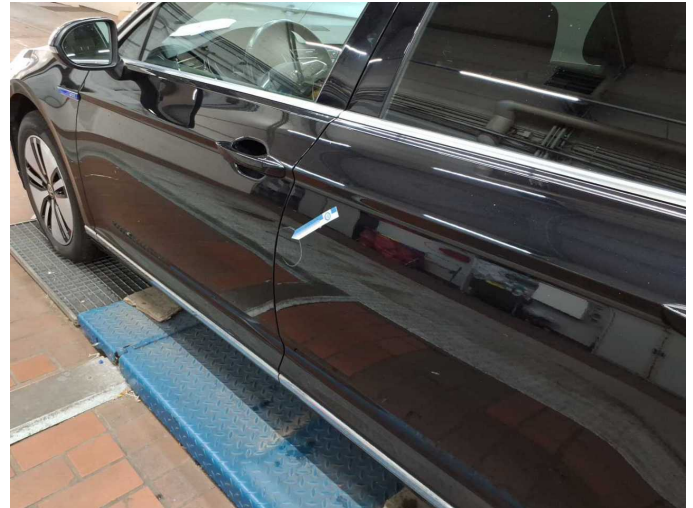
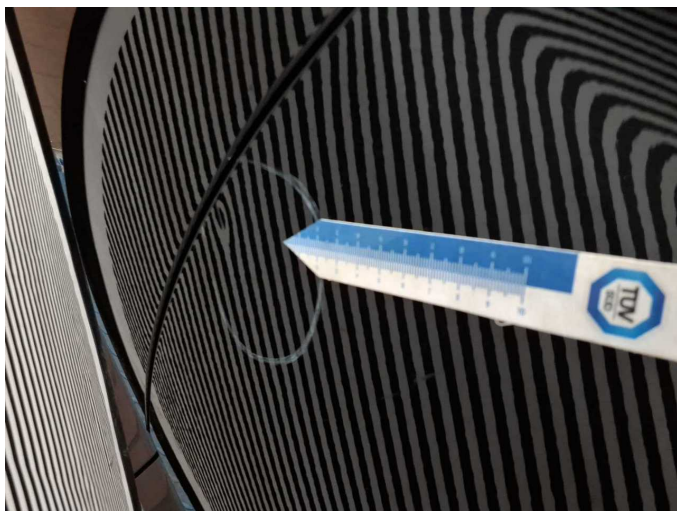
| No. | Component group | Description |
|---|---|---|
| 3 | Door - rear left side | Door - dent(s) - Smart repair |

**Damage 3:** Door - rear left side: Door - dent(s) - Smart repair

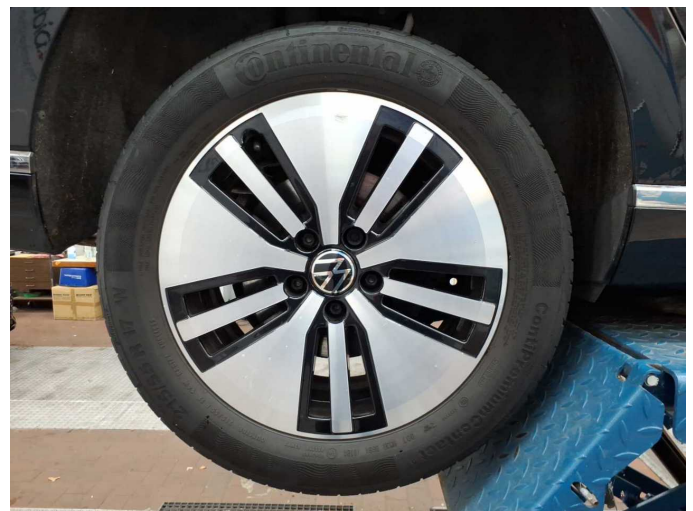
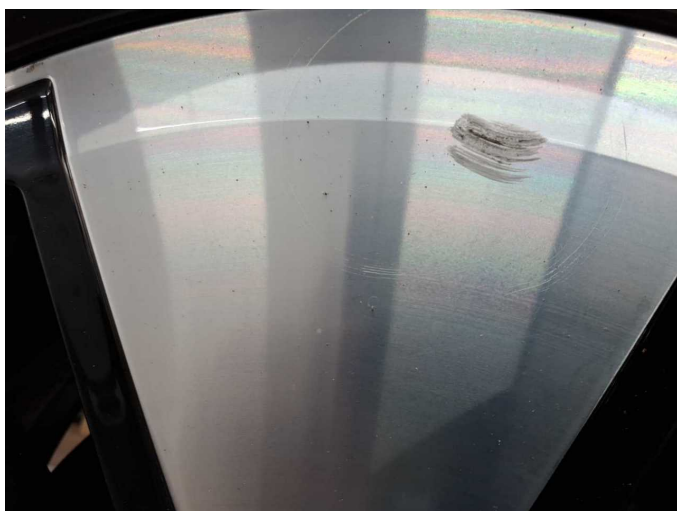
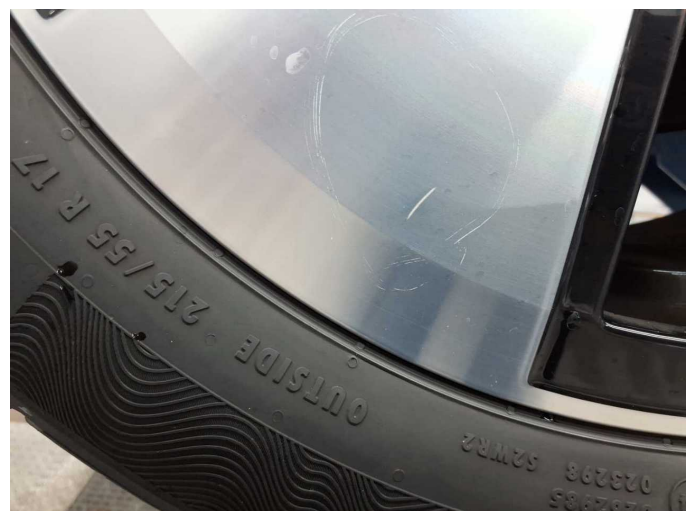
| No. | Component group | Description |
|---|---|---|
| 4 | Wheel / tyres | Alloy rim - rear right side - Scratched - Loss in value |

**Damage 4:** Wheel / tyres: Alloy rim - rear right side - Scratched - Loss in value

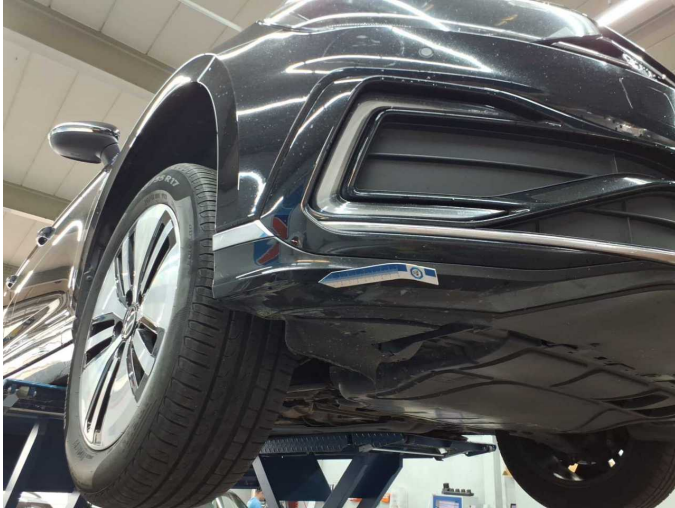
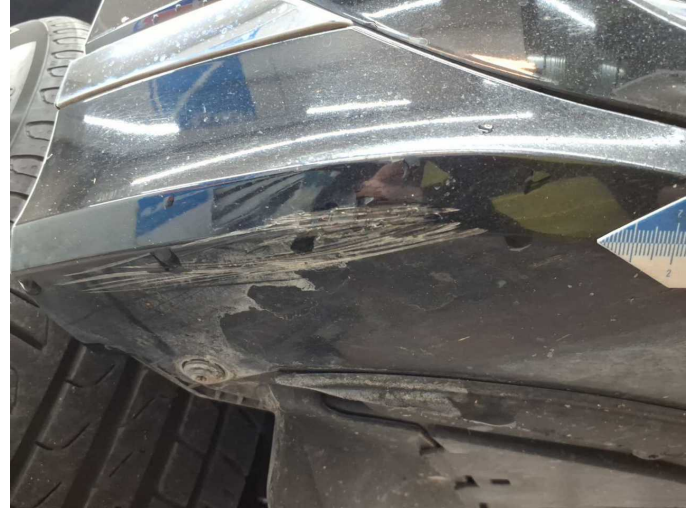
| No. | Component group | Description |
|---|---|---|
| 5 | Front bumper | Spoiler - Scratched - Smart repair |

**Damage 5:** Front bumper: Spoiler - Scratched - Smart repair

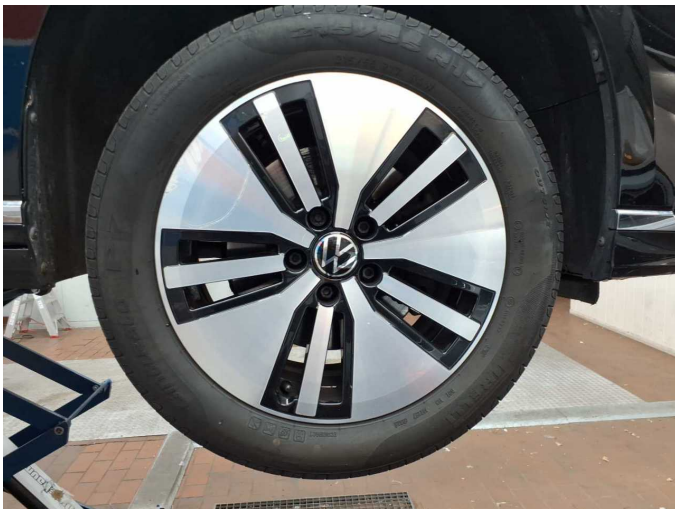
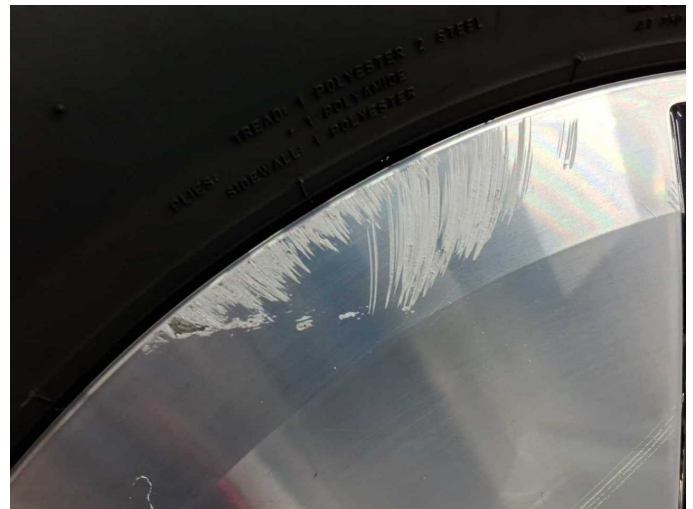
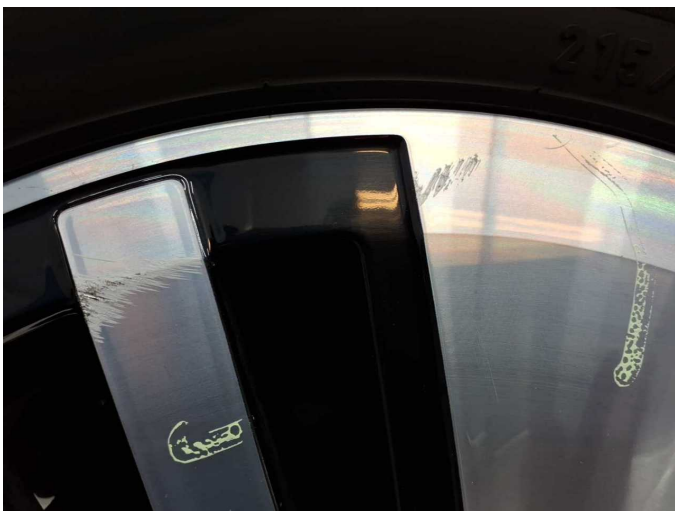
| No. | Component group | Description |
|---|---|---|
| 6 | Wheel / tyres | Alloy rim - front right side - Scratched - Loss in value |

**Damage 6:** Wheel / tyres: Alloy rim - front right side - Scratched - Loss in value

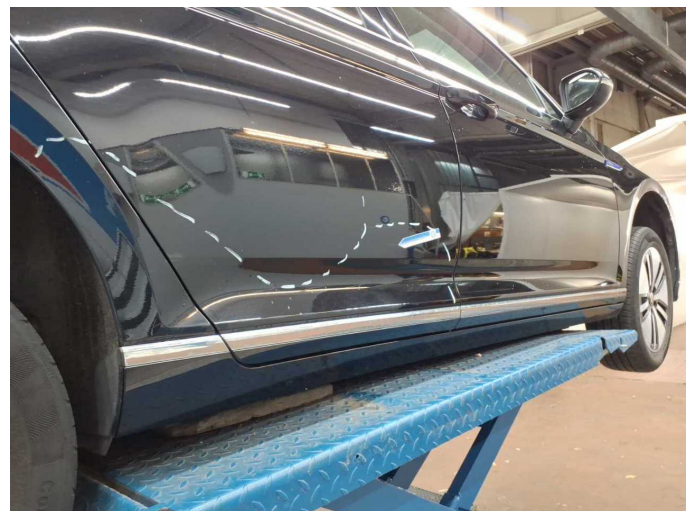
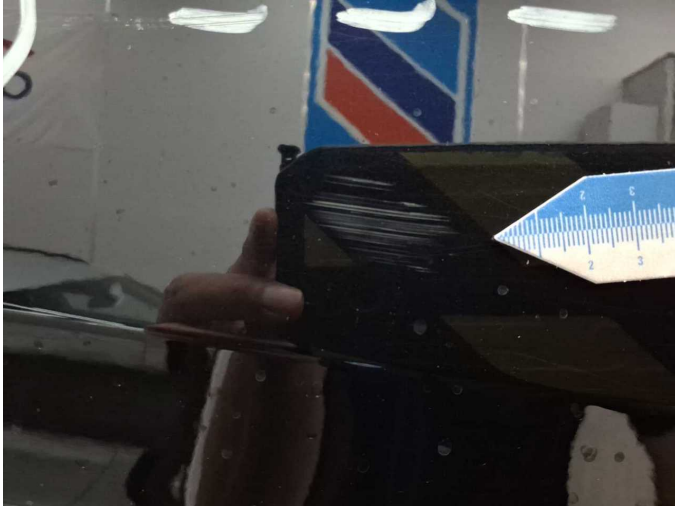
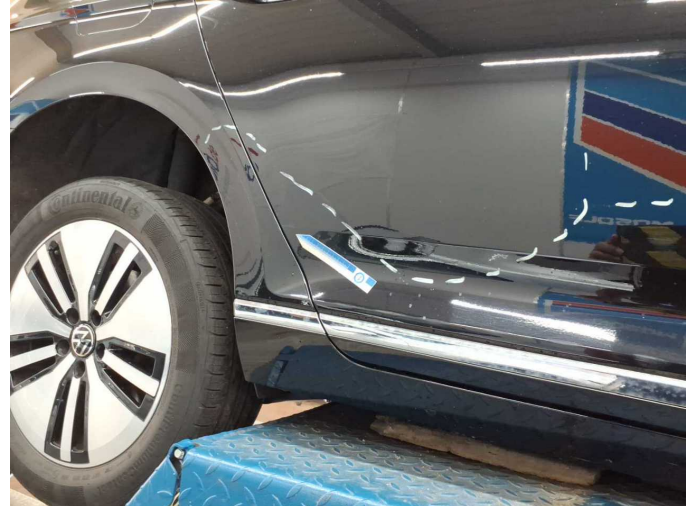
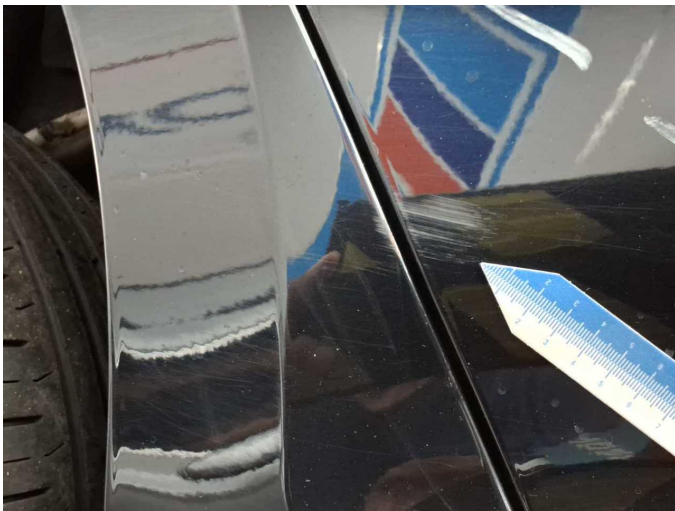
| No. | Component group | Description |
|---|---|---|
| 7 | Door - rear right side | Door - Scratch(es) - Paint |

**Damage 7:** Door - rear right side: Door - Scratch(es) - Paint

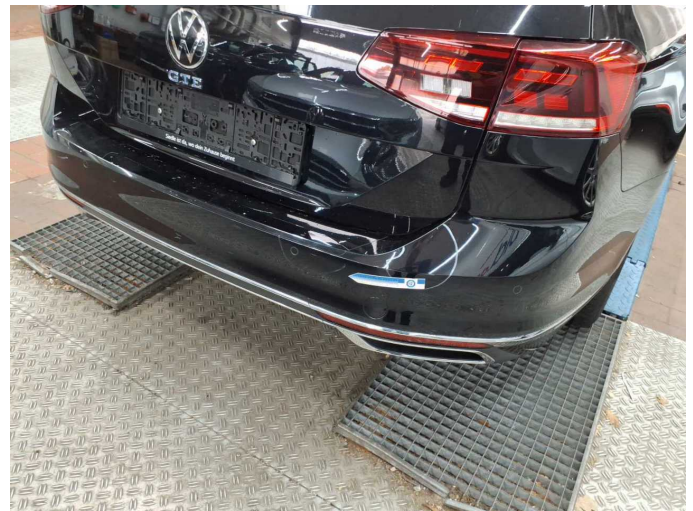
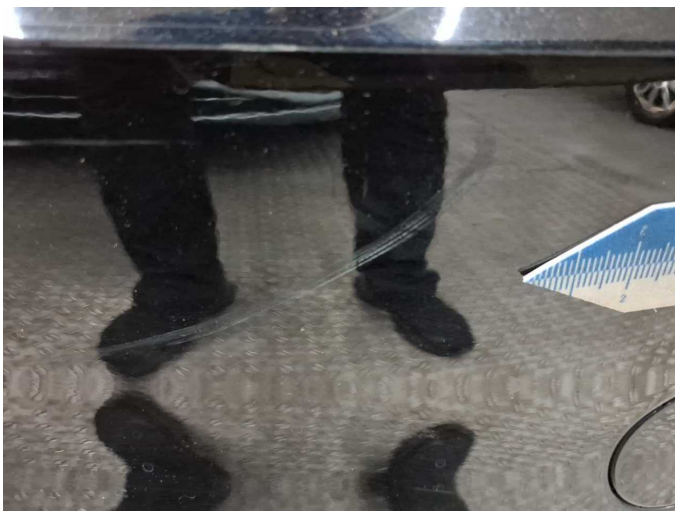
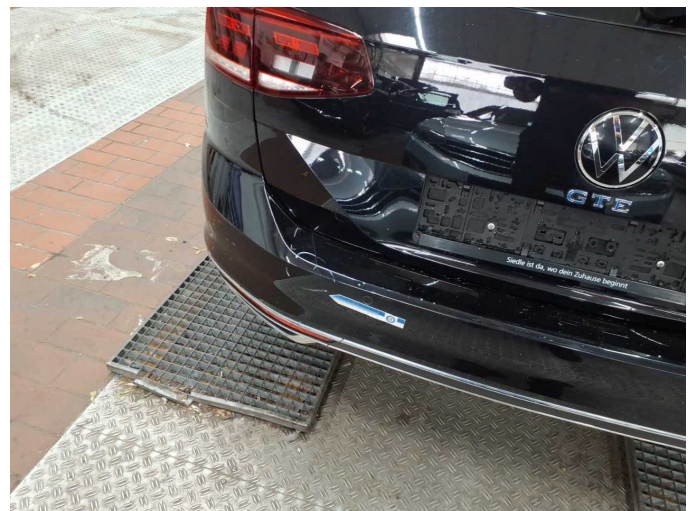
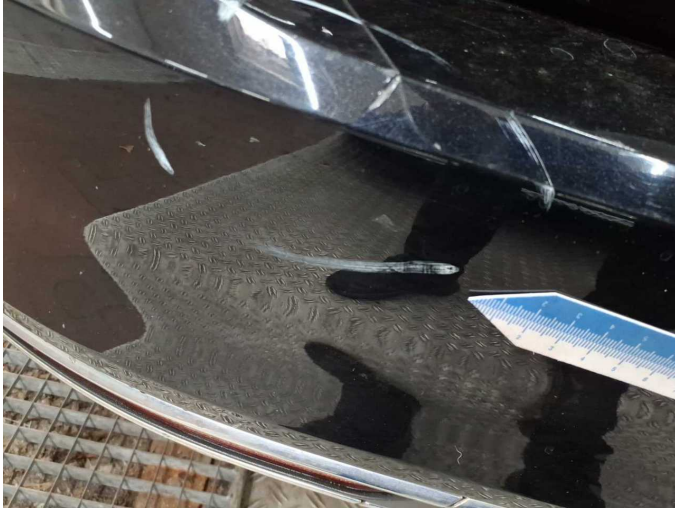
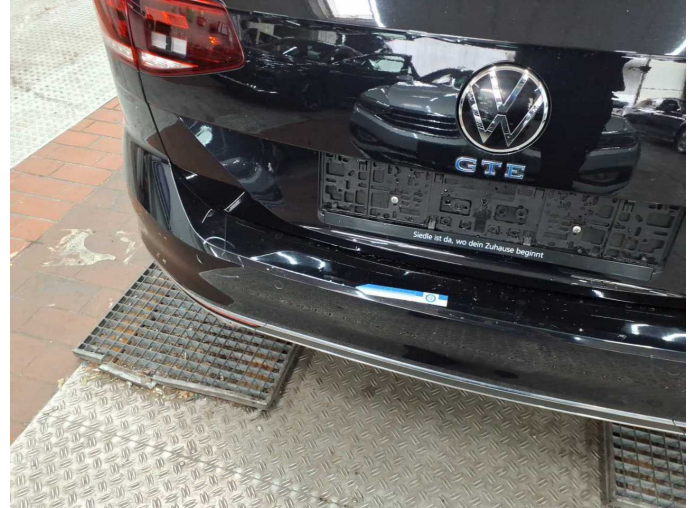
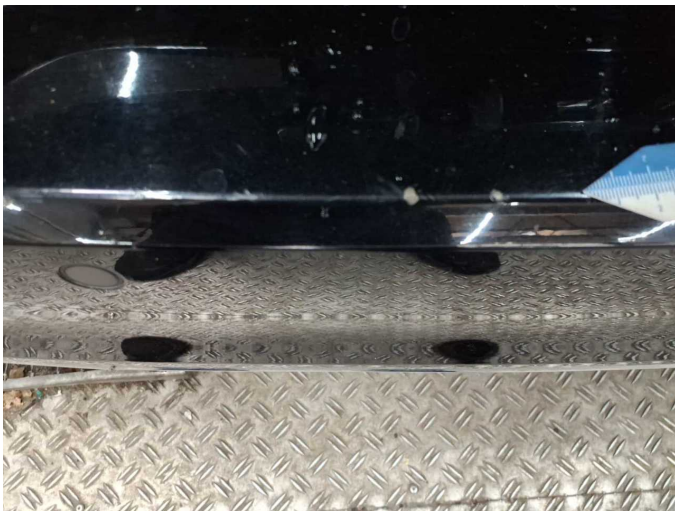
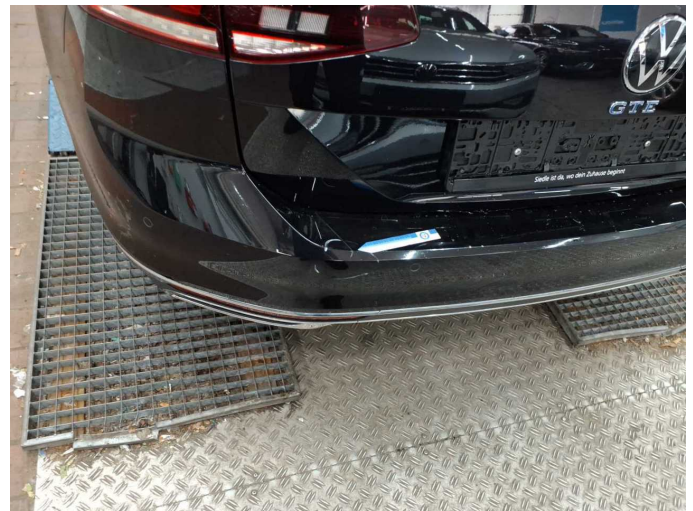
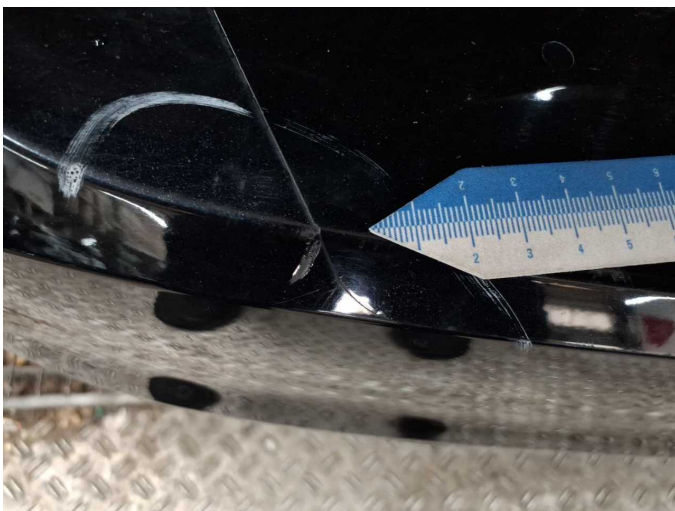
| No. | Component group | Description |
|---|---|---|
| 8 | Rear bumper | Rear bumper - Scratch(es) - Paint |

**Damage 8:** Rear bumper: Rear bumper - Scratch(es) - Paint

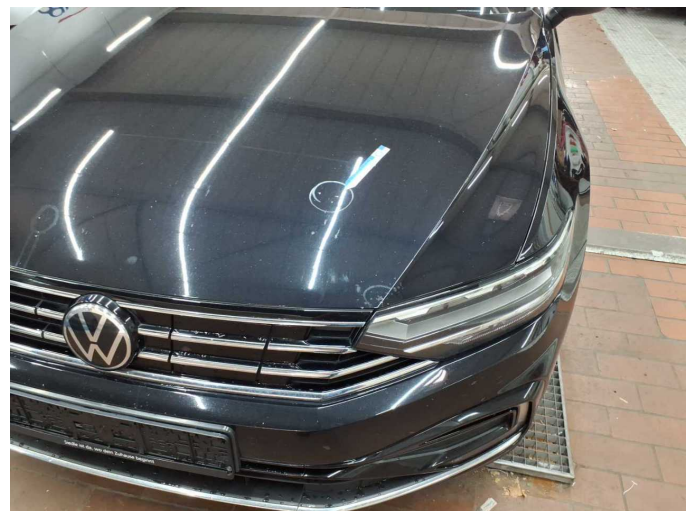
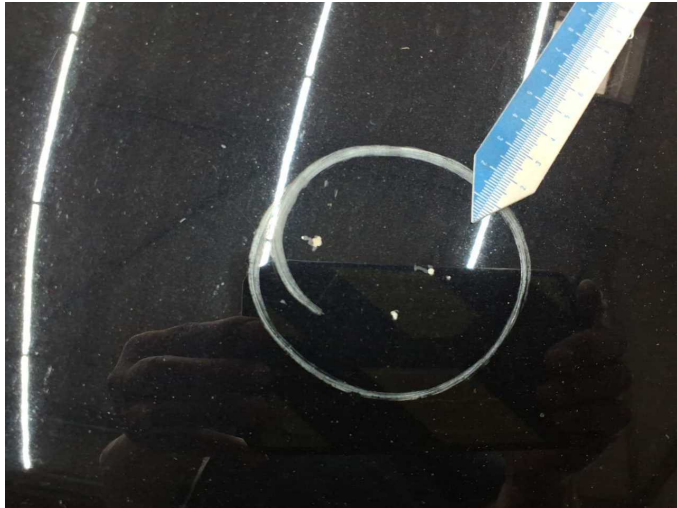
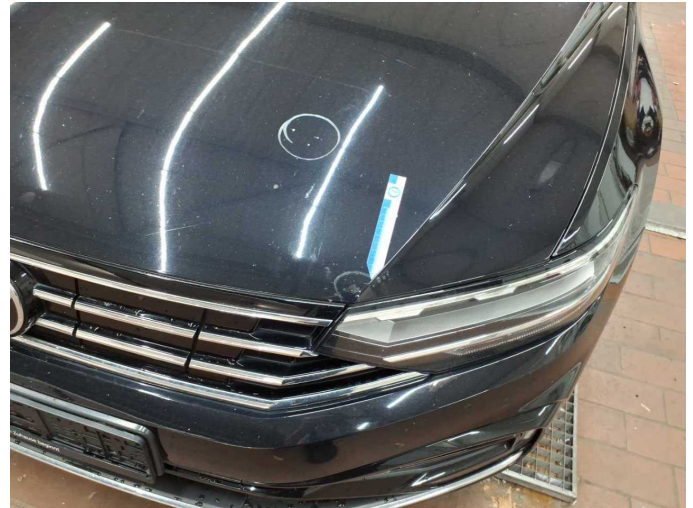
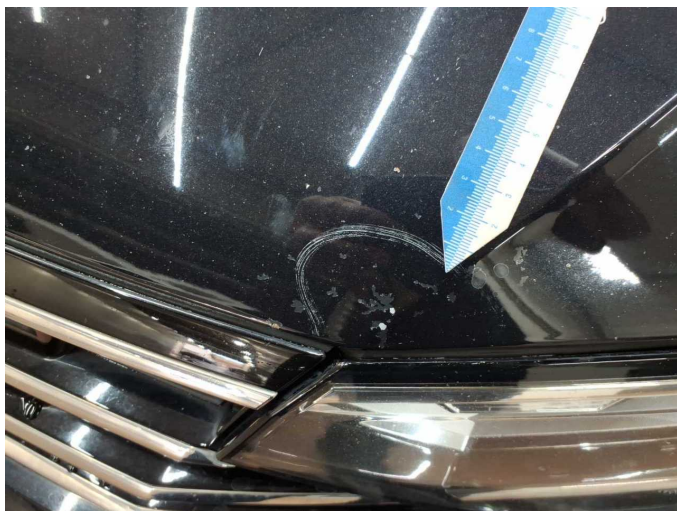
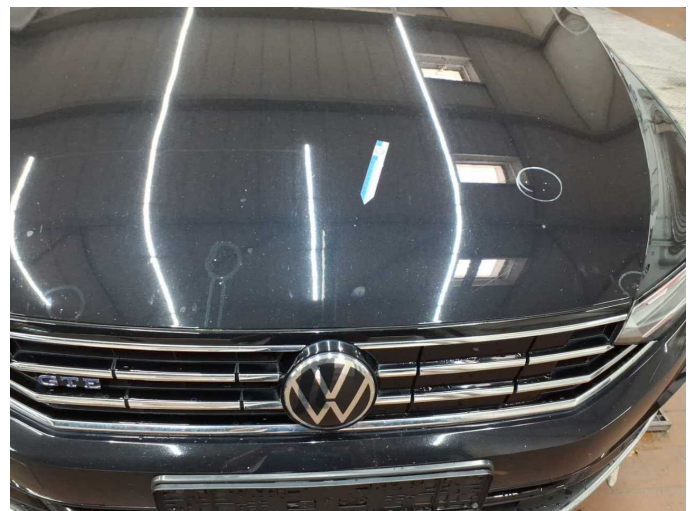
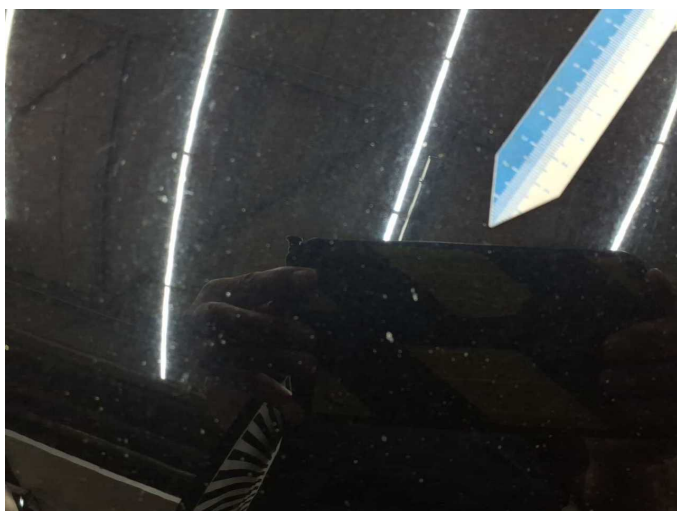
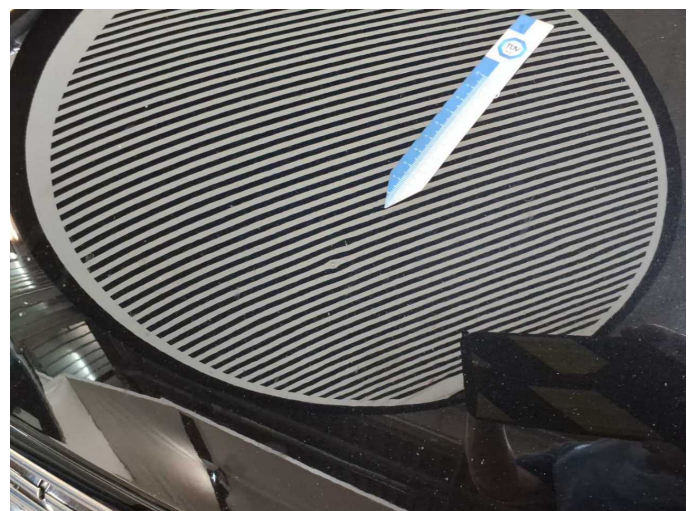
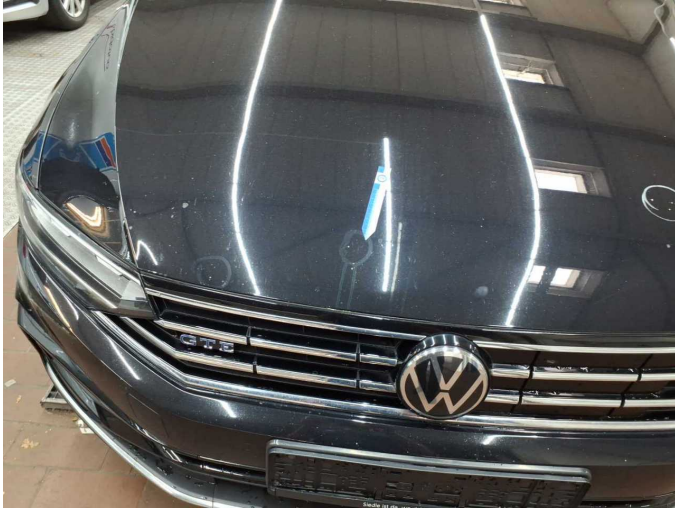
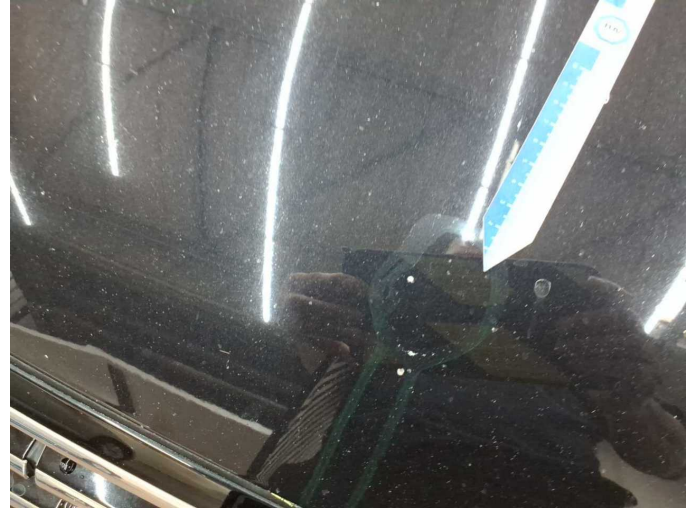
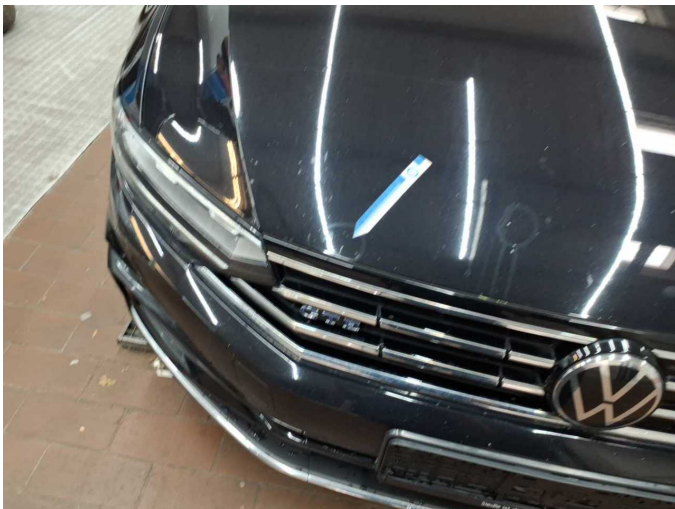
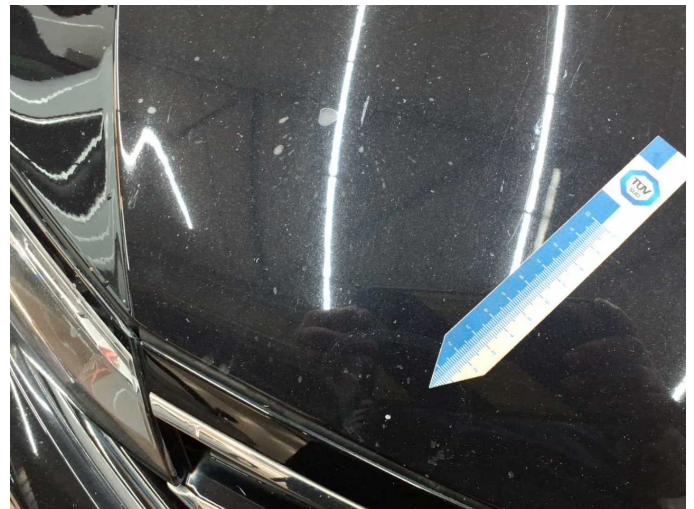
| No. | Component group | Description |
|---|---|---|
| 9 | Bonnet | Bonnet - Dent / paintcoat damage - Paint |

**Damage 9:** Bonnet: Bonnet - Dent / paintcoat damage - Paint

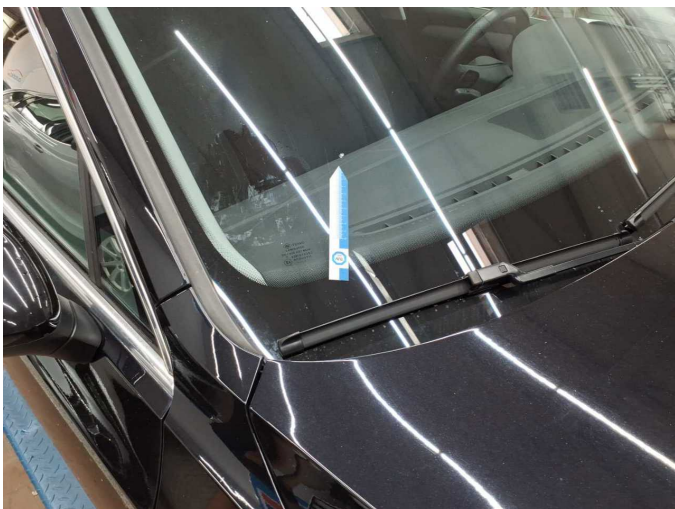
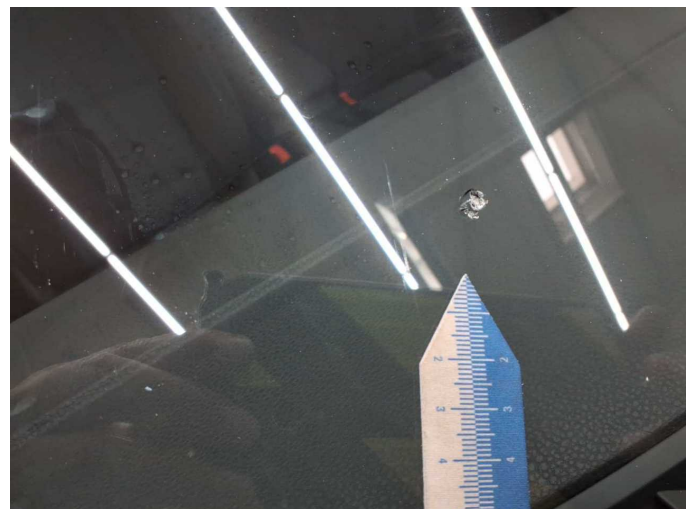
| No. | Component group | Description |
|---|---|---|
| 10 | Vehicle glazing | Windscreen - Broken / torn - Replace |

**Damage 10:** Vehicle glazing: Windscreen - Broken / torn - Replace
