## Expertise

Protocol number: 45783939  
Order No. / Reference: 26311209  
Inspection date: 2 Jun 2026

Model: Focus Turnier 1.0 EcoBoost Hybrid TITANIUM EDITION

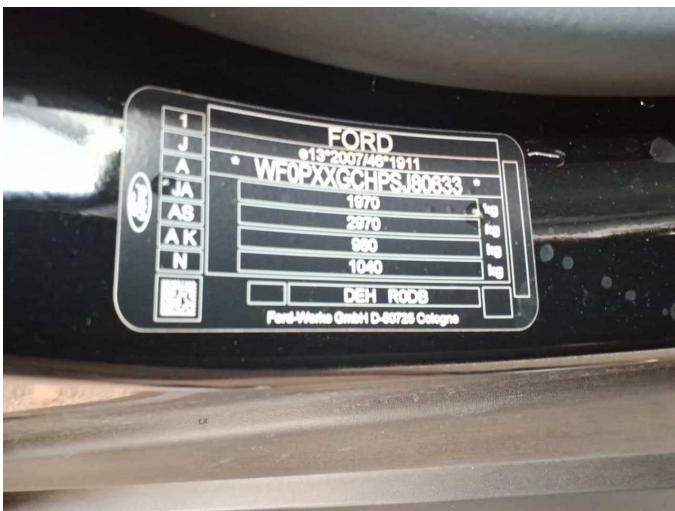
Figure 11: VIN

Documents submitted	At the time of the inspection, the vehicle registration certificate Part 2 (title) was available, but the vehicle registration certificate Part 1 (document) was not. (Copy)
VIN comparison	The vehicle identification number (VIN) was read from the vehicle and its conformity with the submitted documents was confirmed by the undersigned during the inspection.
Inspection	The inspection conditions were sufficient for the assessment of the vehicle. No lifting equipment or pit was available for inspecting the vehicle. Therefore, inspection of the vehicle's underside was only possible to a limited extent.
Test drive	No test drive/shunting maneuver was carried out during the inspection of the vehicle.
Engine function test	An engine test run was performed.

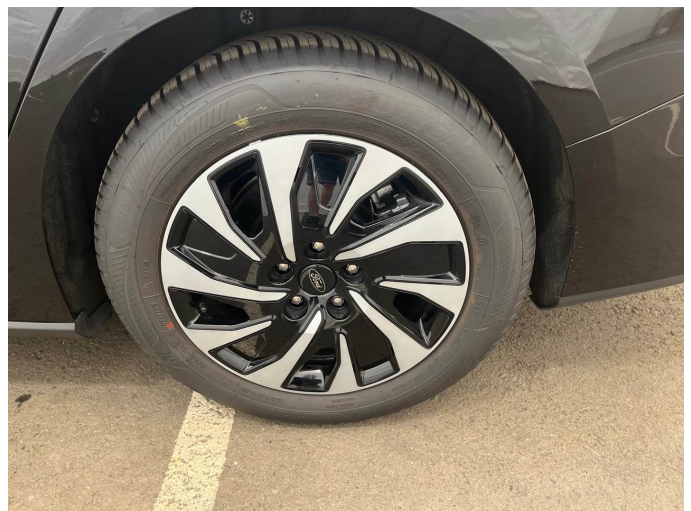
Figure 12: Mounted tyres

#	Tyre size	Type of tyre	Manufacturer	Tread depth
1)	205/60 R16 96V	All-season tyres on Steel rim with wheel cover	Goodyear	7mm / 7mm
2)	205/60 R16 96V	All-season tyres on Steel rim with wheel cover	Goodyear	7mm / 7mm

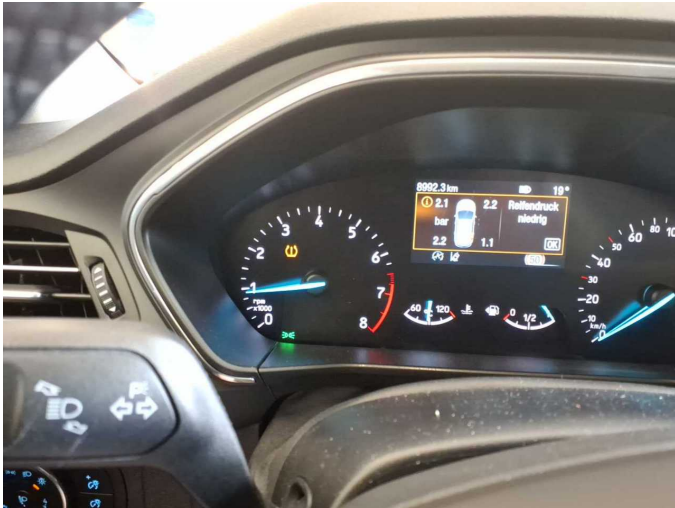
**Damage 1:** Instrument panel: Indicator light (Reifendruckkontrolle) - on - Perform diagnosis

No.	Component group	Description
1	Instrument panel	Indicator light (Reifendruckkontrolle) - on - Perform diagnosis
2	Vehicle glazing	Windscreen (Im Fahrersichtfeld) - Stone chips - Replace

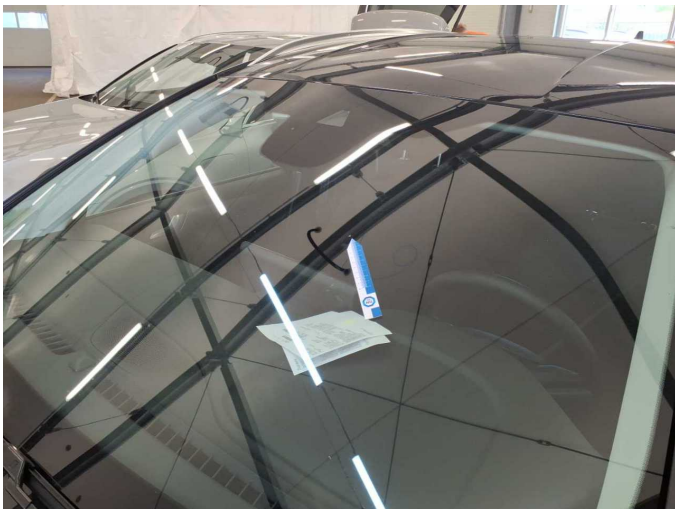
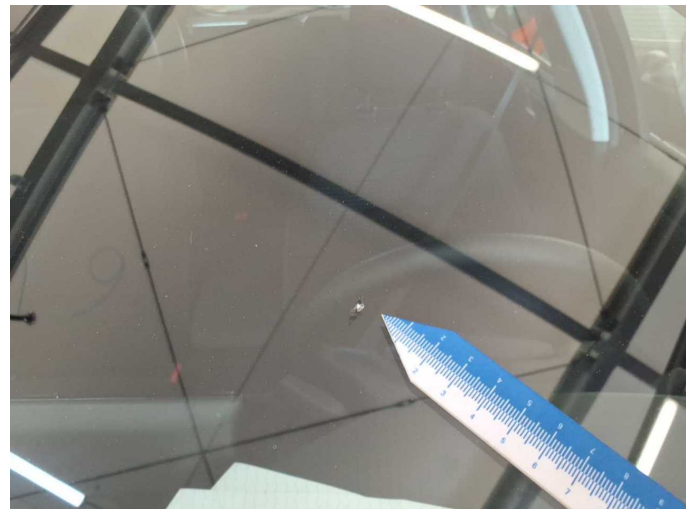
**Damage 2:** Vehicle glazing: Windscreen (Im Fahrersichtfeld) - Stone chips - Replace
