Protocol number: 45814238
Order No. / Reference: 26325349
Inspection date: 3 Jun 2026

Manufacturer: Volvo

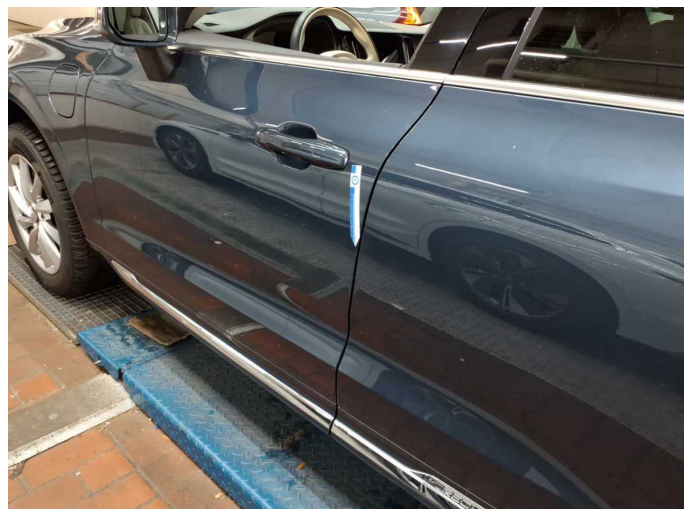
Damage 1: Door - front left side: Door - Scratch(es) - Smart repair

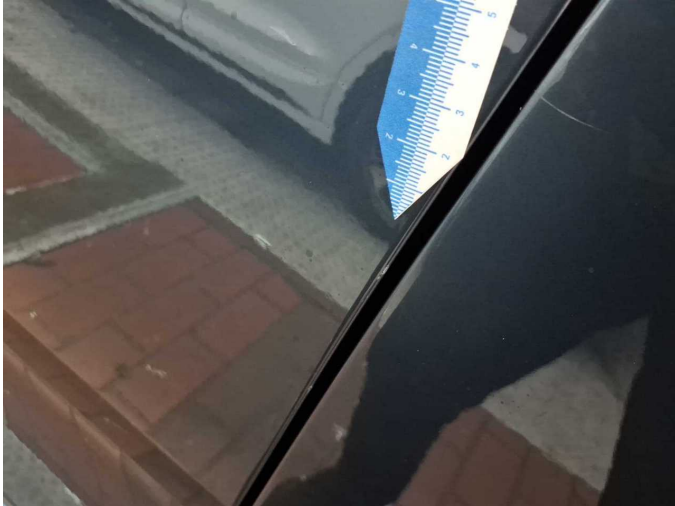
Damage 1: Door - front left side: Door - Scratch(es) - Smart repair

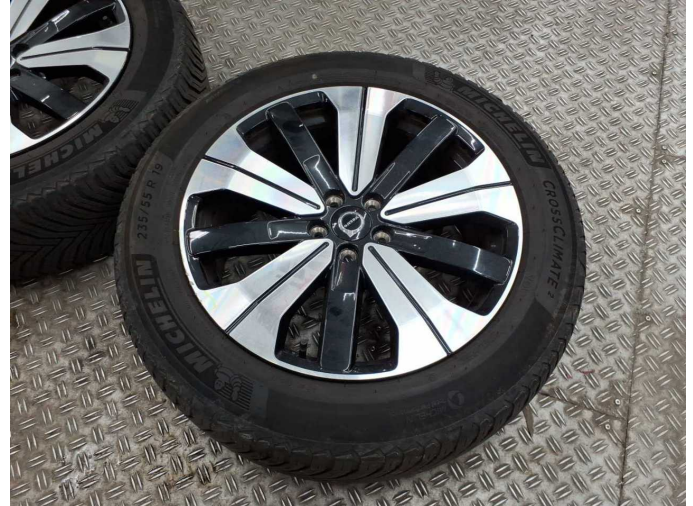
Damage 3: 2nd wheel set: 1 alloy rim - Scratched - Loss in value

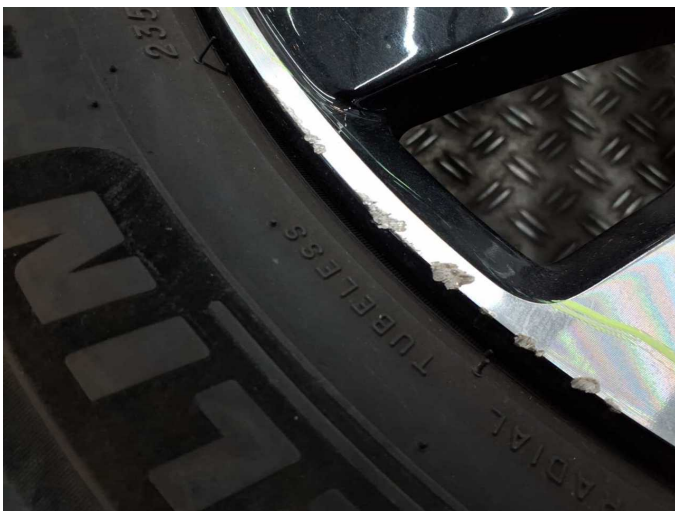
Damage 3: 2nd wheel set: 1 alloy rim - Scratched - Loss in value

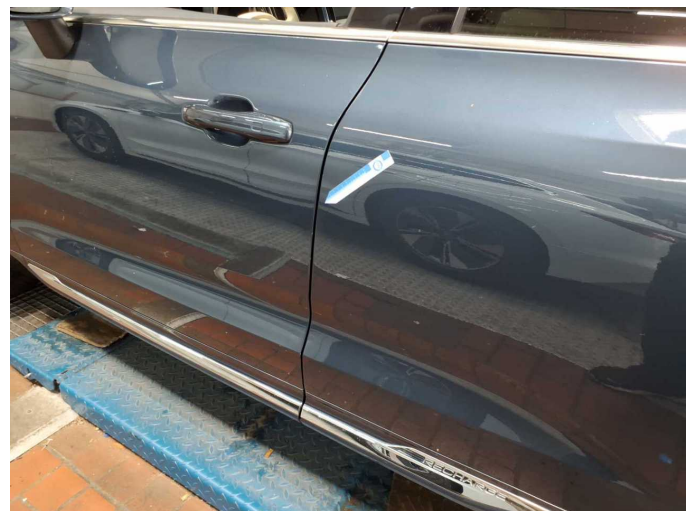
Damage 4: Door - rear left side: Door - Scratch(es) - Paint

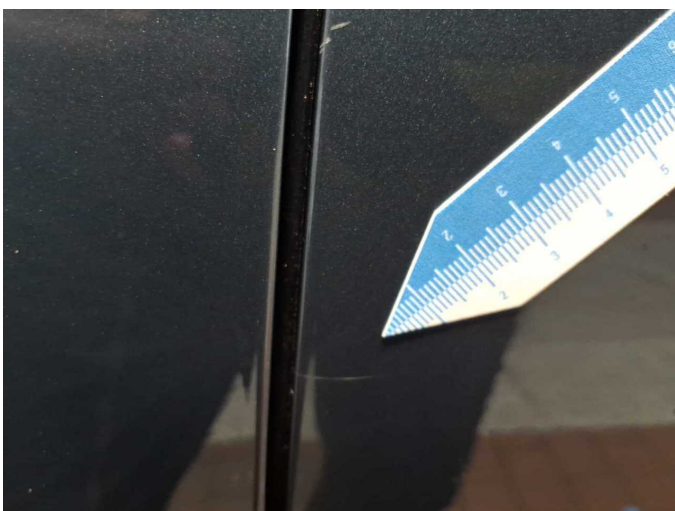
Damage 4: Door - rear left side: Door - Scratch(es) - Paint

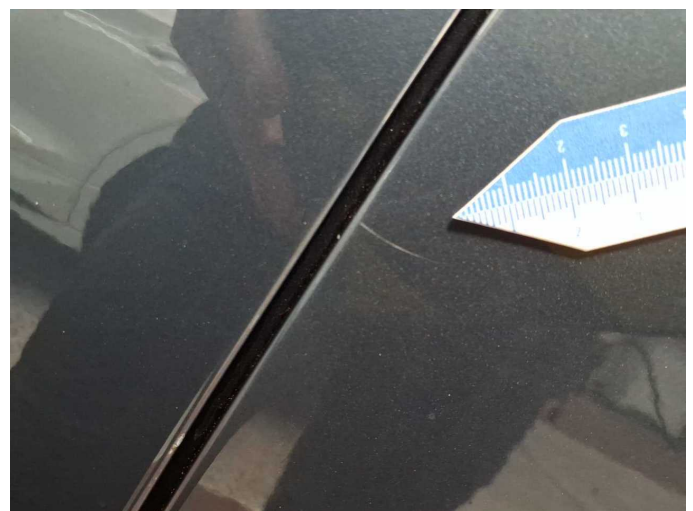
Damage 4: Door - rear left side: Door - Scratch(es) - Paint

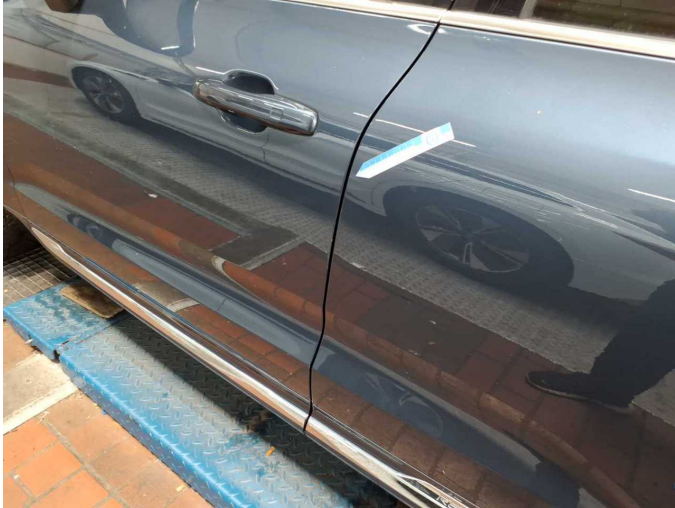
Damage 4: Door - rear left side: Door - Scratch(es) - Paint

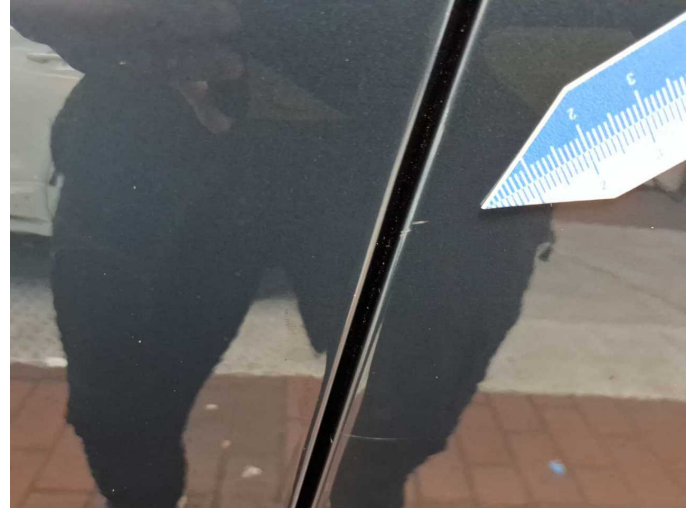
Damage 4: Door - rear left side: Door - Scratch(es) - Paint

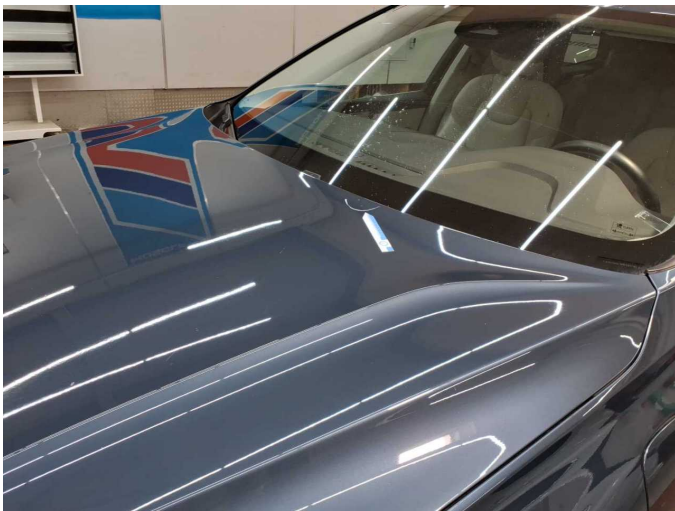
Wear and tear 2: Bonnet: Bonnet - Stone chips - No deduction

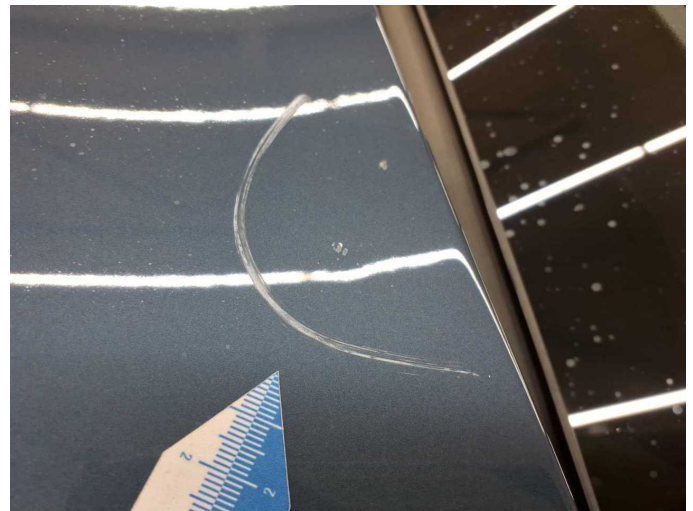
Wear and tear 2: Bonnet: Bonnet - Stone chips - No deduction

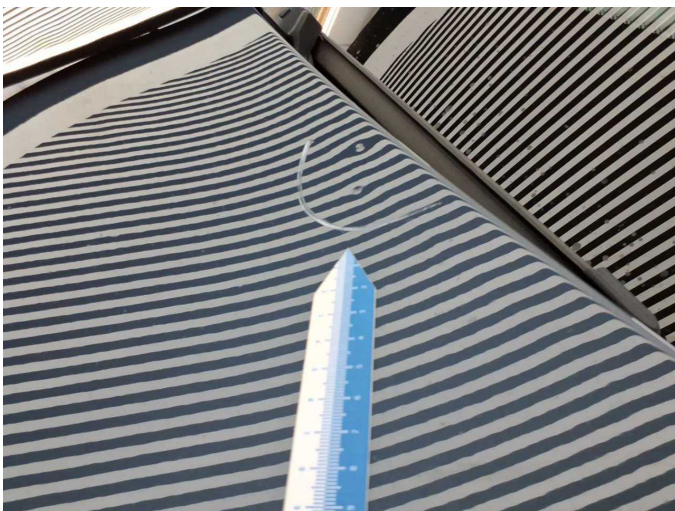
Wear and tear 2: Bonnet: Bonnet - Stone chips - No deduction

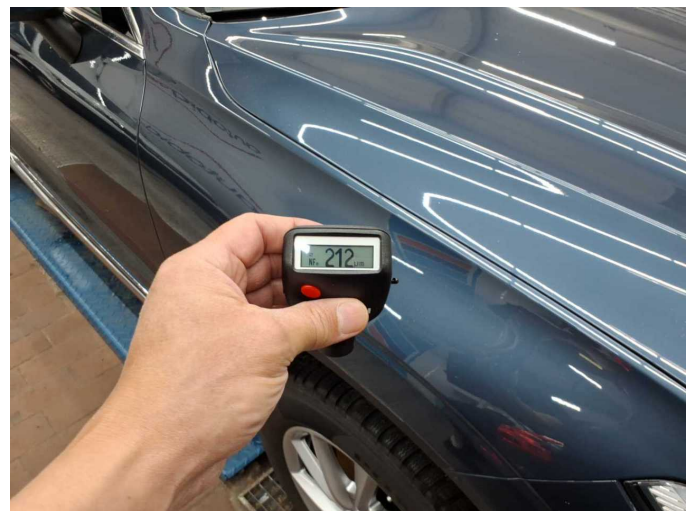
Repainting 1: Roof, Mudguard - left side, Mudguard - right side, Door - front left side, Door - front right side
