Expertise

Protocol number: 46005934
Order No. / Reference: 26489467
Inspection date: 18 Jun 2026

Model: Touran 2.0 TDI SCR DSG Comfortline

VIN: WVGZZZ1TZNW010497

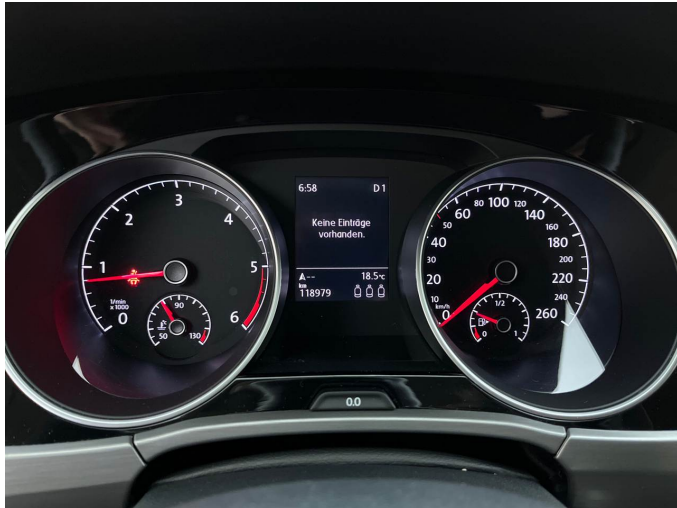
Figure 7: Instrument cluster

Vehicle Identification number	WVGZZZ1TZNW010497
Mileage (Read)	118,979 km
First registration	28 Mar 2022
Number of holders	1
Next periodical technical inspection (Report on hand)	05/2027

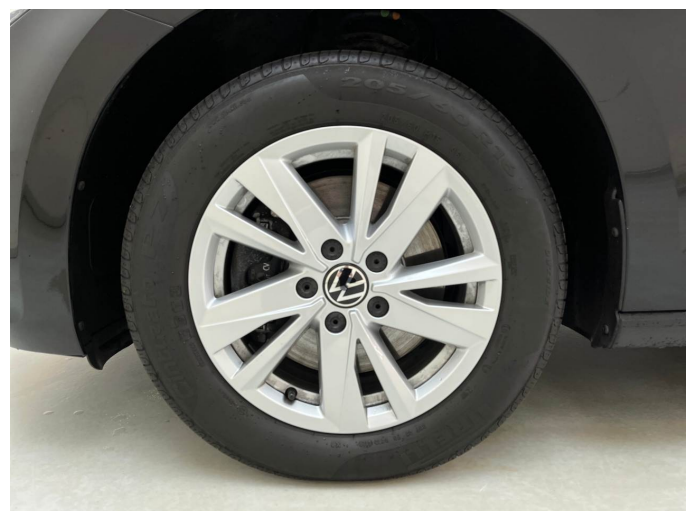
Figure 12: Mounted tyres

#	Tyre size	Type of tyre	Manufacturer	Tread depth
1)	205/60 R16 96V	Summer tyres on Light alloy	Pirelli	5mm / 5mm
2)	205/60 R16 96V	Summer tyres on Light alloy	Pirelli	4mm / 4mm

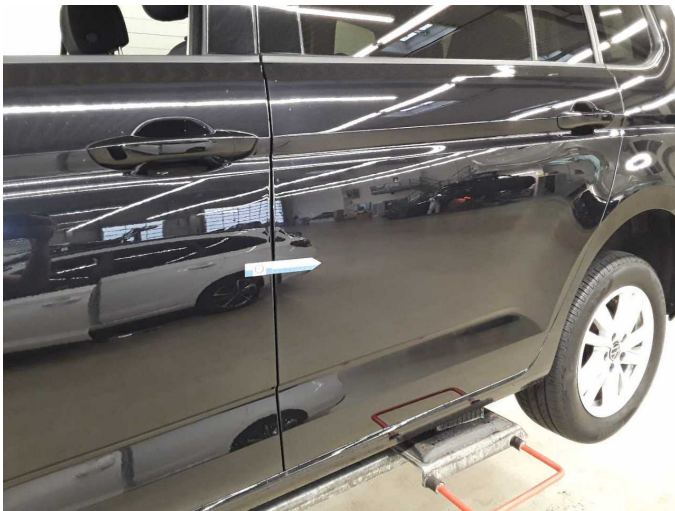
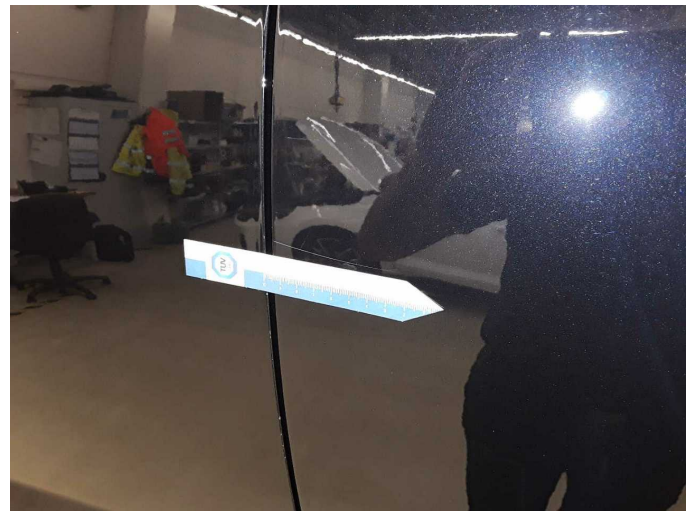
Damage 1: Door - rear right side: Door - Scratch(es) - Smart repair

No.	Component group	Description
1	Door - rear right side	Door - Scratch(es) - Smart repair

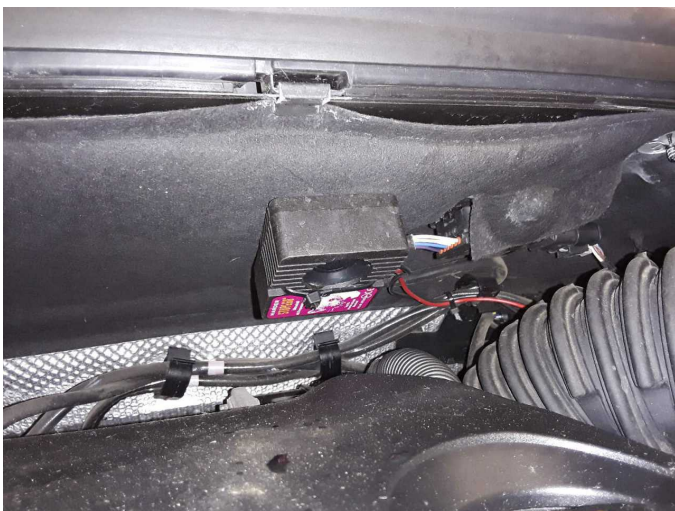
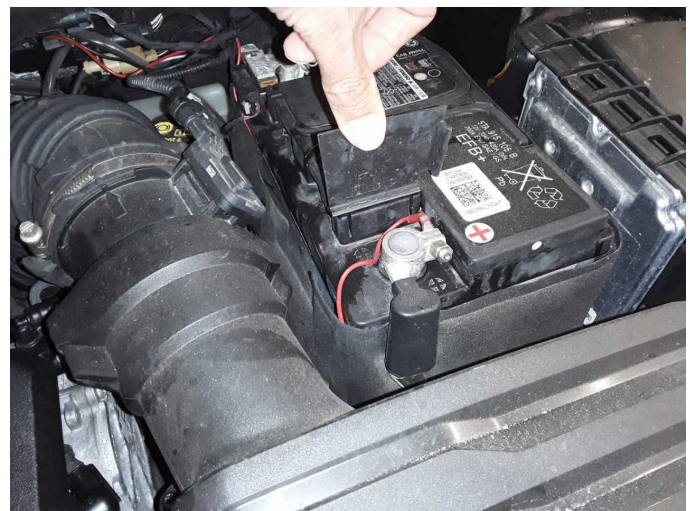
Wear and tear 1: Misc.: Misc. (Marderschutz verbaut) - No deduction

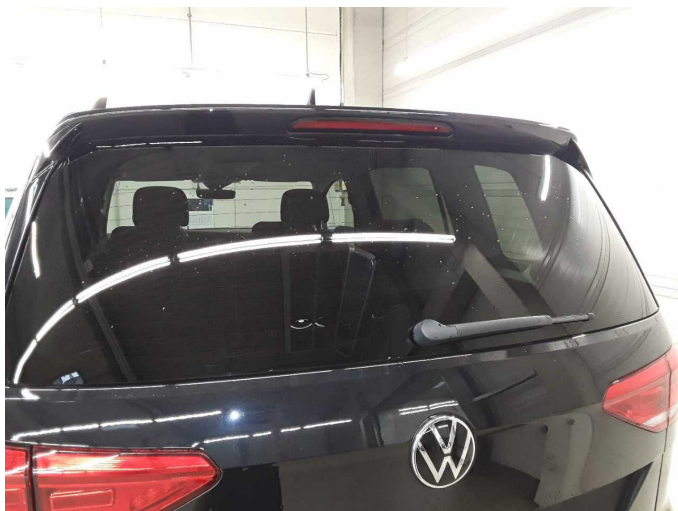
Wear and tear 2: Vehicle glazing: Rear window - Scratch(es) - No deduction

No.	Component group	Description
1	Misc.	Misc. (Marderschutz verbaut) - No deduction
2	Vehicle glazing	Rear window - Scratch(es) - No deduction
3	Misc.	Inspection / maintenance - No evidence - No deduction

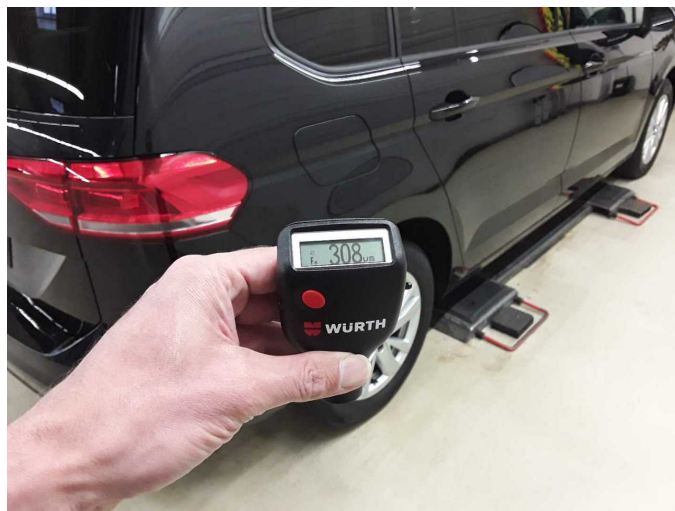
1 Side panel - rear right side, Professionally carried out, Invoice of repair done Non-existent

Side panel - rear right side 308 µm |

Side panel - rear right side: 308 µm
