Expertise

Protocol number: 46193354  
Order No. / Reference: 26517773  
Inspection date: 26 Jun 2026

Manufacturer: Volkswagen

Model: Passat Variant 2.0 TDI SCR DSG 4Motion Business

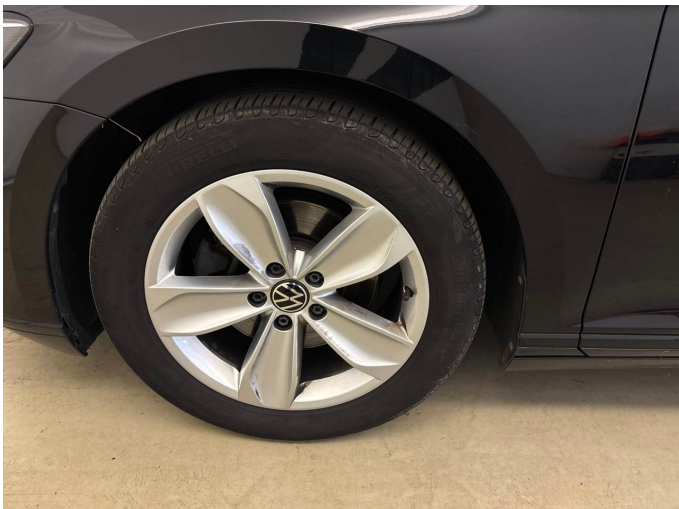
Figure 12: Mounted tyres

| # | Tyre size | Type of tyre | Manufacturer | Tread depth |
|---|---|---|---|---|
| 1) | 215/55 R17 94W | Summer tyres on Light alloy | Pirelli | 4mm / 4mm |
| 2) | 215/55 R17 94W | Summer tyres on Light alloy | Pirelli | 4mm / 4mm |

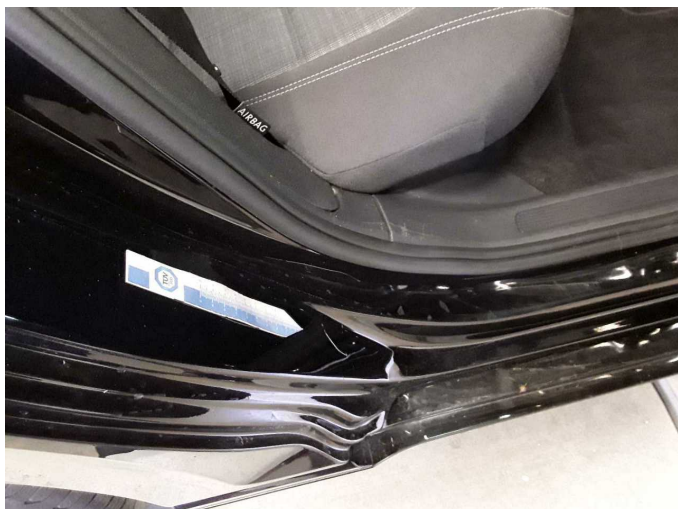
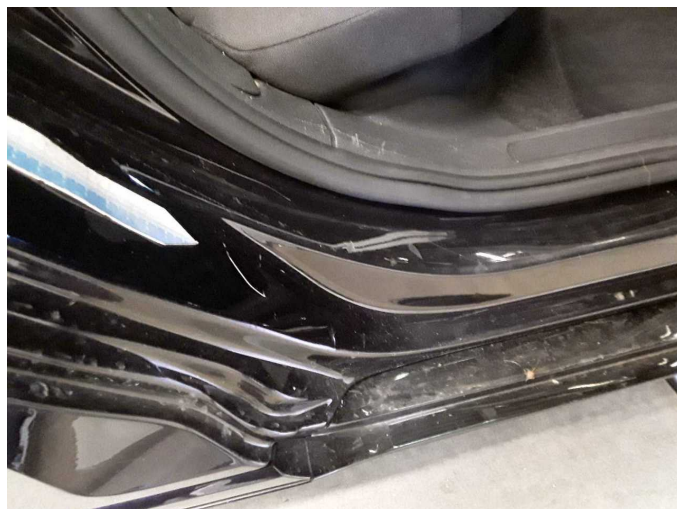
| No. | Component group | Description |
|---|---|---|
| 3 | Side panel - rear right side | Sill - Scratch(es) - Smart repair |

**Damage 3:** Side panel - rear right side: Sill - Scratch(es) - Smart repair

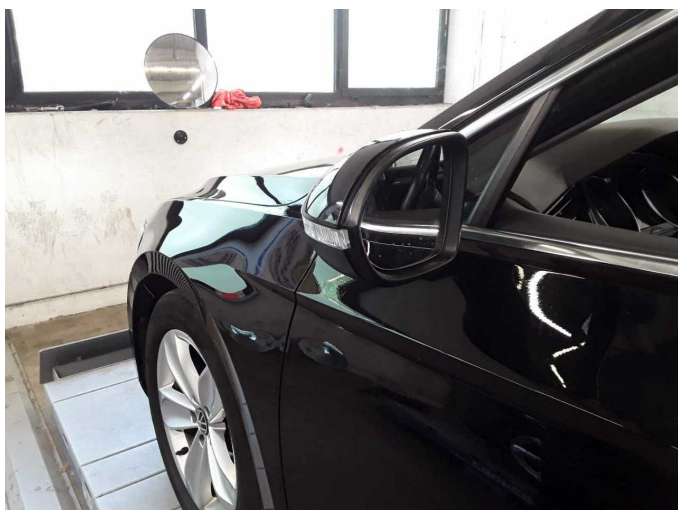
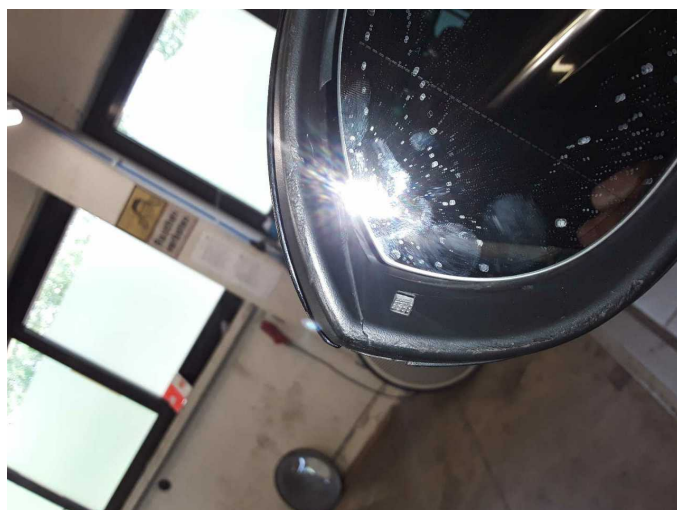
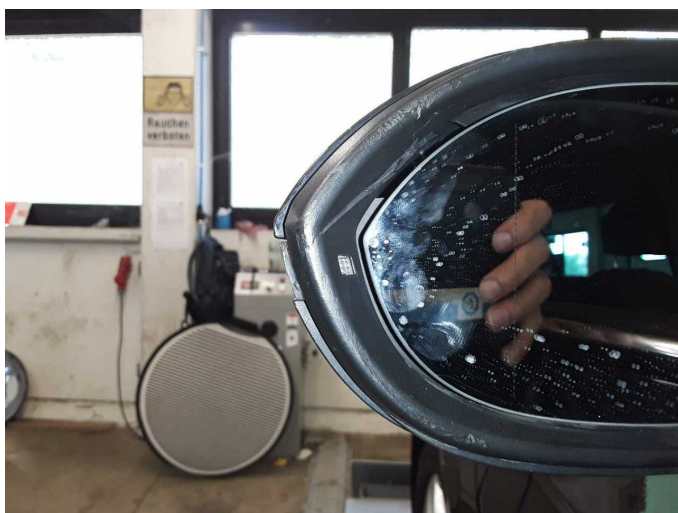
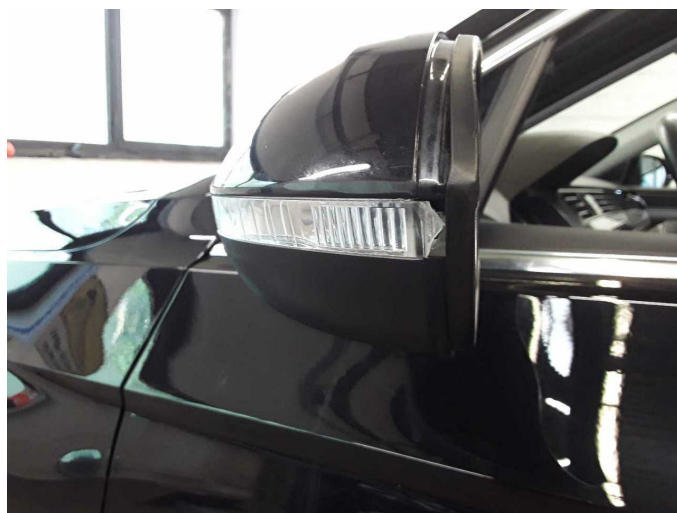
| No. | Component group | Description |
|---|---|---|
| 4 | Wing mirror - left side | Mirror housing (Rahmen & Blinkleuchte) - Broken / torn - Replace |

**Damage 4:** Wing mirror - left side: Mirror housing (Rahmen & Blinkleuchte) - Broken / torn - Replace

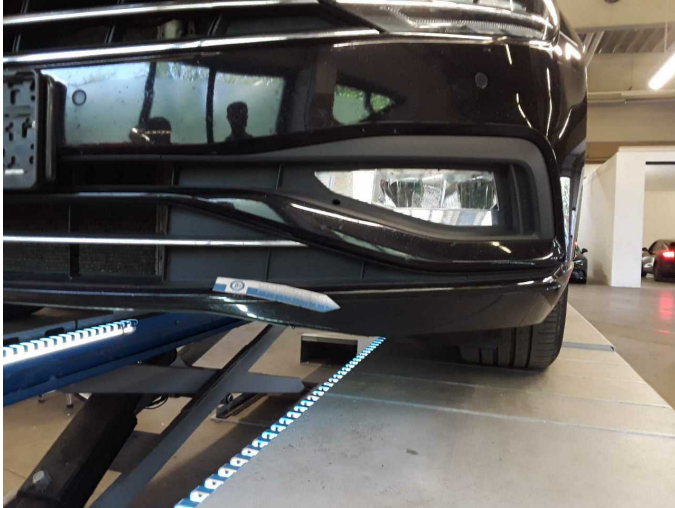
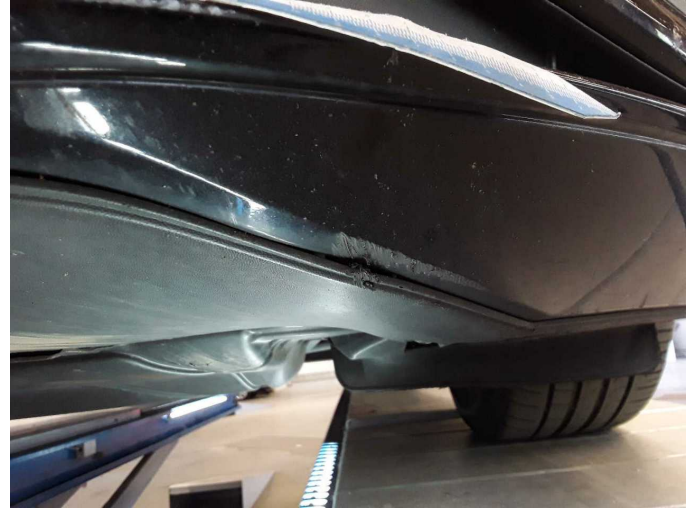
| No. | Component group | Description |
|---|---|---|
| 5 | Front bumper | Front bumper - Scratch(es) - Smart repair |

**Damage 5:** Front bumper: Front bumper - Scratch(es) - Smart repair

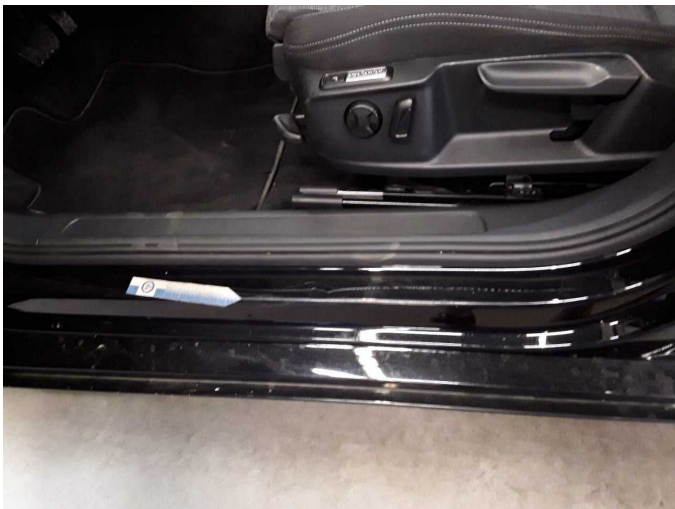
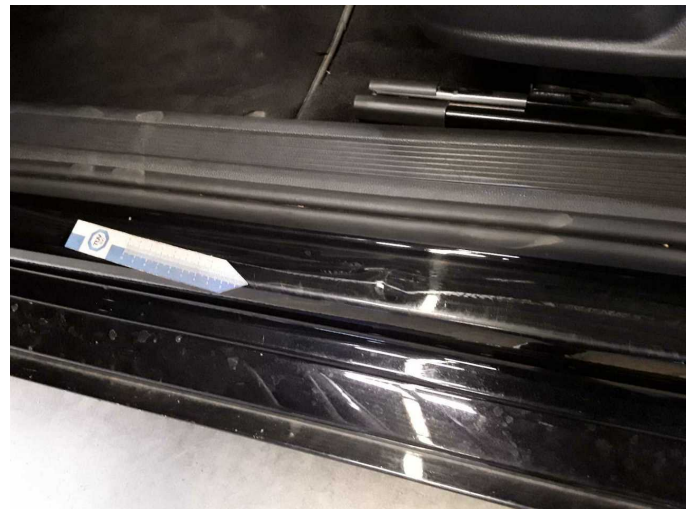
| No. | Component group | Description |
|---|---|---|
| 6 | Sill - left side | Sill - Dent / paintcoat damage - Smart repair |

**Damage 6:** Sill - left side: Sill - Dent / paintcoat damage - Smart repair

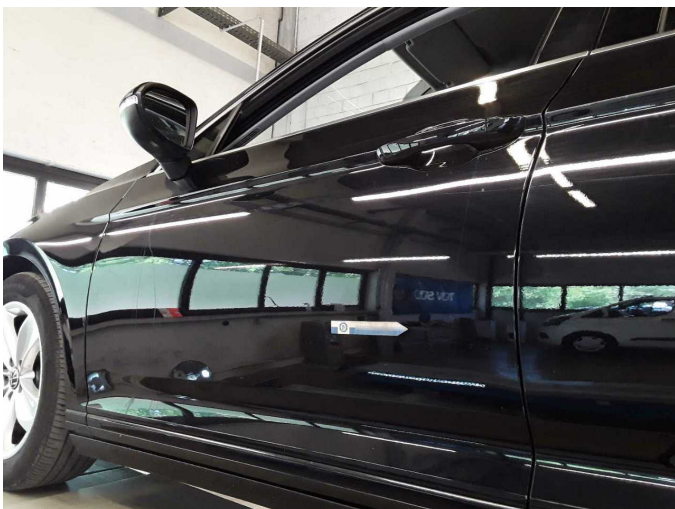
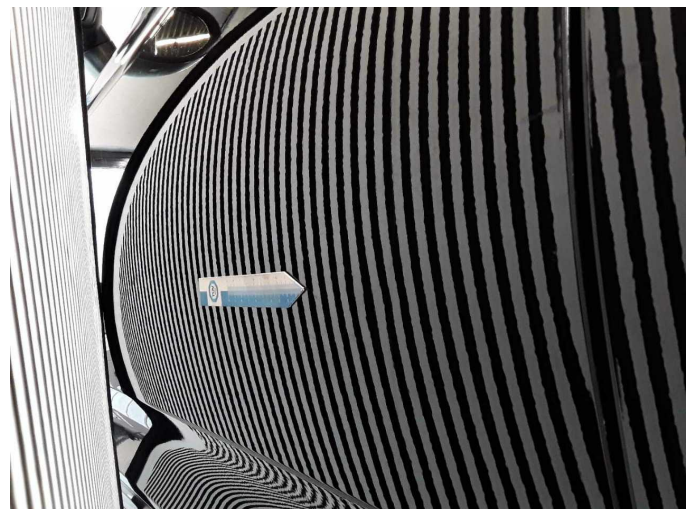
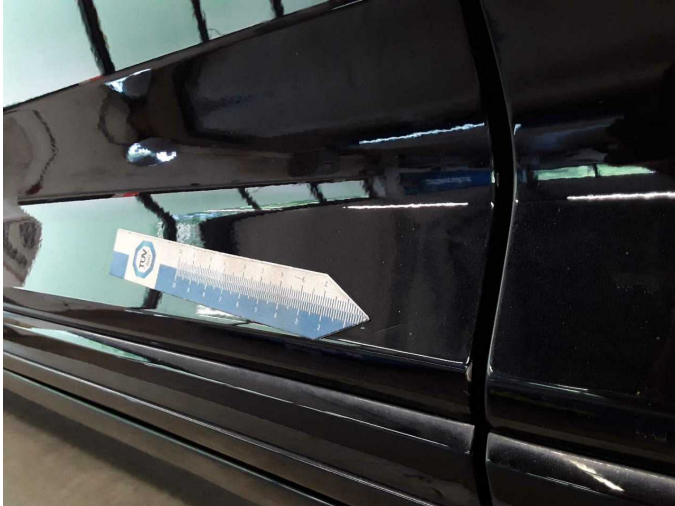
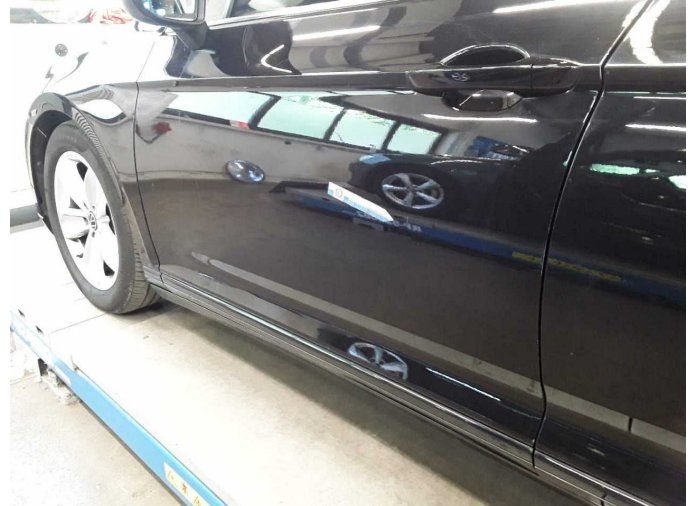
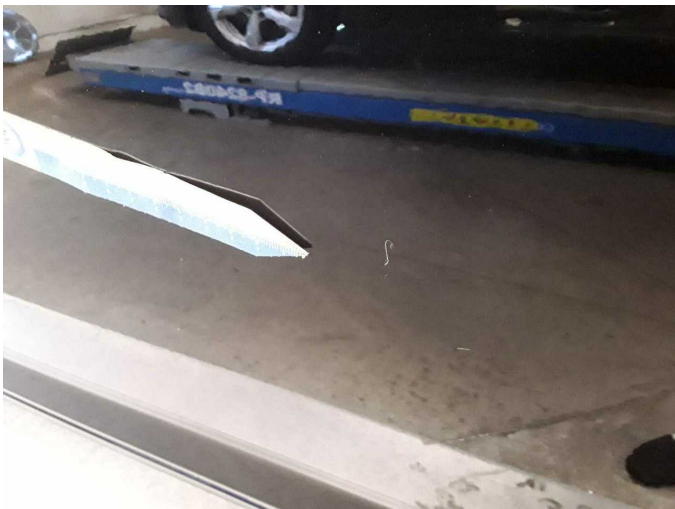
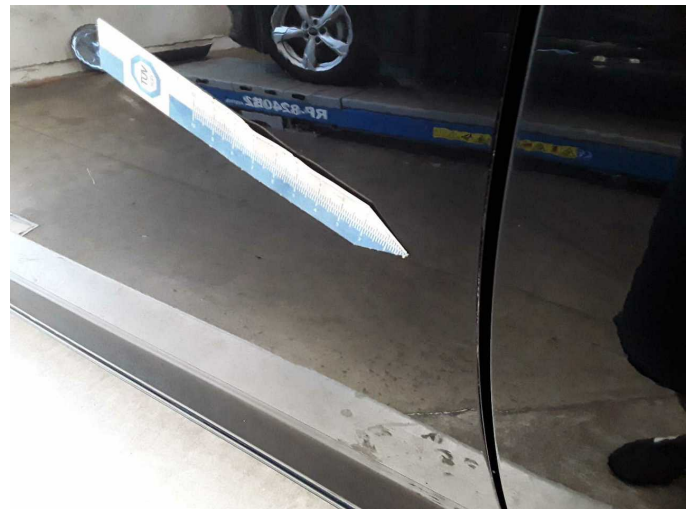
| No. | Component group | Description |
|---|---|---|
| 7 | Door - front left side | Door - Dent / paintcoat damage - Repair and paint |

**Damage 7:** Door - front left side: Door - Dent / paintcoat damage - Repair and paint

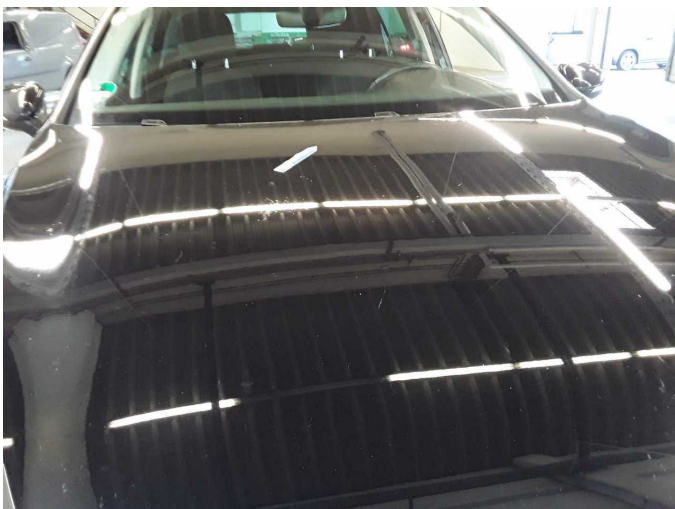
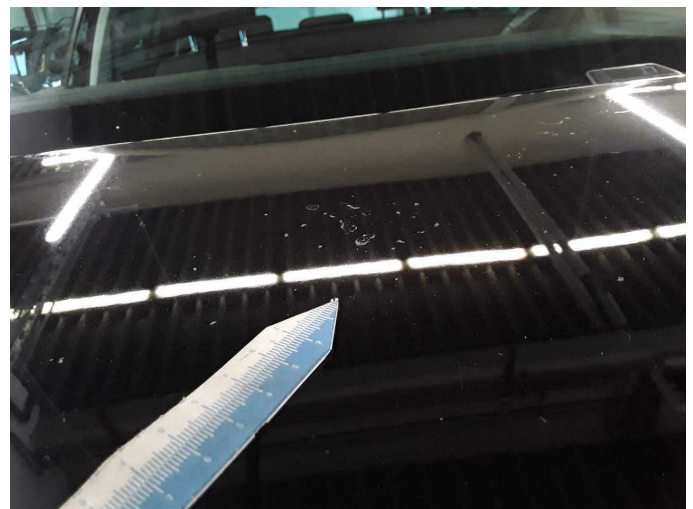
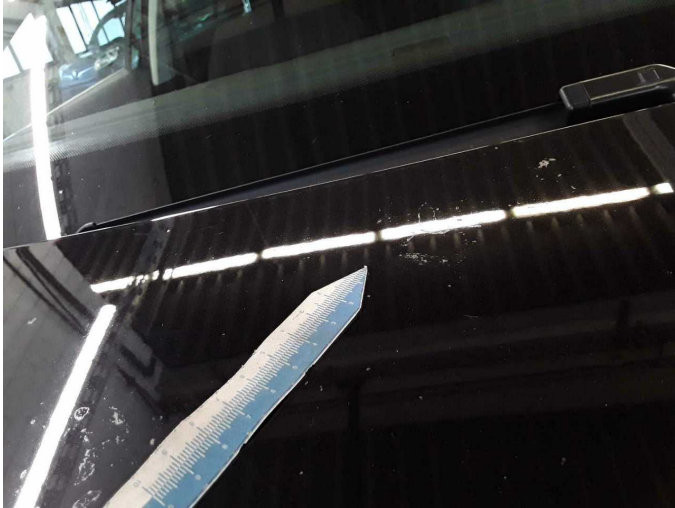
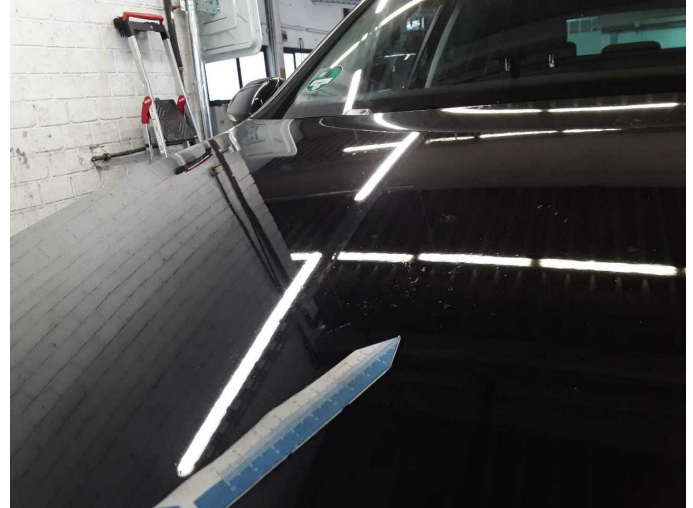
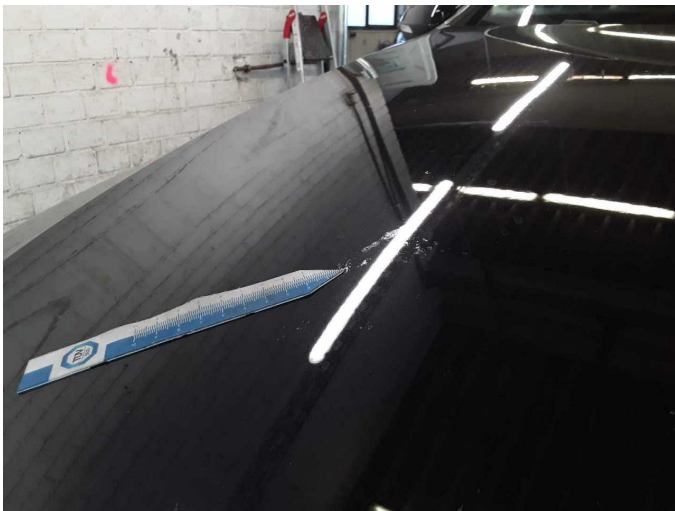
| No. | Component group | Description |
|---|---|---|
| 8 | Bonnet | Bonnet (Vogelkot) - Paint defect - Paint |

**Damage 8:** Bonnet: Bonnet (Vogelkot) - Paint defect - Paint

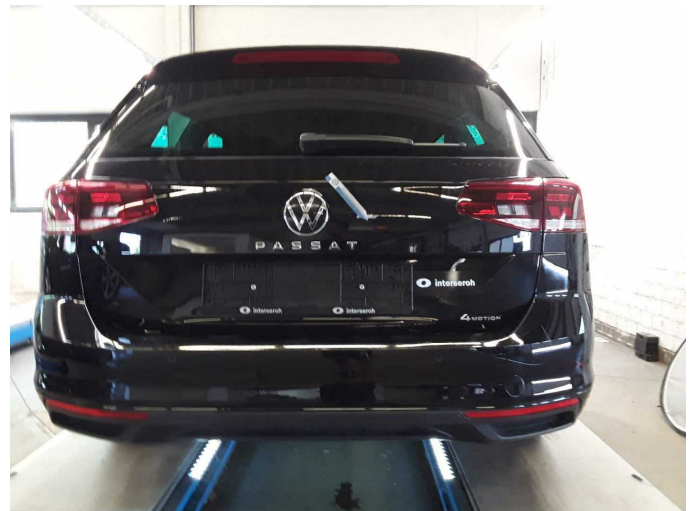
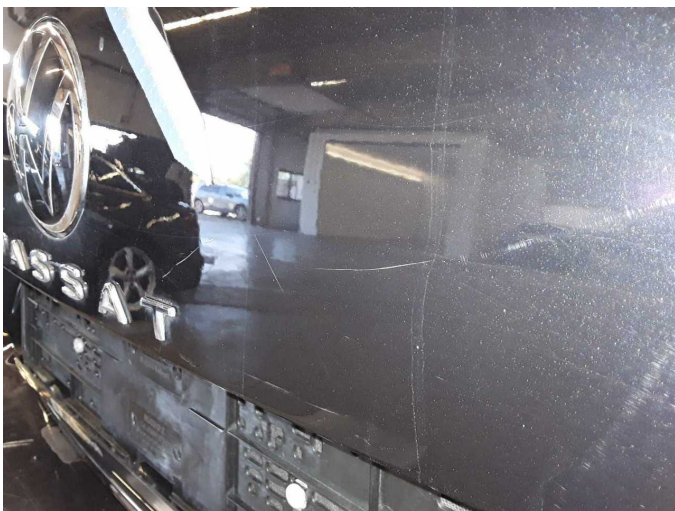
| No. | Component group | Description |
|---|---|---|
| 9 | Boot lid / rear door | Boot lid - Scratch(es) - Paint |

**Damage 9:** Boot lid / rear door: Boot lid - Scratch(es) - Paint

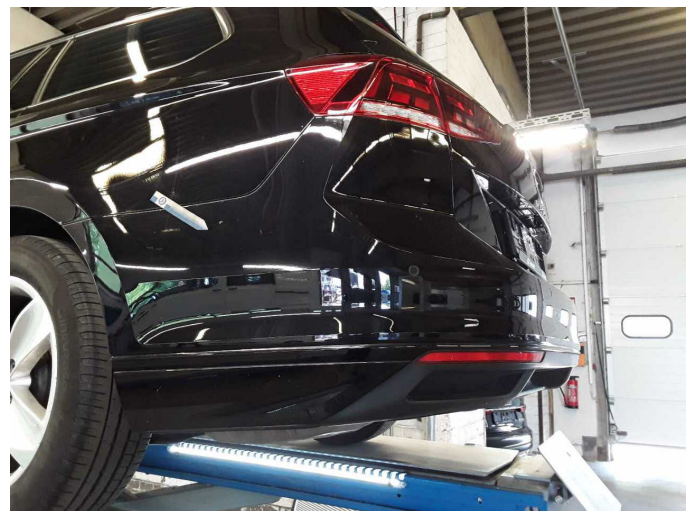
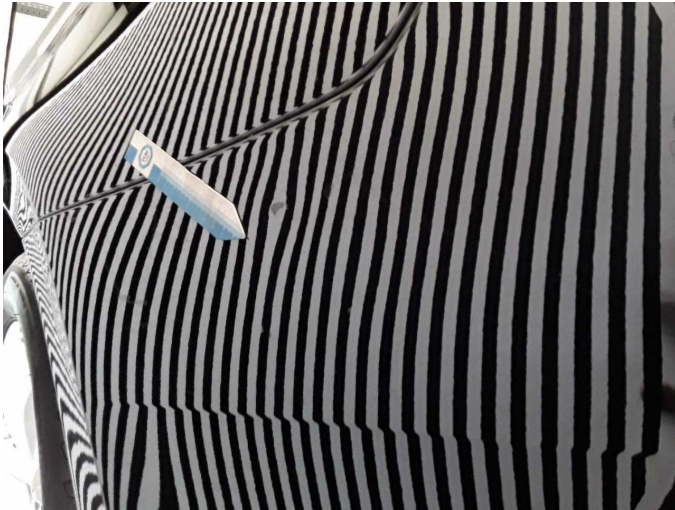
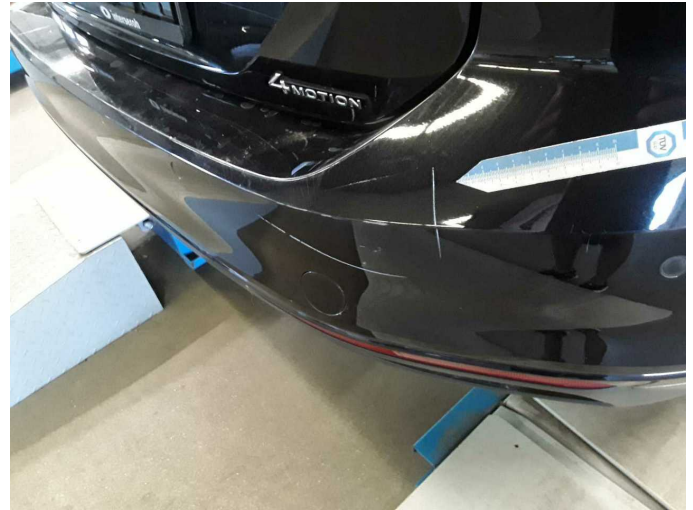
| No. | Component group | Description |
|---|---|---|
| 10 | Rear bumper | Rear bumper - Dent / paintcoat damage - Repair and paint |

**Damage 10:** Rear bumper: Rear bumper - Dent / paintcoat damage - Repair and paint
