Expertise

Protocol number: 46876766  
Order No. / Reference: 26821431  
Inspection date: 31 Jul 2026

Manufacturer: Ford

Model: Kuga 2.5 Duratec PHEV VIGNALE

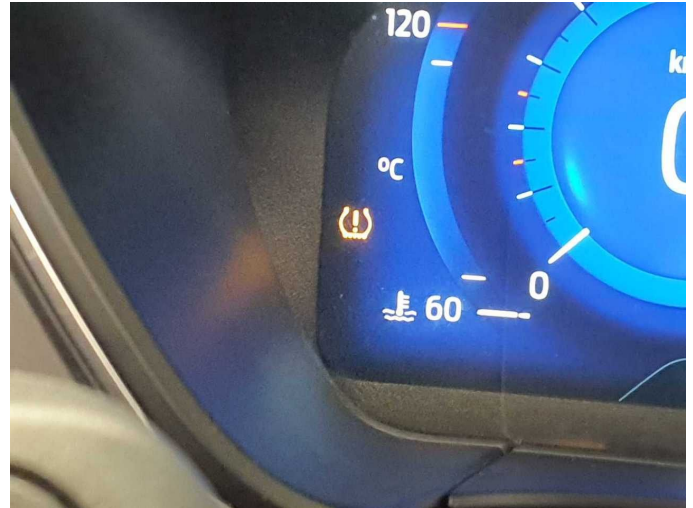
| No. | Component group | Description |
|---|---|---|
| 1 | Wheel / tyres | Tyres - complete set (Reifendruck) - Specify findings - Perform diagnosis |

**Damage 1:** Wheel / tyres: Tyres - complete set (Reifendruck) - Specify findings - Perform diagnosis

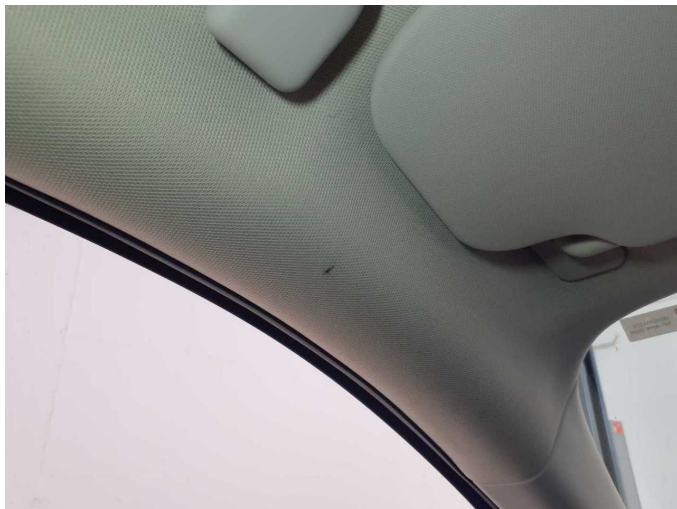
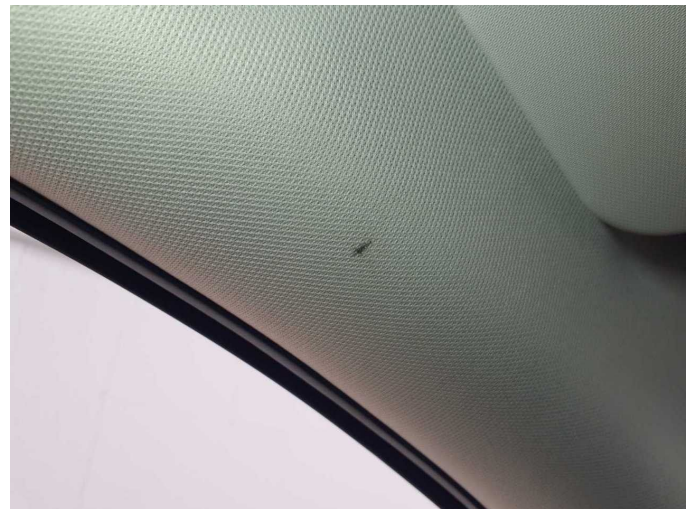
| No. | Component group | Description |
|---|---|---|
| 2 | Trim / covers | Roof lining - Burn hole (cigarettes) - Smart repair |

**Damage 2:** Trim / covers: Roof lining - Burn hole (cigarettes) - Smart repair

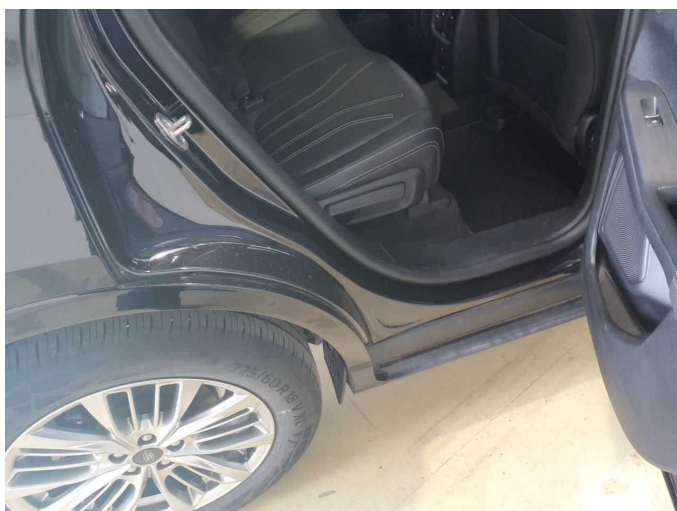
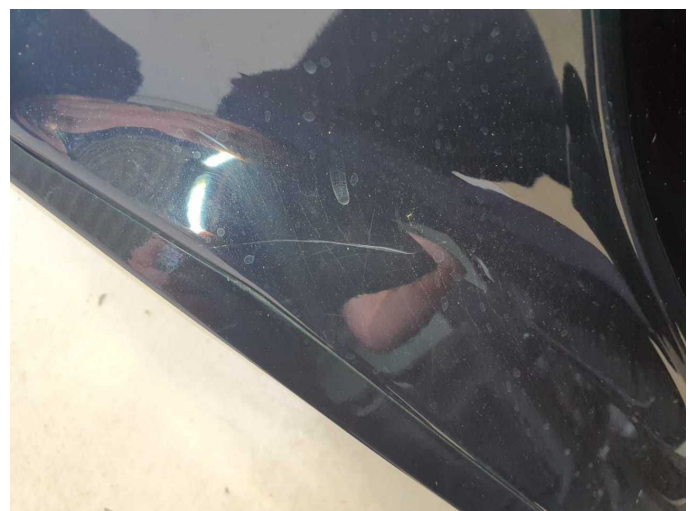
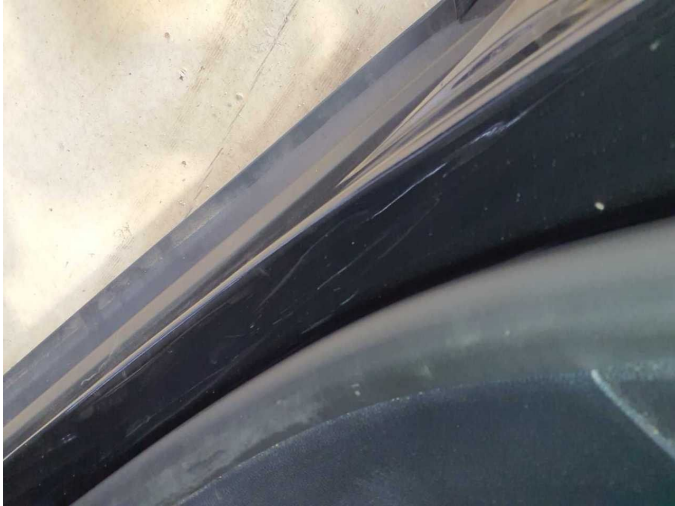
| No. | Component group | Description |
|---|---|---|
| 3 | Side panel - rear right side | Sill - Scratch(es) - Smart repair |

**Damage 3:** Side panel - rear right side: Sill - Scratch(es) - Smart repair

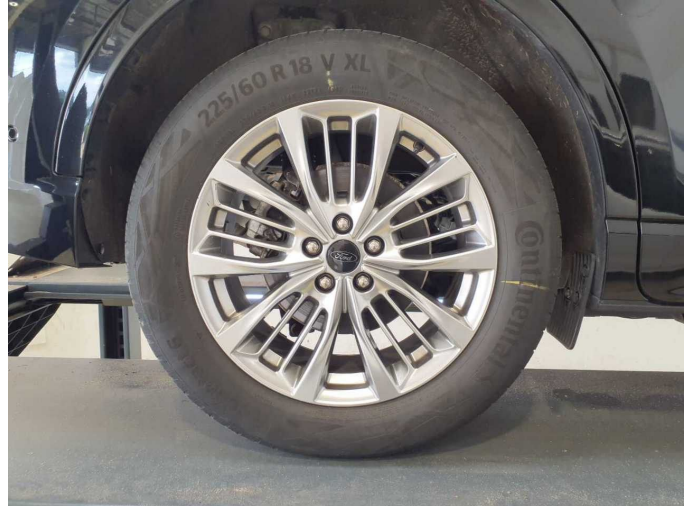
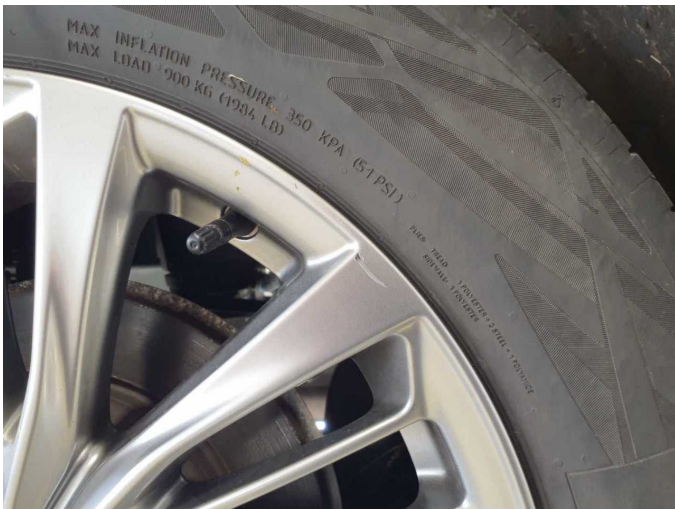
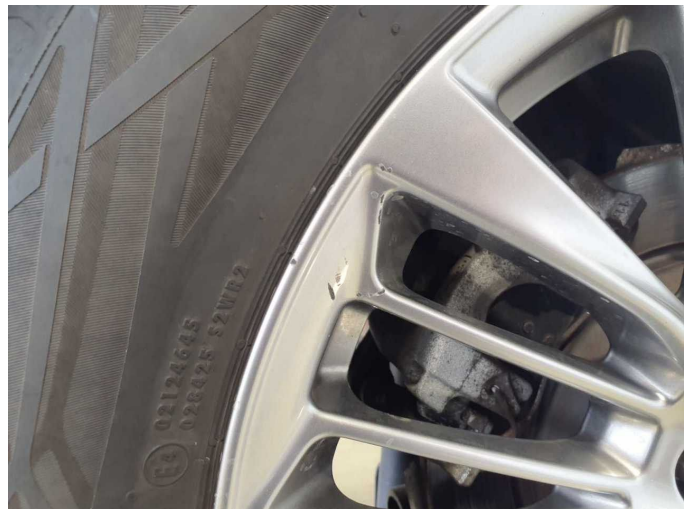
| No. | Component group | Description |
|---|---|---|
| 4 | Wheel / tyres | Alloy rim - rear right side - Scratch(es) - Smart repair |

**Damage 4:** Wheel / tyres: Alloy rim - rear right side - Scratch(es) - Smart repair

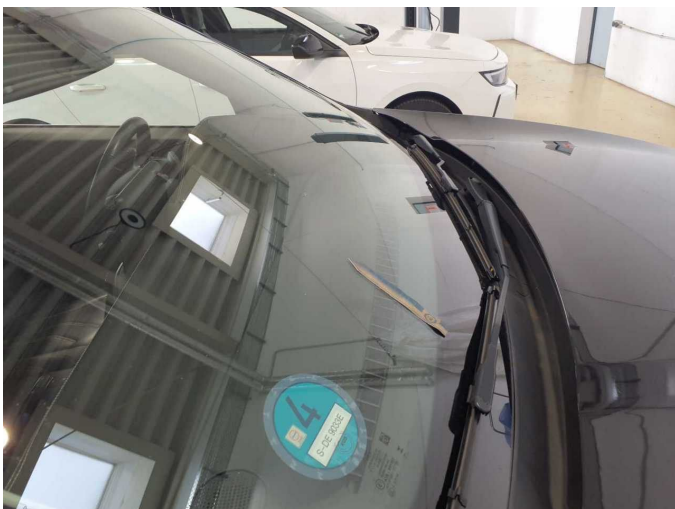
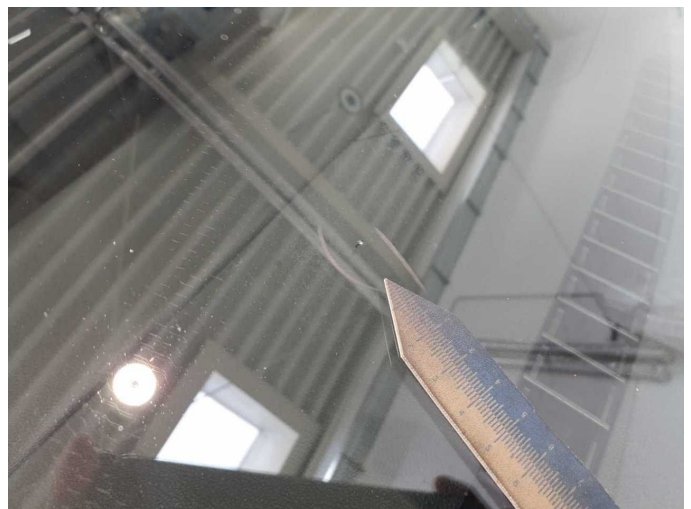
| No. | Component group | Description |
|---|---|---|
| 5 | Vehicle glazing | Windscreen - Stone chips - Smart repair |

**Damage 5:** Vehicle glazing: Windscreen - Stone chips - Smart repair

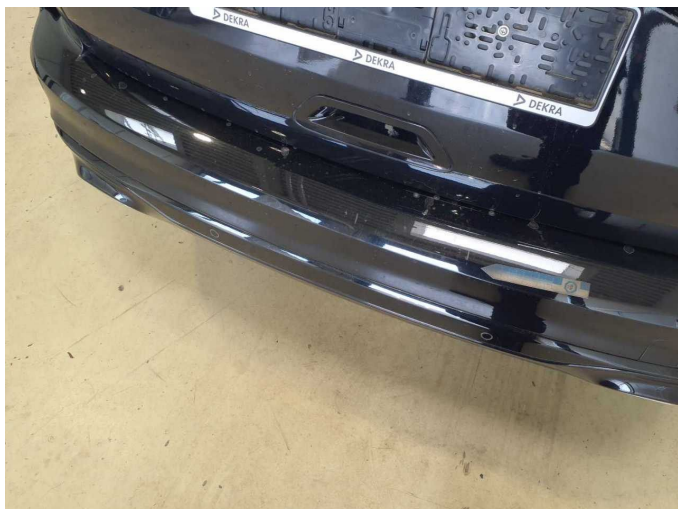
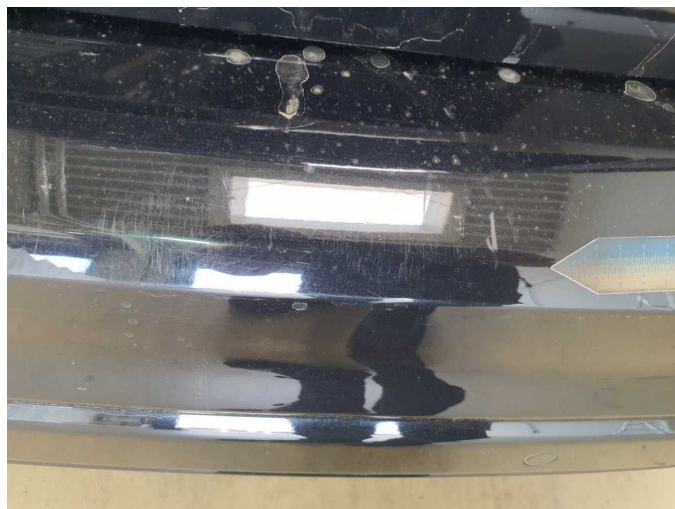
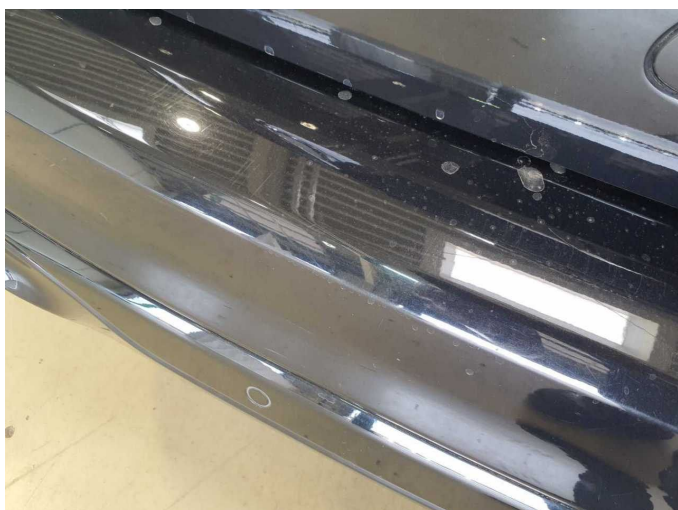
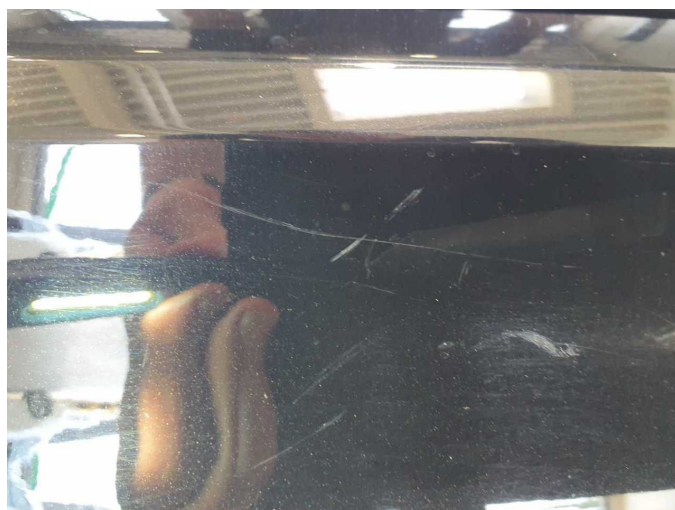
| No. | Component group | Description |
|---|---|---|
| 6 | Rear bumper | Rear bumper - Scratch(es) - Smart repair |

**Damage 6:** Rear bumper: Rear bumper - Scratch(es) - Smart repair

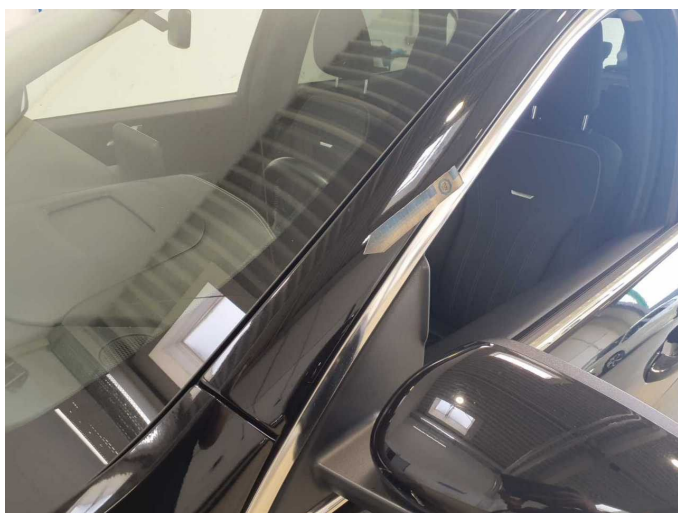
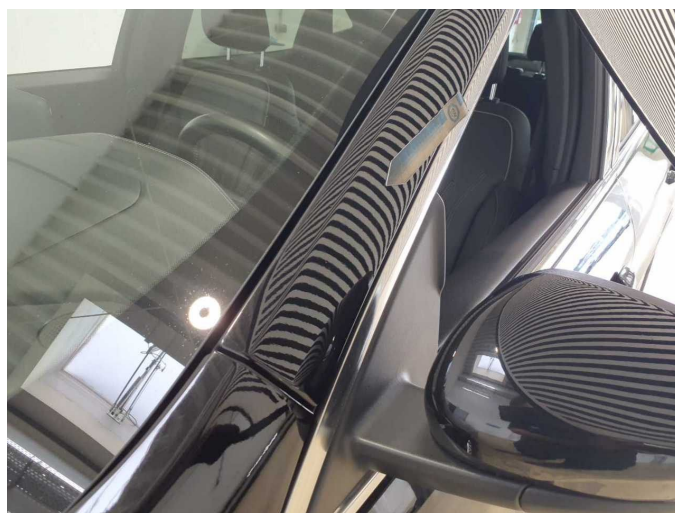
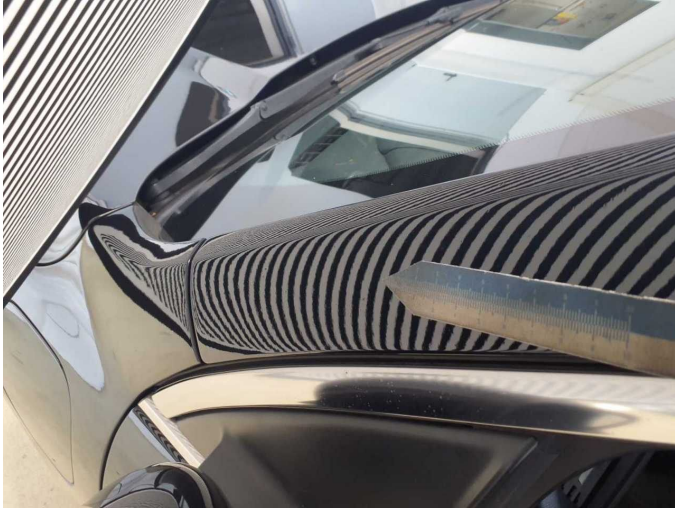
| No. | Component group | Description |
|---|---|---|
| 7 | Body | A-pillar - left side (Einschlüsse-Mehrkosten möglich) - Paint defect - Conditioning |

**Damage 7:** Body: A-pillar - left side (Einschlüsse-Mehrkosten möglich) - Paint defect - Conditioning

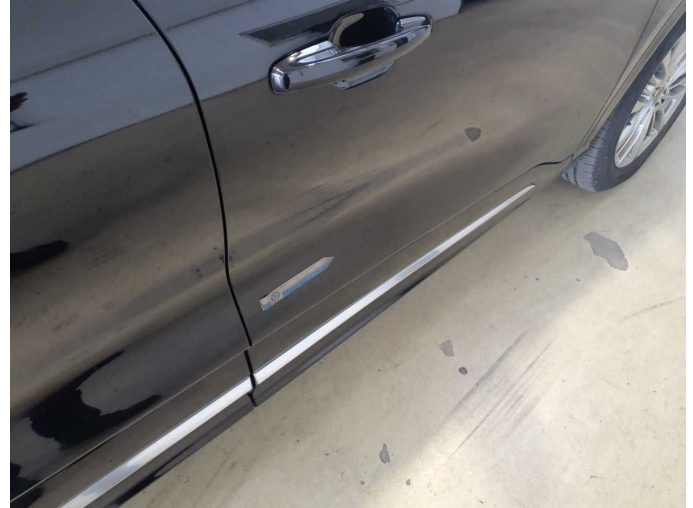
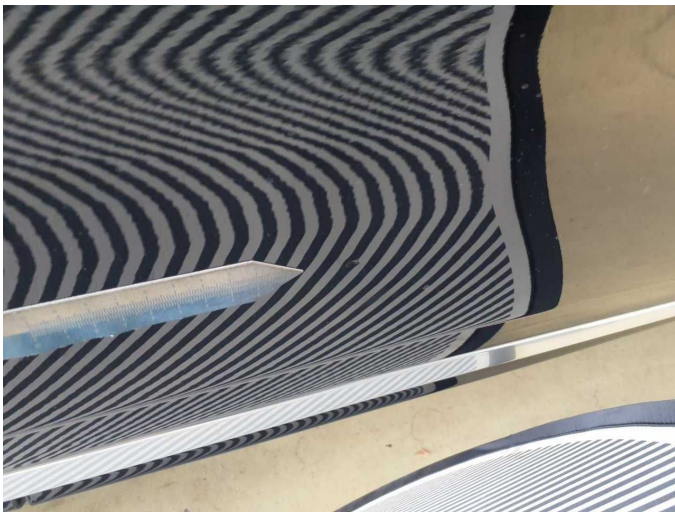
| No. | Component group | Description |
|---|---|---|
| 8 | Door - front right side | Door - Dent / paintcoat damage - Smart repair |

**Damage 8:** Door - front right side: Door - Dent / paintcoat damage - Smart repair

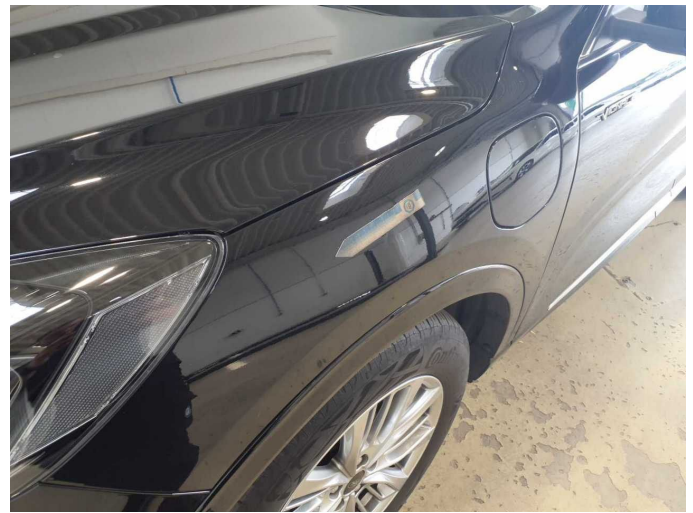
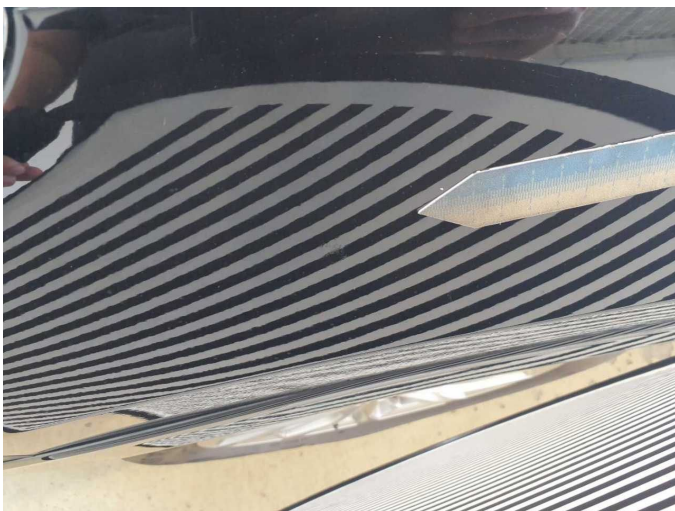
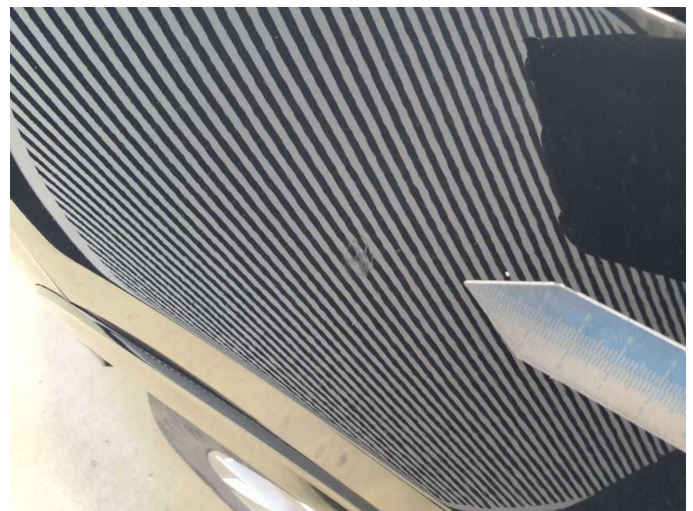
| No. | Component group | Description |
|---|---|---|
| 9 | Mudguard - left side | Mudguard - left side (Spachtel eingefallen) - Unprofessionally repaired - Repair and paint |

| 3 | Mudguard - left side, Unprofessionally carried out, Invoice of repair done Non-existent |

| Mudguard - left side | 213 µm | Mudguard - right side | 230 µm |

**Damage 9:** Mudguard - left side: Mudguard - left side (Spachtel eingefallen) - Unprofessionally repaired - Repair and paint

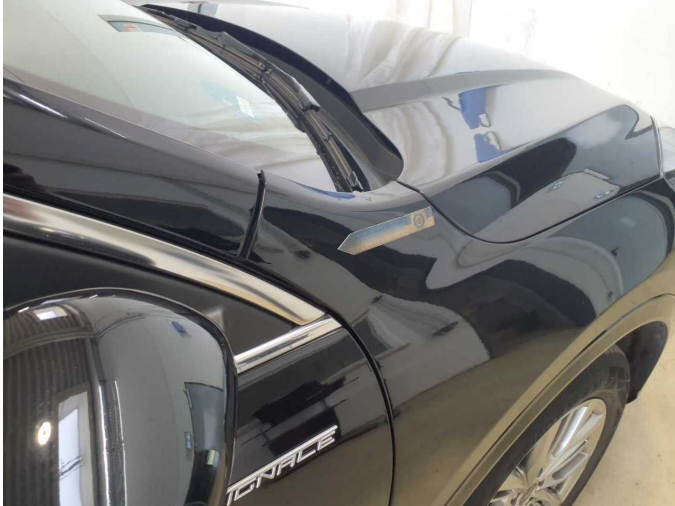
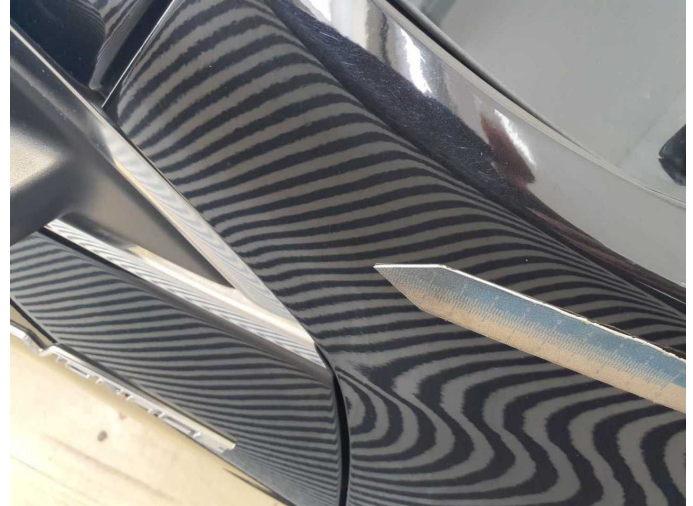
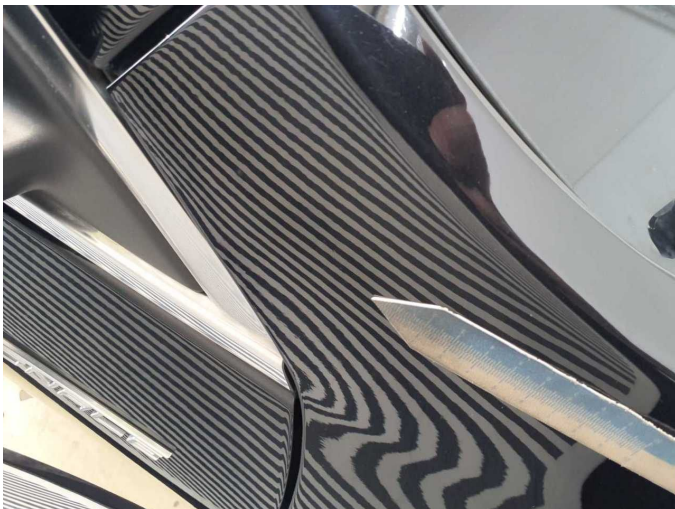
| No. | Component group | Description |
|---|---|---|
| 10 | Mudguard - right side | Mudguard - right side (Kratzer im Spachtel) - Unprofessionally repaired - Repair and paint |

| 4 | Mudguard - right side, Unprofessionally carried out, Invoice of repair done Non-existent |

**Damage 10:** Mudguard - right side: Mudguard - right side (Kratzer im Spachtel) - Unprofessionally repaired - Repair and paint

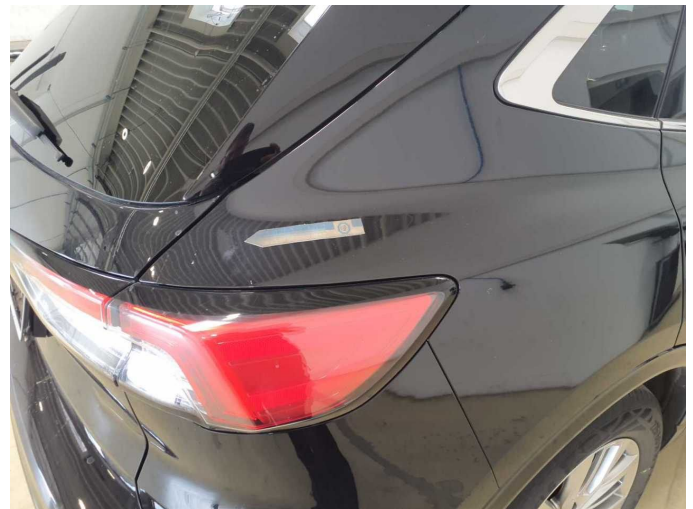
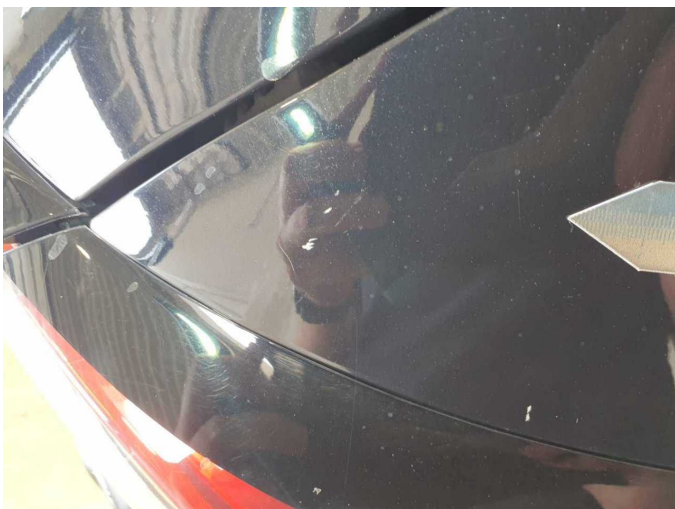
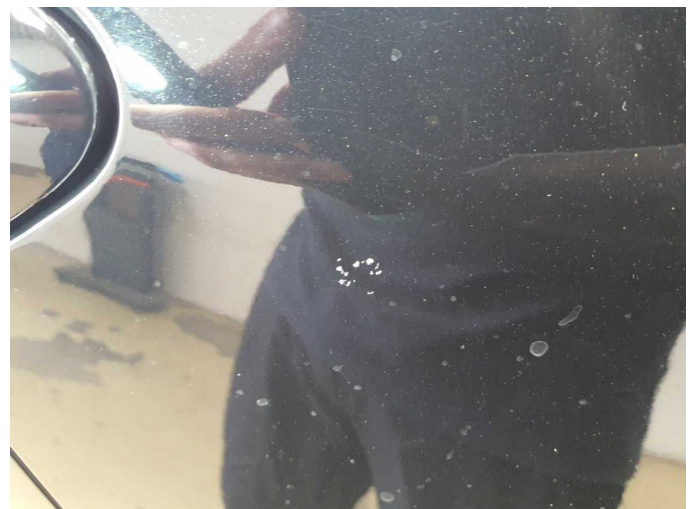
| No. | Component group | Description |
|---|---|---|
| 11 | Side panel - rear right side | Side panel - Scratch(es) - Paint |

**Damage 11:** Side panel - rear right side: Side panel - Scratch(es) - Paint

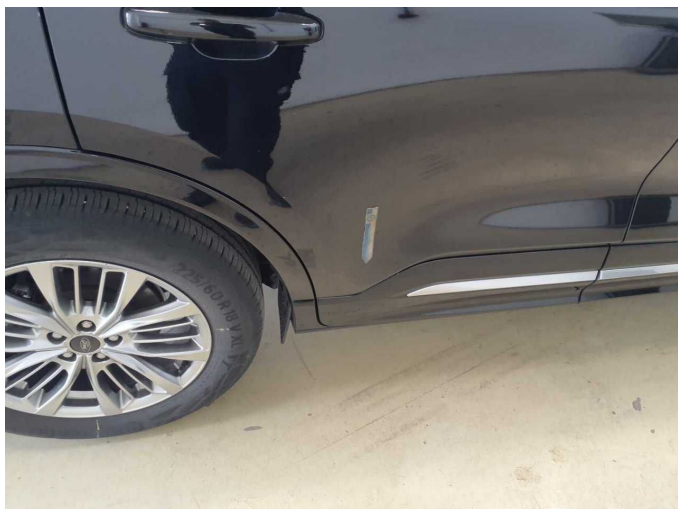
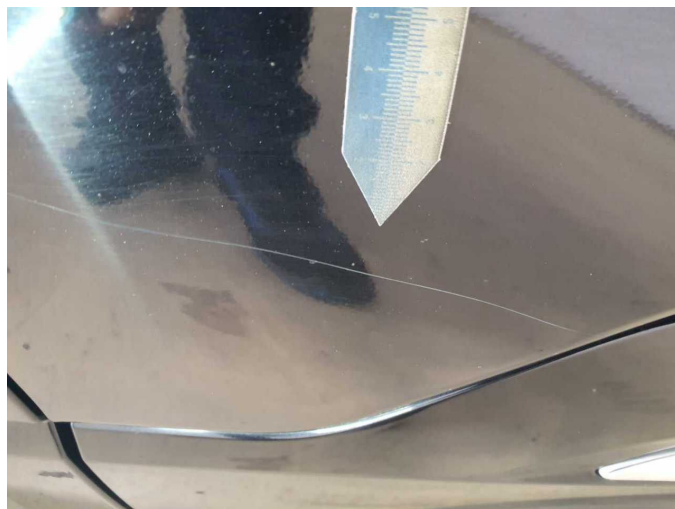
| No. | Component group | Description |
|---|---|---|
| 12 | Door - rear right side | Door - Scratch(es) - Paint |

**Damage 12:** Door - rear right side: Door - Scratch(es) - Paint

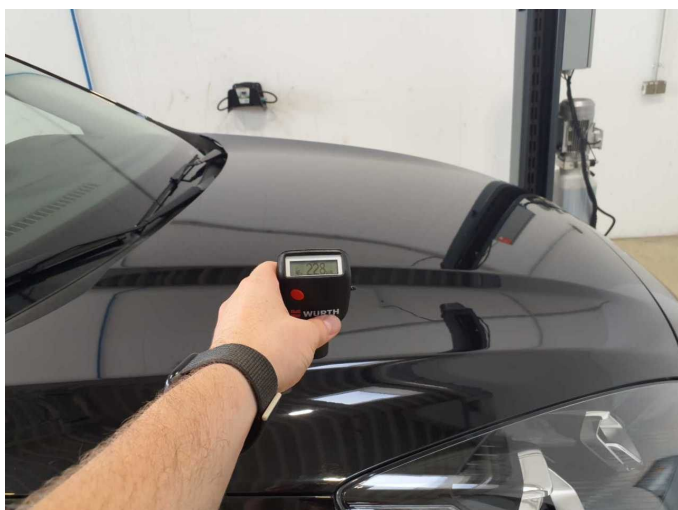
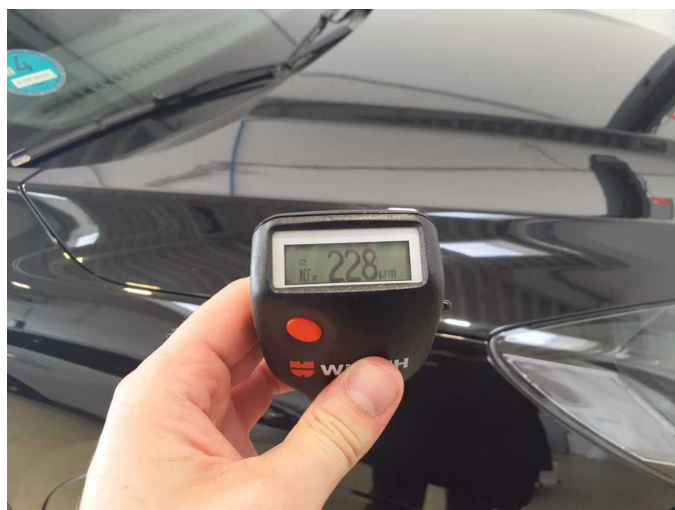
| 1 | Bonnet, Professionally carried out, Invoice of repair done Non-existent |

| Bonnet | 228 µm | Door - front left side | 172 µm |

**Repainting 1:** Bonnet

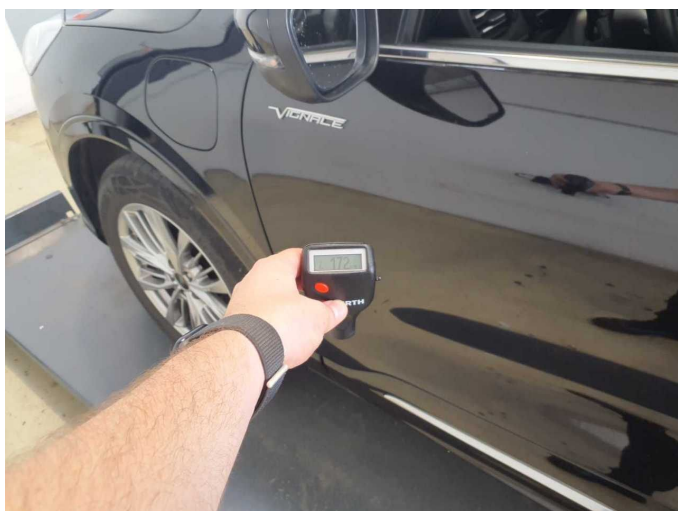
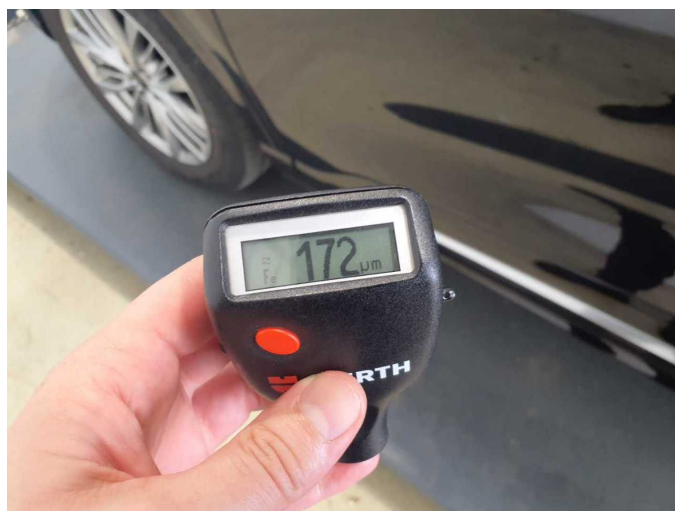
| 2 | Door - front left side, Professionally carried out, Invoice of repair done Non-existent |

**Repainting 2:** Door - front left side

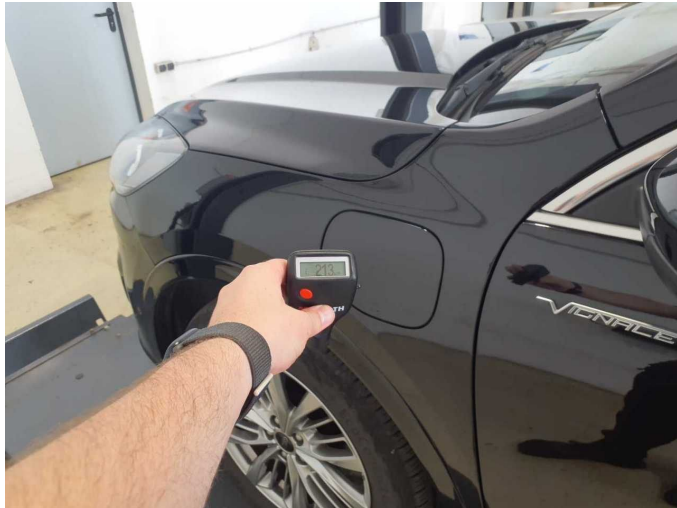
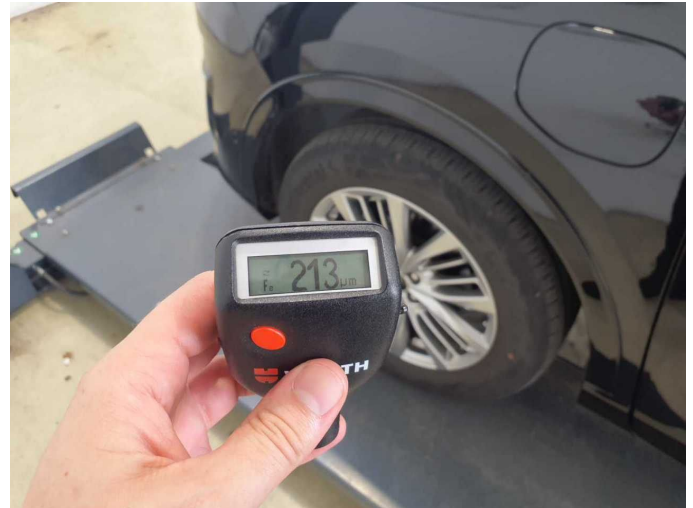
**Repainting 3:** Mudguard - left side
