Expertise

Protocol number: 46418459  
Order No. / Reference: 26520437  
Inspection date: 9 Jul 2026

Manufacturer: Mercedes-Benz  
VIN: W1KAH0FB0PF102630

Model: C 220 d 4Matic T 9G-TRONIC Avantgarde

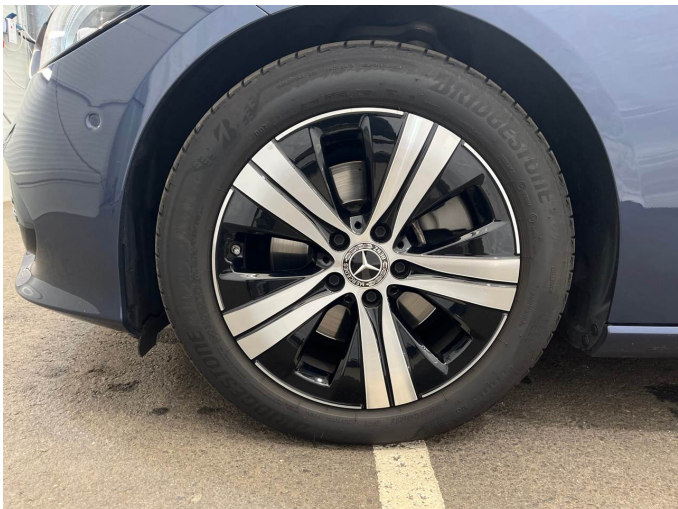
| # | Tyre size | Type of tyre | Manufacturer | Tread depth |
|---|---|---|---|---|
| 1) | 225/50 R17 94Y | Summer tyres on Light alloy | Bridgestone | 6mm / 6mm |
| 2) | 225/50 R17 94Y | Summer tyres on Light alloy | Bridgestone | 4mm / 4mm |

Figure 12: Mounted tyres

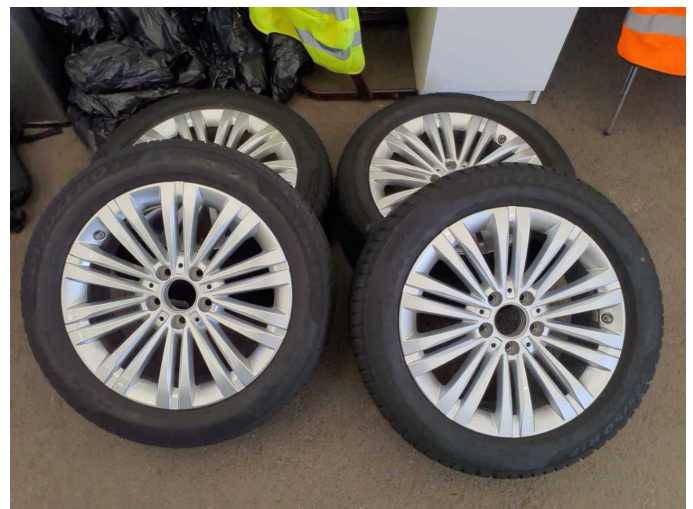
| # | Tyre size | Type of tyre | Manufacturer | Tread depth |
|---|---|---|---|---|
| 1) | 225/50 R17 98H | Winter tyres on Light alloy | Pirelli | 6mm / 6mm |
| 2) | 225/50 R17 98H | Winter tyres on Light alloy | Pirelli | 7mm / 7mm |

Figure 18: Additional tyres

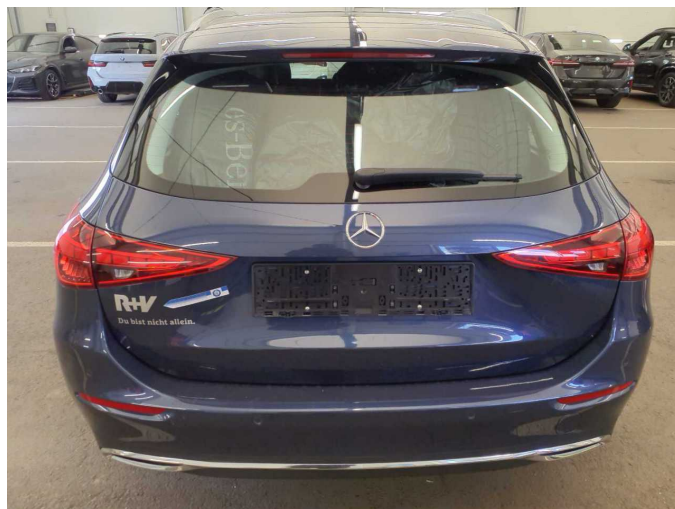
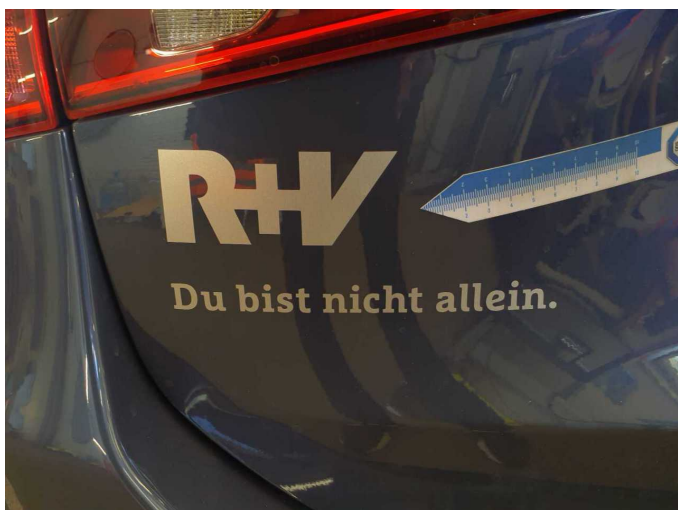
| No. | Component group | Description |
|---|---|---|
| 1 | Boot lid / rear door | Boot lid - Glued / labelled - De-glue / neutralise |

**Damage 1:** Boot lid / rear door: Boot lid - Glued / labelled - De-glue / neutralise

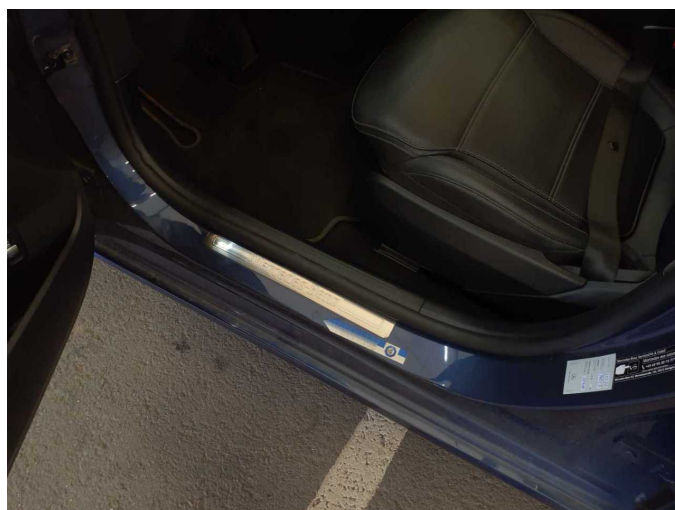
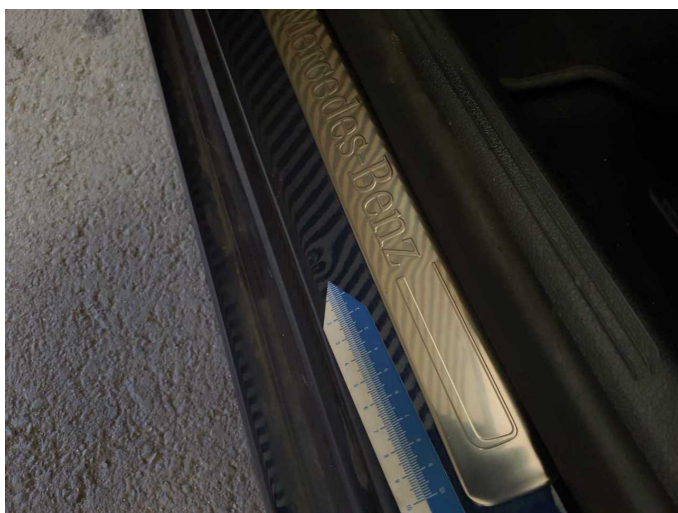
| No. | Component group | Description |
|---|---|---|
| 2 | Sill - left side | Sill - dent(s) - Smart repair |

**Damage 2:** Sill - left side: Sill - dent(s) - Smart repair

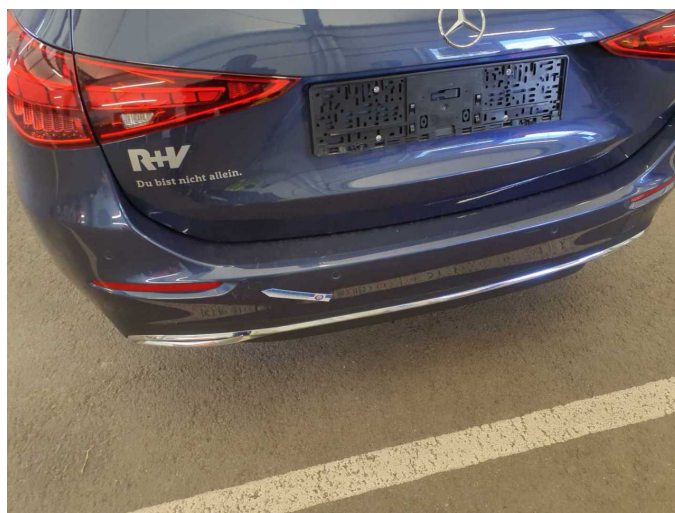
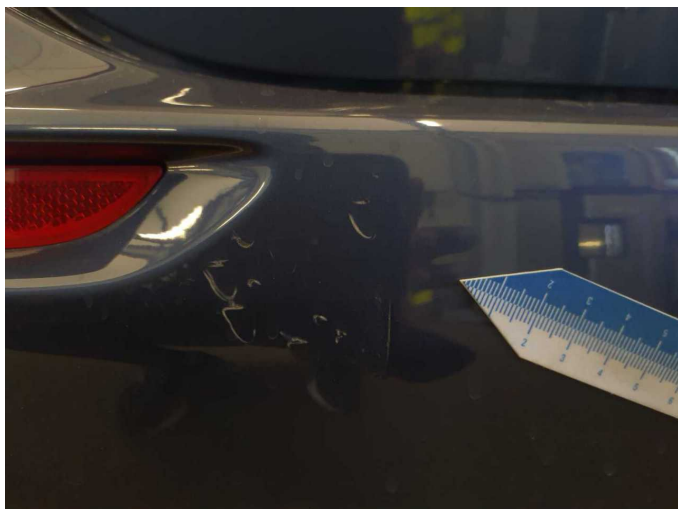
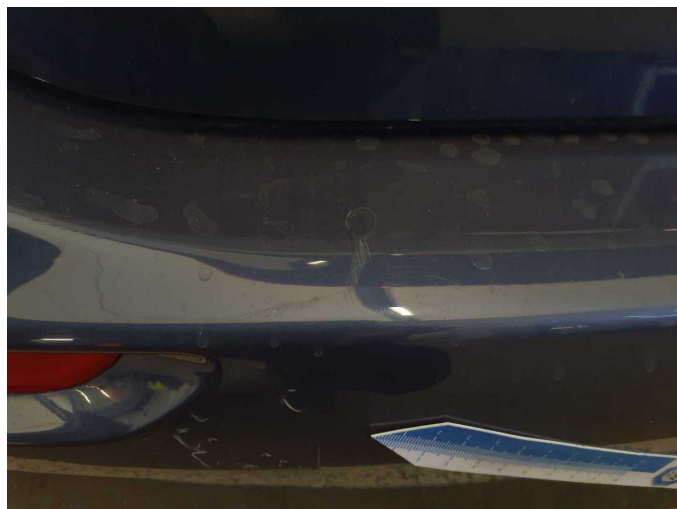
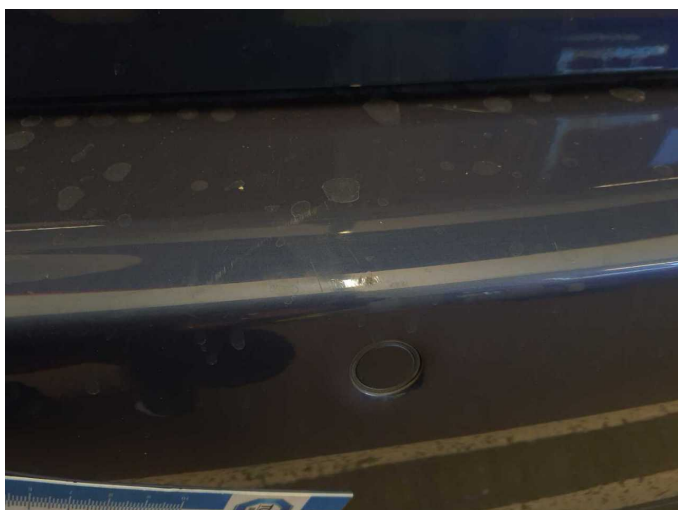
| No. | Component group | Description |
|---|---|---|
| 3 | Rear bumper | Rear bumper - Scratch(es) - Smart repair |

**Damage 3:** Rear bumper: Rear bumper - Scratch(es) - Smart repair

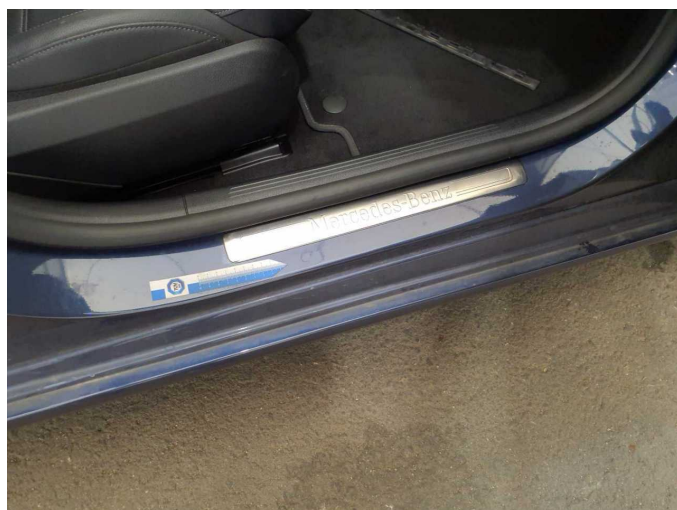
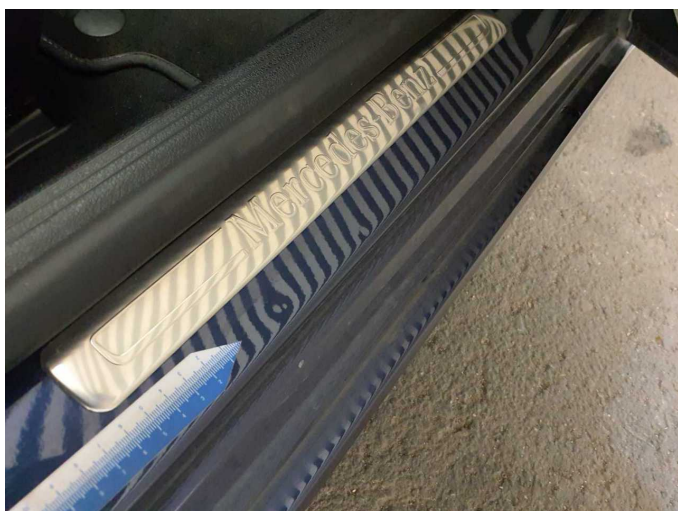
| No. | Component group | Description |
|---|---|---|
| 4 | Sill - right side | Sill - dent(s) - Smart repair |

**Damage 4:** Sill - right side: Sill - dent(s) - Smart repair

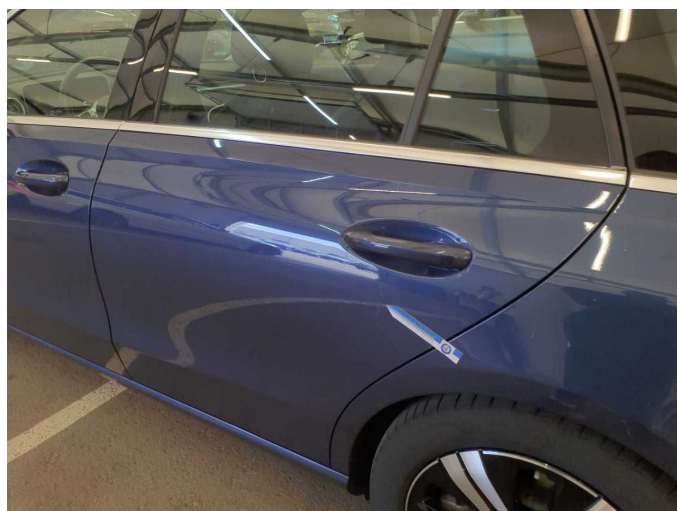
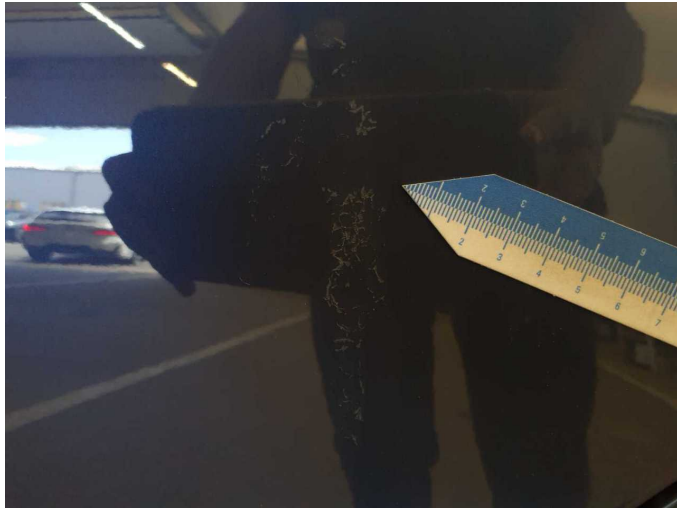
| No. | Component group | Description |
|---|---|---|
| 5 | Door - rear left side | Door - Paint defect - Paint |

**Damage 5:** Door - rear left side: Door - Paint defect - Paint

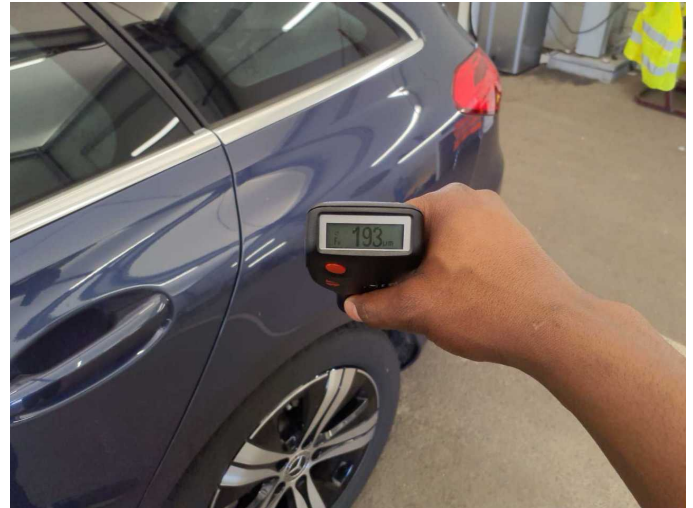
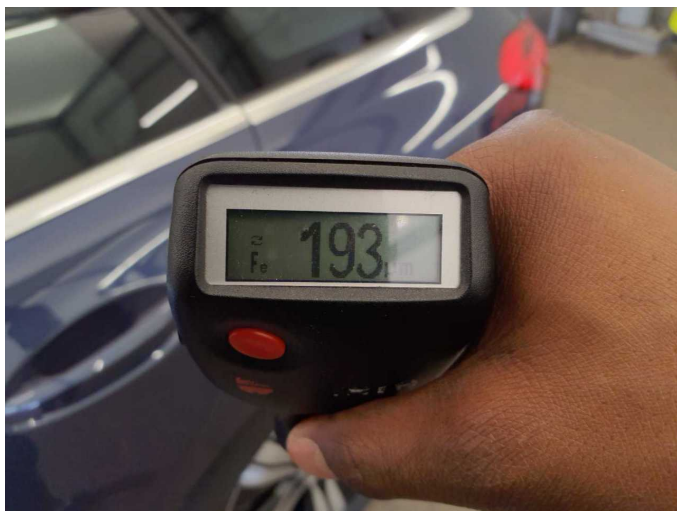
| No. | Repainting |
|---|---|
| 1 | Side panel - rear left side, Professionally carried out, Invoice of repair done Non-existent |

| Side panel - rear left side | 193 µm | Side panel - rear right side | 296 µm |

**Repainting 1:** Side panel - rear left side

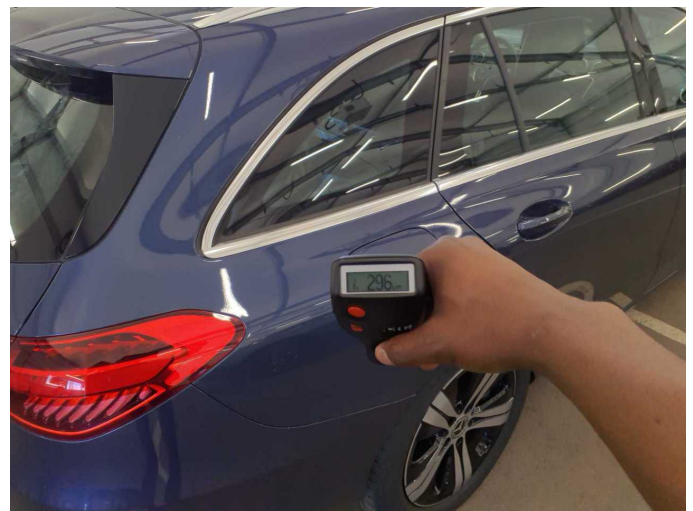
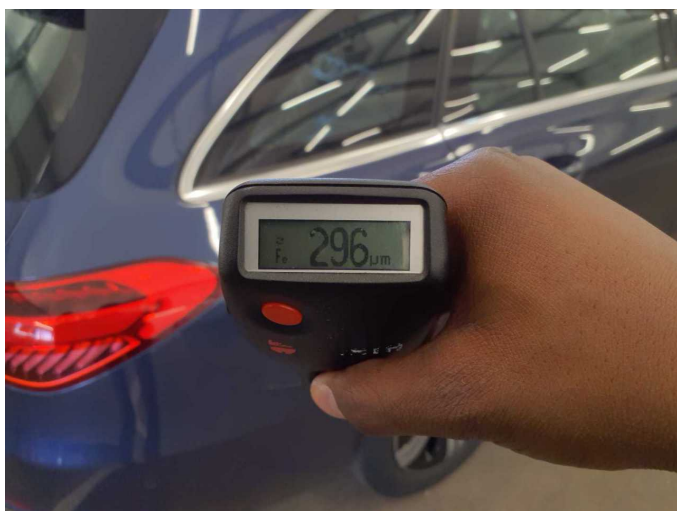
| No. | Repainting |
|---|---|
| 2 | Side panel - rear right side, Professionally carried out, Invoice of repair done Non-existent |

**Repainting 2:** Side panel - rear right side

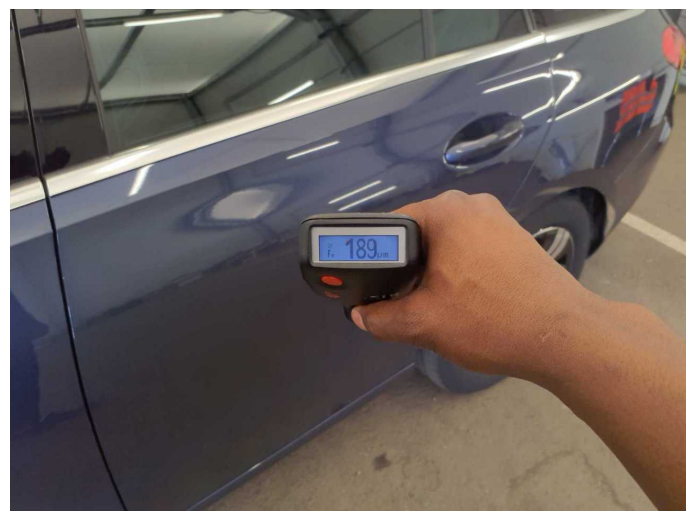
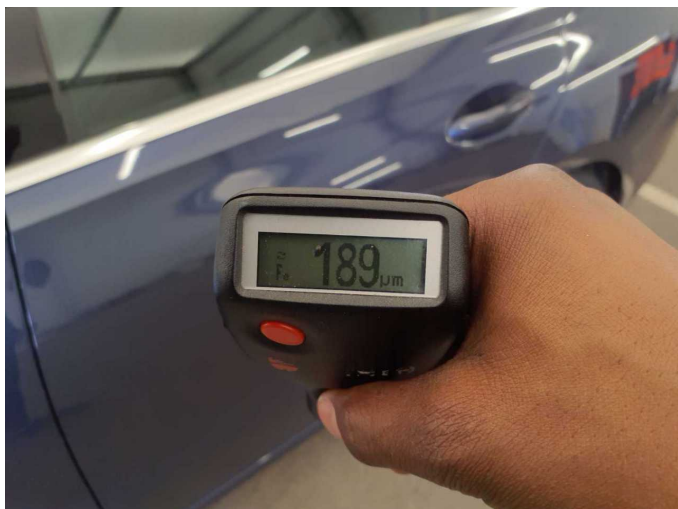
| No. | Repainting |
|---|---|
| 3 | Door - rear left side, Unprofessionally carried out, Invoice of repair done Non-existent |

| Door - rear left side | 189 µm | | |

**Repainting 3:** Door - rear left side
