Expertise

Protocol number: 45968209
Order No. / Reference: 26390300
Inspection date: 16 Jun 2026

Model: C 300 e T 9G-TRONIC AMG Line

VIN: W1KAH5EB7PF120492

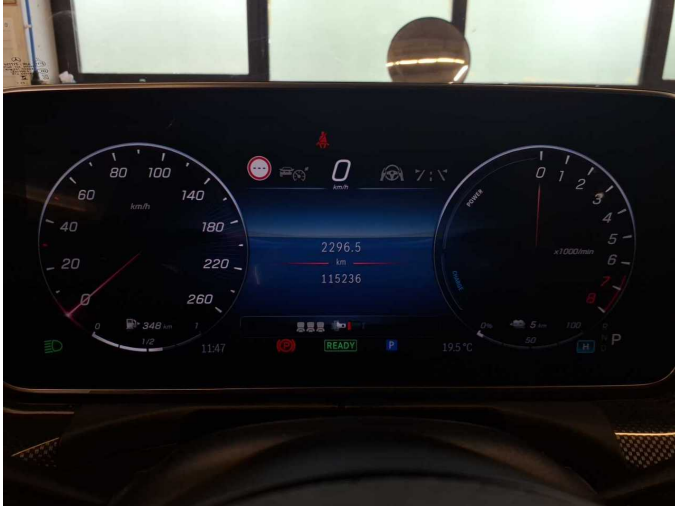
Mileage (Read) 115,236 km

Figure 7: Instrument cluster

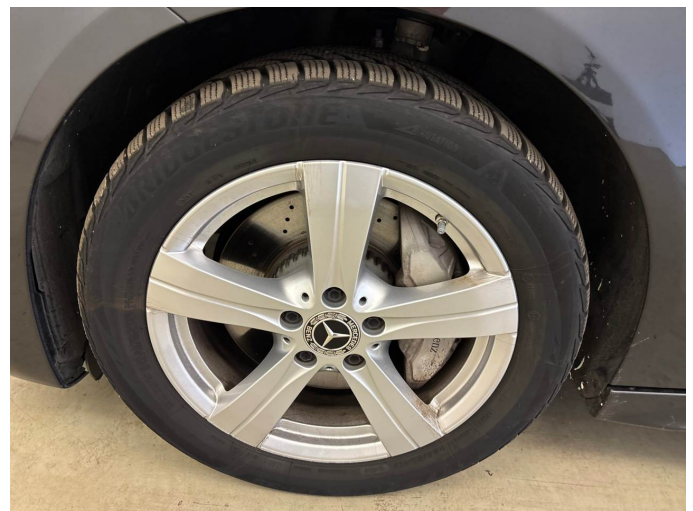
| # | Tyre size | Type of tyre | Manufacturer | Tread depth |
|---|---|---|---|---|
| 1) | 225/50 R17 94H | Winter tyres on Light alloy | Bridgestone | 5mm / 5mm |
| 2) | 245/45 R17 99H | Winter tyres on Light alloy | Michelin | 5mm / 5mm |

Figure 12: Mounted tyres

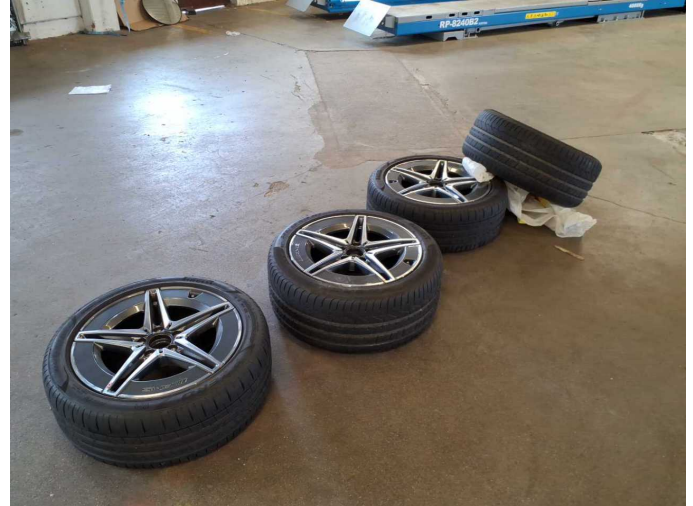
| # | Tyre size | Type of tyre | Manufacturer | Tread depth |
|---|---|---|---|---|
| 1) | 225/45 R18 95Y | Summer tyres on Light alloy | Pirelli | 5mm / 5mm |
| 2) | 255/40 R18 99Y | Summer tyres on Light alloy | Pirelli | 5mm / 5mm |

Figure 14: Additional tyres

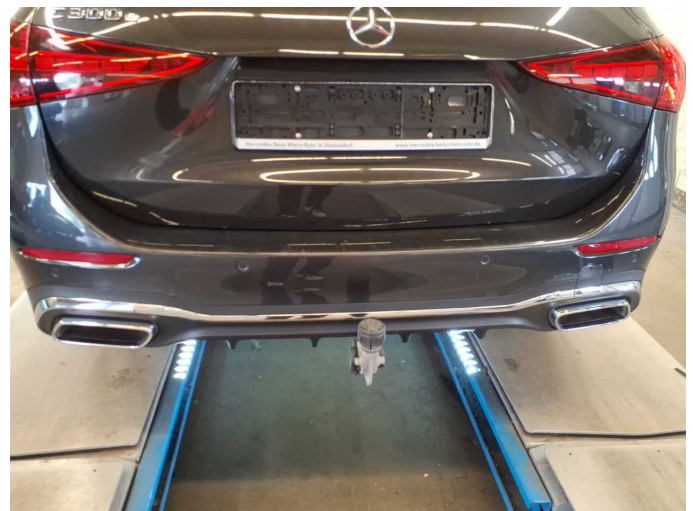
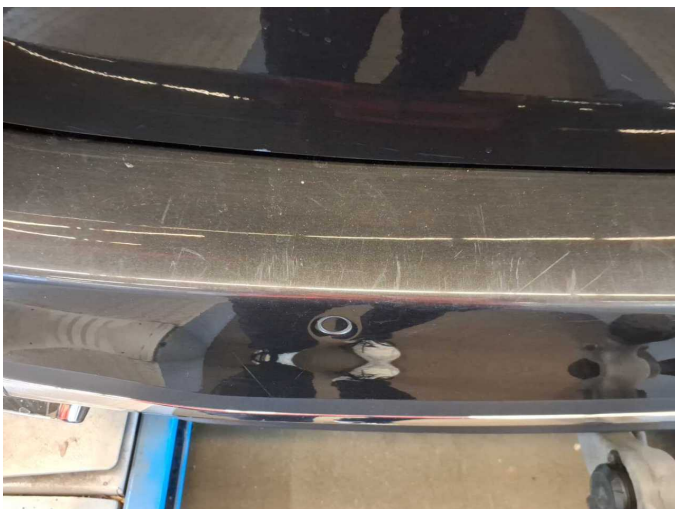
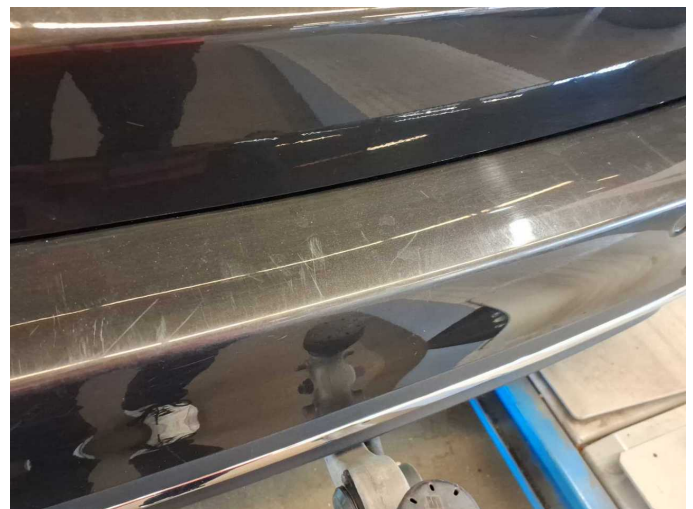
| No. | Component group | Description |
|---|---|---|
| 1 | Rear bumper | Rear bumper - Scratch(es) - Smart repair |

Damage 1: Rear bumper: Rear bumper - Scratch(es) - Smart repair

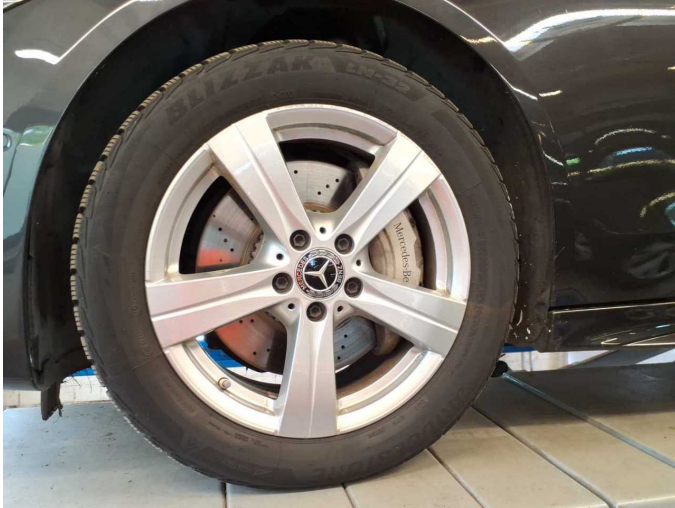
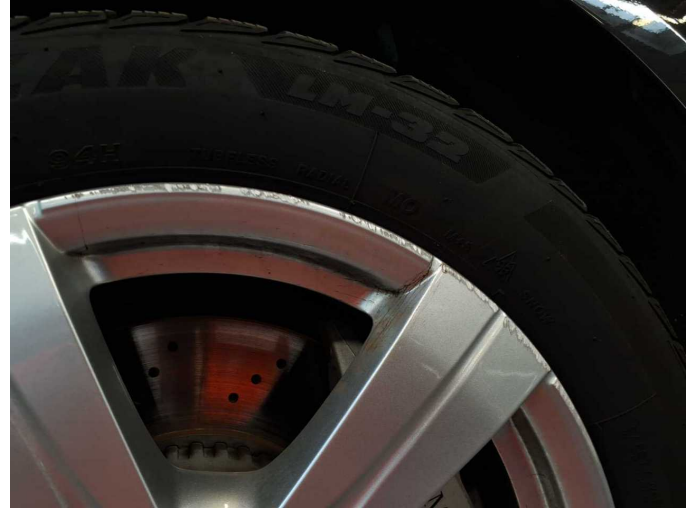
| No. | Component group | Description |
|---|---|---|
| 2 | Wheel / tyres | Alloy rim - front left side - Scratch(es) - Loss in value |

Damage 2: Wheel / tyres: Alloy rim - front left side - Scratch(es) - Loss in value

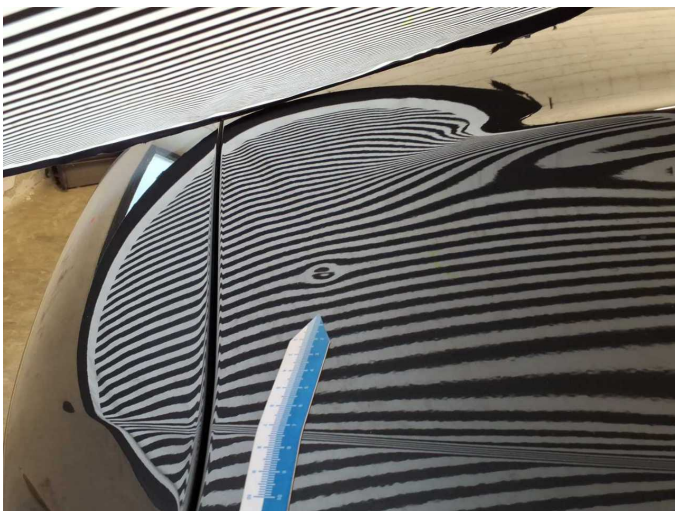
| No. | Component group | Description |
|---|---|---|
| 3 | Bonnet | Bonnet - Dent / paintcoat damage - Repair and paint |

Damage 3: Bonnet: Bonnet - Dent / paintcoat damage - Repair and paint

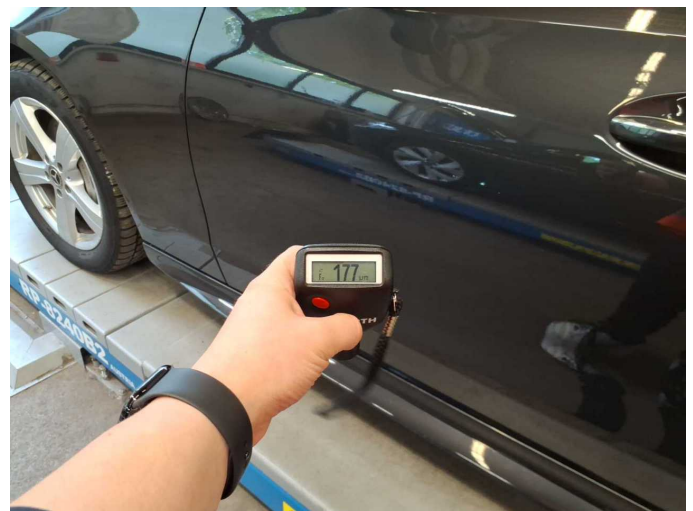
1 Mudguard - left side, Door - front left side, Professionally carried out, Invoice of repair done Non-existent

Mudguard - left side 155 µm | Door - front left side 177 µm

Repainting 1: Mudguard - left side, Door - front left side
