Expertise

Protocol number: 46411854  
Order No. / Reference: 26644656  
Inspection date: 9 Jul 2026

Manufacturer: Opel

Model: Grandland 1.5 D Automatik Elegance

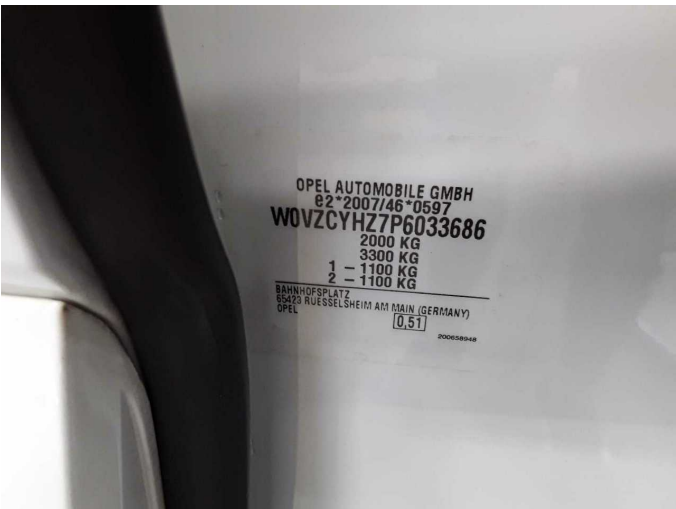
Figure 11: VIN

| VIN comparison | The vehicle identification number (VIN) was read from the vehicle and its conformity with the submitted documents was confirmed by the undersigned during the inspection. |

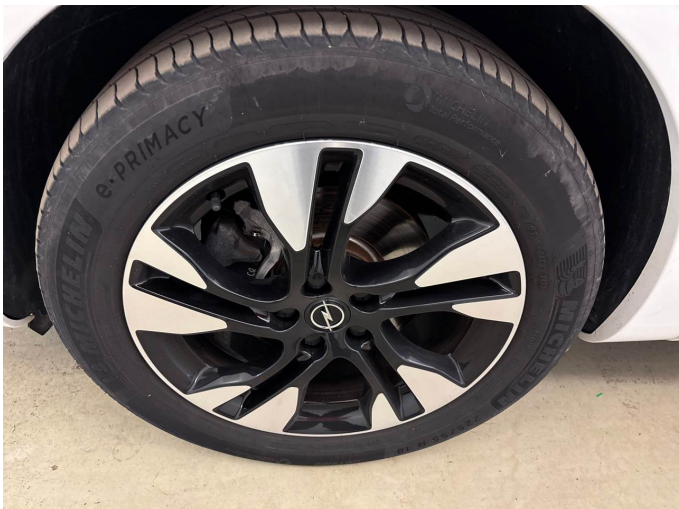
Figure 12: Mounted tyres

| # | Tyre size | Type of tyre | Manufacturer | Tread depth |
|---|---|---|---|---|
| 1) | 225/55 R18 102V | Summer tyres on Light alloy | Michelin | 4mm / 4mm |
| 2) | 225/55 R18 102V | Summer tyres on Light alloy | Michelin | 4mm / 4mm |

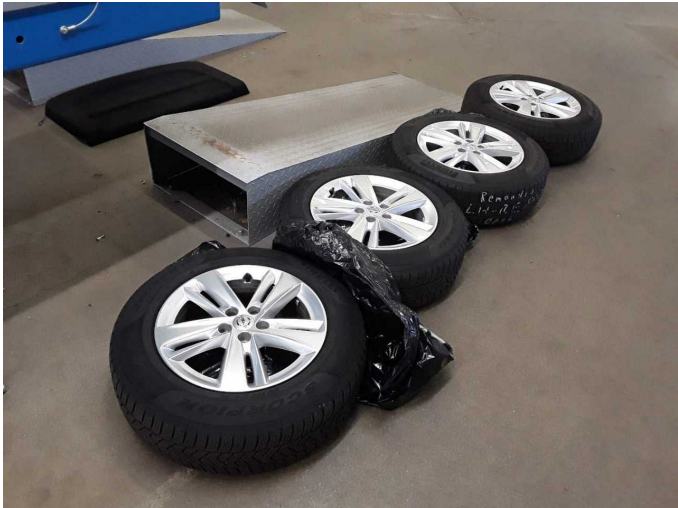
Figure 16: Additional tyres

| # | Tyre size | Type of tyre | Manufacturer | Tread depth |
|---|---|---|---|---|
| 1) | 215/65 R17 103H | Winter tyres on Light alloy | Pirelli | 5mm / 5mm |
| 2) | 215/65 R17 103H | Winter tyres on Light alloy | Pirelli | 4mm / 4mm |

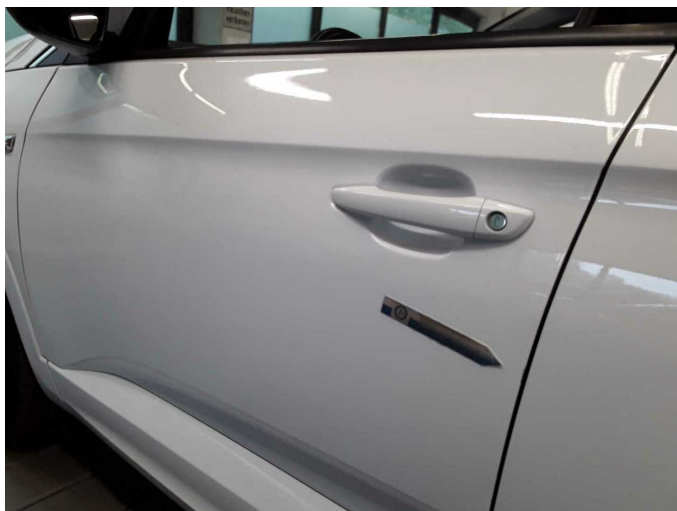
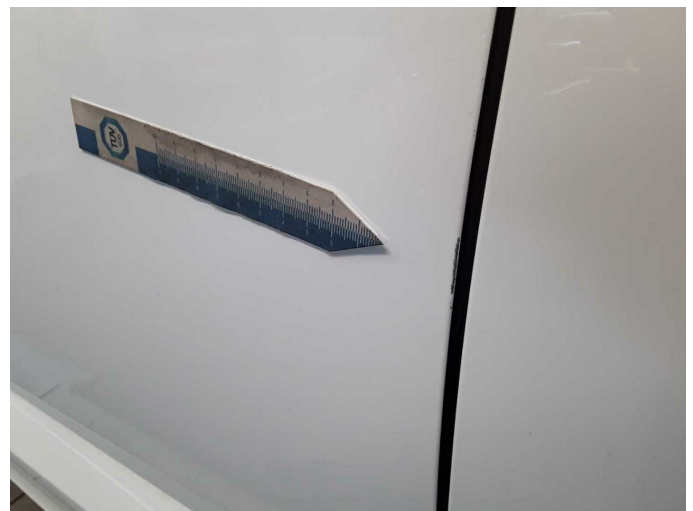
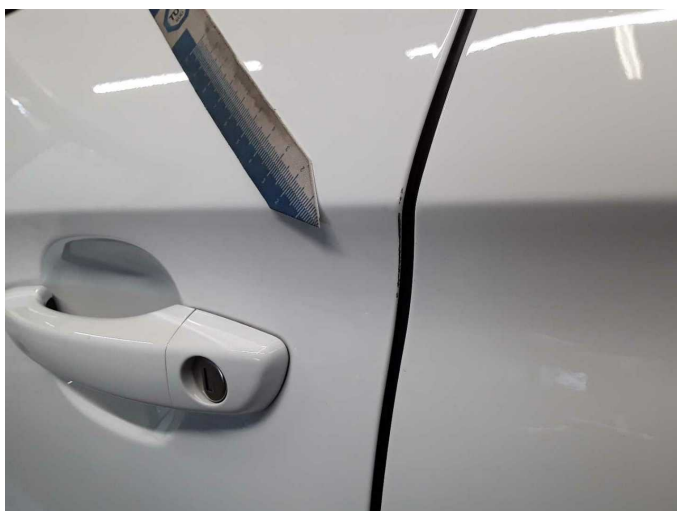
| No. | Component group | Description |
|---|---|---|
| 1 | Door - front left side | Door - Scratch(es) - Smart repair |

Damage 1: Door - front left side: Door - Scratch(es) - Smart repair

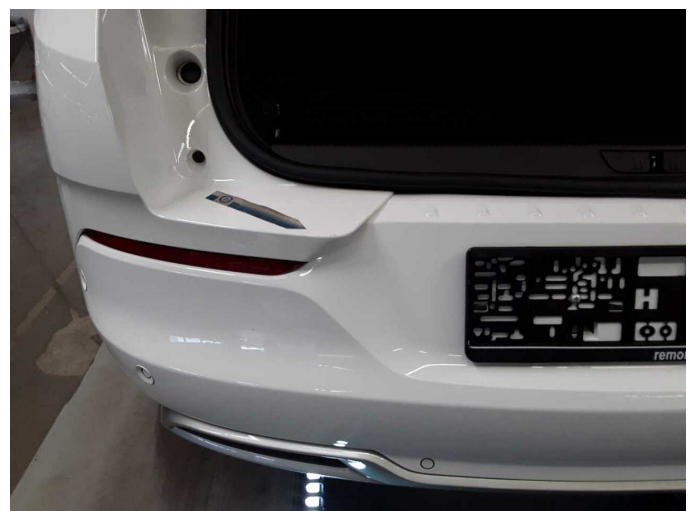
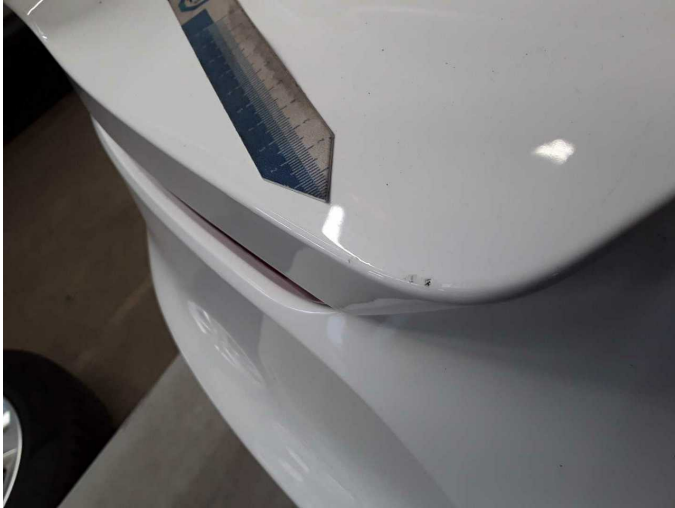
| No. | Component group | Description |
|---|---|---|
| 2 | Rear bumper | Rear bumper - Scratch(es) - Smart repair |

Damage 2: Rear bumper: Rear bumper - Scratch(es) - Smart repair

**Damage 2:** Rear bumper: Rear bumper - Scratch(es) - Smart repair

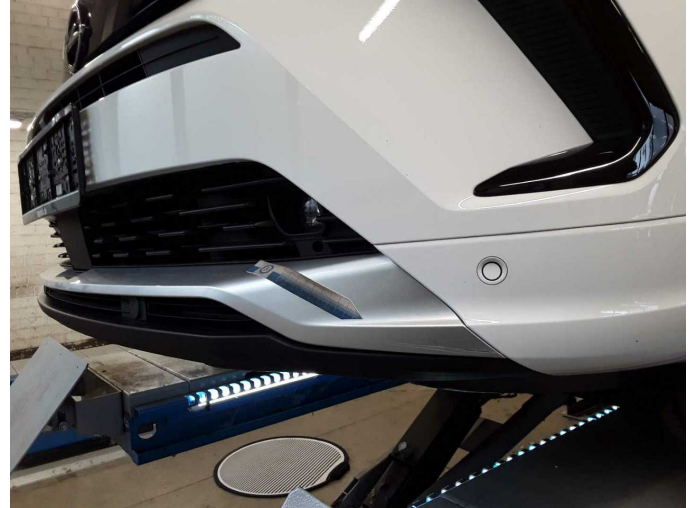
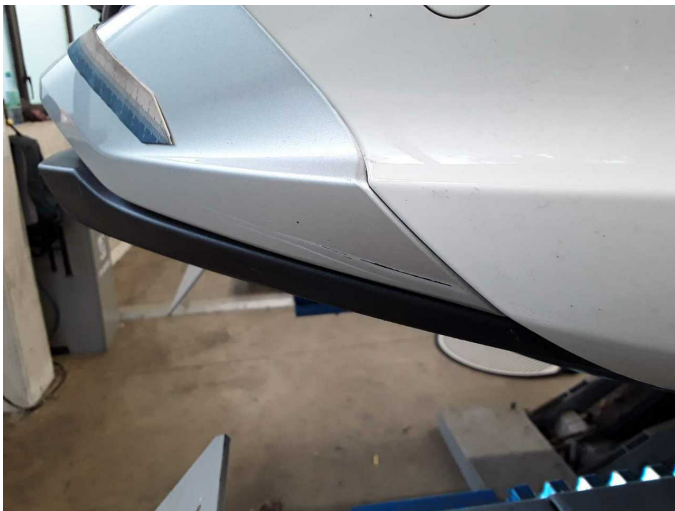
| No. | Component group | Description |
|---|---|---|
| 5 | Front bumper | Spoiler - Scratch(es) - No deduction |

**Wear and tear 5:** Front bumper: Spoiler - Scratch(es) - No deduction
