Expertise

Protocol number: 46622807  
Order No. / Reference: 26712484  
Inspection date: 20 Jul 2026

Model: Tiguan 2.0 TDI SCR DSG Life

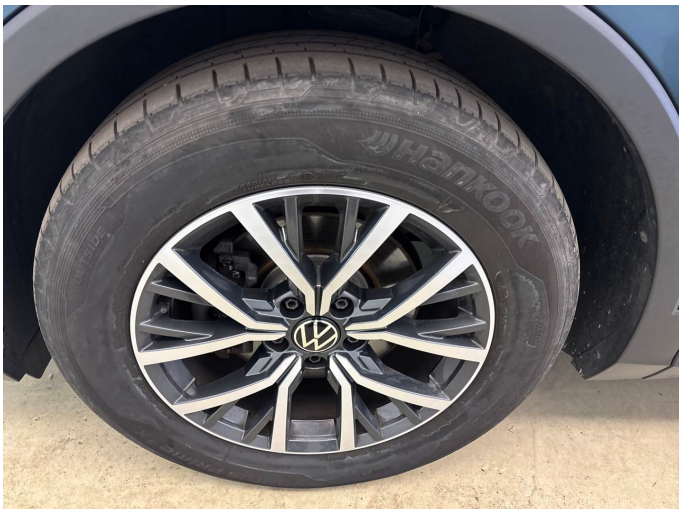
Figure 12: Mounted tyres

| # | Tyre size | Type of tyre | Manufacturer | Tread depth |
|---|---|---|---|---|
| 1) | 215/65 R17 99V | Summer tyres on Light alloy | Hankook | 4mm / 4mm |
| 2) | 215/65 R17 99V | Summer tyres on Light alloy | Hankook | 5mm / 5mm |

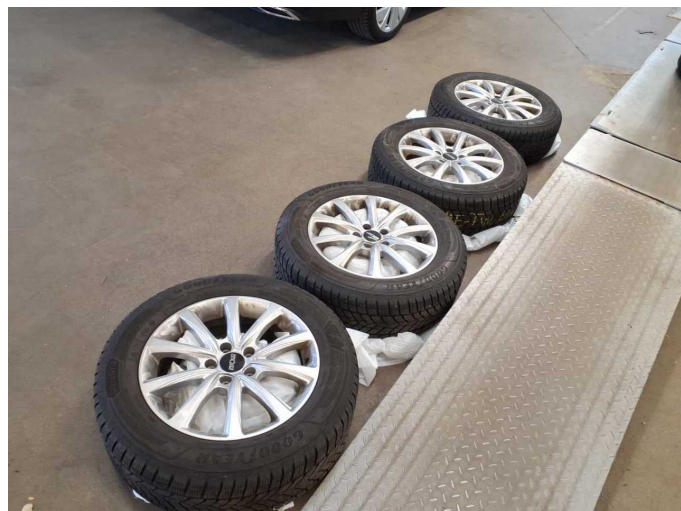
Figure 17: Additional tyres

| # | Tyre size | Type of tyre | Manufacturer | Tread depth |
|---|---|---|---|---|
| 1) | 215/65 R17 99V | Winter tyres on Light alloy | Goodyear | 5mm / 5mm |
| 2) | 215/65 R17 99V | Winter tyres on Light alloy | Goodyear | 6mm / 6mm |

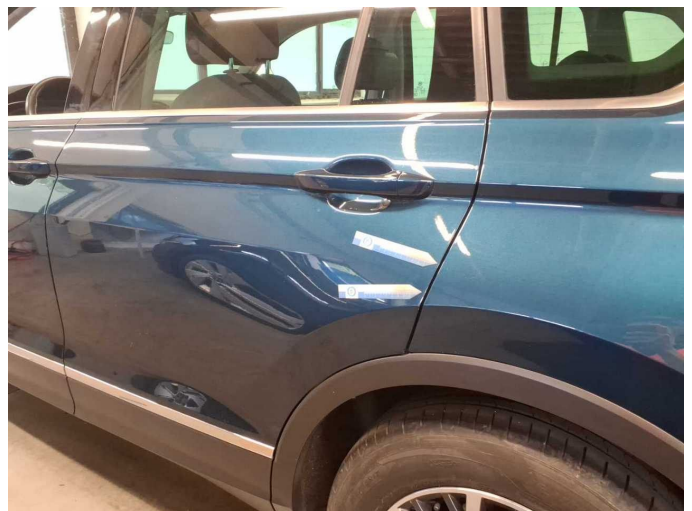
| No. | Component group | Description |
|---|---|---|
| 3 | Door - rear left side | Door edge - Scratch(es) - Smart repair |

Damage 3: Door - rear left side: Door edge - Scratch(es) - Smart repair

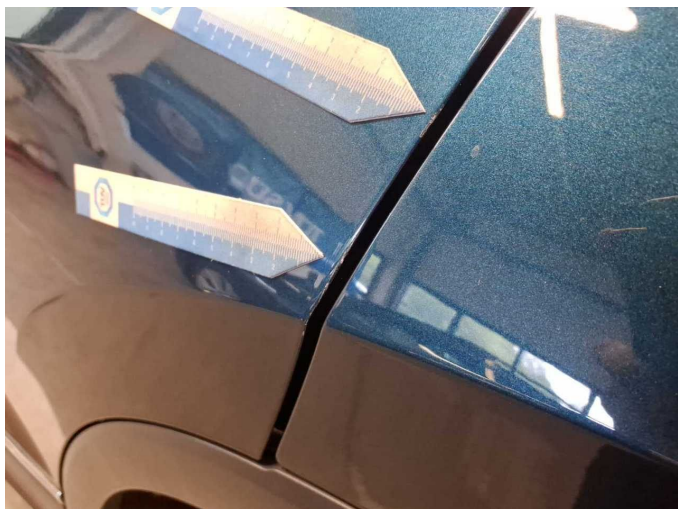
**Damage 3:** Door - rear left side: Door edge - Scratch(es) - Smart repair

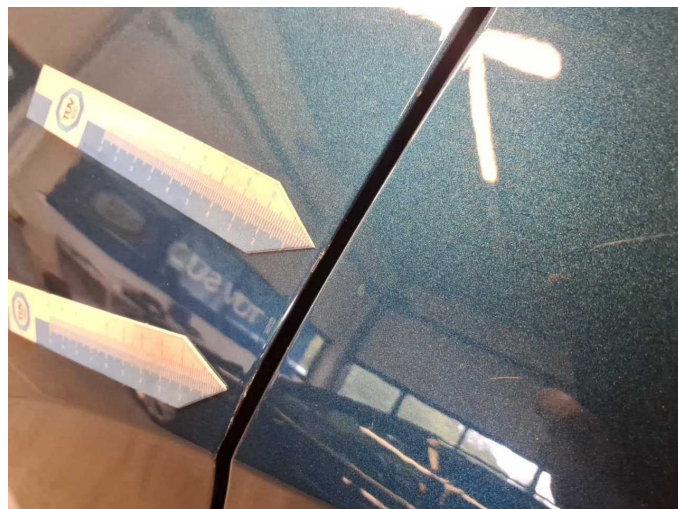
**Damage 3:** Door - rear left side: Door edge - Scratch(es) - Smart repair

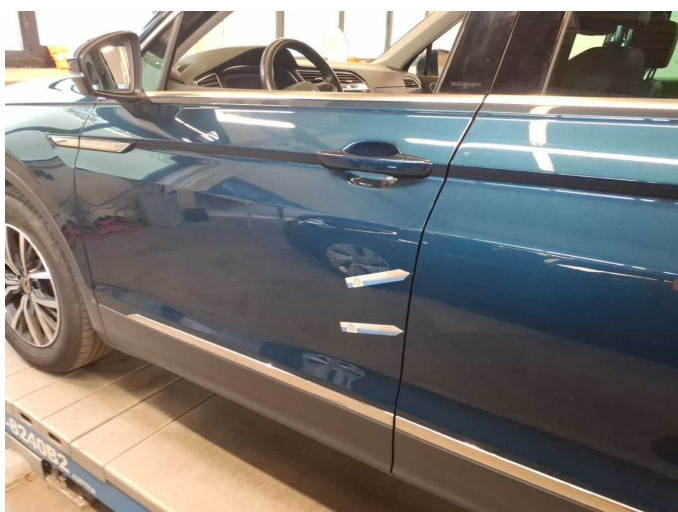
| No. | Component group | Description |
|---|---|---|
| 4 | Door - front left side | Door edge - Scratch(es) - Smart repair |

**Damage 4:** Door - front left side: Door edge - Scratch(es) - Smart repair

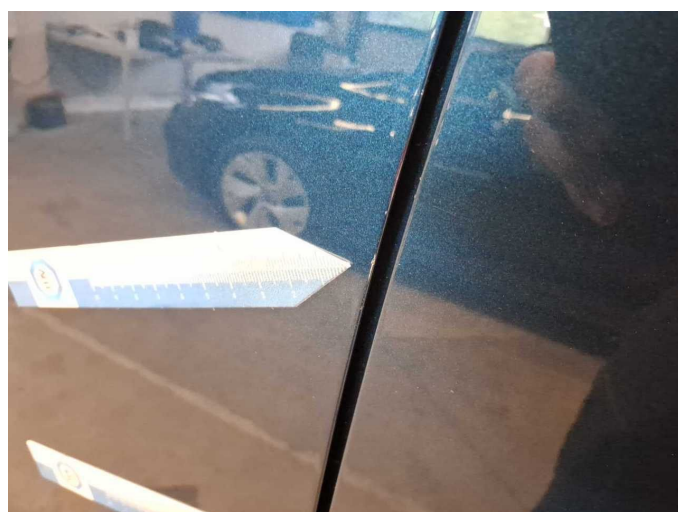
**Damage 4:** Door - front left side: Door edge - Scratch(es) - Smart repair

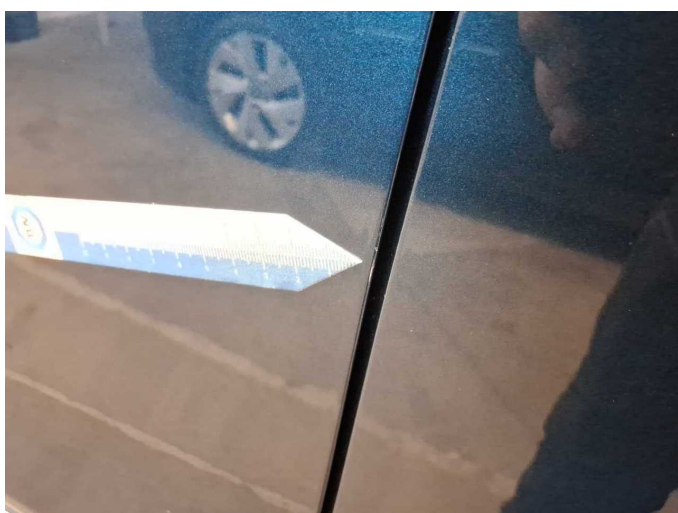
**Damage 4:** Door - front left side: Door edge - Scratch(es) - Smart repair

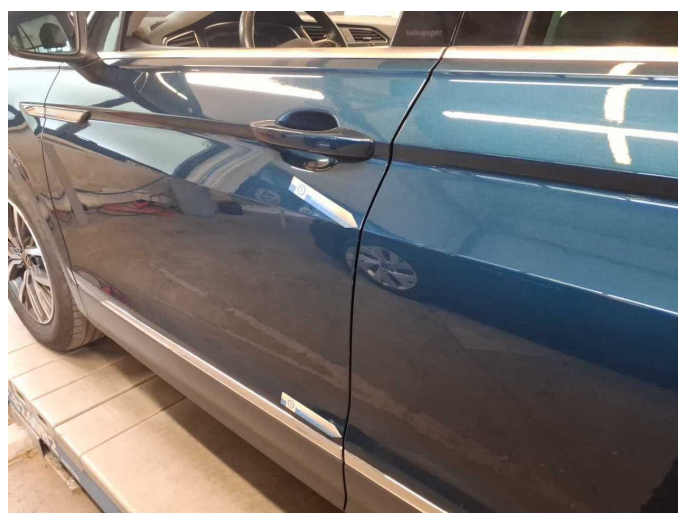
**Damage 4:** Door - front left side: Door edge - Scratch(es) - Smart repair

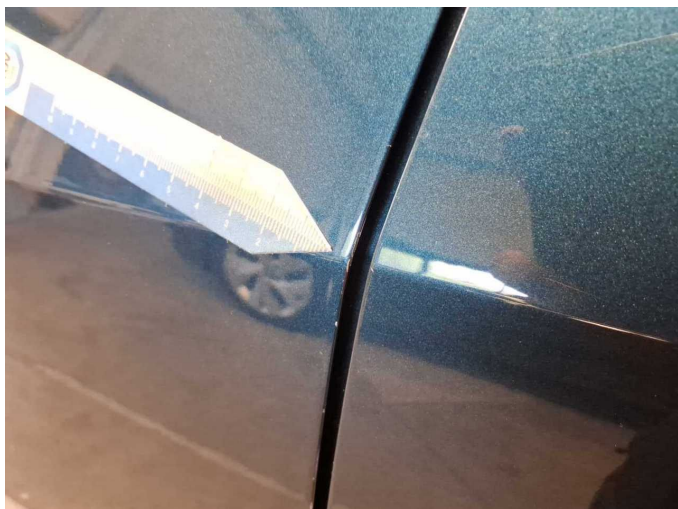
**Damage 4:** Door - front left side: Door edge - Scratch(es) - Smart repair

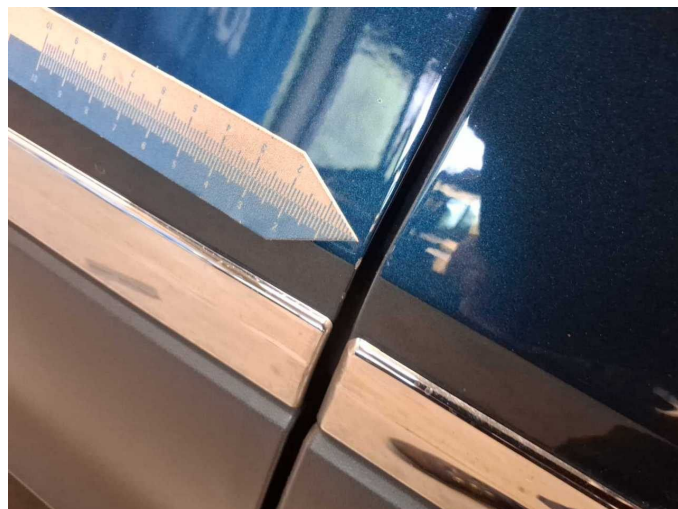
**Damage 4:** Door - front left side: Door edge - Scratch(es) - Smart repair

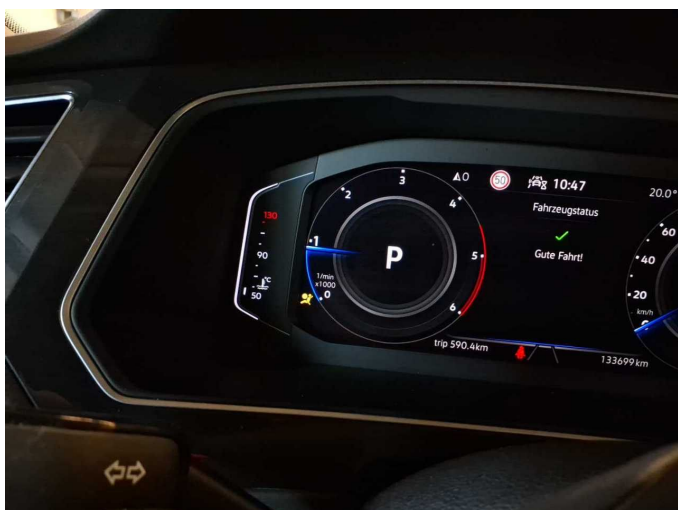
| No. | Component group | Description |
|---|---|---|
| 5 | Airbag systems | Airbag system - Electrical fault - Perform diagnosis |

**Damage 5:** Airbag systems: Airbag system - Electrical fault - Perform diagnosis

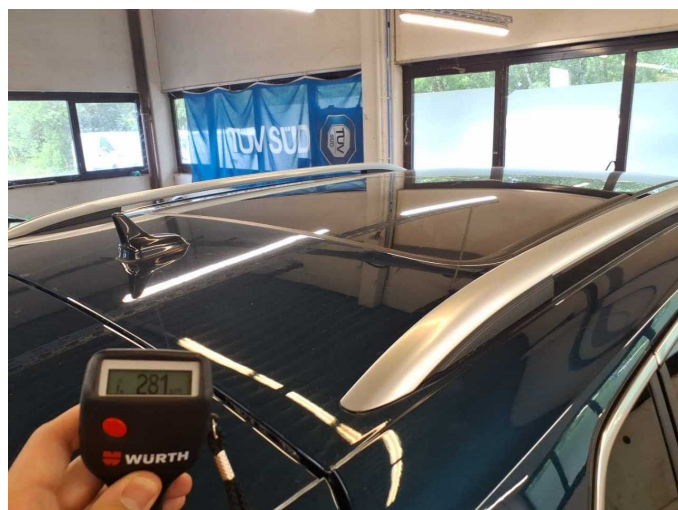
| No. | Repainting |
|---|---|
| 1 | Roof, Professionally carried out, Invoice of repair done |

| Roof | 281 µm | Roof rail - right side | 232 µm |

**Repainting 1:** Roof

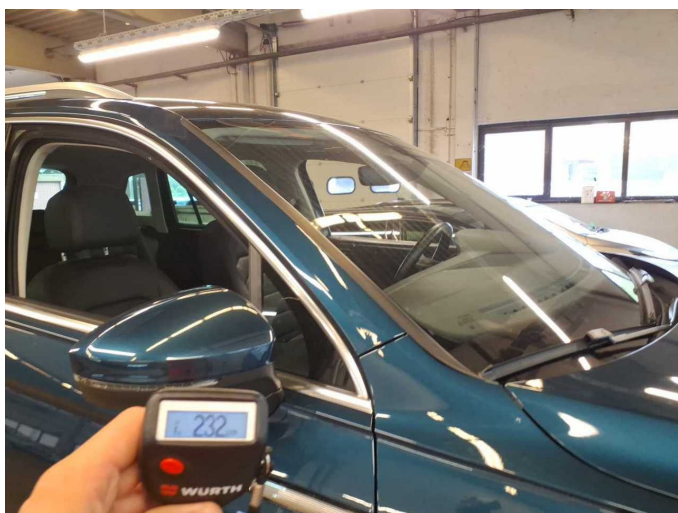
| No. | Repainting |
|---|---|
| 2 | Roof rail - right side, Professionally carried out, Invoice of repair done |

**Repainting 2:** Roof rail - right side

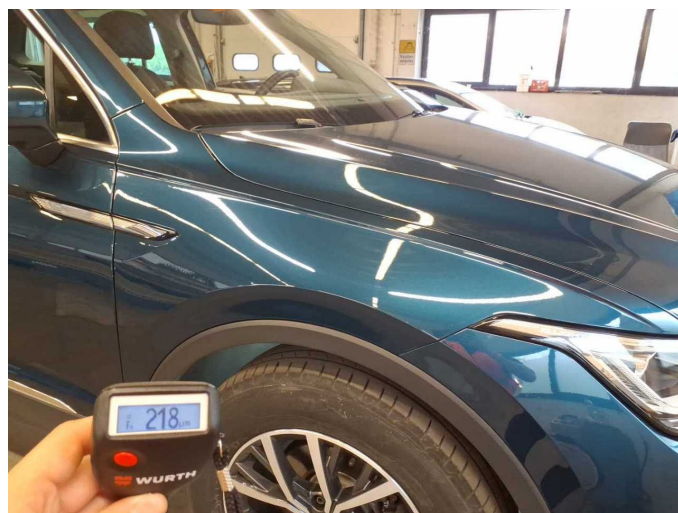
| No. | Repainting |
|---|---|
| 3 | Mudguard - right side, Professionally carried out, Invoice of repair done |

**Repainting 3:** Mudguard - right side

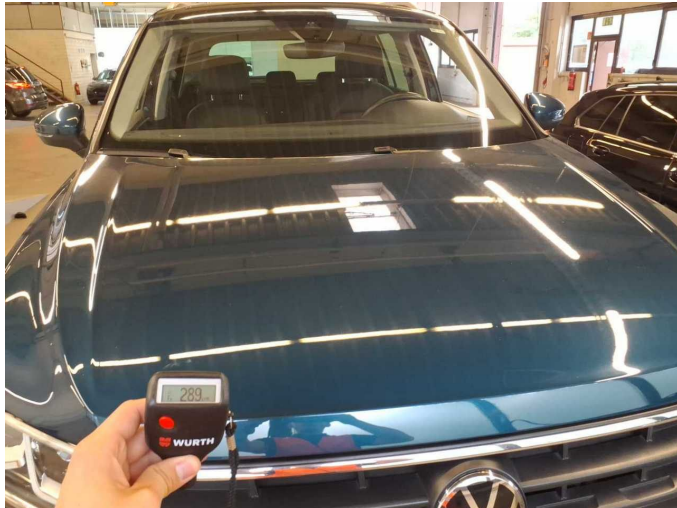
| No. | Repainting |
|---|---|
| 4 | Bonnet, Professionally carried out, Invoice of repair done |

**Repainting 4: Bonnet**

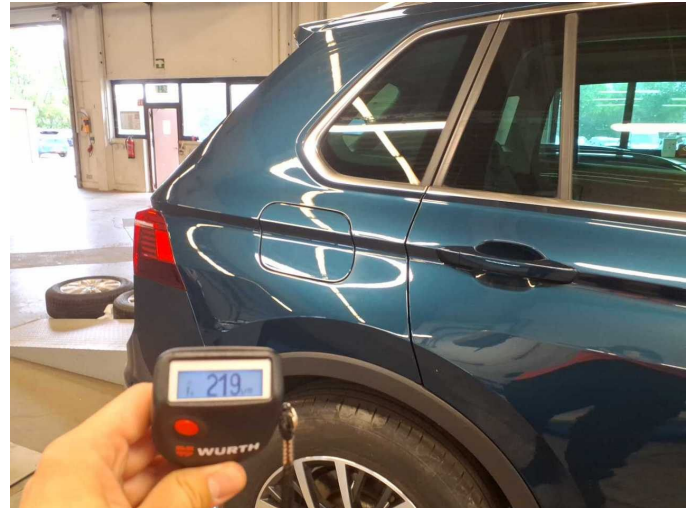
| No. | Repainting |
|---|---|
| 5 | Side panel - rear right side, Professionally carried out, Invoice of repair done |

**Repainting 5: Side panel - rear right side**

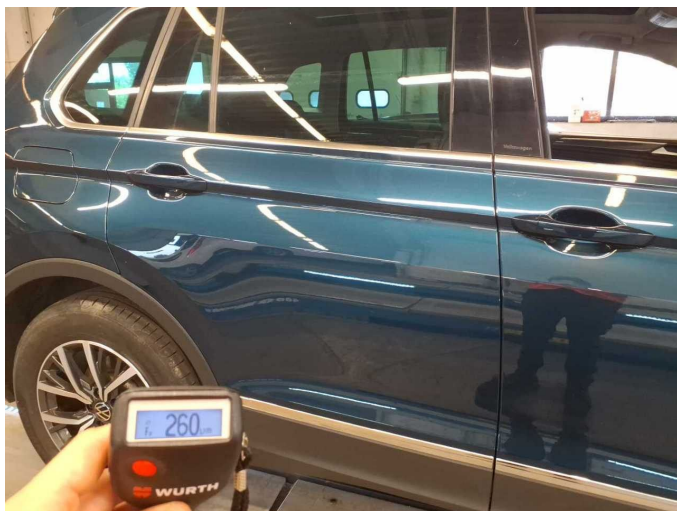
| No. | Repainting |
|---|---|
| 6 | Door - rear right side, Professionally carried out, Invoice of repair done |

**Repainting 6: Door - rear right side**

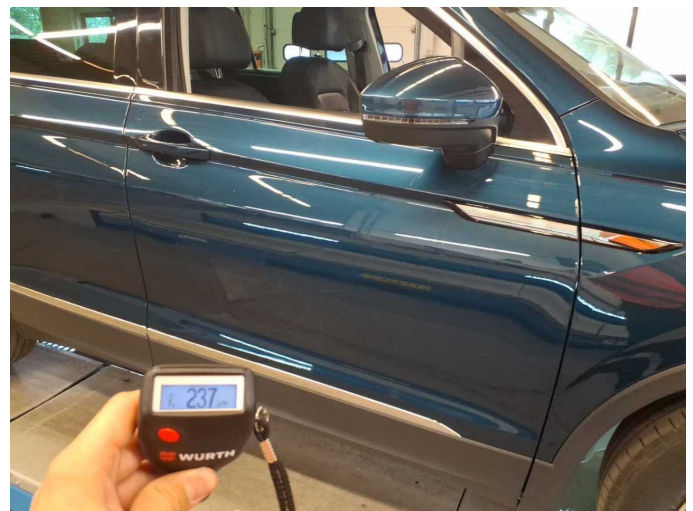
| No. | Repainting |
|---|---|
| 7 | Door - front right side, Professionally carried out, Invoice of repair done |

**Repainting 7: Door - front right side**
