Expertise

Protocol number: 45506394
Order No. / Reference: 26114770
Inspection date: 18 May 2026

Manufacturer: Volvo

Model: XC60 B4 D AWD Plus Dark

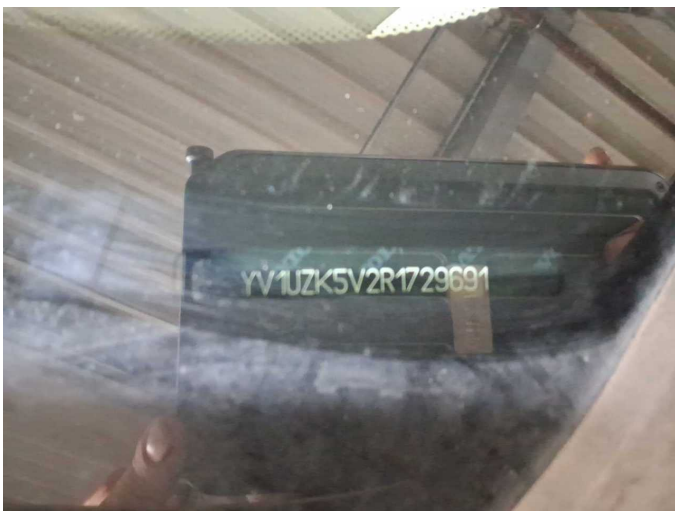
Figure 11: VIN

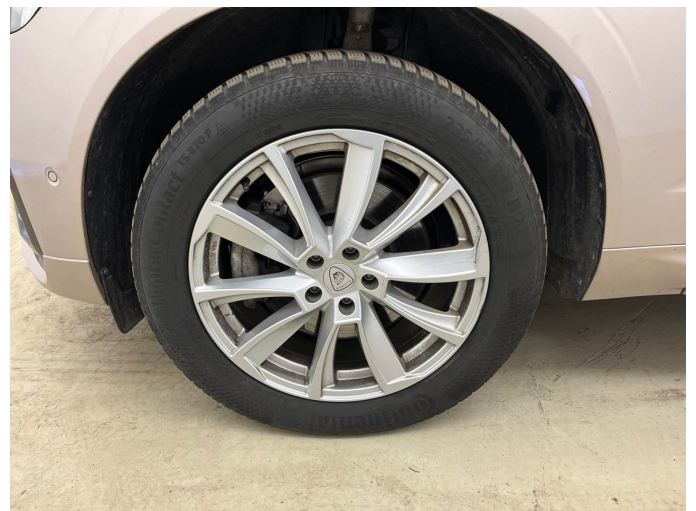
Figure 12: Mounted tyres

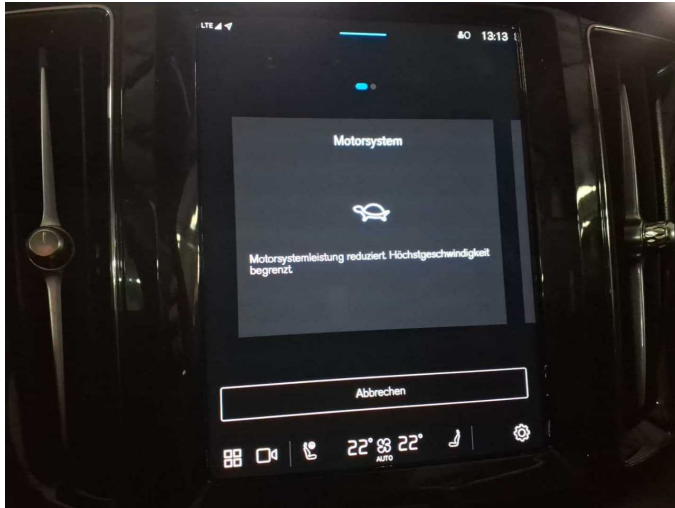
Damage 1: Engine: Engine - Functional / admissibility - Perform diagnosis

| No. | Component group | Description |
|---|---|--|
| 1 | Engine | Engine - Functional / admissibility - Perform diagnosis |

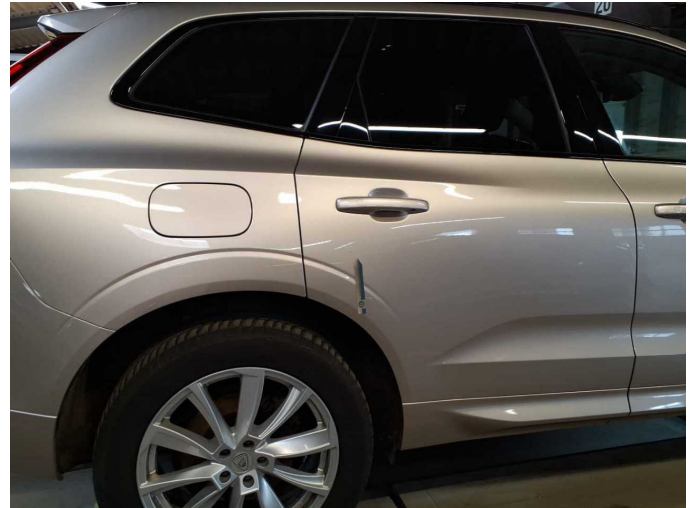
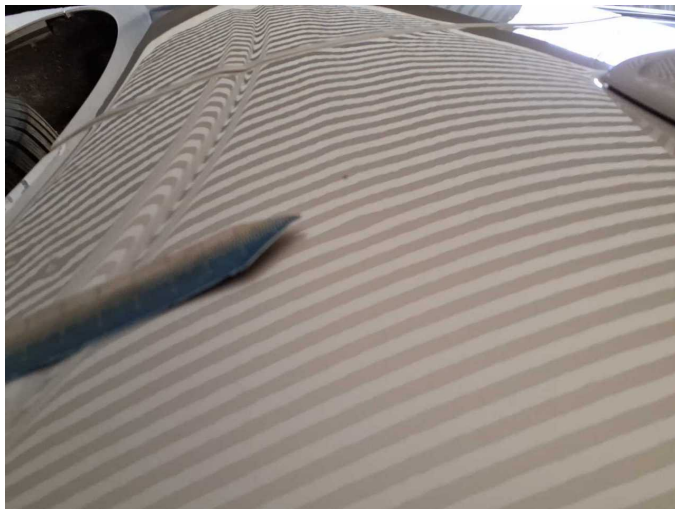
Damage 2: Door - rear right side: Door - dent(s) - Smooth repair work

| No. | Component group | Description |
|---|---|--|
| 2 | Door - rear right side | Door - dent(s) - Smooth repair work |

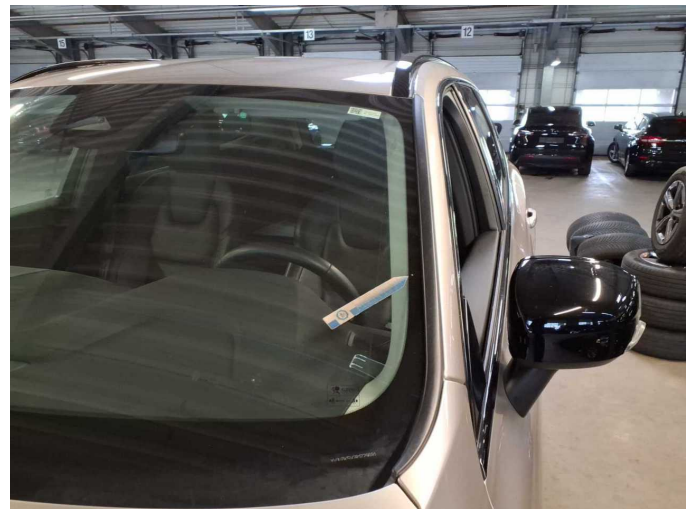
Damage 3: Vehicle glazing: Windscreen - Stone chips - repair according to calculation

| No. | Component group | Description |
|---|---|--|
| 3 | Vehicle glazing | Windscreen - Stone chips - repair according to calculation |
