## Expertise

Protocol number: 45128926  
Order No. / Reference: 26114282  
Inspection date: 23 Apr 2026

Model: Focus Turnier 1.5 EcoBlue Start-Stopp-System Aut.  
COOL&CONNECT

VIN: WF0PXXGCHPNB00403

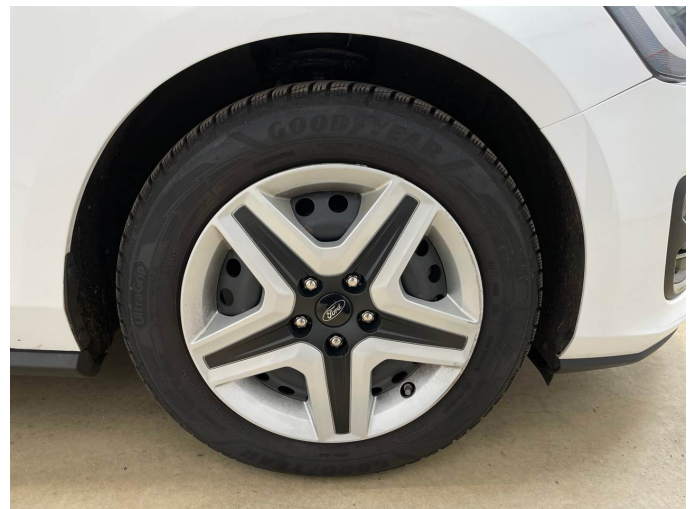
Figure 12: Mounted tyres

#	Tyre size	Type of tyre	Manufacturer	Tread depth
1)	205/60 R16 96H	Winter tyres on Steel rim with wheel cover	Goodyear	7mm / 7mm
2)	205/60 R16 96H	Winter tyres on Steel rim with wheel cover	Goodyear	8mm / 8mm

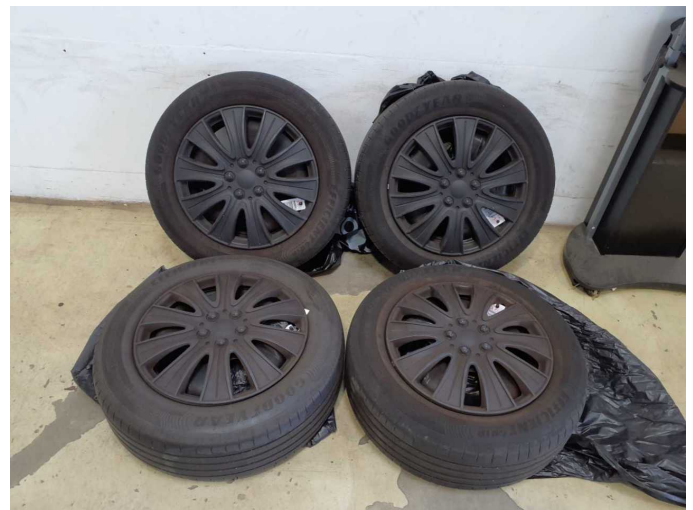
Figure 16: Additional tyres

#	Tyre size	Type of tyre	Manufacturer	Tread depth
1)	205/60 R16 92V	Summer tyres on Steel rim with wheel cover	Goodyear	4mm / 4mm
2)	205/60 R16 92V	Summer tyres on Steel rim with wheel cover	Goodyear	4mm / 4mm

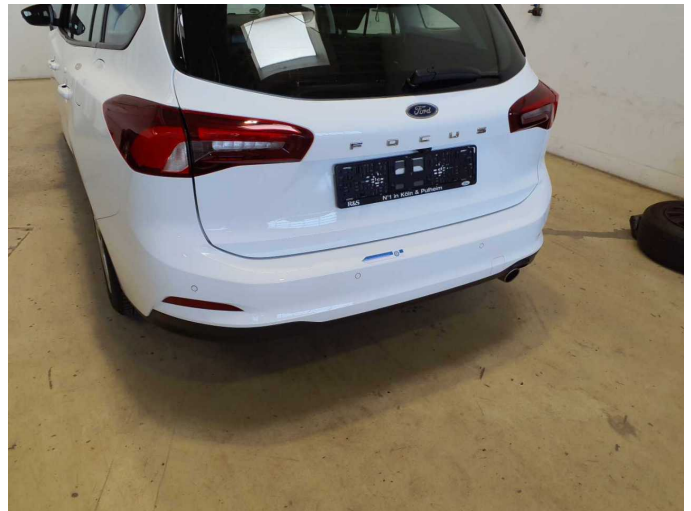
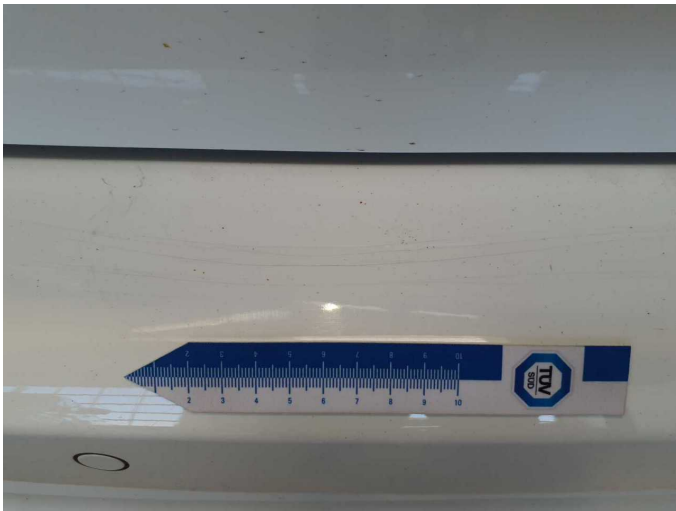
No.	Component group	Description
1	Misc.	Inspection / maintenance (Nachweis 2025 fehlt) - Incomplete - No deduction
2	Rear bumper	Rear bumper (Lack gebrochen) - Paint defect - Repair and paint

Damage 2: Rear bumper: Rear bumper (Lack gebrochen) - Paint defect - Repair and paint

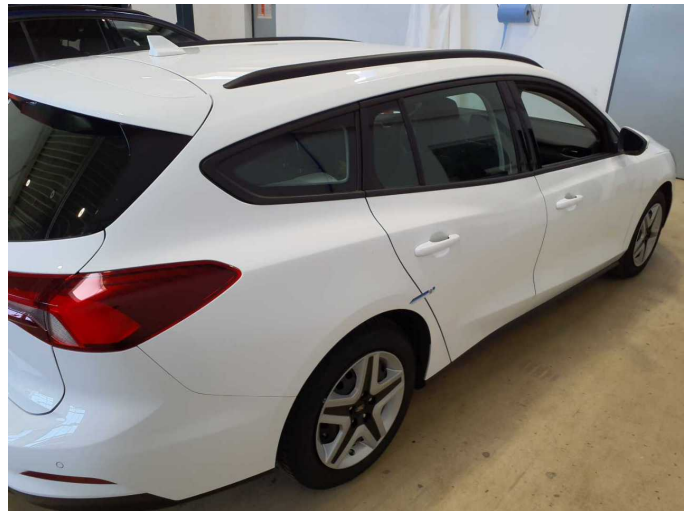
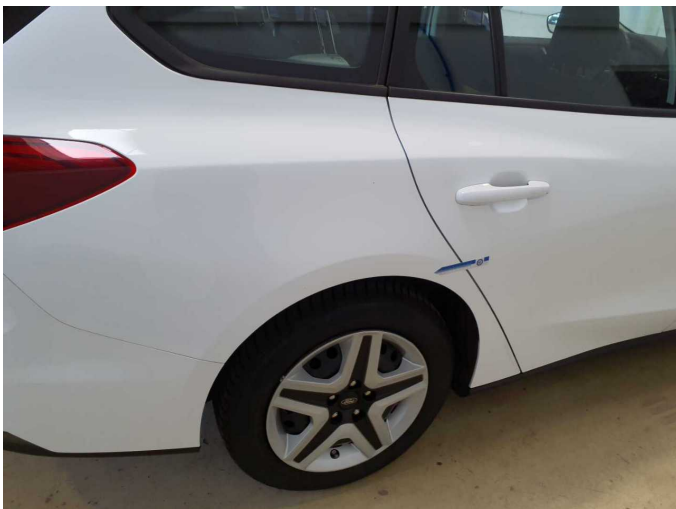
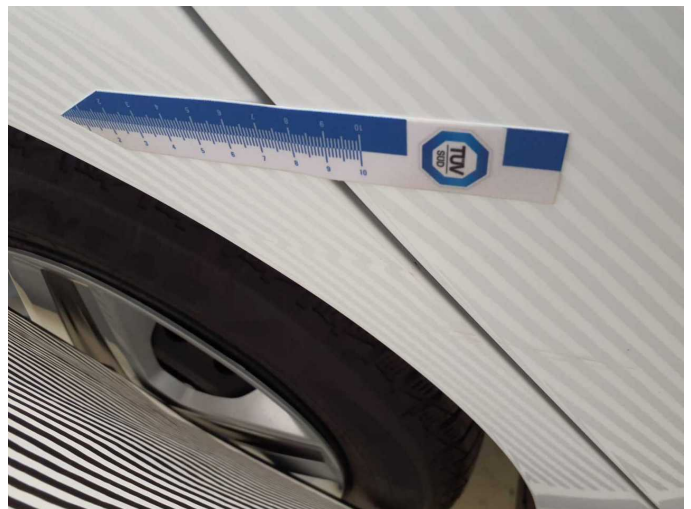
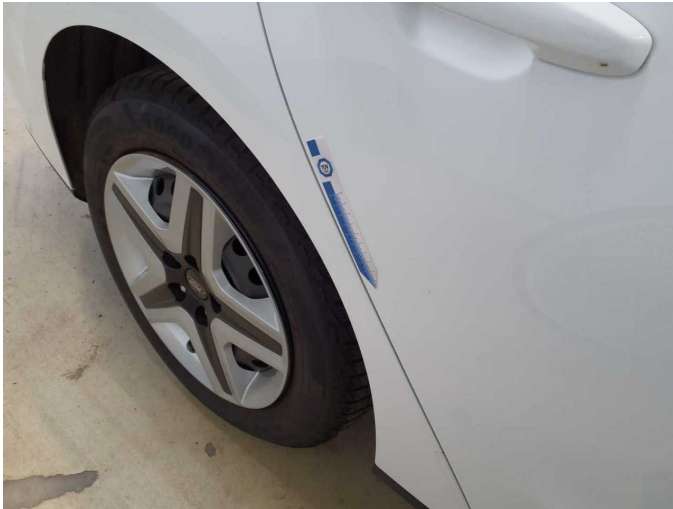
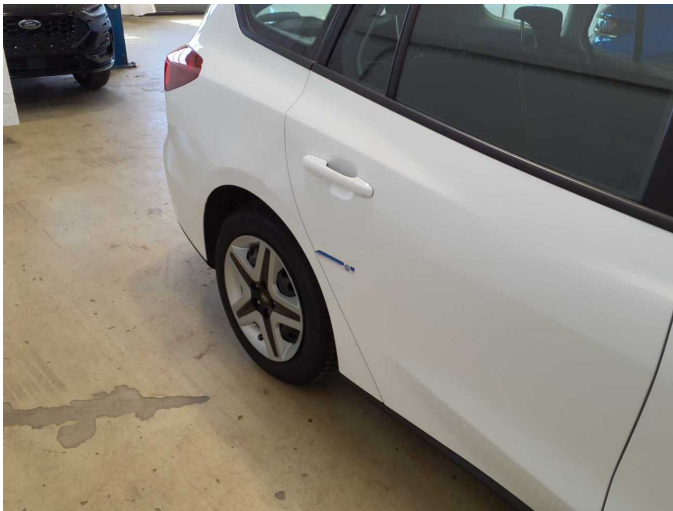
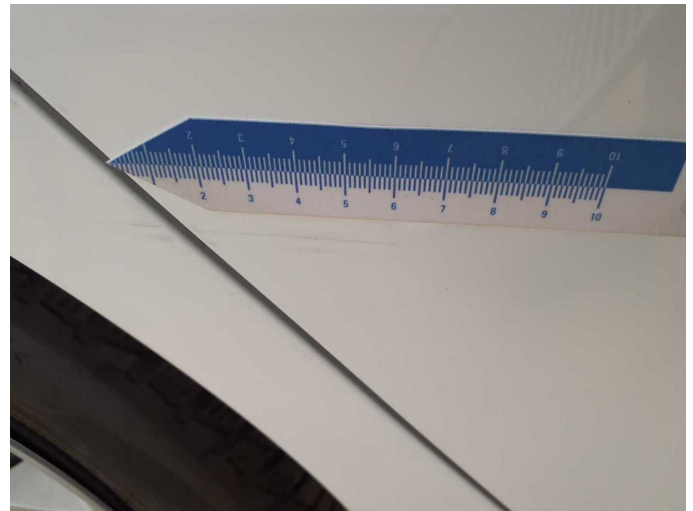
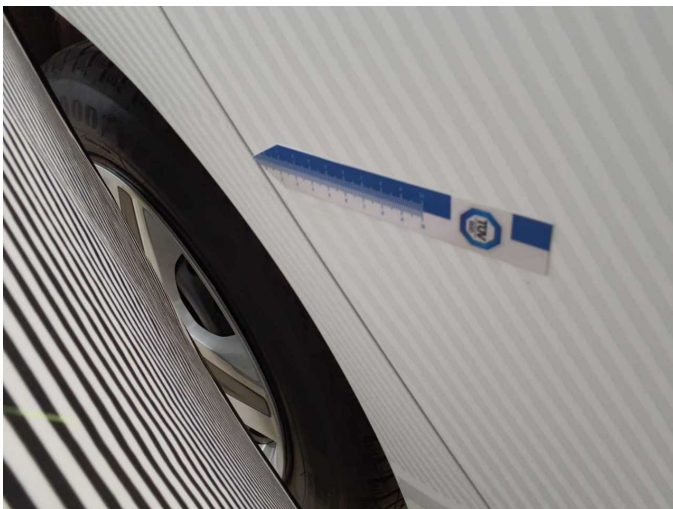
No.	Accident
1	Side right

Accident 1: Side right

**Accident 1:** Side right

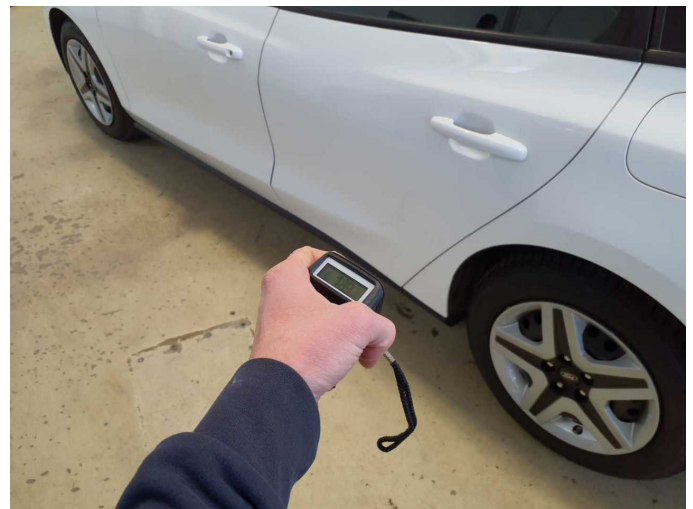
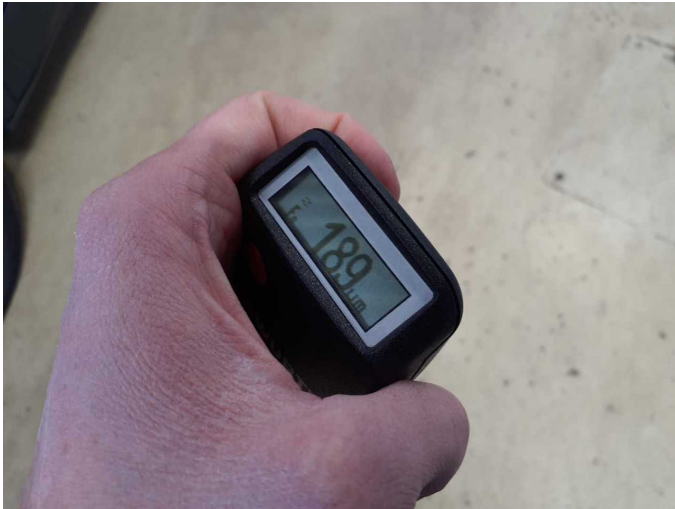
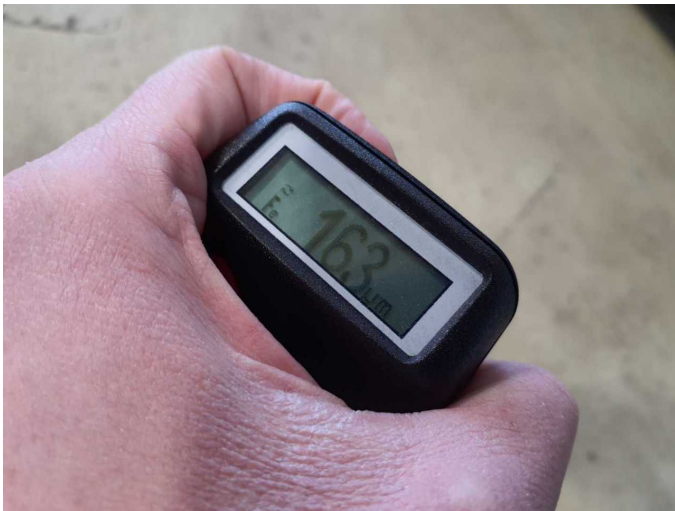
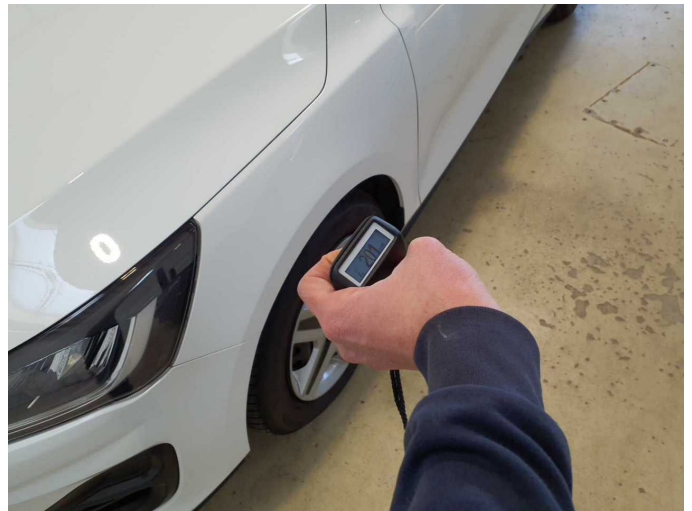
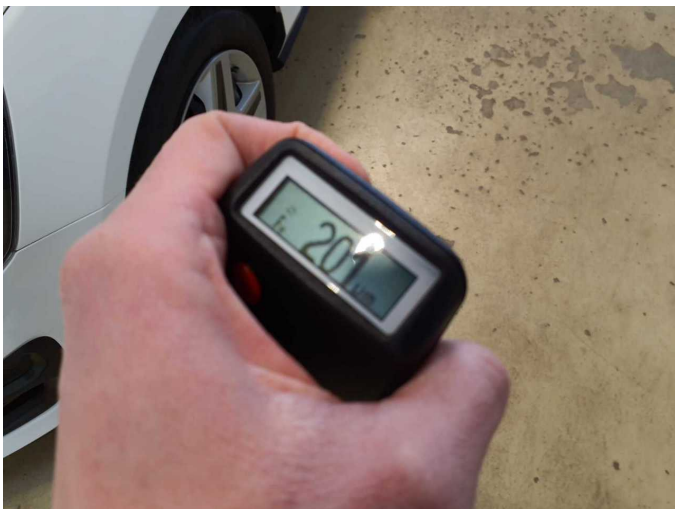
1 Mudguard - left side, Door - rear left side, Door - front left side, Professionally carried out, Invoice of repair done Non-existent

Mudguard - left side	201 µm	Door - rear left side	189 µm
Door - front left side	163 µm

**Repainting 1:** Mudguard - left side, Door - rear left side, Door - front left side
