Expertise

Protocol number: 46203538  
Order No. / Reference: 26509697  
Inspection date: 19 Jun 2026

Manufacturer: Volkswagen

Model: Touareg 3.0 V6 TDI SCR 4Motion Aut. R-Line

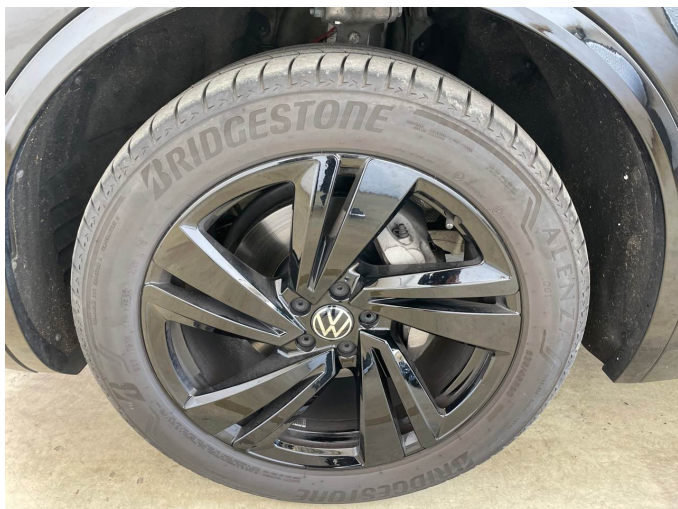
Figure 13: Mounted tyres

| Tyres | | | | |
|---|---|---|---|---|
| 1) | 285/45 R20 108W | Summer tyres on Light alloy | Bridgestone | 5mm / 5mm |
| 2) | 285/45 R20 108W | Summer tyres on Light alloy | Bridgestone | 6mm / 6mm |

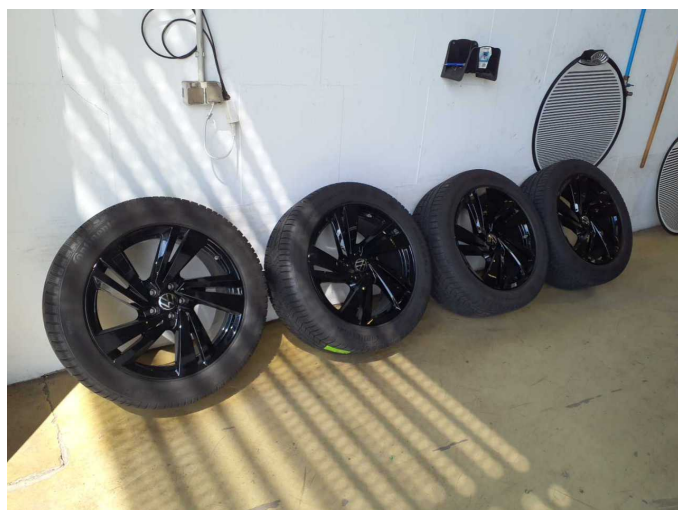
Figure 16: Additional tyres

| Tyres | | | | |
|---|---|---|---|---|
| 1) | 285/45 R20 112V | Winter tyres on Light alloy | Continental | 7mm / 7mm |
| 2) | 285/45 R20 112V | Winter tyres on Light alloy | Continental | 7mm / 7mm |

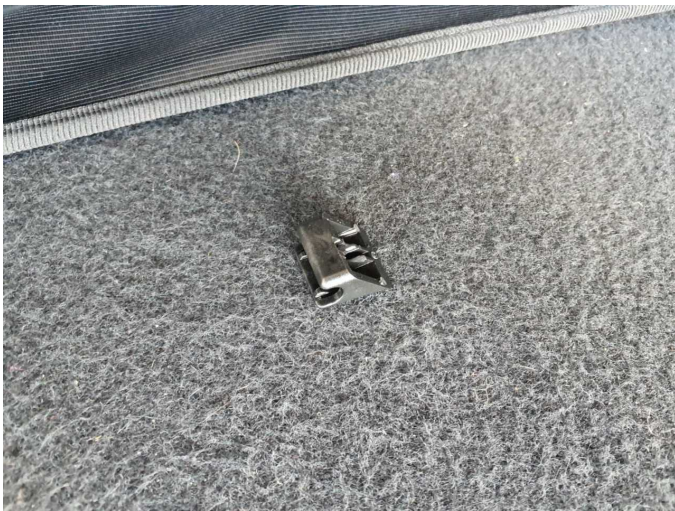
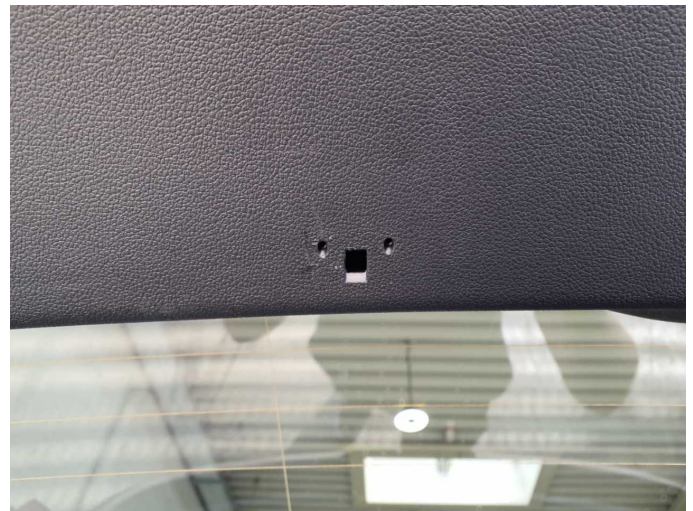
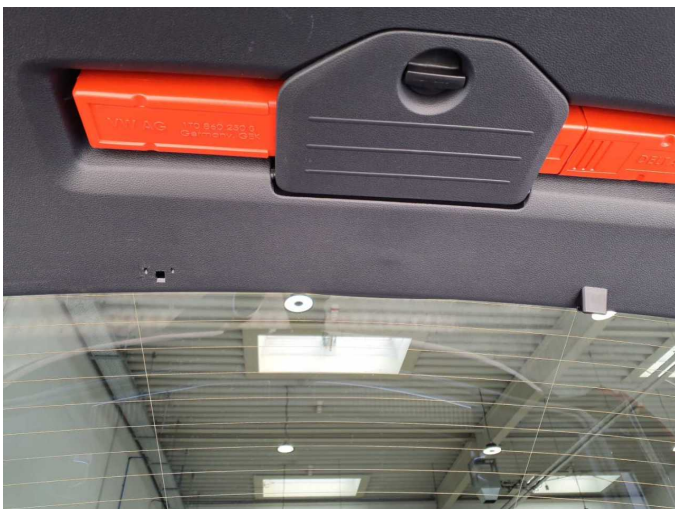
| No. | Component group | Description |
|---|---|---|
| 1 | Trim / covers | Boot lid - interior trim (Clip) - Broken / torn - Replace |

**Damage 1:** Trim / covers: Boot lid - interior trim (Clip) - Broken / torn - Replace

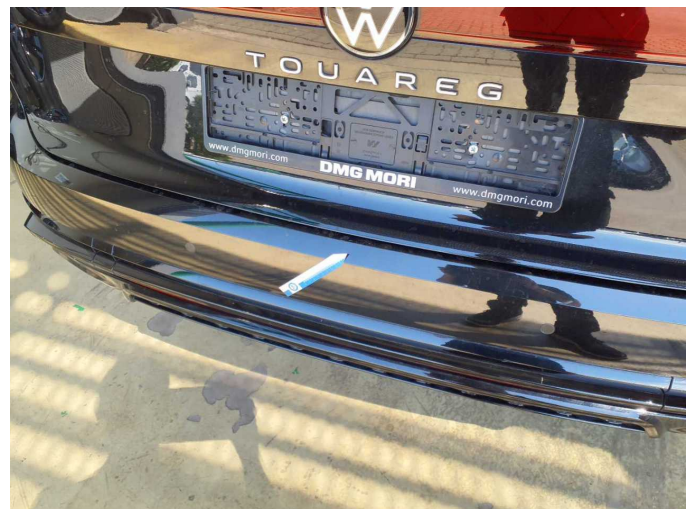
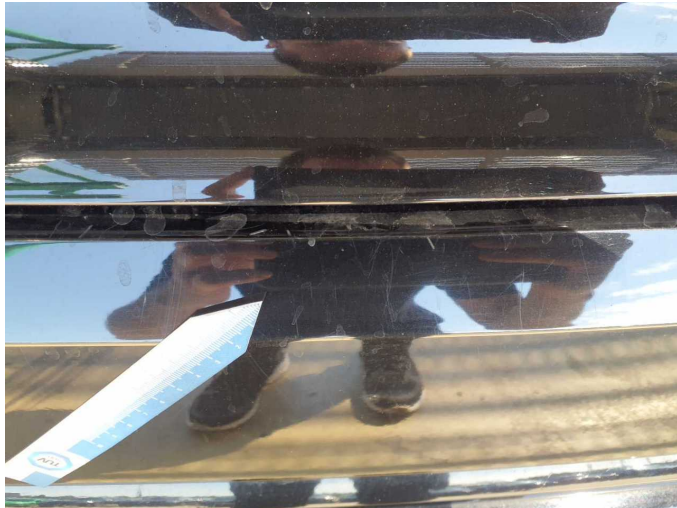
| No. | Component group | Description |
|---|---|---|
| 2 | Rear bumper | Rear bumper - Scratched - Smart repair |

**Damage 2:** Rear bumper: Rear bumper - Scratched - Smart repair

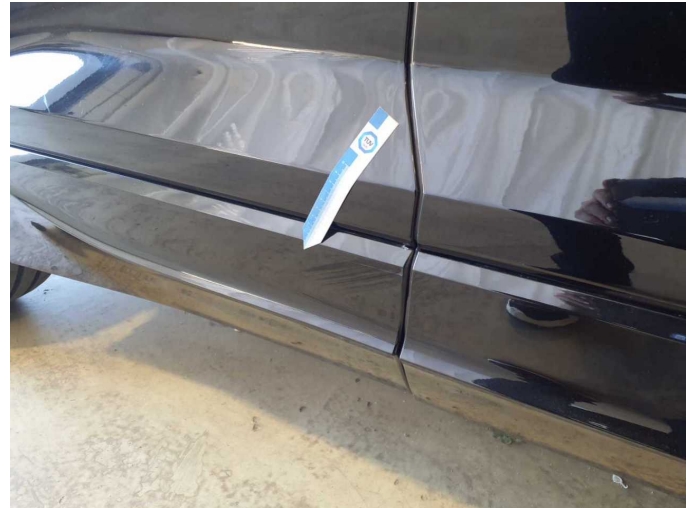
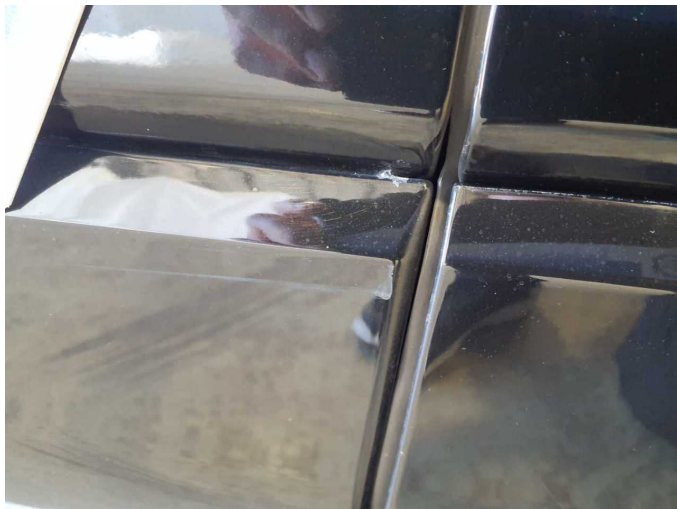
| No. | Component group | Description |
|---|---|---|
| 3 | Door - rear right side | Brightware - lower - Scratched - Smart repair |

**Damage 3:** Door - rear right side: Brightware - lower - Scratched - Smart repair

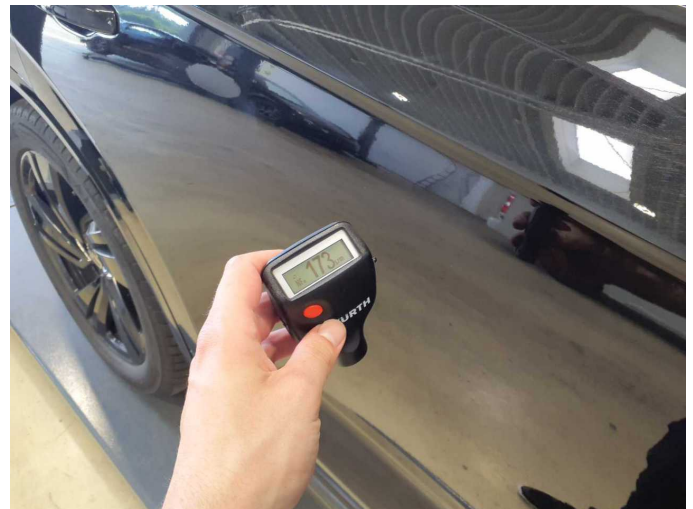
1 Door - rear right side, Professionally carried out, Invoice of repair done Non-existent

Door - rear right side 173 µm

**Repainting 1:** Door - rear right side
