Expertise

Protocol number: 46014733
Order No. / Reference: 26464955
Inspection date: 17 Jun 2026

Model: Kodiaq 2.0 TDI DSG Style

VIN: TMBJJ9NS5P8052350

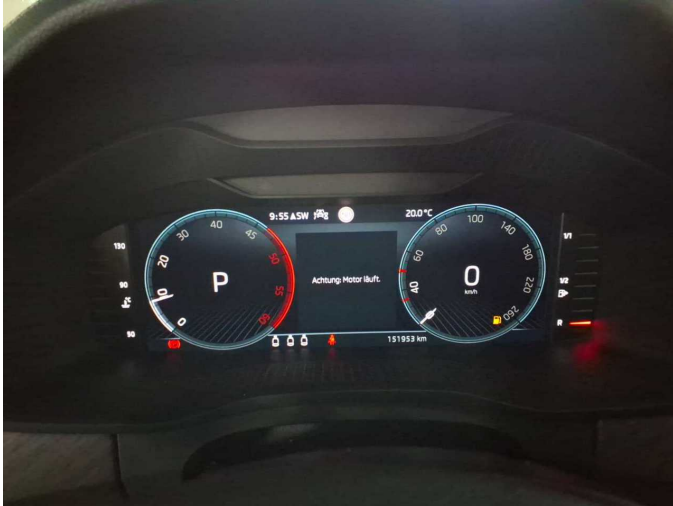
Mileage (Read) 151,953 km

Figure 7: Instrument cluster

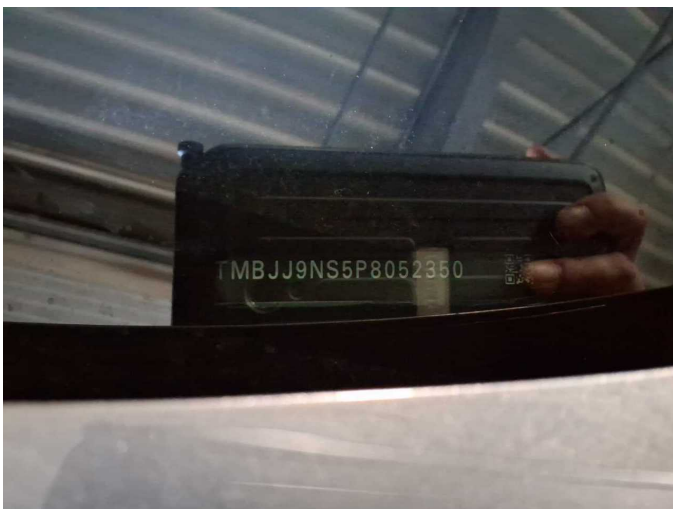
Documents submitted	At the time of the inspection, the vehicle registration certificate Part 2 (title) was available, but the vehicle registration certificate Part 1 (document) was not. (Copy)
VIN comparison	The vehicle identification number (VIN) was read from the vehicle and its conformity with the submitted documents was confirmed by the undersigned during the inspection.
Inspection	The inspection conditions were sufficient for the assessment of the vehicle. Lifting equipment and/or a pit were available for examining the vehicle.
Test drive	No test drive/shunting maneuver was carried out during the inspection of the vehicle.
Engine function test	An engine test run was performed.

Figure 11: VIN

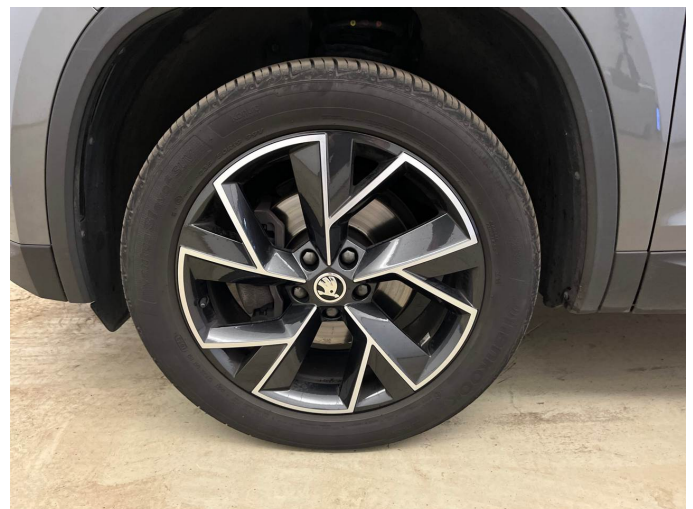
#	Tyre size	Type of tyre	Manufacturer	Tread depth
1)	235/50 R19 99V	Summer tyres on Light alloy	Hankook	5mm / 5mm
2)	235/50 R19 99V	Summer tyres on Light alloy	Hankook	6mm / 6mm

Figure 12: Mounted tyres

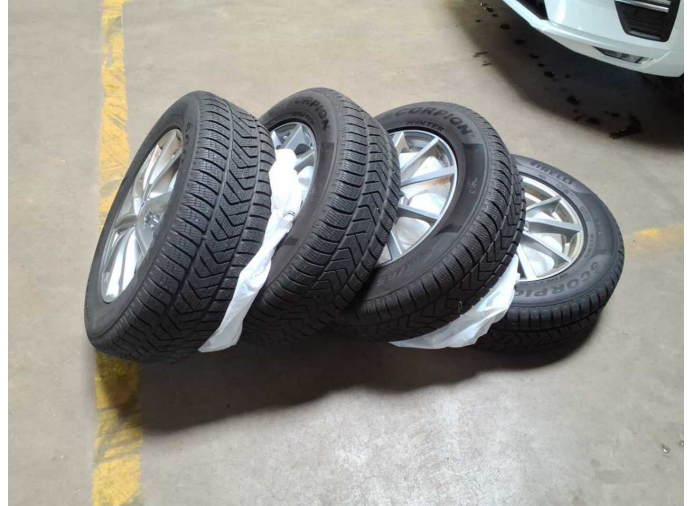
#	Tyre size	Type of tyre	Manufacturer	Tread depth
1)	215/65 R17 99H	Winter tyres on Light alloy	Pirelli	5mm / 5mm
2)	215/65 R17 99H	Winter tyres on Light alloy	Pirelli	5mm / 5mm

Figure 14: Additional tyres

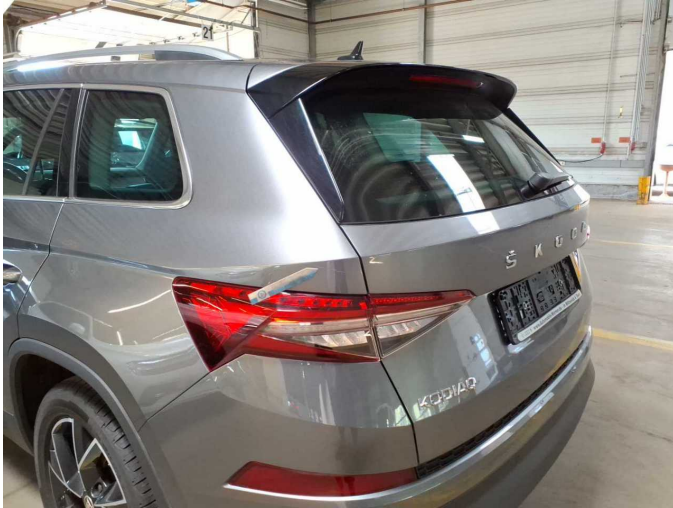
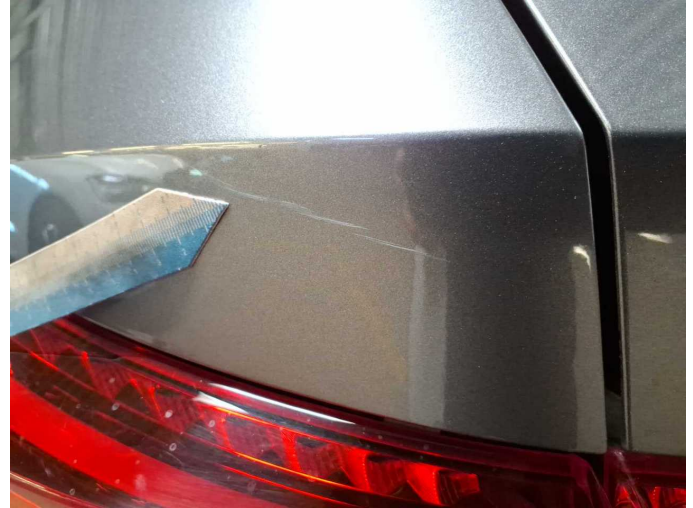
Damage 1: Side panel - rear left side: Side panel - Scratch(es) - Smart repair

No.	Component group	Description
1	Side panel - rear left side	Side panel - Scratch(es) - Smart repair
2	Door - rear right side	Door - Scratch(es) - Smart repair

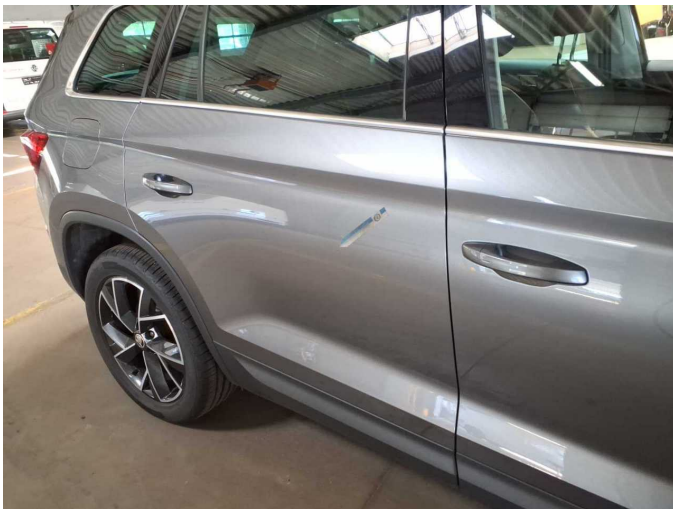
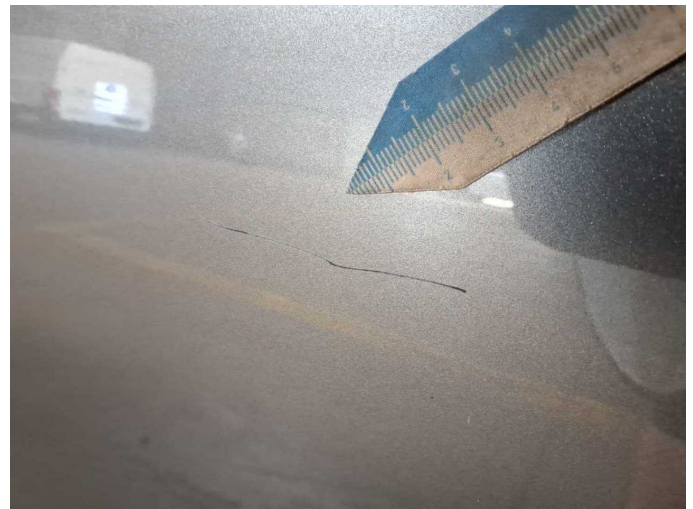
Damage 2: Door - rear right side: Door - Scratch(es) - Smart repair
