Expertise

Protocol number: 46199891  
Order No. / Reference: 26496528  
Inspection date: 29 Jun 2026

Manufacturer: Volkswagen

Model: Tiguan Allspace 2.0 TDI SCR DSG Life

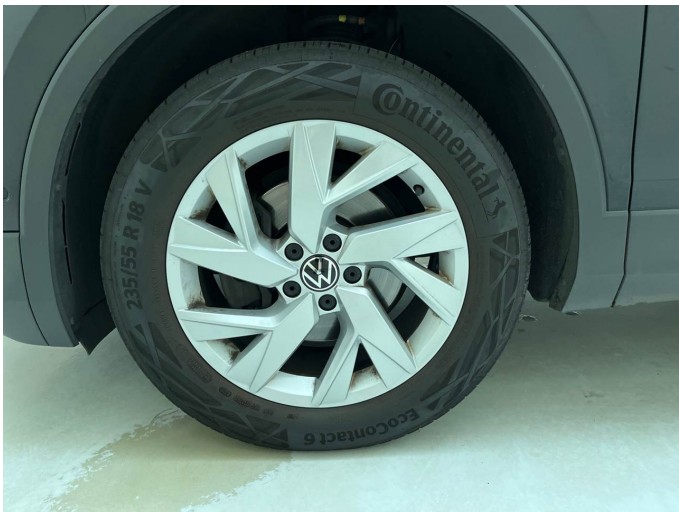
Figure 12: Mounted tyres

| # | Tyre size | Type of tyre | Manufacturer | Tread depth |
|---|---|---|---|---|
| 1) | 235/55 R18 100V | Summer tyres on Light alloy | Continental | 5mm / 5mm |
| 2) | 235/55 R18 100V | Summer tyres on Light alloy | Continental | 6mm / 6mm |

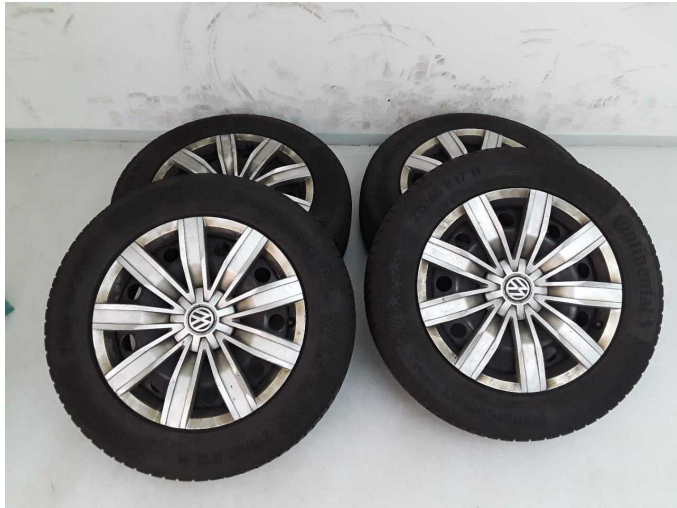
Figure 19: Additional tyres

| # | Tyre size | Type of tyre | Manufacturer | Tread depth |
|---|---|---|---|---|
| 1) | 215/65 R17 99H | Winter tyres on Steel rim with wheel cover | Continental | 5mm / 5mm |
| 2) | 215/65 R17 99H | Winter tyres on Steel rim with wheel cover | Continental | 5mm / 5mm |

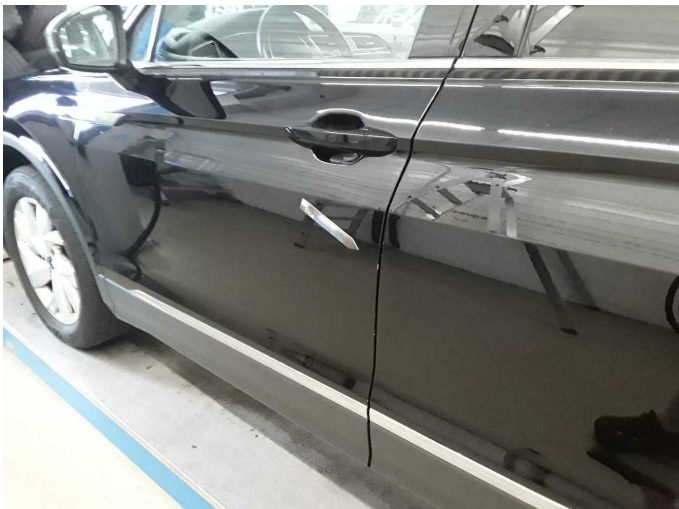
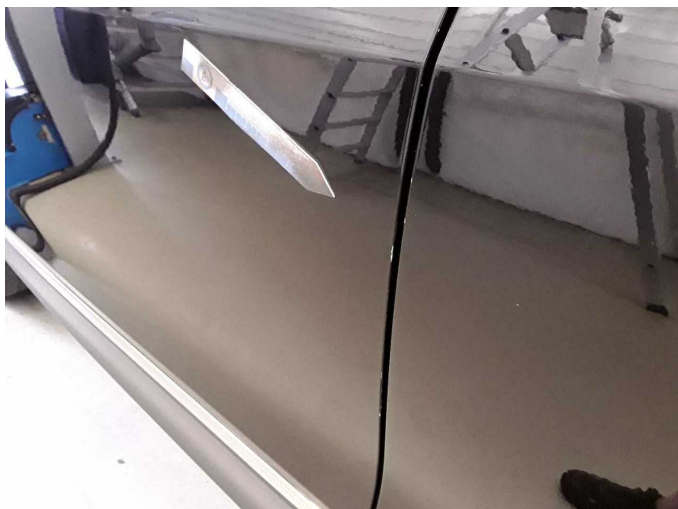
| No. | Component group | Description |
|---|---|---|
| 1 | Door - front left side | Door edge - Scratch(es) - Smart repair |

Damage 1: Door - front left side: Door edge - Scratch(es) - Smart repair

**Damage 1:** Door - front left side: Door edge - Scratch(es) - Smart repair

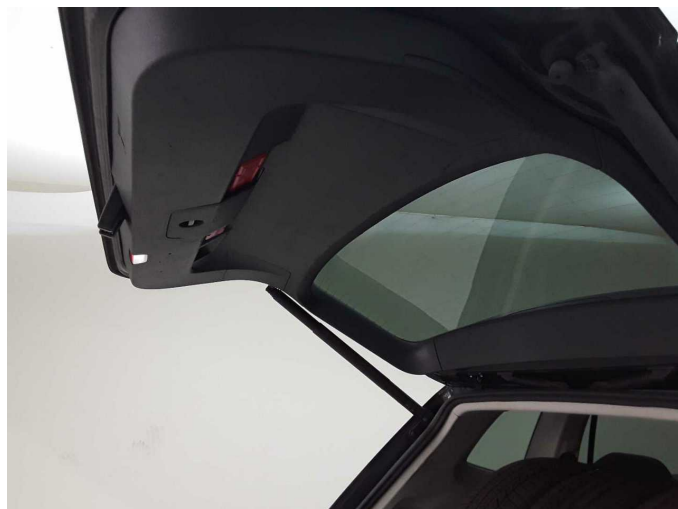
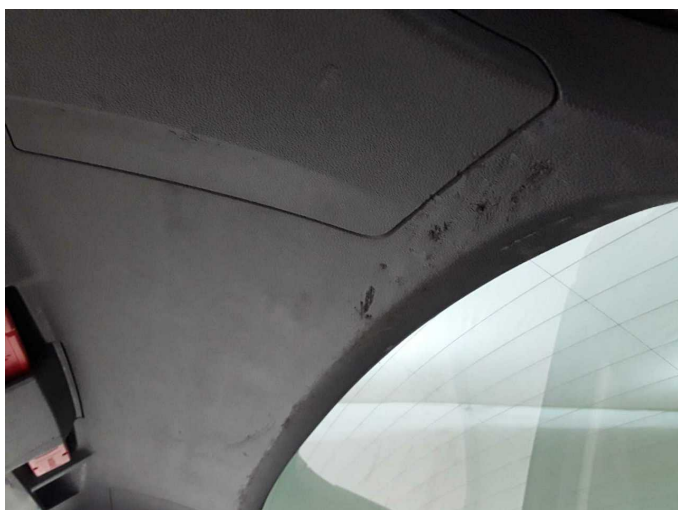
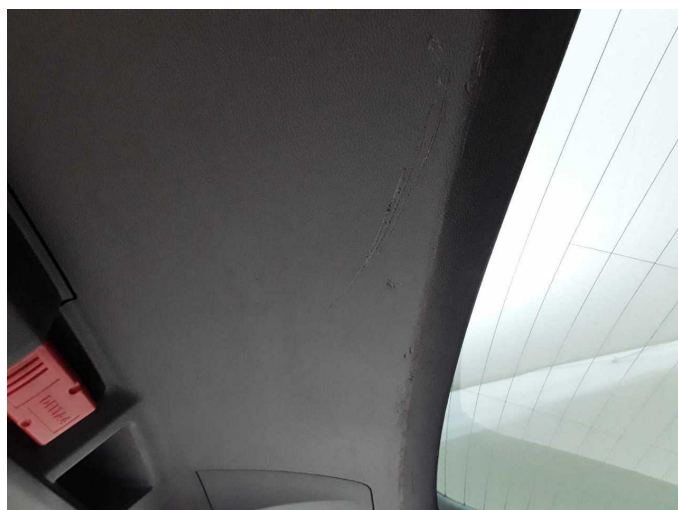
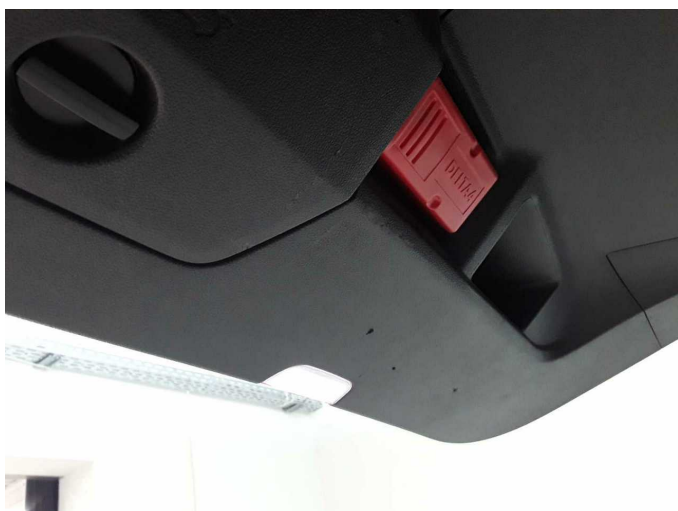
| No. | Component group | Description |
|---|---|---|
| 2 | Trim / covers | Boot lid - interior trim - Scratched - Loss in value |

**Damage 2:** Trim / covers: Boot lid - interior trim - Scratched - Loss in value

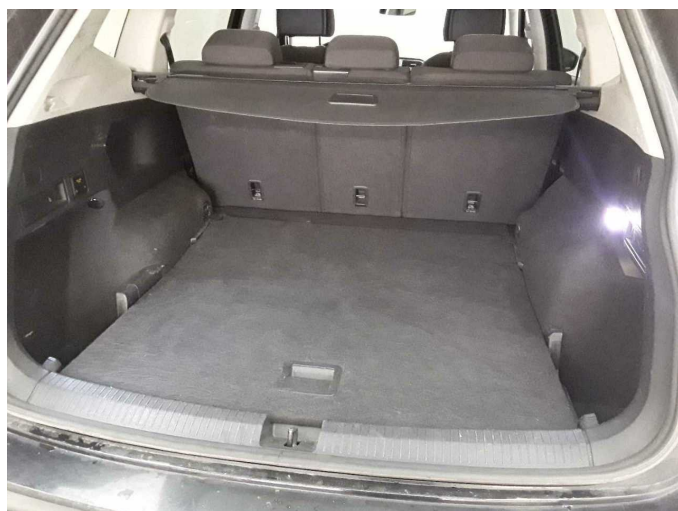
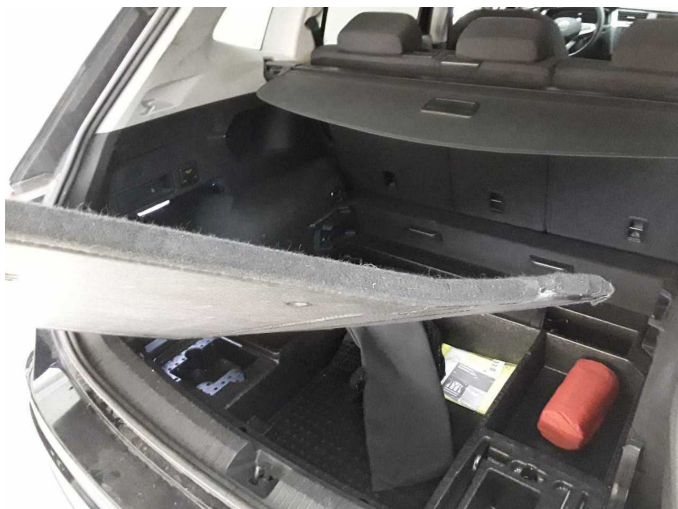
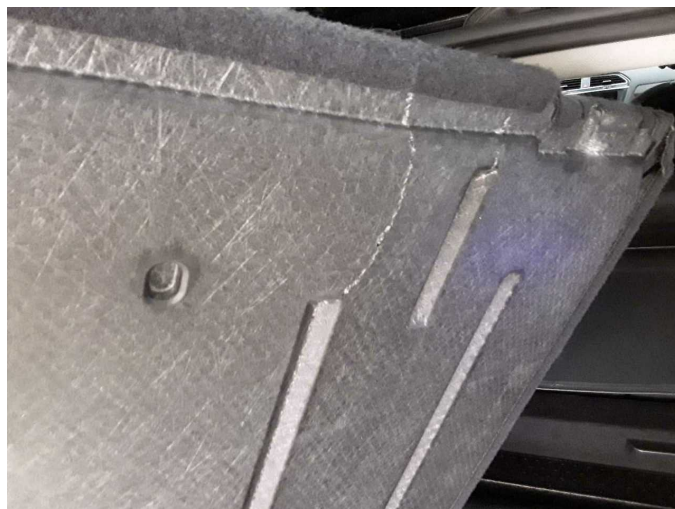
| No. | Component group | Description |
|---|---|---|
| 3 | Interior | Cargo area floor - Deformed - Replace |

**Damage 3:** Interior: Cargo area floor - Deformed - Replace

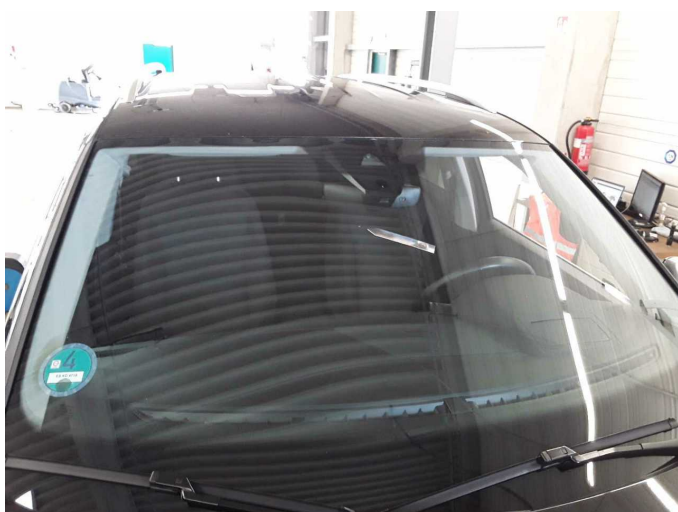
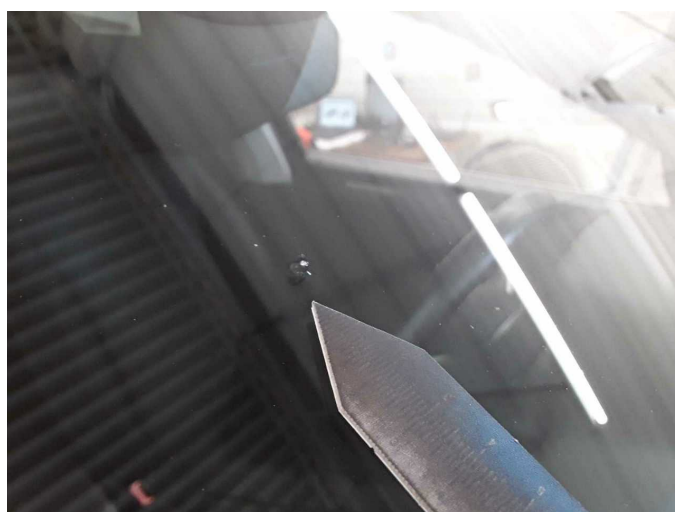
| No. | Component group | Description |
|---|---|---|
| 4 | Vehicle glazing | Windscreen with lane departure assistant - Stone chips - Smart repair |

**Damage 4:** Vehicle glazing: Windscreen with lane departure assistant - Stone chips - Smart repair

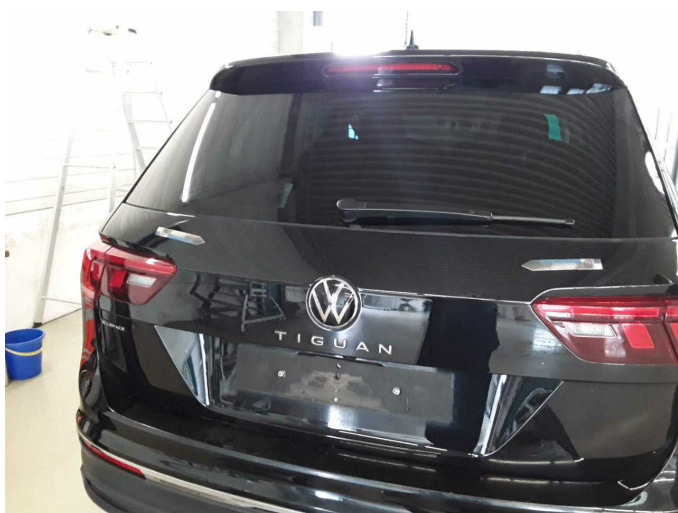
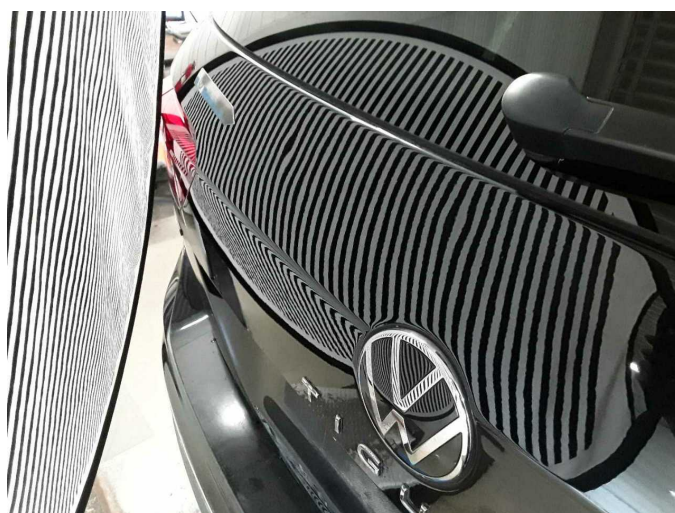
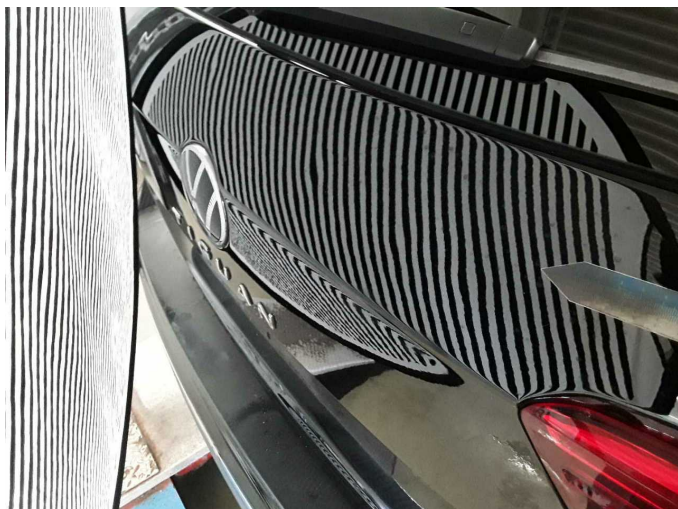
| No. | Component group | Description |
|---|---|---|
| 5 | Boot lid / rear door | Boot lid glazed - dent(s) - Smart repair |

**Damage 5:** Boot lid / rear door: Boot lid glazed - dent(s) - Smart repair

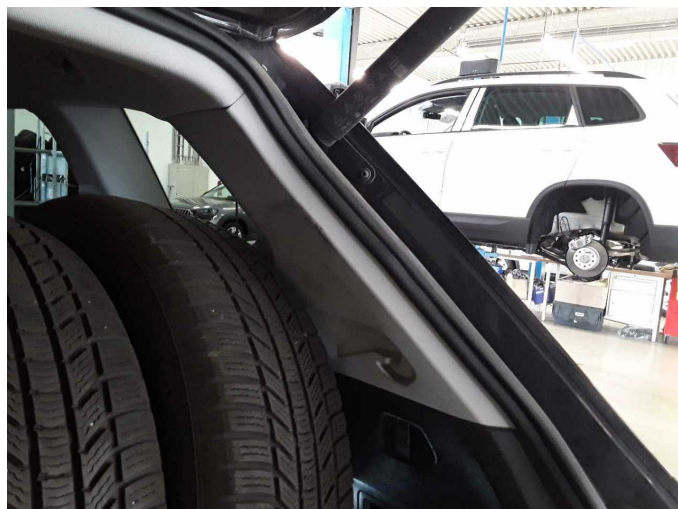
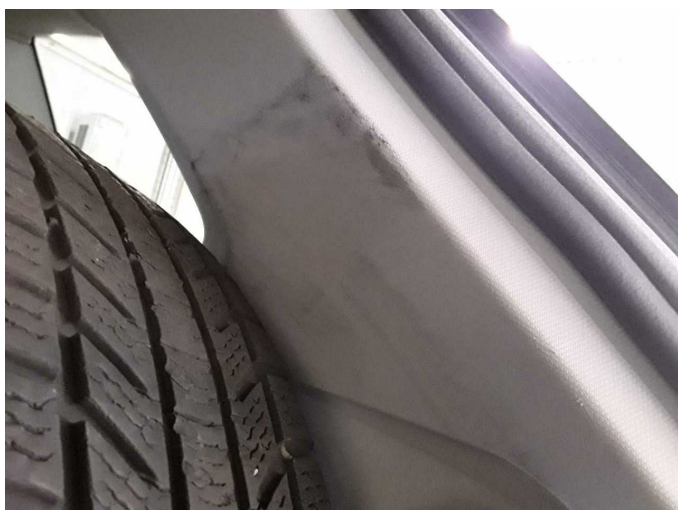
| No. | Component group | Description |
|---|---|---|
| 6 | Trim / covers | D-pillar - trim - interior, right side - Scratched - Replace |

**Damage 6:** Trim / covers: D-pillar - trim - interior, right side - Scratched - Replace

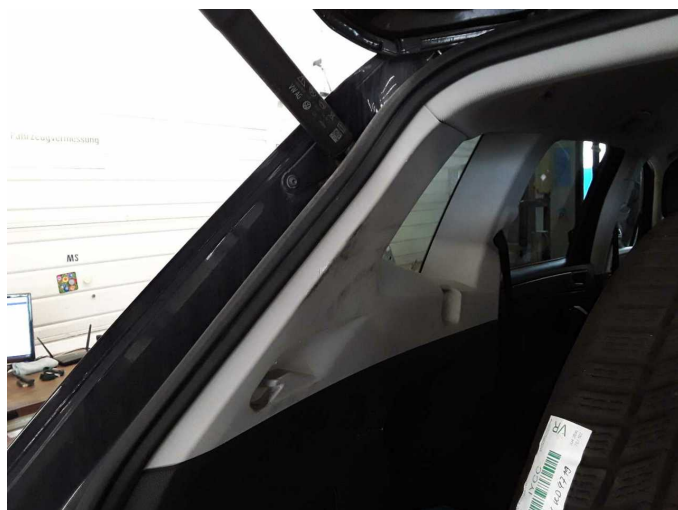
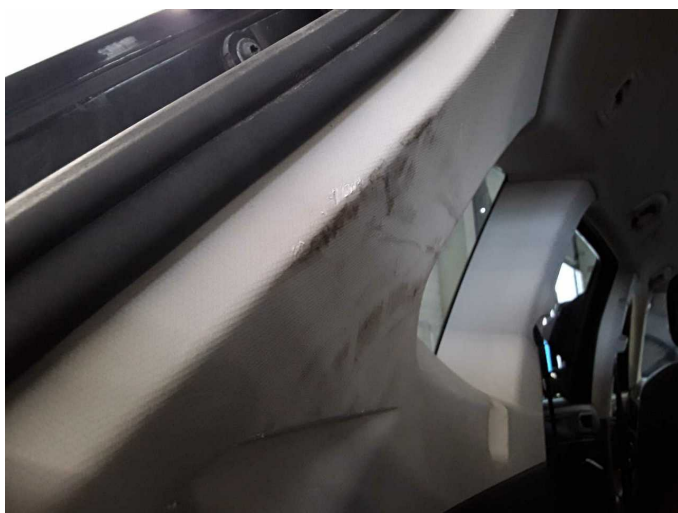
| No. | Component group | Description |
|---|---|---|
| 7 | Trim / covers | D-pillar trim - interior, left side - Scratched - Replace |

**Damage 7:** Trim / covers: D-pillar trim - interior, left side - Scratched - Replace

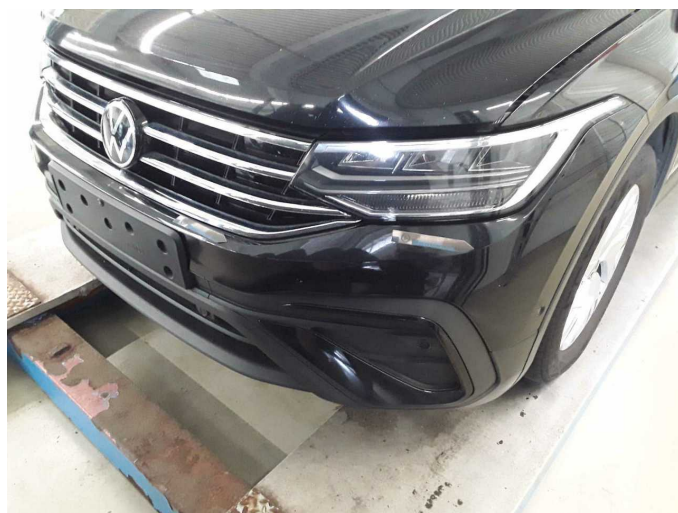
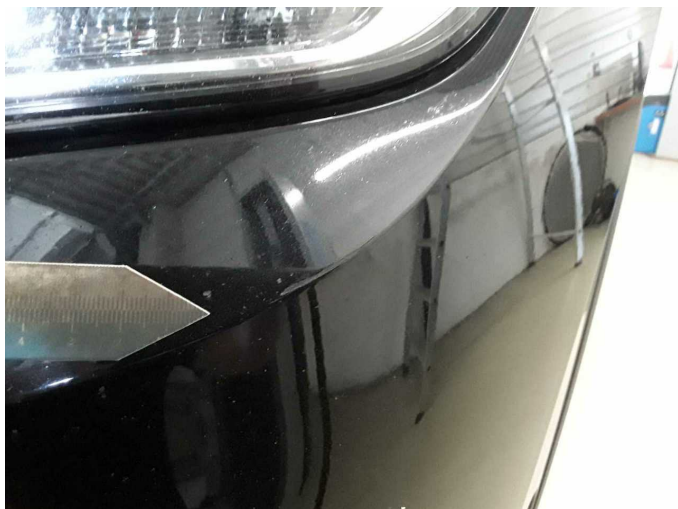
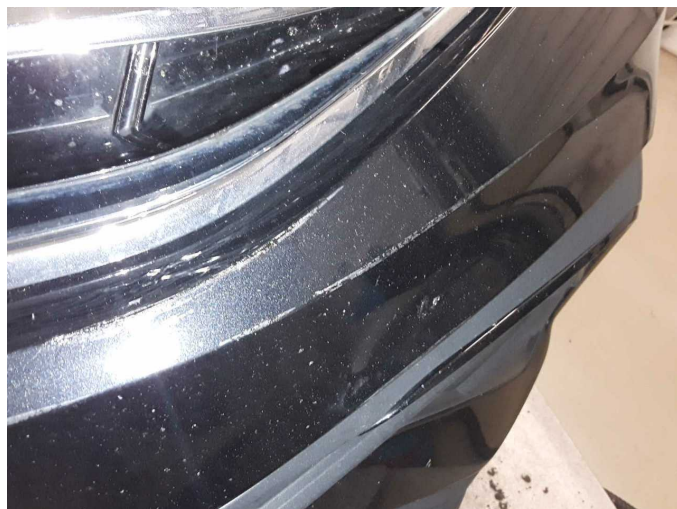
| No. | Component group | Description |
|---|---|---|
| 8 | Front bumper | Front bumper - Scratch(es) - Paint |

**Damage 8:** Front bumper: Front bumper - Scratch(es) - Paint

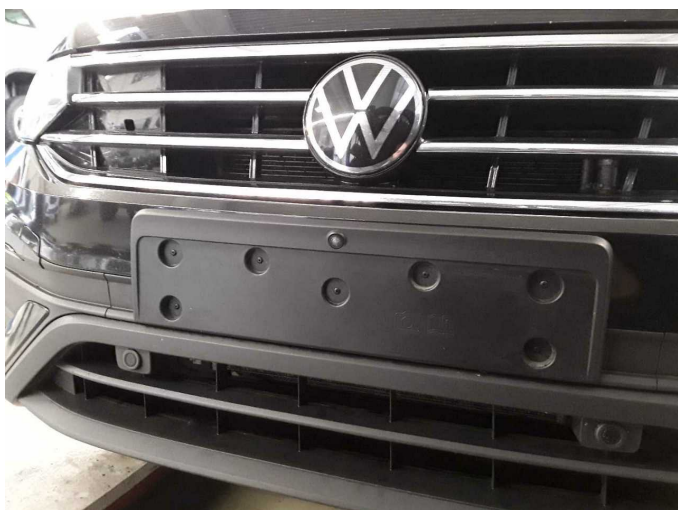
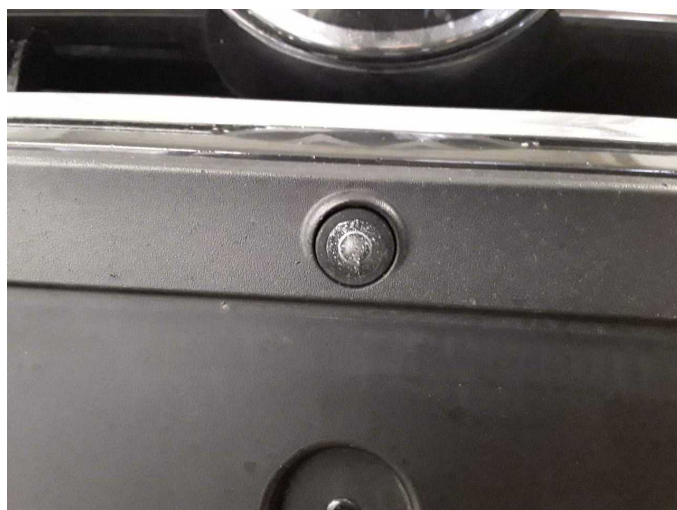
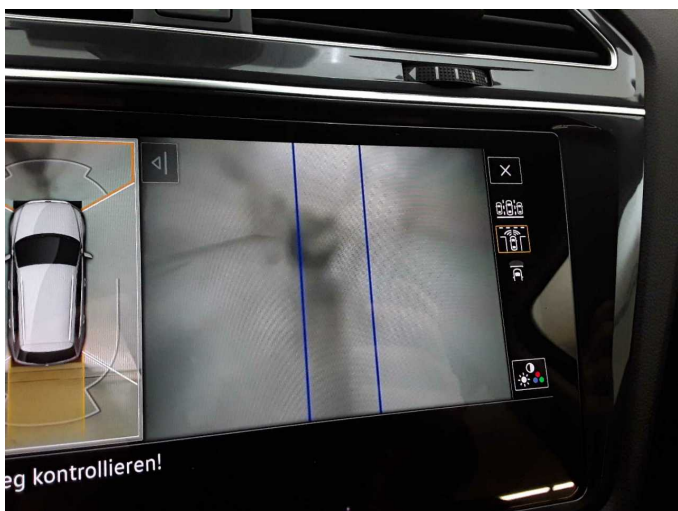
| No. | Component group | Description |
|---|---|---|
| 9 | Electronic systems | Front camera - Broken / torn - Replace |

**Damage 9:** Electronic systems: Front camera - Broken / torn - Replace

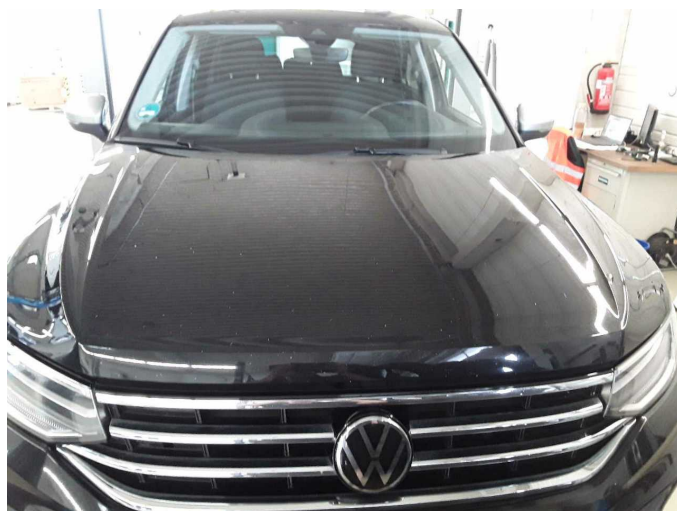
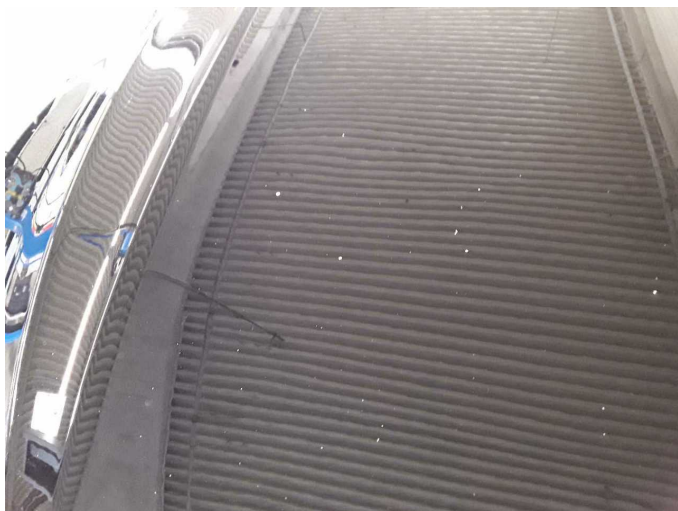
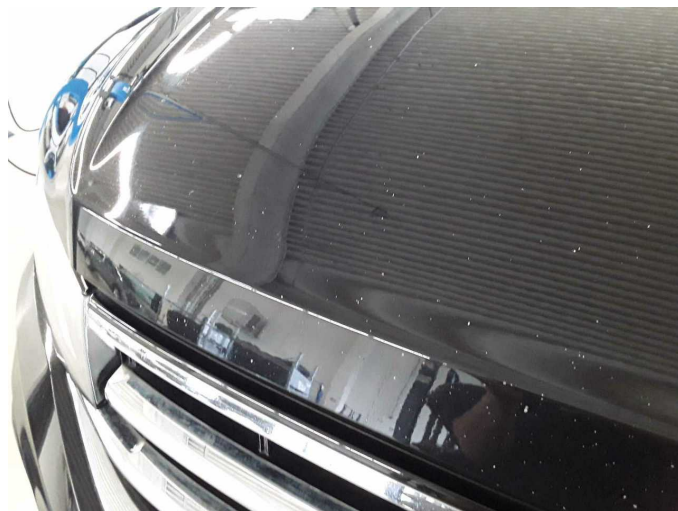
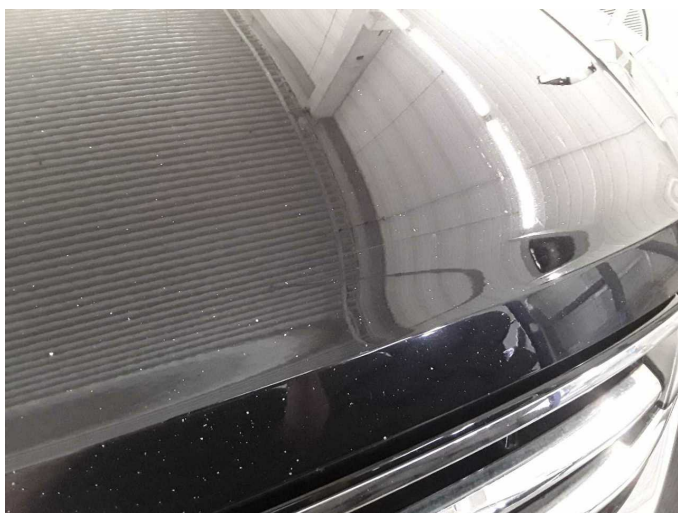
| No. | Component group | Description |
|---|---|---|
| 10 | Bonnet | Bonnet - Stone chips - Paint |

**Damage 10:** Bonnet: Bonnet - Stone chips - Paint

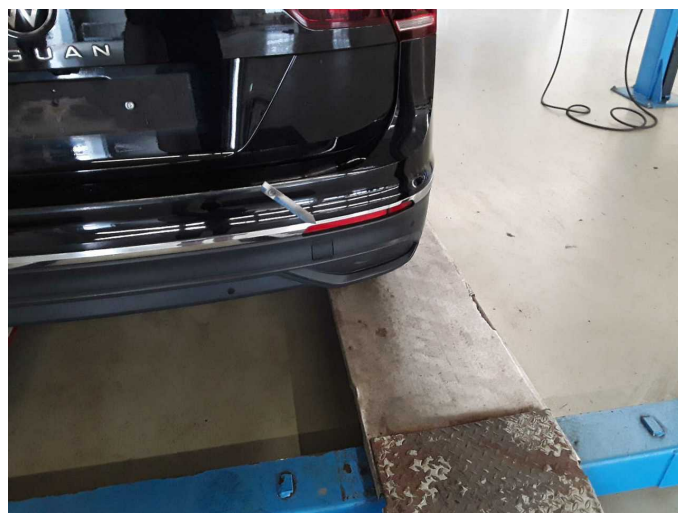
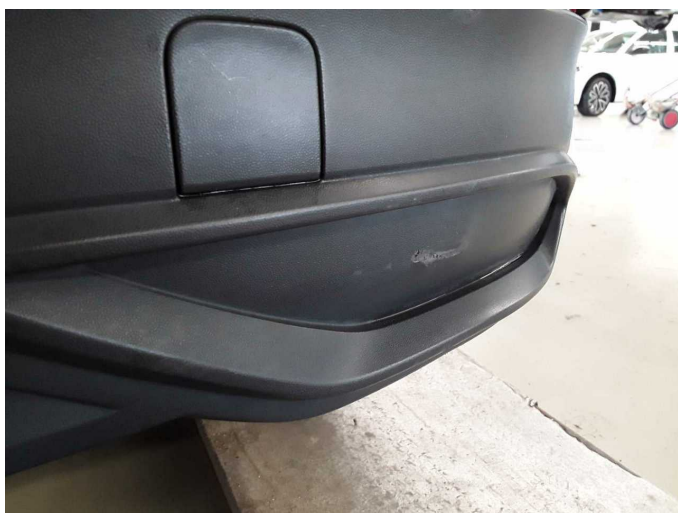
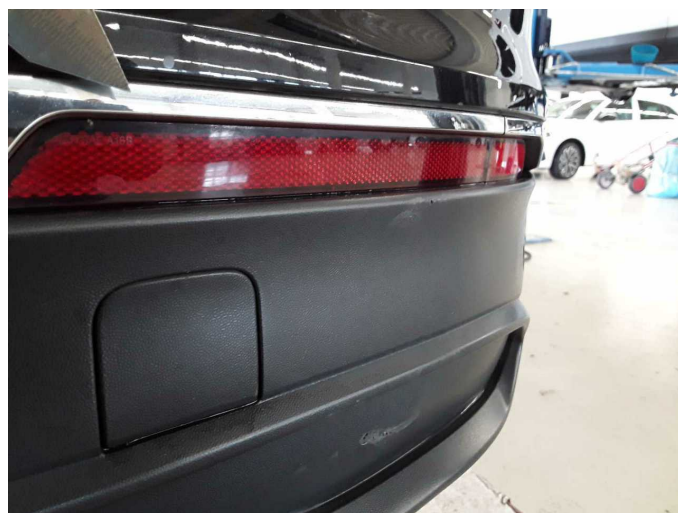
| No. | Component group | Description |
|---|---|---|
| 11 | Rear bumper | Bumper with Parktronic (Unterteil) - Deformed - Replace |

**Damage 11:** Rear bumper: Bumper with Parktronic (Unterteil) - Deformed  
- Replace
