Expertise

Protocol number: 46531705  
Order No. / Reference: 26679426  
Inspection date: 10 Jul 2026

Manufacturer: Ford

Model: S-Max 2.0 EcoBlue Allrad Aut. ST-LINE

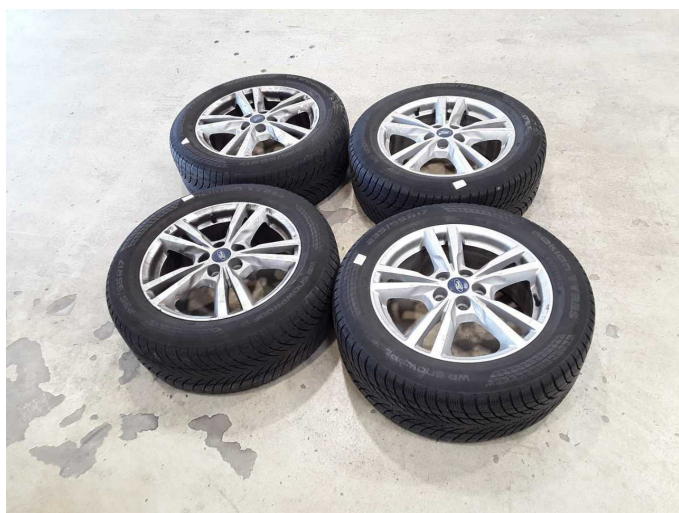
Figure 15: Additional tyres

| No. | Component group | Description |
|---|---|---|
| 2 | 2nd wheel set | 2 tyres - Worn - No deduction |

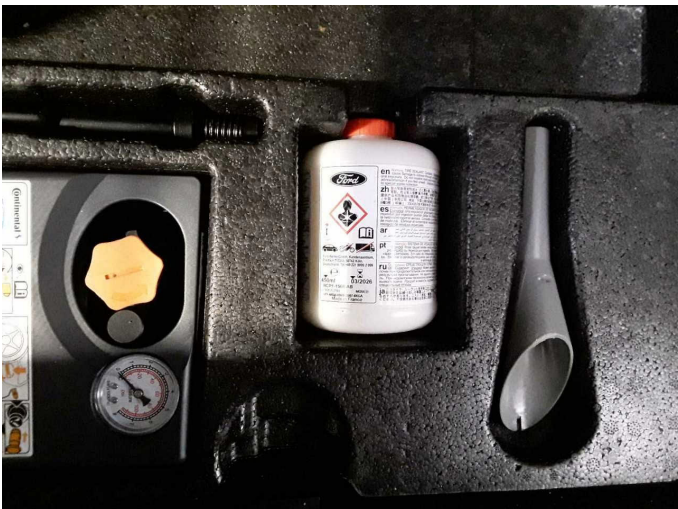
| No. | Component group | Description |
|---|---|---|
| 1 | Equipment | Tirefit filler - Expired - Replace |

Damage 1: Equipment: Tirefit filler - Expired - Replace

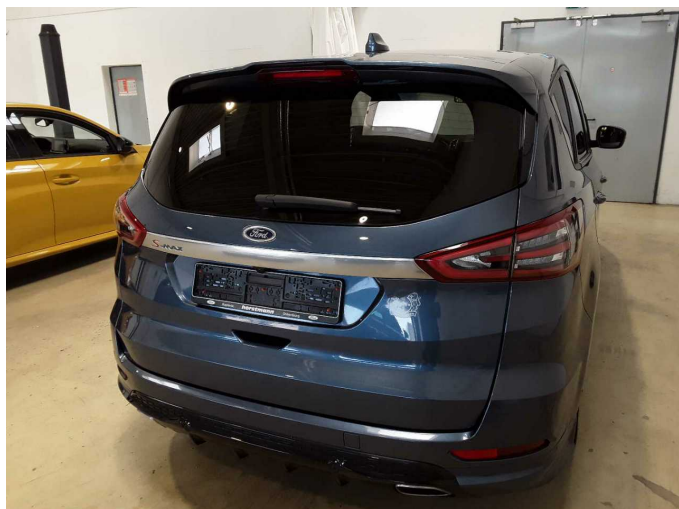
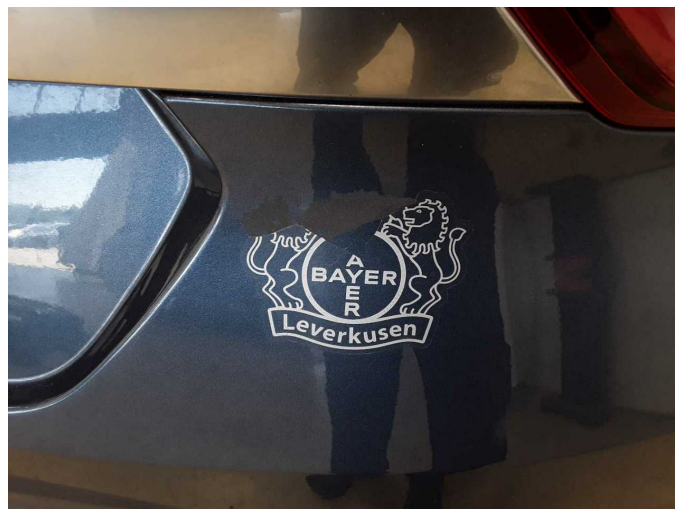
| No. | Component group | Description |
|---|---|---|
| 2 | Boot lid / rear door | Boot lid - Glued / labelled - De-glue / neutralise |

**Damage 2:** Boot lid / rear door: Boot lid - Glued / labelled - De-glue / neutralise

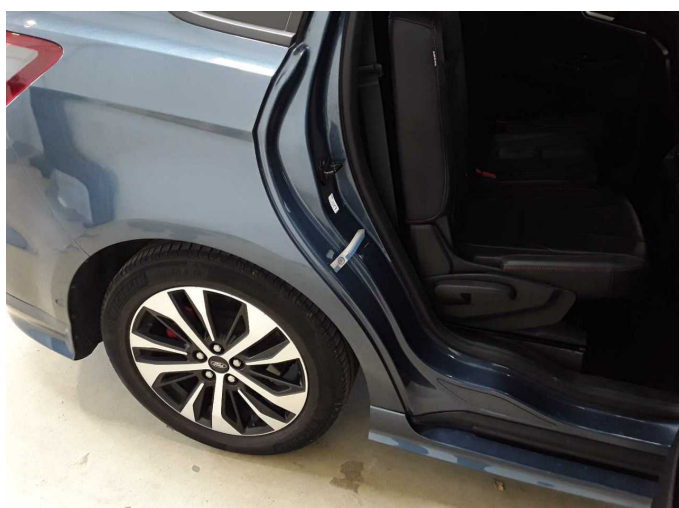
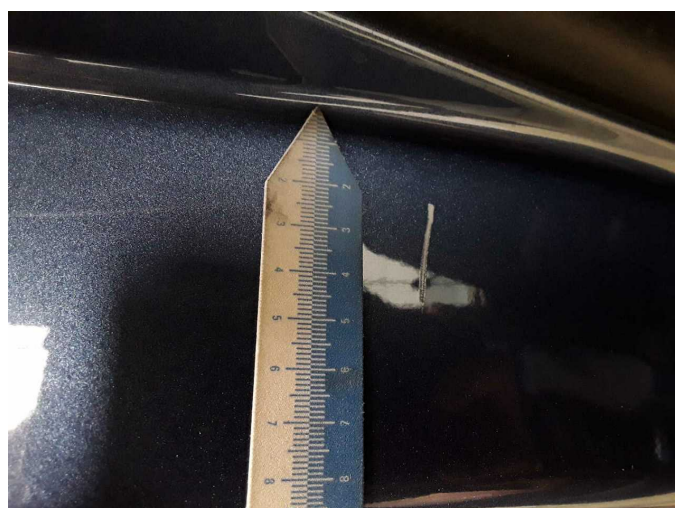
| No. | Component group | Description |
|---|---|---|
| 3 | Side panel - rear right side | Sill - Scratch(es) - Smart repair |

**Damage 3:** Side panel - rear right side: Sill - Scratch(es) - Smart repair

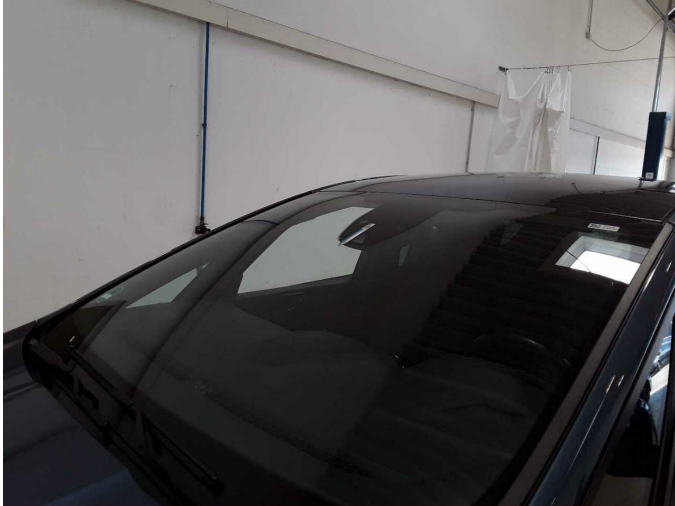
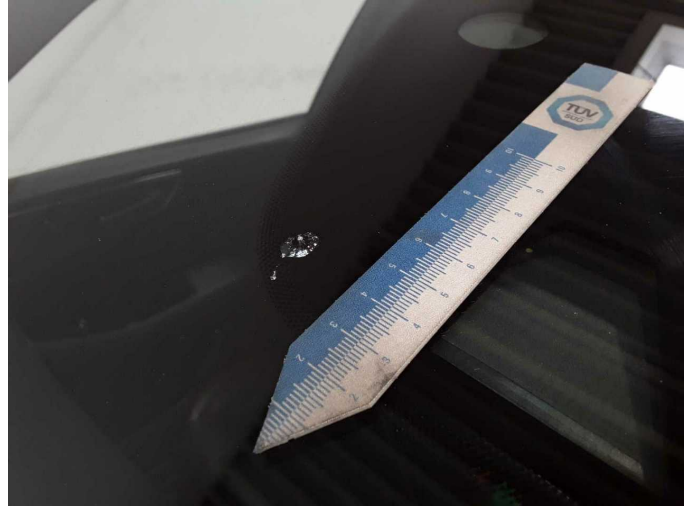
| No. | Component group | Description |
|---|---|---|
| 5 | Vehicle glazing | Windscreen - Damaged - Replace |

**Damage 5:** Vehicle glazing: Windscreen - Damaged - Replace

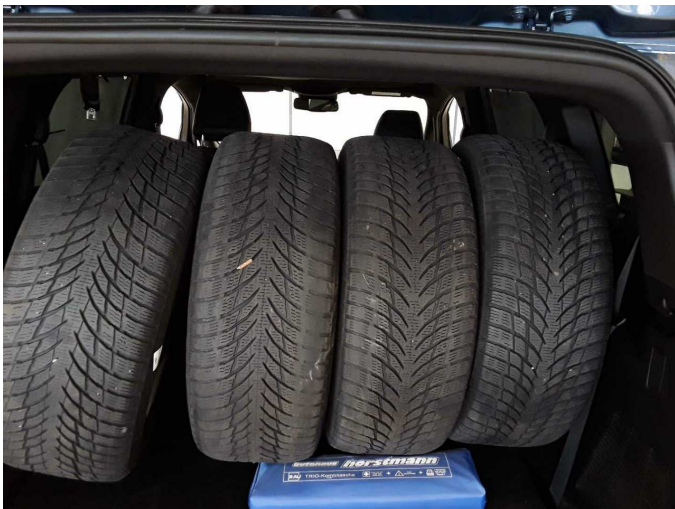
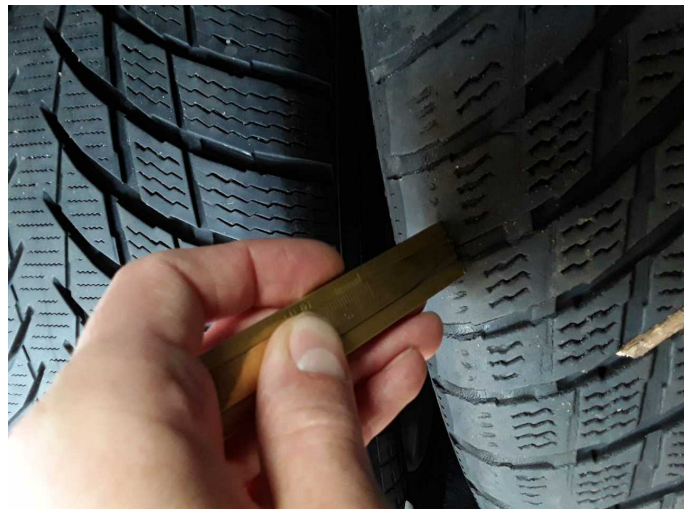
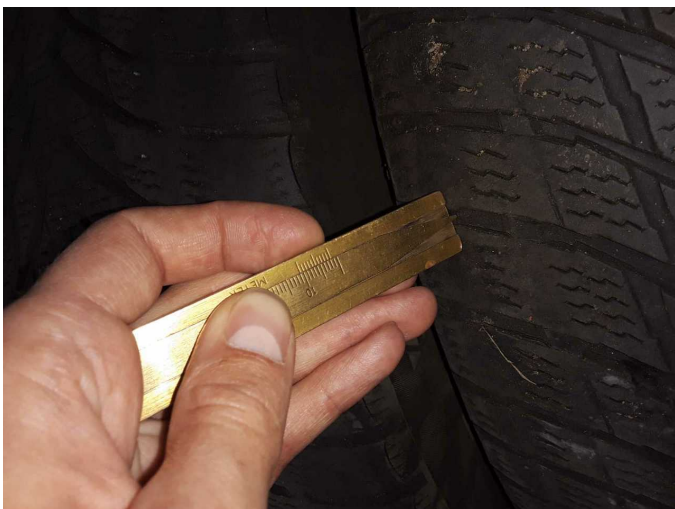
| Tyres | | | | |
|---|---|---|---|---|
| 1) | 235/55 R17 103V | Winter tyres on Light alloy | Nokian | 1mm / 1mm |

**Wear and tear 2:** 2nd wheel set: 2 tyres - Worn - No deduction

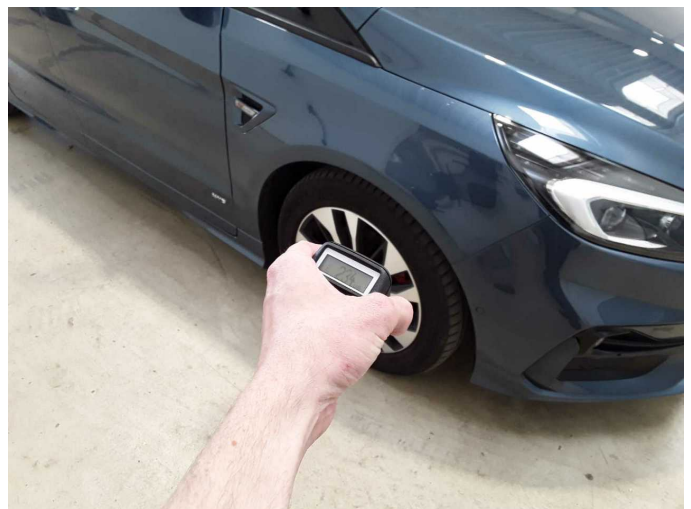
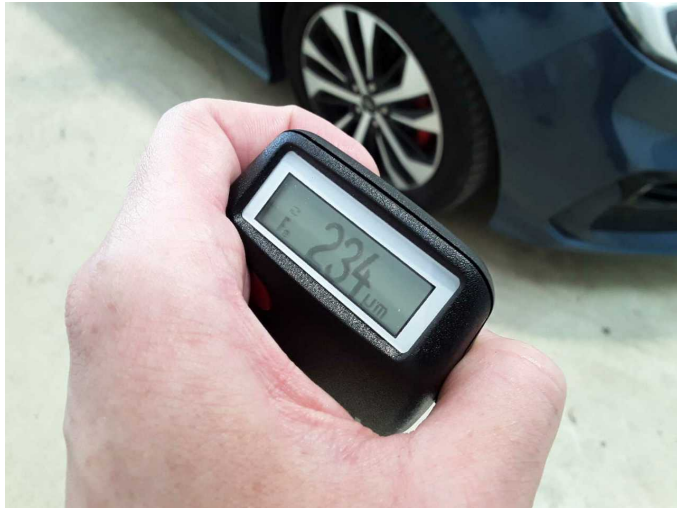
| No. | Repainting |
|---|---|
| 1 | Mudguard - right side, Professionally carried out, Invoice of repair done Non-existent |

| Mudguard - right side | 234 µm | Door - rear right side | 209 µm |

**Repainting 1:** Mudguard - right side

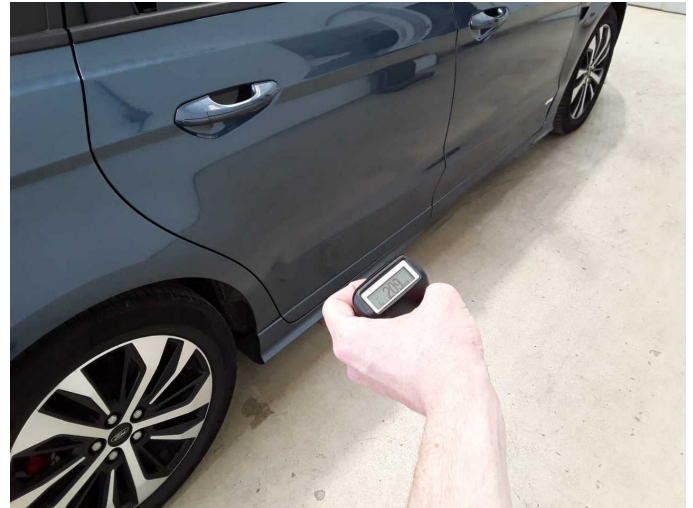
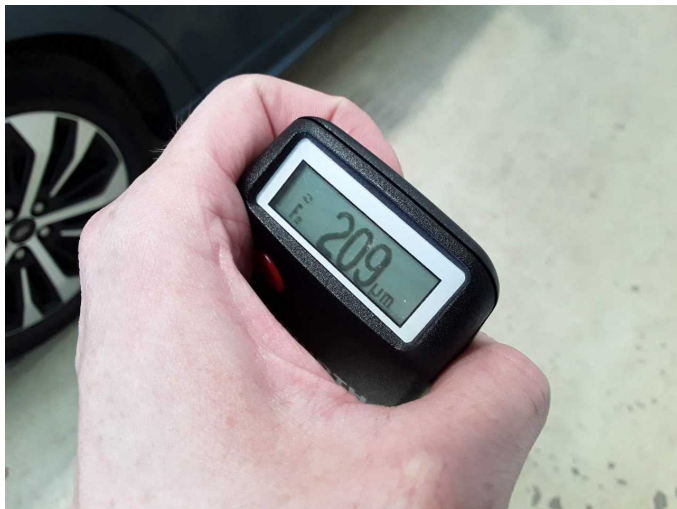
| No. | Repainting |
|---|---|
| 2 | Door - rear right side, Professionally carried out, Invoice of repair done Non-existent |

**Repainting 2:** Door - rear right side

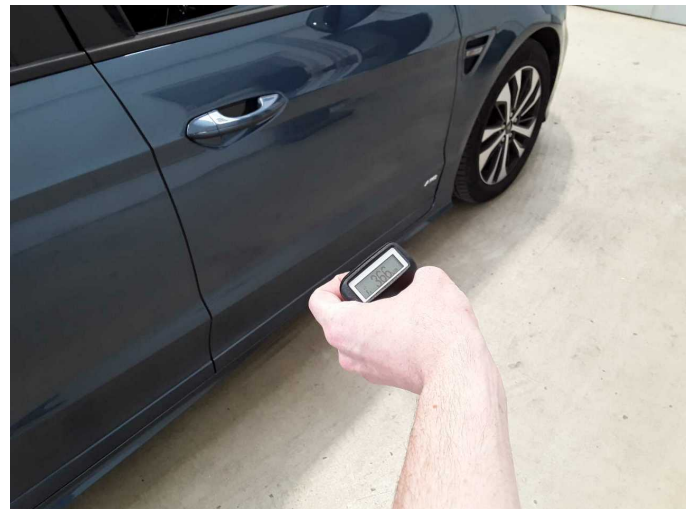
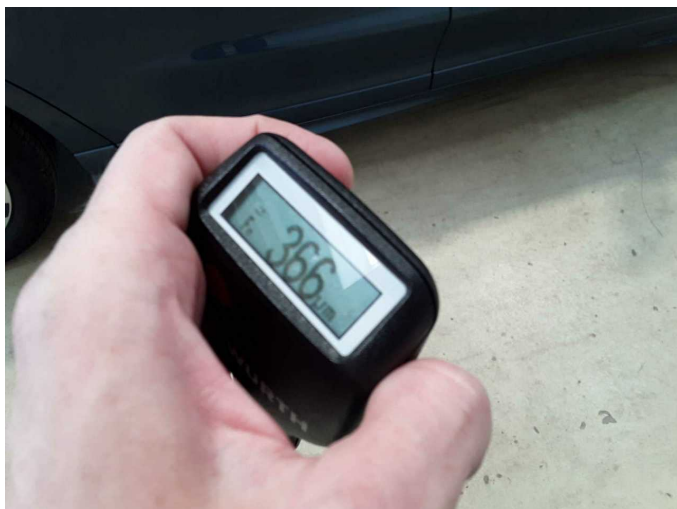
| No. | Repainting |
|---|---|
| 3 | Door - front right side, Professionally carried out, Invoice of repair done Non-existent |

| Door - front right side | 366 µm | | |

**Repainting 3:** Door - front right side
