Expertise

Protocol number: 46514092  
Order No. / Reference: 26662135  
Inspection date: 1 Jul 2026

Manufacturer: Volkswagen  
VIN: WVVZZZCDZNW193444

Model: Golf Life 2.0 TDI SCR DSG Active

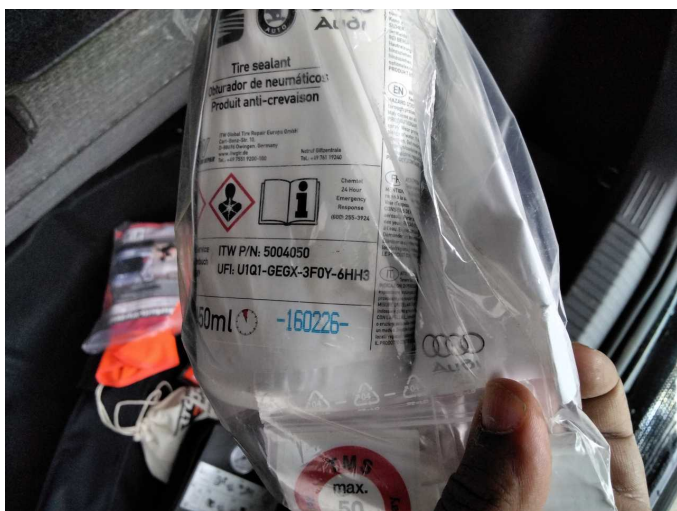
Damage 1: Equipment: Tirefit filler - Expired - Replace

| No. | Component group | Description |
|---|---|---|
| 1 | Equipment | Tirefit filler - Expired - Replace |

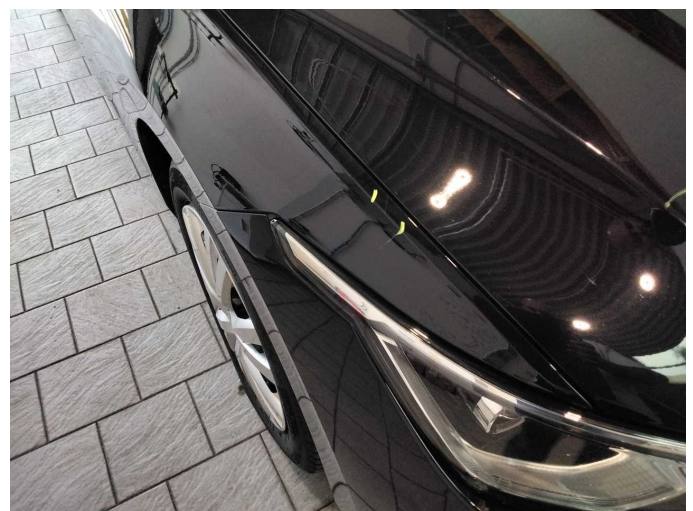
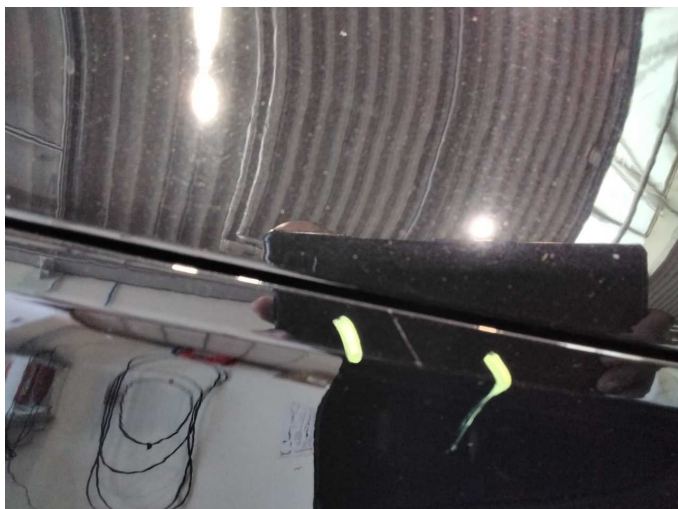
Damage 2: Mudguard - right side: Mudguard - right side - Scratch(es) - Smart repair

**Damage 2:** Mudguard - right side: Mudguard - right side - Scratch(es) - Smart repair

| No. | Component group | Description |
|---|---|---|
| 2 | Mudguard - right side | Mudguard - right side - Scratch(es) - Smart repair |

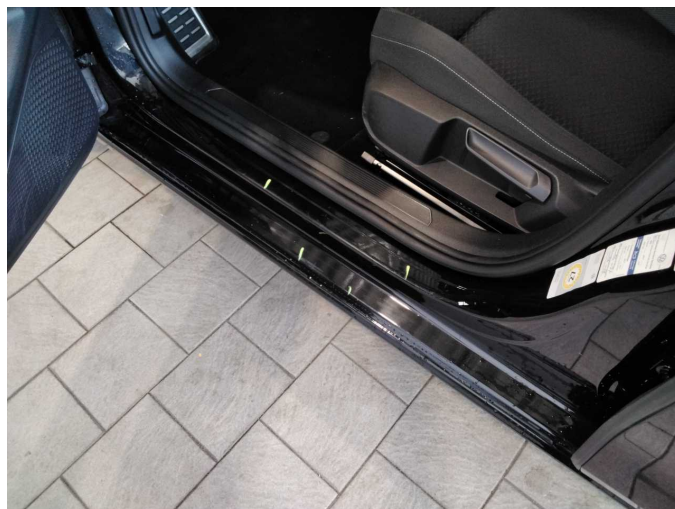
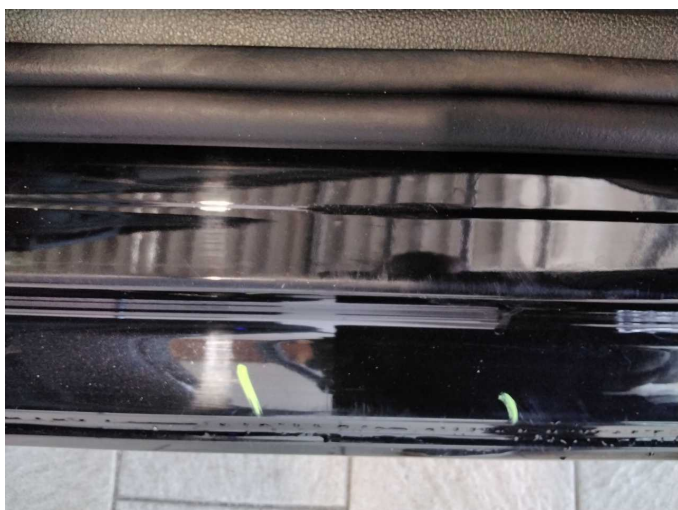
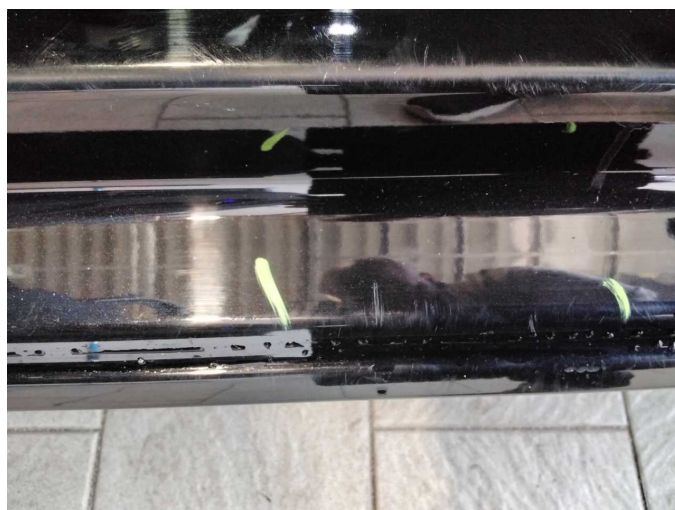
**Damage 3:** Sill - left side: Sill - Scratch(es) - Smart repair

| No. | Component group | Description |
|---|---|---|
| 3 | Sill - left side | Sill - Scratch(es) - Smart repair |

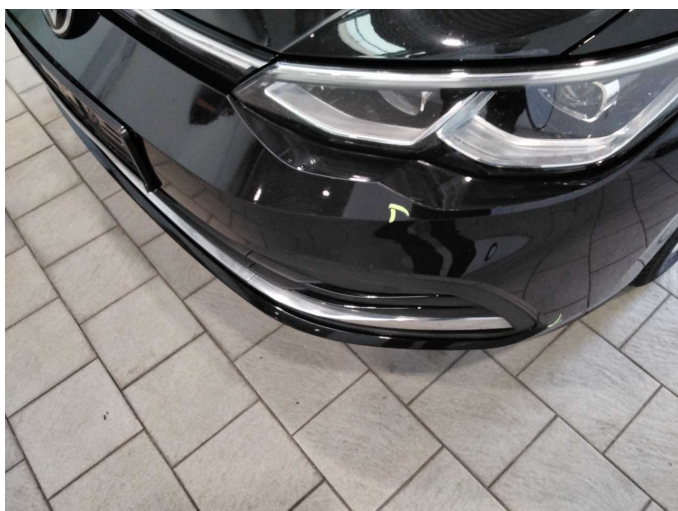
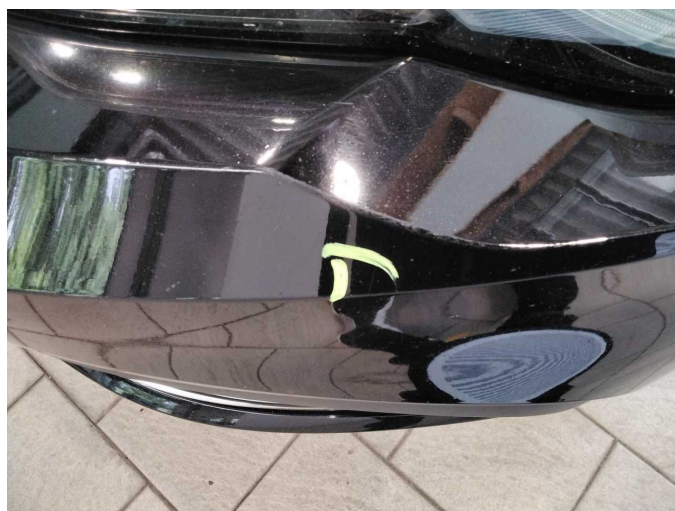
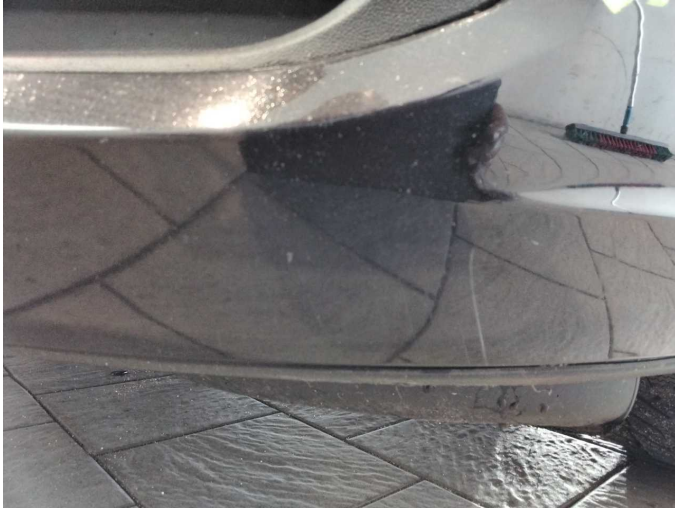
**Damage 4:** Front bumper: Front bumper - Scratch(es) - Smart repair

| No. | Component group | Description |
|---|---|---|
| 4 | Front bumper | Front bumper - Scratch(es) - Smart repair |

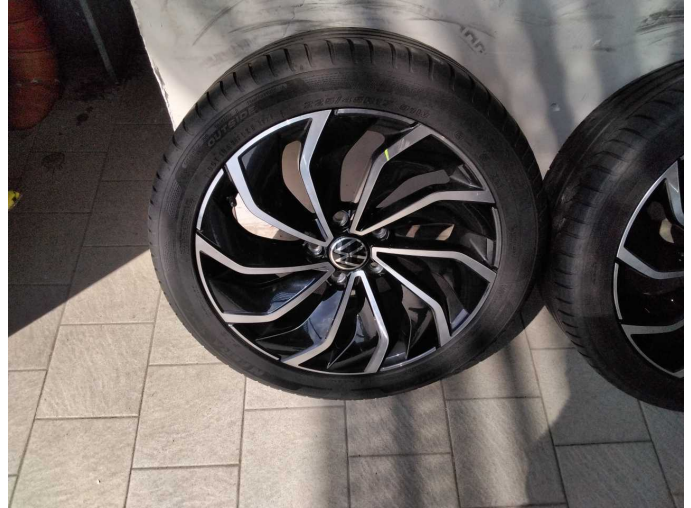
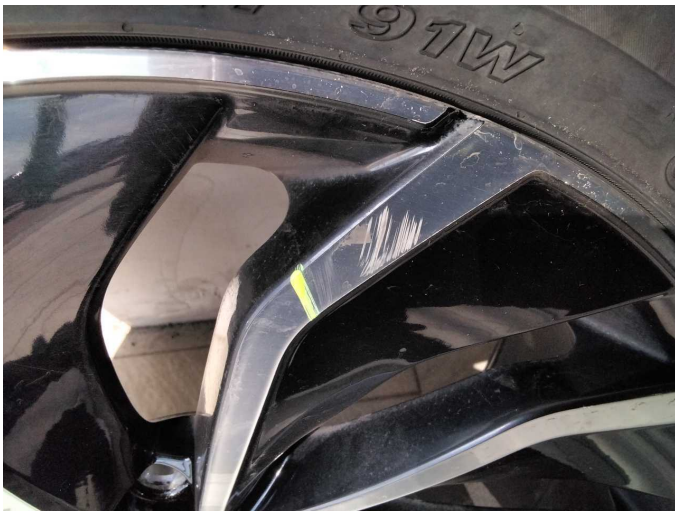
**Damage 5:** 2nd wheel set: 1 alloy rim - Scratch(es) - Loss in value

| No. | Component group | Description |
|---|---|---|
| 5 | 2nd wheel set | 1 alloy rim - Scratch(es) - Loss in value |

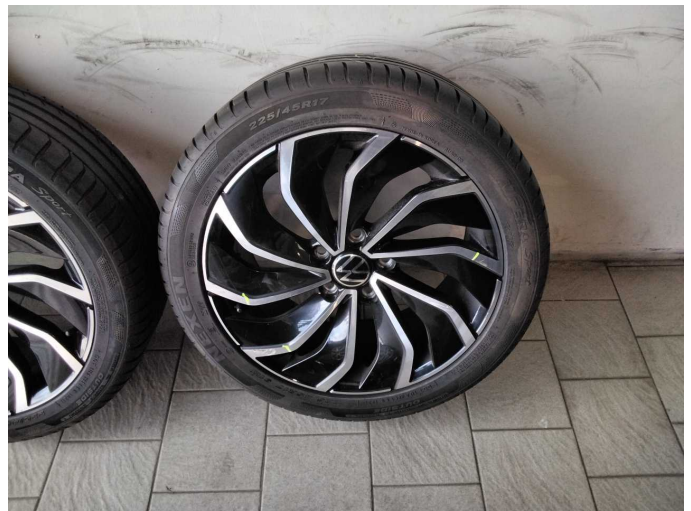
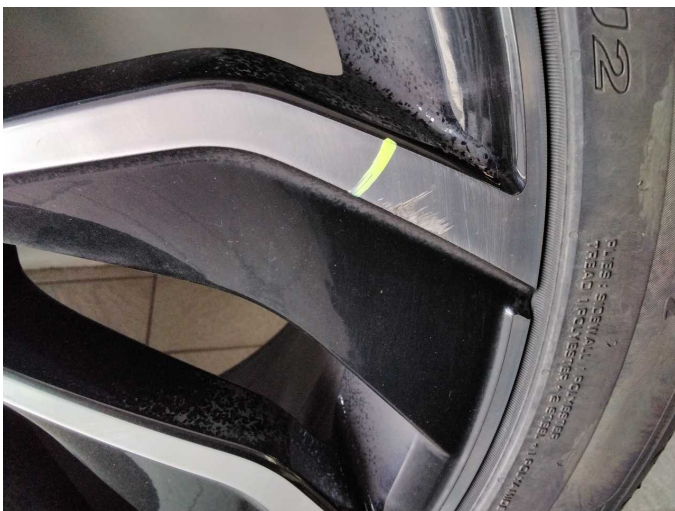
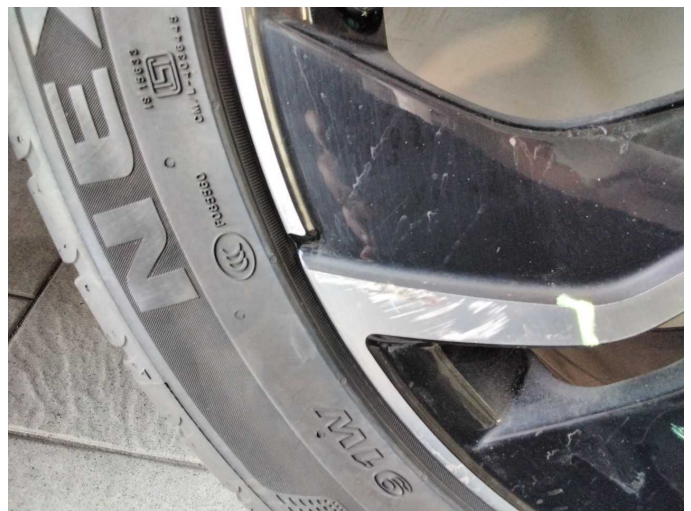
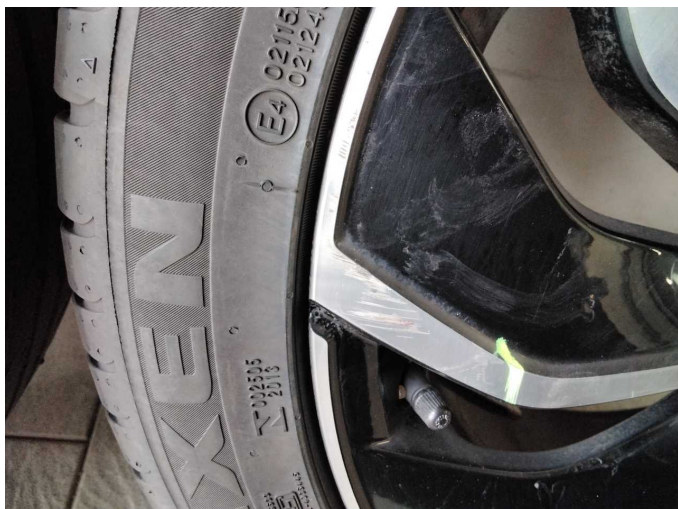
**Damage 6:** 2nd wheel set: 1 alloy rim - Scratch(es) - Loss in value

| No. | Component group | Description |
|---|---|---|
| 6 | 2nd wheel set | 1 alloy rim - Scratch(es) - Loss in value |

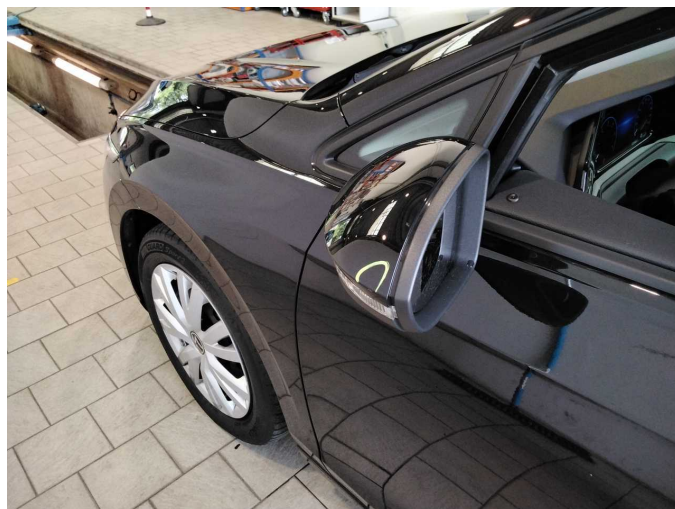
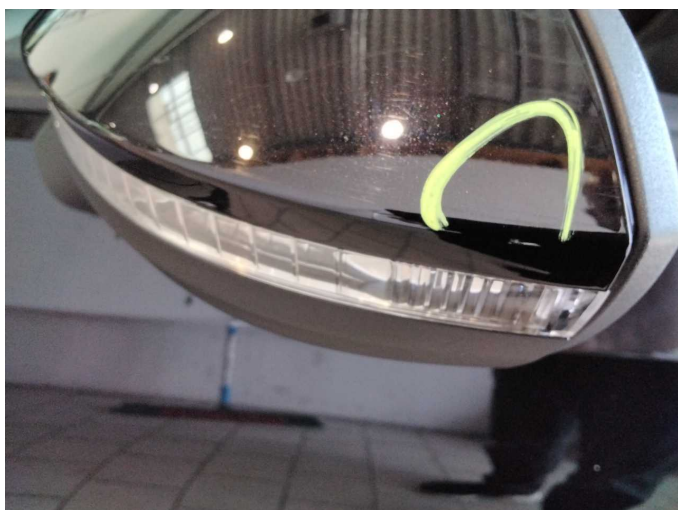
**Damage 7:** Wing mirror - left side: Cap - Scratch(es) - Paint

| No. | Component group | Description |
|---|---|---|
| 7 | Wing mirror - left side | Cap - Scratch(es) - Paint |

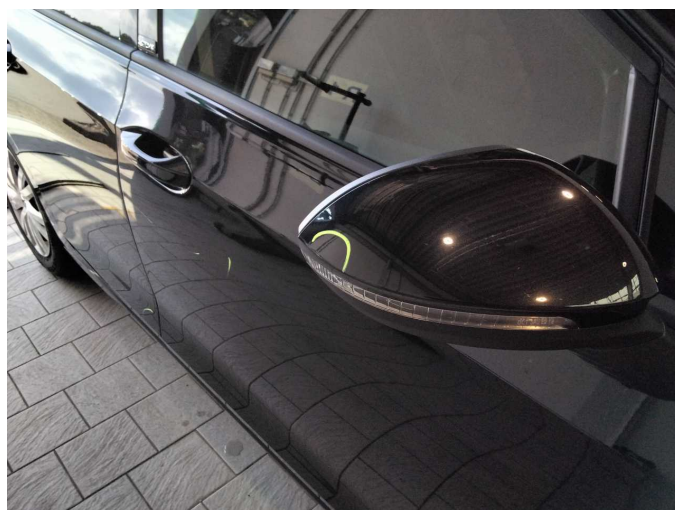
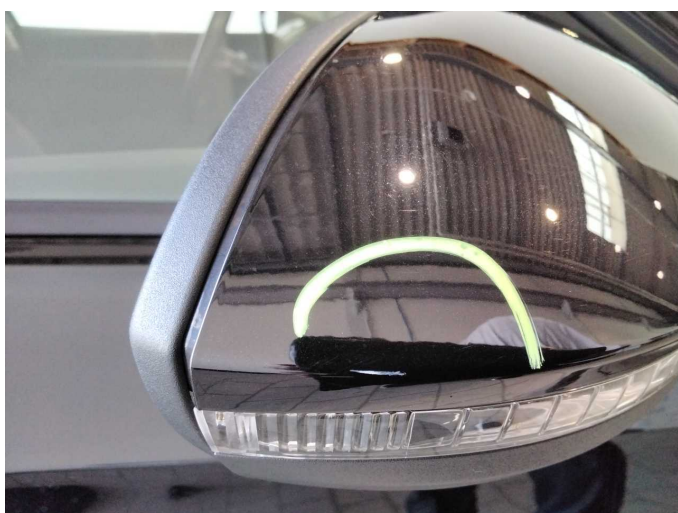
**Damage 8:** Wing mirror - right side: Cap - Scratch(es) - Paint

| No. | Component group | Description |
|---|---|---|
| 8 | Wing mirror - right side | Cap - Scratch(es) - Paint |

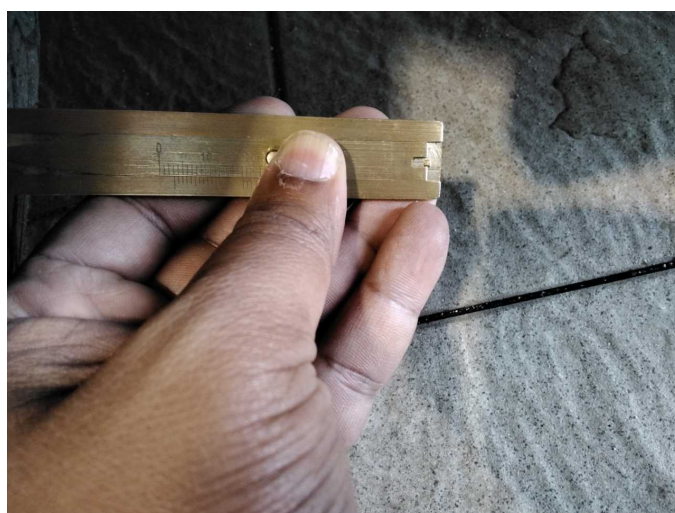
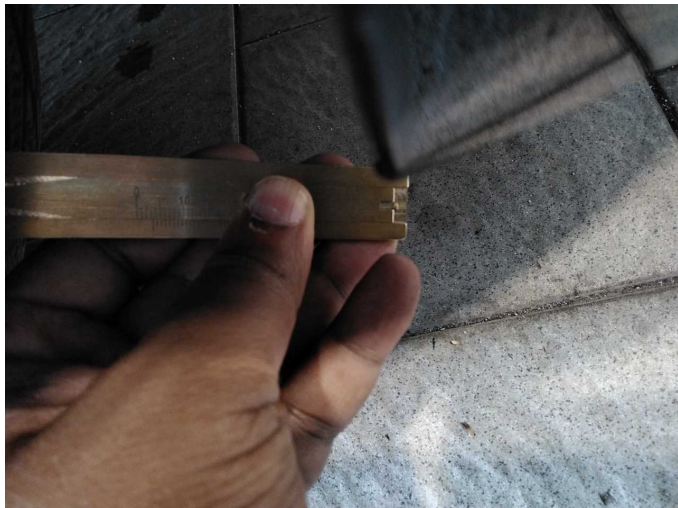
**Damage 9:** Wheel / tyres: Tyre - front (3mm) - does not meet manufacturer specifications - Replace

| No. | Component group | Description |
|---|---|---|
| 9 | Wheel / tyres | Tyre - front (3mm) - does not meet manufacturer specifications - Replace |

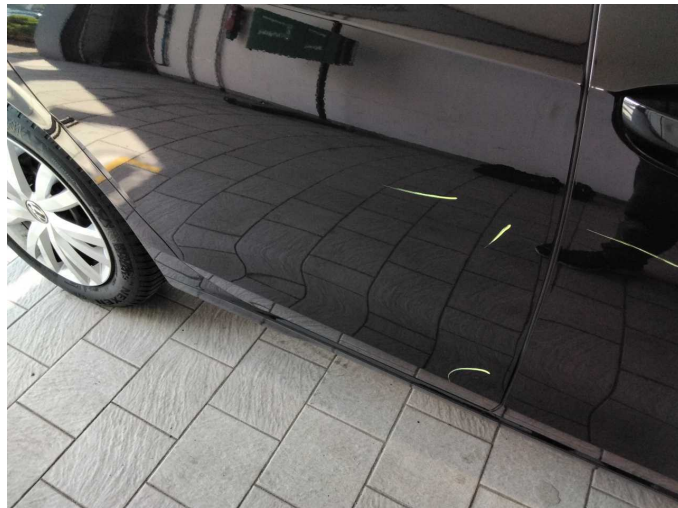
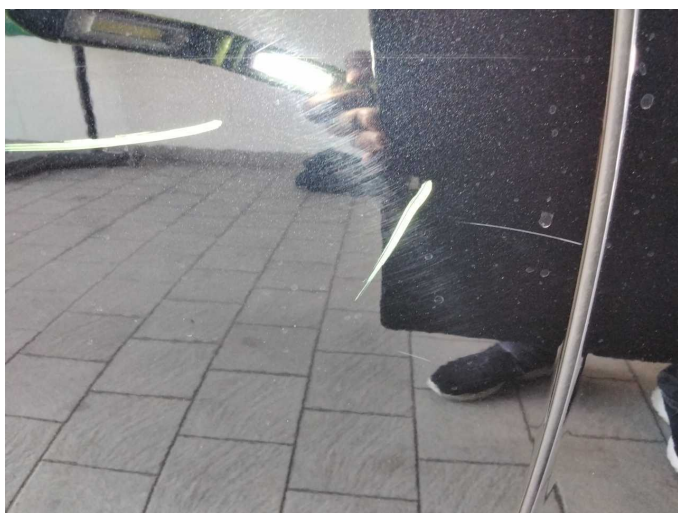
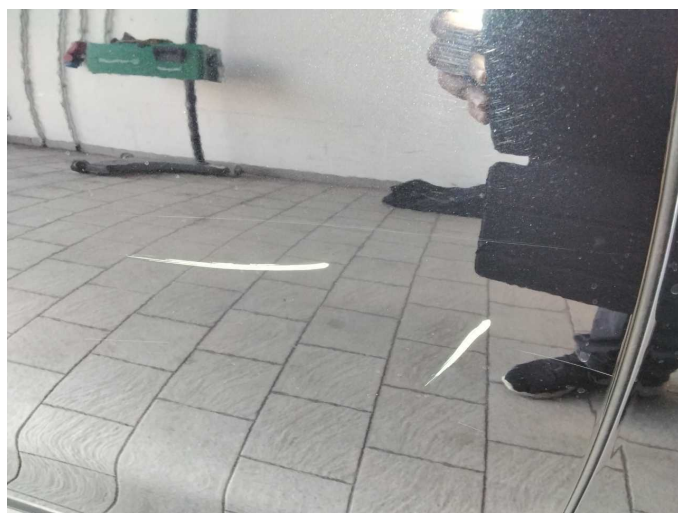
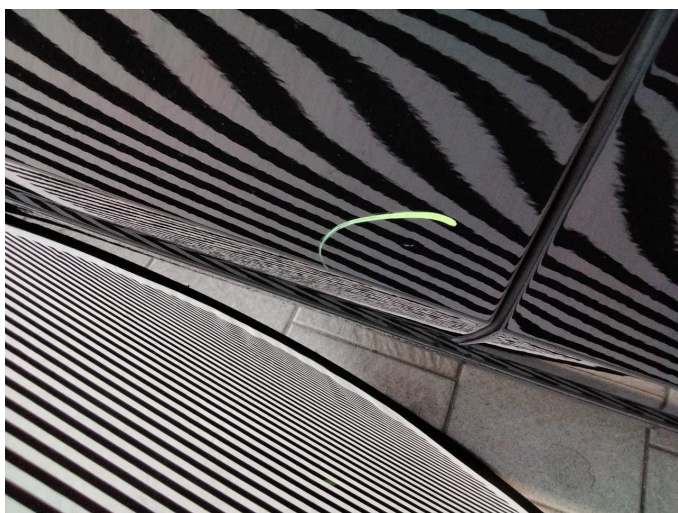
**Damage 10:** Door - rear right side: Door - Dent / paintcoat damage - Repair and paint

| No. | Component group | Description |
|---|---|---|
| 10 | Door - rear right side | Door - Dent / paintcoat damage - Repair and paint |

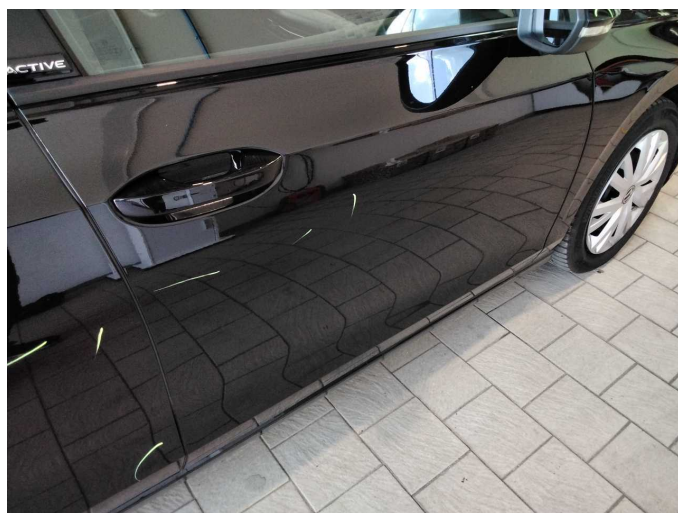
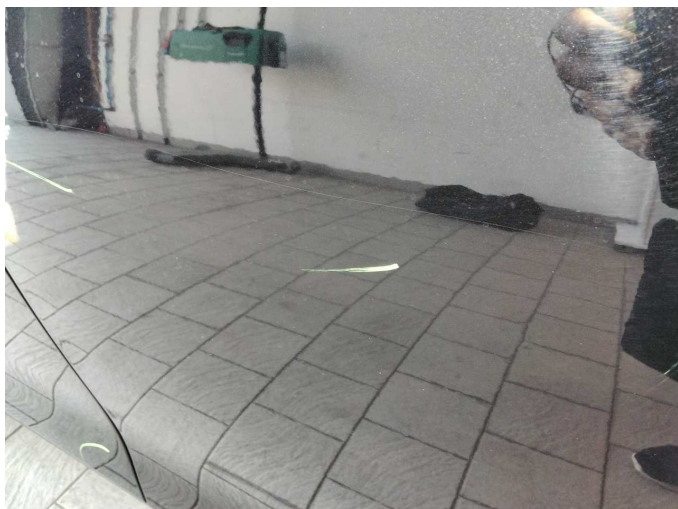
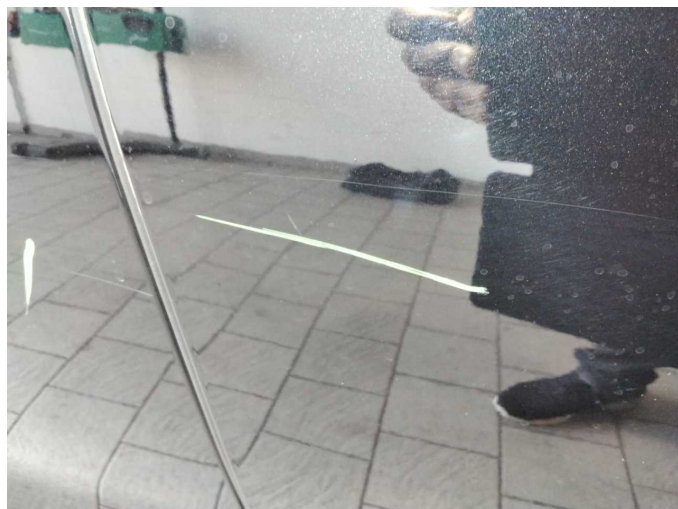
**Damage 11:** Door - front right side: Door - Scratch(es) - Paint

| No. | Component group | Description |
|---|---|---|
| 11 | Door - front right side | Door - Scratch(es) - Paint |

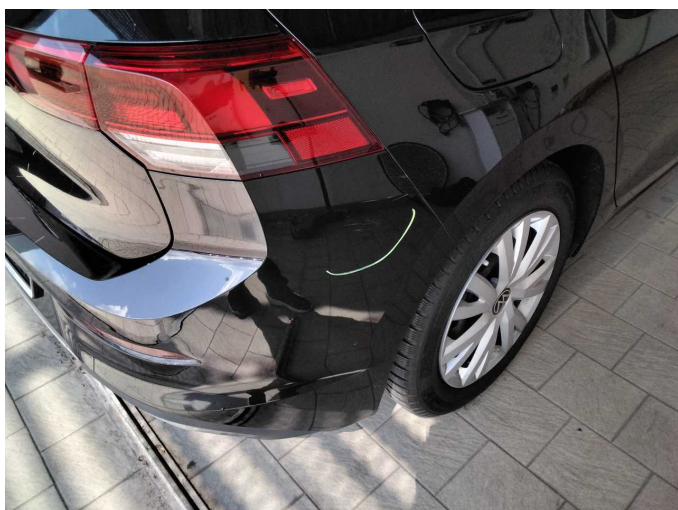
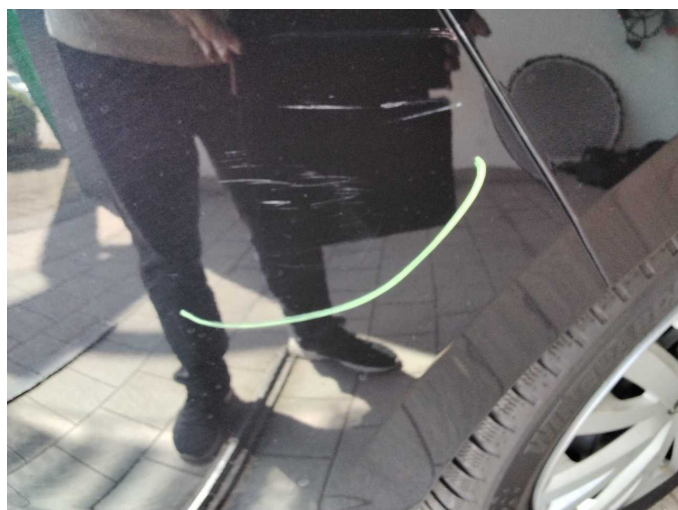
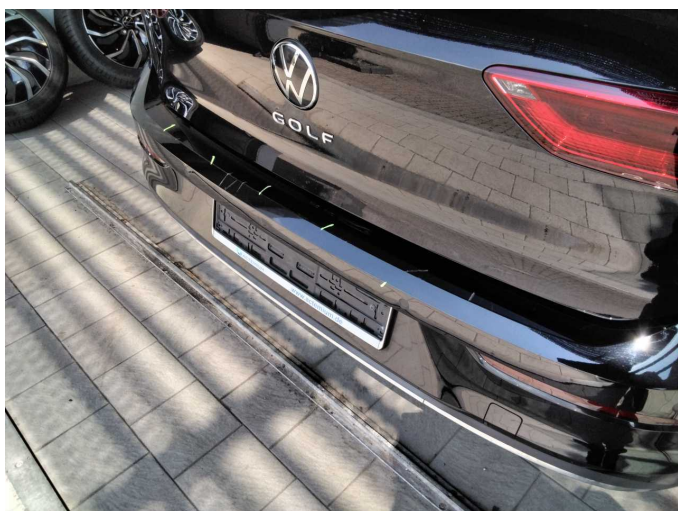
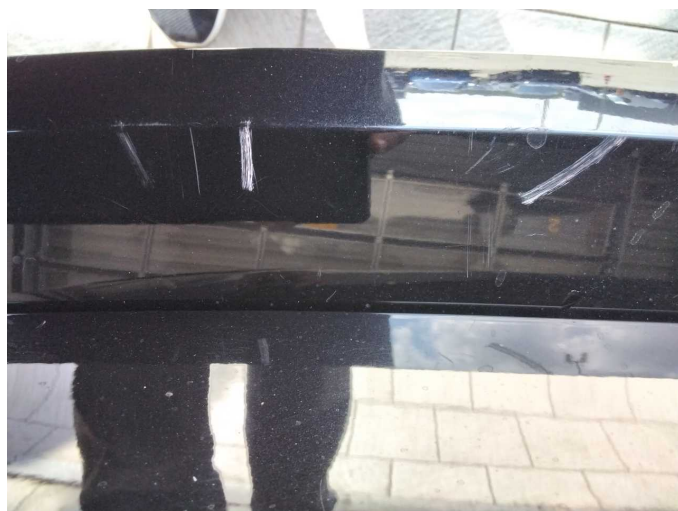
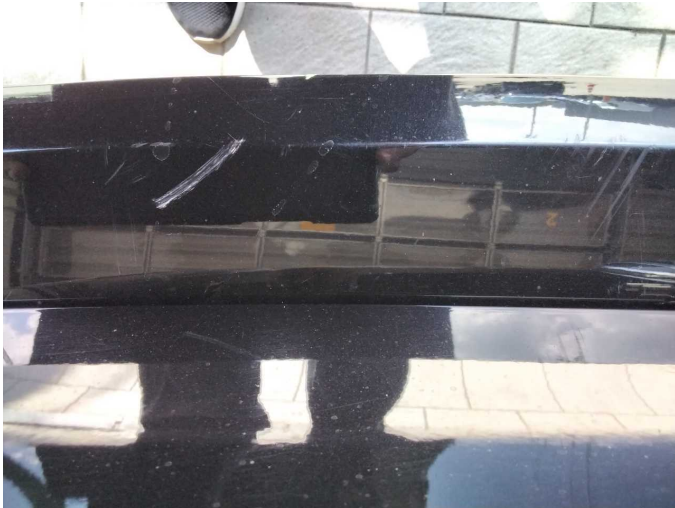
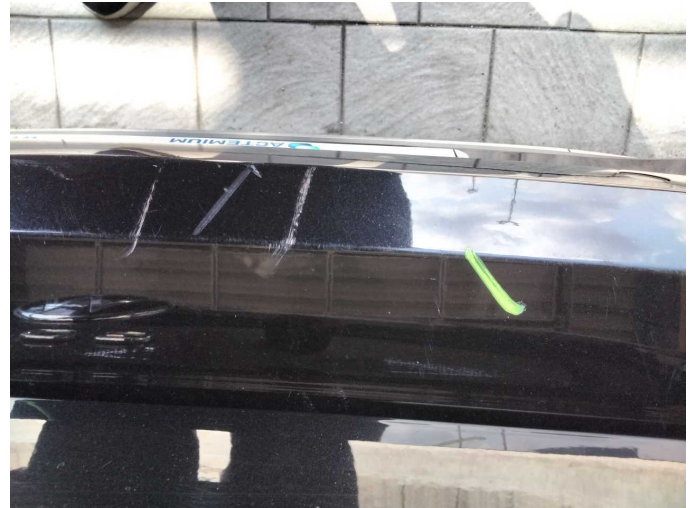
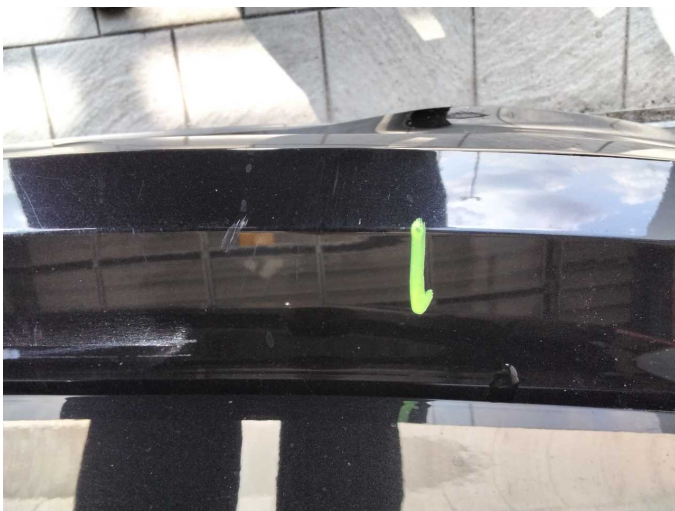
**Damage 12:** Rear bumper: Rear bumper - Scratch(es) - Paint

| No. | Component group | Description |
|---|---|---|
| 12 | Rear bumper | Rear bumper - Scratch(es) - Paint |

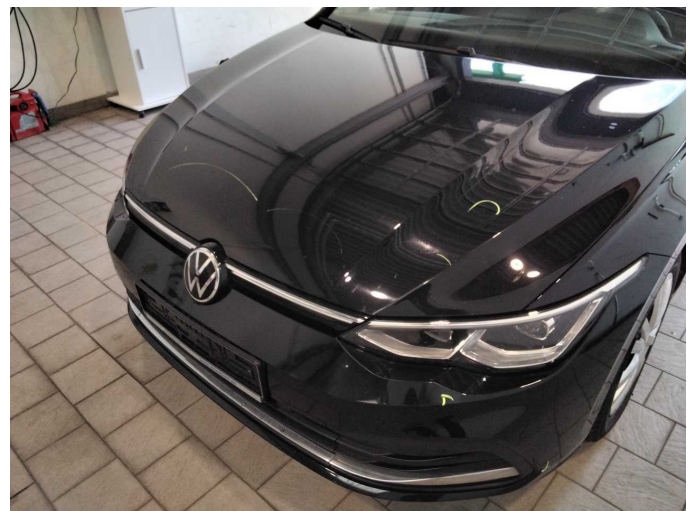
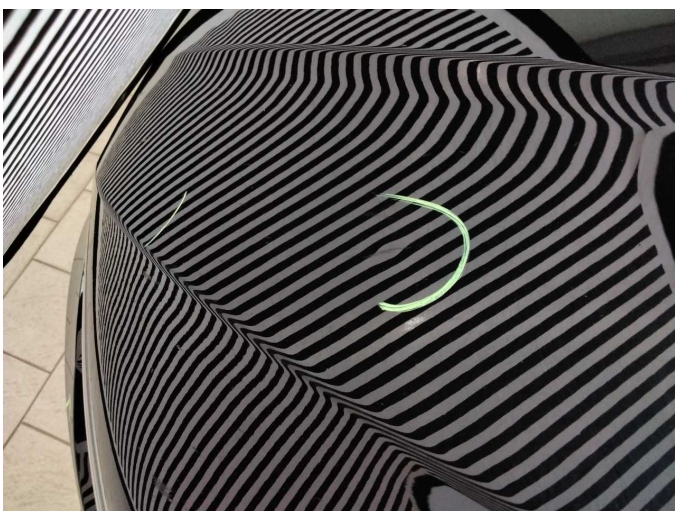
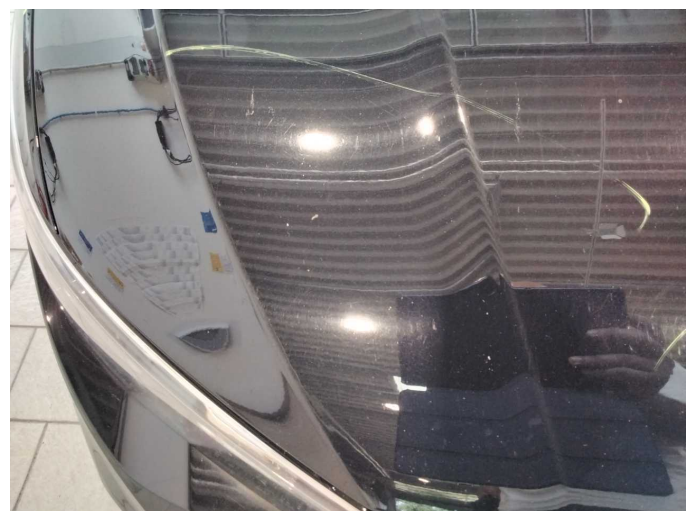
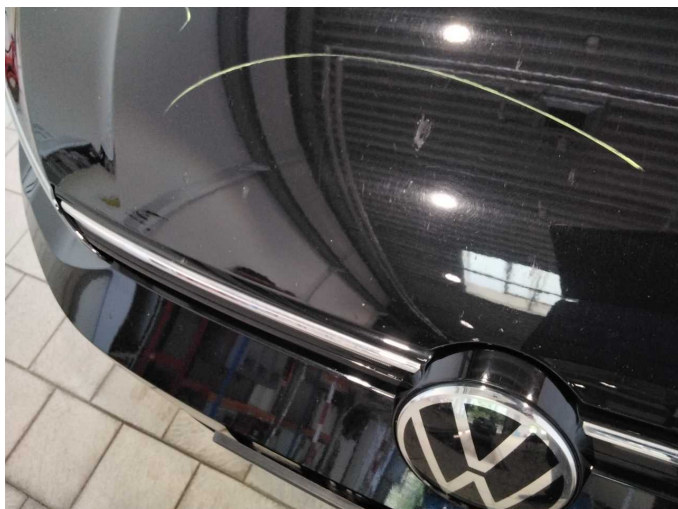
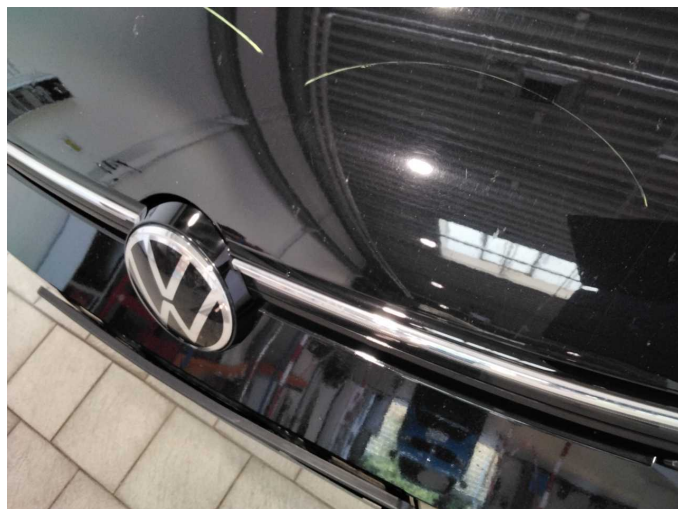
**Damage 13:** Bonnet: Bonnet - Dent / paintcoat damage - Repair and paint

| No. | Component group | Description |
|---|---|---|
| 13 | Bonnet | Bonnet - Dent / paintcoat damage - Repair and paint |

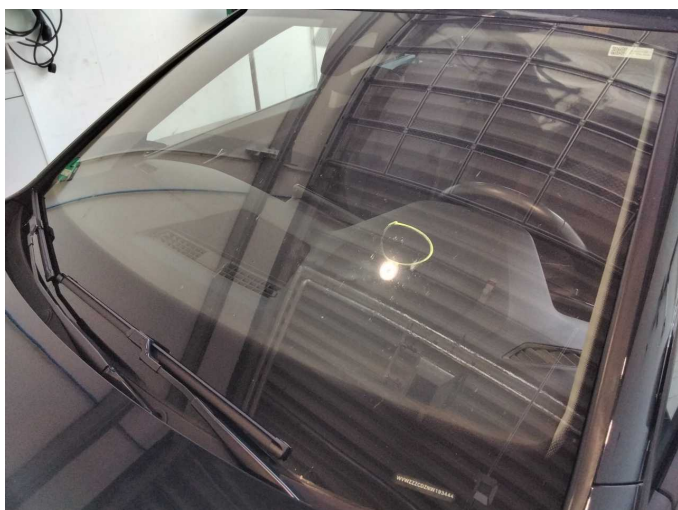
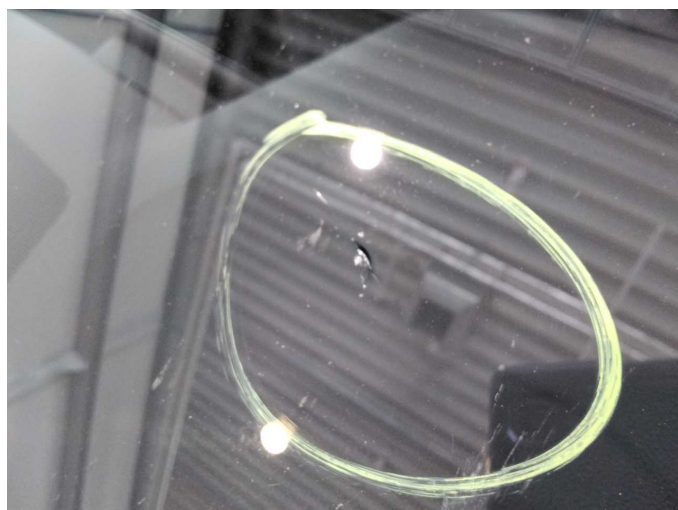
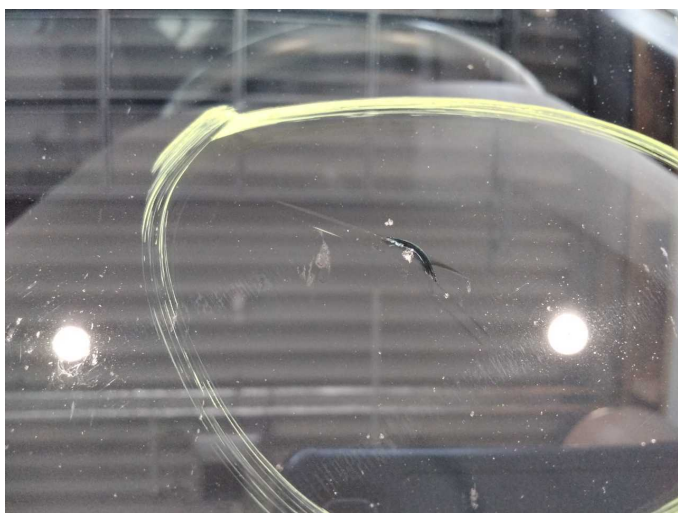
**Damage 14:** Vehicle glazing: Windscreen - Stone chips - Replace

| No. | Component group | Description |
|---|---|---|
| 14 | Vehicle glazing | Windscreen - Stone chips - Replace |
