Expertise

Protocol number: 46738789  
Order No. / Reference: 26631150  
Inspection date: 27 Jul 2026

Manufacturer: Audi

Model: Q3 35 TDI Sportback S tronic S line

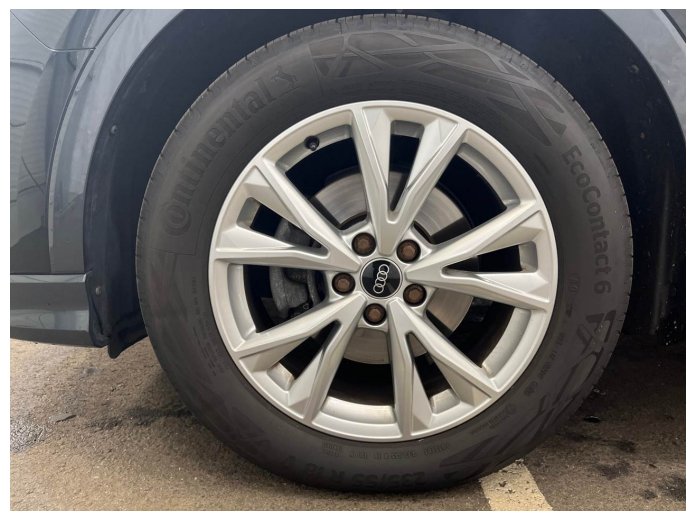
Figure 12: Mounted tyres

| # | Tyre size | Type of tyre | Manufacturer | Tread depth |
|---|---|---|---|---|
| 1) | 235/55 R18 100V | Summer tyres on Light alloy | Continental | 5mm / 5mm |
| 2) | 235/55 R18 100V | Summer tyres on Light alloy | Continental | 5mm / 5mm |

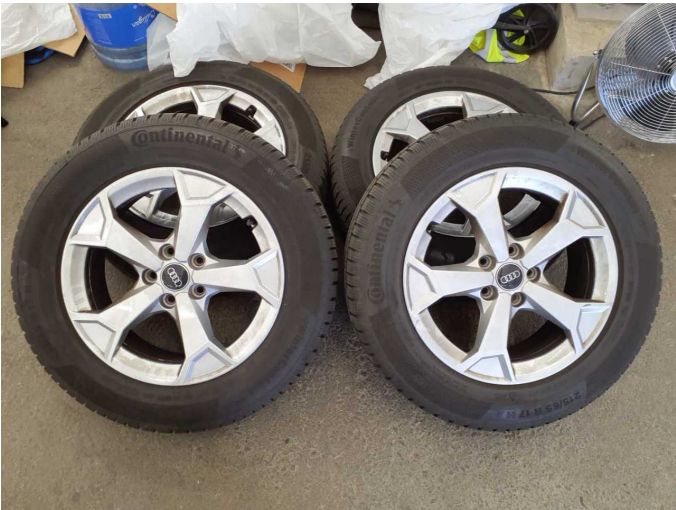
Figure 17: Additional tyres

| # | Tyre size | Type of tyre | Manufacturer | Tread depth |
|---|---|---|---|---|
| 1) | 215/65 R17 99H | Winter tyres on Light alloy | Continental | 6mm / 6mm |
| 2) | 215/65 R17 99H | Winter tyres on Light alloy | Continental | 5mm / 5mm |

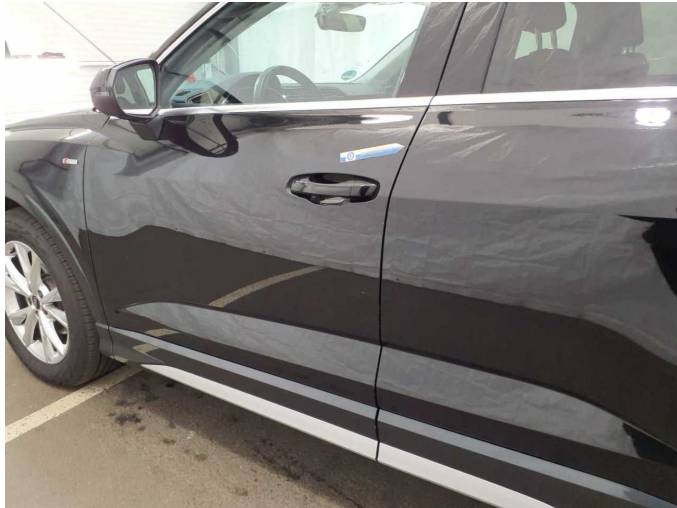
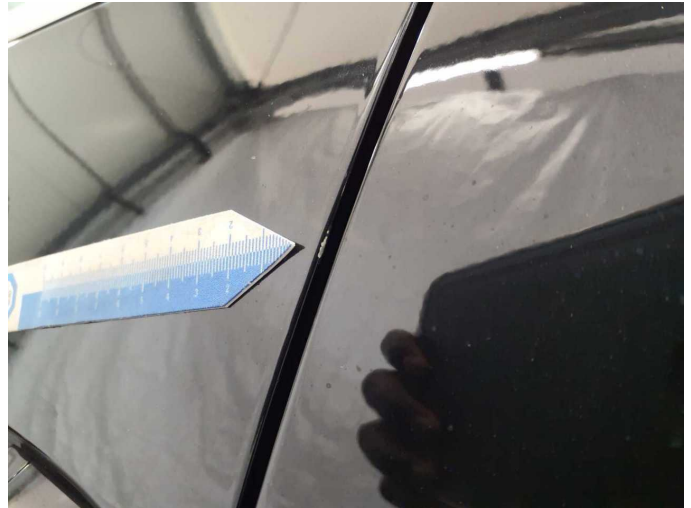
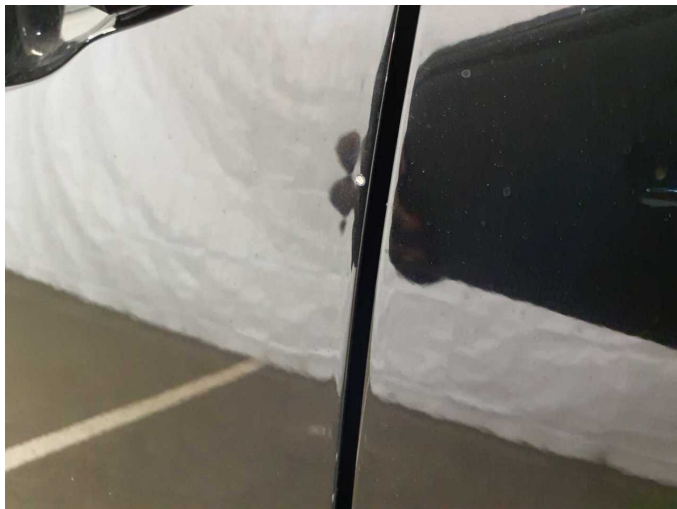
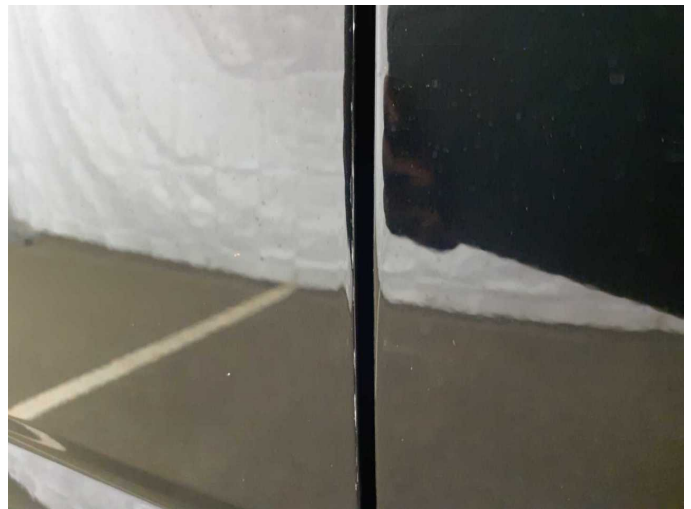
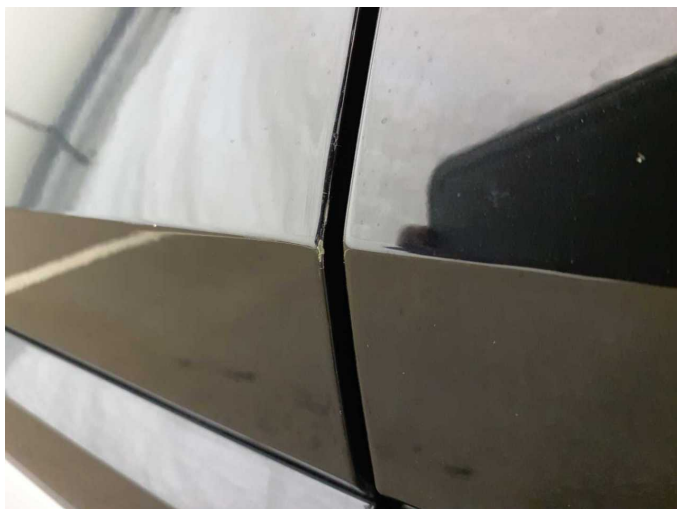
| No. | Component group | Description |
|---|---|---|
| 1 | Door - front left side | Door edge - Scratch(es) - Smart repair |

**Damage 1:** Door - front left side: Door edge - Scratch(es) - Smart repair

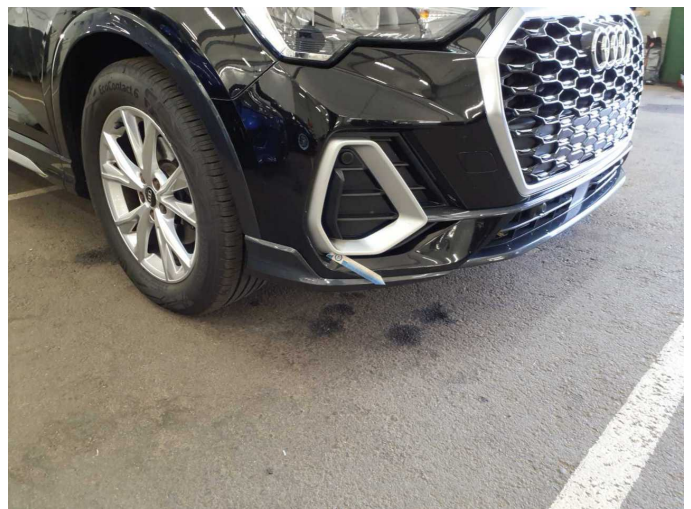
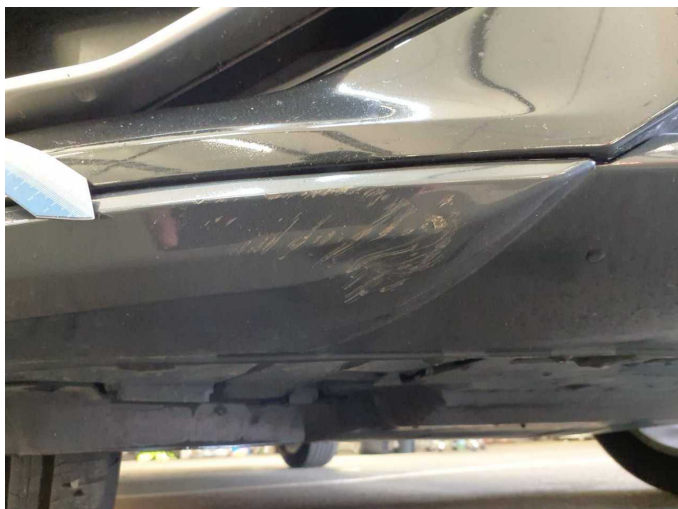
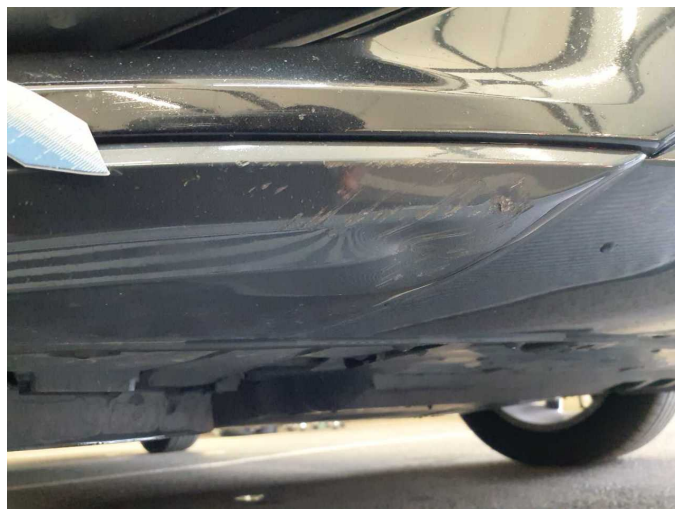
| No. | Component group | Description |
|---|---|---|
| 2 | Front bumper | Spoiler - Deformed - Replace |

**Damage 2:** Front bumper: Spoiler - Deformed - Replace

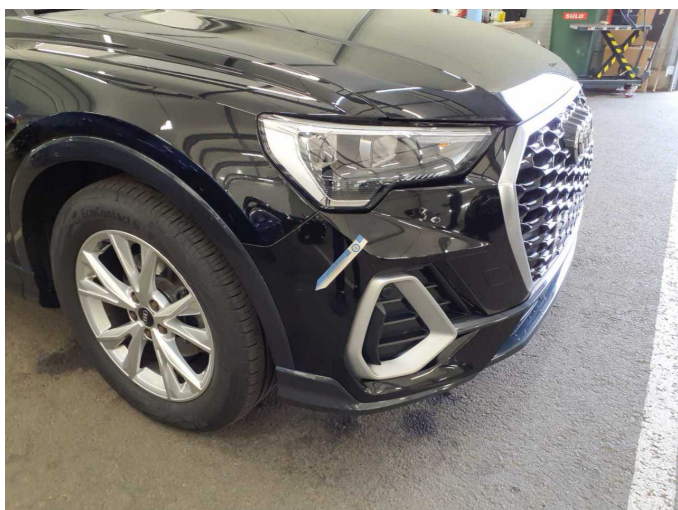
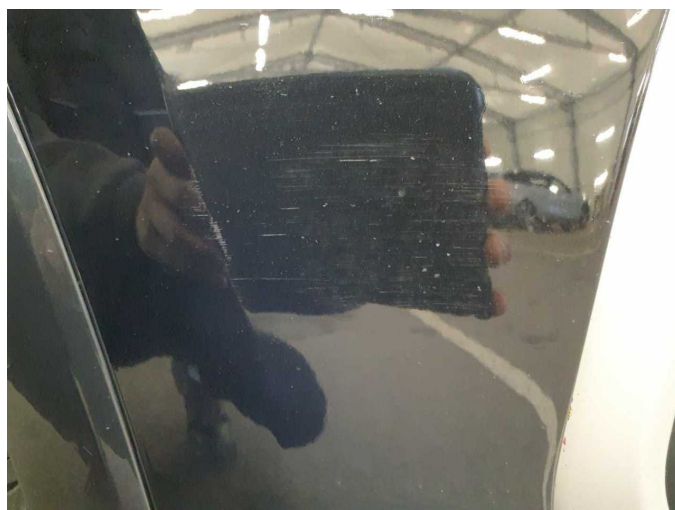
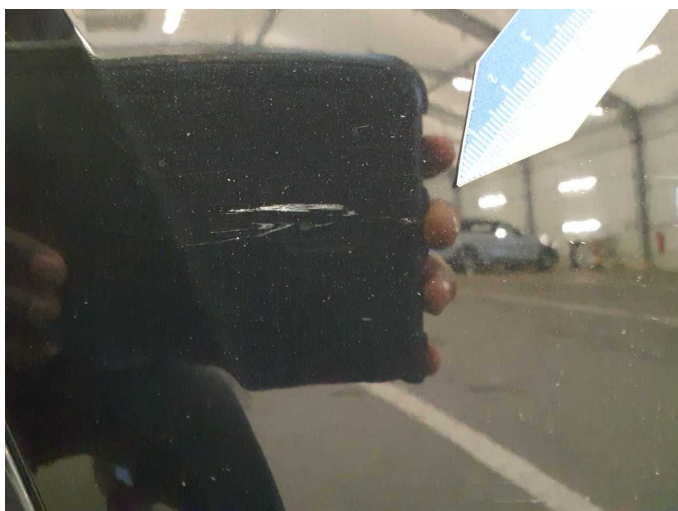
| No. | Component group | Description |
|---|---|---|
| 3 | Front bumper | Front bumper - Scratch(es) - Paint |

**Damage 3:** Front bumper: Front bumper - Scratch(es) - Paint

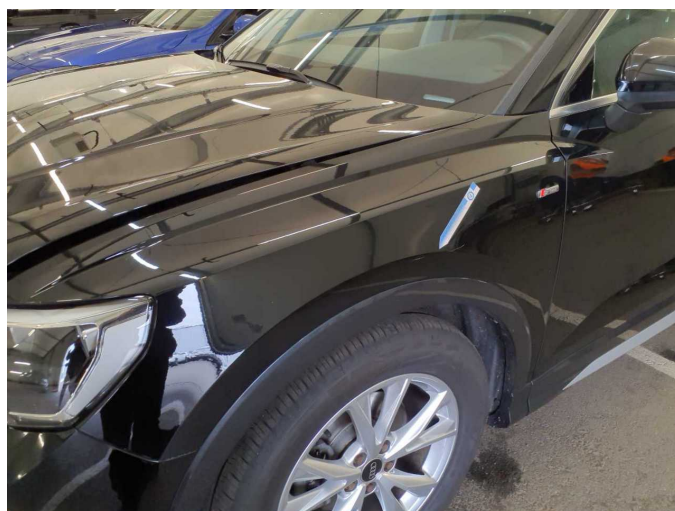
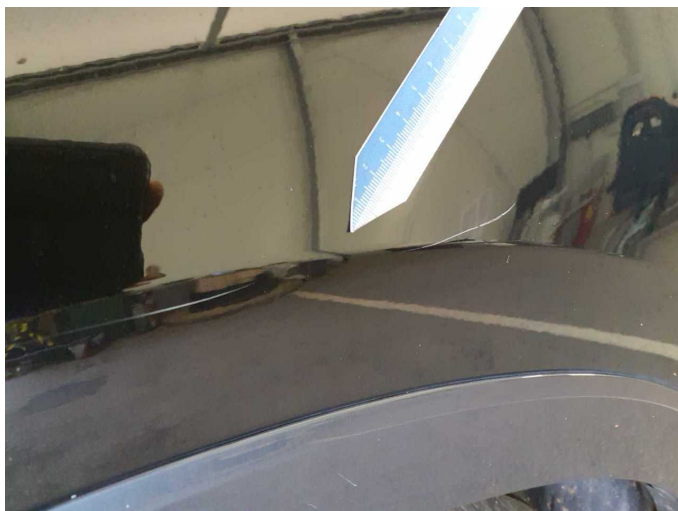
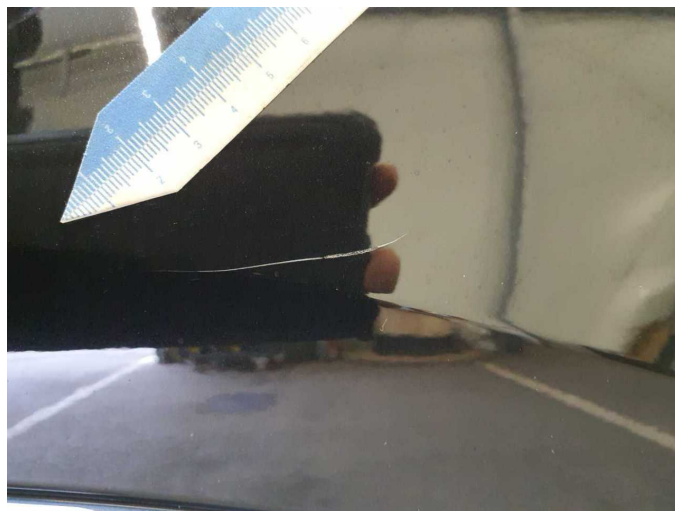
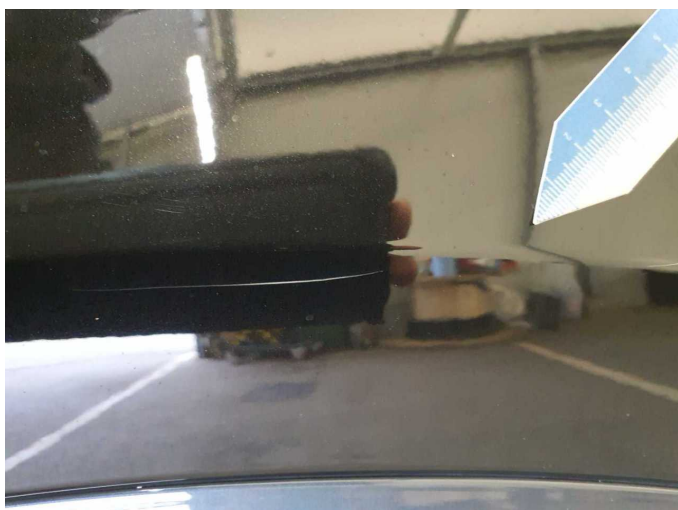
| No. | Component group | Description |
|---|---|---|
| 4 | Mudguard - left side | Mudguard - left side - Scratch(es) - Paint |

**Damage 4:** Mudguard - left side: Mudguard - left side - Scratch(es) - Paint

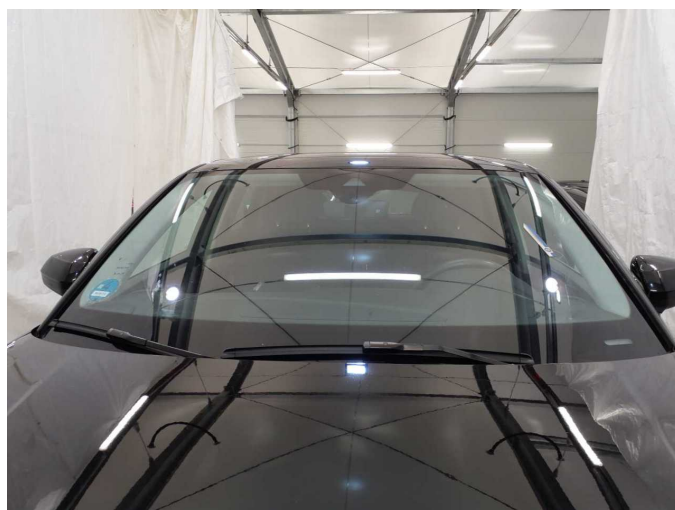
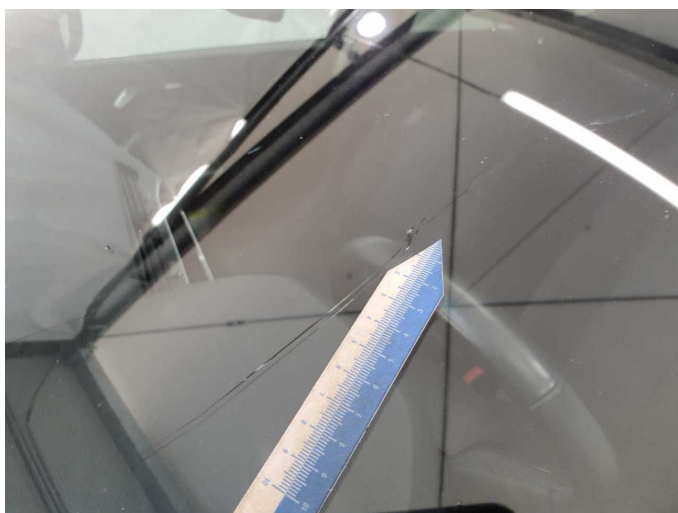
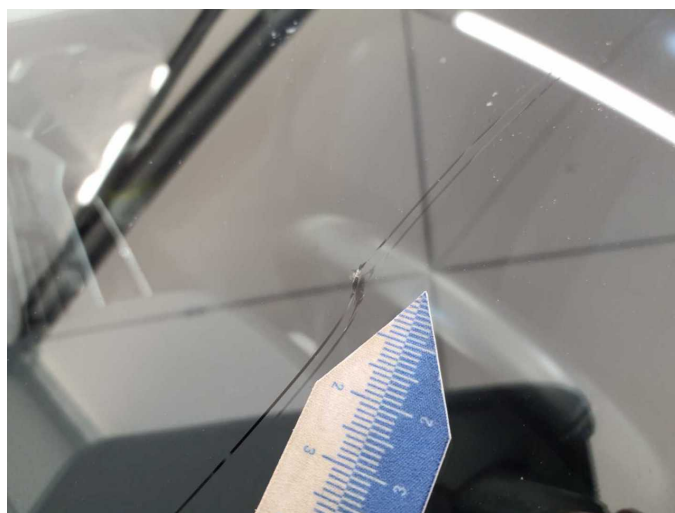
| No. | Component group | Description |
|---|---|---|
| 5 | Vehicle glazing | Windscreen with lane departure assistant - Broken / torn - Replace |

**Damage 5:** Vehicle glazing: Windscreen with lane departure assistant - Broken / torn - Replace

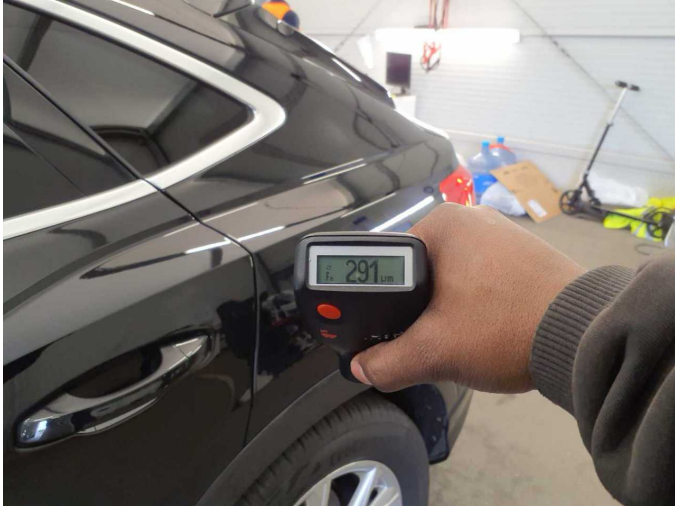
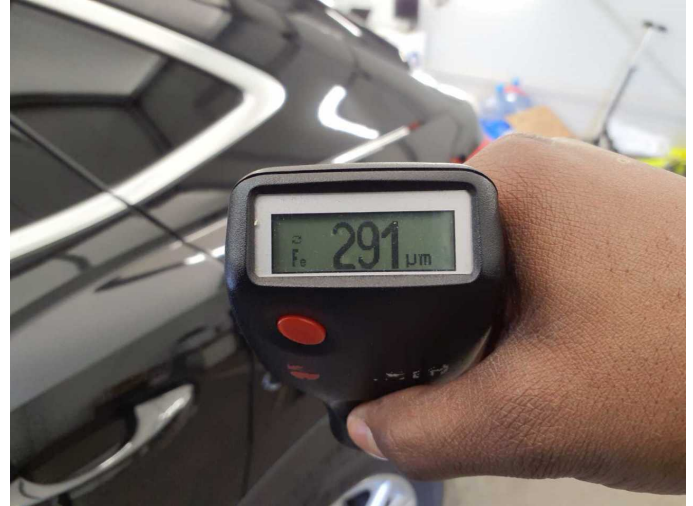
| No. | Repainting |
|---|---|
| 1 | Side panel - rear left side, Professionally carried out, Invoice of repair done Non-existent |

| Side panel - rear left side | 291 µm | Side panel - rear right side | 249 µm |

**Repainting 1:** Side panel - rear left side

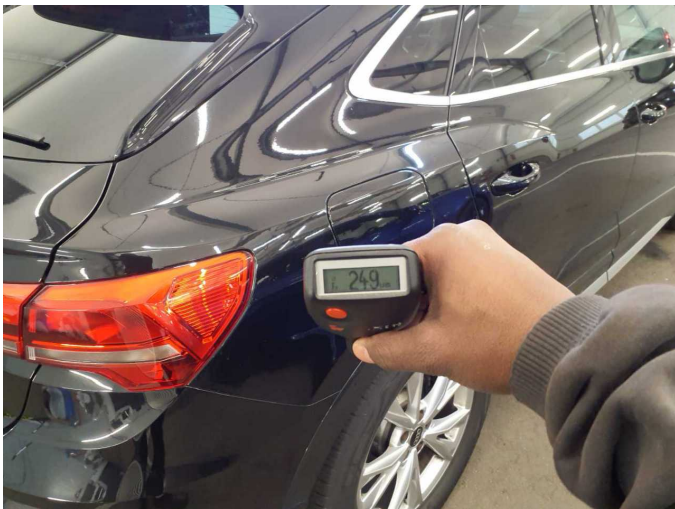
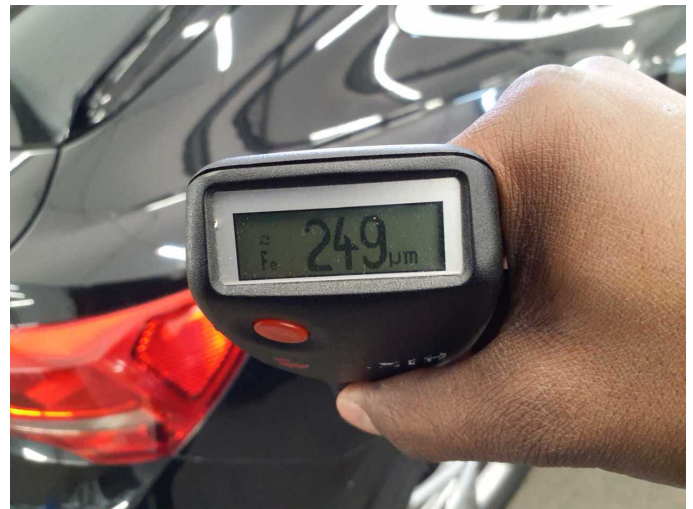
| No. | Repainting |
|---|---|
| 2 | Side panel - rear right side, Professionally carried out, Invoice of repair done Non-existent |

**Repainting 2:** Side panel - rear right side

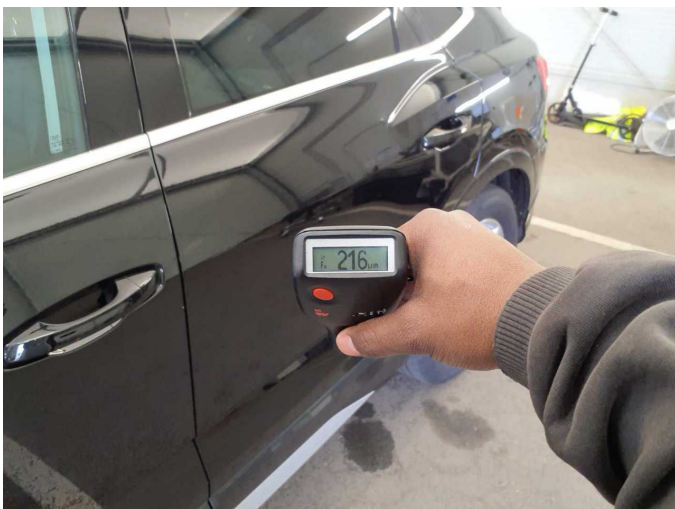
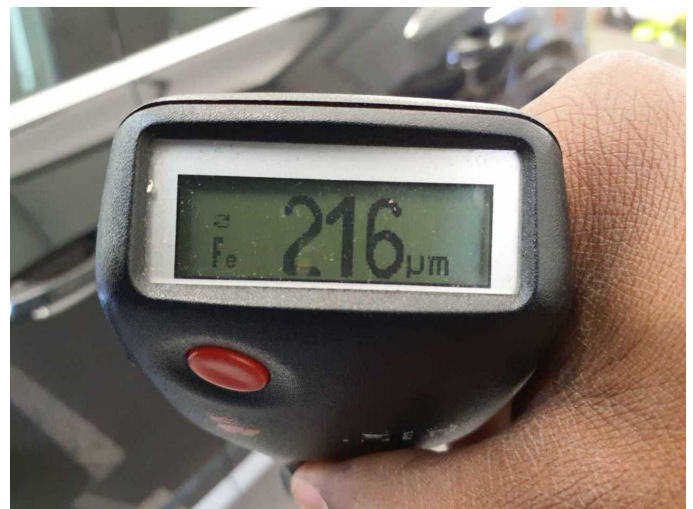
| No. | Repainting |
|---|---|
| 3 | Door - rear left side, Professionally carried out, Invoice of repair done Non-existent |

| Door - rear left side | 216 µm | Door - rear right side | 575 µm |

**Repainting 3:** Door - rear left side

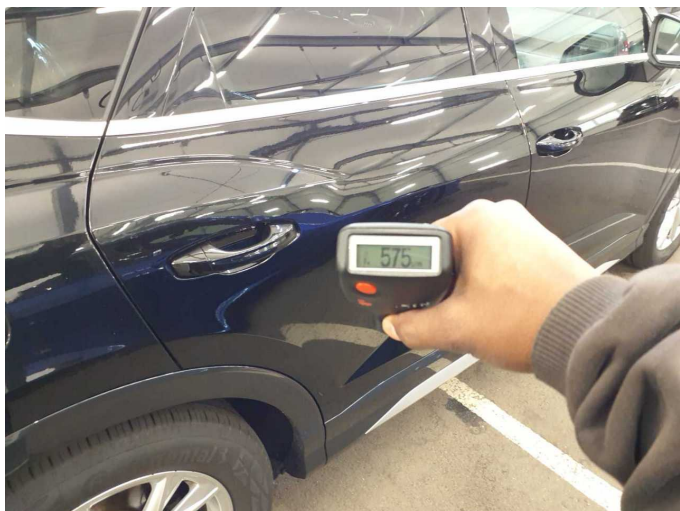
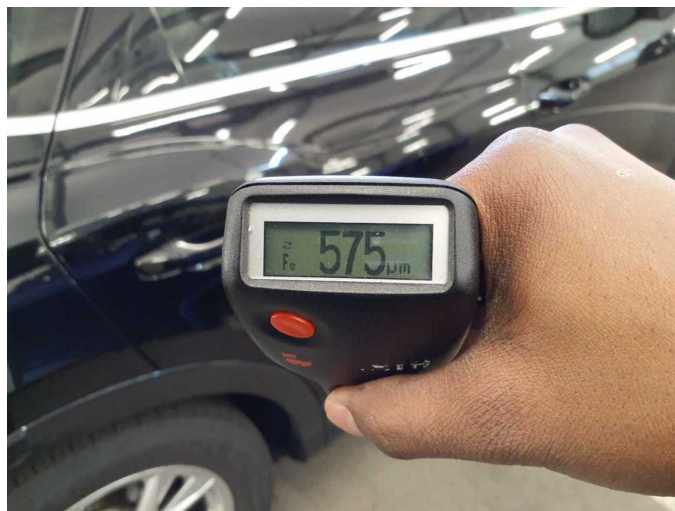
| No. | Repainting |
|---|---|
| 4 | Door - rear right side, Professionally carried out, Invoice of repair done Non-existent |

**Repainting 4:** Door - rear right side
