Expertise

Protocol number: 46639241  
Order No. / Reference: 26687401  
Inspection date: 21 Jul 2026

Manufacturer: Volkswagen

Model: ID.4 GTX

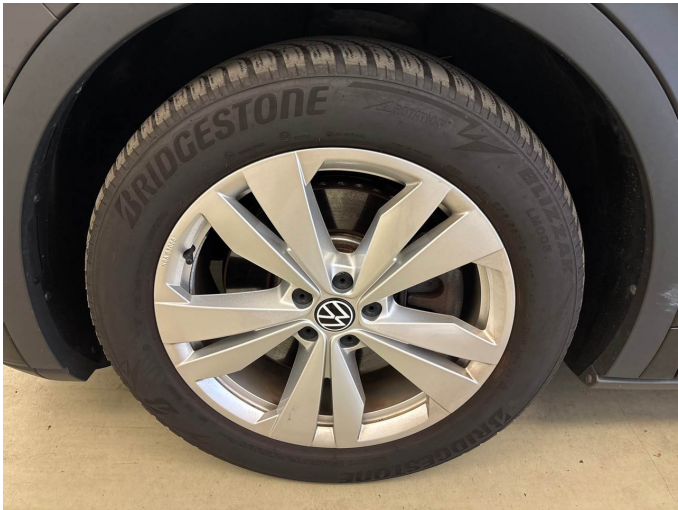
Figure 12: Mounted tyres

| Tyres | | | | |
|---|---|---|---|---|
| 1) | 235/55 R19 101T | Winter tyres on Light alloy | Bridgestone | 5mm / 5mm |
| 2) | 255/50 R19 103T | Winter tyres on Light alloy | Bridgestone | 6mm / 6mm |

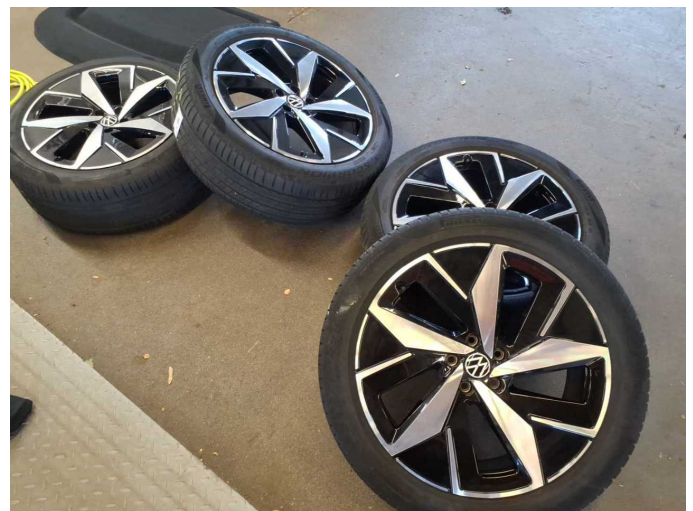
Figure 16: Additional tyres

| Tyres | | | | |
|---|---|---|---|---|
| 1) | 235/50 R20 100T | Summer tyres on Light alloy | Pirelli | 5mm / 5mm |
| 2) | 255/45 R20 101T | Summer tyres on Light alloy | Pirelli | 6mm / 6mm |

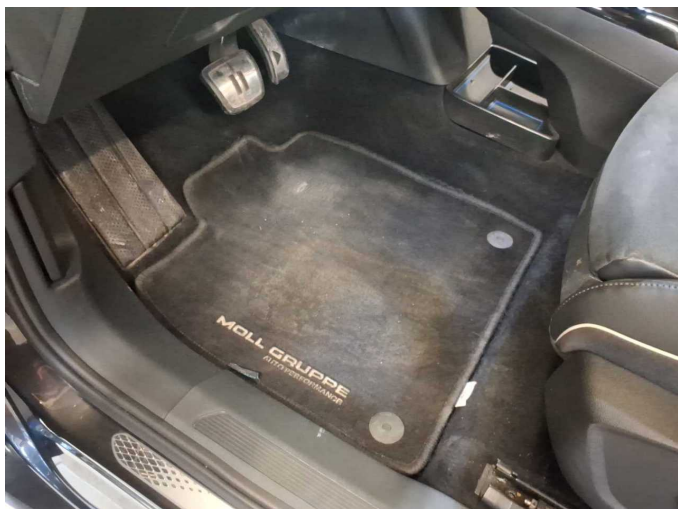
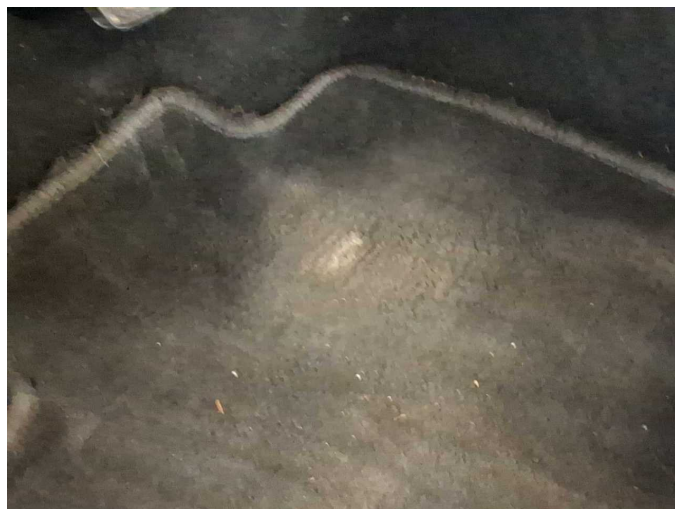
| No. | Component group | Description |
|---|---|---|
| 1 | Trim / covers | Floor mats - Broken / torn - Replace |

**Damage 1:** Trim / covers: Floor mats - Broken / torn - Replace

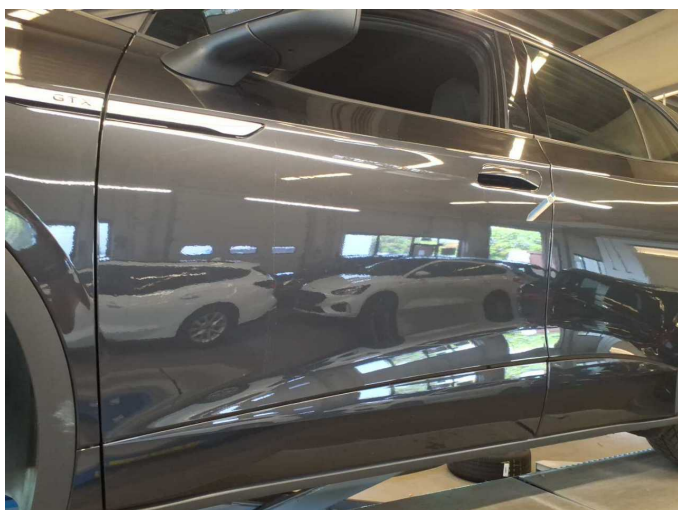
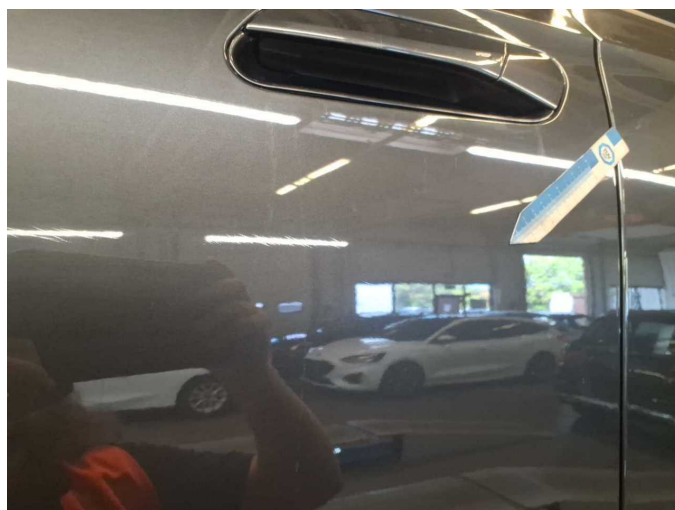
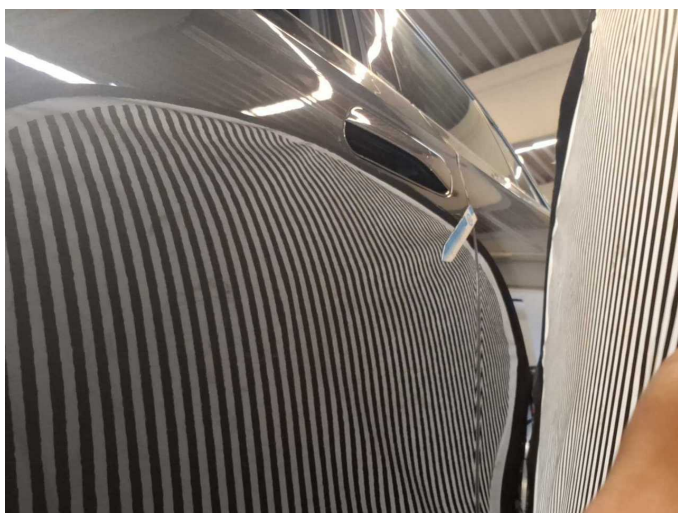
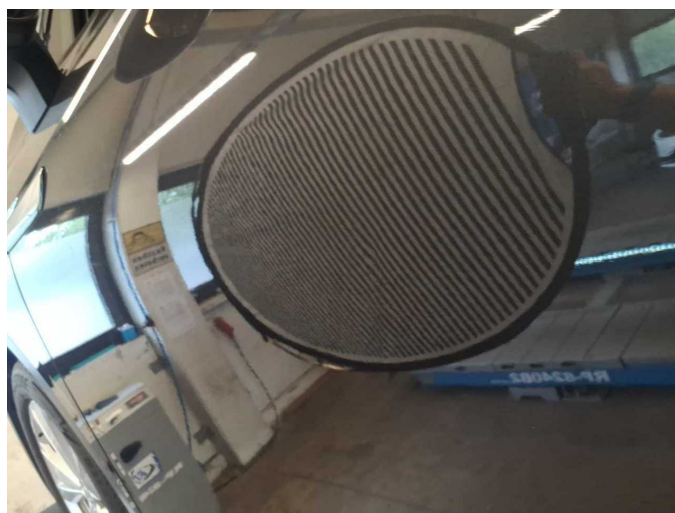
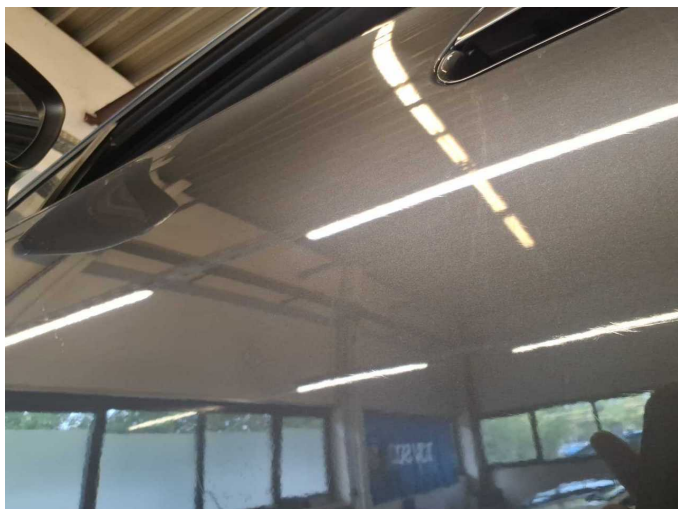
| No. | Component group | Description |
|---|---|---|
| 2 | Door - front left side | Door (Schleifspuren im Lack) - Unprofessionally repaired - Repair and paint |

**Damage 2:** Door - front left side: Door (Schleifspuren im Lack) - Unprofessionally repaired - Repair and paint

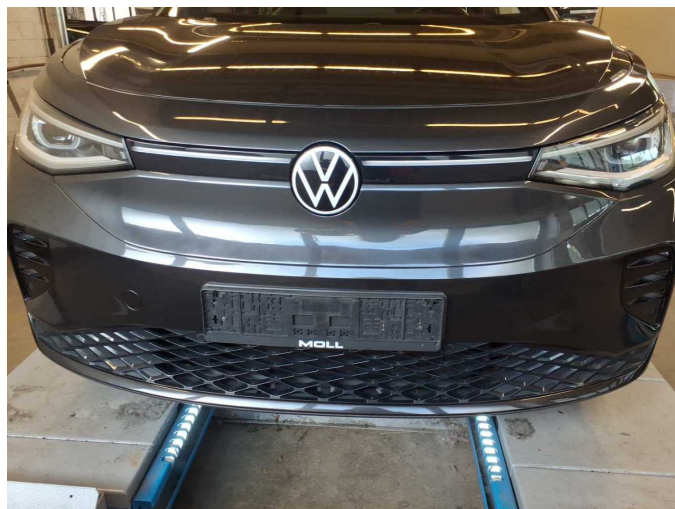
| No. | Component group | Description |
|---|---|---|
| 1 | Front bumper | Front bumper - Stone chips - No deduction |

**Wear and tear 1:** Front bumper: Front bumper - Stone chips - No deduction

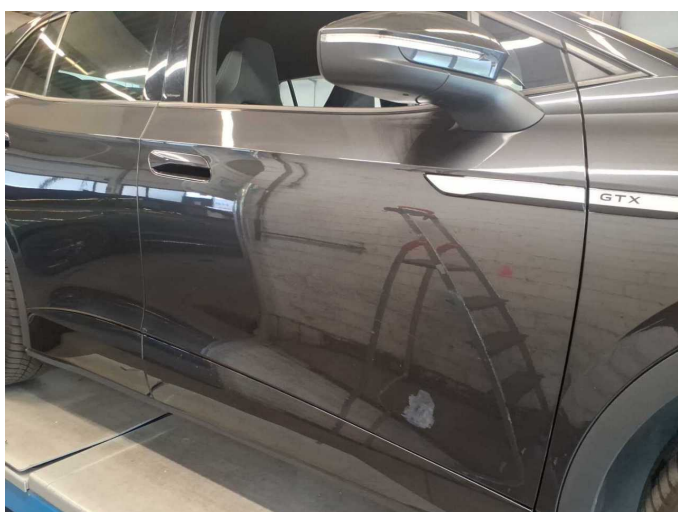
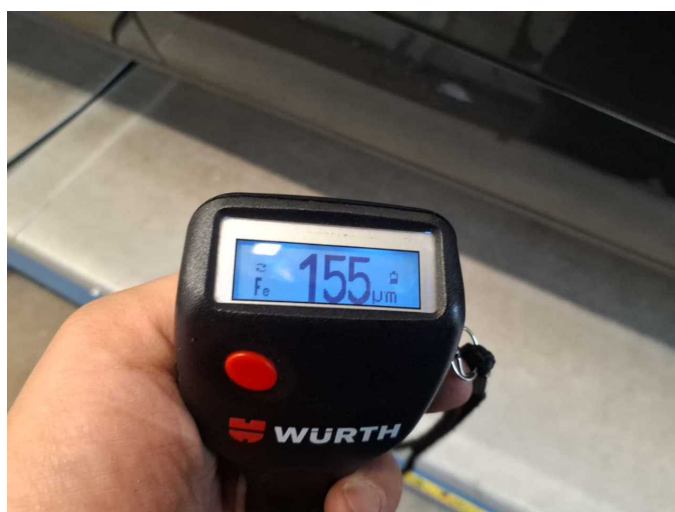
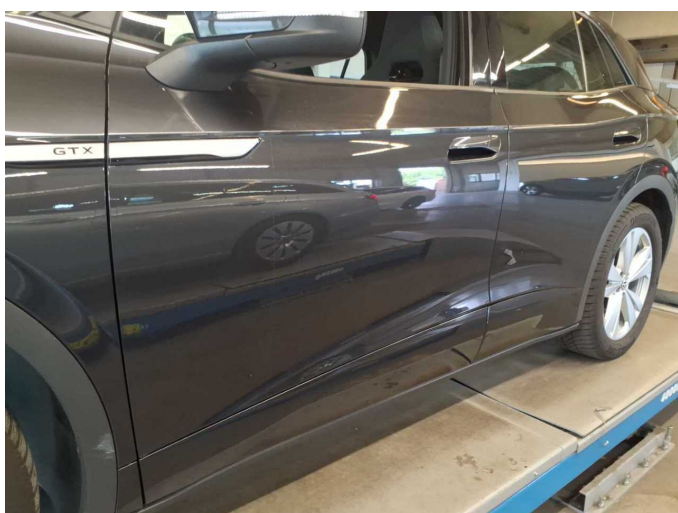
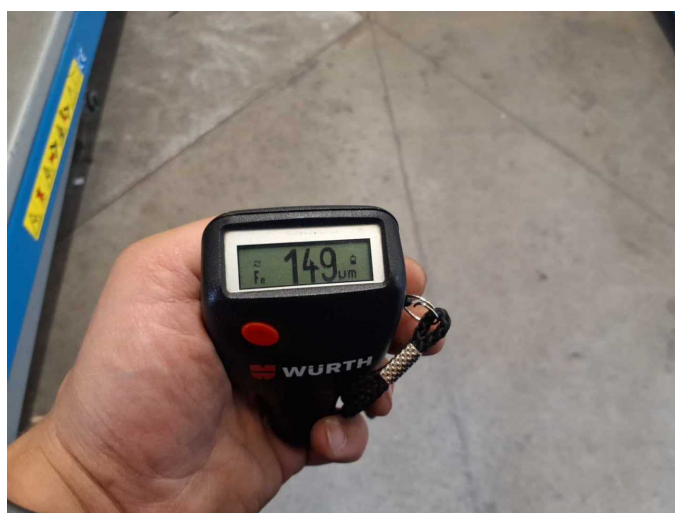
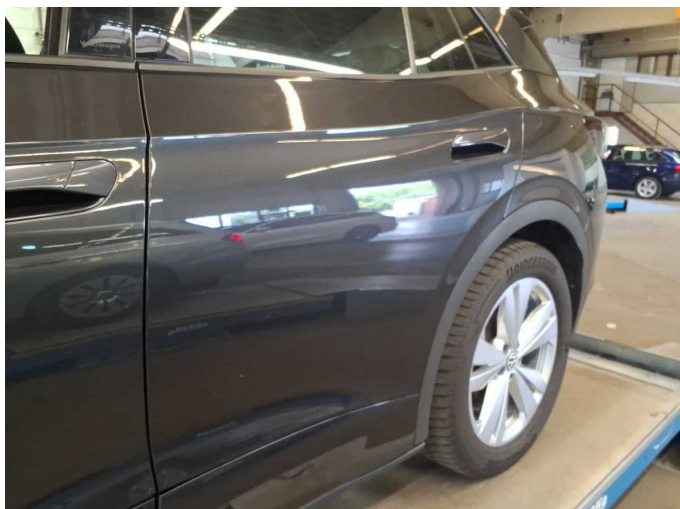
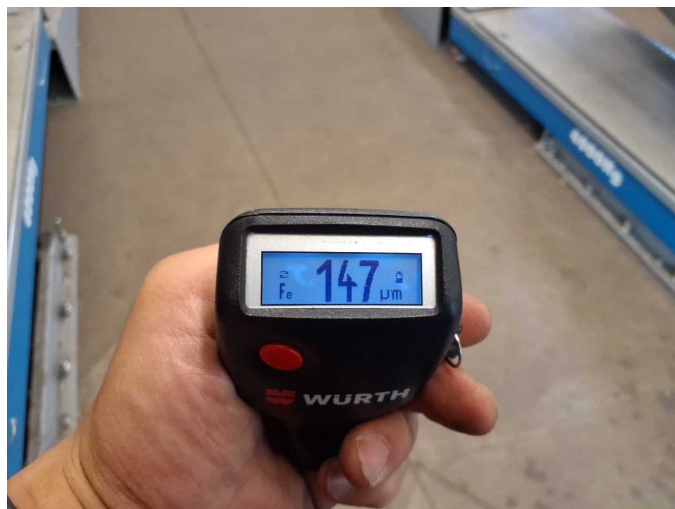
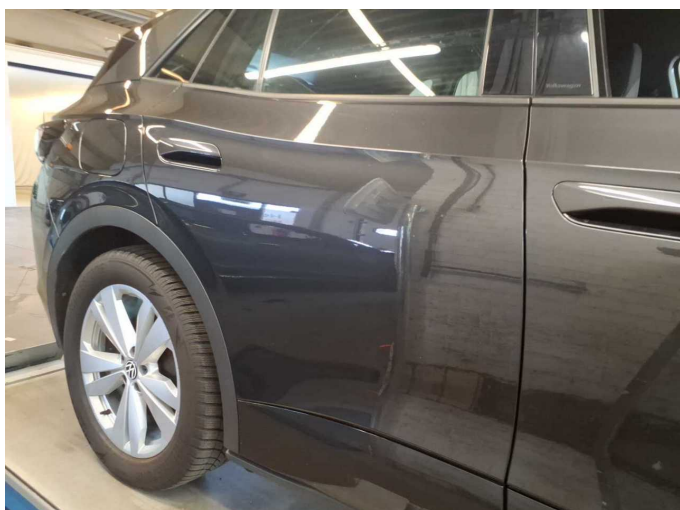
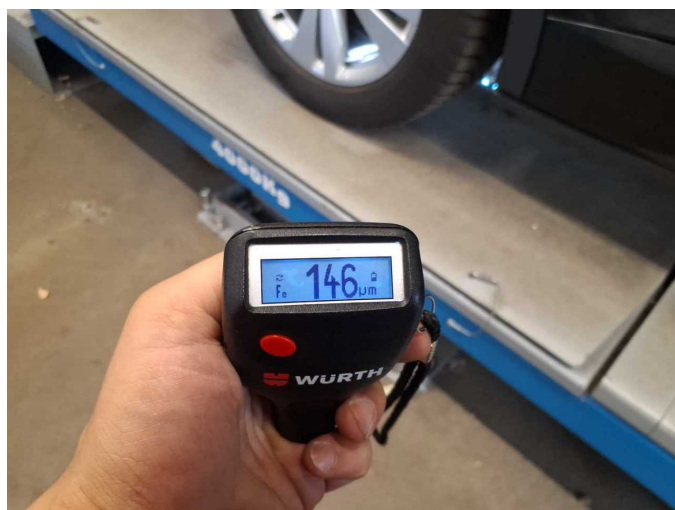
| No. | Repainting |
|---|---|
| 1 | Door - rear left side, Door - rear right side, Door - front left side, Door - front right side |

| Door - rear left side | 146 µm | Door - rear right side | 163 µm |
| Door - front left side | 161 µm | Door - front right side | 156 µm |

**Repainting 1:** Door - rear left side, Door - rear right side, Door - front left side, Door - front right side
