Expertise

Protocol number: 46058405  
Order No. / Reference: 26539954  
Inspection date: 19 Jun 2026

Manufacturer: Ford

Model: Grand Tourneo Connect 1.5 EcoBlue Start/Stop Trend

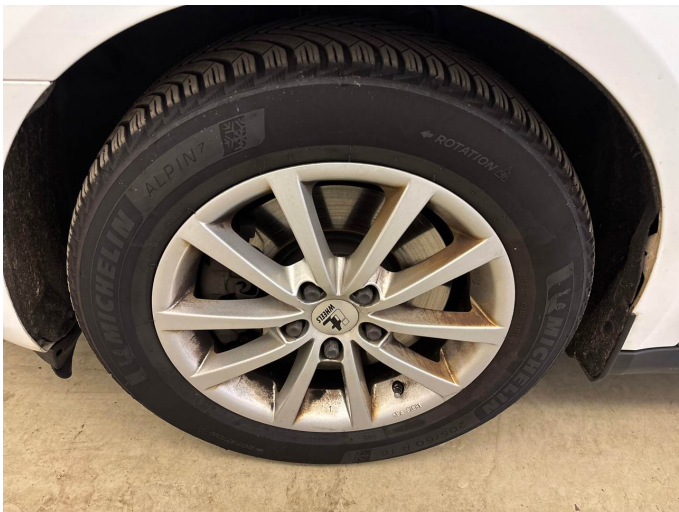
Figure 12: Mounted tyres

| # | Tyre size | Type of tyre | Manufacturer | Tread depth |
|---|---|---|---|---|
| 1) | 205/60 R16 96H | Winter tyres on Light alloy | Michelin | 5mm / 5mm |
| 2) | 205/60 R16 96H | Winter tyres on Light alloy | Michelin | 5mm / 5mm |

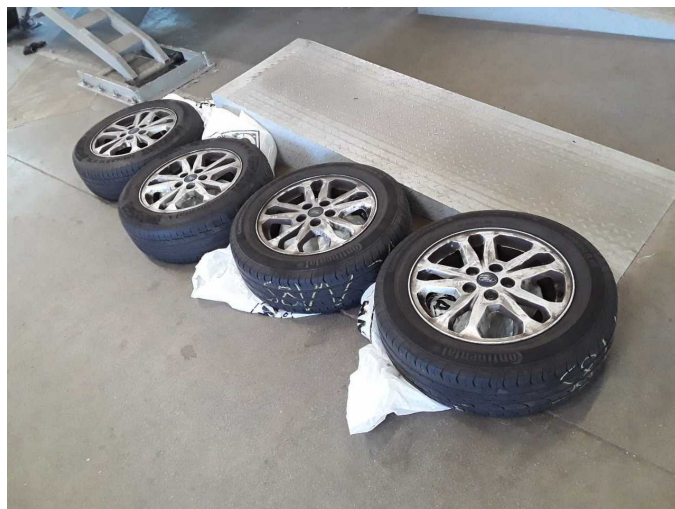
Figure 14: Additional tyres

| # | Tyre size | Type of tyre | Manufacturer | Tread depth |
|---|---|---|---|---|
| 1) | 205/60 R16 96H | Summer tyres on Light alloy | Continental | 5mm / 5mm |
| 2) | 205/60 R16 96H | Summer tyres on Light alloy | Continental | 5mm / 5mm |

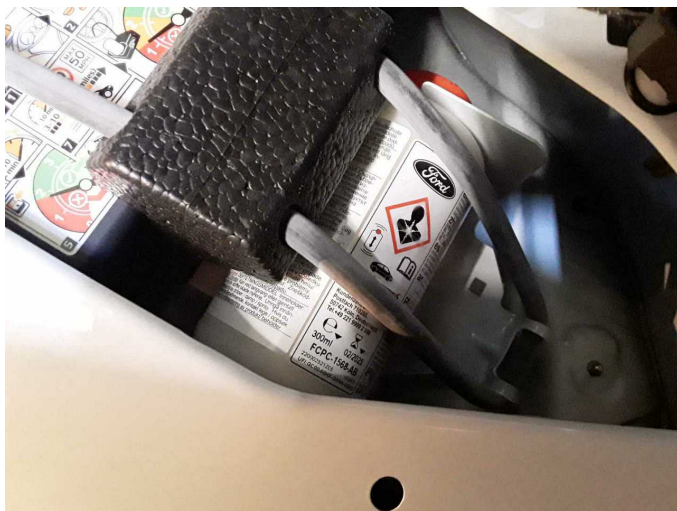
| No. | Component group | Description |
|---|---|---|
| 1 | Equipment | Tirefit filler - Expired - Replace |

Damage 1: Equipment: Tirefit filler - Expired - Replace

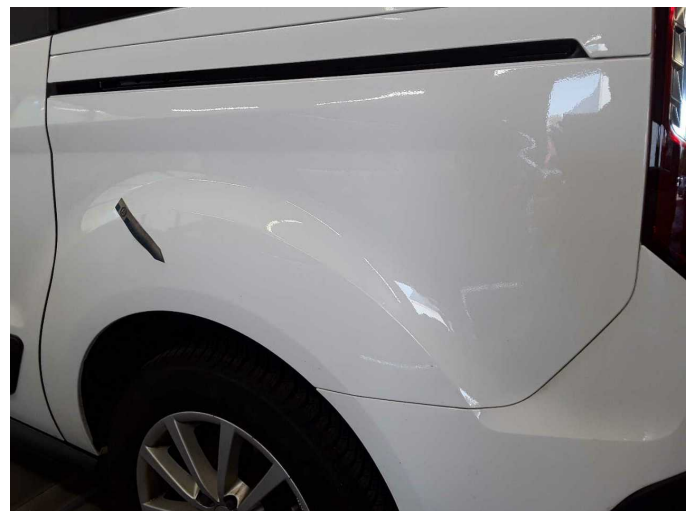
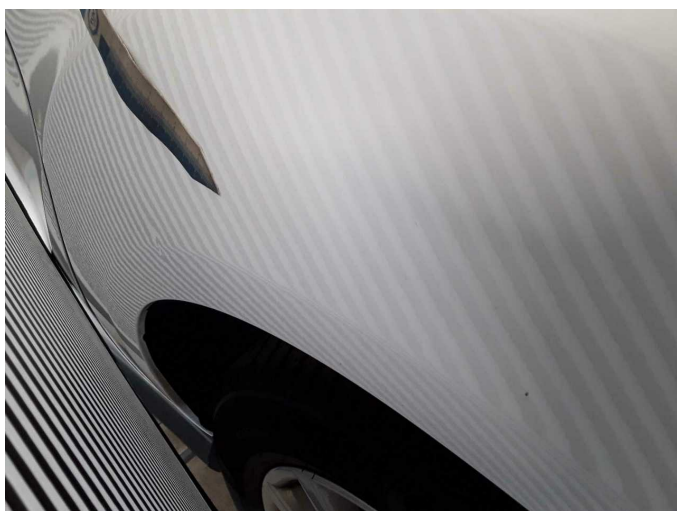
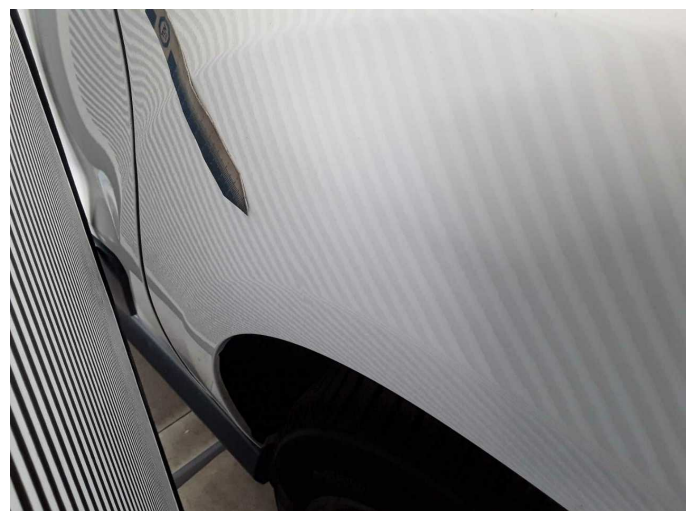
| No. | Component group | Description |
|---|---|---|
| 2 | Side panel - rear left side | Side panel - dent(s) - Smooth repair work |

Damage 2: Side panel - rear left side: Side panel - dent(s) - Smooth repair work

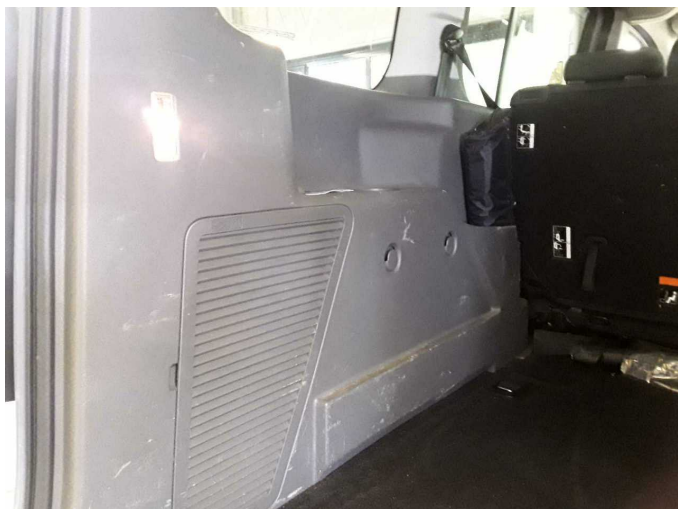
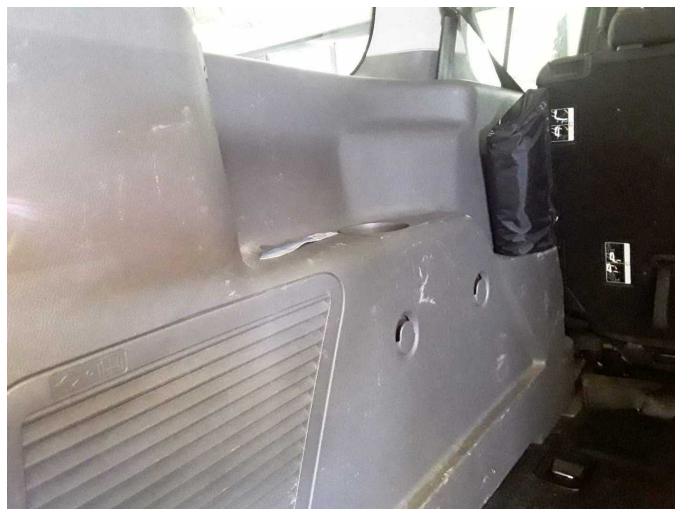
| No. | Component group | Description |
|---|---|---|
| 3 | Side panel - rear left side | Interior trim - Scratched - Loss in value |

**Damage 3:** Side panel - rear left side: Interior trim - Scratched - Loss in value

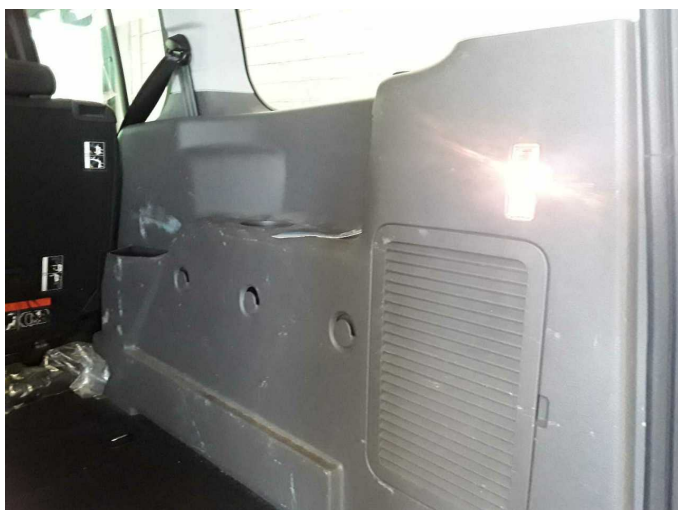
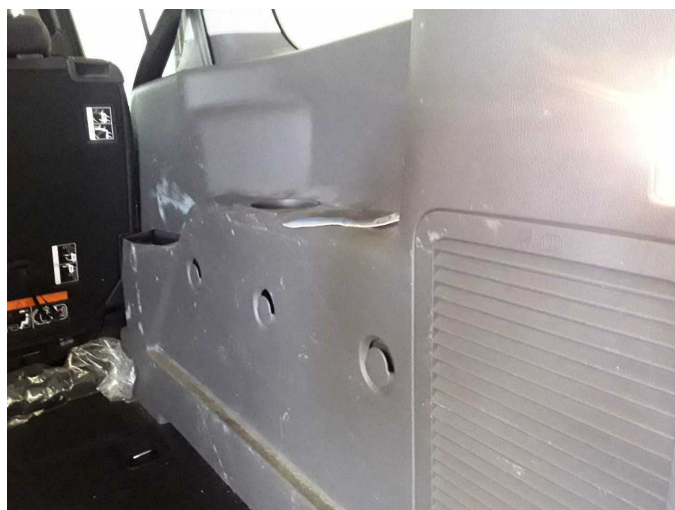
| No. | Component group | Description |
|---|---|---|
| 4 | Side panel - rear right side | Interior trim - Scratched - Loss in value |

**Damage 4:** Side panel - rear right side: Interior trim - Scratched - Loss in value

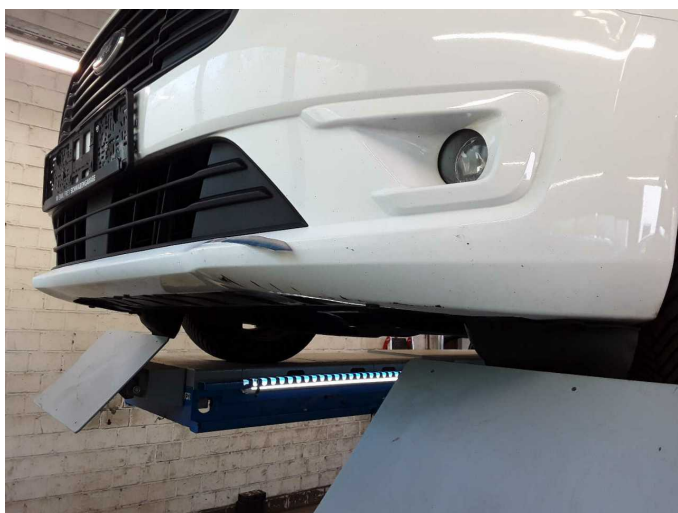
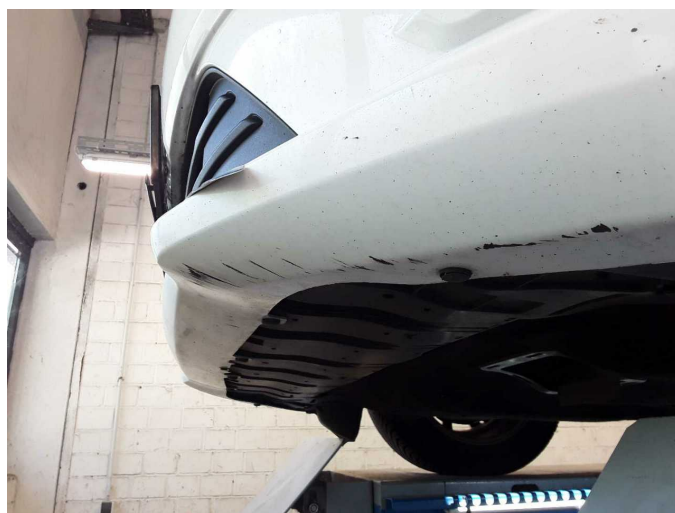
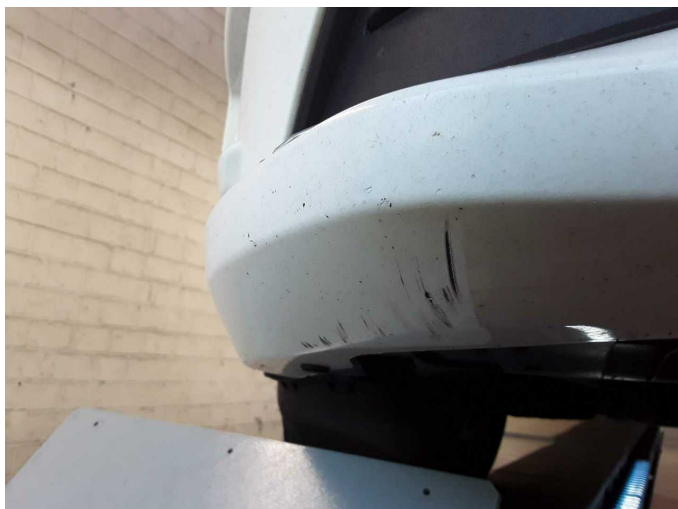
| No. | Component group | Description |
|---|---|---|
| 5 | Front bumper | Front bumper - Scratch(es) - Smart repair |

**Damage 5:** Front bumper: Front bumper - Scratch(es) - Smart repair

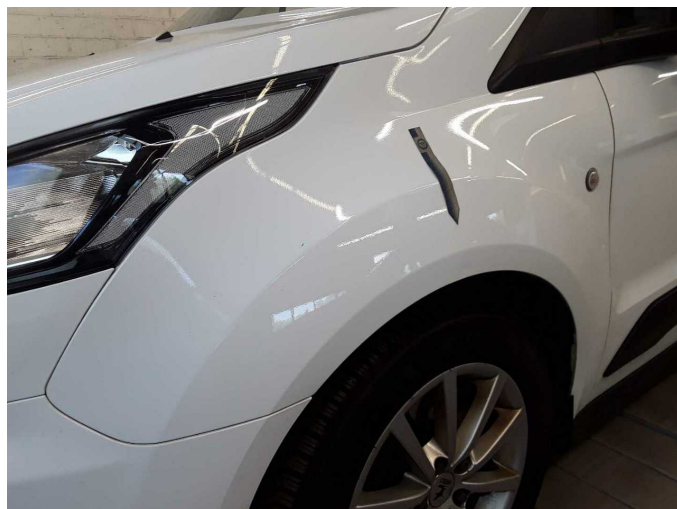
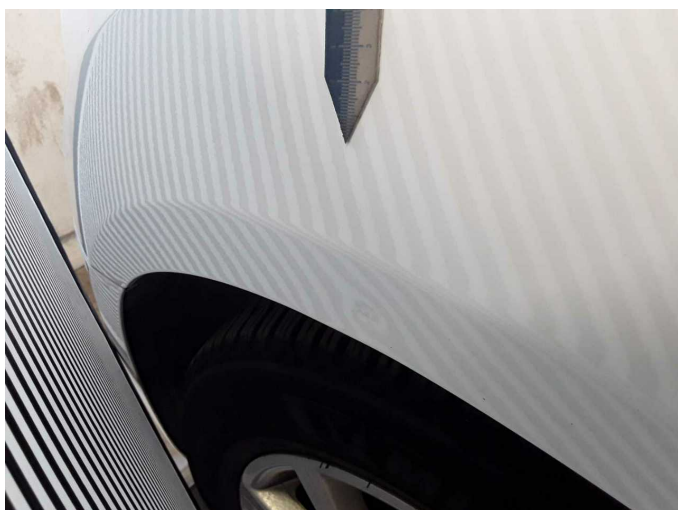
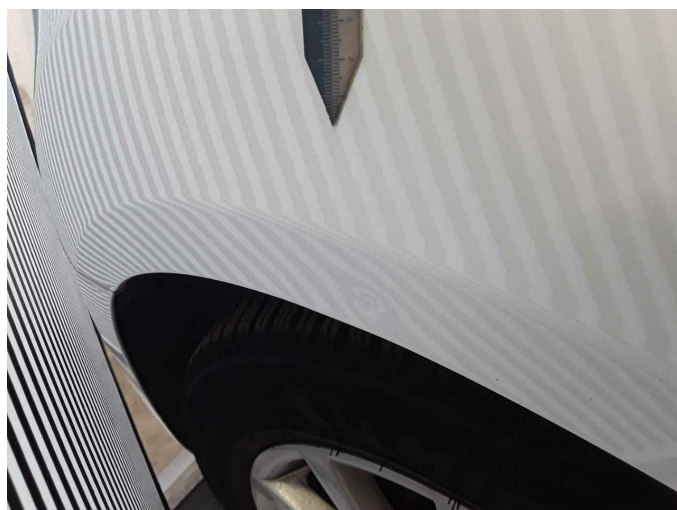
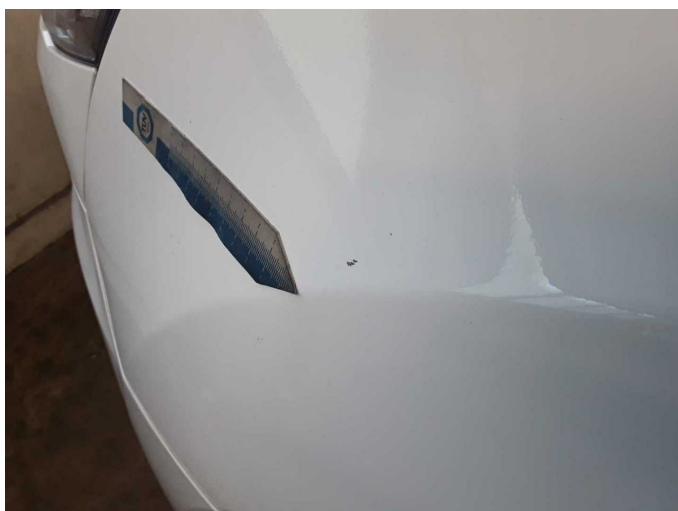
| No. | Component group | Description |
|---|---|---|
| 6 | Mudguard - left side | Mudguard - left side - Dent / paintcoat damage - Smart repair |

**Damage 6:** Mudguard - left side: Mudguard - left side - Dent / paintcoat damage - Smart repair

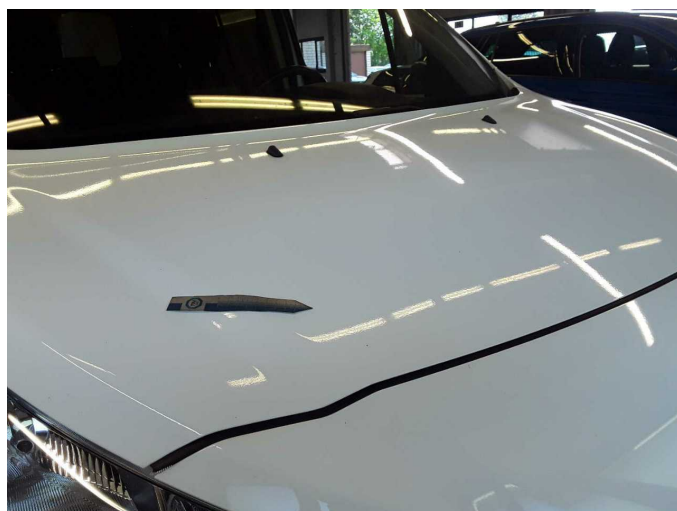
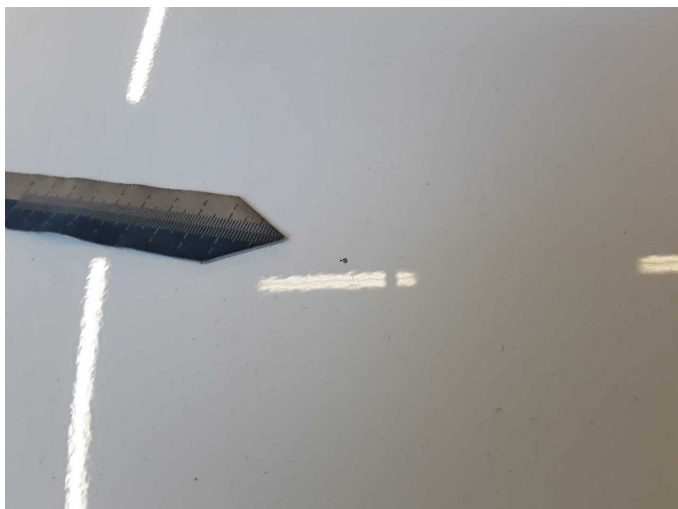
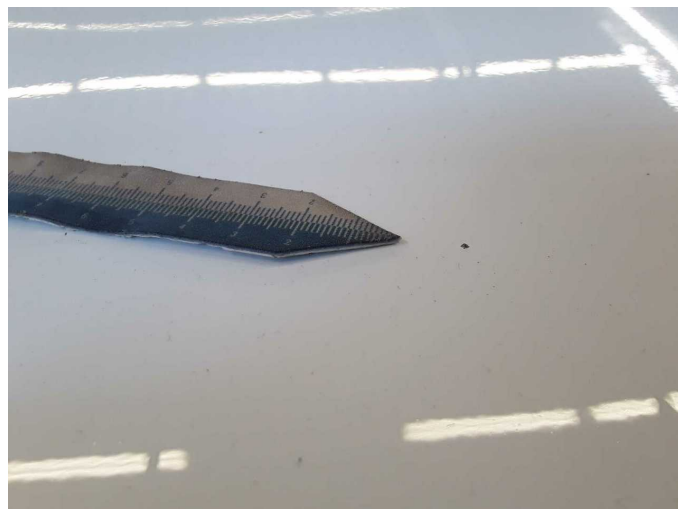
| No. | Component group | Description |
|---|---|---|
| 1 | Bonnet | Bonnet - Stone chips - No deduction |

**Wear and tear 1:** Bonnet: Bonnet - Stone chips - No deduction

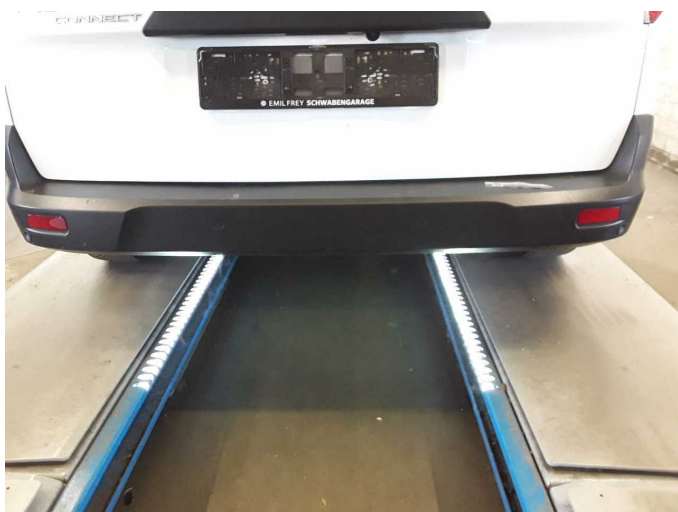
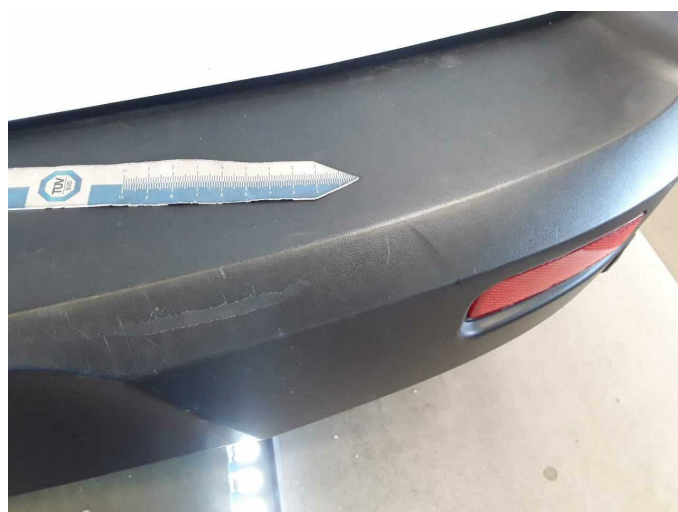
| No. | Component group | Description |
|---|---|---|
| 2 | Rear bumper | Rear bumper (unpainted) - Scratch(es) - No deduction |

**Wear and tear 2:** Rear bumper: Rear bumper (unpainted) - Scratch(es) - No deduction

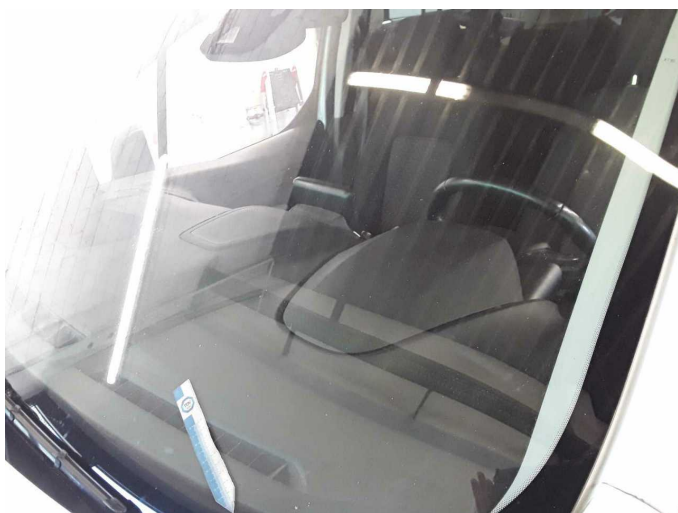
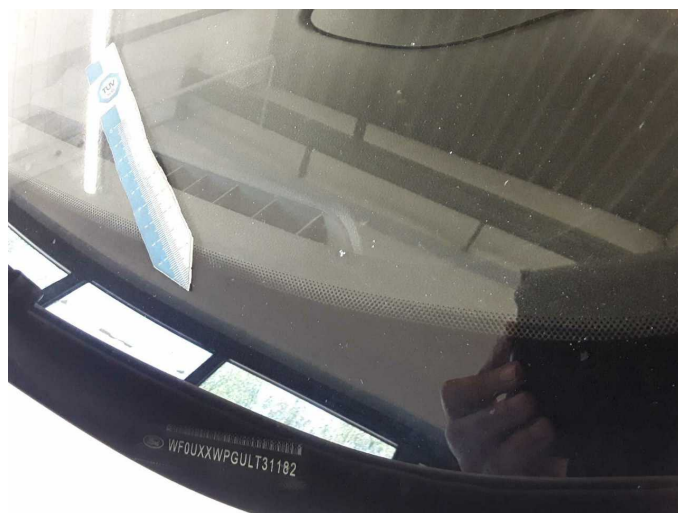
| No. | Component group | Description |
|---|---|---|
| 3 | Vehicle glazing | Windscreen - Stone chips - No deduction |

**Wear and tear 3:** Vehicle glazing: Windscreen - Stone chips - No deduction
