Expertise

Protocol number: 46883626  
Order No. / Reference: 26747152  
Inspection date: 4 Aug 2026

Manufacturer: Mercedes-Benz  
VIN: W1KAH0EB3PF109542

Model: C 220 d T 9G-TRONIC AMG Line

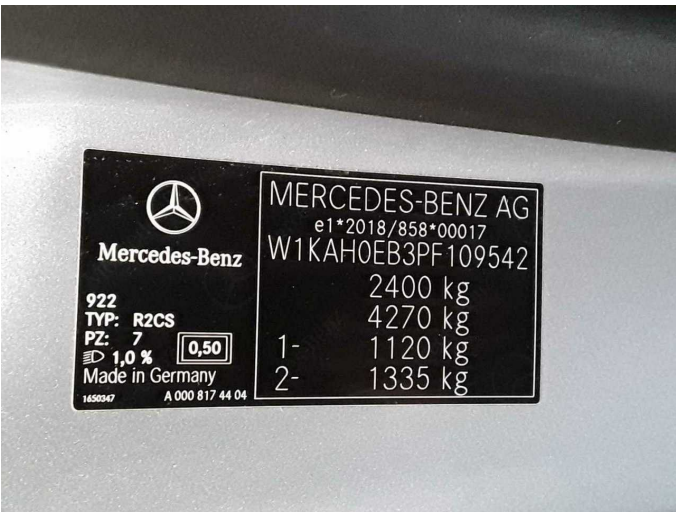
| VIN comparison | The vehicle identification number (VIN) was read from the vehicle and its conformity with the submitted documents was confirmed by the undersigned during the inspection. |

Figure 11: VIN

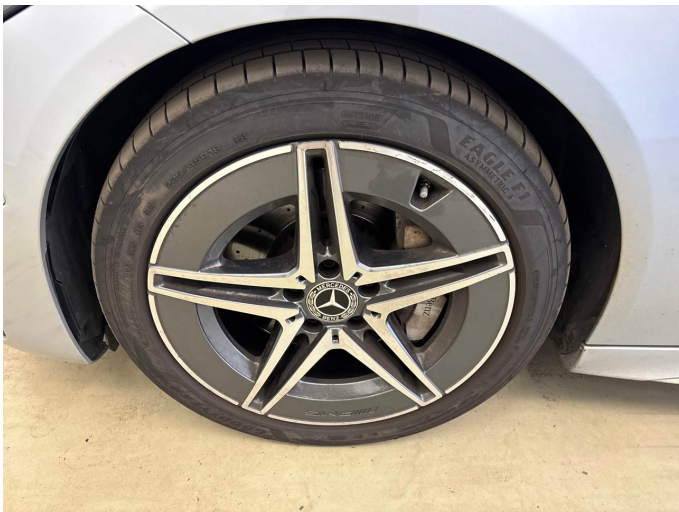
| # | Tyre size | Type of tyre | Manufacturer | Tread depth |
|---|---|---|---|---|
| 1) | 225/45 R18 95Y | Summer tyres on Light alloy | Goodyear | 5mm / 5mm |
| 2) | 245/40 R18 97Y | Summer tyres on Light alloy | Goodyear | 6mm / 6mm |

Figure 12: Mounted tyres

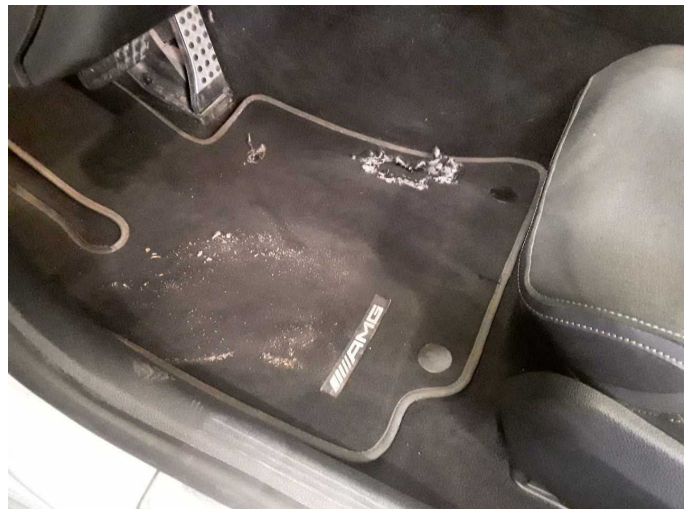
| No. | Component group | Description |
|---|---|---|
| 1 | Trim / covers | Floor mats - Broken / torn - Replace |

Damage 1: Trim / covers: Floor mats - Broken / torn - Replace

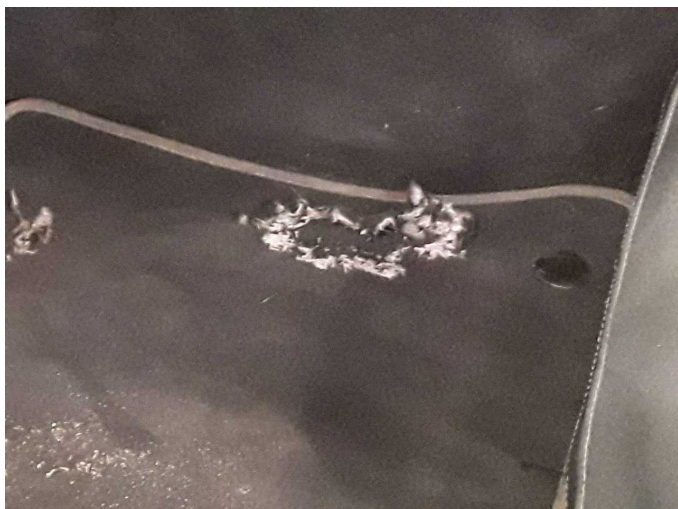
**Damage 1:** Trim / covers: Floor mats - Broken / torn - Replace

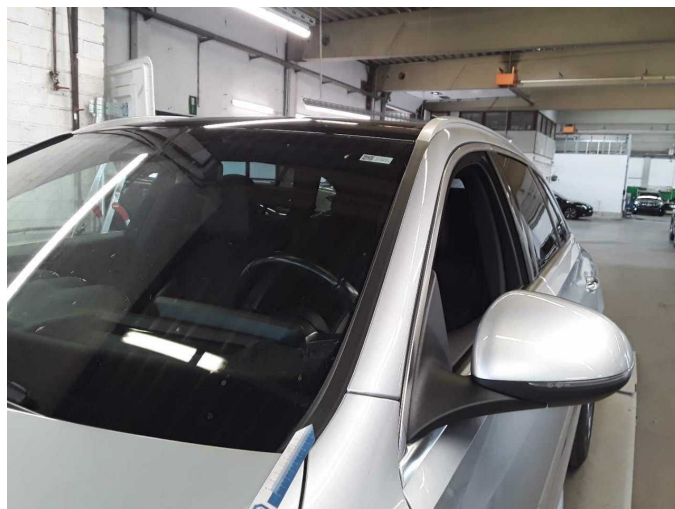
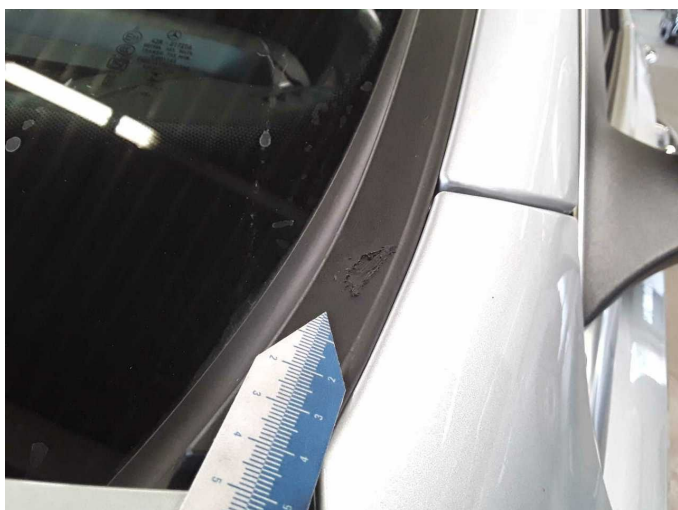
| No. | Component group | Description |
|---|---|---|
| 2 | Vehicle glazing | Windscreen seal - Scratched - Replace |

**Damage 2:** Vehicle glazing: Windscreen seal - Scratched - Replace

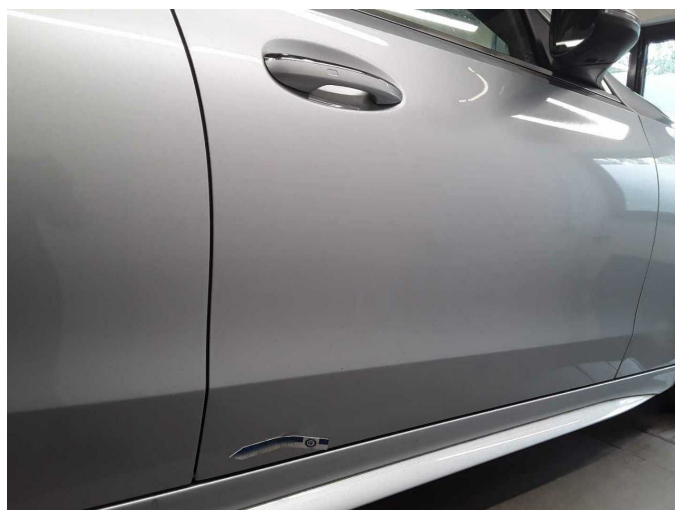
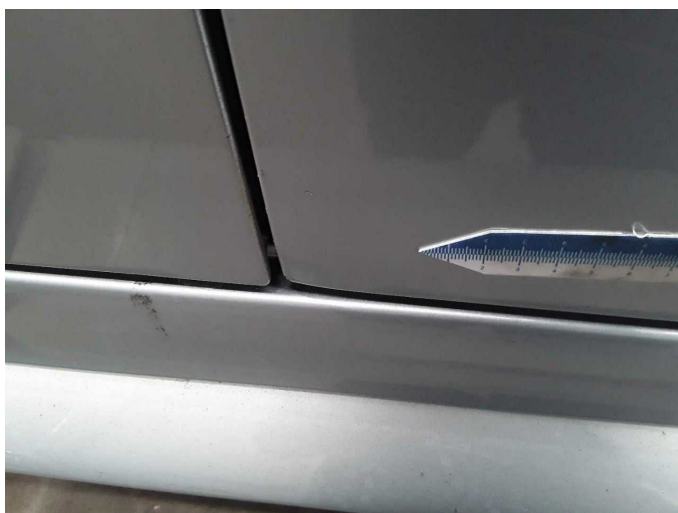
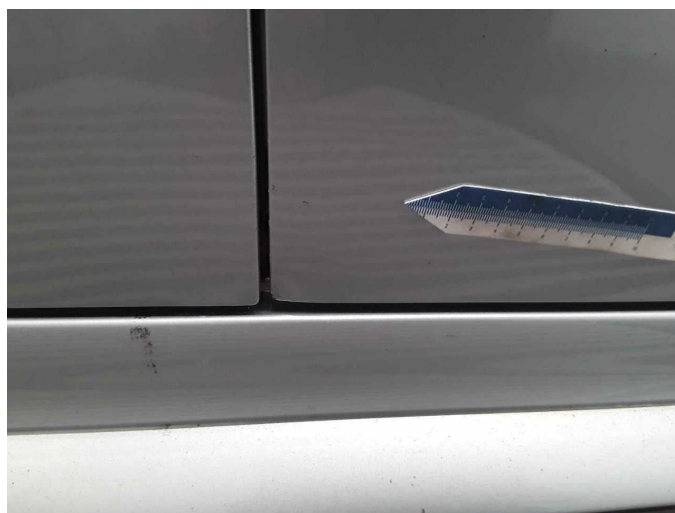
| No. | Component group | Description |
|---|---|---|
| 3 | Door - front right side | Door - Deformed - Smooth repair work |

**Damage 3:** Door - front right side: Door - Deformed - Smooth repair work

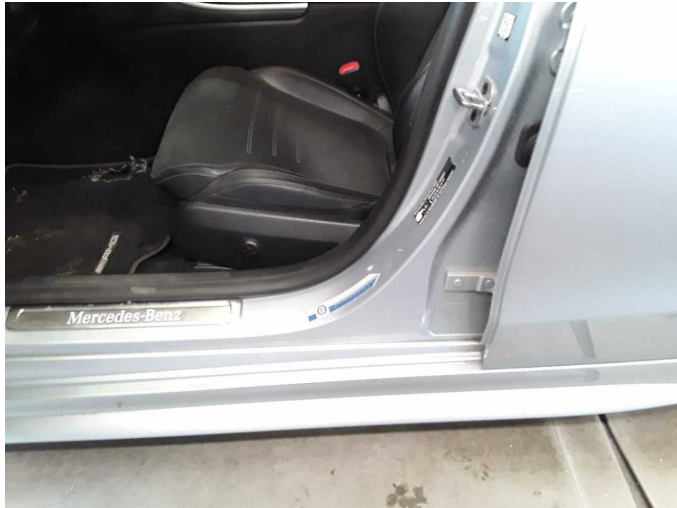
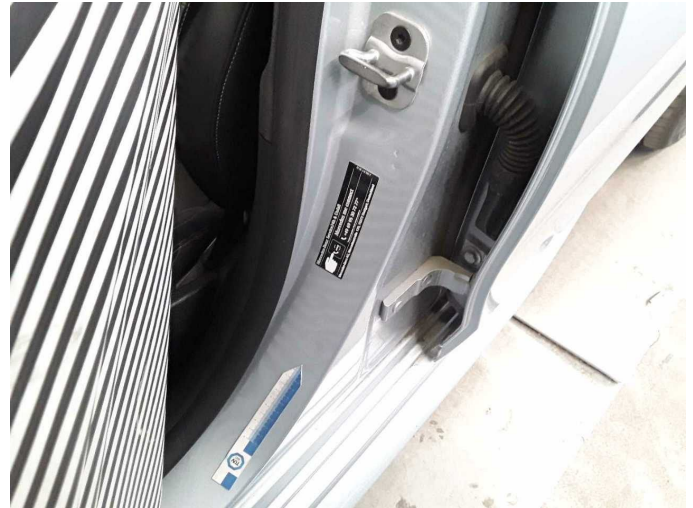
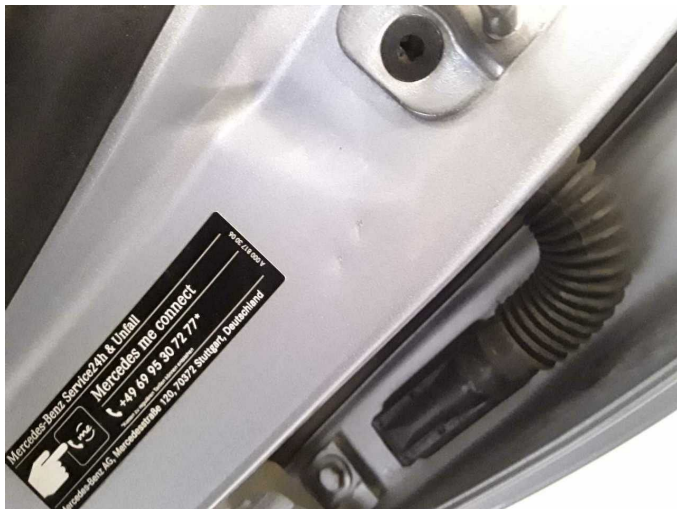
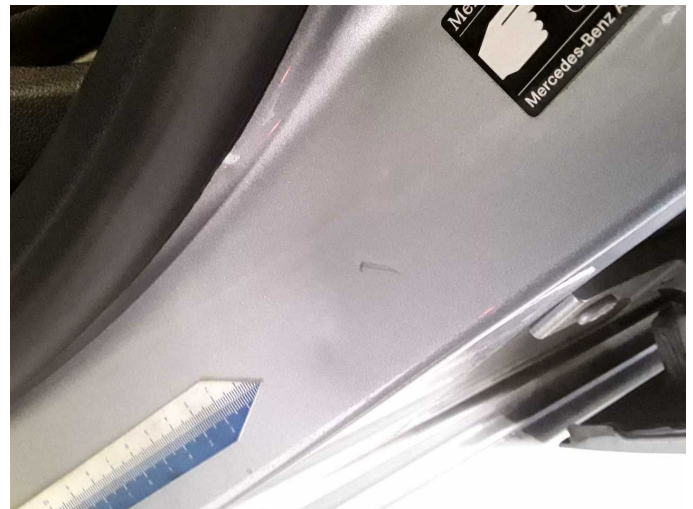
| No. | Component group | Description |
|---|---|---|
| 4 | Sill - left side | Sill - Dent / paintcoat damage - Smart repair |

**Damage 4:** Sill - left side: Sill - Dent / paintcoat damage - Smart repair

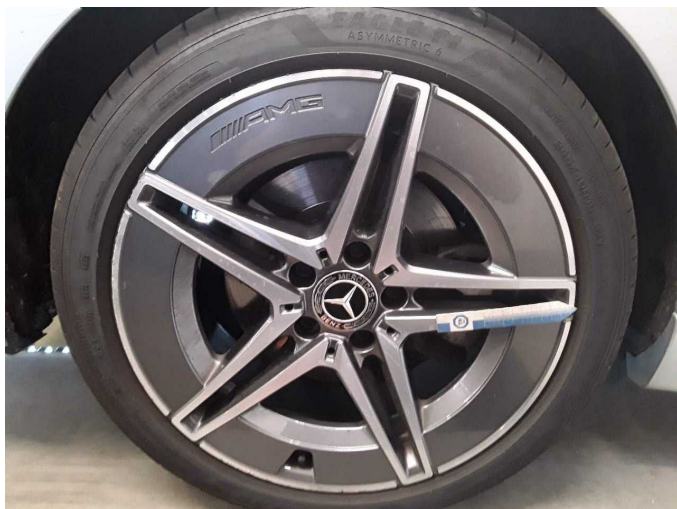
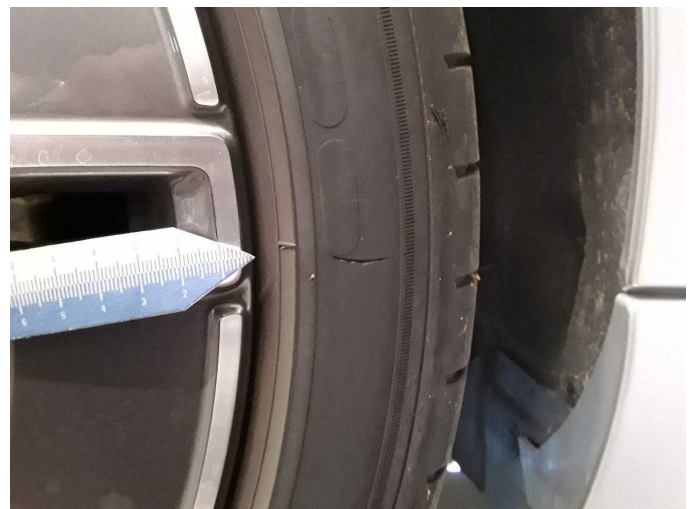
| No. | Component group | Description |
|---|---|---|
| 5 | Wheel / tyres | Tyre - rear right side - Broken / torn - Replace |

**Damage 5:** Wheel / tyres: Tyre - rear right side - Broken / torn - Replace

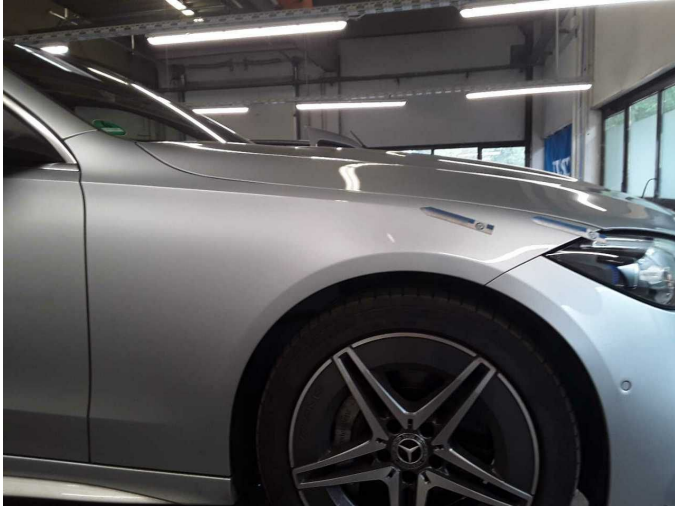
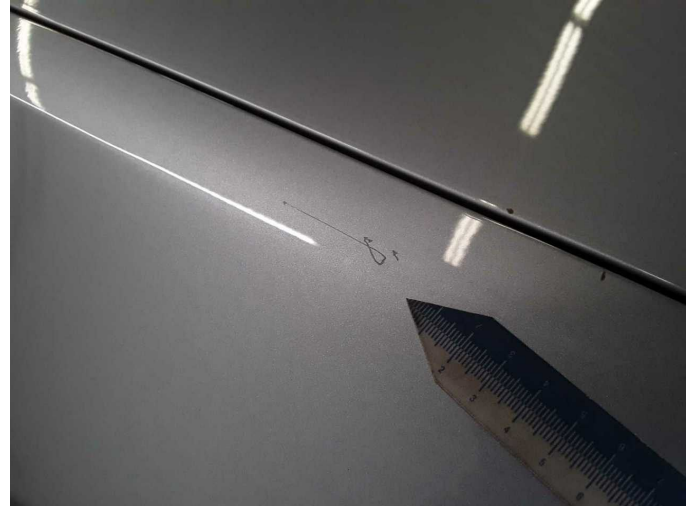
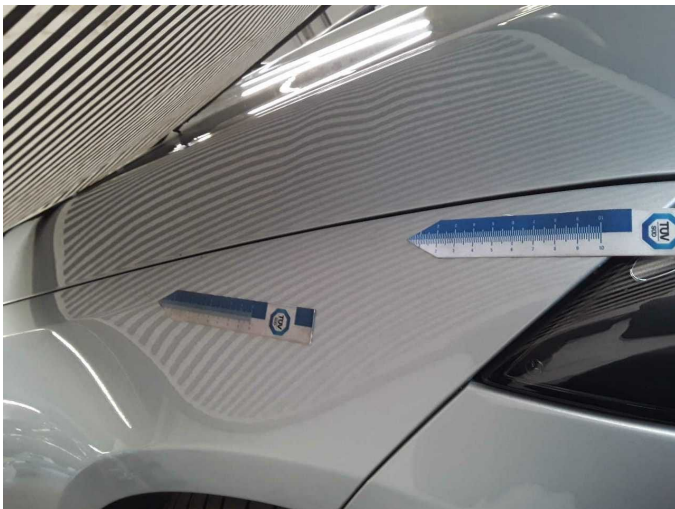
| No. | Component group | Description |
|---|---|---|
| 6 | Mudguard - right side | Mudguard - right side - Dent / paintcoat damage - Repair and paint |

**Damage 6:** Mudguard - right side: Mudguard - right side - Dent / paintcoat damage - Repair and paint

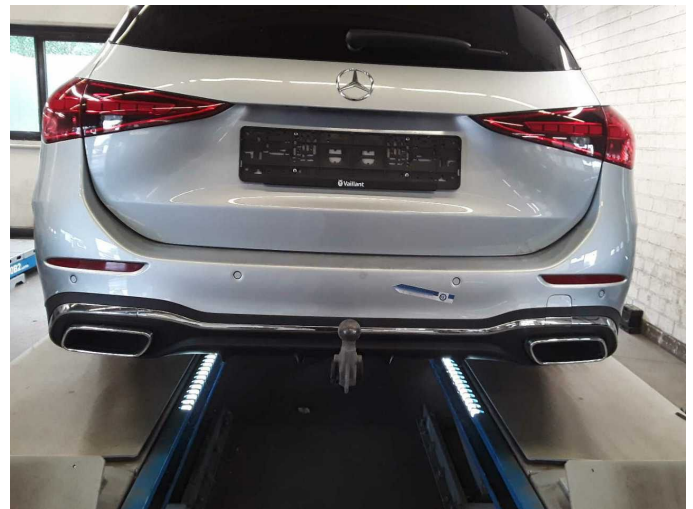
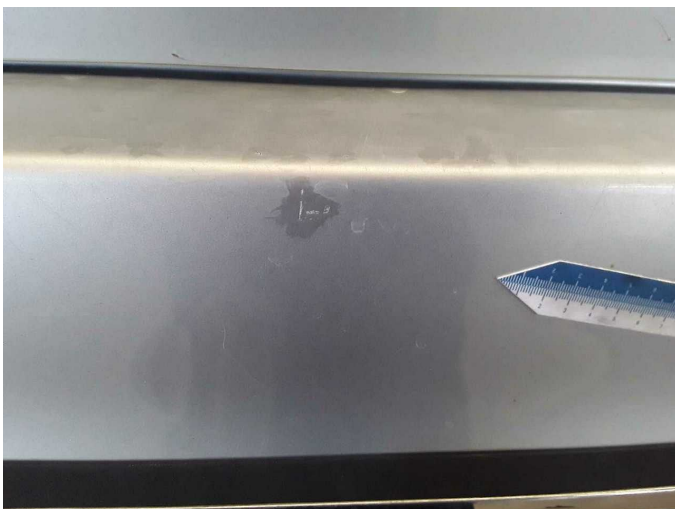
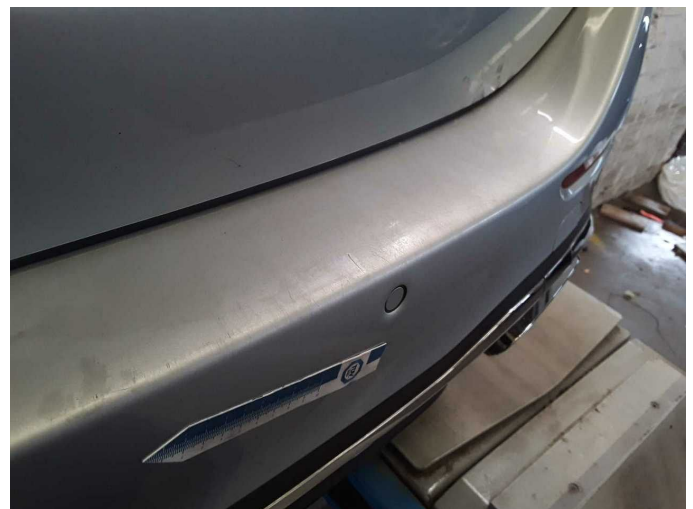
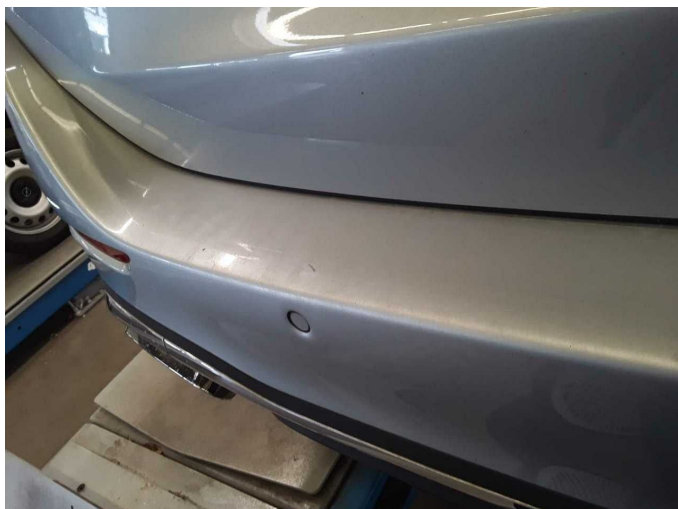
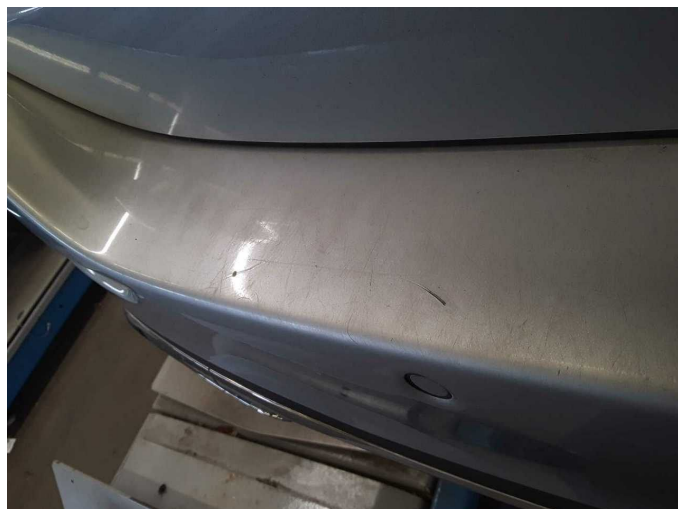
| No. | Component group | Description |
|---|---|---|
| 7 | Rear bumper | Rear bumper - Scratched - Paint |

**Damage 7:** Rear bumper: Rear bumper - Scratched - Paint

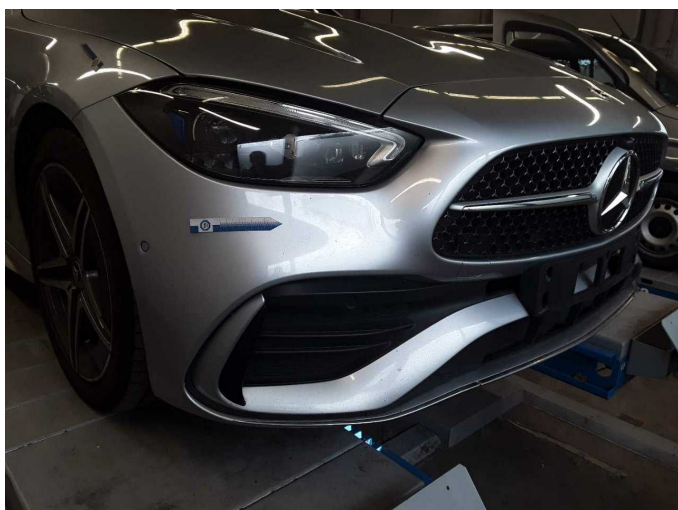
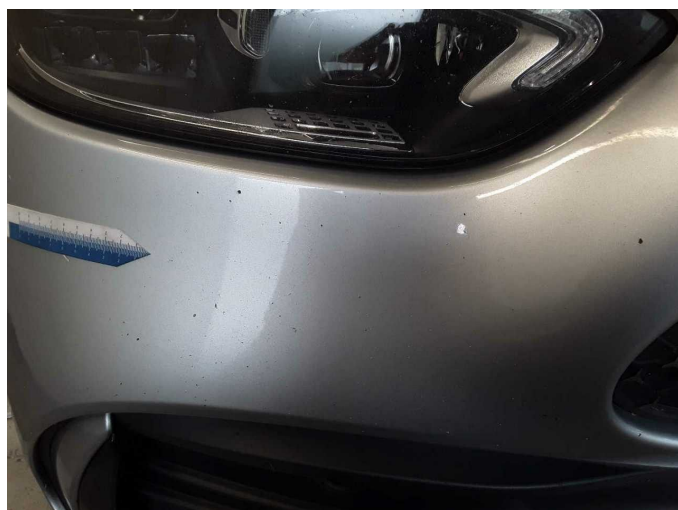
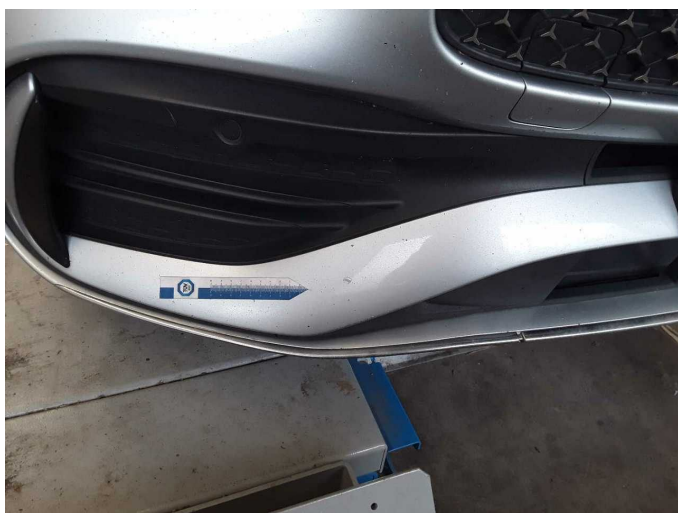
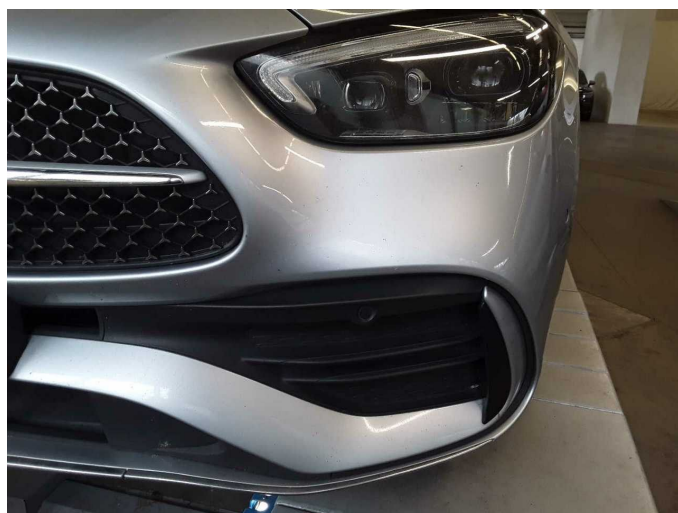
| No. | Component group | Description |
|---|---|---|
| 8 | Front bumper | Front bumper - Stone chips - Paint |

**Damage 8:** Front bumper: Front bumper - Stone chips - Paint

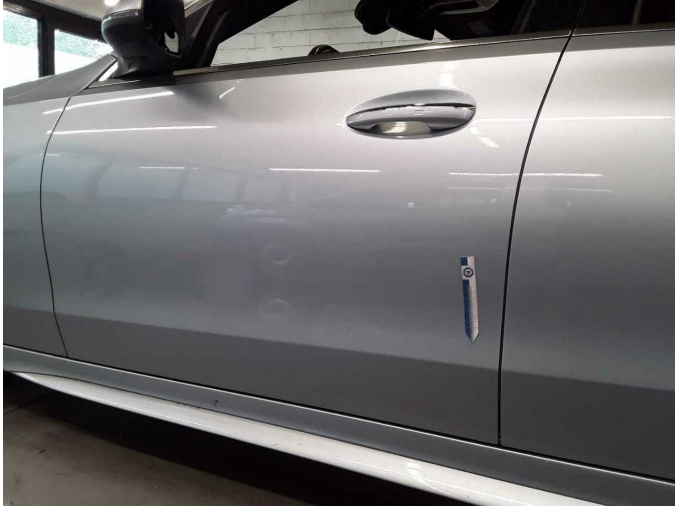
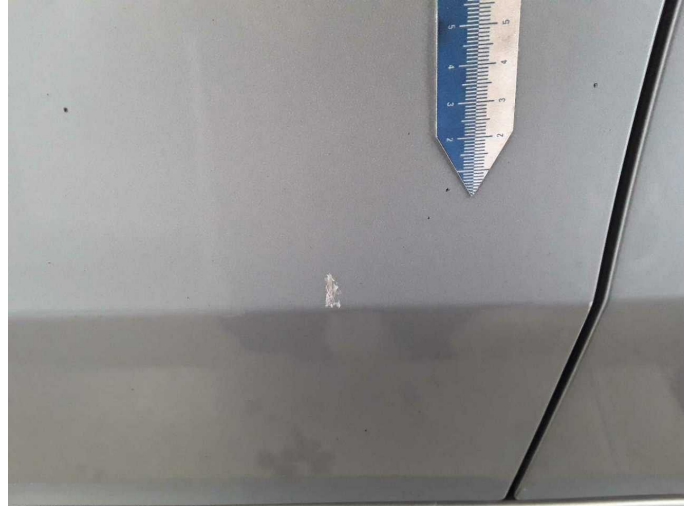
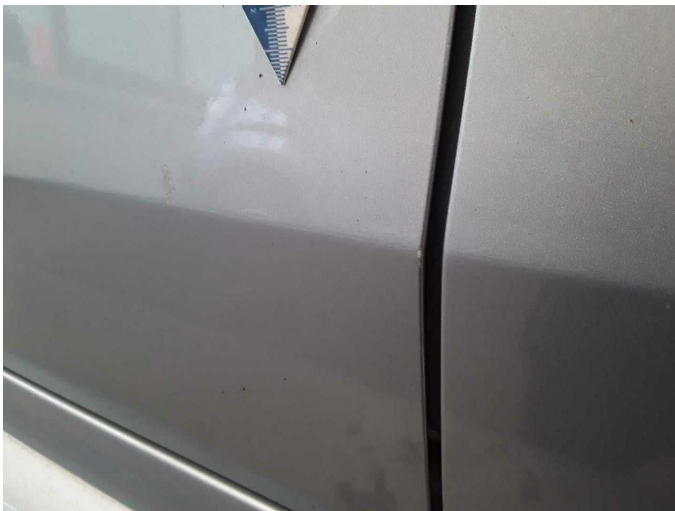
| No. | Component group | Description |
|---|---|---|
| 9 | Door - front left side | Door - Scratched - Paint |

**Damage 9:** Door - front left side: Door - Scratched - Paint

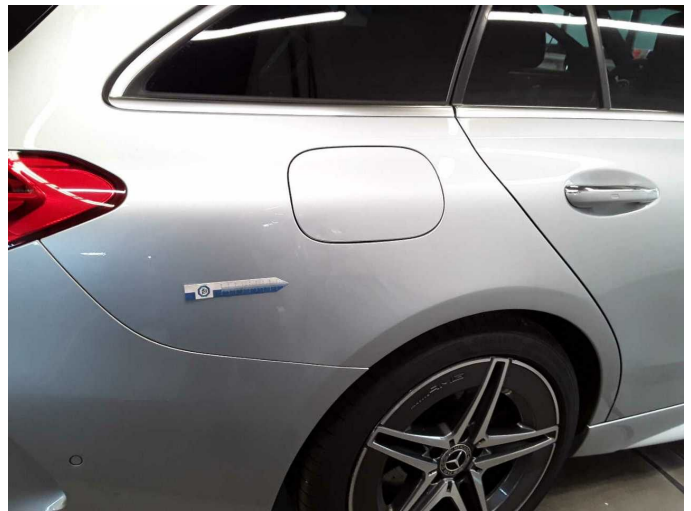
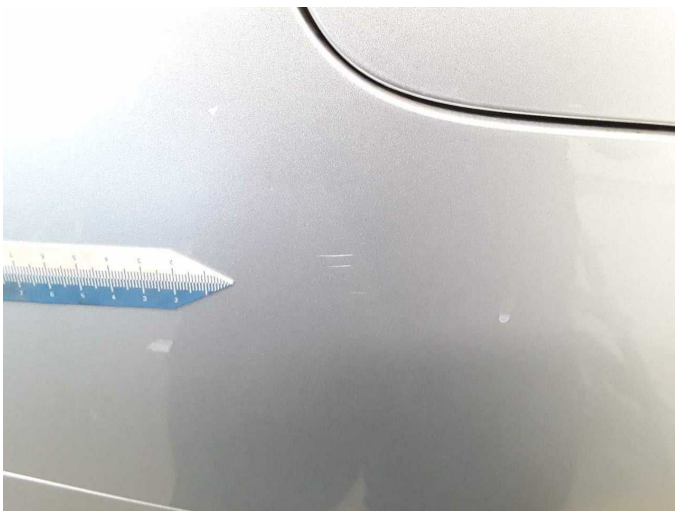
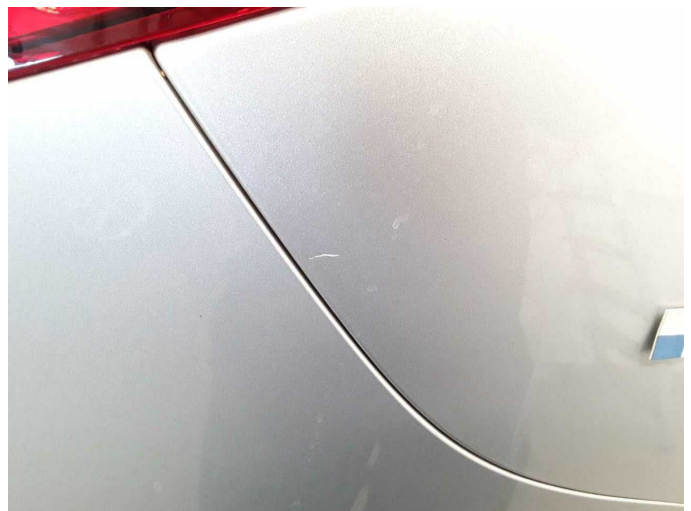
| No. | Component group | Description |
|---|---|---|
| 10 | Side panel - rear right side | Side panel - Scratch(es) - Paint |

| 1 | Side panel - rear right side |

Side panel - rear right side

704 µm |

**Damage 10:** Side panel - rear right side: Side panel - Scratch(es) - Paint

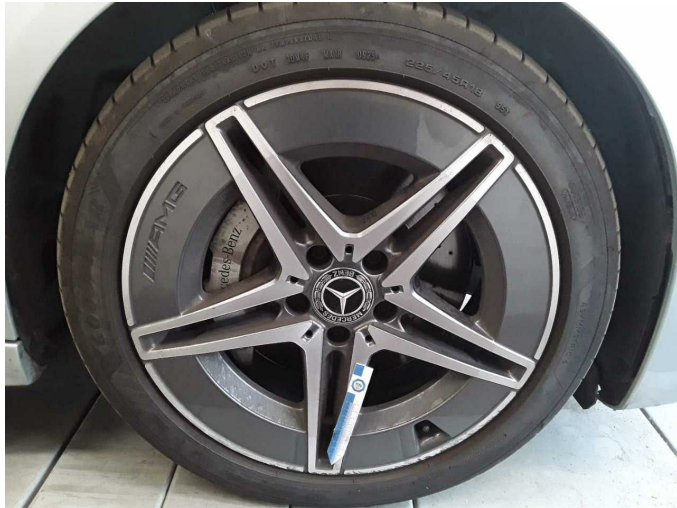
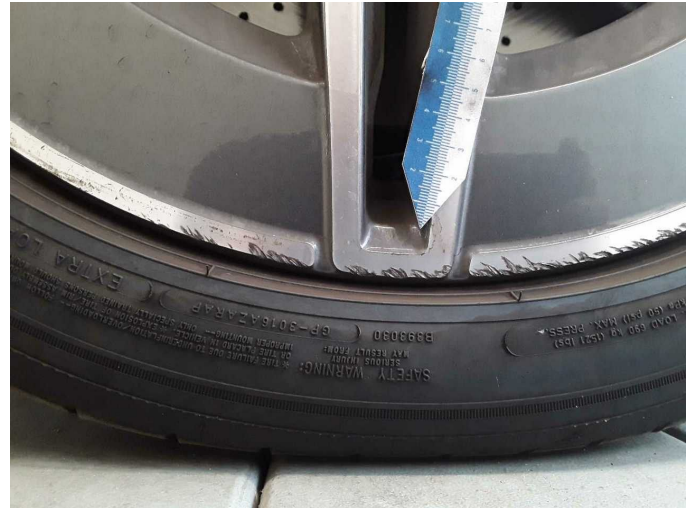
| No. | Component group | Description |
|---|---|---|
| 11 | Wheel / tyres | Alloy rim - front right side - Scratched - Replace |

**Damage 11:** Wheel / tyres: Alloy rim - front right side - Scratched - Replace

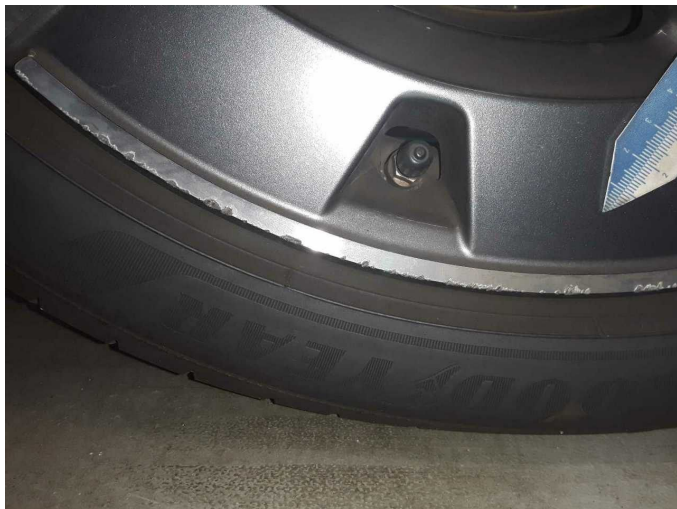
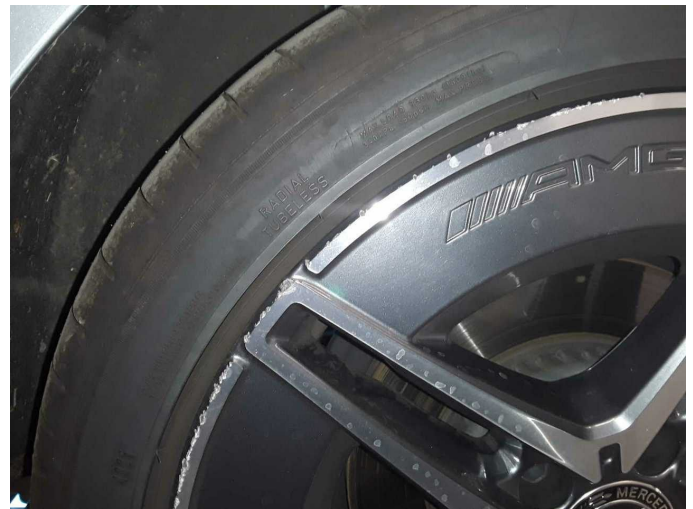
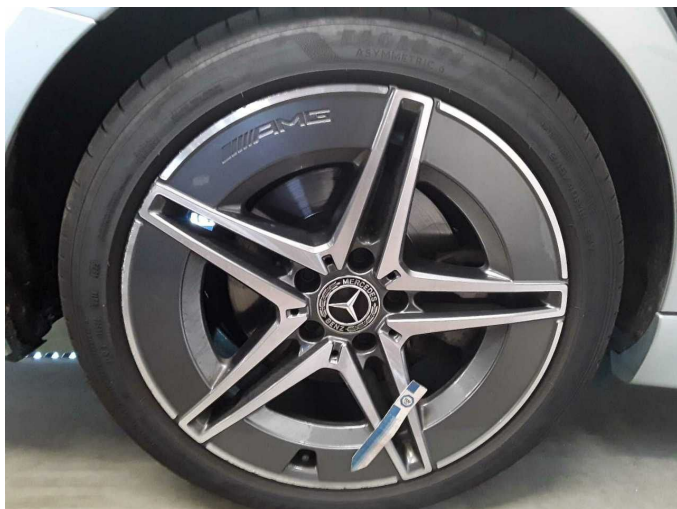
| No. | Component group | Description |
|---|---|---|
| 12 | Wheel / tyres | Alloy rim - rear right side (Materialabtrag) - Scratched - Replace |

**Damage 12:** Wheel / tyres: Alloy rim - rear right side (Materialabtrag) - Scratched - Replace

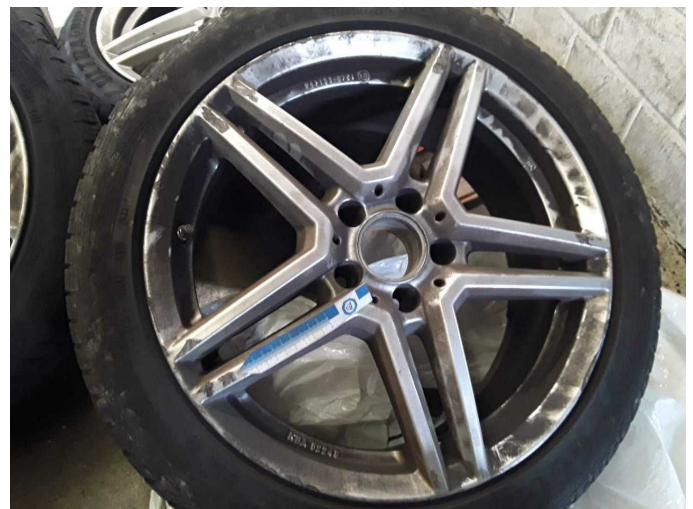
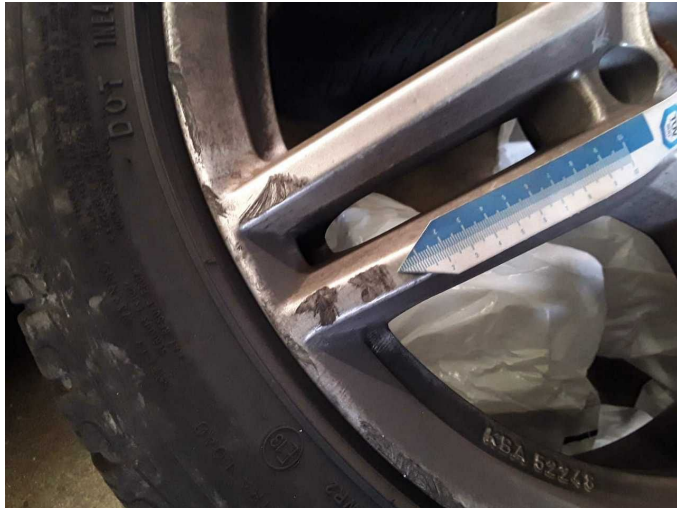
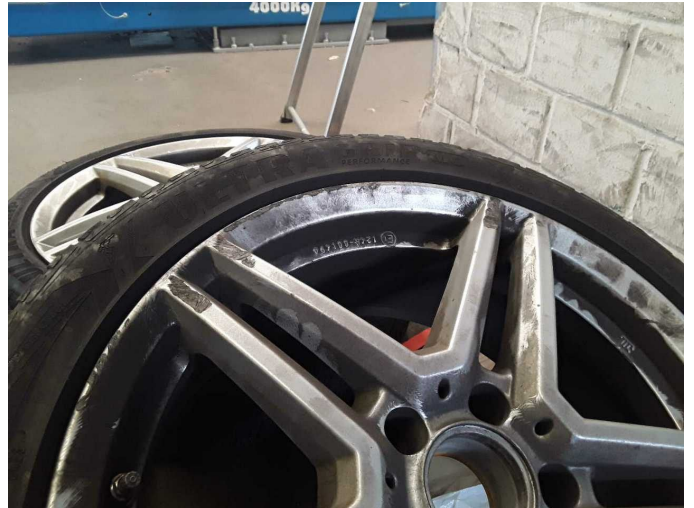
| No. | Component group | Description |
|---|---|---|
| 1 | 2nd wheel set | 1 alloy rim - Scratched - No deduction |

**Wear and tear 1:** 2nd wheel set: 1 alloy rim - Scratched - No deduction

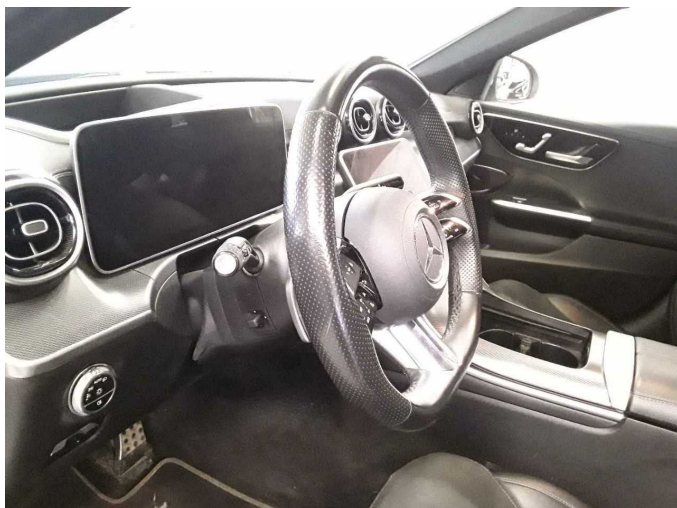
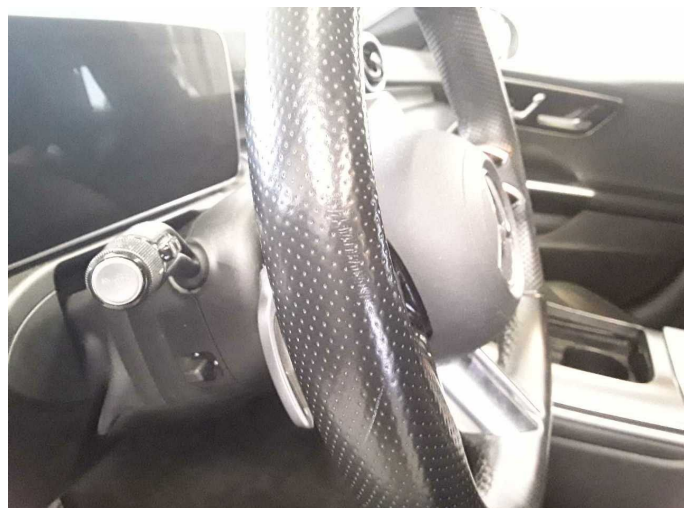
| No. | Component group | Description |
|---|---|---|
| 3 | Steering system | Steering wheel sheath - Scratch(es) - No deduction |

**Wear and tear 3:** Steering system: Steering wheel sheath - Scratch(es) - No deduction

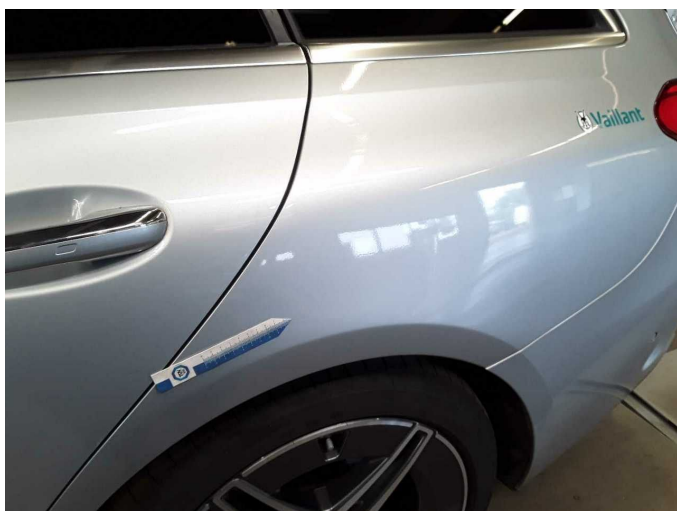
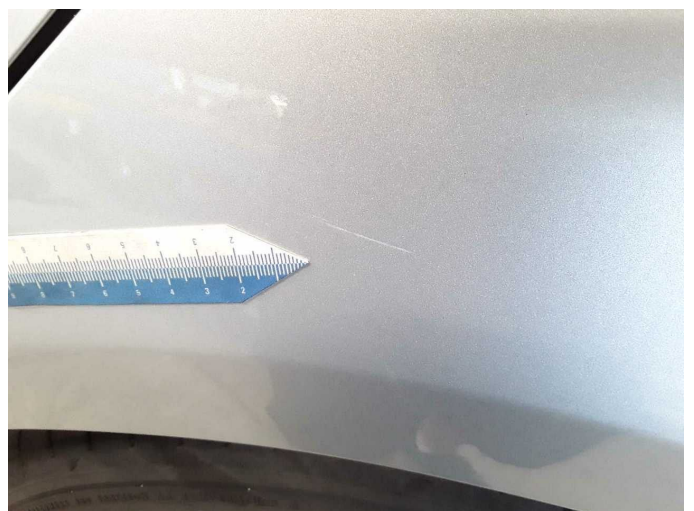
| No. | Component group | Description |
|---|---|---|
| 4 | Side panel - rear left side | Side panel - Soiled - No deduction |

**Wear and tear 4:** Side panel - rear left side: Side panel - Soiled - No deduction

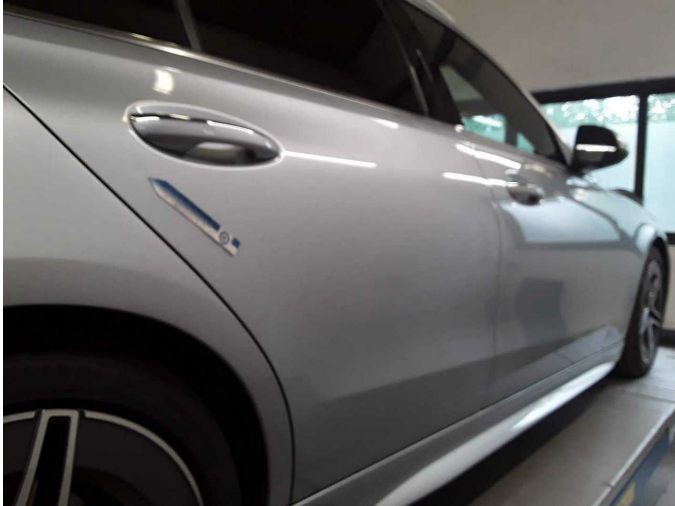
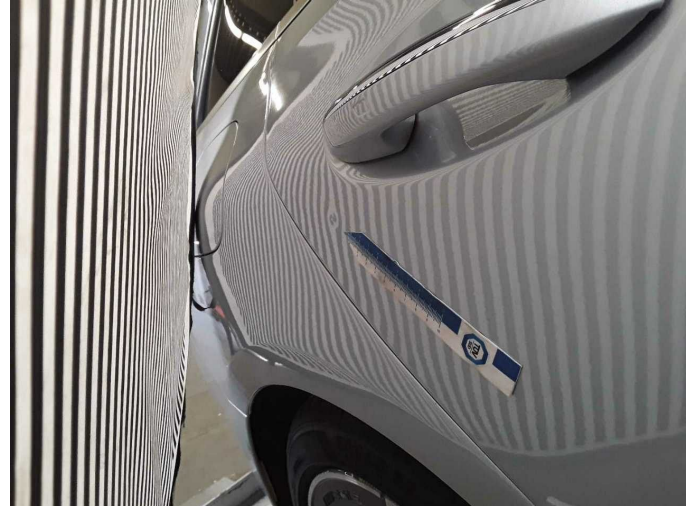
| No. | Component group | Description |
|---|---|---|
| 5 | Door - rear right side | Door - dent(s) - No deduction |

**Wear and tear 5:** Door - rear right side: Door - dent(s) - No deduction
