Expertise

Protocol number: 46042375  
Order No. / Reference: 26394615  
Inspection date: 19 Jun 2026

Manufacturer: Skoda  
VIN: TMBJJ9NS7P8021696

Model: Kodiaq 2.0 TDI DSG Style

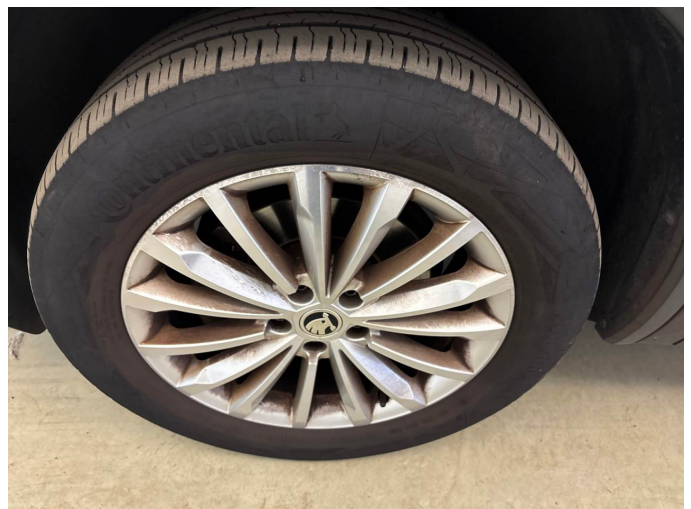
| # | Tyre size | Type of tyre | Manufacturer | Tread depth |
|---|---|---|---|---|
| 1) | 235/55 R18 100V | Summer tyres on Light alloy | Continental | 4mm / 4mm |
| 2) | 235/55 R18 100V | Summer tyres on Light alloy | Continental | 4mm / 4mm |

Figure 12: Mounted tyres

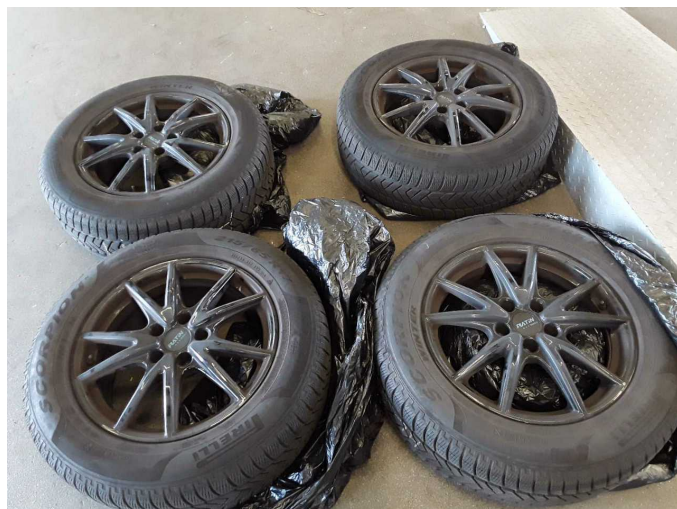
| # | Tyre size | Type of tyre | Manufacturer | Tread depth |
|---|---|---|---|---|
| 1) | 215/55 R17 99H | Winter tyres on Light alloy | Pirelli | 5mm / 5mm |
| 2) | 215/55 R17 99H | Winter tyres on Light alloy | Pirelli | 5mm / 5mm |

Figure 14: Additional tyres

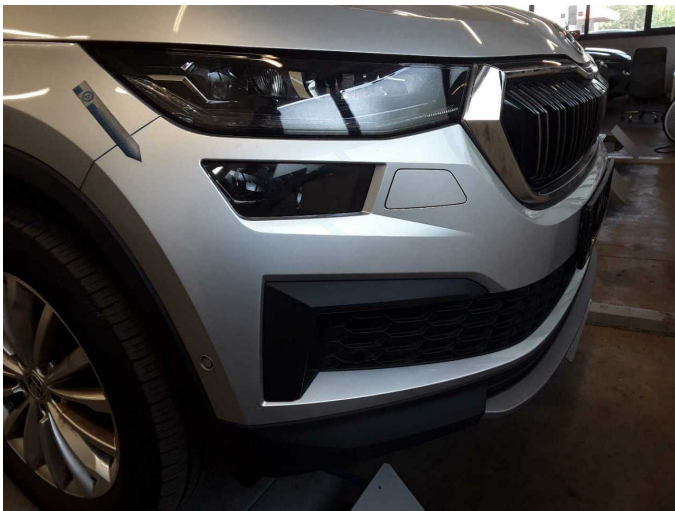
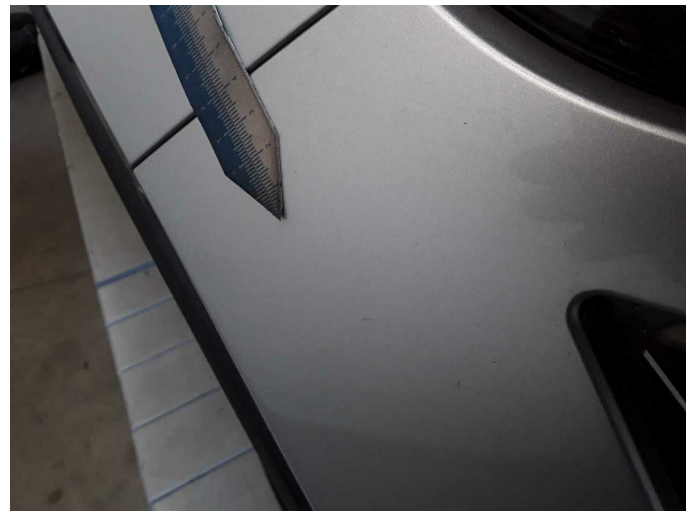
| No. | Component group | Description |
|---|---|---|
| 2 | Front bumper | Front bumper - Stone chips - No deduction |

**Wear and tear 2:** Front bumper: Front bumper - Stone chips - No deduction

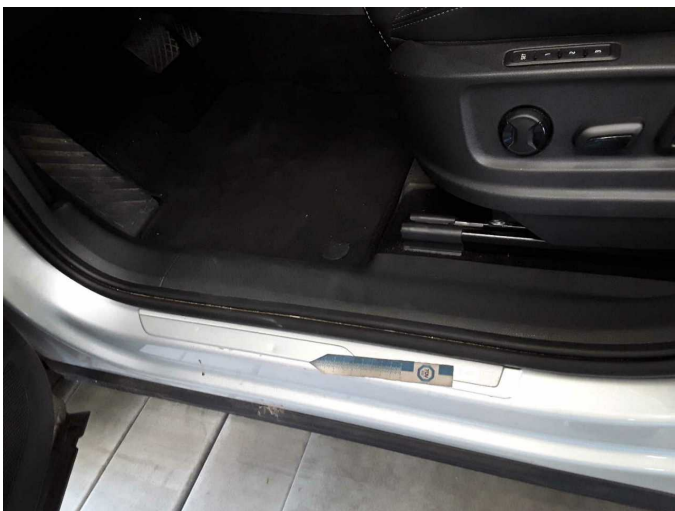
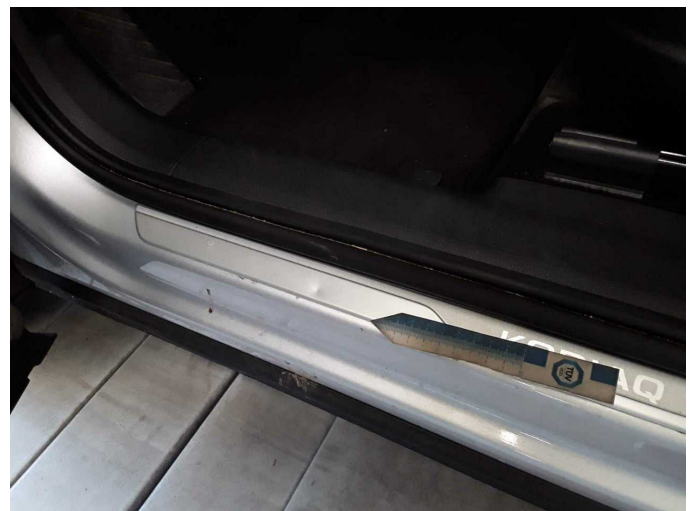
| No. | Component group | Description |
|---|---|---|
| 3 | Sill - left side | Sill - dent(s) - No deduction |

**Wear and tear 3:** Sill - left side: Sill - dent(s) - No deduction

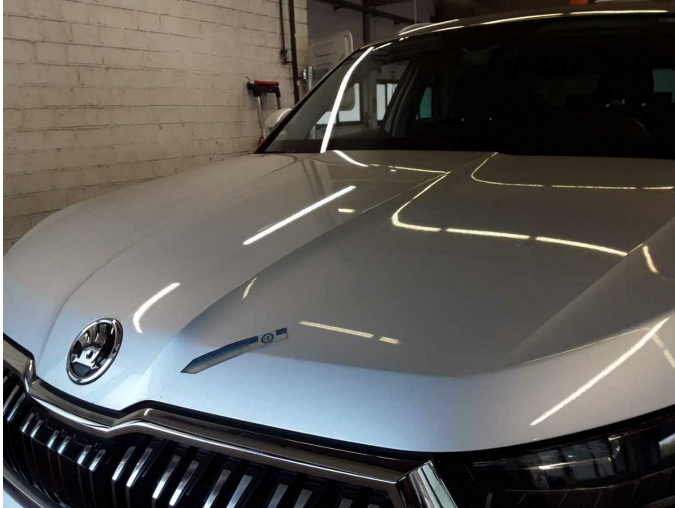
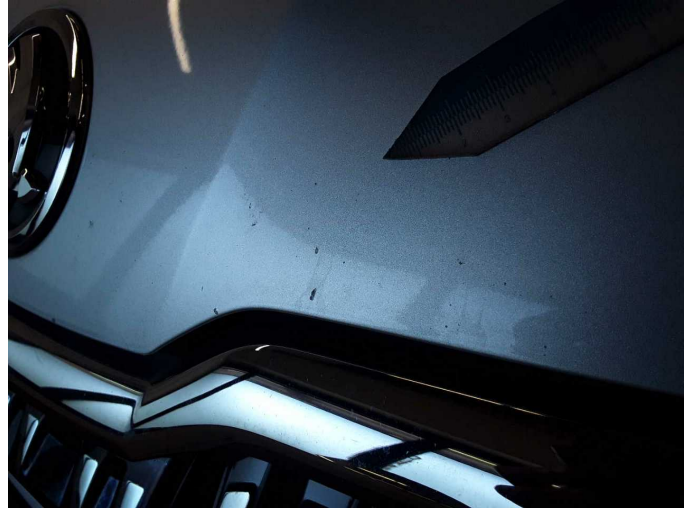
| No. | Component group | Description |
|---|---|---|
| 5 | Bonnet | Bonnet - Stone chips - No deduction |

**Wear and tear 5:** Bonnet: Bonnet - Stone chips - No deduction

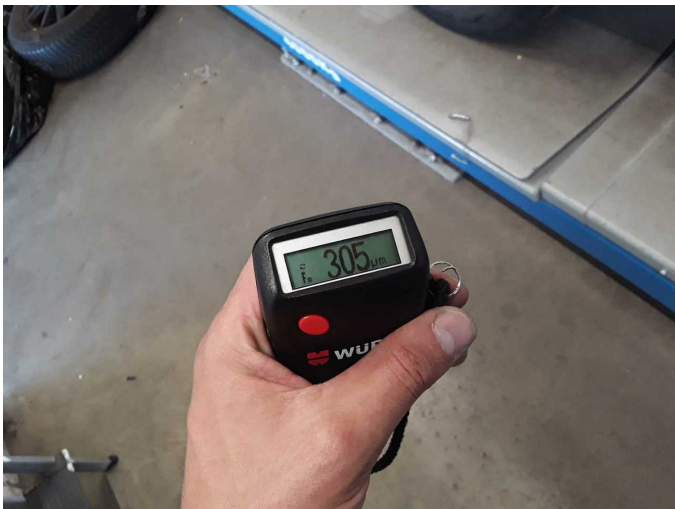
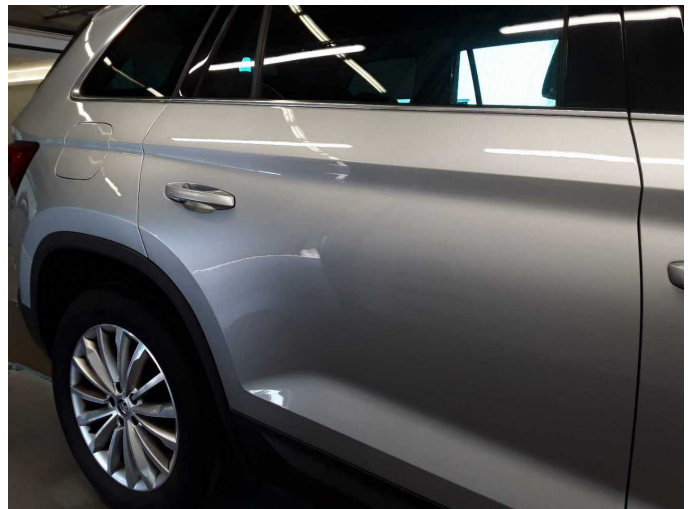
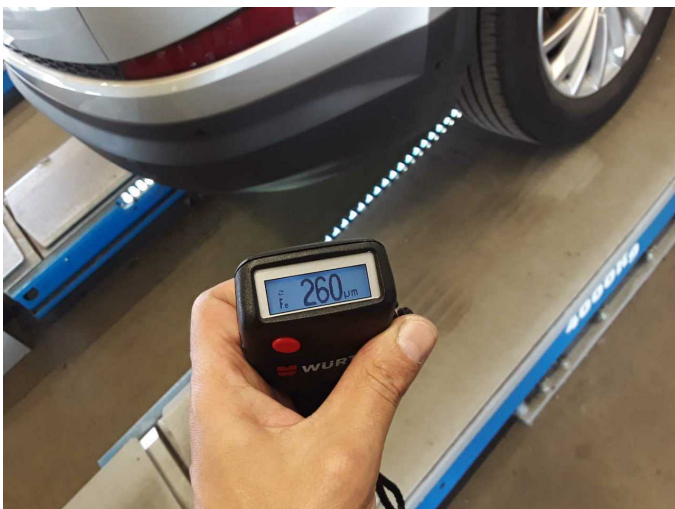
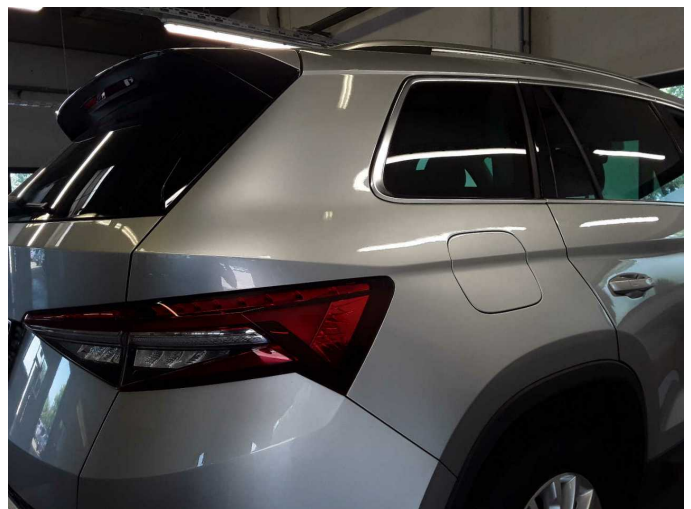
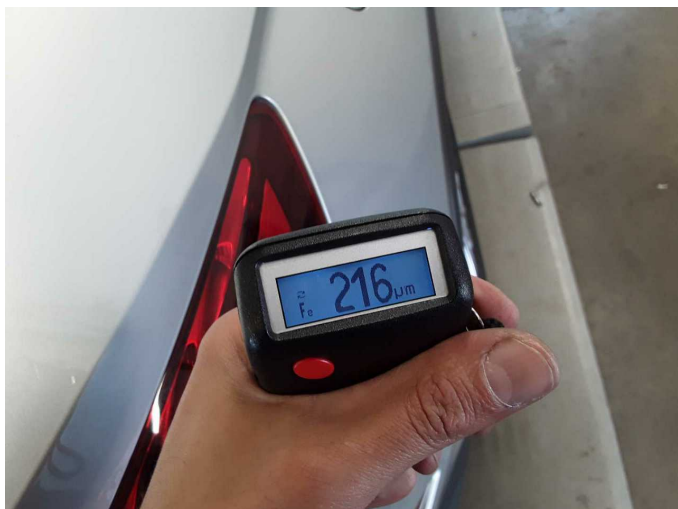
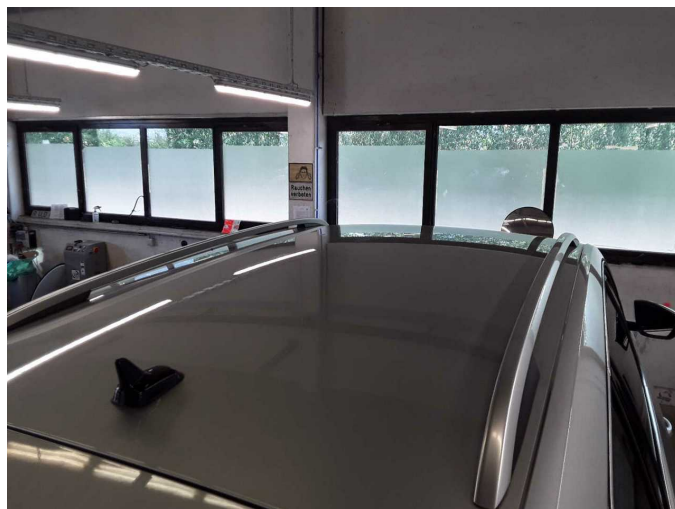
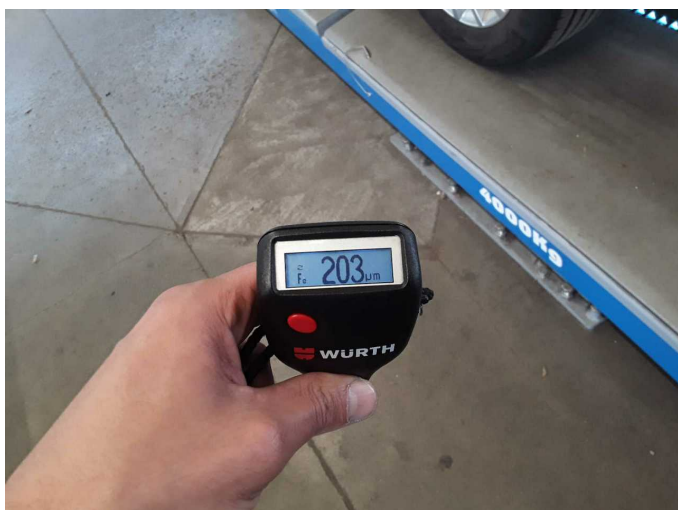
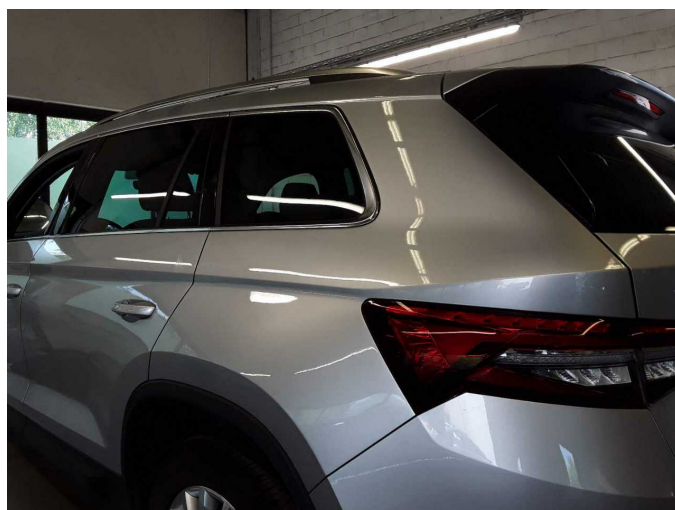
- 1 Roof, Side panel - rear left side, Side panel - rear right side, Door - rear right side, Professionally carried out, Invoice of repair done Non-existent

| Roof | 216 µm | Side panel - rear left side | 203 µm |
| Side panel - rear right side | 260 µm | Door - rear right side | 305 µm |

**Repainting 1:** Roof, Side panel - rear left side, Side panel - rear right side, Door - rear right side
