Expertise

Protocol number: 46553765  
Order No. / Reference: 26657065  
Inspection date: 14 Jul 2026

Manufacturer: Ford

Model: S-Max 2.0 EcoBlue Aut. Titanium

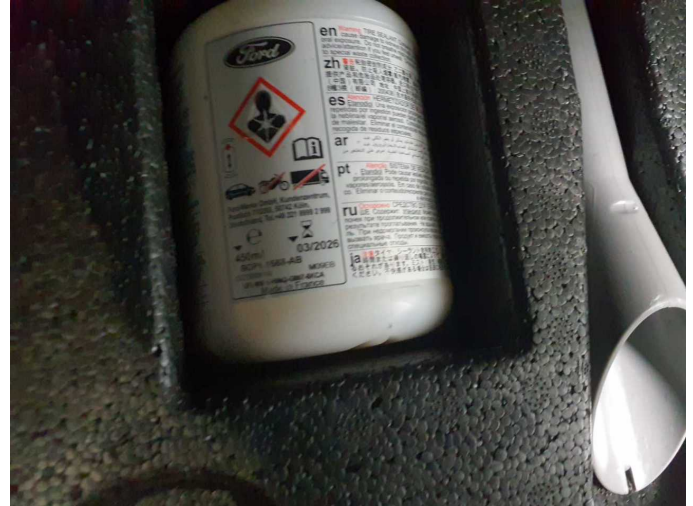
**Damage 1:** Equipment: Tirefit filler - Expired - Replace

| No. | Component group | Description |
|---|---|---|
| 1 | Equipment | Tirefit filler - Expired - Replace |

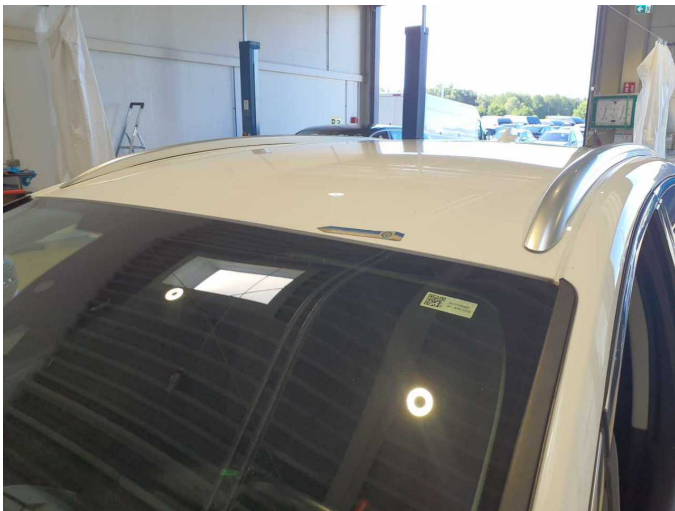
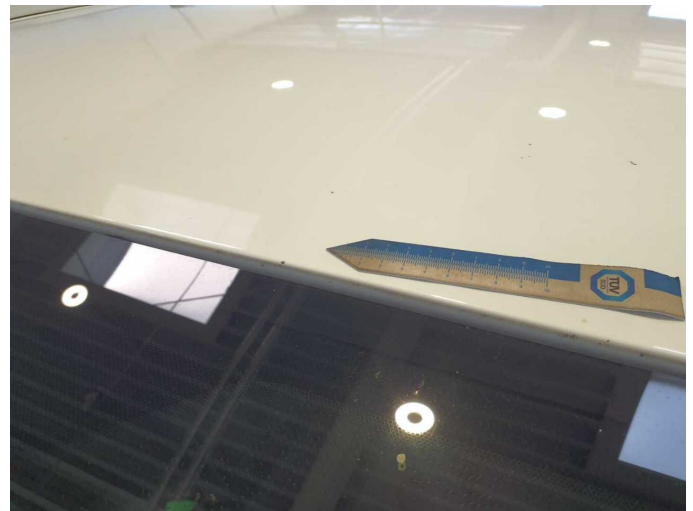
**Damage 2:** Roof: Roof - Stone chips - Smart repair

| No. | Component group | Description |
|---|---|---|
| 2 | Roof | Roof - Stone chips - Smart repair |

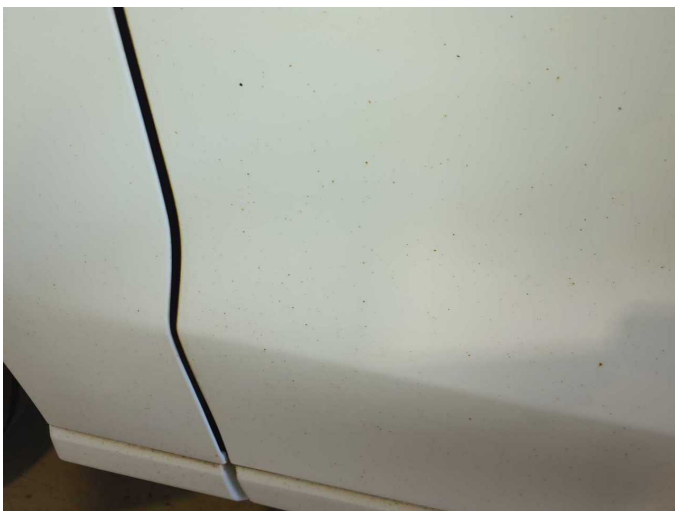
**Damage 3:** Body: Body (Flugrost) - Paint defect - Conditioning

| No. | Component group | Description |
|---|---|---|
| 3 | Body | Body (Flugrost) - Paint defect - Conditioning |

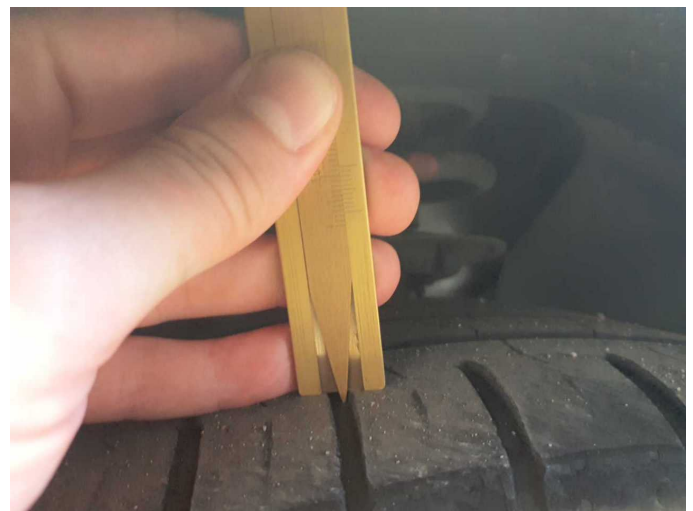
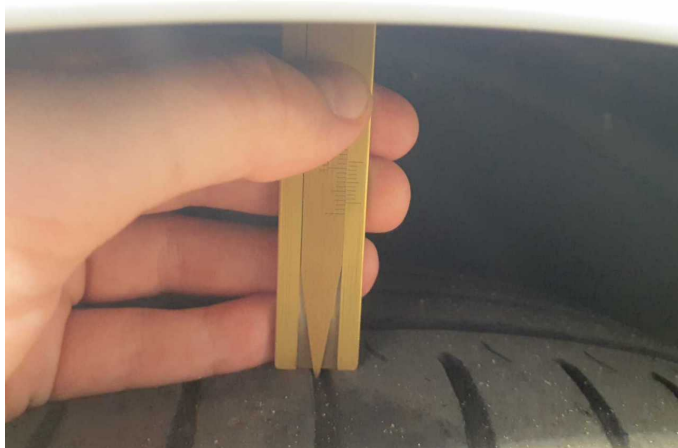
| # | Tyre size | Type of tyre | Manufacturer | Tread depth |
|---|---|---|---|---|
| 1) | 235/55 R17 103V | Summer tyres on Light alloy | Continental | 2mm / 2mm |

**Damage 4:** Wheel / tyres: Tyre - front - does not meet manufacturer specifications - Replace

| No. | Component group | Description |
|---|---|---|
| 4 | Wheel / tyres | Tyre - front - does not meet manufacturer specifications - Replace |

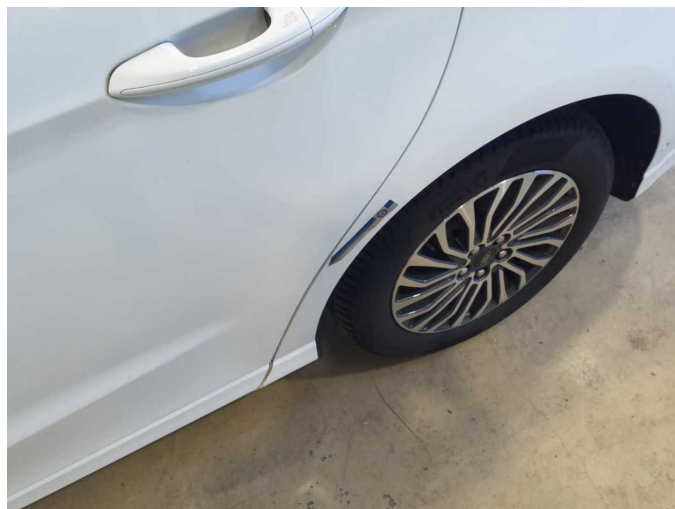
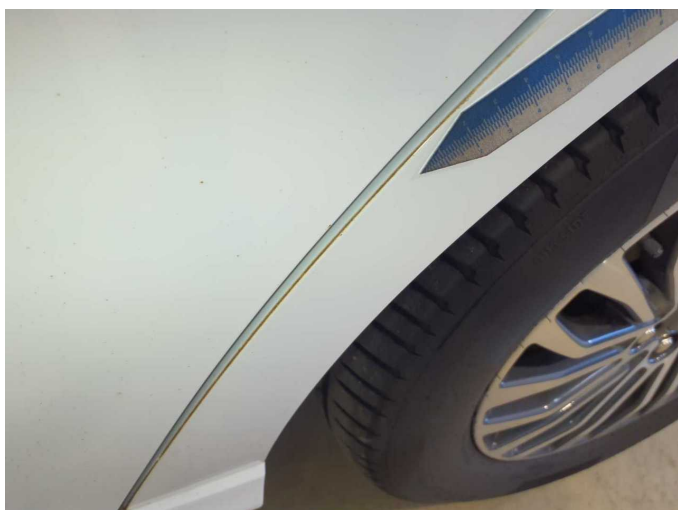
**Damage 5:** Side panel - rear left side: Side panel - Corrosion - Paint

| No. | Component group | Description |
|---|---|---|
| 5 | Side panel - rear left side | Side panel - Corrosion - Paint |

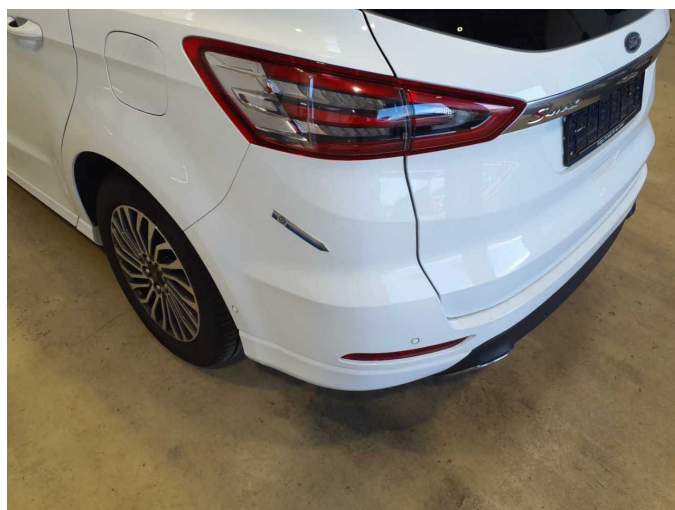
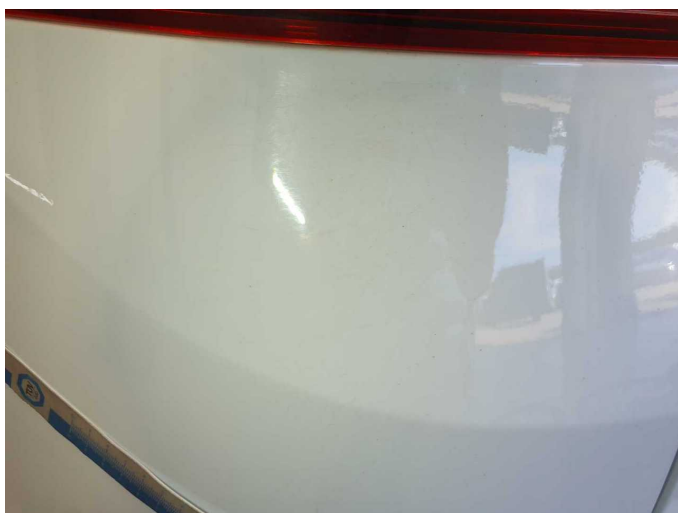
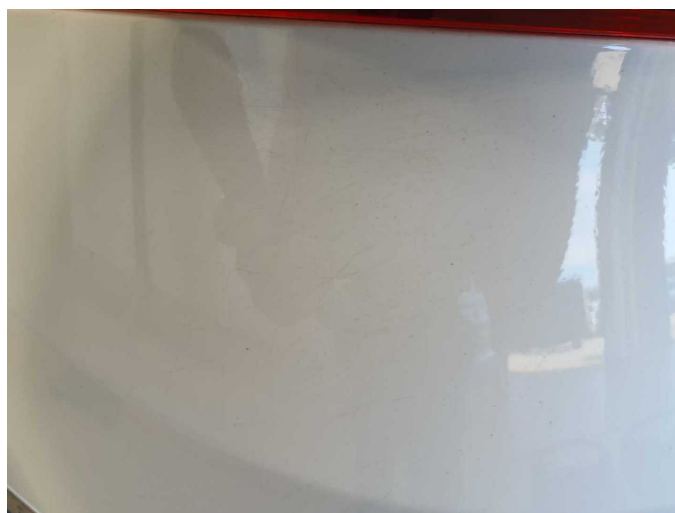
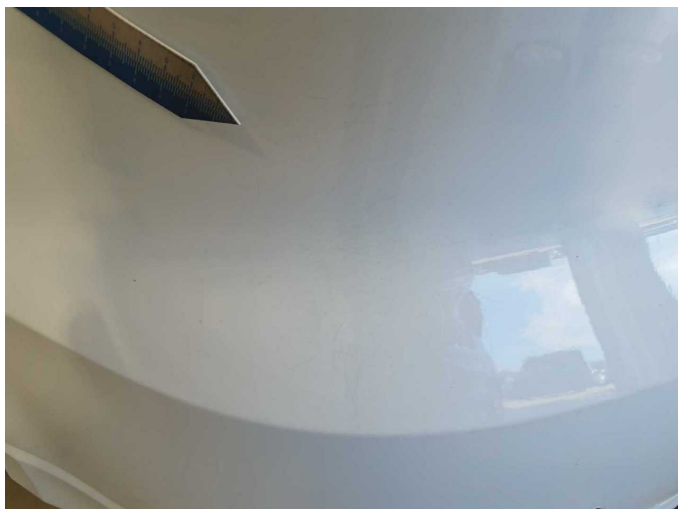
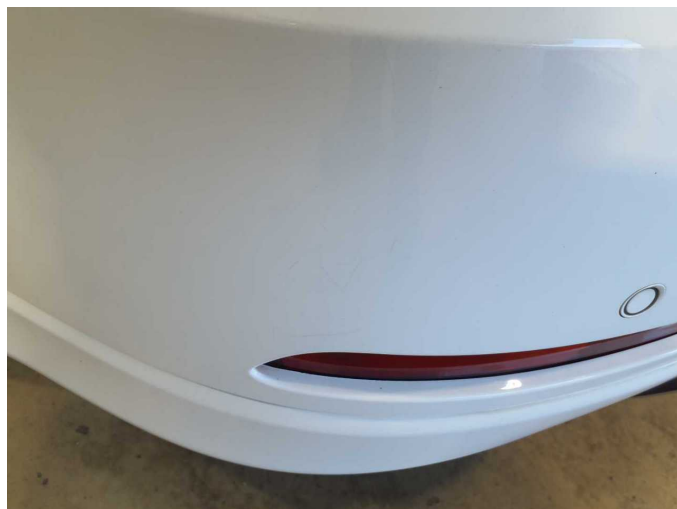
**Damage 6:** Rear bumper: Rear bumper - Scratch(es) - Paint

| No. | Component group | Description |
|---|---|---|
| 6 | Rear bumper | Rear bumper - Scratch(es) - Paint |

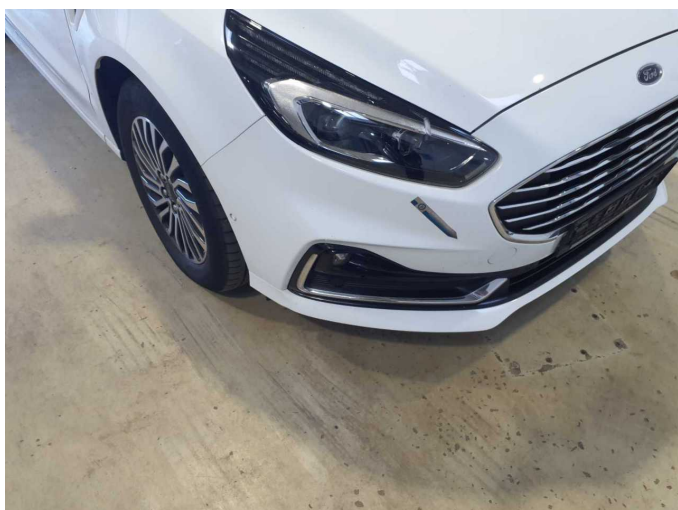
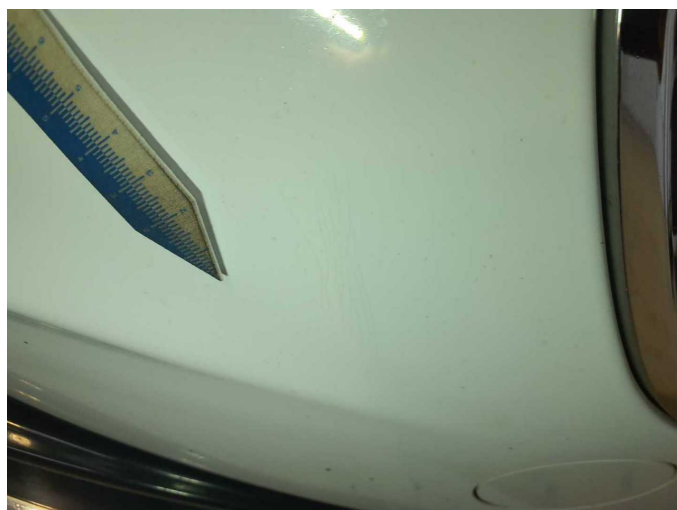
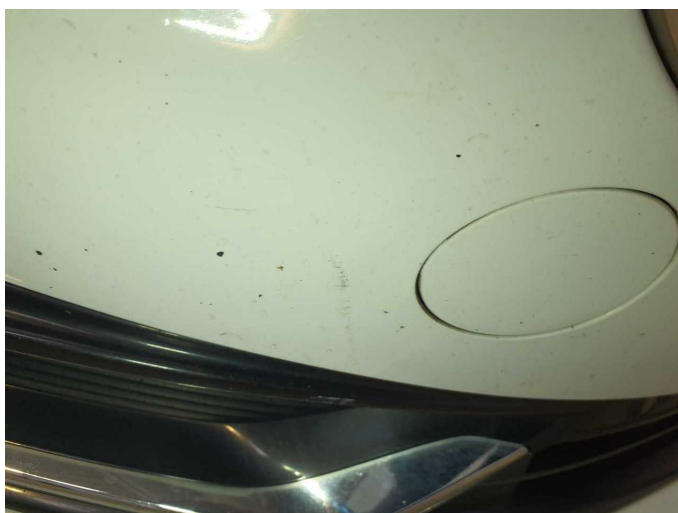
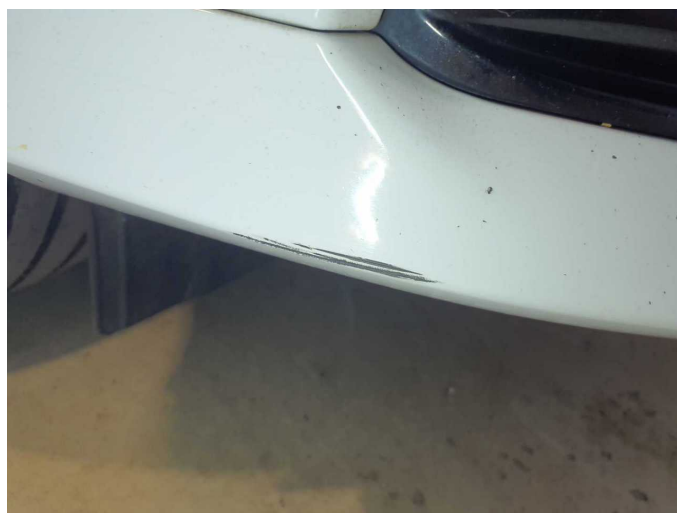
**Damage 7:** Front bumper: Front bumper - Scratch(es) - Paint

| No. | Component group | Description |
|---|---|---|
| 7 | Front bumper | Front bumper - Scratch(es) - Paint |

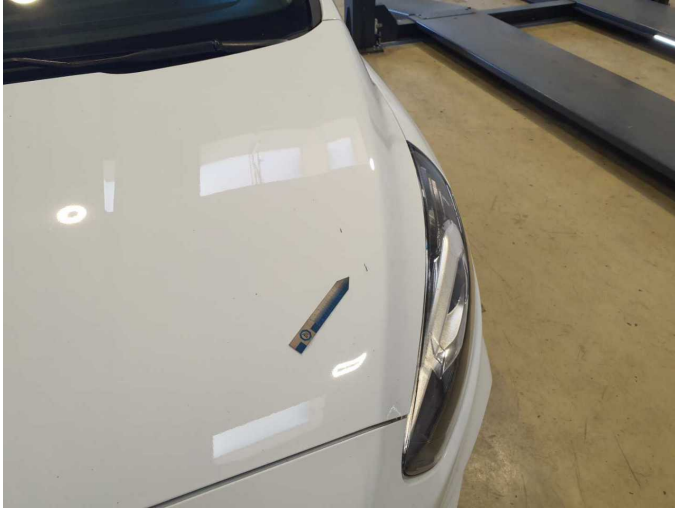
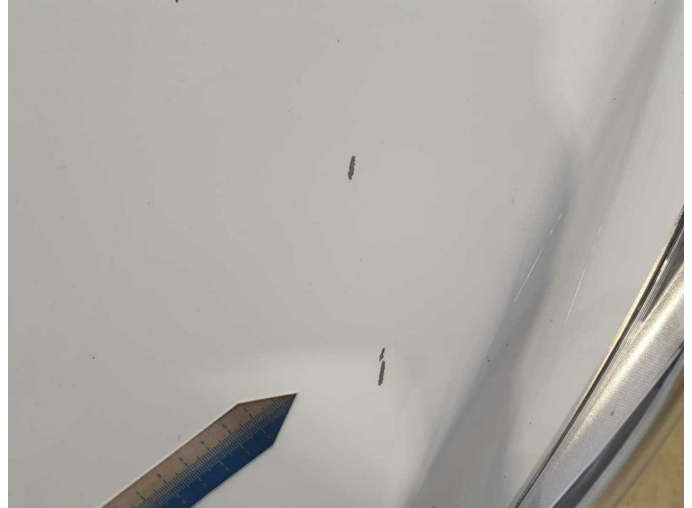
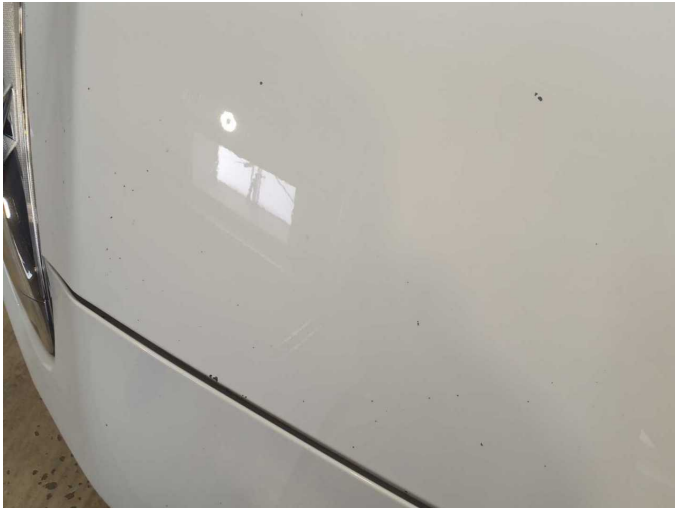
**Damage 8:** Bonnet: Bonnet - Scratch(es) - Paint

| No. | Component group | Description |
|---|---|---|
| 8 | Bonnet | Bonnet - Scratch(es) - Paint |
