Expertise

Protocol number: 45963106  
Order No. / Reference: 26539831  
Inspection date: 15 Jun 2026

Manufacturer: Skoda  
VIN: TMBJK8NX6NY025285

Model: Octavia Combi 2.0 TDI DSG RS

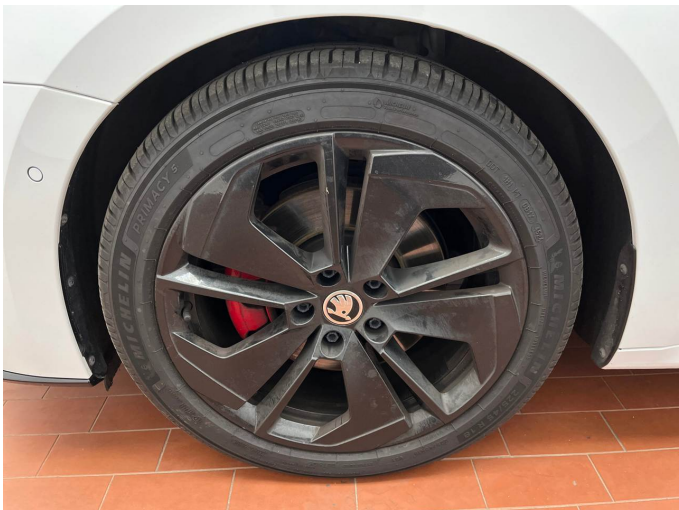
Figure 12: Mounted tyres

| Tyres | | | | |
|---|---|---|---|---|
| 1) | 225/45 R18 95Y | Summer tyres on Light alloy | Michelin | 6mm / 6mm |
| 2) | 225/45 R18 95Y | Summer tyres on Light alloy | Sonstige | 7mm / 7mm |

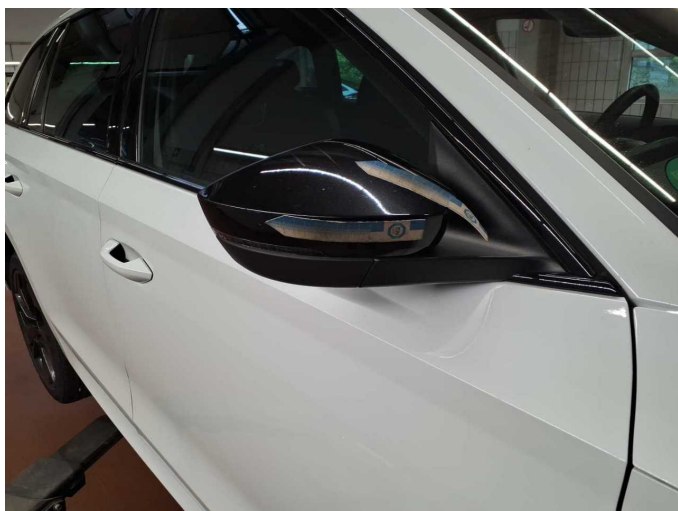
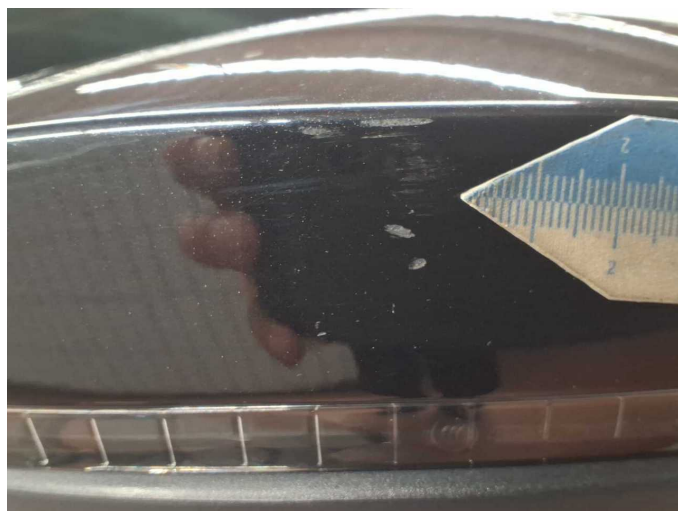
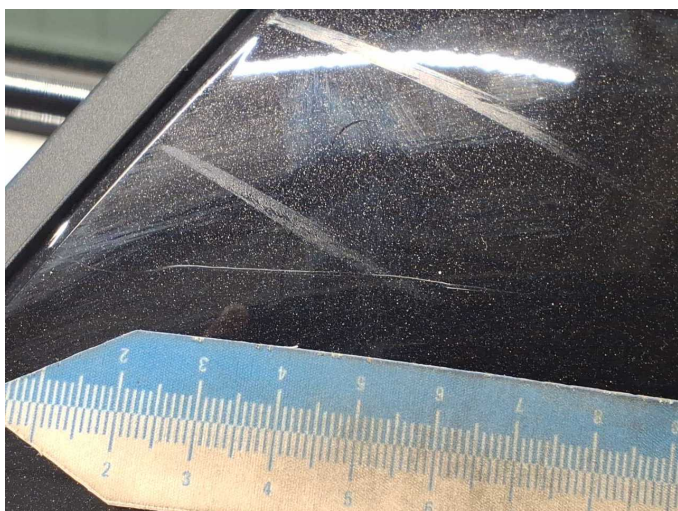
| No. | Component group | Description |
|---|---|---|
| 1 | Wing mirror - right side | Cap - Scratch(es) - Smart repair |

**Damage 1:** Wing mirror - right side: Cap - Scratch(es) - Smart repair

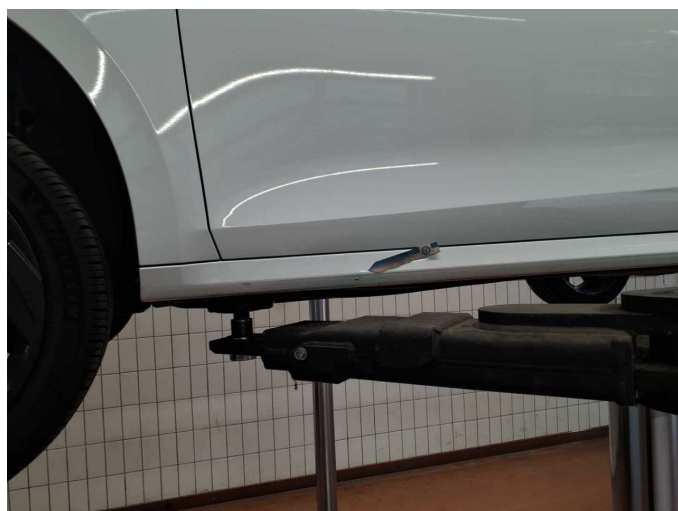
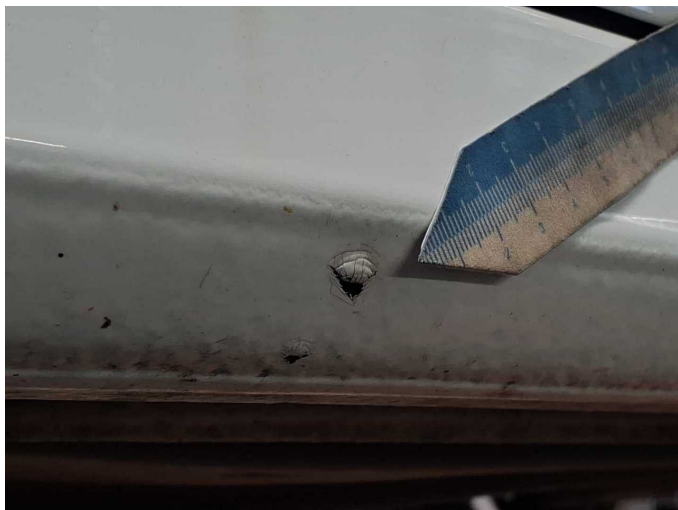
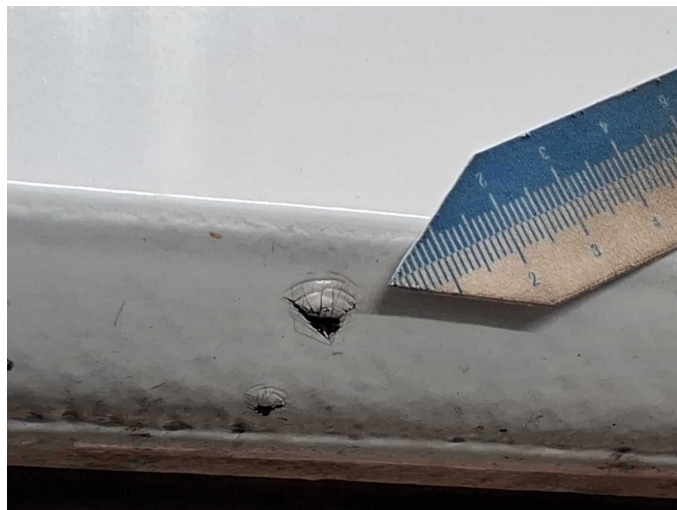
| No. | Component group | Description |
|---|---|---|
| 2 | Sill - left side | Sill - Scratch(es) - Smart repair |

**Damage 2:** Sill - left side: Sill - Scratch(es) - Smart repair

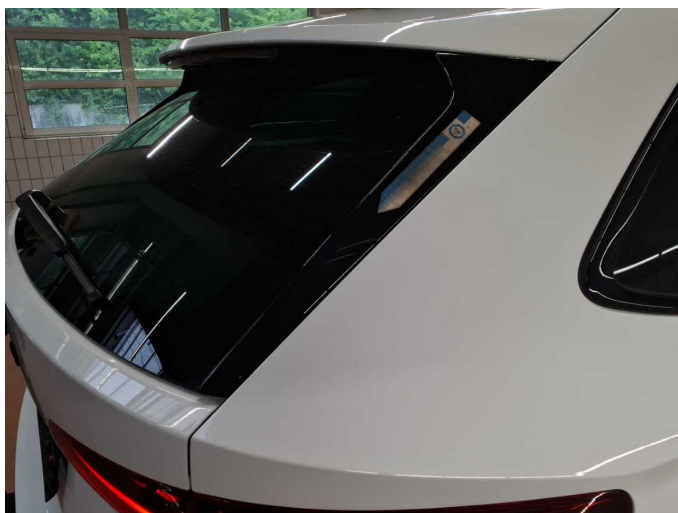
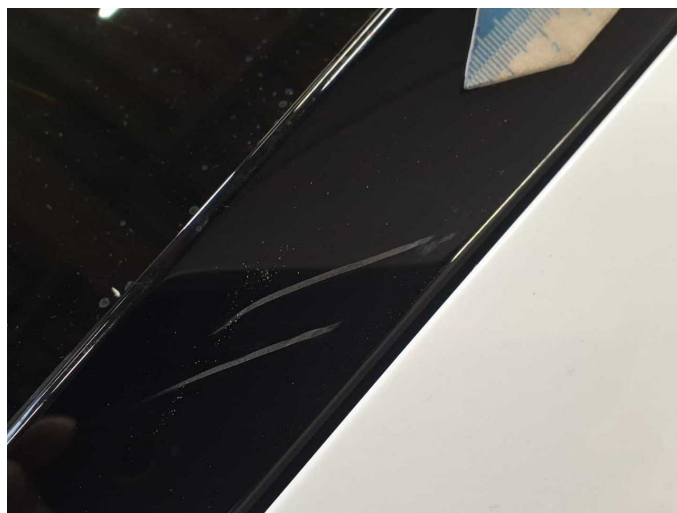
| No. | Component group | Description |
|---|---|---|
| 3 | Trim / covers | Brightware / decorative strip (Heckklappe rechts) - Scratch(es) - Smart repair |

**Damage 3:** Trim / covers: Brightware / decorative strip (Heckklappe rechts) - Scratch(es) - Smart repair

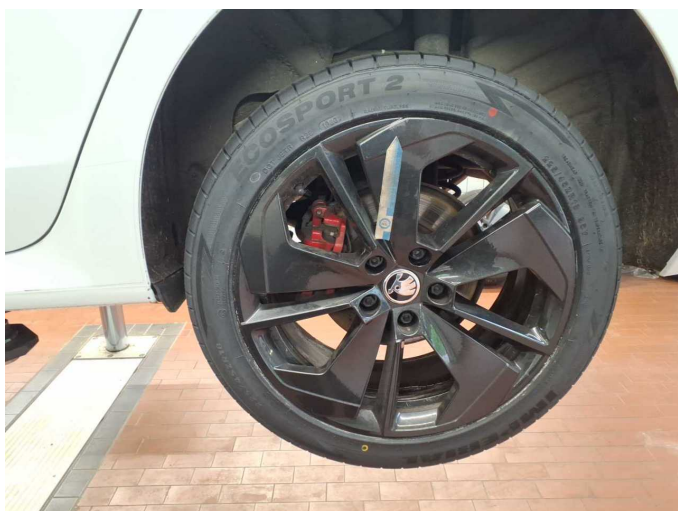
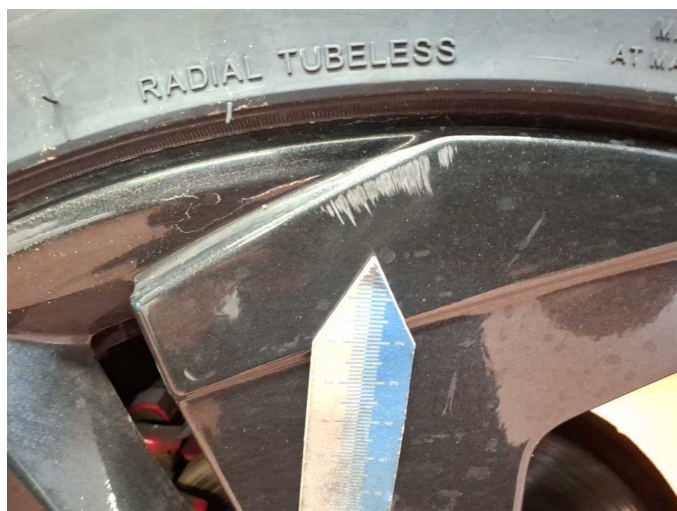
| No. | Component group | Description |
|---|---|---|
| 4 | Wheel / tyres | Alloy rim - rear left side - Scratch(es) - Loss in value |

**Damage 4:** Wheel / tyres: Alloy rim - rear left side - Scratch(es) - Loss in value

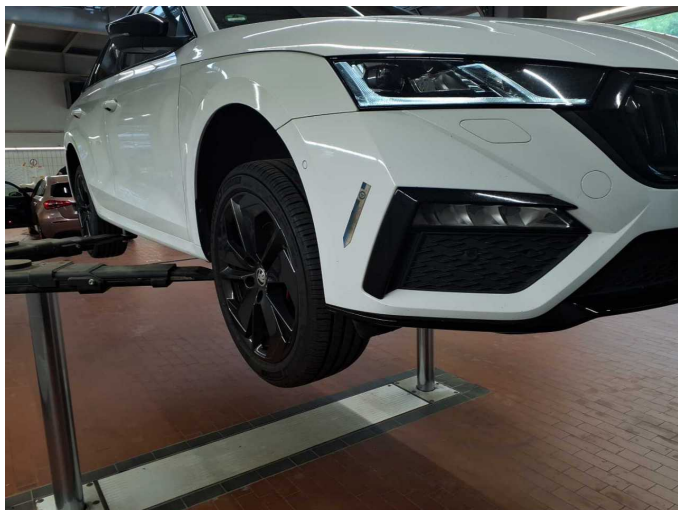
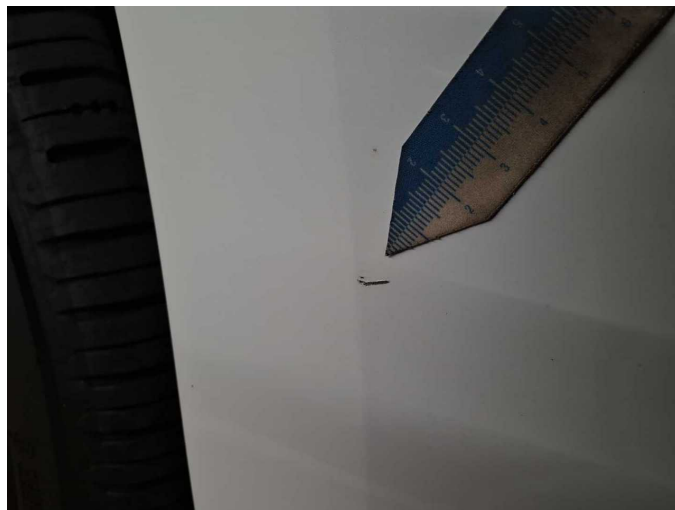
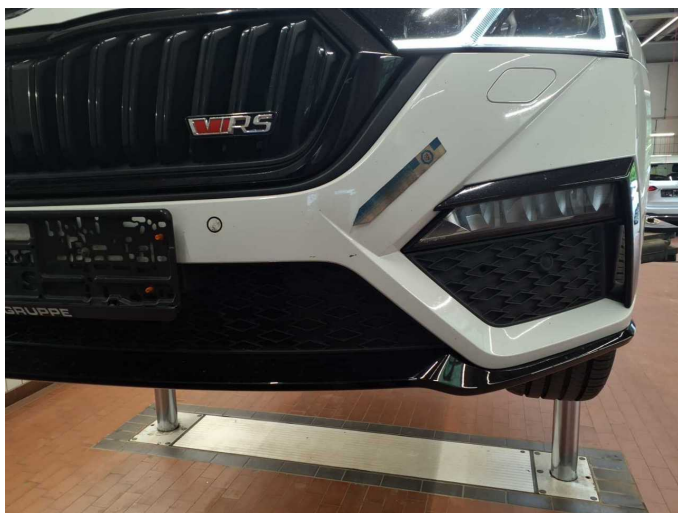
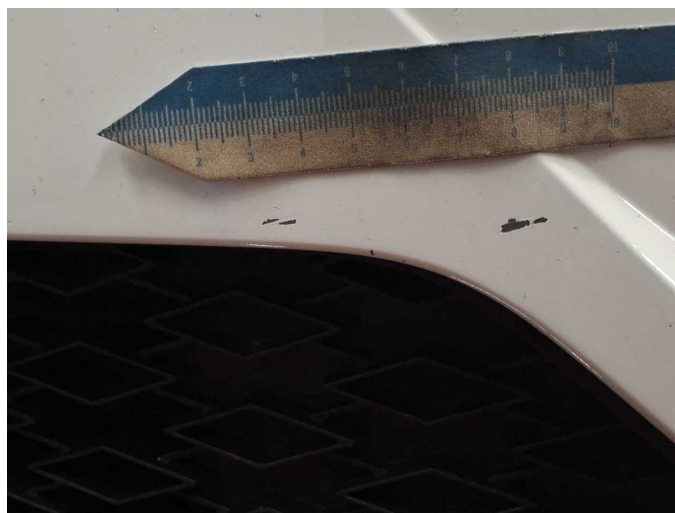
| No. | Component group | Description |
|---|---|---|
| 5 | Front bumper | Front bumper - Scratch(es) - Paint |

**Damage 5:** Front bumper: Front bumper - Scratch(es) - Paint

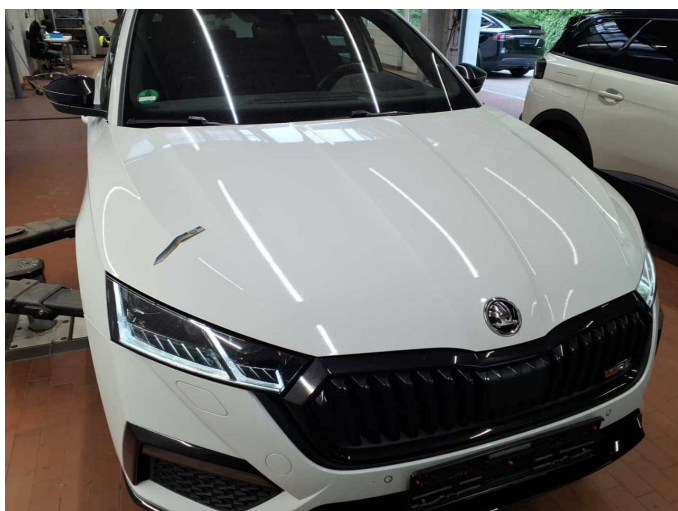
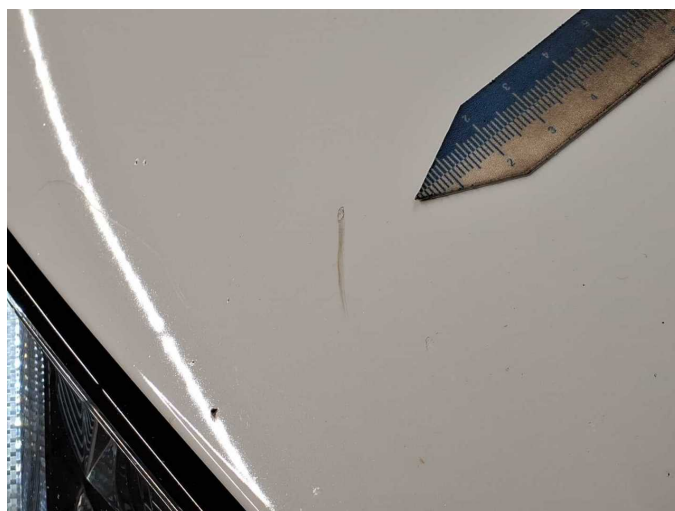
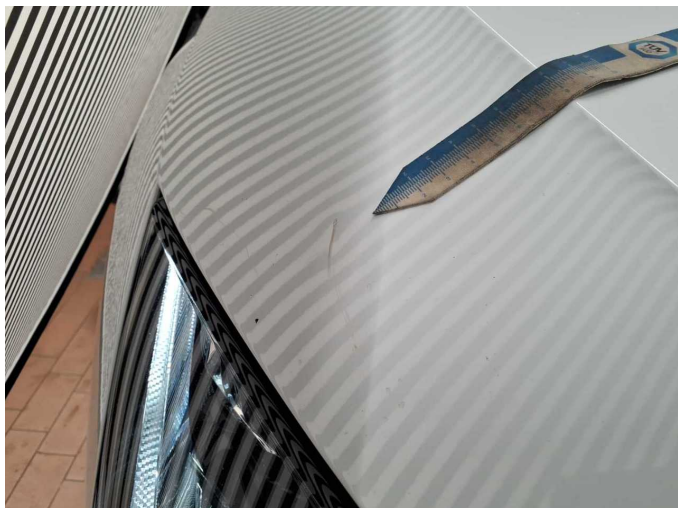
| No. | Component group | Description |
|---|---|---|
| 6 | Bonnet | Bonnet - Dent / paintcoat damage - Paint |

**Damage 6:** Bonnet: Bonnet - Dent / paintcoat damage - Paint

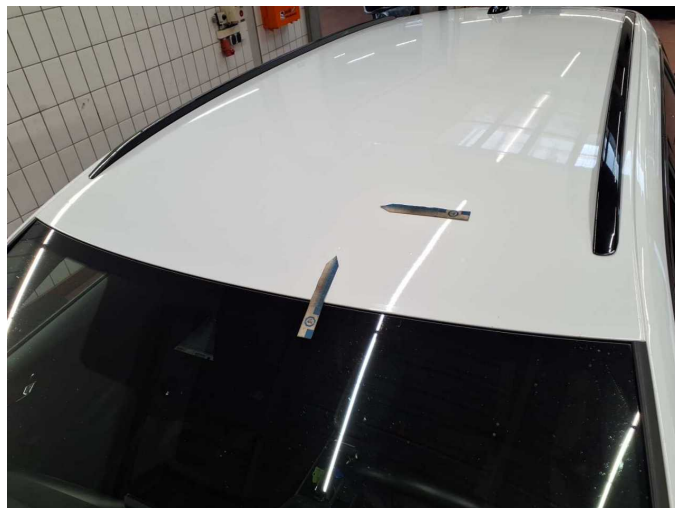
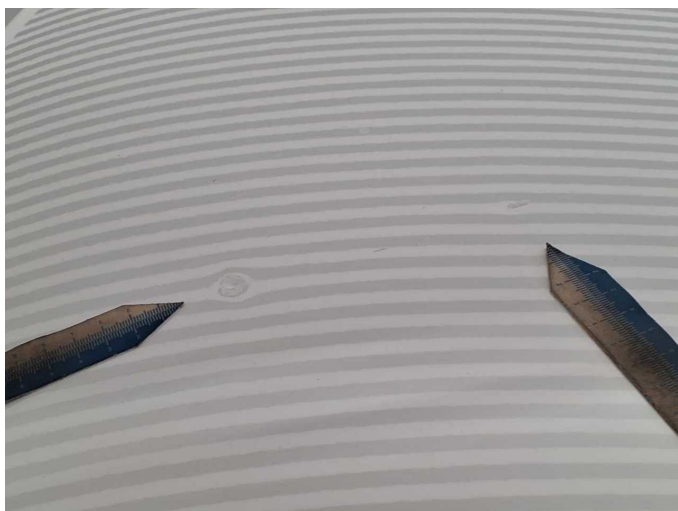
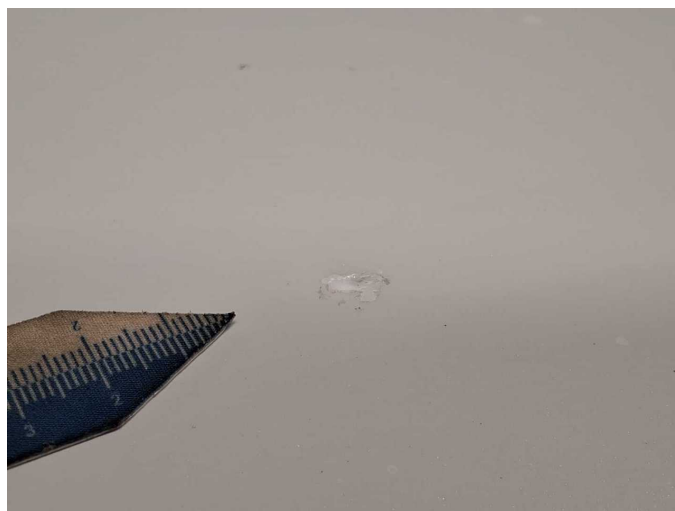
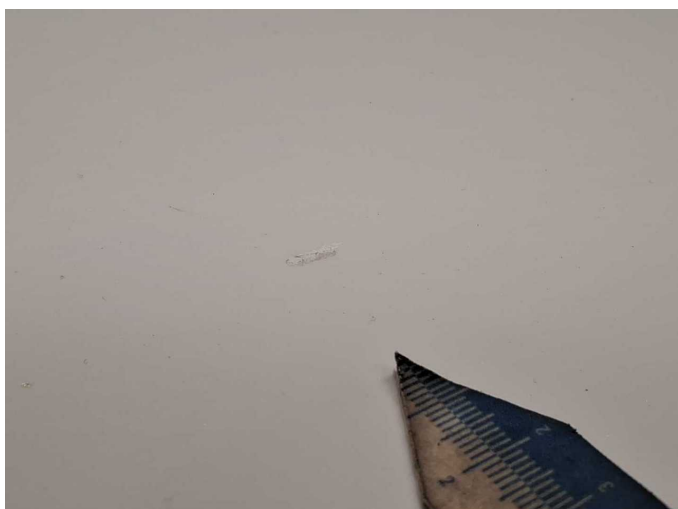
| No. | Component group | Description |
|---|---|---|
| 7 | Roof | Roof - Dent / paintcoat damage - Repair and paint |

**Damage 7:** Roof: Roof - Dent / paintcoat damage - Repair and paint

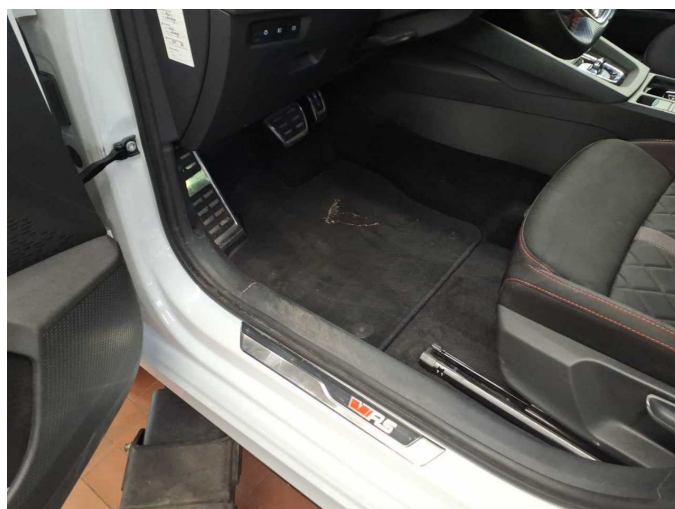
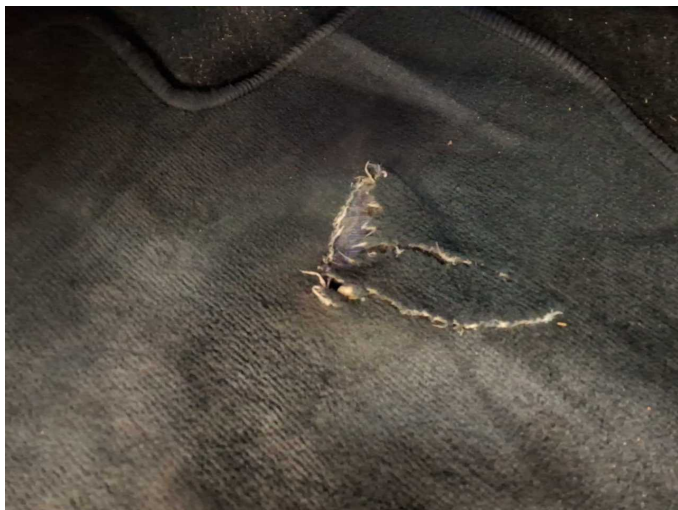
| No. | Component group | Description |
|---|---|---|
| 5 | Trim / covers | Floor mats (Vorne links) - Holes - No deduction |

**Wear and tear 5:** Trim / covers: Floor mats (Vorne links) - Holes - No deduction
