Expertise

Protocol number: 46262376
Order No. / Reference: 26577869
Inspection date: 29 Jun 2026

Model: Passat Variant 2.0 TDI SCR DSG Business

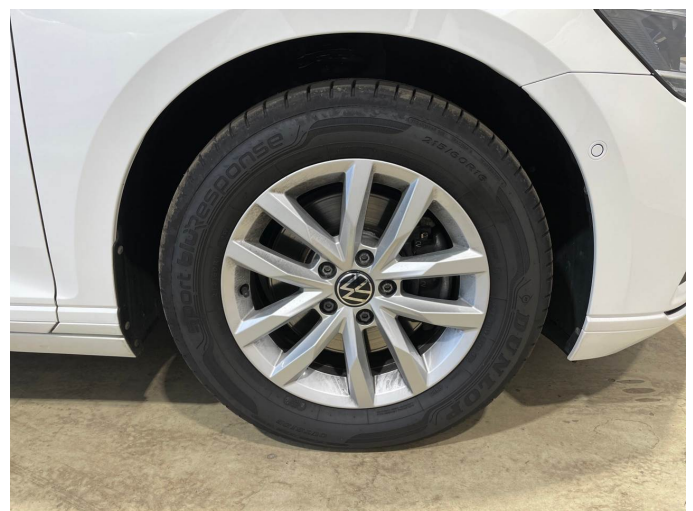
#	Tyre size	Type of tyre	Manufacturer	Tread depth
1)	215/60 R16 95V	Summer tyres on Light alloy	Dunlop	4mm / 4mm
2)	215/60 R16 95V	Summer tyres on Light alloy	unterschiedliche Hersteller	3mm / 4mm

Figure 12: Mounted tyres

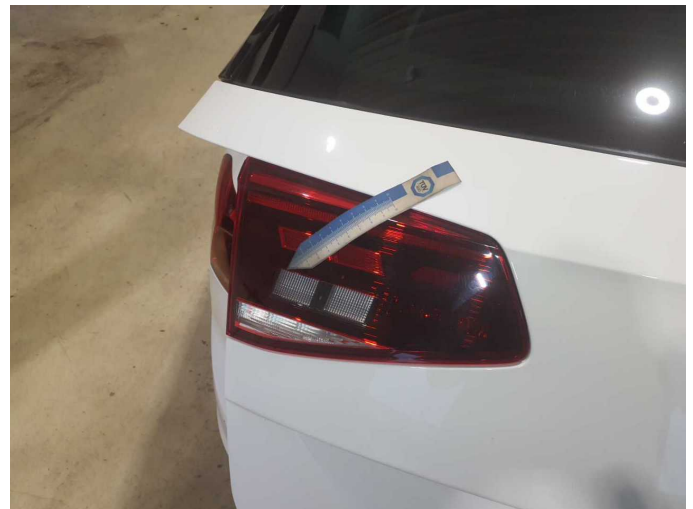
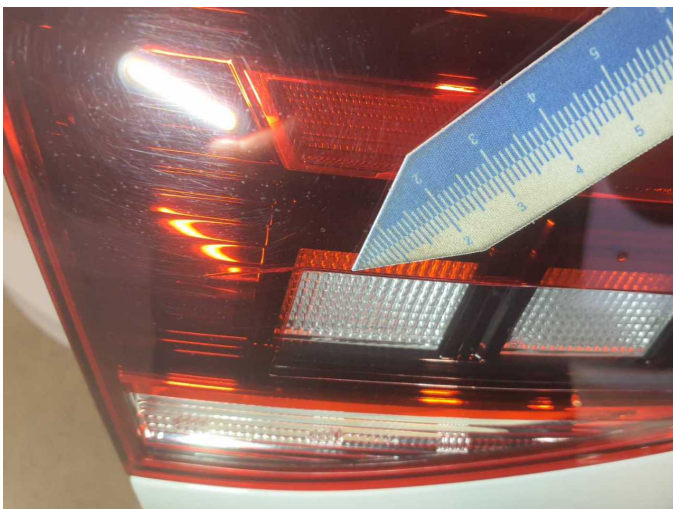
No.	Component group	Description
1	Tail light	Tail lamp - left side - Broken / torn - Replace

Damage 1: Tail light: Tail lamp - left side - Broken / torn - Replace

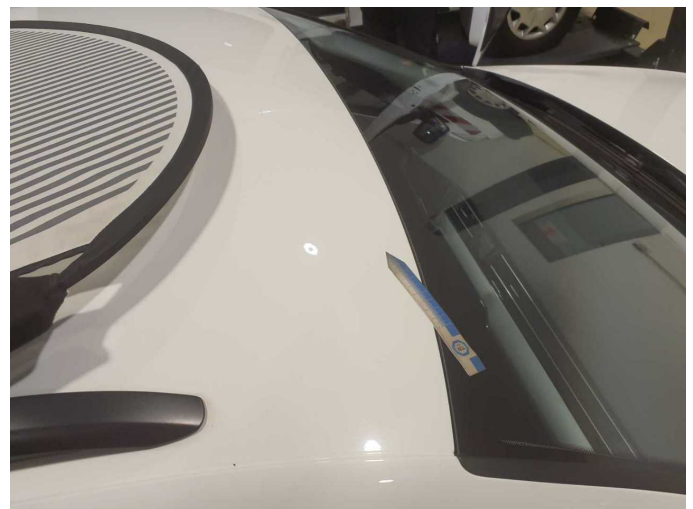
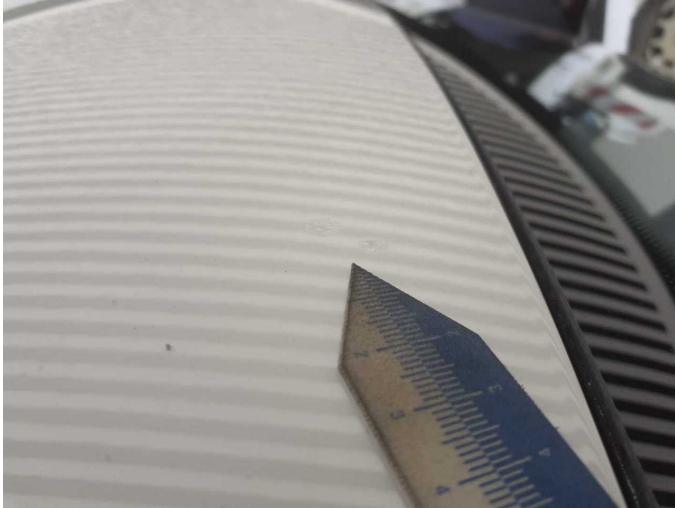
No.	Component group	Description
1	Bonnet	Bonnet - Stone chips - No deduction
2	Front bumper	Front bumper - Stone chips - No deduction
3	Vehicle glazing	Windscreen - Stone chips - No deduction
4	Roof	Roof (Lack stiff) - Paint defect - No deduction

Wear and tear 4: Roof: Roof (Lack stift) - Paint defect - No deduction

Wear and tear 4: Roof: Roof (Lack stiff) - Paint defect - No deduction

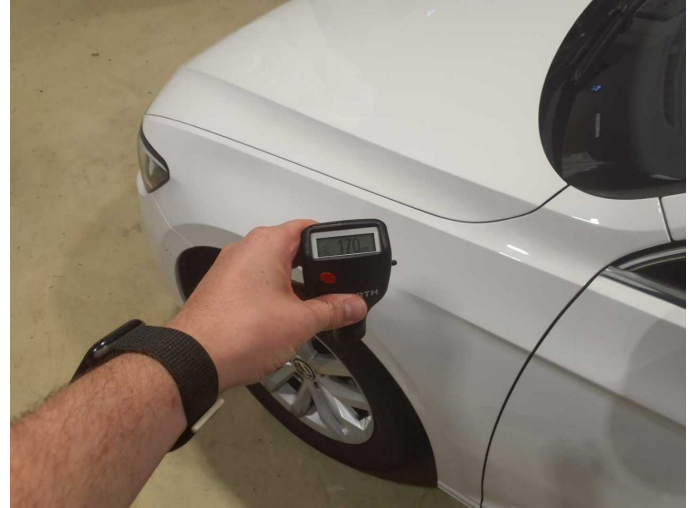
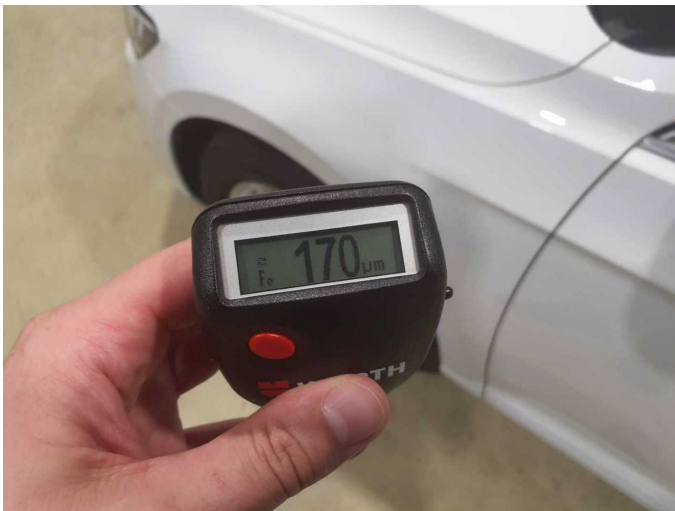
No.	Repainting
1	Mudguard - left side, Professionally carried out, Invoice of repair done Non-existent
2	Mudguard - right side, Professionally carried out, Invoice of repair done Non-existent
3	Bonnet, Professionally carried out, Invoice of repair done Non-existent
4	Door - rear left side, Professionally carried out

Mudguard - left side	170 µm	Mudguard - right side	193 µm
Bonnet	336 µm	Door - rear left side	195 µm

Repainting 1: Mudguard - left side

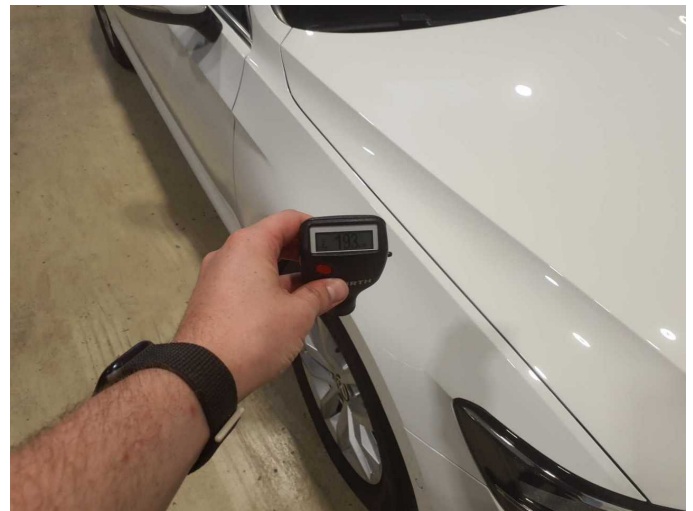
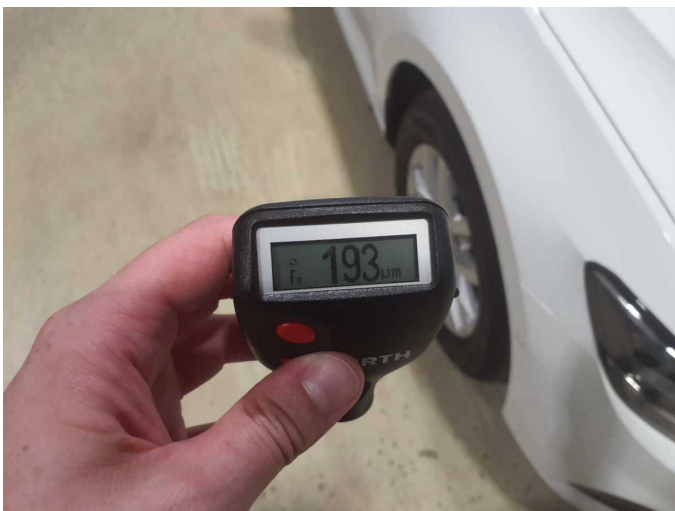
Repainting 2: Mudguard - right side

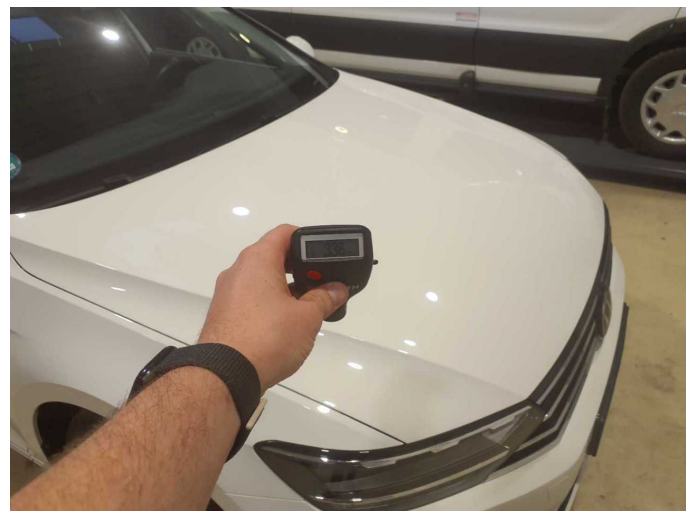
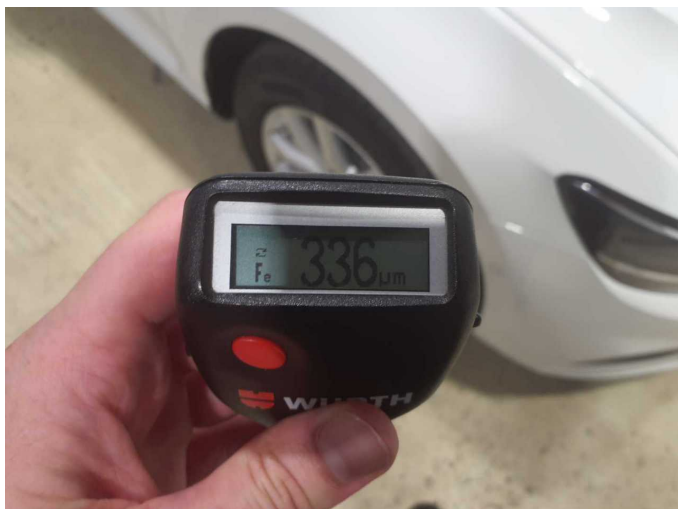
Repainting 3: Bonnet

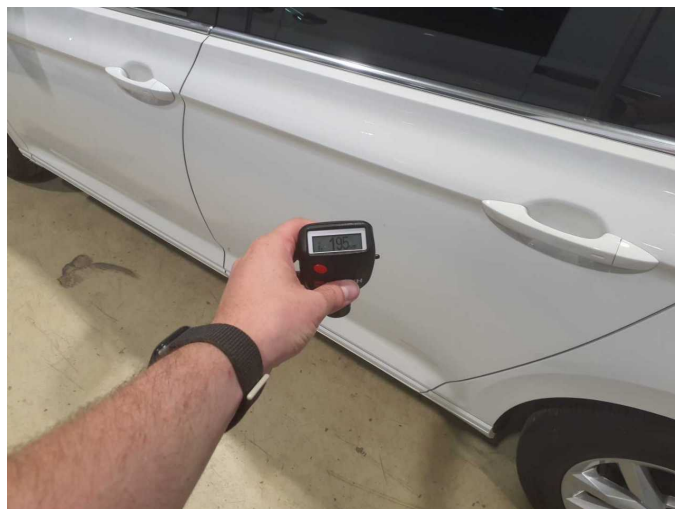
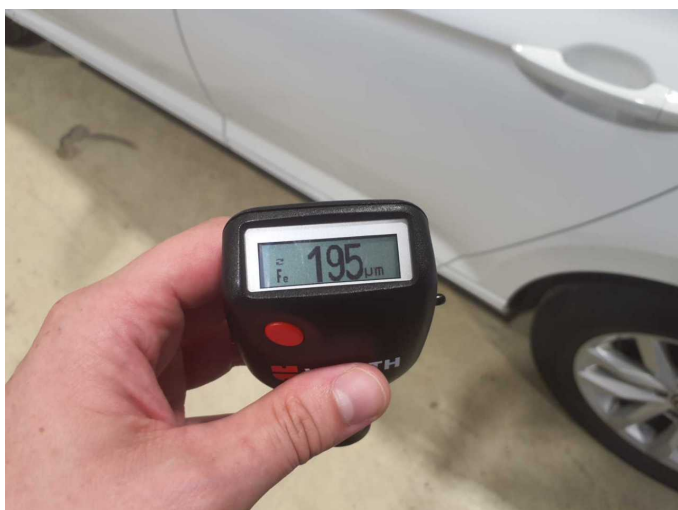
Repainting 4: Door - rear left side
