Expertise

Protocol number: 46374513  
Order No. / Reference: 26348778  
Inspection date: 7 Jul 2026

Manufacturer: Mercedes-Benz  
VIN: W1KAH0DB1PF114224

Model: C 200 d T 9G-TRONIC

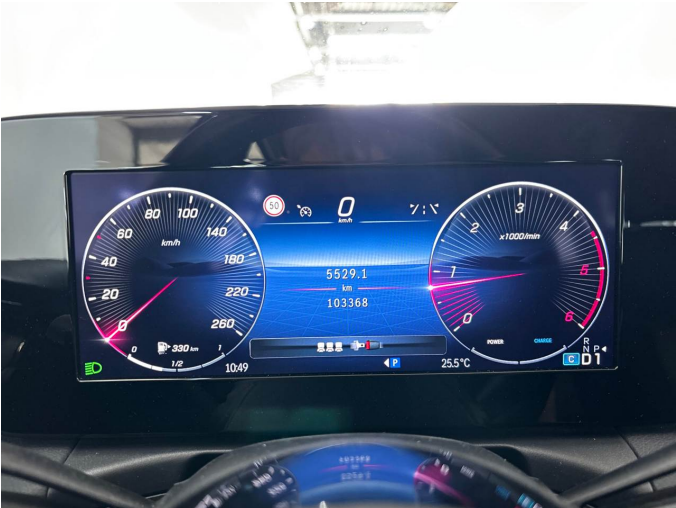
| Vehicle details | |
|---|---|
| Mileage (Read) | 103,368 km |

Figure 7: Instrument cluster

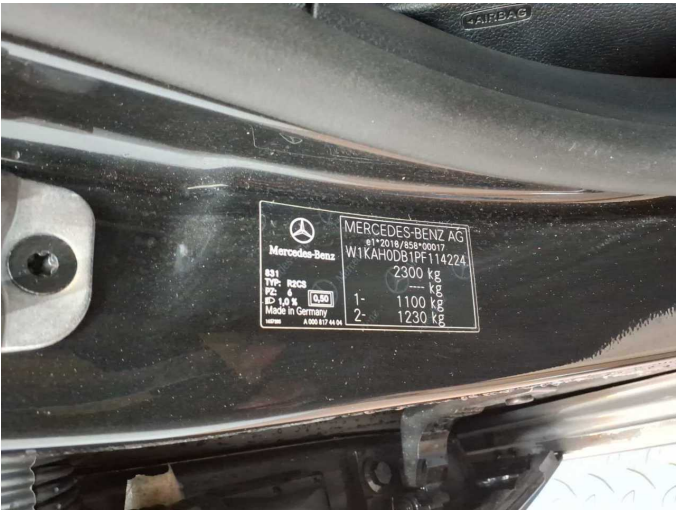
| VIN comparison | The vehicle identification number (VIN) was read from the vehicle and its conformity with the submitted documents was confirmed by the undersigned during the inspection. |

Figure 11: VIN

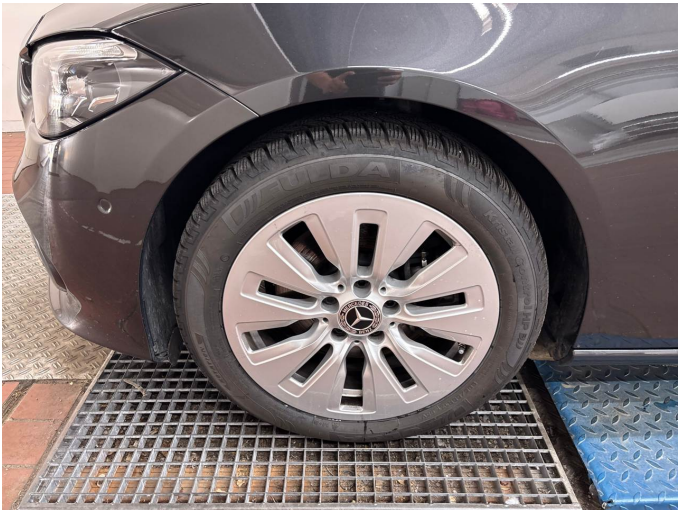
| # | Tyre size | Type of tyre | Manufacturer | Tread depth |
|---|---|---|---|---|
| 1) | 205/55 R17 95V | Winter tyres on Light alloy | Fulda | 7mm / 7mm |
| 2) | 205/55 R17 95V | Winter tyres on Light alloy | Fulda | 7mm / 7mm |

Figure 12: Mounted tyres

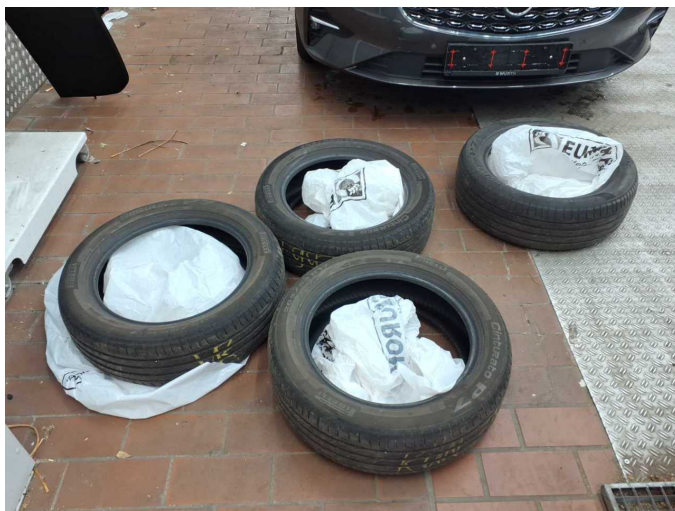
| # | Tyre size | Type of tyre | Manufacturer | Tread depth |
|---|---|---|---|---|
| 1) | 205/55 R17 91W | Summer tyres (Without wheel rim) | Pirelli | 3mm / 3mm |
| 2) | 205/55 R17 91W | Summer tyres (Without wheel rim) | Pirelli | 3mm / 3mm |

Figure 15: Additional tyres

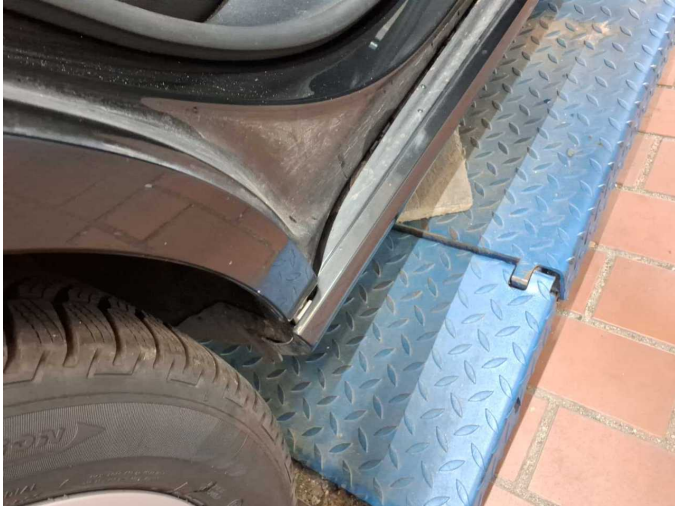
| No. | Component group | Description |
|---|---|---|
| 2 | Sill - right side | Trim - Loose - Repair |

Damage 2: Sill - right side: Trim - Loose - Repair

**Damage 2:** Sill - right side: Trim - Loose - Repair

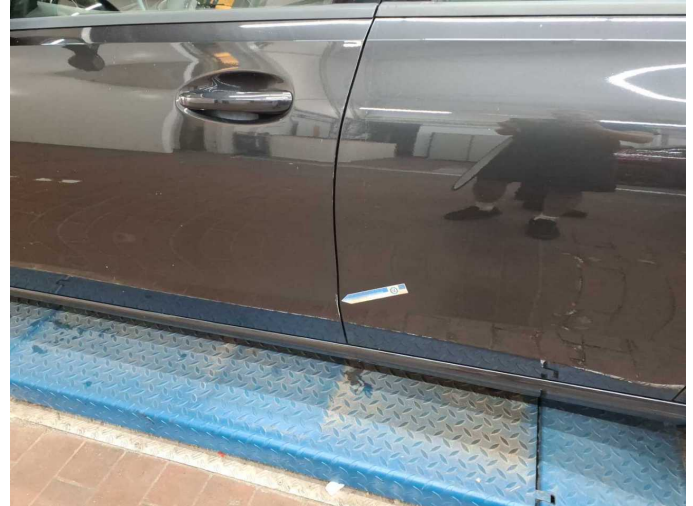
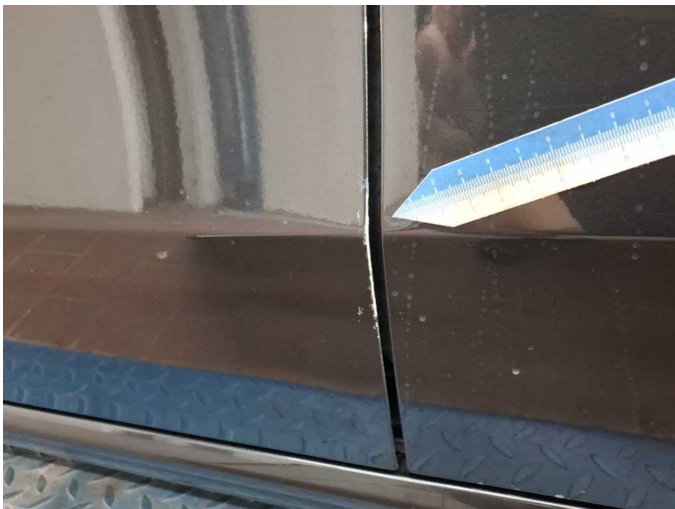
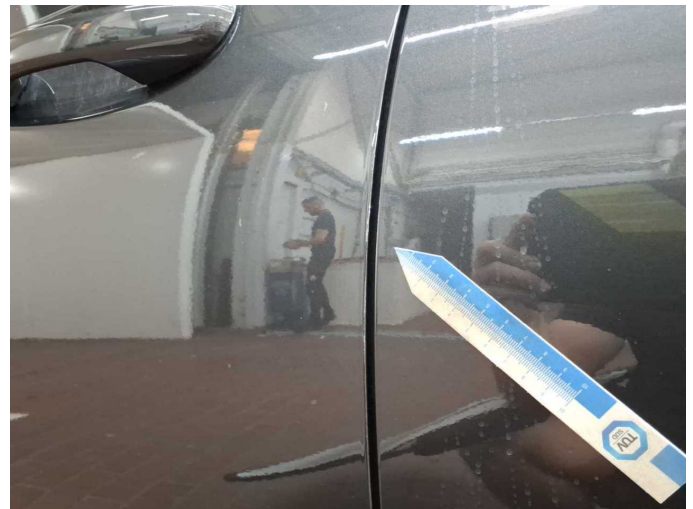
| No. | Component group | Description |
|---|---|---|
| 3 | Door - front left side | Door - Scratch(es) - Smart repair |

**Damage 3:** Door - front left side: Door - Scratch(es) - Smart repair

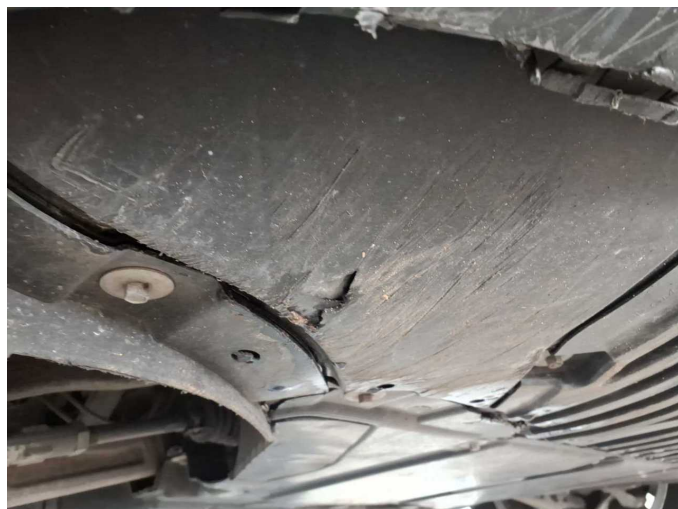
| No. | Component group | Description |
|---|---|---|
| 5 | Body | Underbody panelling (Links) - Broken / torn - Replace |

**Damage 5:** Body: Underbody panelling (Links) - Broken / torn - Replace

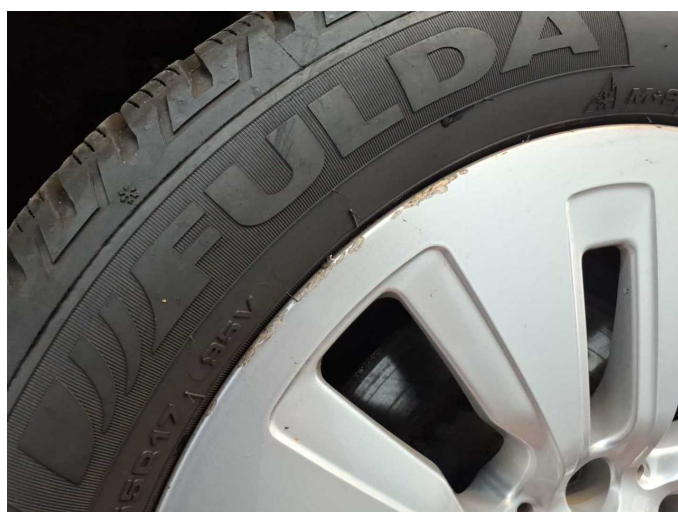
| No. | Component group | Description |
|---|---|---|
| 6 | Wheel / tyres | Alloy rim - rear right side - Scratch(es) - Loss in value |

**Damage 6:** Wheel / tyres: Alloy rim - rear right side - Scratch(es) - Loss in value

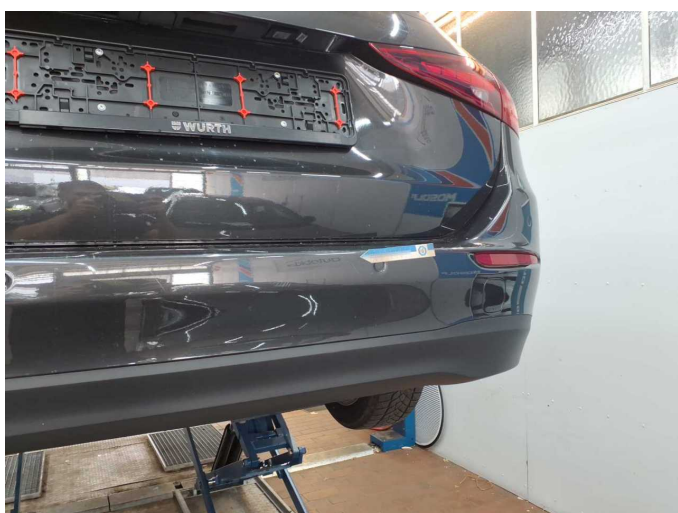
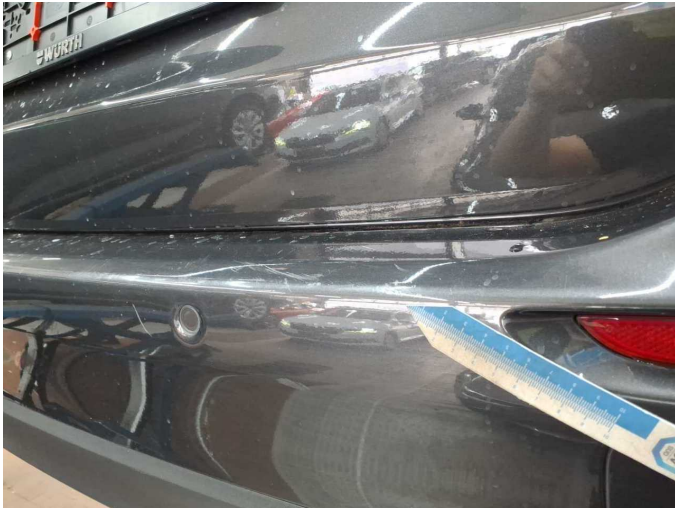
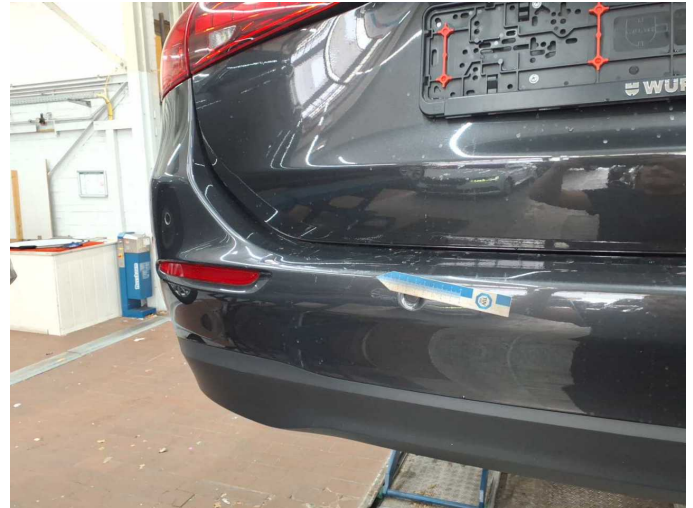
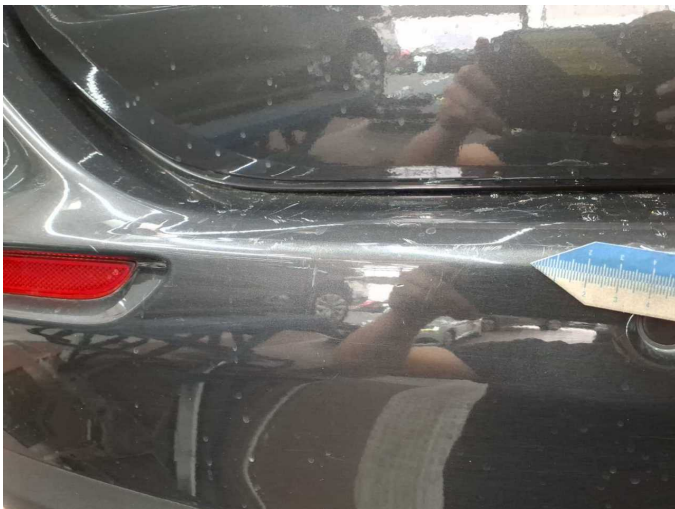
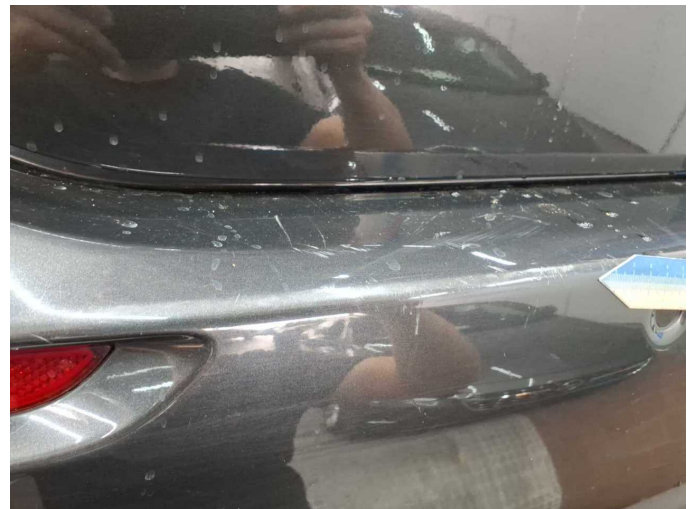
| No. | Component group | Description |
|---|---|---|
| 7 | Rear bumper | Rear bumper - Scratch(es) - Paint |

**Damage 7:** Rear bumper: Rear bumper - Scratch(es) - Paint

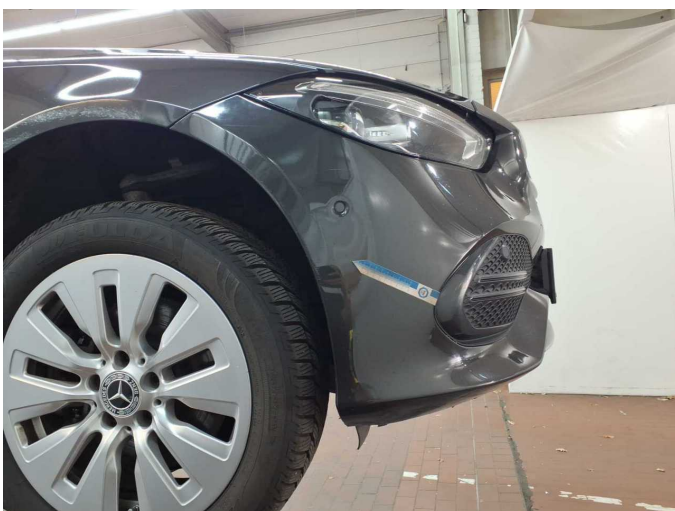
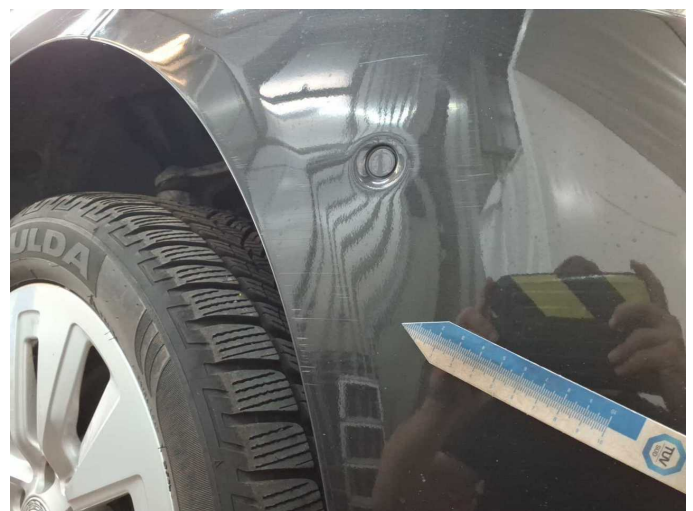
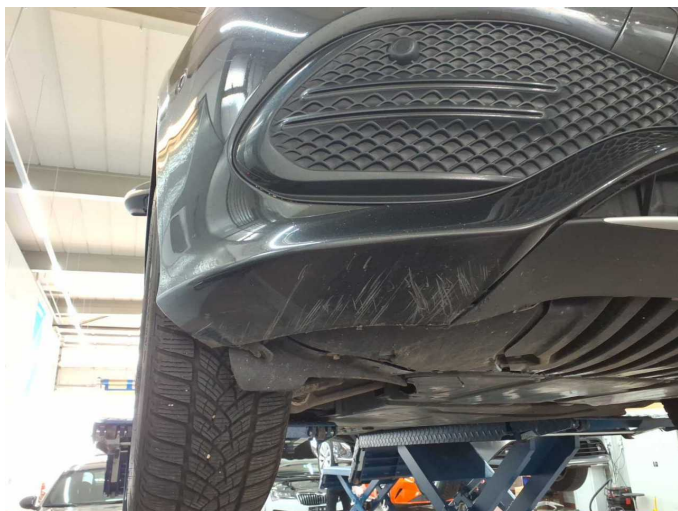
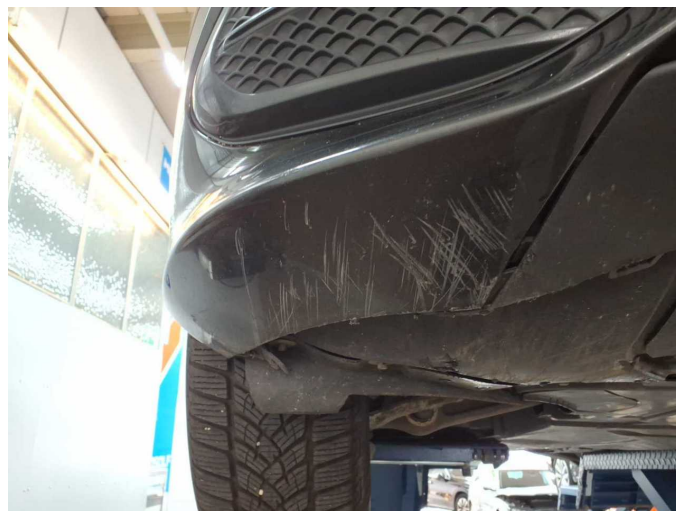
| No. | Component group | Description |
|---|---|---|
| 8 | Front bumper | Front bumper - Scratch(es) - Paint |

**Damage 8:** Front bumper: Front bumper - Scratch(es) - Paint
