Expertise

Protocol number: 46417628  
Order No. / Reference: 26383093  
Inspection date: 9 Jul 2026

Manufacturer: Ford

Model: Mustang Mach-E AWD PREMIUM

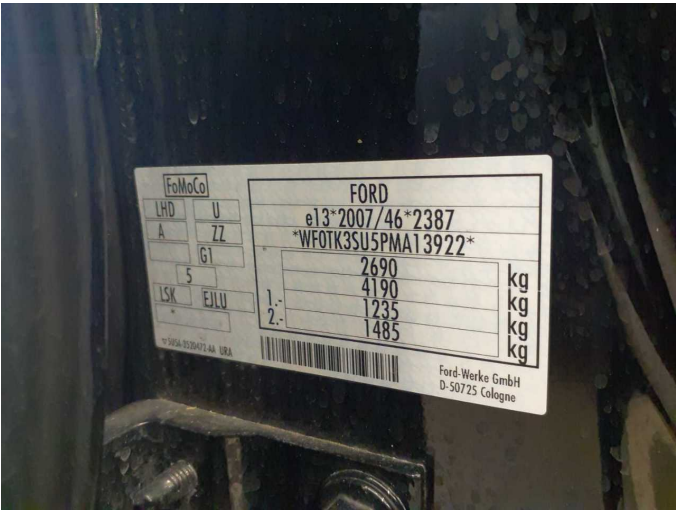
Figure 11: VIN

| VIN comparison | The vehicle identification number (VIN) was read from the vehicle and its conformity with the submitted documents was confirmed by the undersigned during the inspection. |

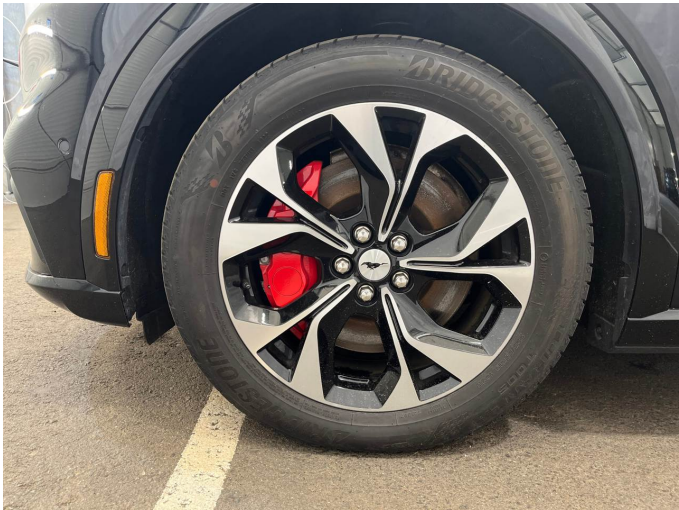
Figure 12: Mounted tyres

| # | Tyre size | Type of tyre | Manufacturer | Tread depth |
|---|---|---|---|---|
| 1) | 225/55 R19 103H | Summer tyres on Light alloy | Bridgestone | 4mm / 4mm |
| 2) | 225/55 R19 103H | Summer tyres on Light alloy | Bridgestone | 5mm / 5mm |

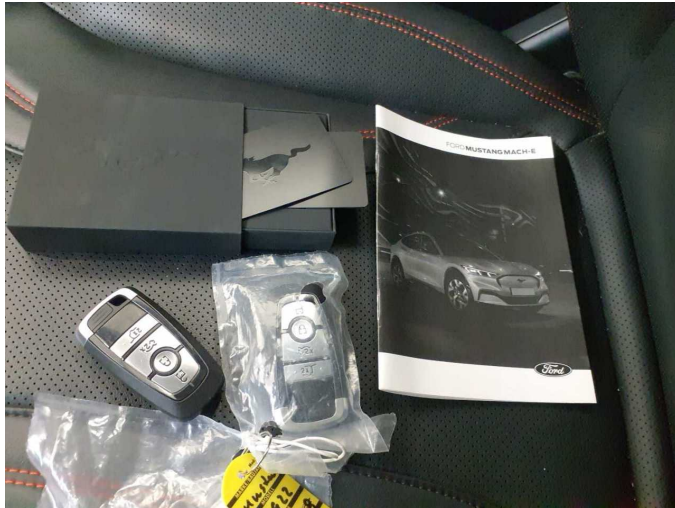
Figure 13: Documents

| Documents submitted | At the time of the inspection, the vehicle registration certificate Part 2 (title) was available, but the vehicle registration certificate Part 1 (document) was not. (Copy) |

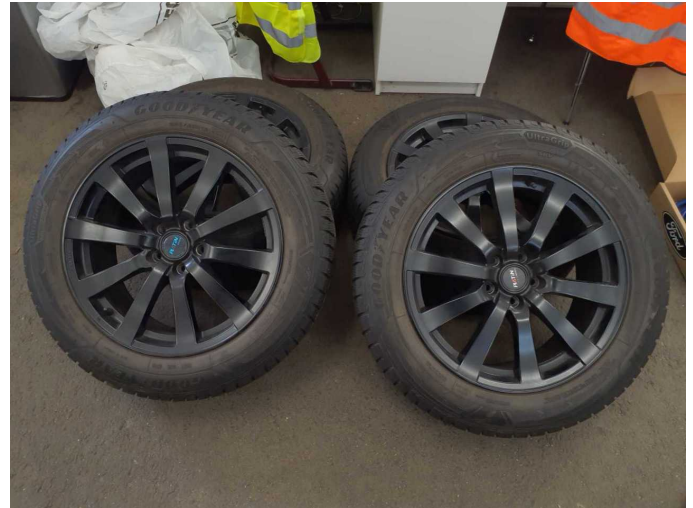
Figure 14: Additional tyres

| # | Tyre size | Type of tyre | Manufacturer | Tread depth |
|---|---|---|---|---|
| 1) | 225/50 R18 104H | Winter tyres on Light alloy | Goodyear | 6mm / 6mm |
| 2) | 225/50 R18 104H | Winter tyres on Light alloy | Goodyear | 7mm / 7mm |

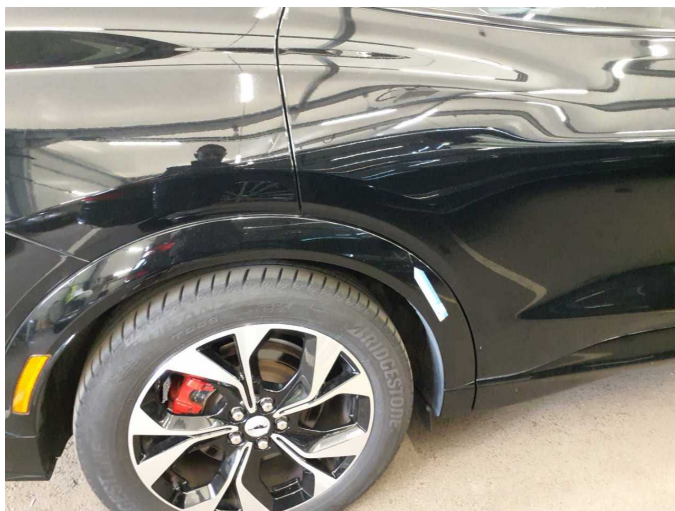
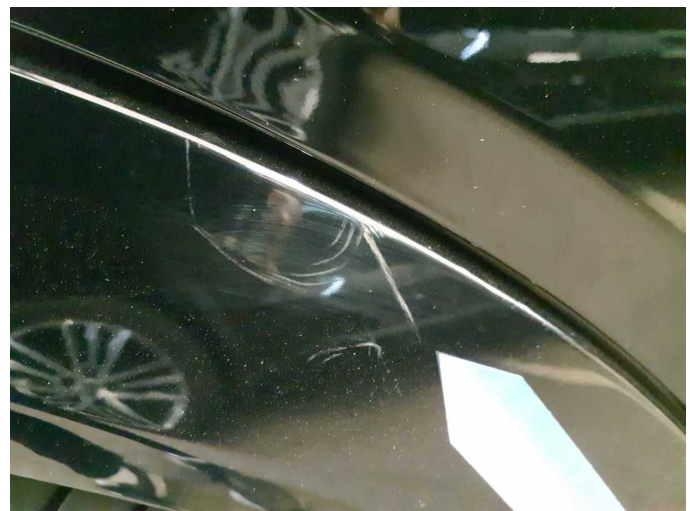
| No. | Component group | Description |
|---|---|---|
| 1 | Side panel - rear right side | Wheel well extension - Scratch(es) - Smart repair |

**Damage 1:** Side panel - rear right side: Wheel well extension - Scratch(es) - Smart repair
