Expertise

Protocol number: 46523325  
Order No. / Reference: 26469353  
Inspection date: 7 Jul 2026

Manufacturer: Mercedes-Benz  
VIN: W1N9N0CB3RJ087883

Model: EQA 250+ Progressive

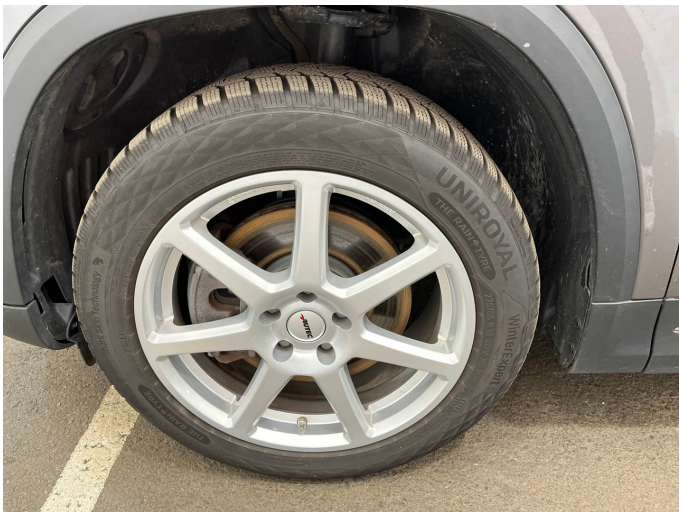
Figure 12: Mounted tyres

| Tyres | | | | |
|---|---|---|---|---|
| 1) | 225/55 R18 102V | Winter tyres on Light alloy | Uniroyal | 5mm / 5mm |
| 2) | 225/55 R18 102V | Winter tyres on Light alloy | Uniroyal | 6mm / 6mm |

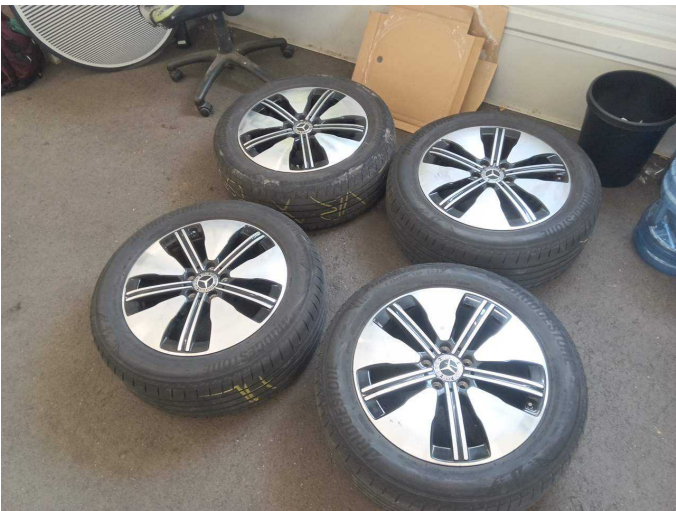
Figure 15: Additional tyres

| Tyres | | | | |
|---|---|---|---|---|
| 1) | 235/55 R18 104T | Summer tyres on Light alloy | Bridgestone | 2mm / 2mm |
| 2) | 235/55 R18 104T | Summer tyres on Light alloy | Bridgestone | 5mm / 5mm |

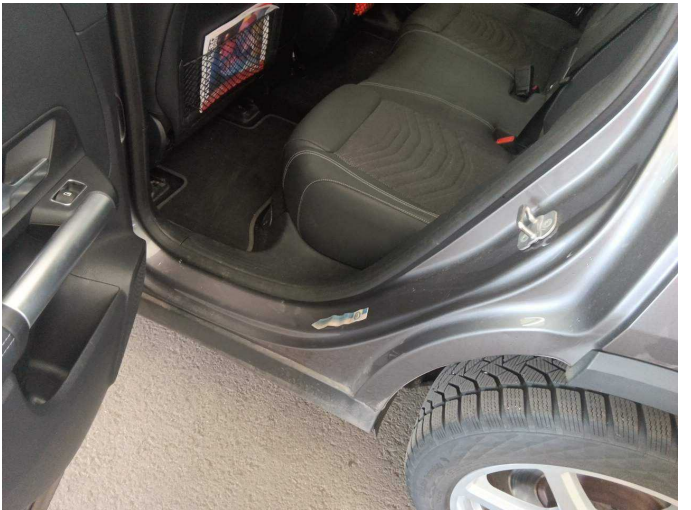
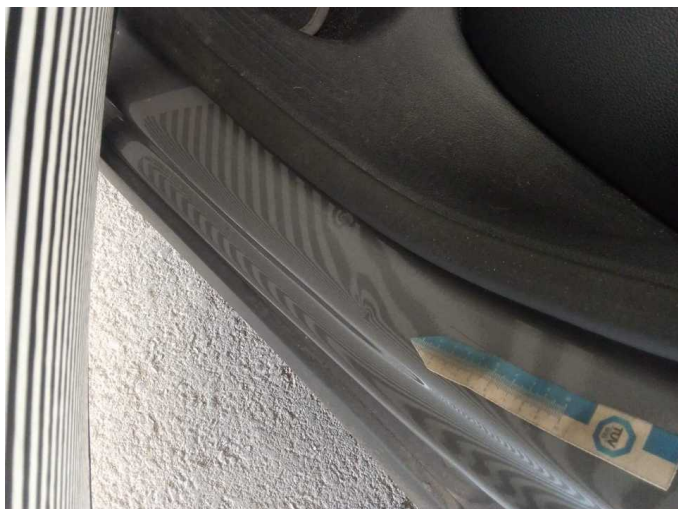
| No. | Component group | Description |
|---|---|---|
| 1 | Side panel - rear left side | Sill - dent(s) - Smooth repair work |

Damage 1: Side panel - rear left side: Sill - dent(s) - Smooth repair work

**Damage 1:** Side panel - rear left side: Sill - dent(s) - Smooth repair work

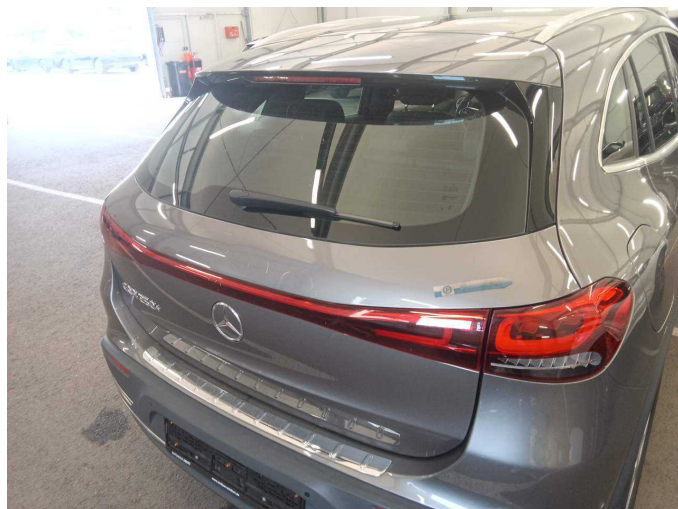
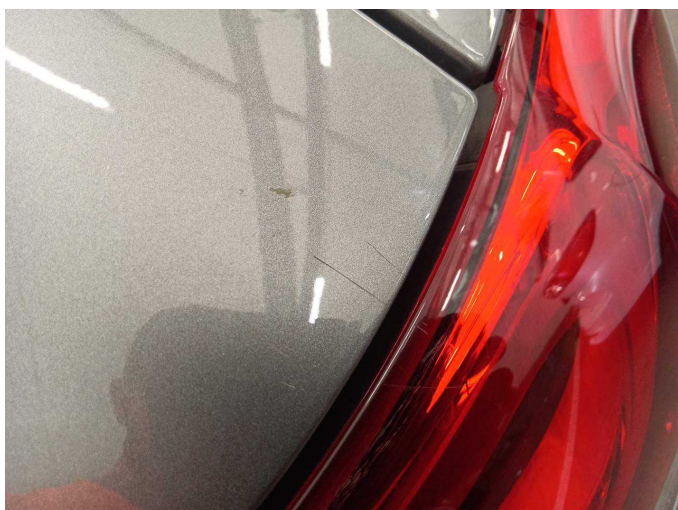
| No. | Component group | Description |
|---|---|---|
| 2 | Boot lid / rear door | Boot lid - Scratch(es) - Smart repair |

**Damage 2:** Boot lid / rear door: Boot lid - Scratch(es) - Smart repair

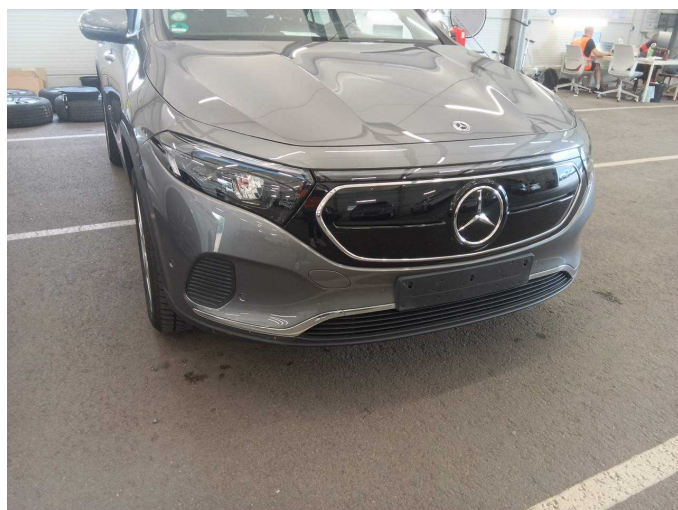
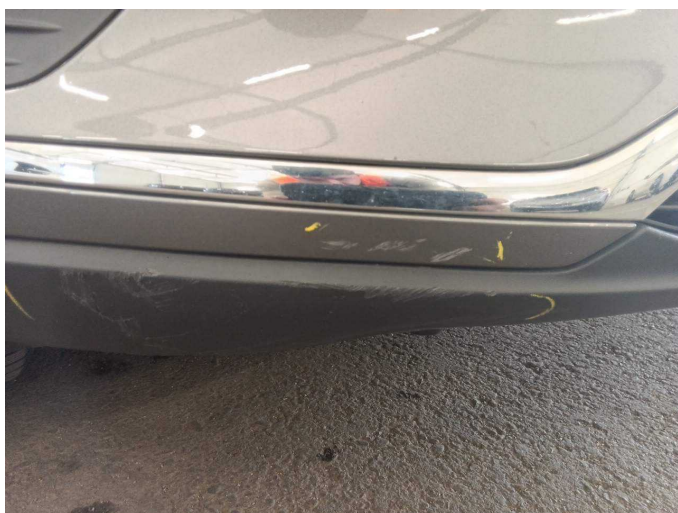
| No. | Component group | Description |
|---|---|---|
| 3 | Front bumper | Front bumper - Scratched - Smart repair |

**Damage 3:** Front bumper: Front bumper - Scratched - Smart repair

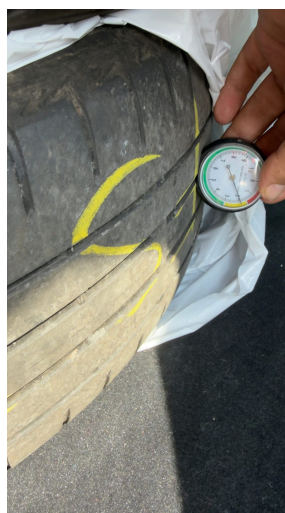
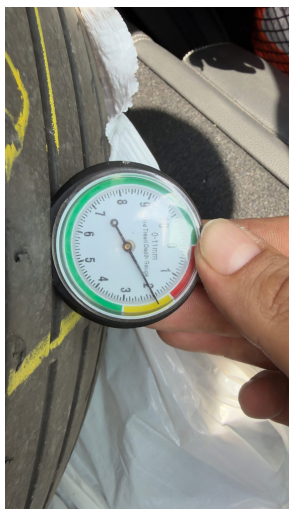
| No. | Component group | Description |
|---|---|---|
| 4 | 2nd wheel set | 1 tyre - Does not meet the leasing specifications - Replace |

**Damage 4:** 2nd wheel set: 1 tyre - Does not meet the leasing specifications - Replace

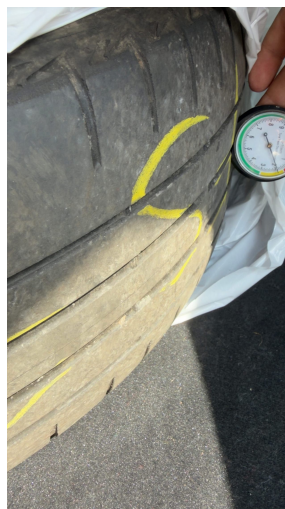
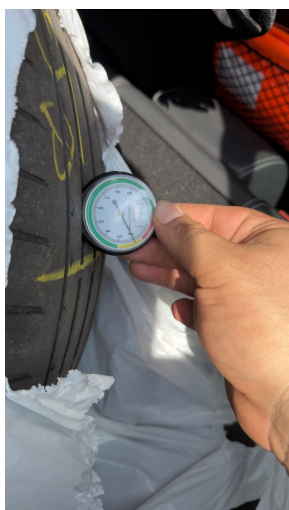
| No. | Component group | Description |
|---|---|---|
| 5 | 2nd wheel set | 1 tyre - Does not meet the leasing specifications - Replace |

**Damage 5:** 2nd wheel set: 1 tyre - Does not meet the leasing specifications - Replace

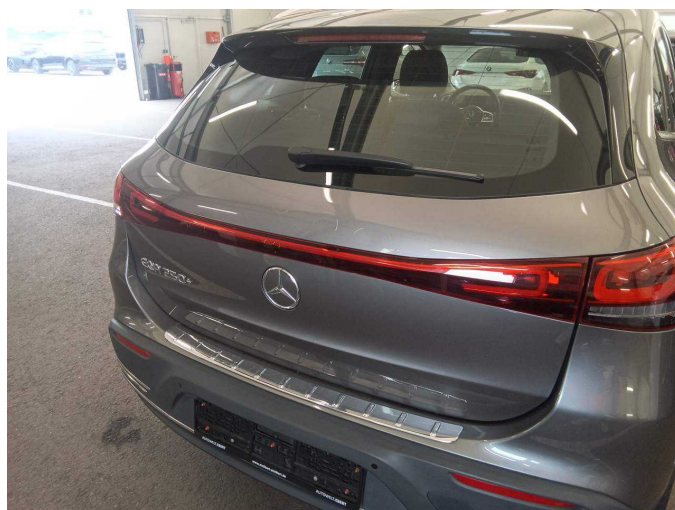
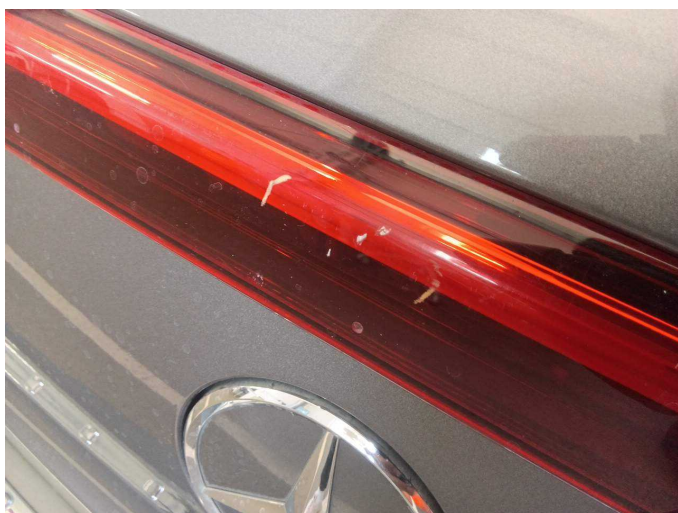
| No. | Component group | Description |
|---|---|---|
| 6 | Tail light | Tail light (Mitte) - Scratched - Replace |

**Damage 6:** Tail light: Tail light (Mitte) - Scratched - Replace

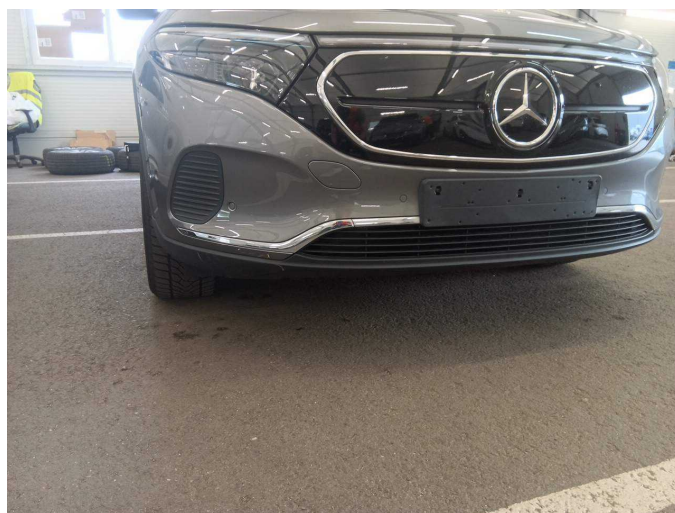
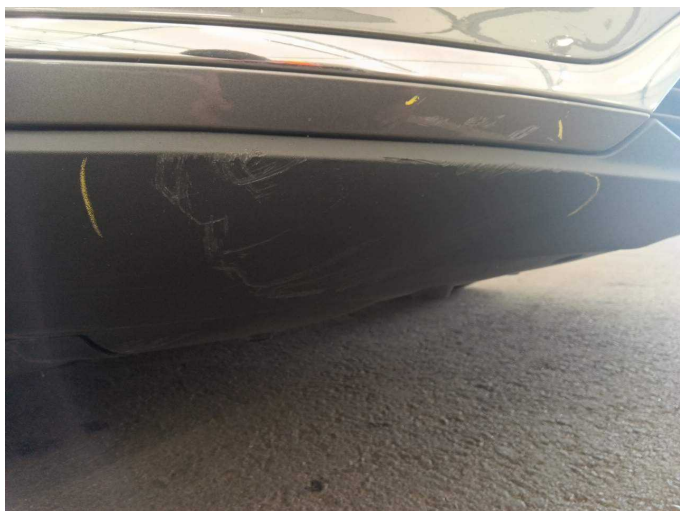
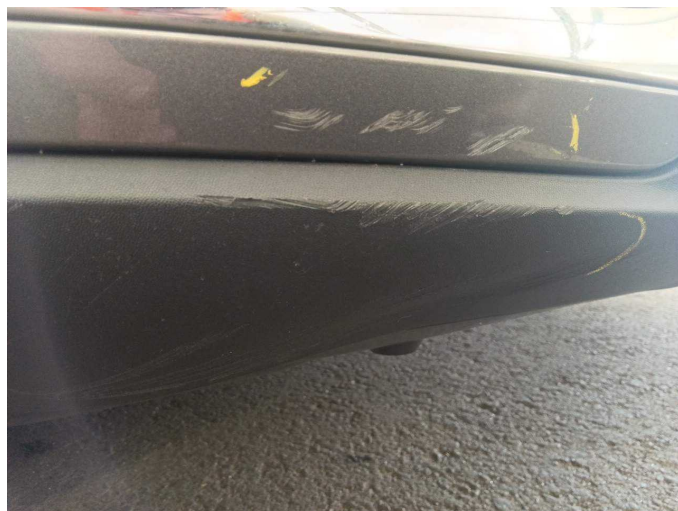
| No. | Component group | Description |
|---|---|---|
| 7 | Front bumper | Spoiler - Scratched - Replace |

**Damage 7:** Front bumper: Spoiler - Scratched - Replace

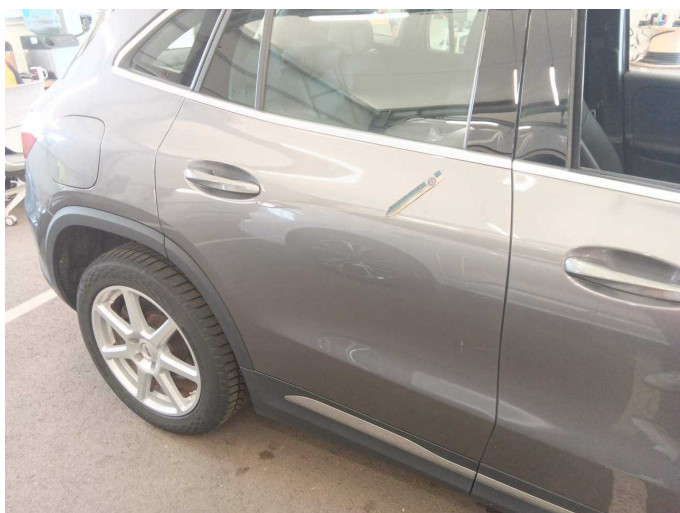
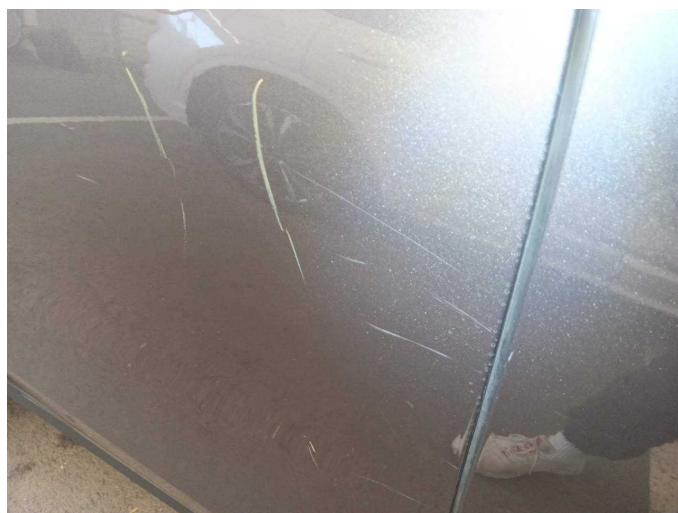
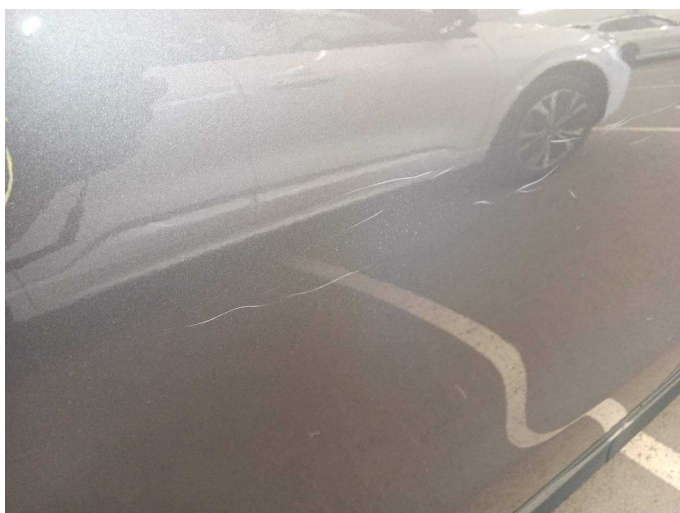
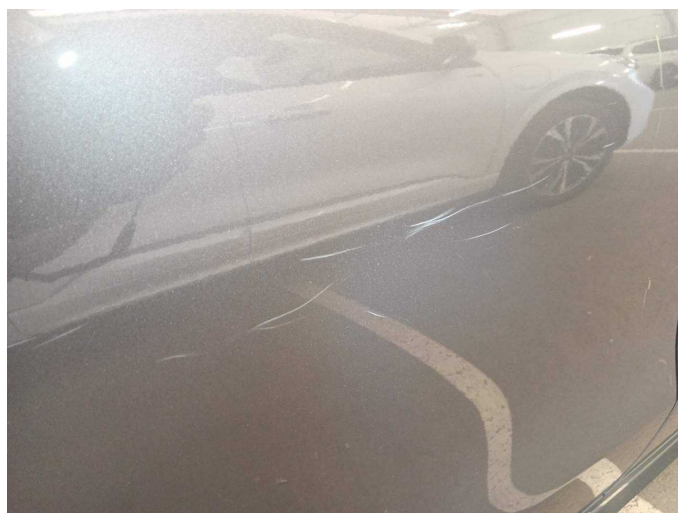
| No. | Component group | Description |
|---|---|---|
| 8 | Door - rear right side | Door - Scratch(es) - Paint |

**Damage 8:** Door - rear right side: Door - Scratch(es) - Paint

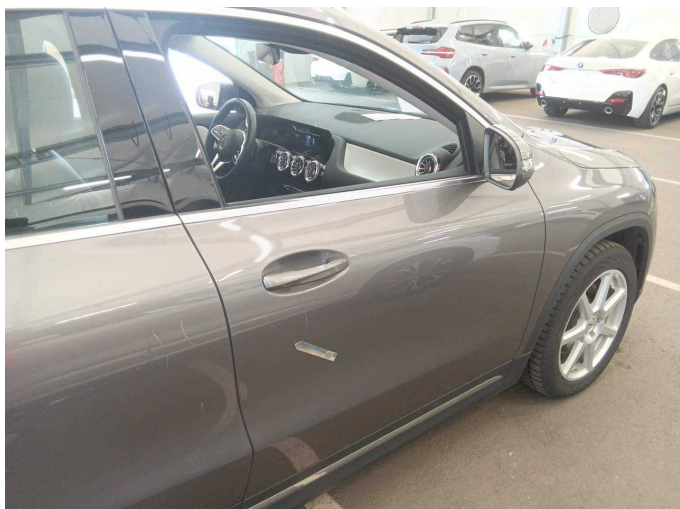
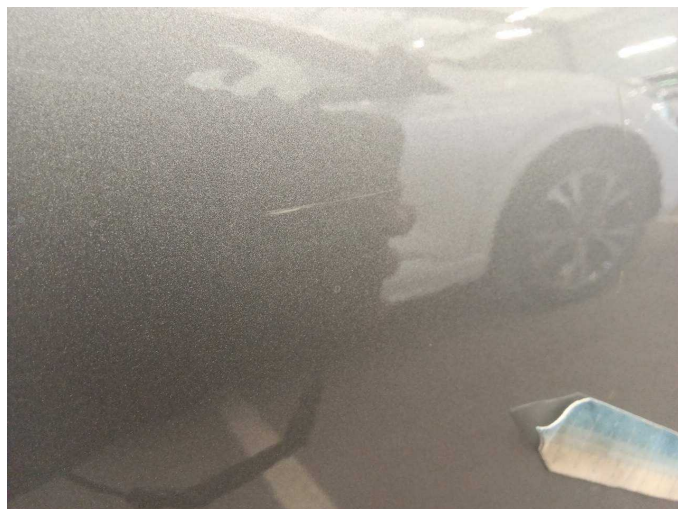
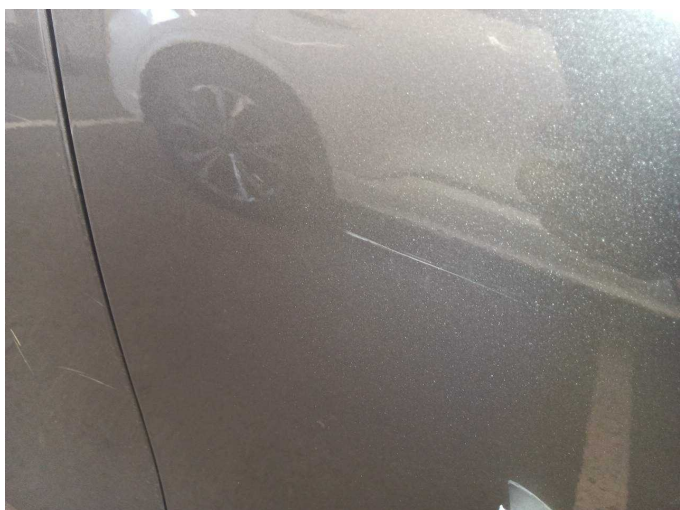
| No. | Component group | Description |
|---|---|---|
| 9 | Door - front right side | Door - Scratch(es) - Paint |

**Damage 9:** Door - front right side: Door - Scratch(es) - Paint

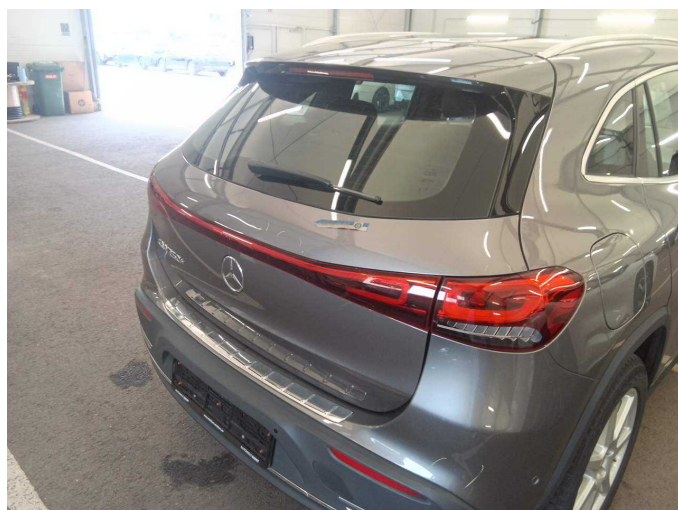
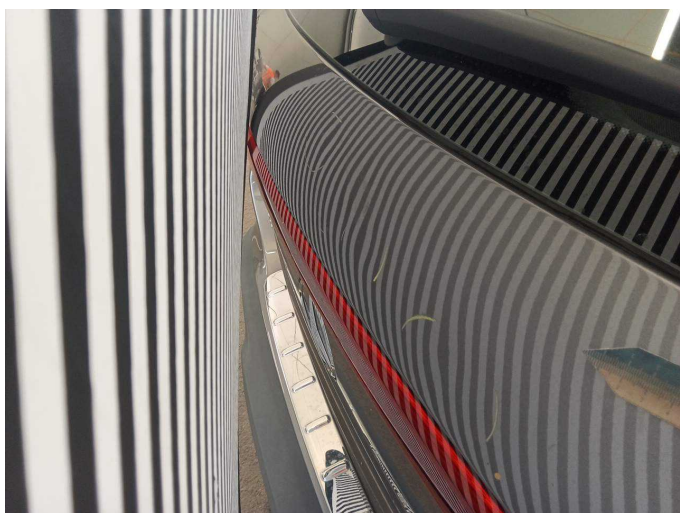
| No. | Component group | Description |
|---|---|---|
| 10 | Boot lid / rear door | Boot lid (3 Dellen & verkratzt/verschürft) - Dent / paintcoat damage - Repair and paint |

**Damage 10:** Boot lid / rear door: Boot lid (3 Dellen & verkratzt/verschürft)  
- Dent / paintcoat damage - Repair and paint

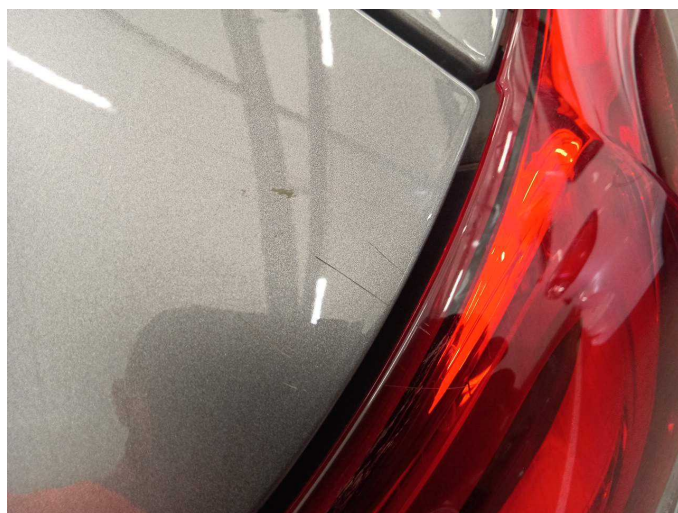
| No. | Component group | Description |
|---|---|---|
| 1 | Tail light | Tail lamp - right side (Oberflächlich, außerhalb des Leuchtbereichs) - Scratch(es) - No deduction |

**Wear and tear 1:** Tail light: Tail lamp - right side (Oberflächlich, außerhalb des Leuchtbereichs) - Scratch(es) - No deduction

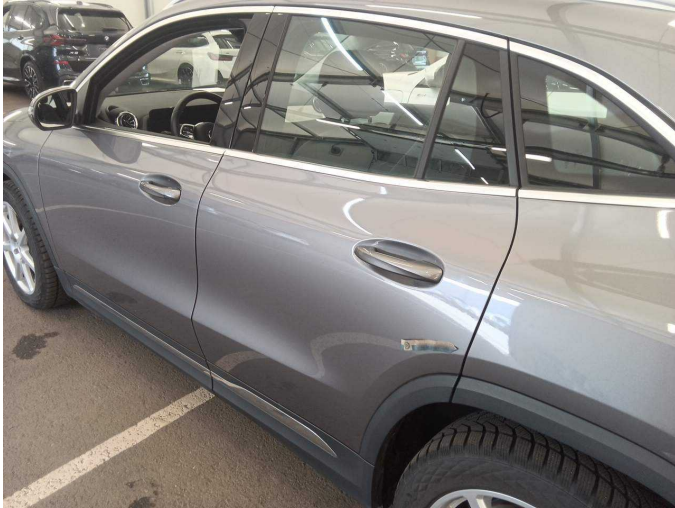
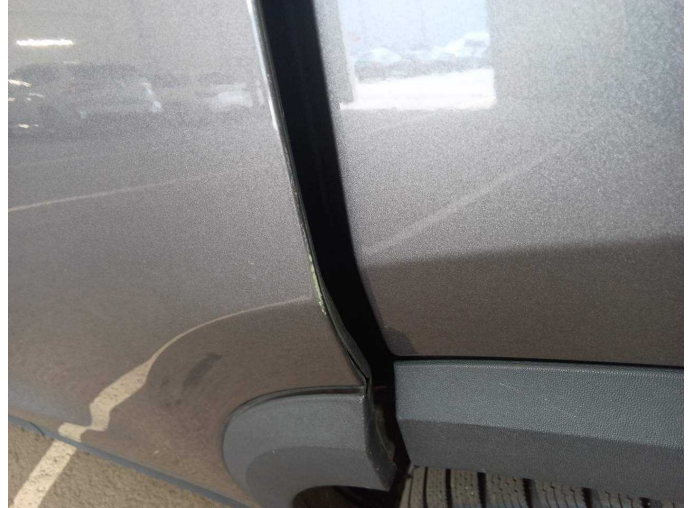
| No. | Component group | Description |
|---|---|---|
| 2 | Door - rear left side | Door edge - Scratch(es) - No deduction |

**Wear and tear 2:** Door - rear left side: Door edge - Scratch(es) - No deduction
