Expertise

Protocol number: 46284114  
Order No. / Reference: 26622555  
Inspection date: 1 Jul 2026

Manufacturer: Seat

Model: Tarraco 1.4 e-Hybrid DSG Xperience

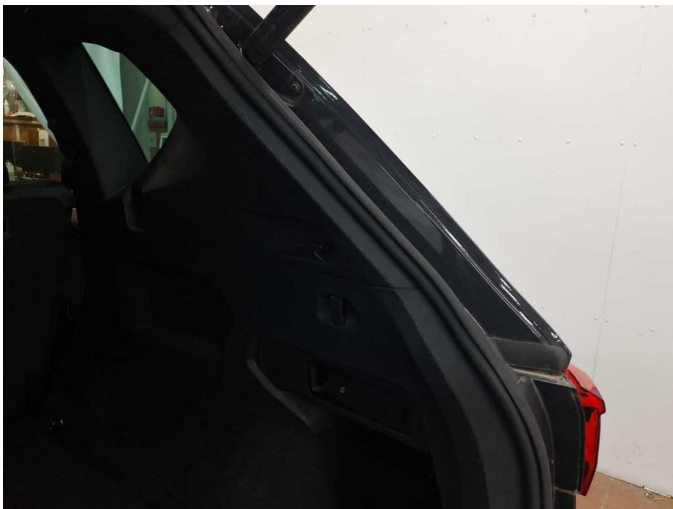
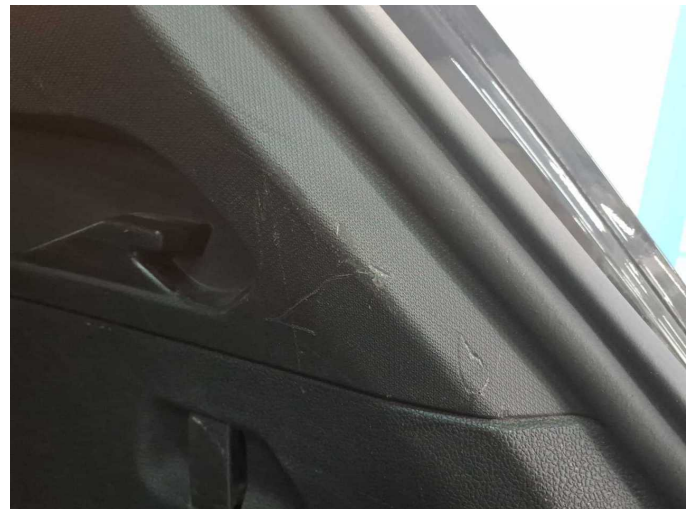
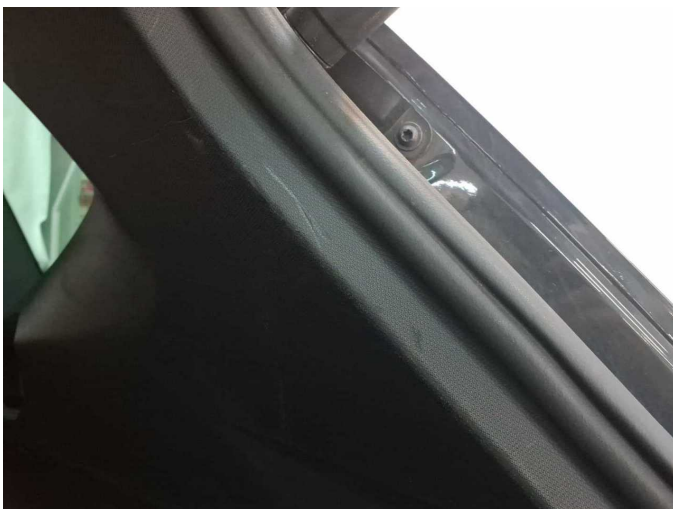
| No. | Component group | Description |
|---|---|---|
| 1 | Side panel - rear right side | Interior trim - Scratch(es) - Loss in value |

**Damage 1:** Side panel - rear right side: Interior trim - Scratch(es) - Loss in value

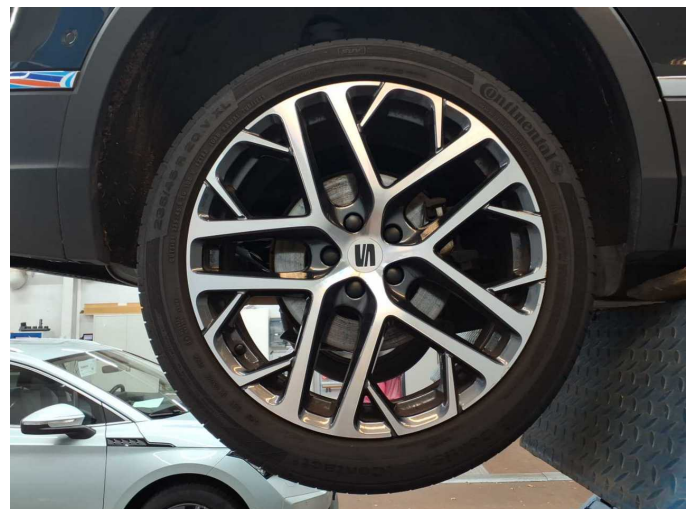
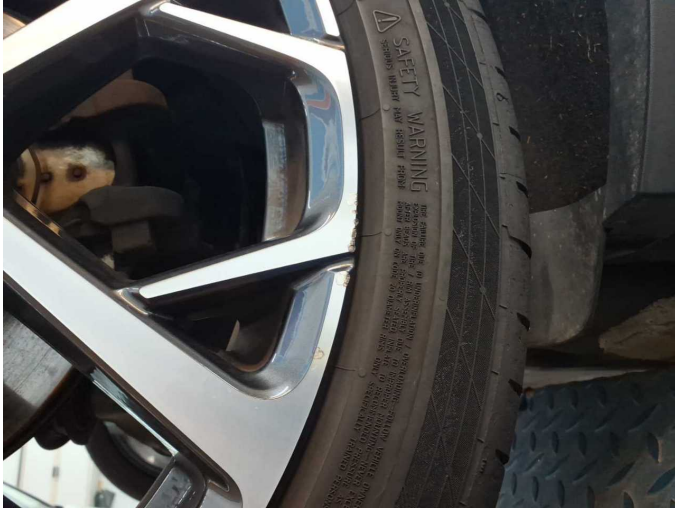
| No. | Component group | Description |
|---|---|---|
| 2 | Wheel / tyres | Alloy rim - rear right side - Scratch(es) - Loss in value |

**Damage 2:** Wheel / tyres: Alloy rim - rear right side - Scratch(es) - Loss in value

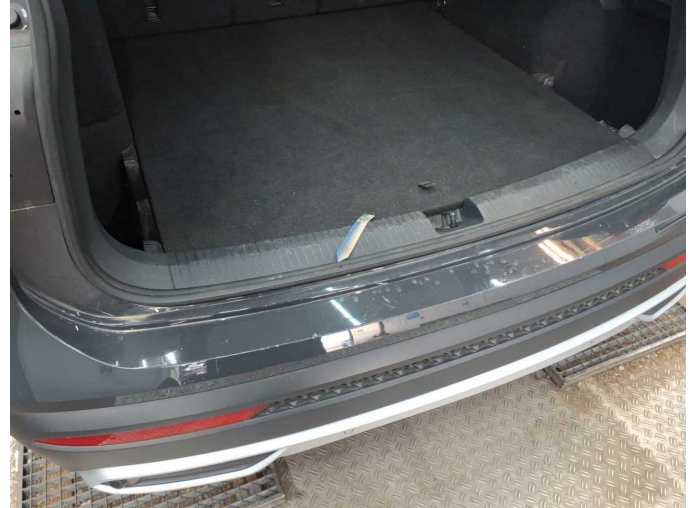
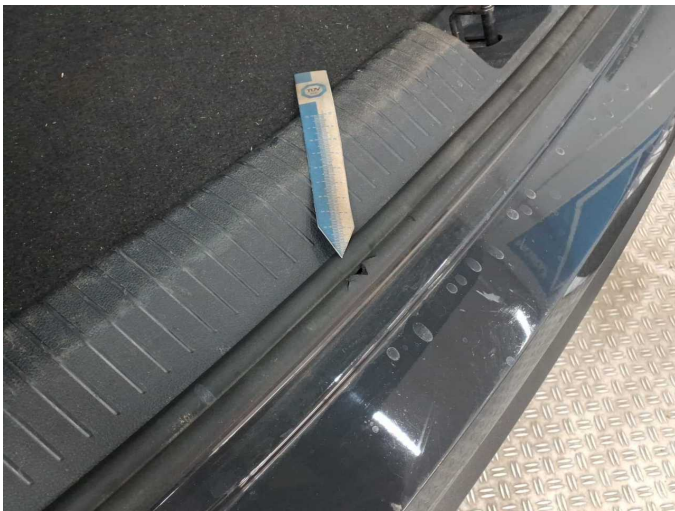
| No. | Component group | Description |
|---|---|---|
| 3 | Boot lid / rear door | Seal - Broken / torn - Replace |

**Damage 3:** Boot lid / rear door: Seal - Broken / torn - Replace

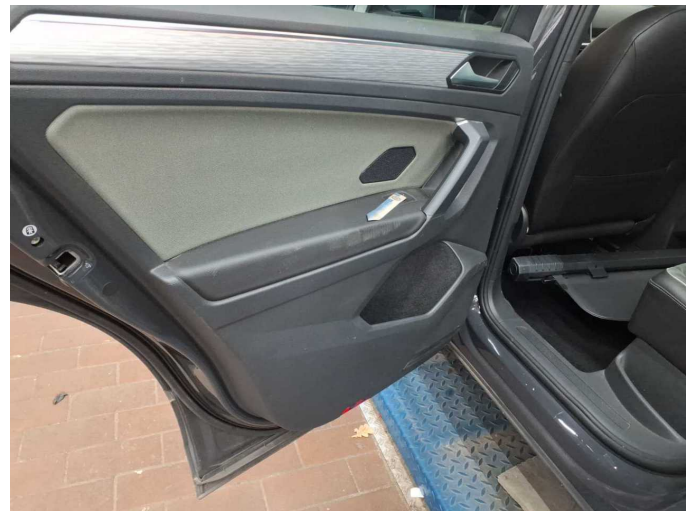
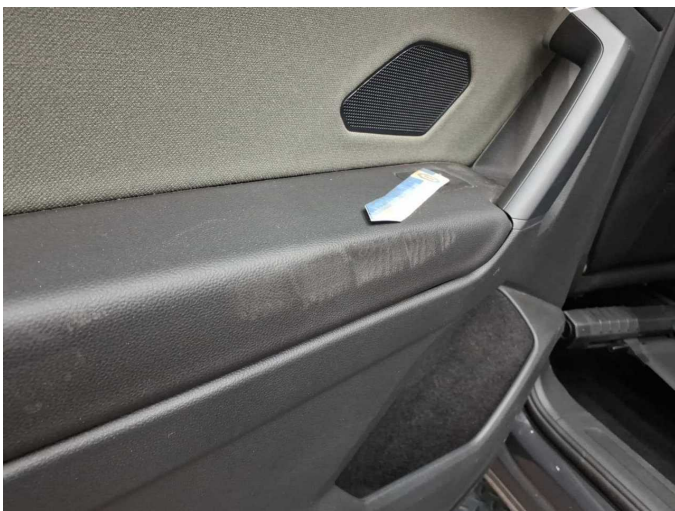
| No. | Component group | Description |
|---|---|---|
| 4 | Trim / covers | Door trim - rear left side (Druckstelle) - Deformed - Smart repair |

**Damage 4:** Trim / covers: Door trim - rear left side (Druckstelle) - Deformed - Smart repair

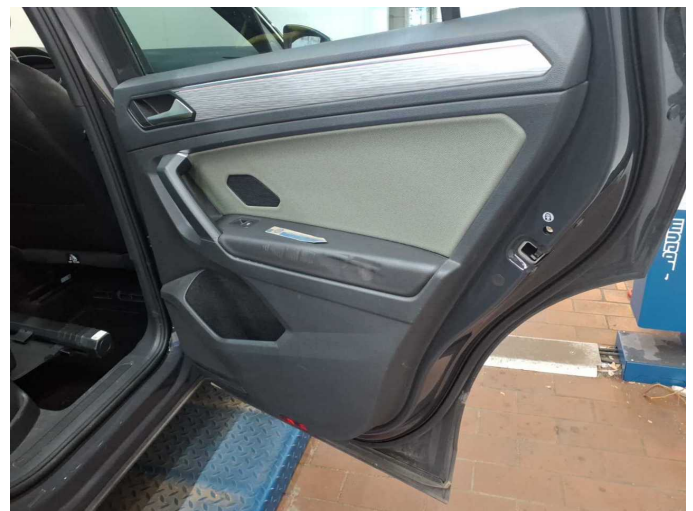
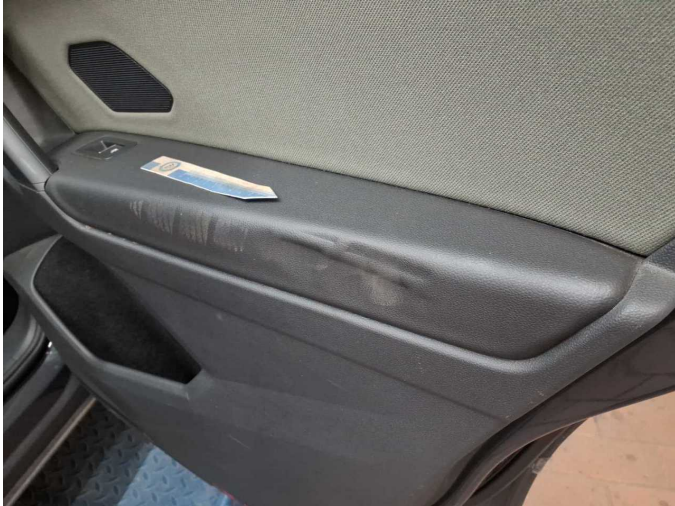
| No. | Component group | Description |
|---|---|---|
| 5 | Trim / covers | Door trim - rear right side (Druckstelle) - Deformed - Smart repair |

**Damage 5:** Trim / covers: Door trim - rear right side (Druckstelle) - Deformed - Smart repair

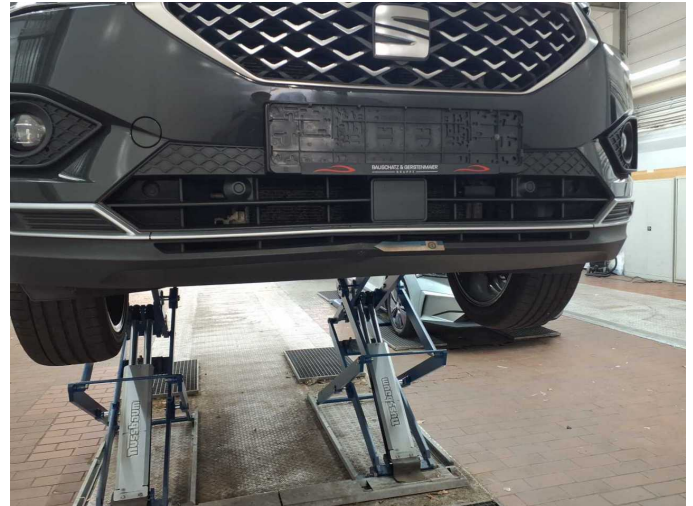
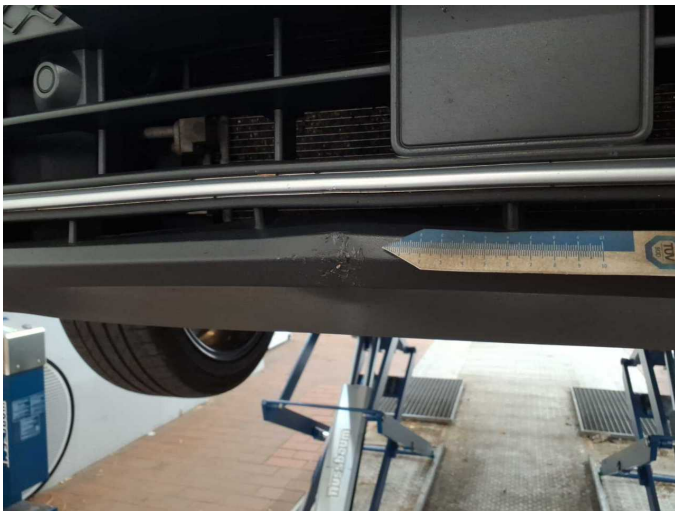
| No. | Component group | Description |
|---|---|---|
| 6 | Front bumper | Spoiler - Deformed - Replace |

**Damage 6:** Front bumper: Spoiler - Deformed - Replace

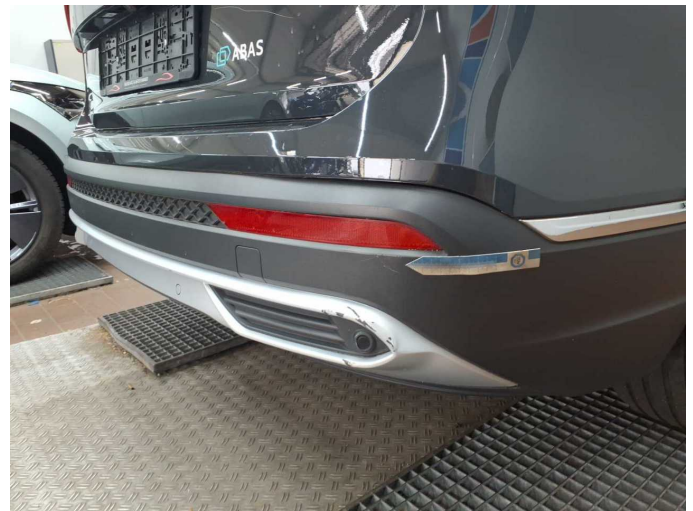
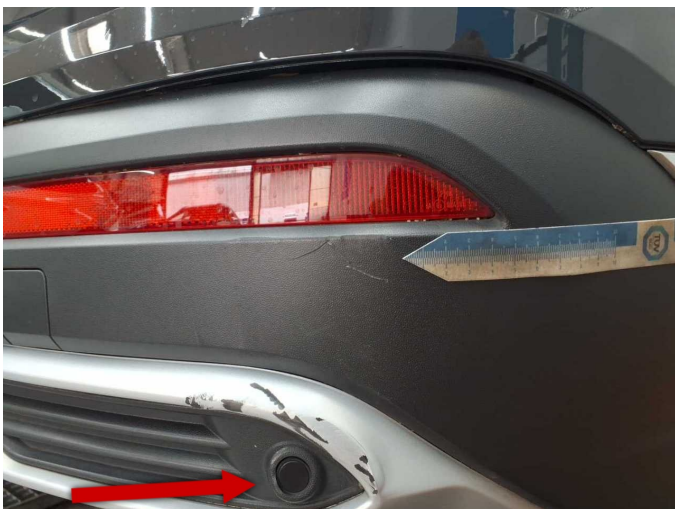
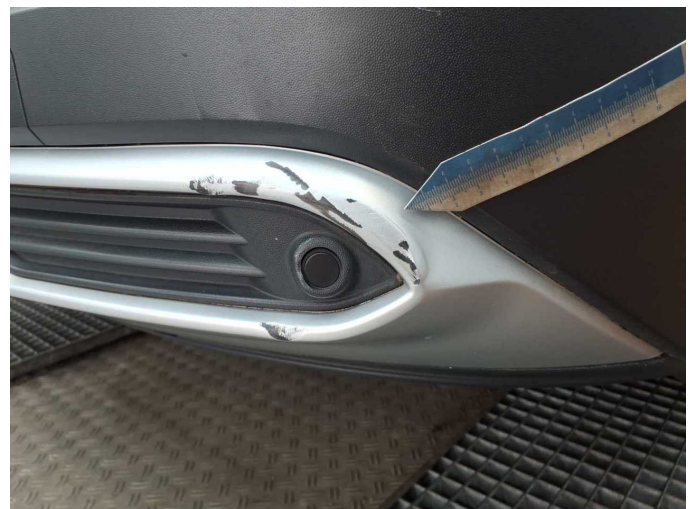
| No. | Component group | Description |
|---|---|---|
| 7 | Rear bumper | Spoiler (inkl. Zierleiste & PDC-Sensor prüfen - Mehrkosten möglich) - Deformed - Replace |

**Damage 7:** Rear bumper: Spoiler (inkl. Zierleiste & PDC-Sensor prüfen - Mehrkosten möglich) - Deformed - Replace

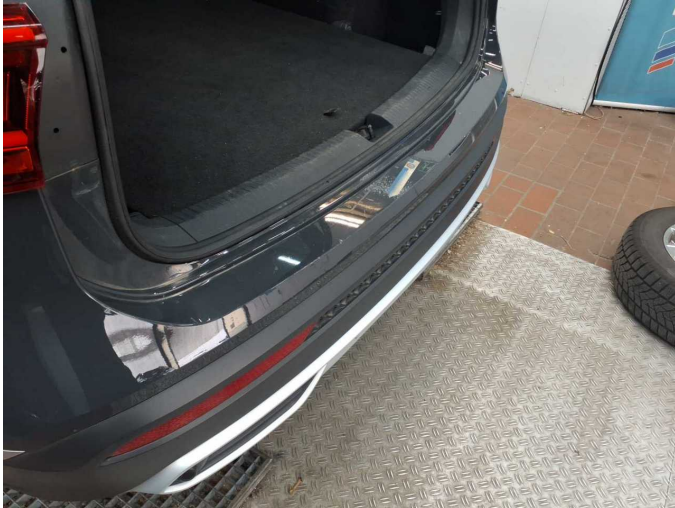
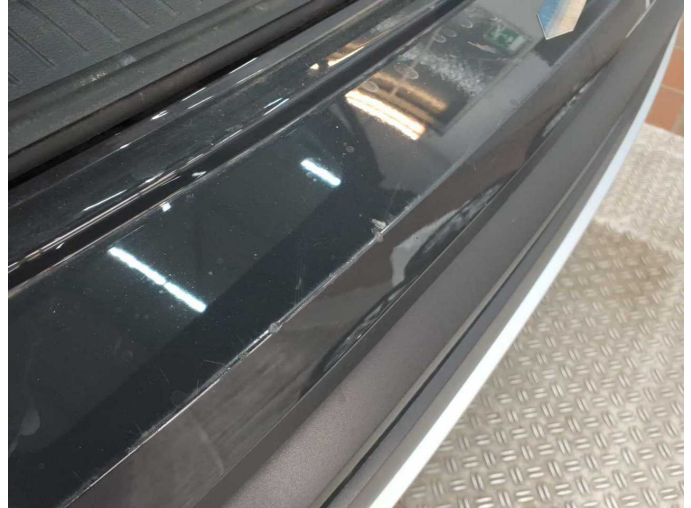
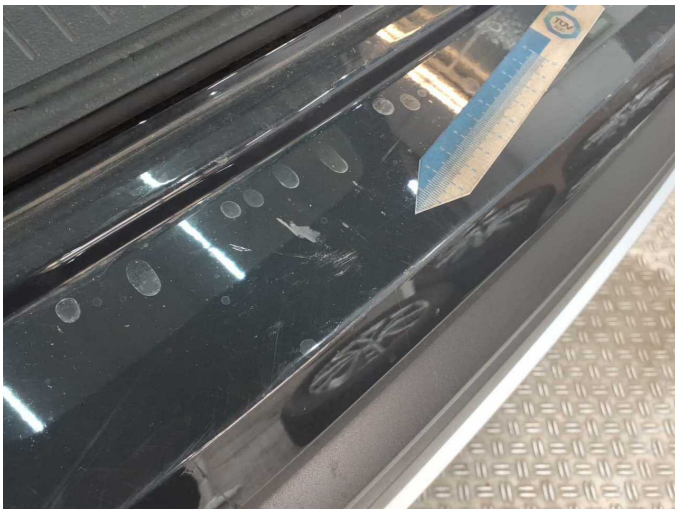
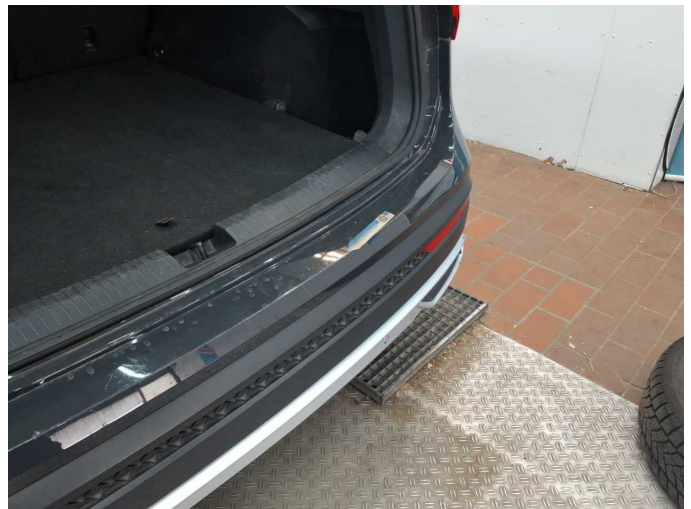
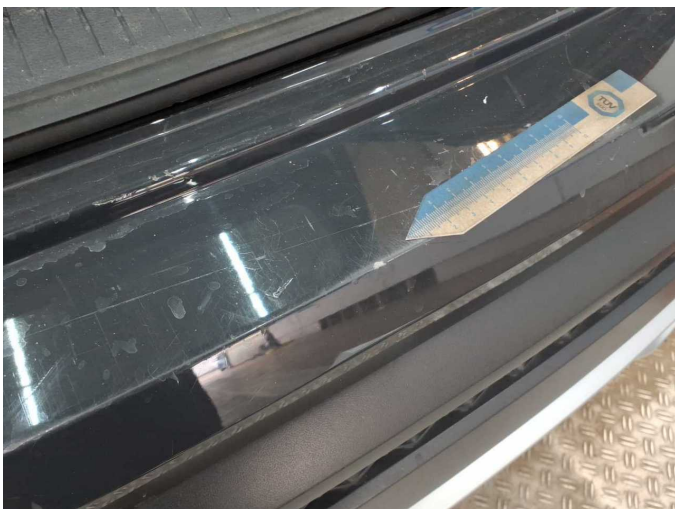
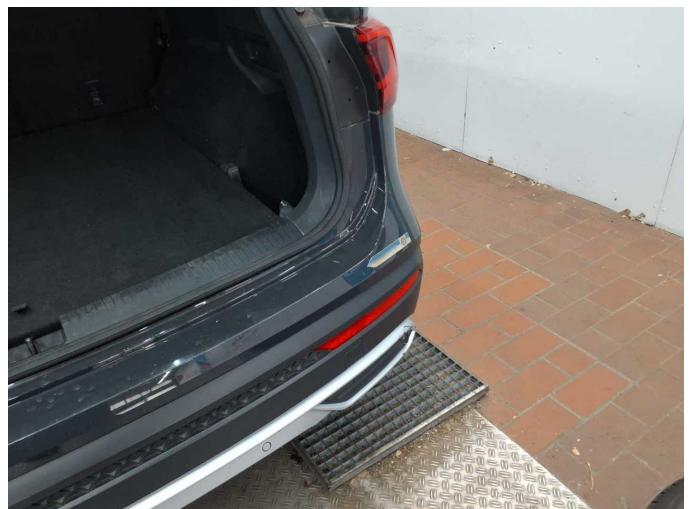
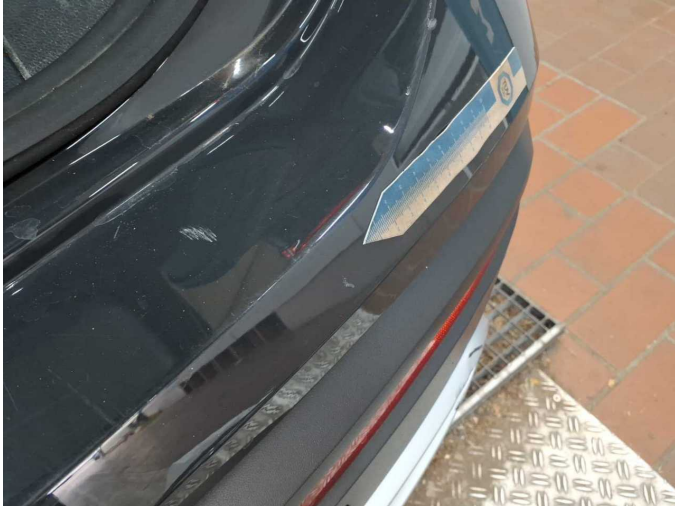
| No. | Component group | Description |
|---|---|---|
| 8 | Rear bumper | Rear bumper - Scratched - Paint |

**Damage 8:** Rear bumper: Rear bumper - Scratched - Paint

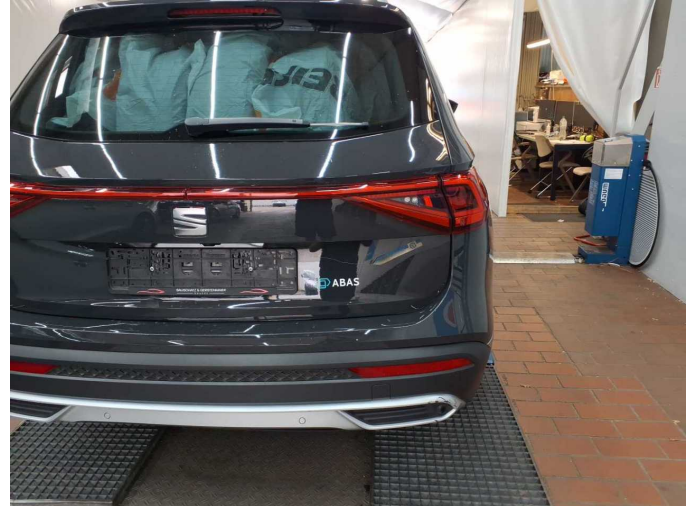
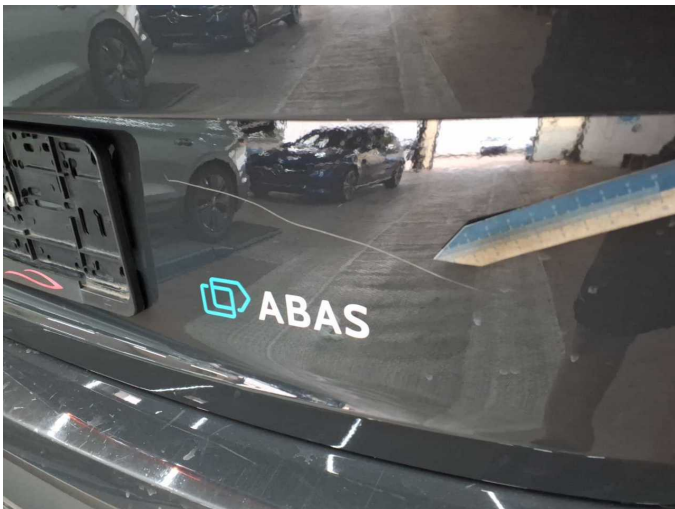
| No. | Component group | Description |
|---|---|---|
| 9 | Boot lid / rear door | Boot lid - Scratch(es) - Paint |

**Damage 9:** Boot lid / rear door: Boot lid - Scratch(es) - Paint

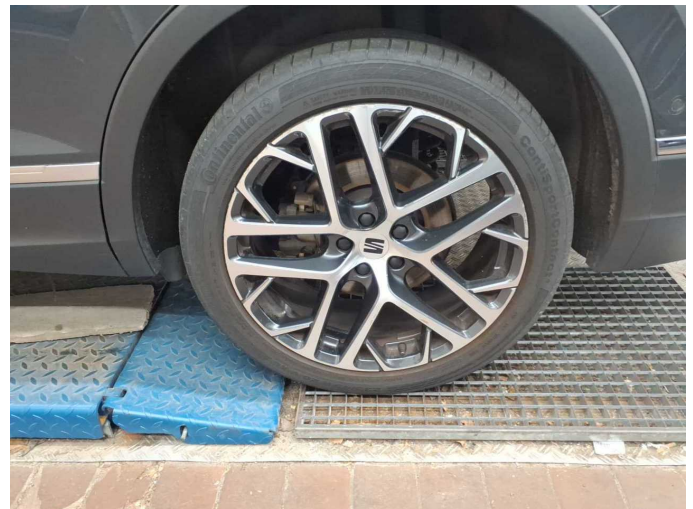
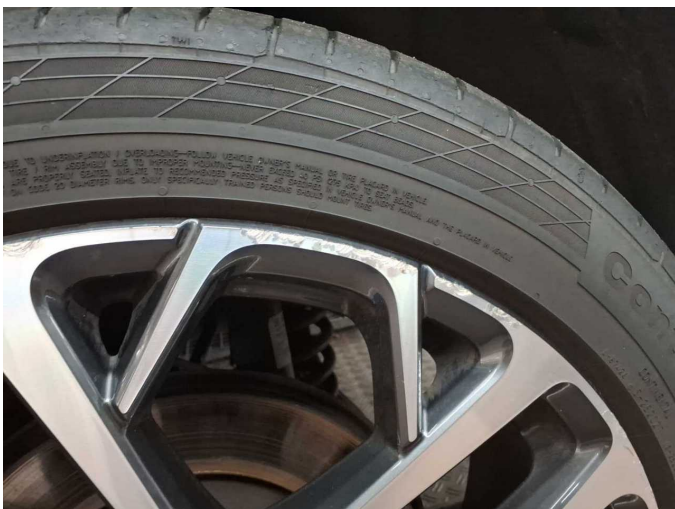
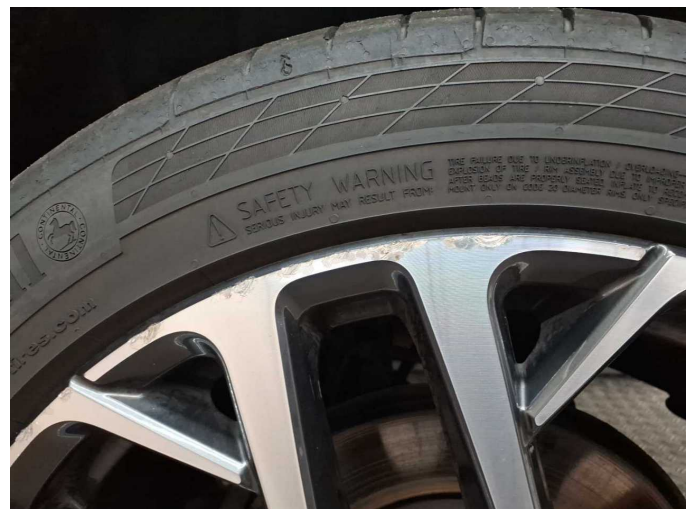
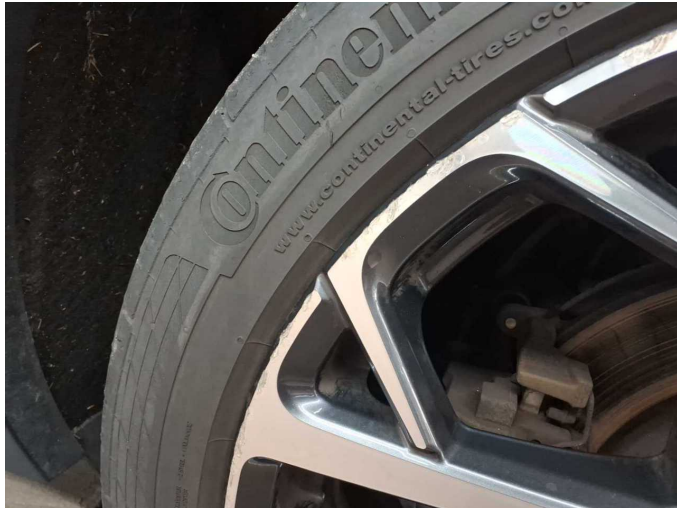
| No. | Component group | Description |
|---|---|---|
| 10 | Wheel / tyres | Alloy rim - rear left side - Scratched - Replace |

**Damage 10:** Wheel / tyres: Alloy rim - rear left side - Scratched - Replace

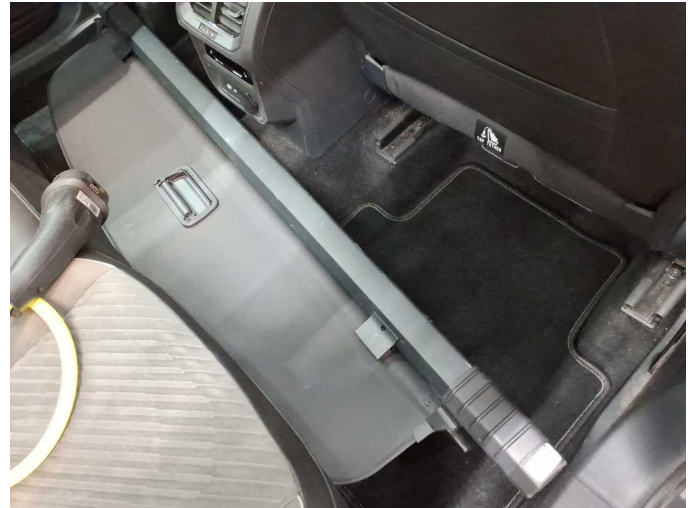
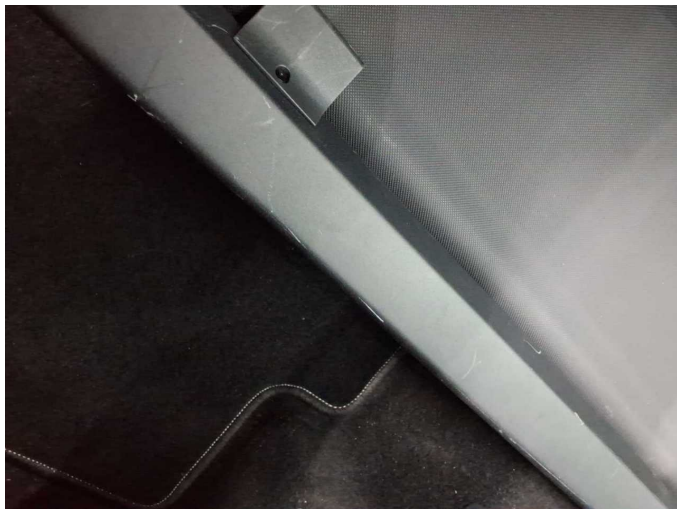
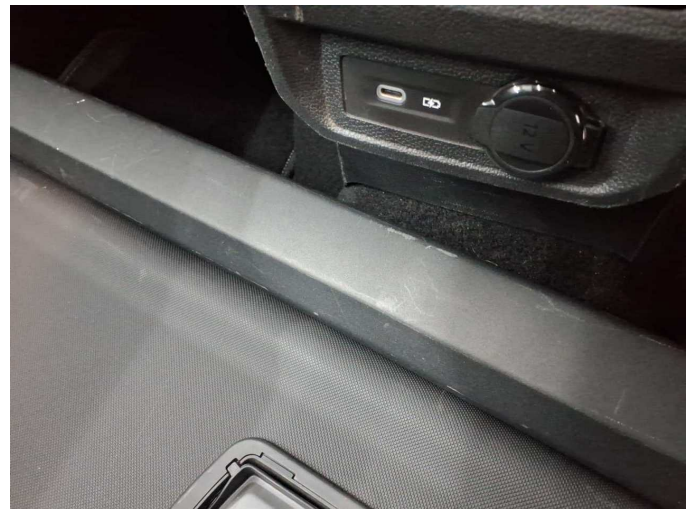
| No. | Component group | Description |
|---|---|---|
| 6 | Interior | Boot cover / roller cover - Scratch(es) - No deduction |

**Wear and tear 6:** Interior: Boot cover / roller cover - Scratch(es) - No deduction

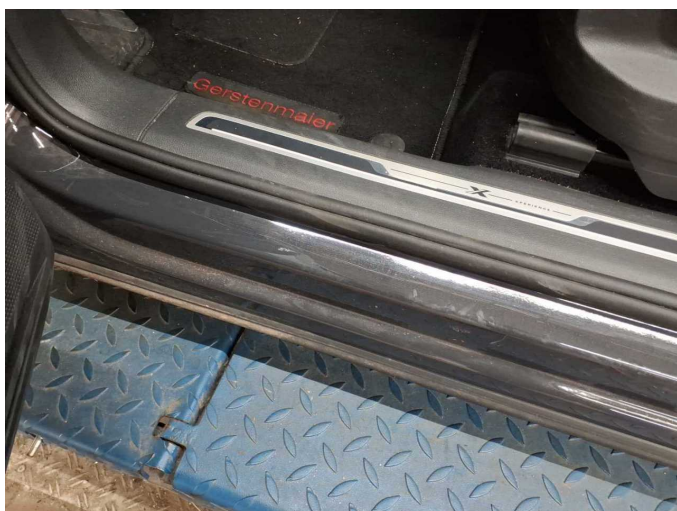
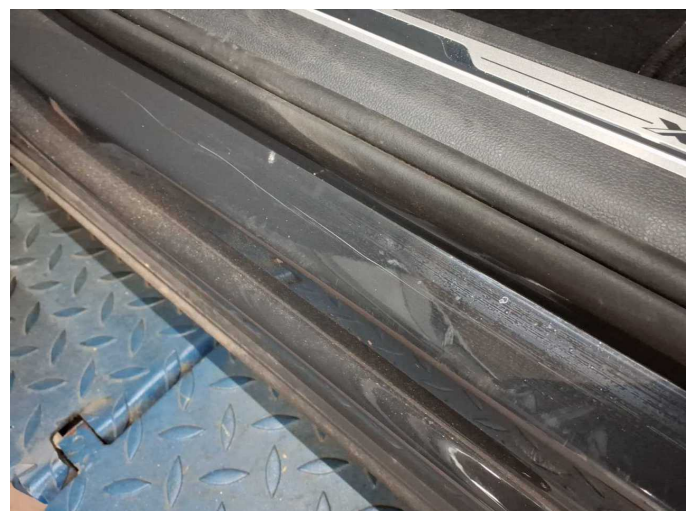
| No. | Component group | Description |
|---|---|---|
| 8 | Sill - left side | Sill - Scratch(es) - No deduction |

**Wear and tear 8:** Sill - left side: Sill - Scratch(es) - No deduction
