Expertise

Protocol number: 46201929
Order No. / Reference: 26308795
Inspection date: 19 Jun 2026

Manufacturer: Alfa Romeo

Model: Stelvio 2.2 Diesel 16V AT8 Q4 Super

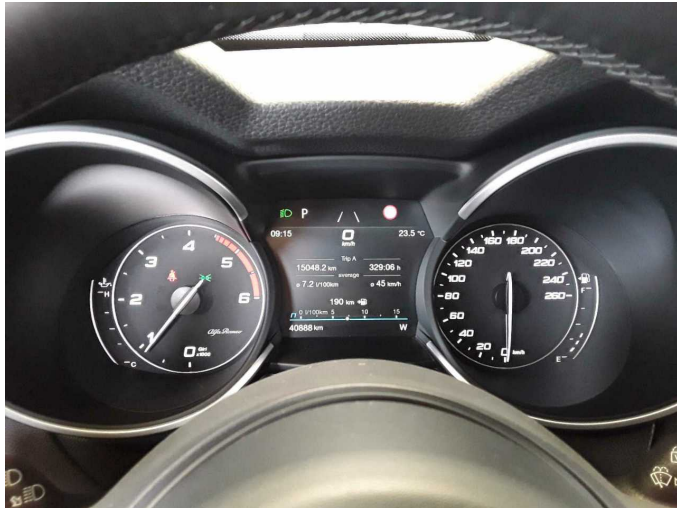
Mileage (Read) 40,888 km

Figure 7: Instrument cluster

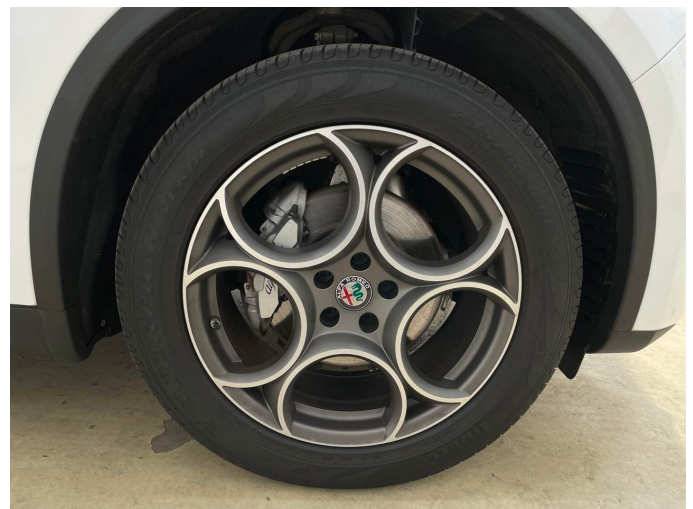
#	Tyre size	Type of tyre	Manufacturer	Tread depth
1)	235/55 R19 105Y	Summer tyres on Light alloy	Pirelli	5mm / 5mm
2)	235/55 R19 105Y	Summer tyres on Light alloy	Pirelli	5mm / 5mm

Figure 12: Mounted tyres

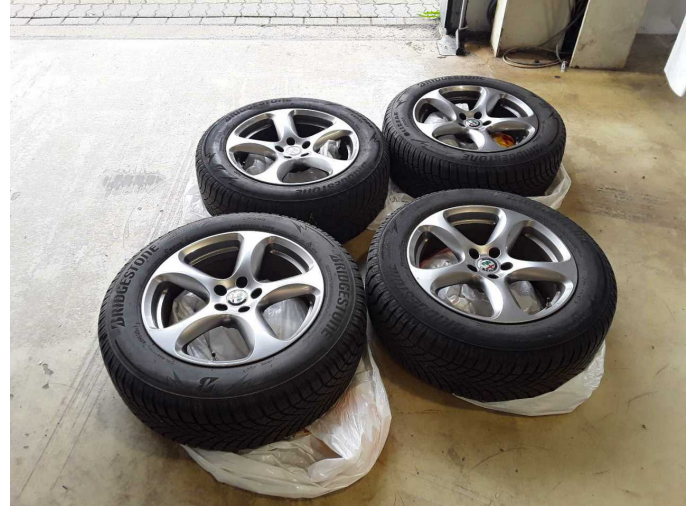
#	Tyre size	Type of tyre	Manufacturer	Tread depth
1)	235/60 R18 107H	Winter tyres on Light alloy	Bridgestone	4mm / 4mm
2)	235/60 R18 107H	Winter tyres on Light alloy	Bridgestone	6mm / 6mm

Figure 14: Additional tyres

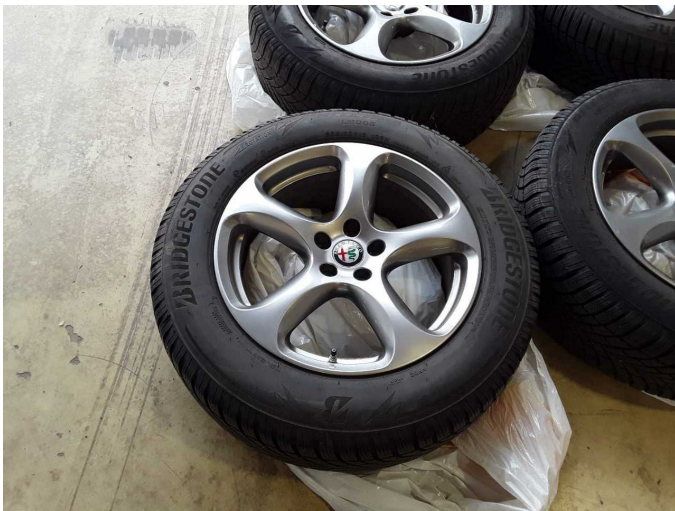
Figure 15: Additional tyres

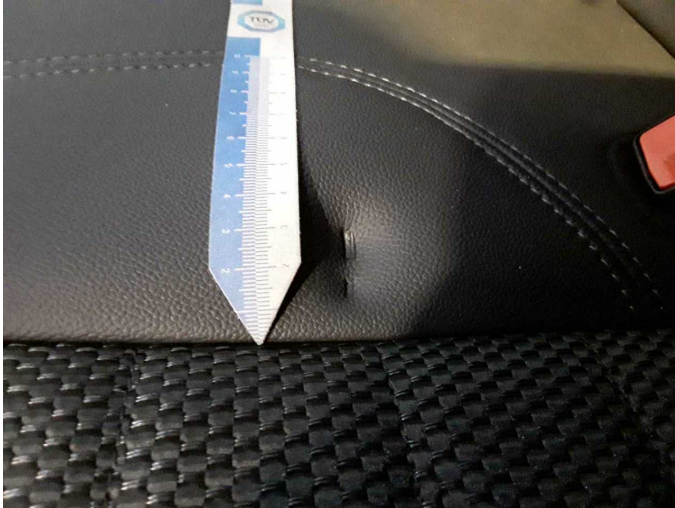
Damage 2: Seat - rear: Upholstery (Abdruck) - Deformed - Loss in value

No.	Component group	Description
1	Misc.	Main inspection - No evidence - No deduction
2	Seat - rear	Upholstery (Abdruck) - Deformed - Loss in value
3	Misc.	Inspection / maintenance - Due - Perform

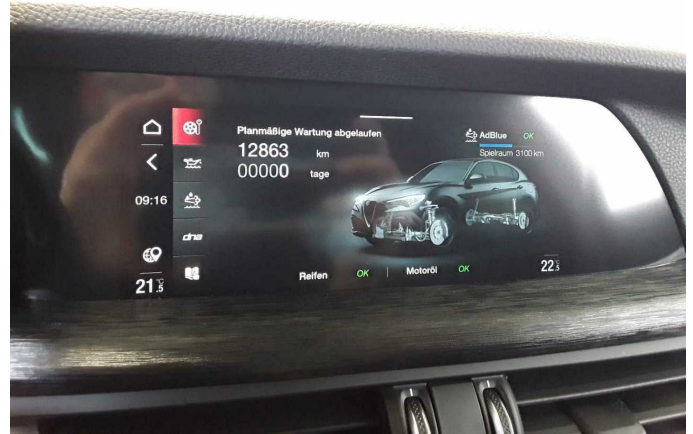
Damage 3: Misc.: Inspection / maintenance - Due - Perform

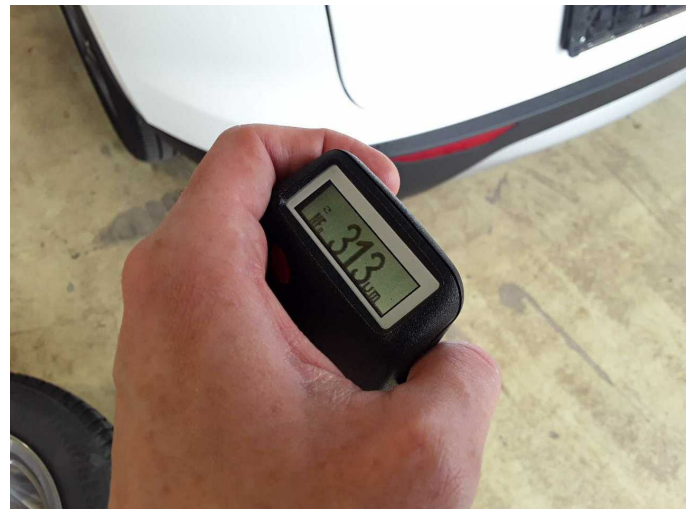
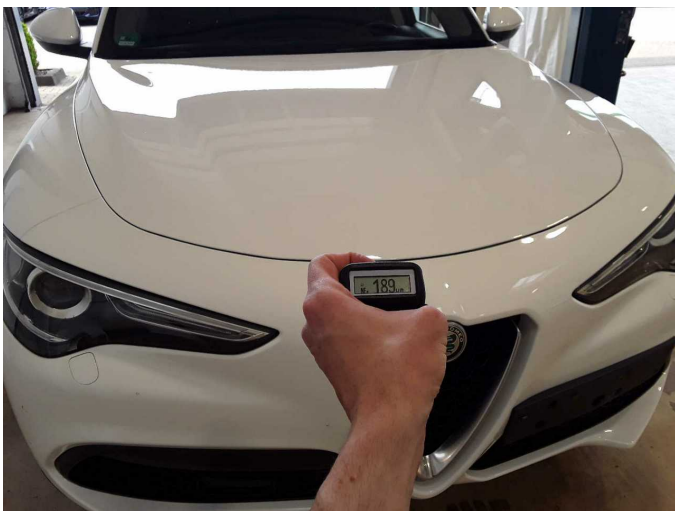
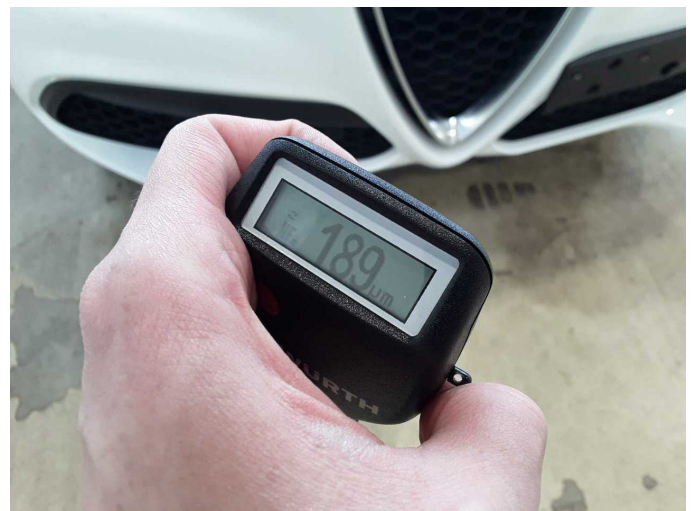
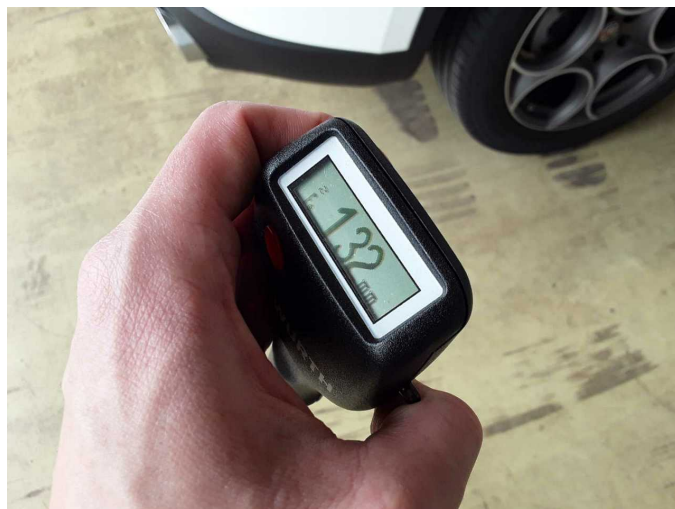
Boot lid / rear door	313 µm	Bonnet	189 µm
Side panel - rear right side	1,320 µm

Repainting 1: Boot lid / rear door, Bonnet, Side panel - rear right side

No.	Repainting
1	Boot lid / rear door, Bonnet, Side panel - rear right side, Professionally carried out, Invoice of repair done Non-existent
