Expertise

Protocol number: 46056945  
Order No. / Reference: 26512670  
Inspection date: 17 Jun 2026

Manufacturer: Volkswagen

Model: ID.3 Pro S (4-Sitzer)

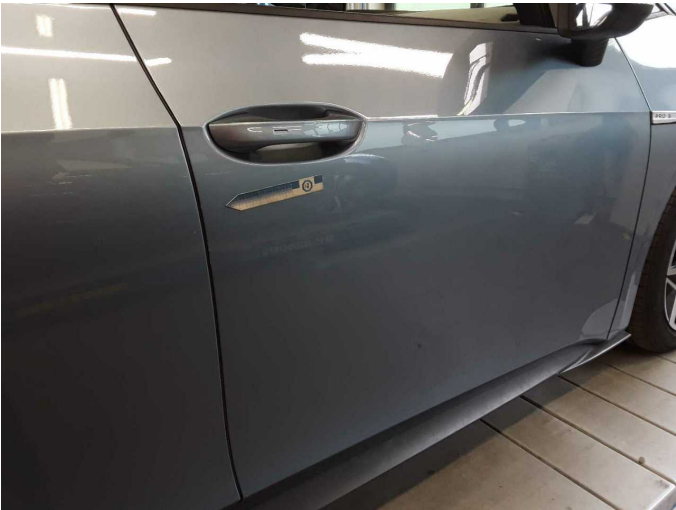
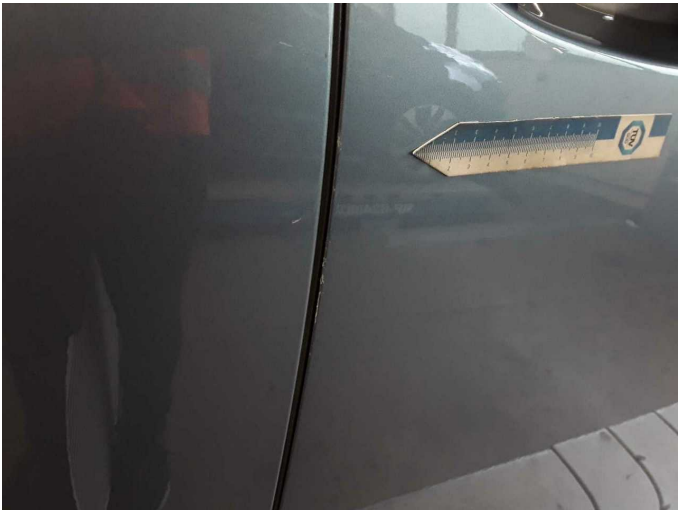
| No. | Component group | Description |
|---|---|---|
| 2 | Door - front right side | Door - Scratch(es) - Smart repair |

Damage 2: Door - front right side: Door - Scratch(es) - Smart repair

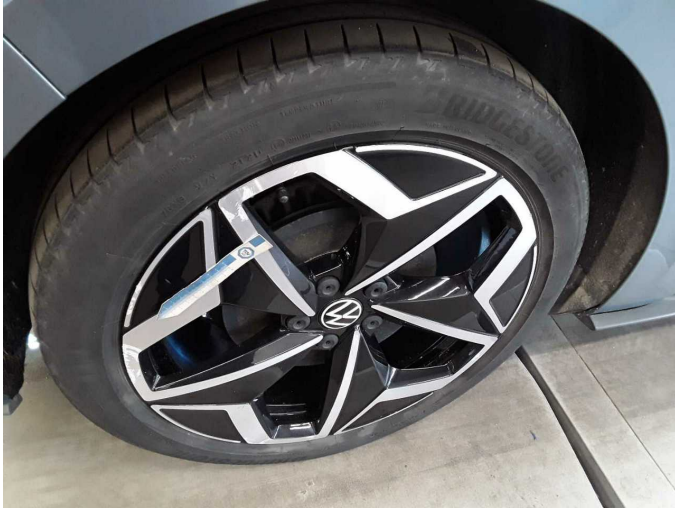
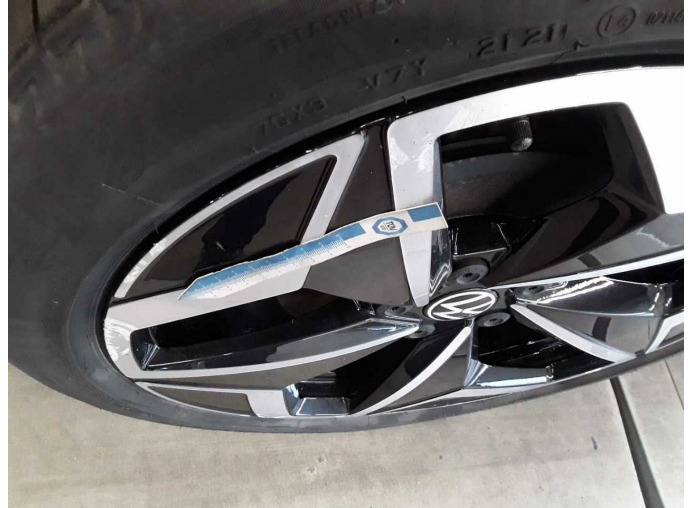
| No. | Component group | Description |
|---|---|---|
| 3 | Wheel / tyres | Alloy rim - rear right side - Scratched - Loss in value |

**Damage 3:** Wheel / tyres: Alloy rim - rear right side - Scratched - Loss in value

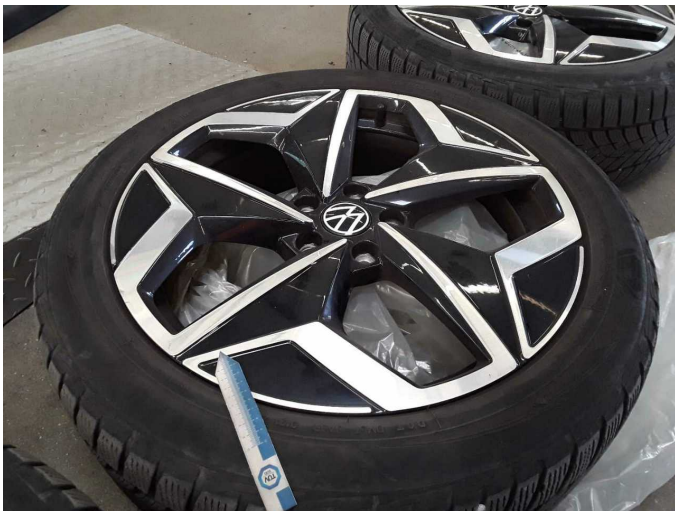
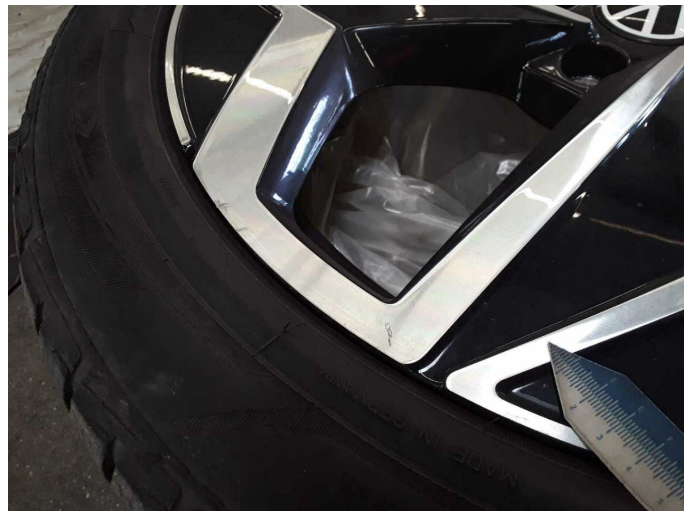
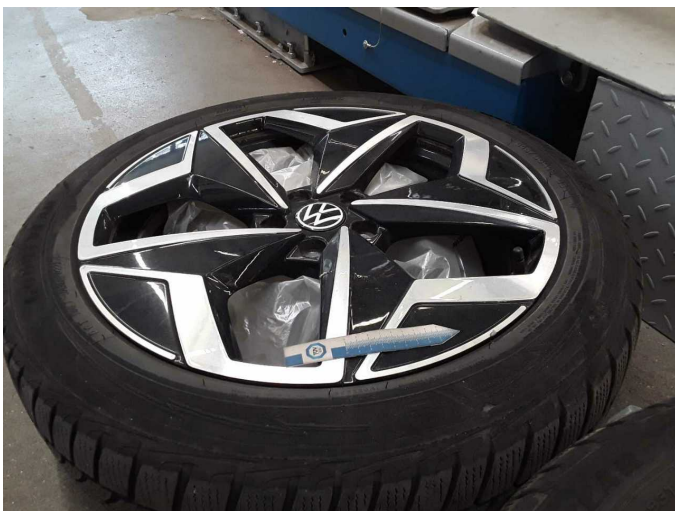
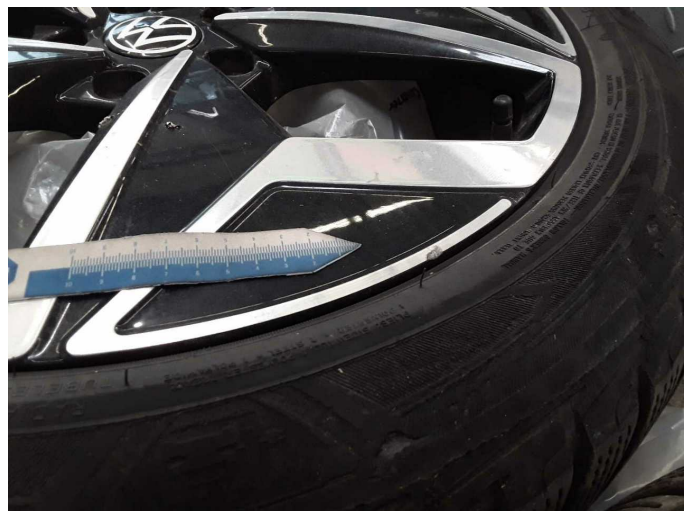
| No. | Component group | Description |
|---|---|---|
| 4 | 2nd wheel set | 2 alloy rims - Scratch(es) - Loss in value |

**Damage 4:** 2nd wheel set: 2 alloy rims - Scratch(es) - Loss in value

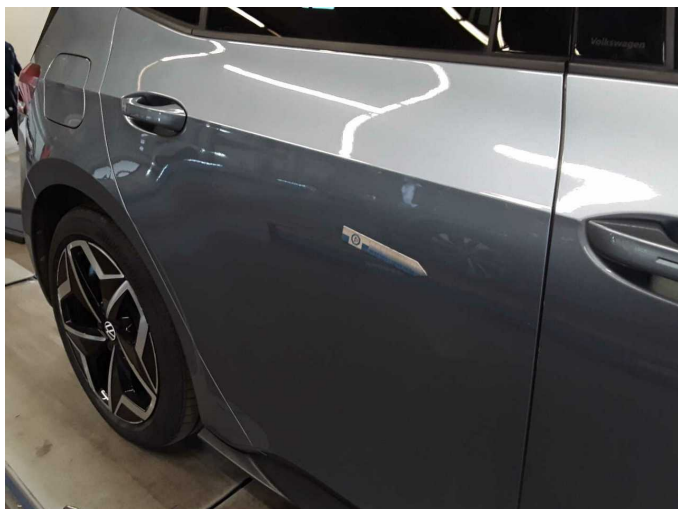
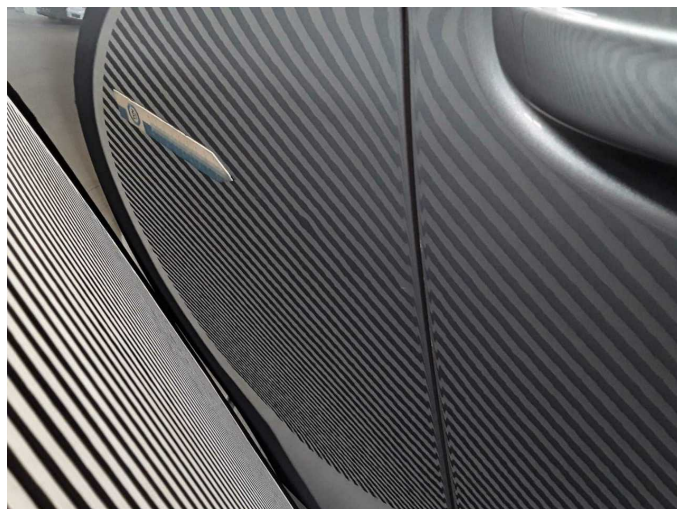
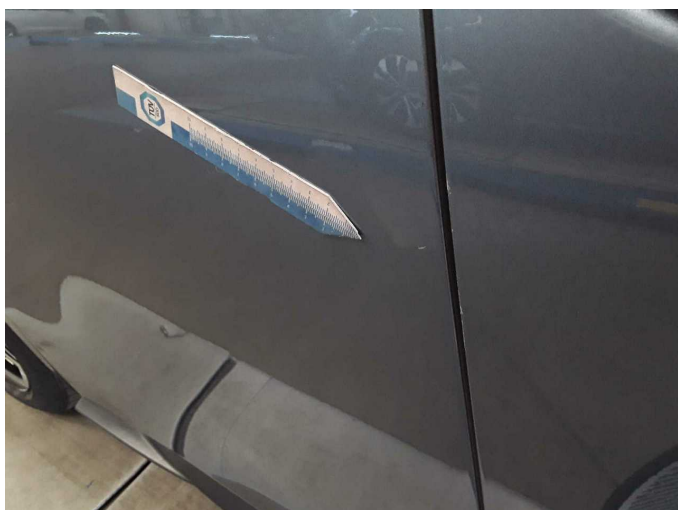
| No. | Component group | Description |
|---|---|---|
| 5 | Door - rear right side | Door - Dent / paintcoat damage - Repair and paint |

**Damage 5:** Door - rear right side: Door - Dent / paintcoat damage - Repair and paint

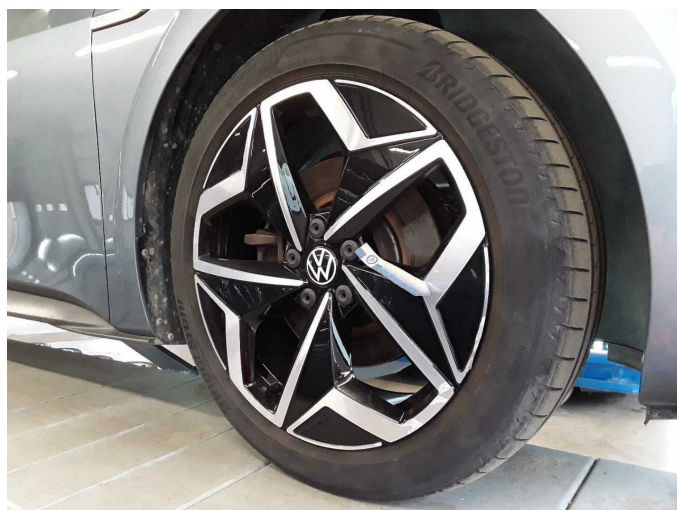
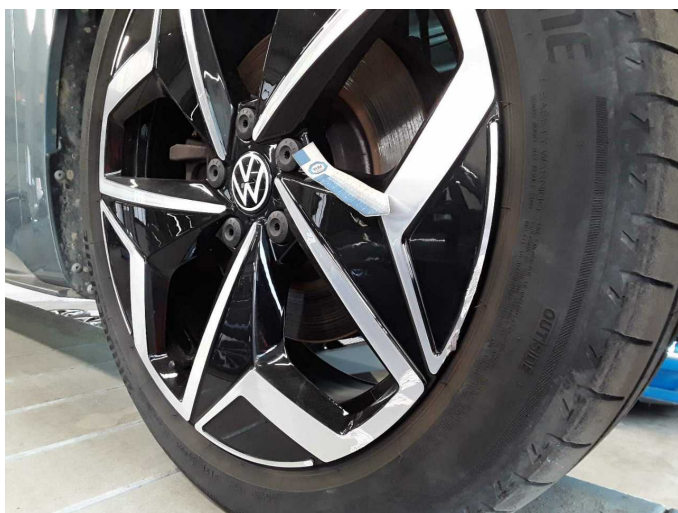
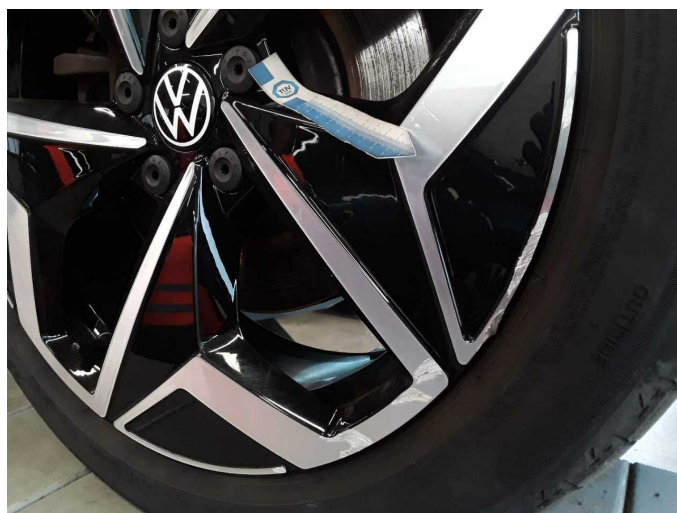
| No. | Component group | Description |
|---|---|---|
| 6 | Wheel / tyres | Alloy rim - front right side - Scratched - Replace |

**Damage 6:** Wheel / tyres: Alloy rim - front right side - Scratched - Replace

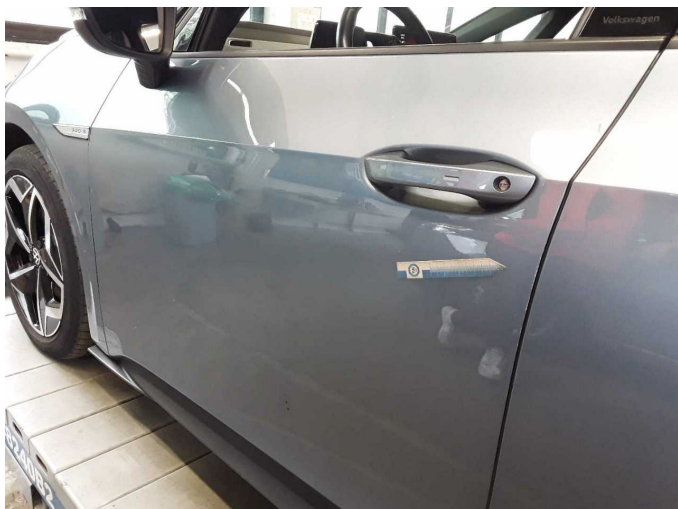
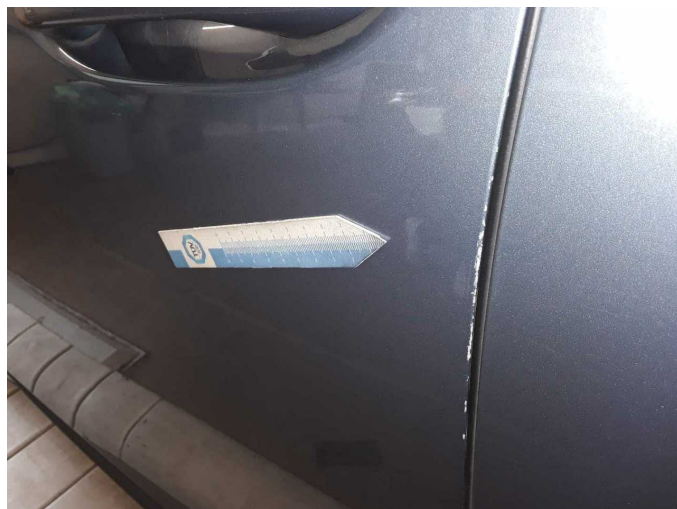
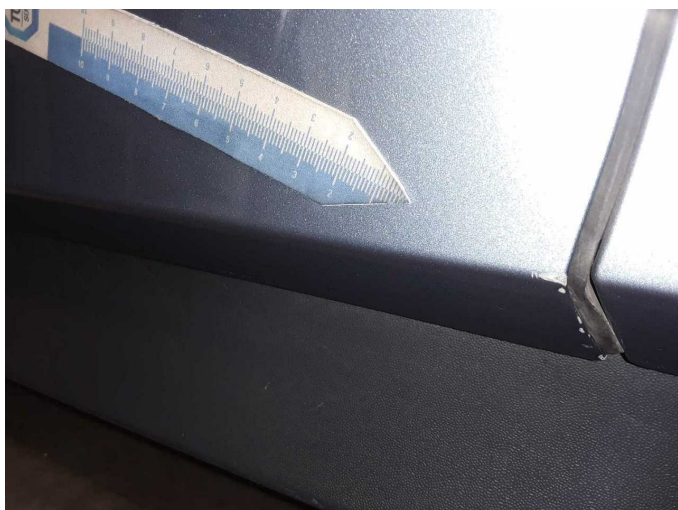
| No. | Component group | Description |
|---|---|---|
| 7 | Door - front left side | Door - Scratch(es) - Paint |

**Damage 7:** Door - front left side: Door - Scratch(es) - Paint

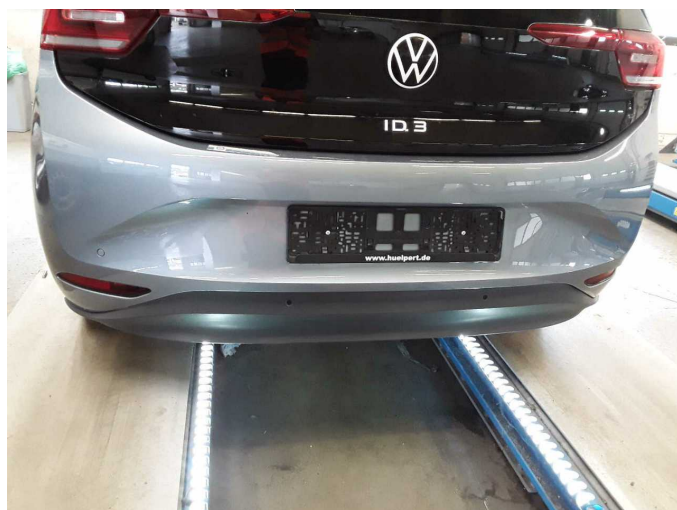
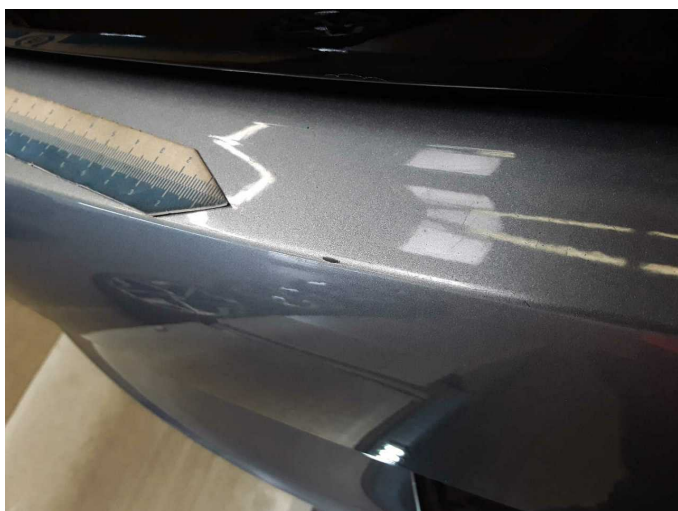
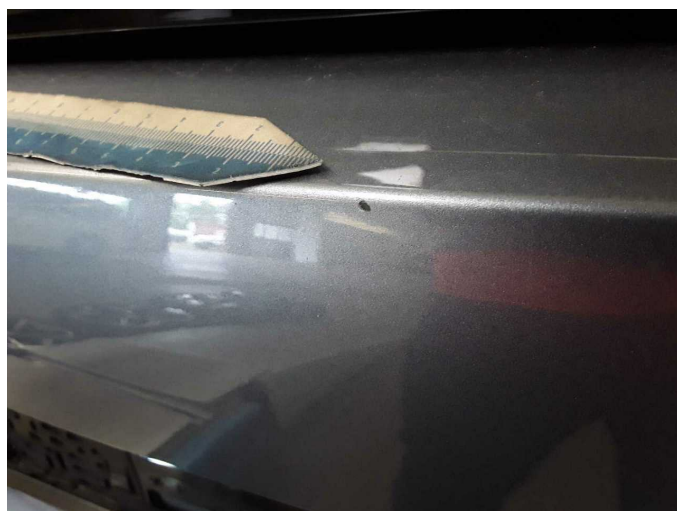
| No. | Component group | Description |
|---|---|---|
| 8 | Rear bumper | Rear bumper - Scratch(es) - Paint |

**Damage 8:** Rear bumper: Rear bumper - Scratch(es) - Paint

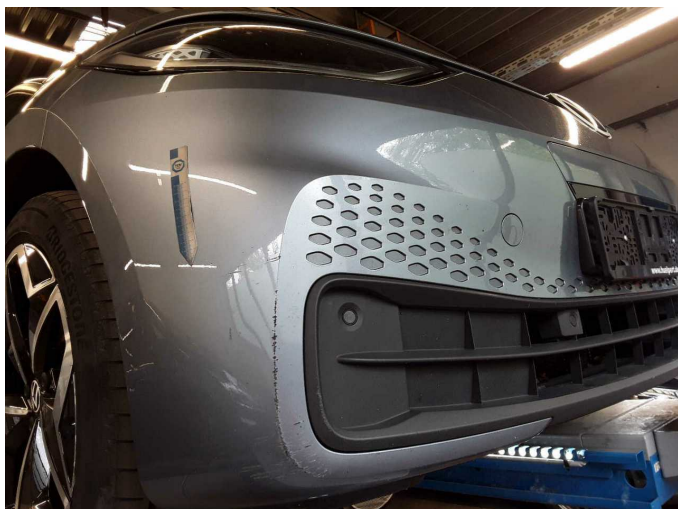
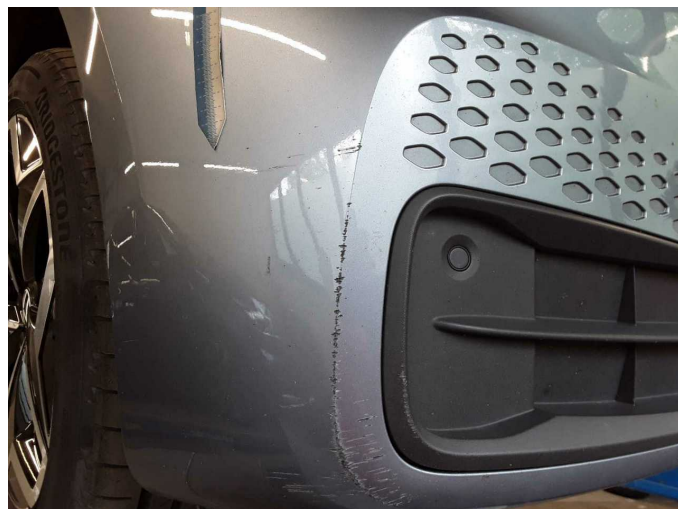
| No. | Component group | Description |
|---|---|---|
| 9 | Front bumper | Front bumper - Scratched - Paint |

**Damage 9:** Front bumper: Front bumper - Scratched - Paint

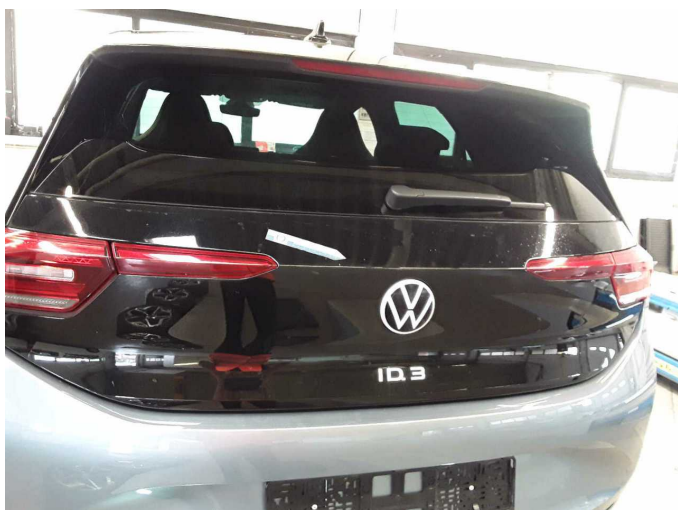
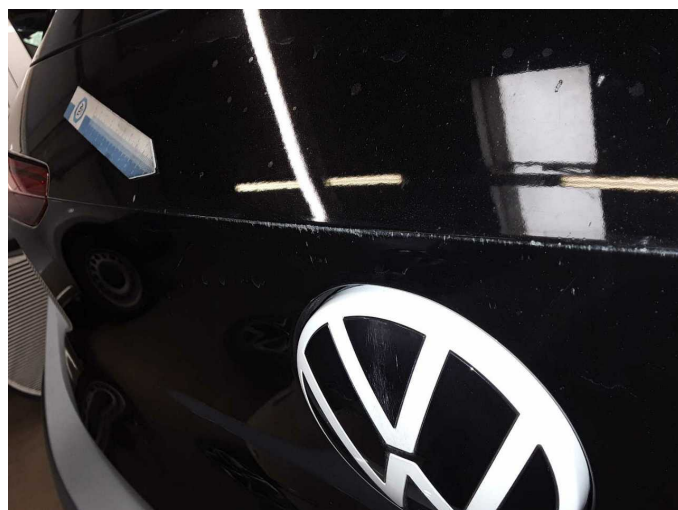
| No. | Component group | Description |
|---|---|---|
| 10 | Boot lid / rear door | Boot lid - Scratched - Paint |

**Damage 10:** Boot lid / rear door: Boot lid - Scratched - Paint

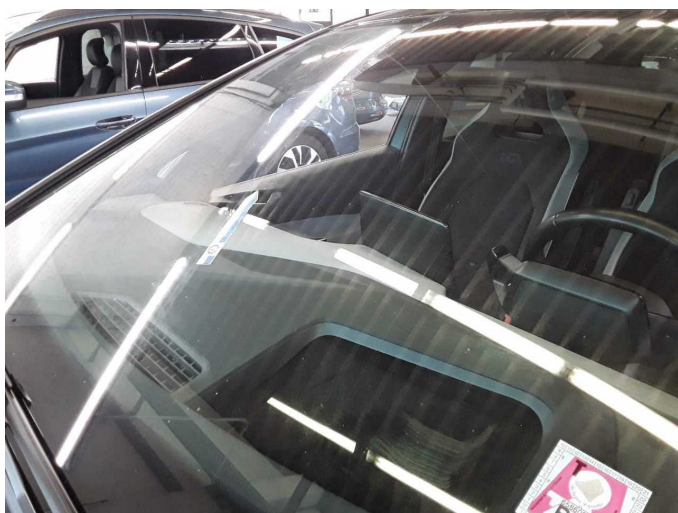
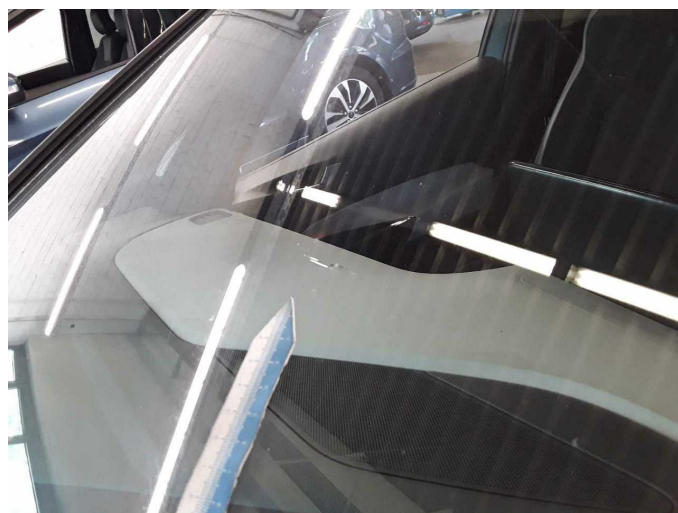
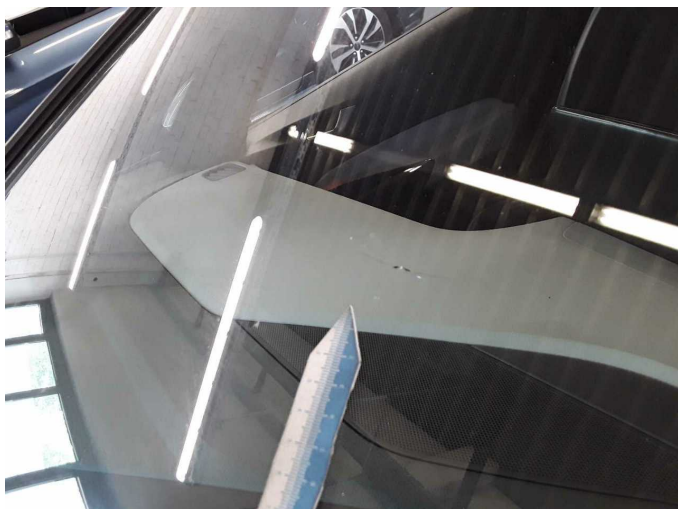
| No. | Component group | Description |
|---|---|---|
| 11 | Vehicle glazing | Windscreen (Rissbildung) - Stone chips - Replace |

**Damage 11:** Vehicle glazing: Windscreen (Rissbildung) - Stone chips - Replace

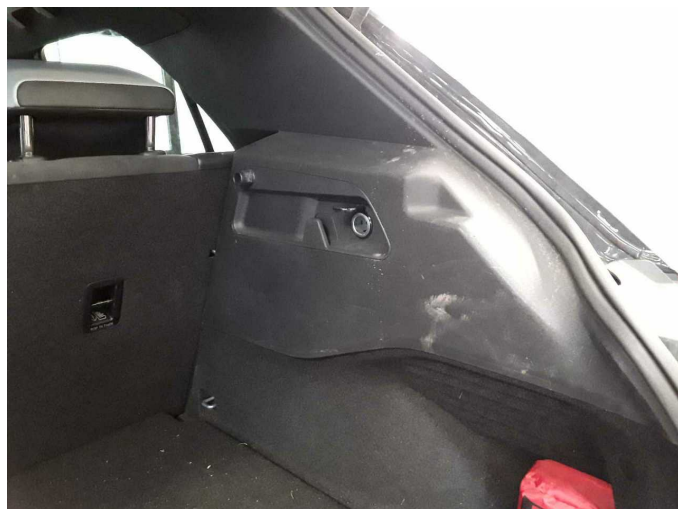
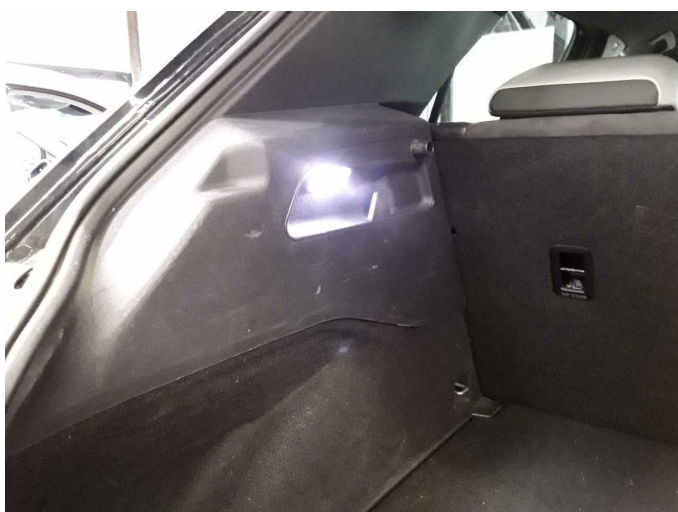
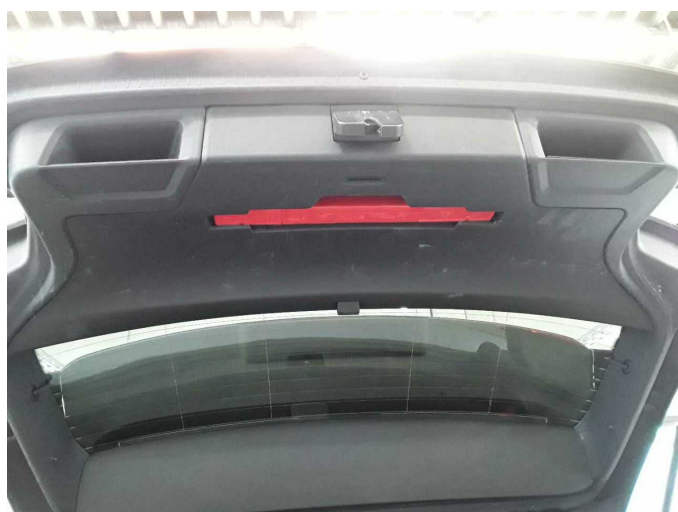
| No. | Component group | Description |
|---|---|---|
| 1 | Interior | Interior - Scratch(es) - No deduction |

The vehicle shows signs of wear and tear commensurate with its age and use.

**Wear and tear 1:** Interior: Interior - Scratch(es) - No deduction

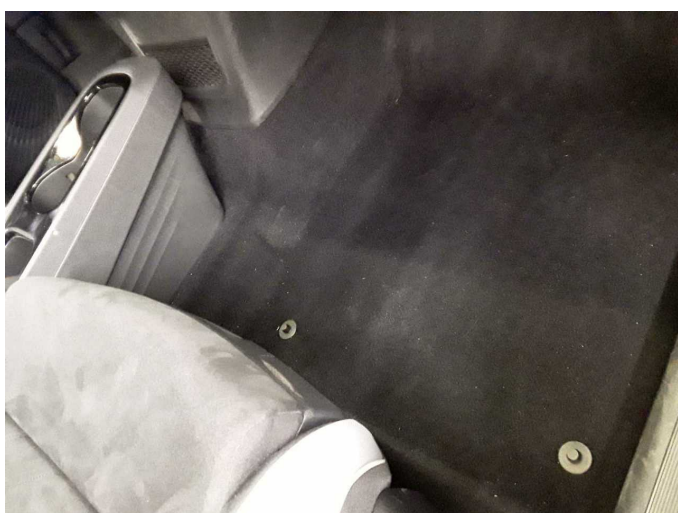
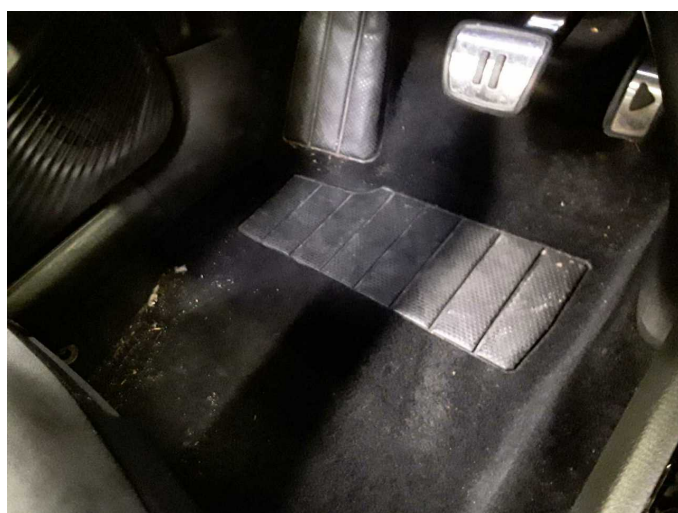
Trim / covers - Floor mats

**Missing part 1:** Trim / covers: Floor mats - Missing - Replace
